**Bat & Bird Survey Report**

**Sunny Bank Farm, Pen-y-bryn**

**Ref: 793B**

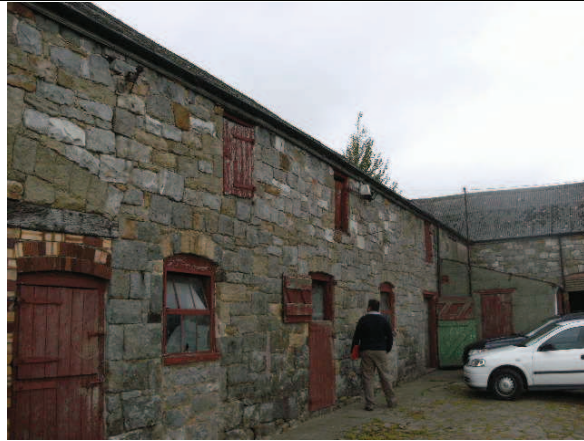
**Photograph 1 – Eastern side of barn**

The barn offers suitable roosting opportunities for bats species, particularly crevice dwelling species such as the Pipistrelles. Numerous holes and crevices suitable as roosting sites were identified within the exterior stonework of the barn. Gaps also exist around window and door lintels and frames. On the interior there are fewer crevices as the walls are generally well pointed. A timber fascia with a gap behind also extends along the edge of the roof. Potential exists for bats to roost behind this fascia.

During the dusk emergence survey in September 2010 five Common Pipistrelle (*Pipistrellus pipistrellus*) bats were recorded emerging from the eastern side of the building. The bats appeared to come from behind a window lintel or part of the fascia on this side of the building (see photograph 5, Appendix 2). The first bat was recorded at 19.38 with the remaining four bats emerging from between 19.38 and 19.46.

During the dusk emergence survey in May 2011 a single Common Pipistrelle (*Pipistrellus pipistrellus*) bat was recorded emerging the fascia on the eastern side of the barn in close proximity to where bats were recorded emerging in 2010. The bat emerged at 21.12 and headed east away from the site. No other bats were recorded emerging from the building. At 21.32 a bat arrived on site from the south and foraged within the barn and over the adjacent courtyard for approximately 20 minutes before leaving the site to the north. This bat was recorded on the static bat detector inside the barn. The static detector did not record any other bats flying within the barn building.

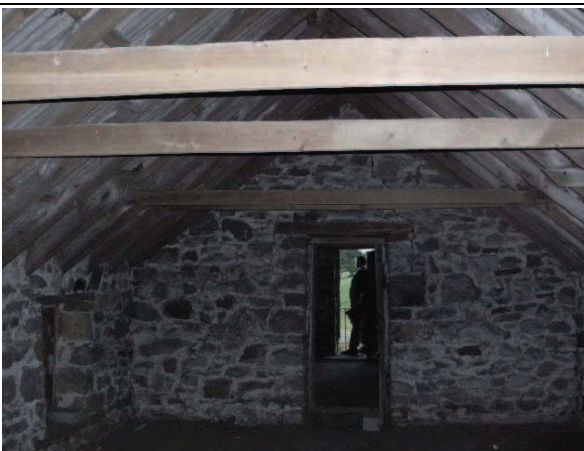
**Photograph 3 – Interior of first floor of barn**

Approximately 20 droppings characteristic of the Pipistrelle bat were found scattered on the interior of the barn during the daytime survey in September 2010. The droppings were not concentrated in any one location and could have been deposited by bats foraging within the barn. A similar scattering of droppings was found during the daytime survey in May 2011.

- 10.1 A number of old passerine nests were found in the barn building during the survey in September 2010. Old Swallow nests were also found throughout the barn building.
- 10.2 In May 2011 a number of active Swallow nests and other common passerine nests were identified within the barn.

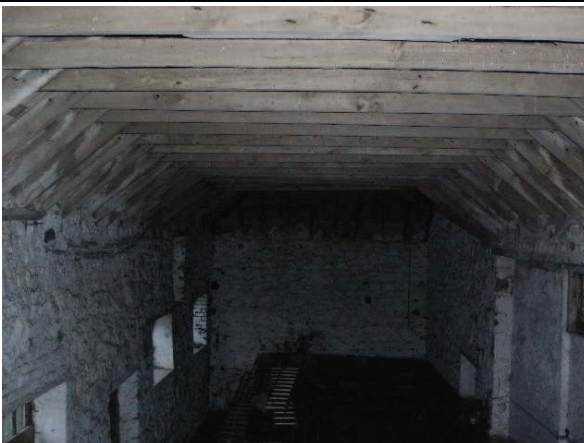
**Photograph 4 – Interior of central section of barn**

The large unobstructed roof space of the building has suitability for species such as the Brown long-eared bat which fly within the roost.
