## **PROTECTED SPECIES SURVEY**

**35 HALL STREET**

**PEN Y CAE**

**2<sup>nd</sup> February 2012**

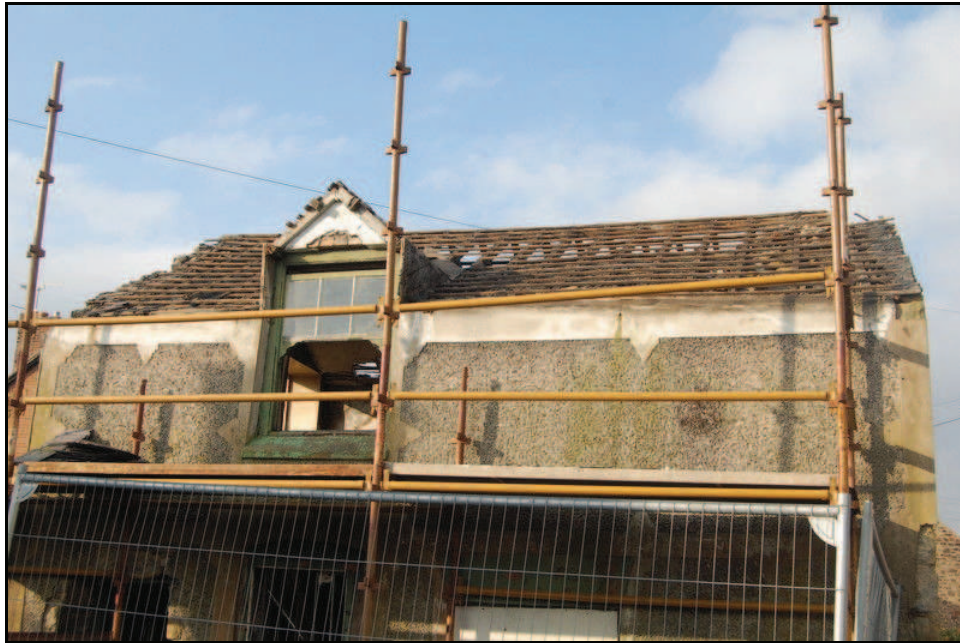
### 1. Front elevation

The focus of this report is the attached cottages which are constructed in a traditional manner adopting load bearing stone walls, supporting a pitched timber framed although the slates are missing exposing the roof and interior areas. Recent storm damage rendered the property unsafe hence the removal of the remaining areas of roof tiles.

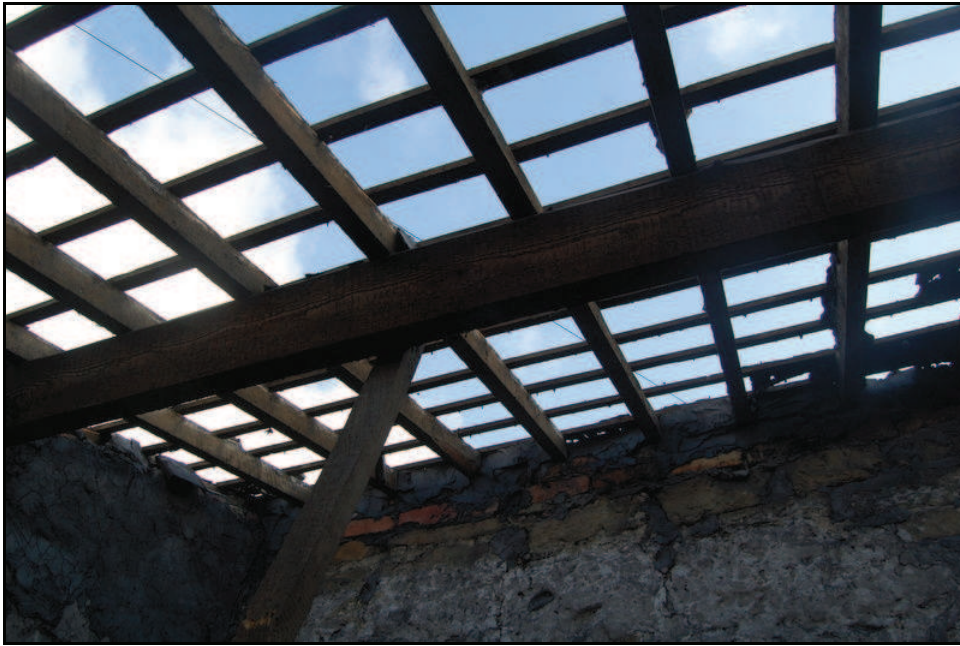
## 5. Interior view of the roof area

No evidence of bats was found anywhere inside or outside of the building. No droppings were apparent on the floor, roof and wall areas and there were no signs of feeding perches. As discussed the property is completely open to the elements because the roof tiles have been removed following recent storm damage.

In its current condition the property has a very low potential to support bats because there are no suitable areas for roosting. The roof areas are open completely exposing the interior and damp is prevalent throughout and all areas are completely light with a high level of airflow.

- **All remaining roof timbers should be removed by hand to ensure that no torpid or hibernating bats are injured during the proposed works.**
- **Door and window frames should be removed with care to ensure that no torpid or hibernating bats are injured during the proposed works.**
- **Structural members, lintel bearings, purlins or wall plates should be removed with care to ensure that no torpid or hibernating bats are injured during the proposed works.**
- **In the event that bats were found then all work should cease and CCW (Mold office) and/or a licensed bat worker should be contacted for further advice.**

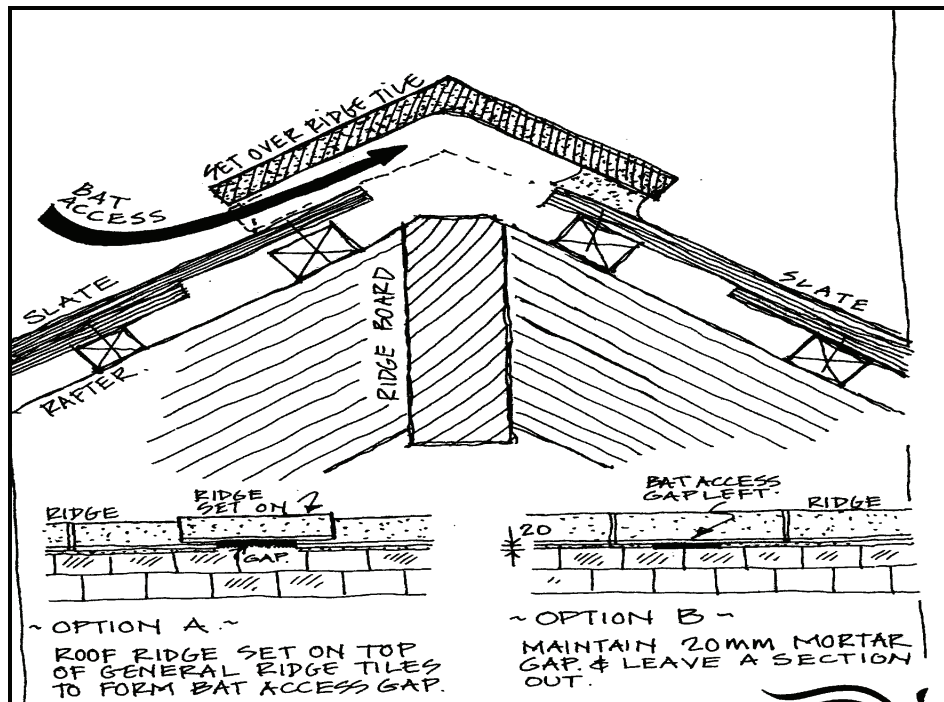
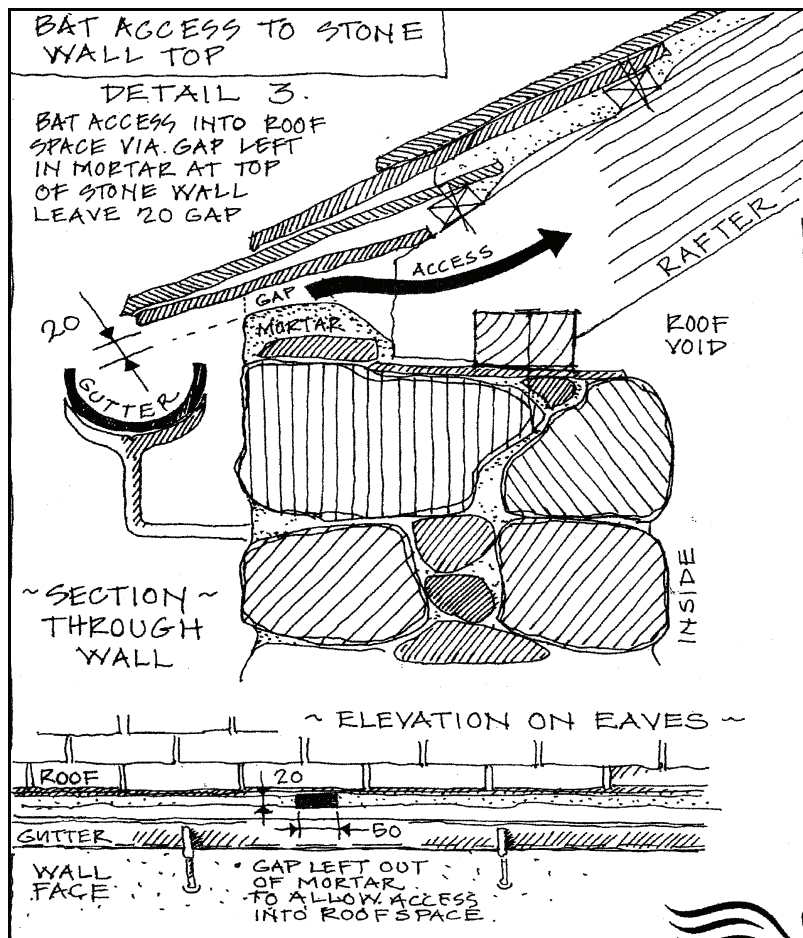
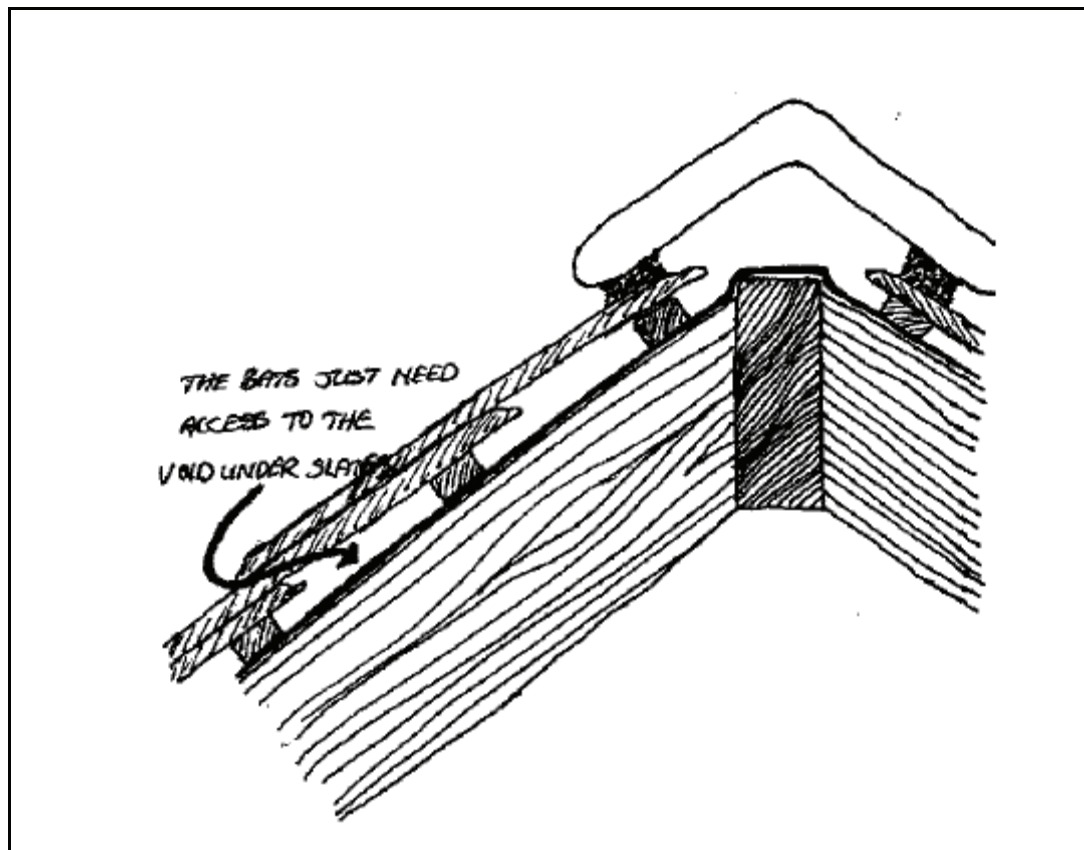
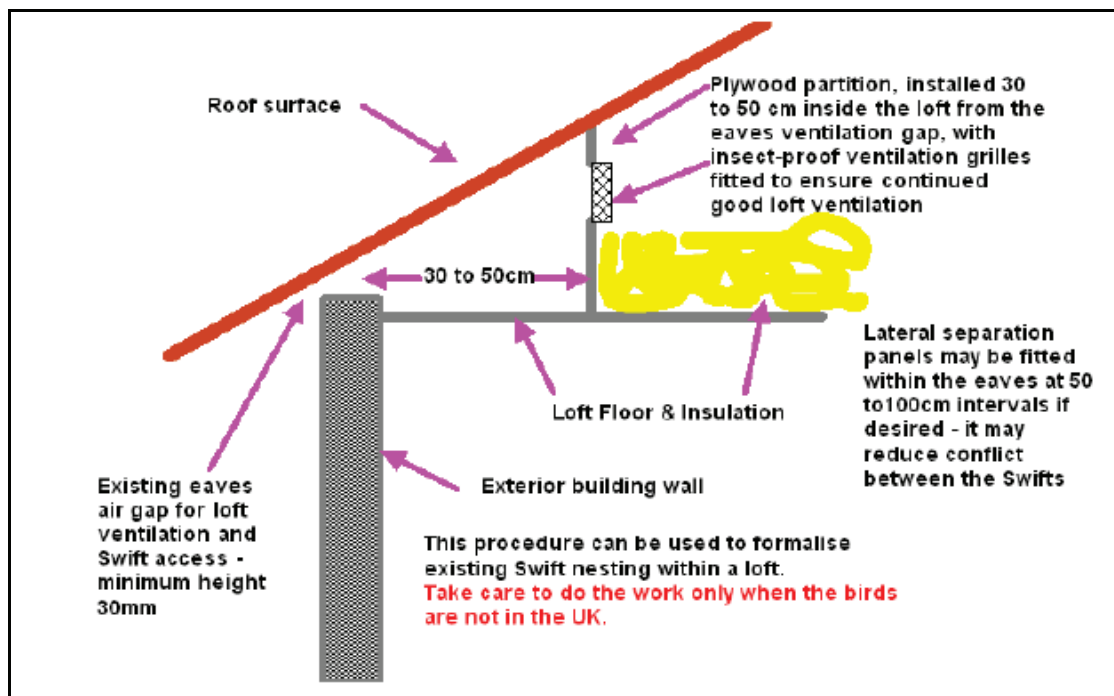
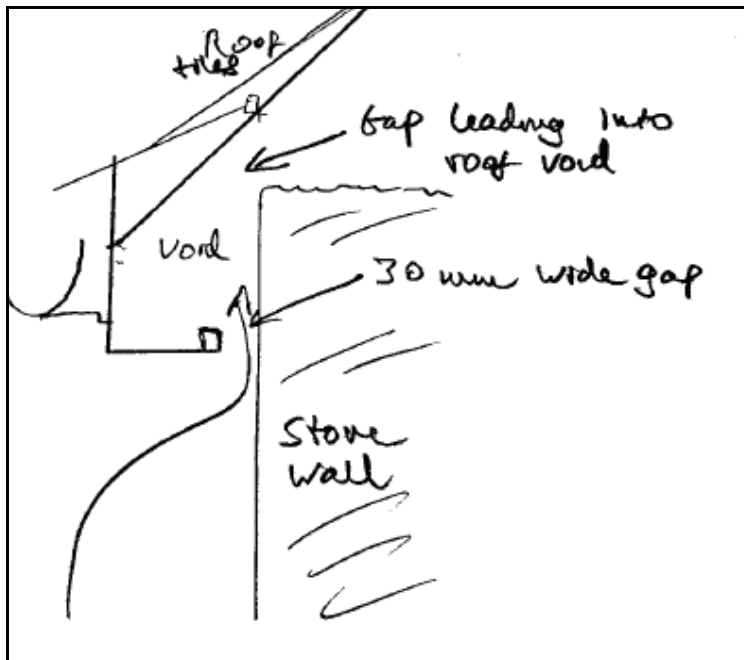
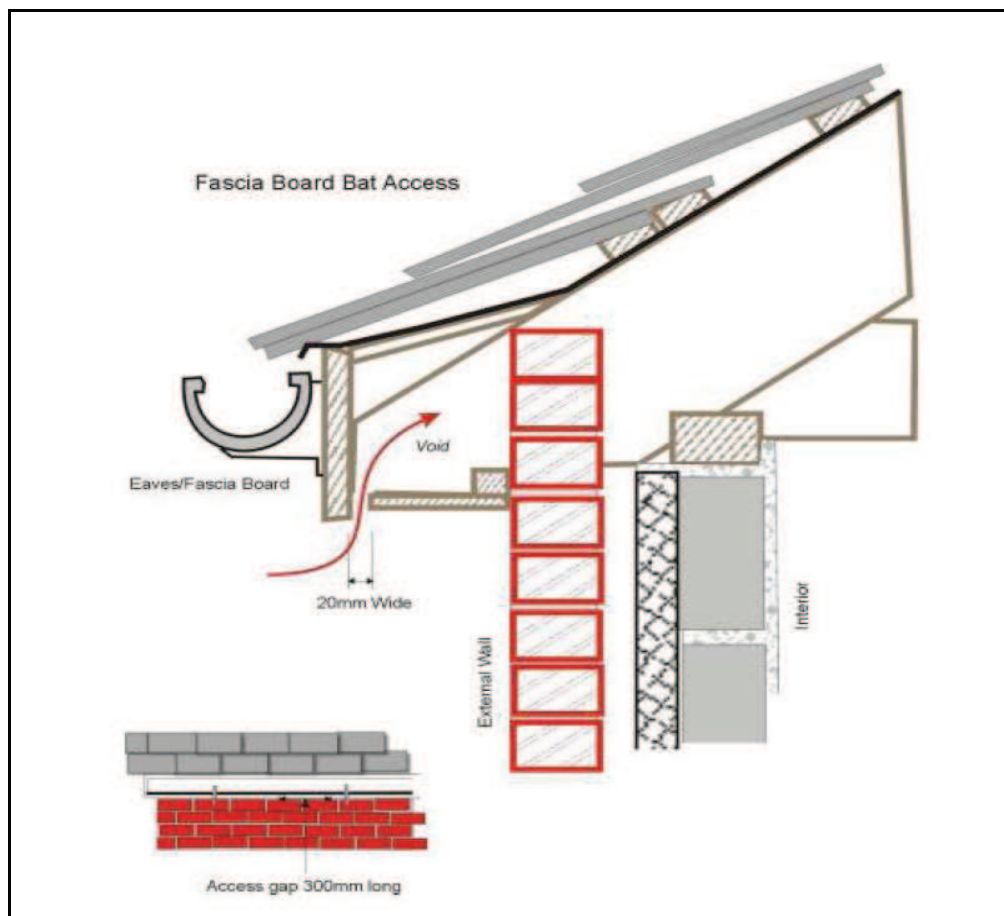
### Appendix 3 – Bat mitigation

A backing board can be used to prevent access into the roof void/living area if desired.

- Use traditional bitumen roofing felt rather than plastic membrane which bats have difficulty clinging onto.
- Install two or three of the ridge tiles using option A or B in the attached example to allow bats access to the spaces below the tiles.
- Permit access under the eaves to the gap along the top of the walls above the wall plate or access under timber fascia boards at the gable ends (20-30mm gap).
- If boxed soffits are proposed then slits can be cut as shown in the drawings below.
- Ensure any timber treatment is undertaken using chemicals shown to be safe for bats.
- Ensure any external lighting is low level and directional towards the ground.
