## Appendix 10.1: Phase I Geoenvironmental Site Assessment

### Land at Lower Berse Farm, Wrexham

Phase I Geoenvironmental Site Assessment  
Ruthin Road, Wrexham

Reference: 14-854-R3-Rev E  
Date: June 2024

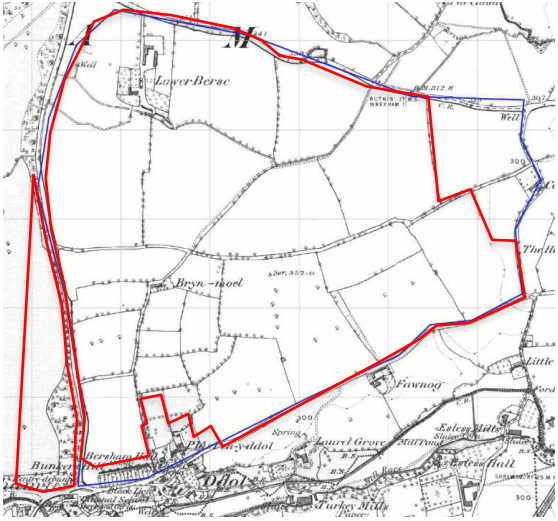
| MAP EDITION | HISTORICAL LAND USE | HISTORICAL MAP EXCERPT |
|---|---|---|
| 1872<br>1:10,560 | <p>Lower Berse Farm and Bryn-Moel are both already constructed in the north and centre of the site.</p> <p>The area is split up into agricultural land with numerous field boundaries. A wooded area is shown in the western sector.</p> <p>There is a road running through the centre of the site and a branch leading south that feeds Bryn-Moel. A footpath is marked through the centre of the site.</p> <p>A well is recorded on-site in the northwest. A pond is present to the south of Lower Berse Farm leading to a drain and two further ponds are present in the south of the site.</p> | |

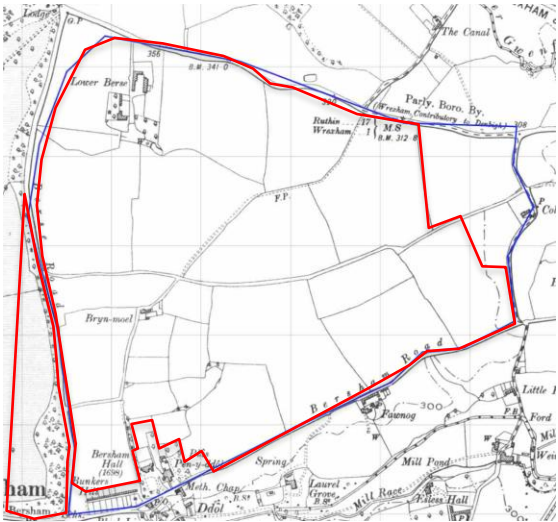
| MAP EDITION | HISTORICAL LAND USE | HISTORICAL MAP EXCERPT |
|---|---|---|
| 1898-1900<br>1:10,560 | <p>The well in the northwest is no longer marked and a well is now recorded to the south of Lower Berse Farm.</p> <p>A field boundary in the southwest is no longer present and the small ponds in the south are no longer shown.</p> | |

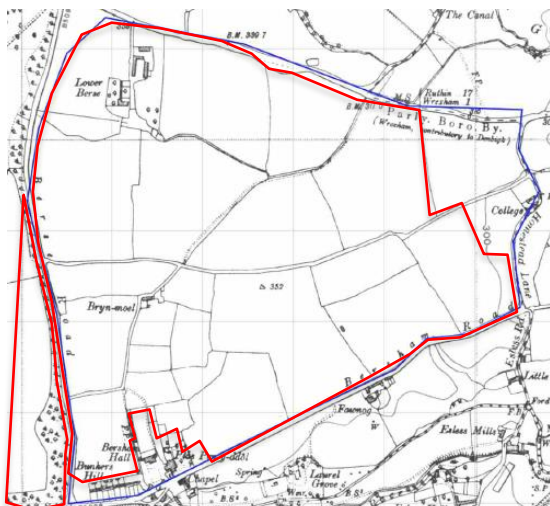
| MAP EDITION | HISTORICAL LAND USE | HISTORICAL MAP EXCERPT |
|---|---|---|
| <p><b>1938</b><br/><b>1:10,560</b></p> | <p>A small pond is shown in the central southern sector. The well is no longer marked.</p> <p>A footpath is present east of Bersham Hall.</p> <p>There are no further changes.</p> | |

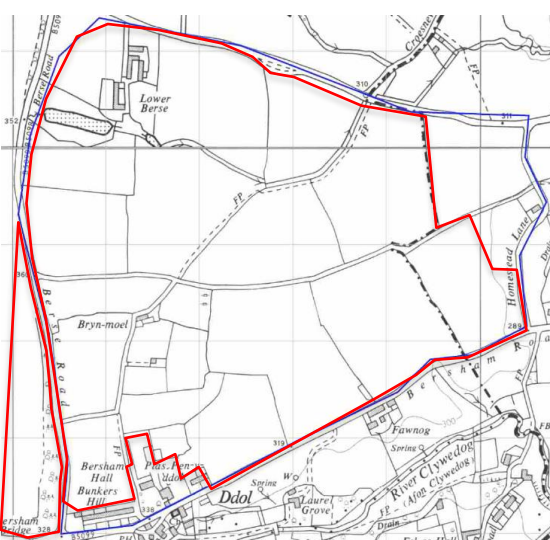
| MAP EDITION | HISTORICAL LAND USE | HISTORICAL MAP EXCERPT |
|---|---|---|
| <p><b>1964</b><br/><b>1:10,560</b></p> | <p>A large pond is shown to the southwest of Lower Berse Farm. The small pond in the central southern sector is no longer shown.</p> <p>A field boundary has been added in the northwest and a field boundary has been removed in the southeast.</p> | |

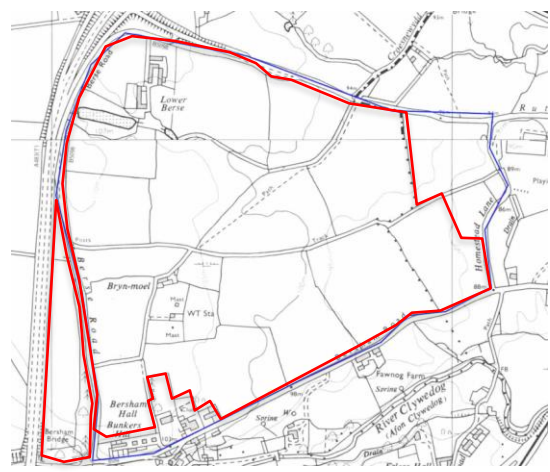
| MAP EDITION | HISTORICAL LAND USE | HISTORICAL MAP EXCERPT |
|---|---|---|
| <p><b>1974-1979</b><br/><b>1:10,560</b></p> | <p>A wireless electricity station has been constructed next to Bryn-Moel. Two masts are shown.</p> <p>A field boundary in the southwest has been removed.</p> | |

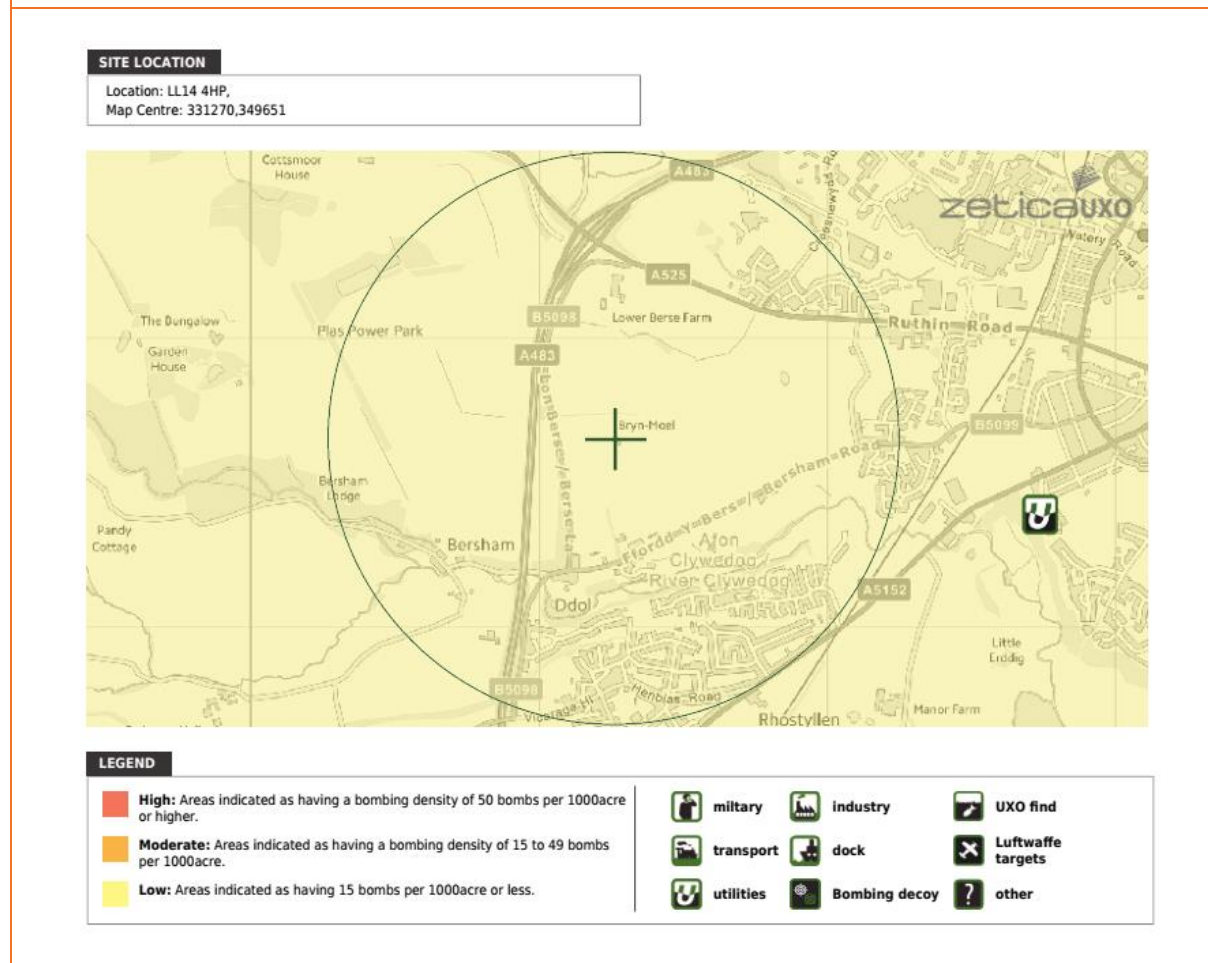
FIGURE 5.1 ZETICA UXO RISK MAP

The regional unexploded bomb risk map from Zetica (2014) indicates that the site is in an area at low risk from possible unexploded ordnance (UXO) resulting from the Second World War. The Zetica UXO Risk Map is presented as Figure 5.1. No further assessment is required.
