## PRELIMINARY BAT ROOST ASSESSMENT

### PINE RIDGE

**Project name:** Pine Ridge, Pitsyll Hill, Marford, Wrexham, LL12 8LE

**Date:** 08/03/2022

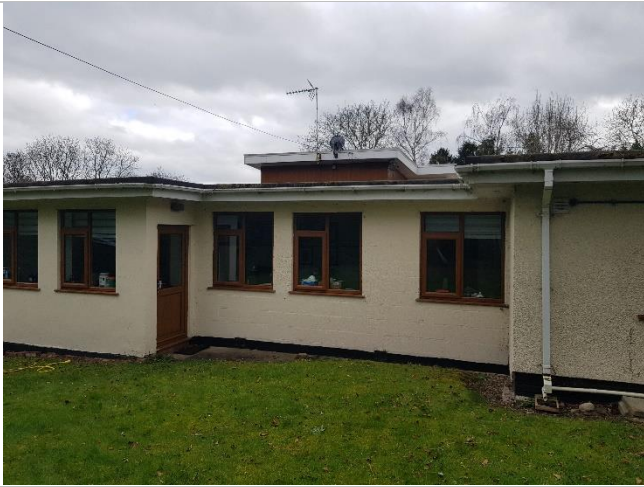
Area of the house to be extended (NW).

The proposals will include a small extension at the north-west elevation, creation of pitched roof areas and internal alterations.

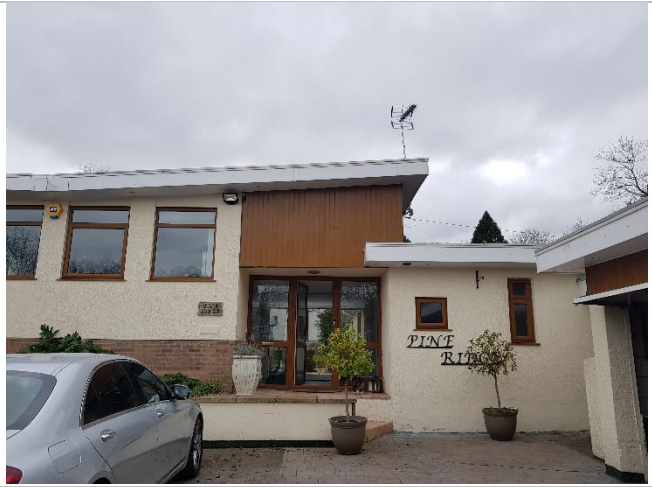
The small roof void above the entrance porch was inspected thoroughly and there was no evidence of bats within nor any potential access points.

Small roof void above entrance.

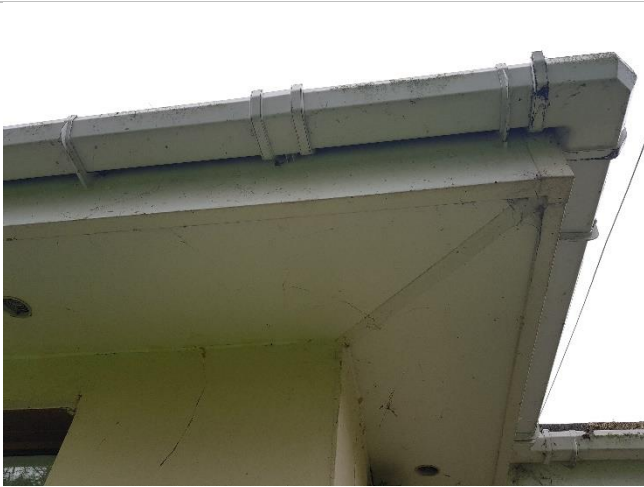
The roof is flat with gently sloping, inverted sections at the upper floor for drainage. Most of the roof is flat and covered with felt. The eaves of the property are boxed in with composite soffit and fascia boards which are tightly fitted to the building. There are gutters and down pipes fixed to these which are directed into covered drains.

The construction style of the property significantly reduces the likelihood of bats being able to use it for roosting. The flat roof is in good condition and the eaves of the building are boxed in with tight-fitting composite soffit and fascia boards. The elevations are mainly rendered offering no external roosting opportunities and where timber cladding is present it is modern and fits together with no gaps or crevices present.

Eaves detail.

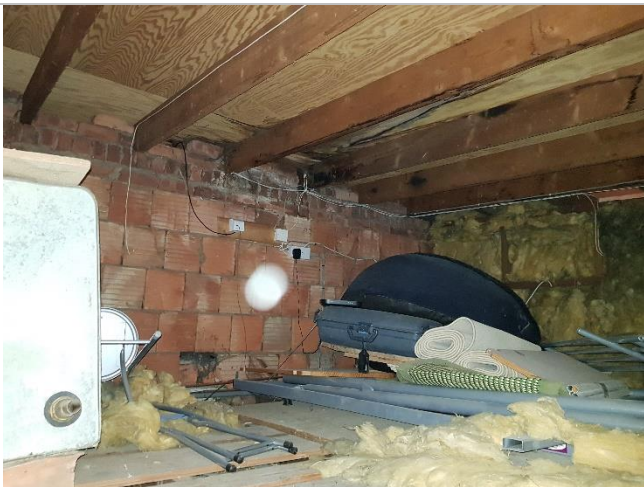
There is single roof void present about the entrance hall of the house which is accessed via a large hatch within. The space is insulated with some boarding to the floor and exposed, modern beams.

Interior of roof void.

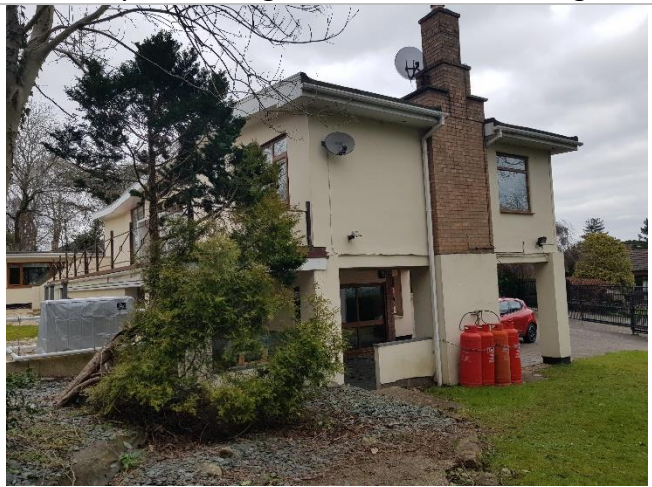
The property is a detached modern construction layered over three storeys. The elevations are mostly rendered with some small areas of timber tongue and groove cladding fitted as features. Some brickwork remains exposed around the base of the house and on the chimney stack. There are numerous composite doors and windows of UPVC in place.

South-east elevation.
