Site Investigation Report  
for land at  
Cwrt Pentwmpath,  
Llay

For: Castlemead Group Limited  
Abenbury House  
17 Wilkinson Business Park  
Clywedog Road South  
Wrexham  
LL13 9AE

21<sup>st</sup> December 2022

| <b>Document Number</b> | 7962si |

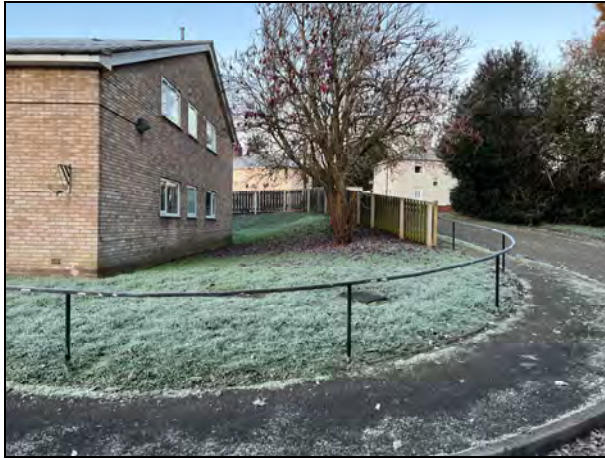
*Photograph 1: View to the north showing site access road and east end of current apartment block*

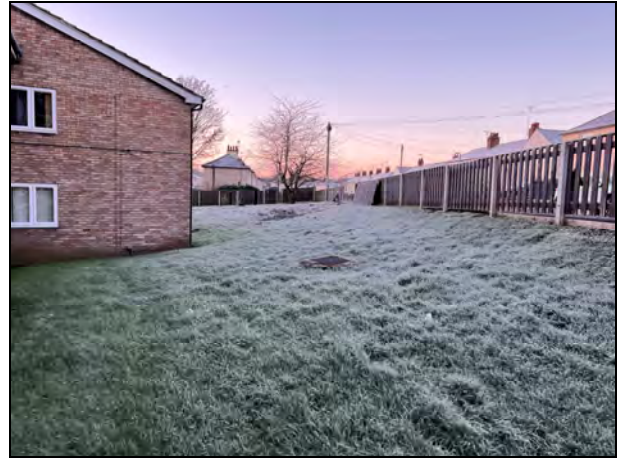
*Photograph 2: View to the south west along the front of the apartment blocks, with slope up to Eighth Avenue and telegraph pole/overhead BT lines in west corner of site*

A BT telegraph pole was located on the western site boundary with overhead wires extended across the western part of the site to the buildings (see Photograph 2). A street light was present in the far west corner and far north corner of the site and a further light was located adjacent to the car park. Manholes for soakaways were observed in the east of the site.

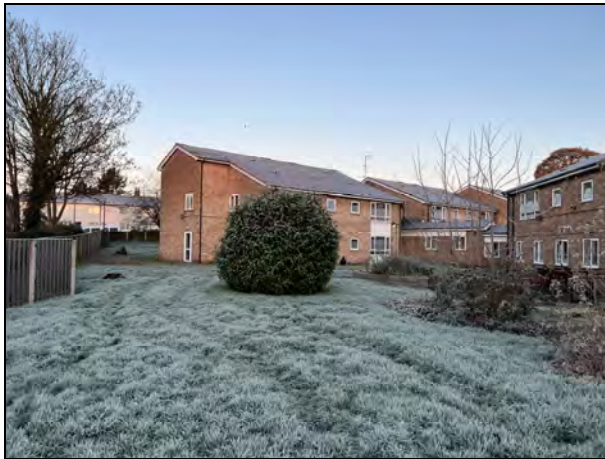
*Photograph 3: View to the north west*

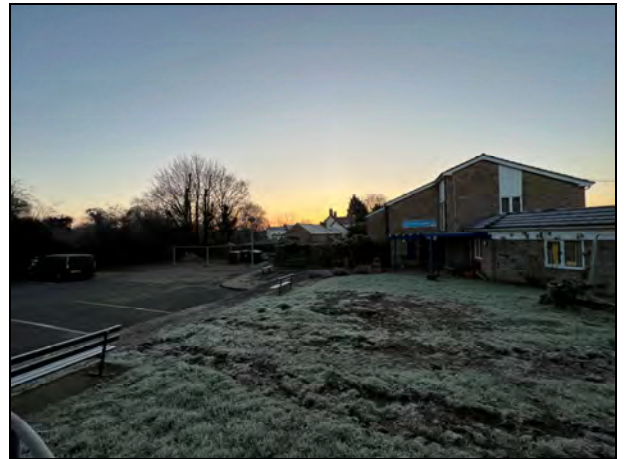
*Photograph 4: View to the south east across the current car park*

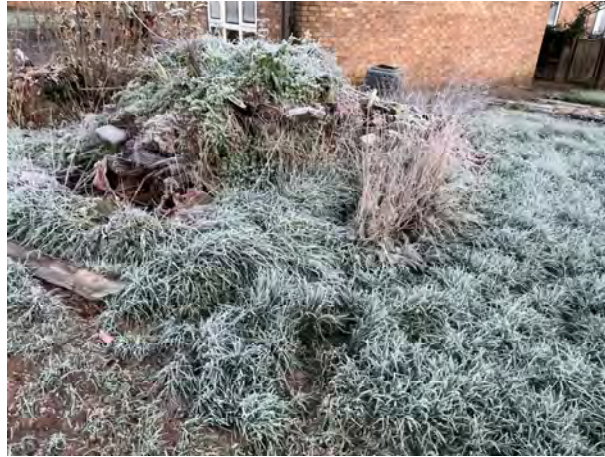
*Photograph 5: Waste heap in west of site*

The site sloped down from the north at approximately 80m above Ordnance Datum (aOD) to 77m aOD in the south. It also sloped down from approximately 78.5m aOD in the far west of the site to 76.5m aOD in the east of the site. The main decrease in site levels was noted to be in the northern half of the site, with a bank falling by approximately 1m over approximately 3m distance to the west and north of the building in the west of the site.

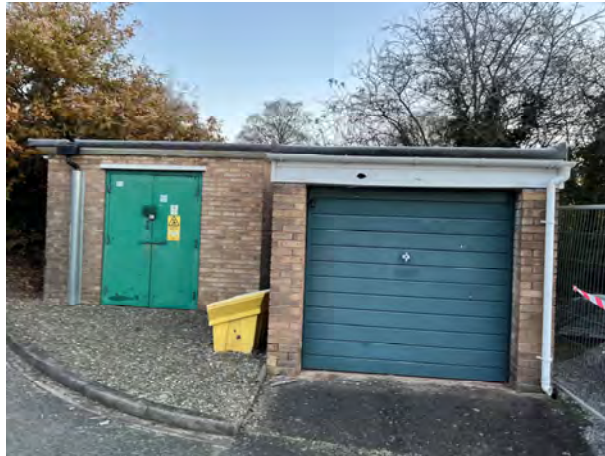
*Photograph 6: View to the north west*

An electrical sub-station was located immediately next to the garage (see Photograph 6) and backing onto the central part of eastern boundary. A coarse limestone gravel, clear of vegetation, was present around the sub-station with turf beyond the gravel surround to the northern side. No evidence of possible contamination was observed around the outside of the sub-station.

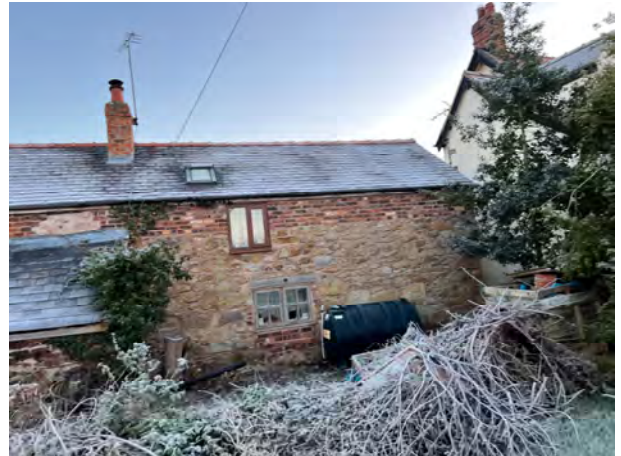
*Photograph 7: View to the south east across the current car park*

As shown in Drawing No. 7962/AP, presented in Appendix 16, the site was bounded by Eighth Avenue to the north west and a public footpath to the south west, with residential properties beyond to the north, west and south of the site. A field was located adjacent to the north east of the site. An above ground domestic kerosene fuel tank was noted adjacent to the far south east corner of the site boundary, as shown in Photograph 7.

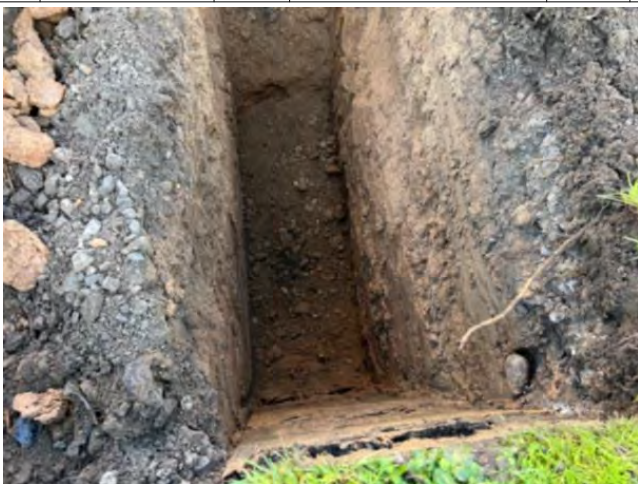
| 2.20 | B | | | | 2.10<br>(0.70) | Light brown, slightly silty, gravelly, fine to coarse (predominantly fine to medium) SAND. Moderate cobble content. Gravel is sub-angular to sub-rounded, fine to coarse of various lithologies. *Assumed as loose to medium dense. | | | | | | |
| | | | | | | Remarks<br><br>Location CAT scanned prior to excavation.<br>Spalling below 2.10m. Minor collapses below 2.50m.<br>Minor seepage at 0.90m during excavation.<br>*Based upon trenchside stability characteristics.<br>Please note that discolouration of photographs may occur when viewed on screen as a PDF, or when printed as a hard copy.<br>A shallow service was encountered on the east face of the trial pit. Moved over 1.00m to the west.<br>The service trended to the north east and comprised a hollow plastic pipe, approximately 100mm diameter.<br>Backfilled upon completion. | | | | | | |

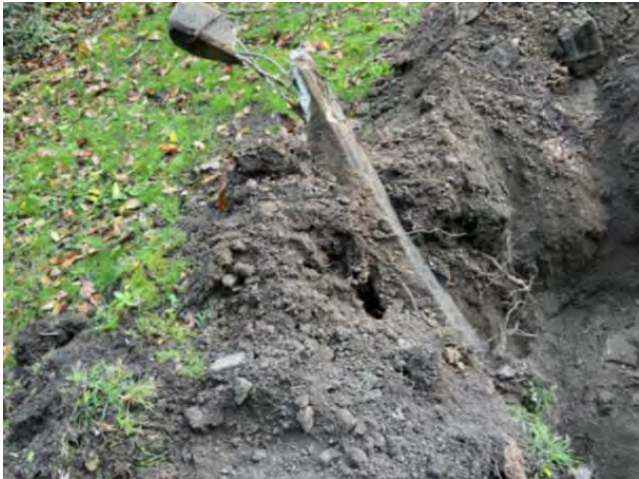
| 0.40<br>0.40 | B<br>JV | | | | (1.10) | MADEGROUND. Brown and grey, slightly gravelly, slightly clayey, fine to coarse SAND. Gravel is angular to sub-angular, fine to coarse of various lithologies including brick fragments and plastic. Low boulder content of concrete. | | | |
| | | | | | Remarks<br><br>Location CAT scanned prior to excavation.<br>Sides stable during excavation.<br>No groundwater encountered during excavation.<br>Please note that discolouration of photographs may occur when viewed on screen as a PDF, or when printed as a hard copy.<br>Trial pit terminated at 1.30m due to unknown obstruction. Obstruction was CAT scanned and returned a positive reading on radio mode.<br>Backfilled upon completion. | | | | |

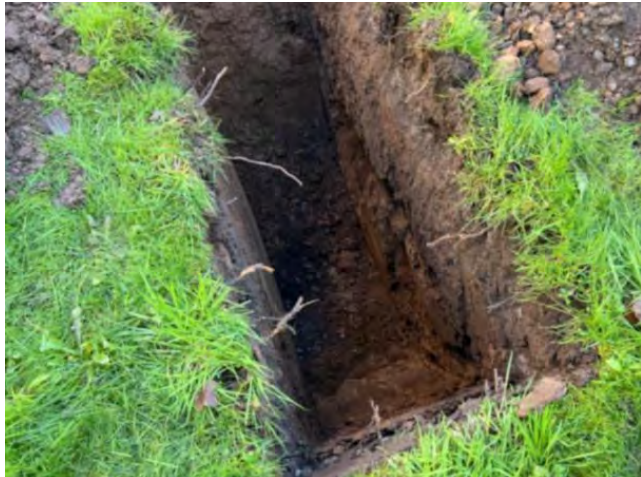
| 1.80 | B | | | | 1.70<br>(0.10)<br>1.80 | Light brown, slightly silty, very gravelly, fine to coarse (predominantly fine to medium) SAND. Gravel is sub-angular to sub-rounded, fine to coarse of various lithologies. *Assumed as loose to medium dense. | | | | |
| | | | | | | <b>Remarks</b><br><br>CAT scanned prior to excavation.<br>Minor spalling from 0.40 - 0.90m during excavation.<br>No groundwater encountered during excavation.<br>*Based upon trenchside stability characteristics.<br>Please note that discolouration of photographs may occur when viewed on screen as a PDF, or when printed as a hard copy.<br>Trial pit excavated to install infiltration test pit, therefore backfilled with single sized stone and slotted pipe. | | | | |

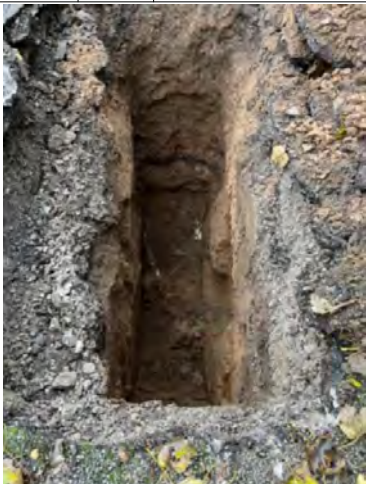
| | | | | | | CAT scanned prior to excavation.<br>Spalling from 0.50 - 1.00m. Minor collapses from 1.40 - 2.50m.<br>Minor seepage at 1.00m during excavation from running sand pocket.<br>*Based upon trenchside stability characteristics.<br>Please note that discolouration of photographs may occur when viewed on screen as a PDF, or when printed as a hard copy.<br>Trial pit excavated to install infiltration test pit, therefore backfilled with single sized stone and slotted pipe. | | | | | | |

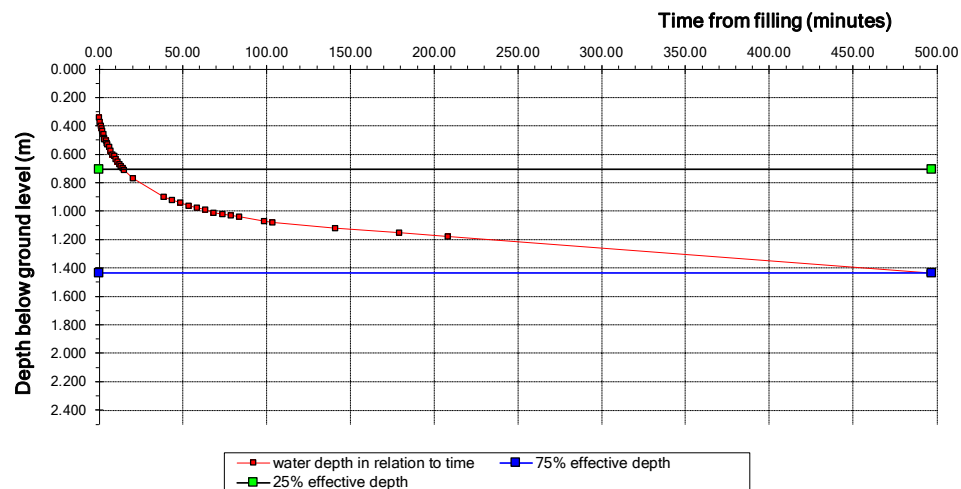
**INFILTRATION TEST PIT No 1 (Test 1 - Extrapolated Results)**

**Soil infiltration Rate****6.56E-03      m/hr****1.82E-06      m/sec**

| Potential Infiltration (Section 20.0) | The three infiltration test locations each failed on the first test, showing the shallow ground conditions would be unsuitable for permeable paving in the proposed car parking area. Infiltration rates at depth in the east of the site were very slow, currently indicating that a deep crate infiltration system would not be practicable. |

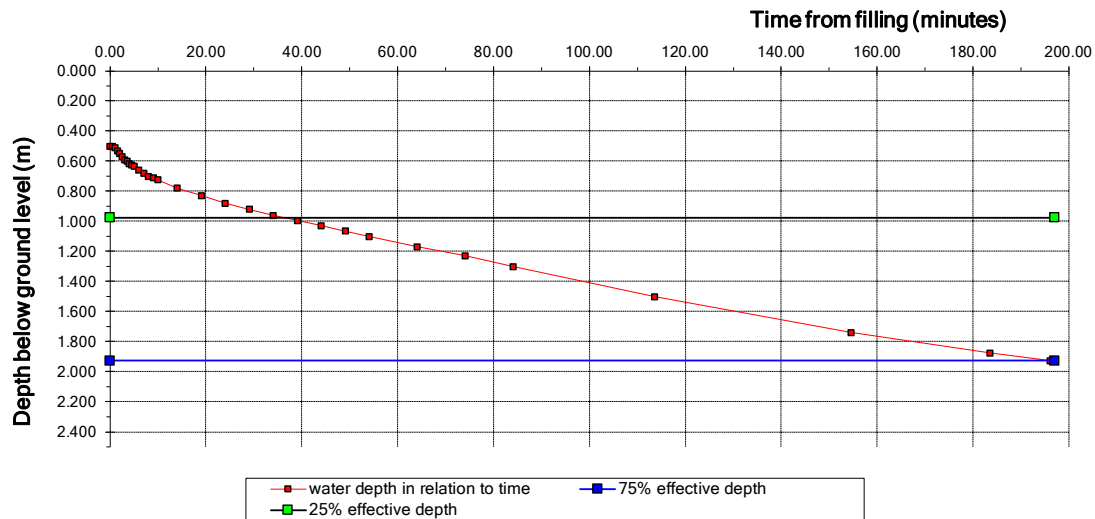
**INFILTRATION TEST PIT No 2 (Test 1)**

**Soil infiltration Rate****2.09E-02****m/hr****5.81E-06****m/sec**

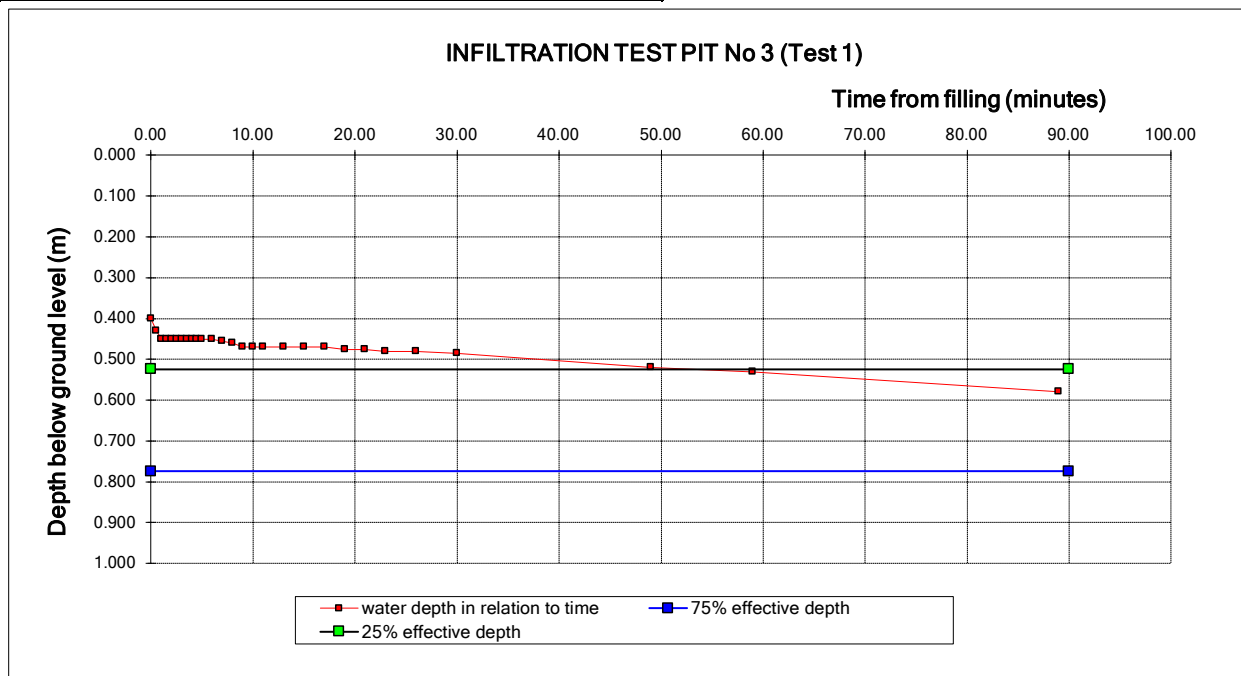
| Infiltration Parameters | |
|---|---|
| Time of Outflow | FAIL min |

| Soil infiltration Rate | N/A | m/hr |
