# **Nantyr Kennels**

## **Bat and Nesting Bird Assessment**

**Nantyr Kennels  
Nantyr  
Llangollen  
Denbighshire  
LL20 7DD**

**July 2023**

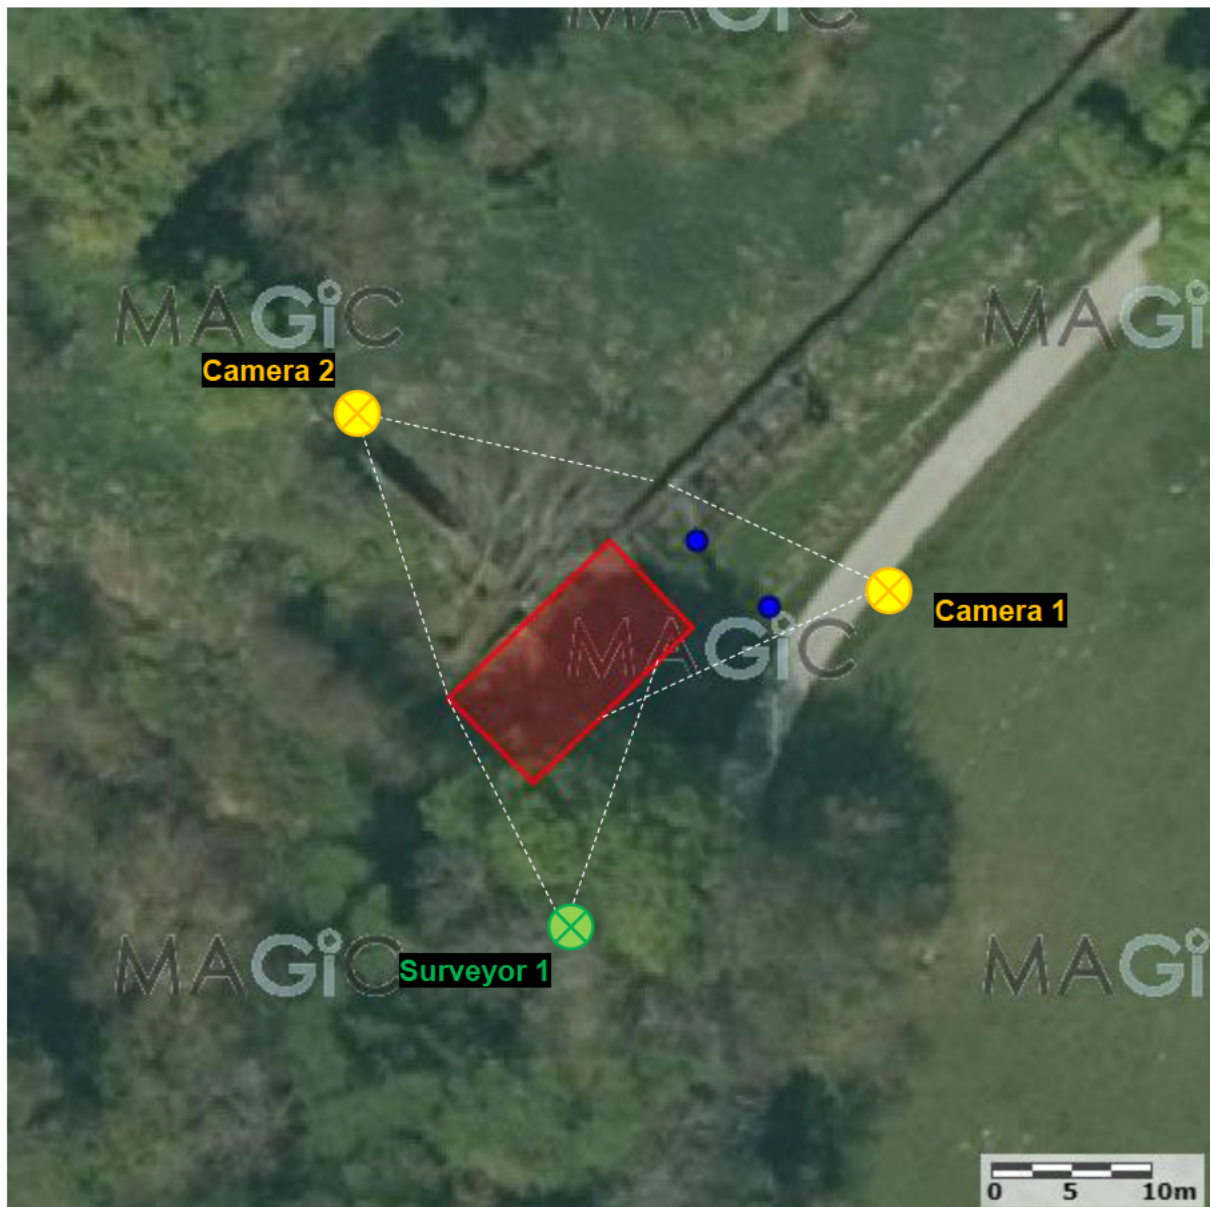
**Figure 2.1:** The positions of the surveyors/equipment during the activity survey. The building to be converted is shown in red. The entrances to the subterranean boiler room are shown in blue.

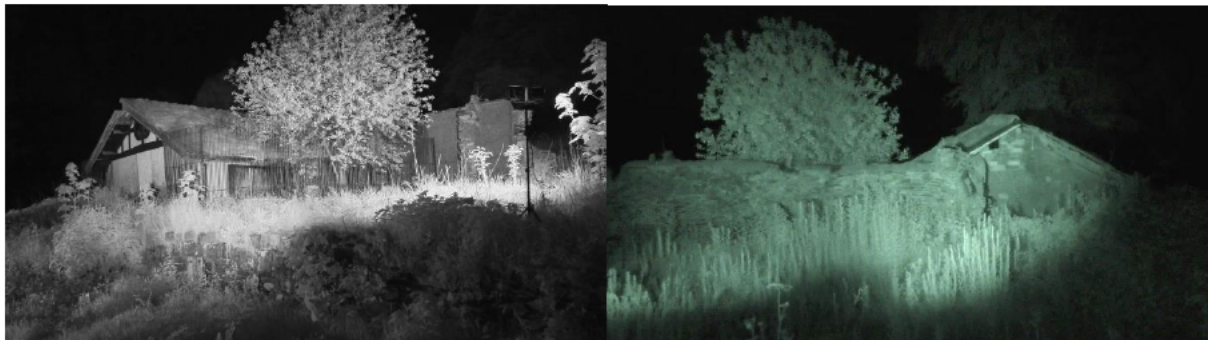
**Figure 2.2:** The field of view of each of the cameras used at the darkest part of the survey (Left: Camera 1 – the Canon XA50; Right: Camera 2 – the Panasonic HC-VX980EB-K. All footage was reviewed in real-time using the open-source PotPlayer software. All sonograms were manually reviewed using the SonoBat 30 UK bat call analysis software.

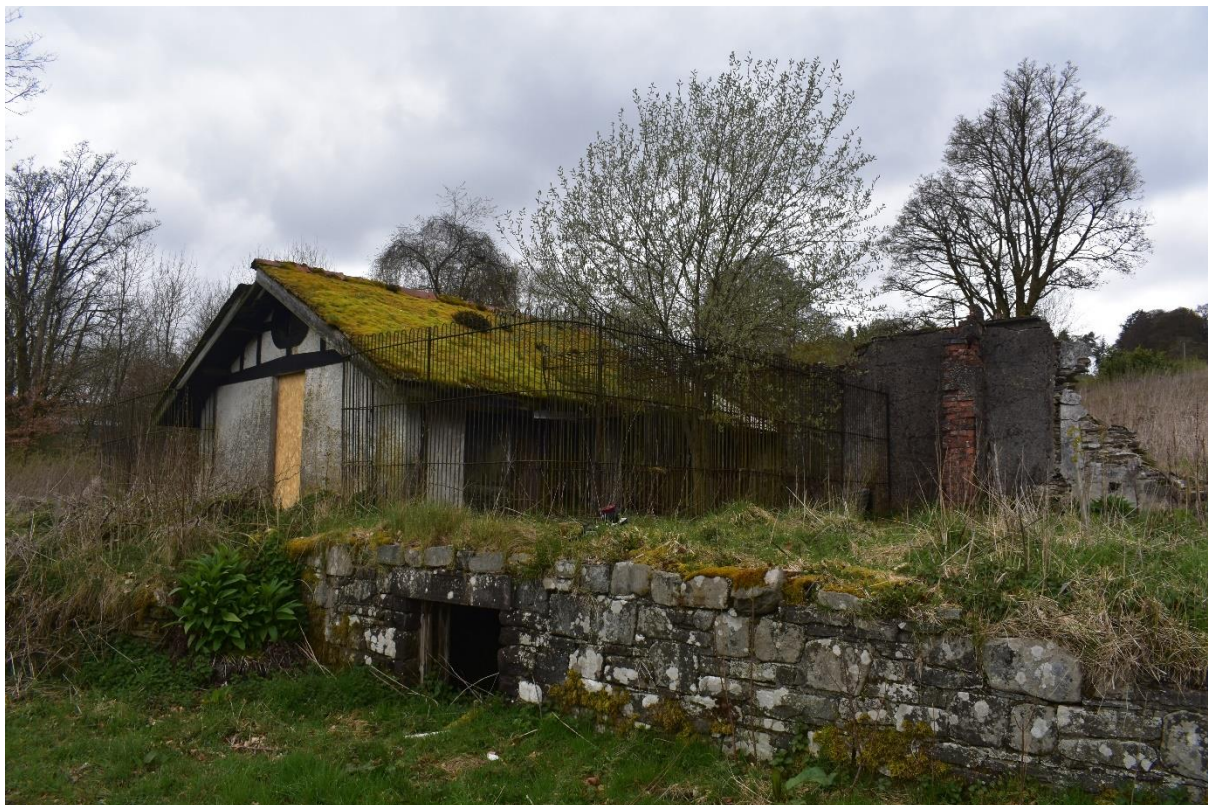
**Figure 3.2:** The front (southeast-facing) and northeast-facing side elevations of the kennels building. The roadside access to the boiler room can be seen in the foreground.

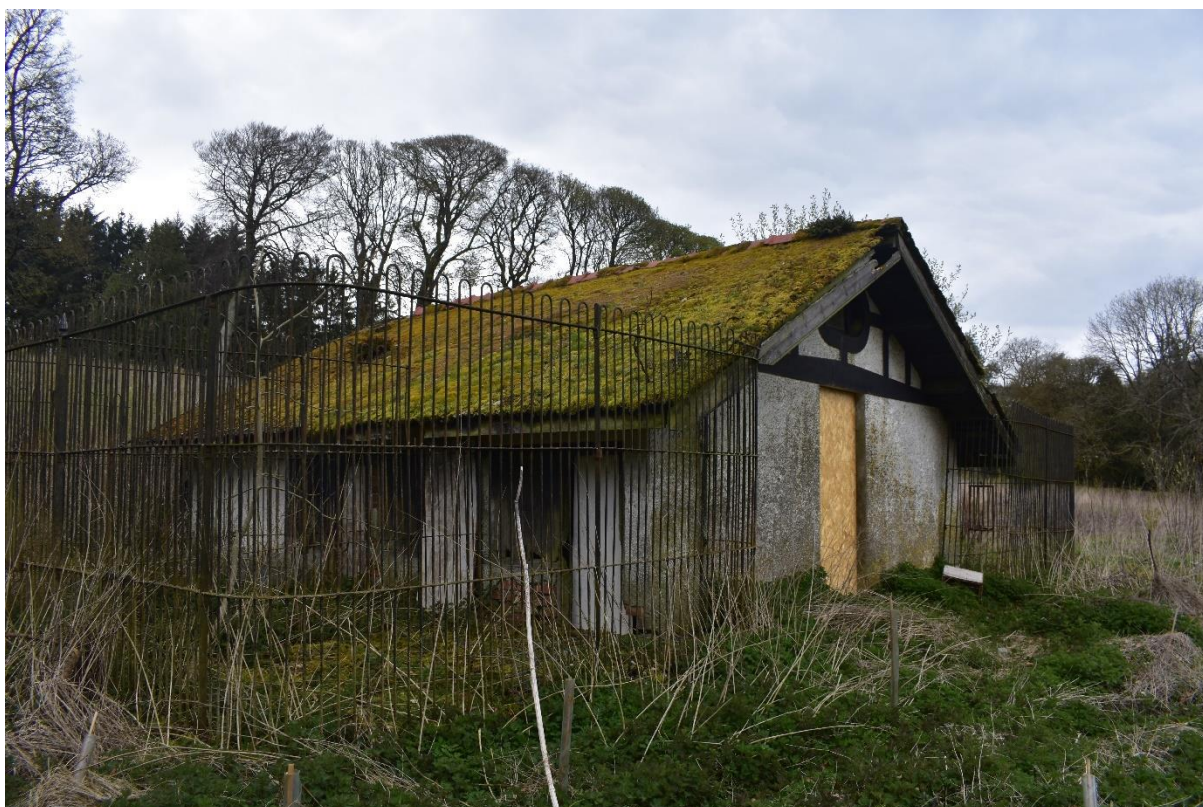
**Figure 3.3:** The front (southeast-facing) and southwest-facing side elevations of the kennels building.

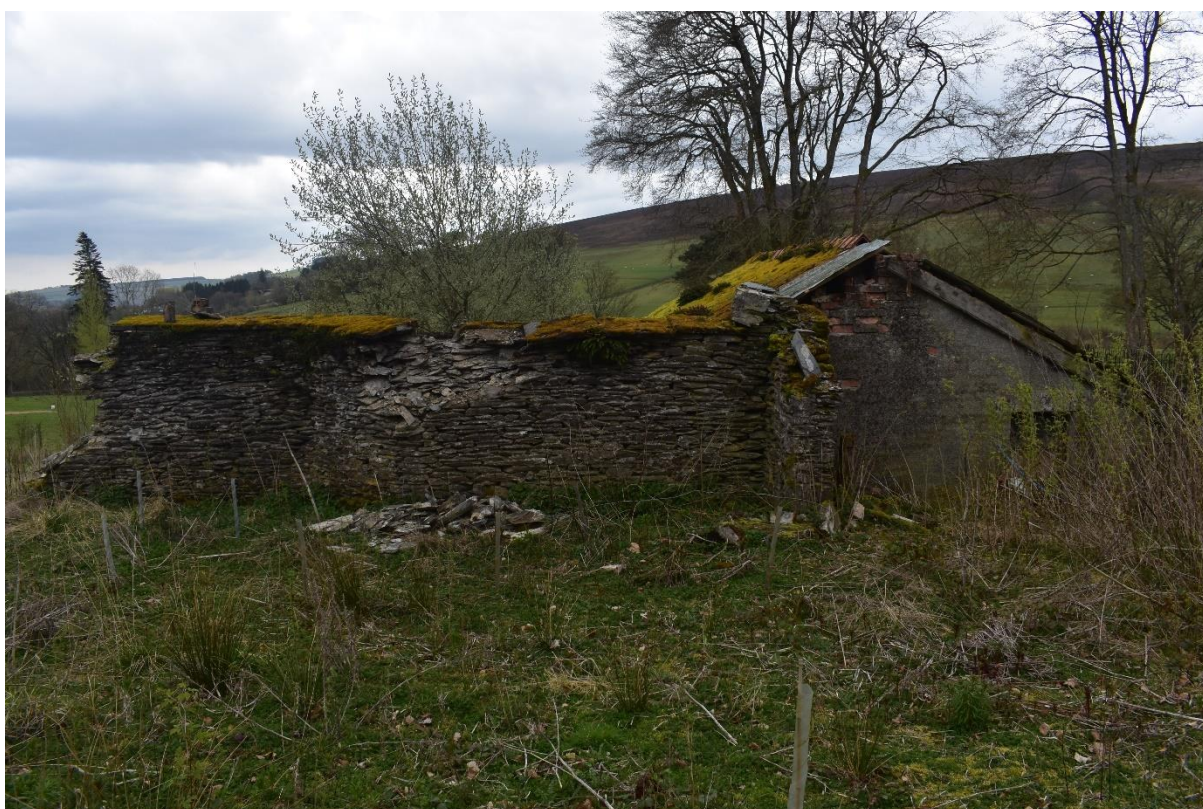
**Figure 3.4:** The rear (northwest-facing) elevation of the kennels building. The stone wall which adjoins the rear of the building can be seen on the left of the image.

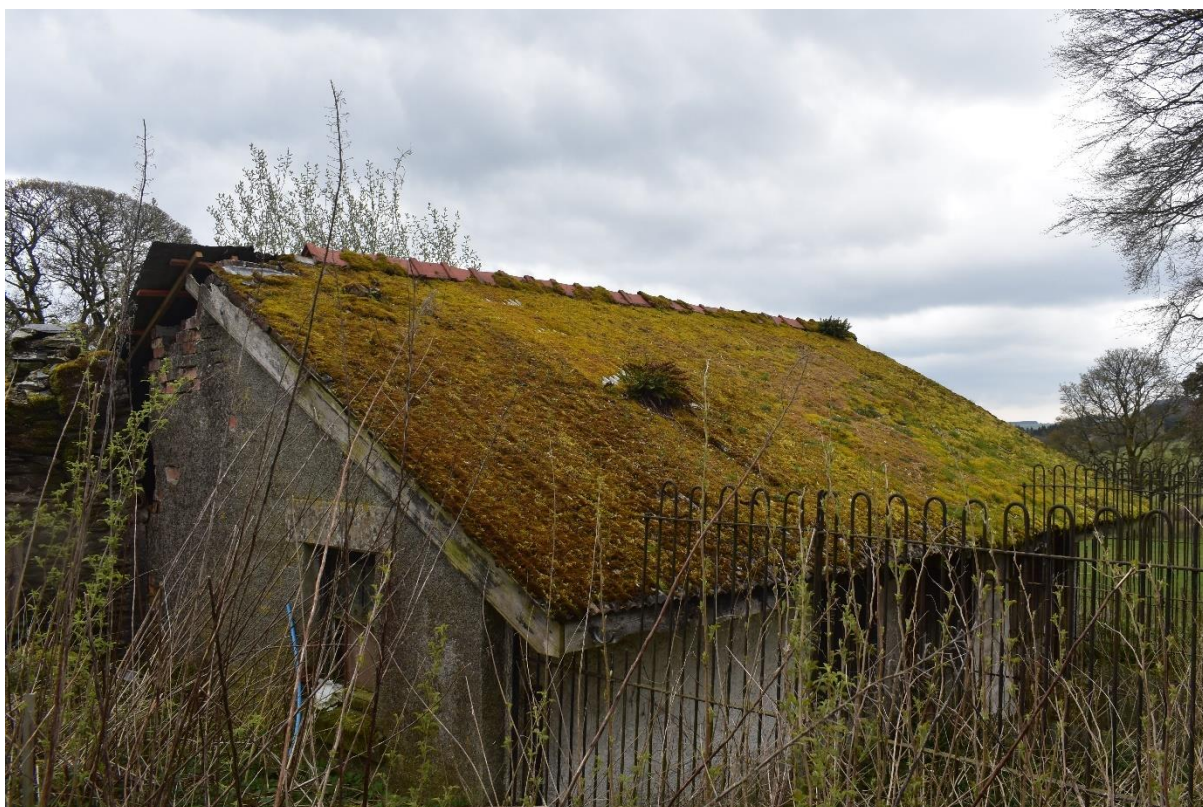
| <b>Exterior Fabric and Features</b> | |
|---|---|
| Roof | <ul style="list-style-type: none"><li>• The roof of the kennels building is constructed of corrugated cement-bonded asbestos sheeting and features rounded ridge tiles. It is in a good state of repair but largely covered in moss.</li><li>• The roof of the boiler room is constructed of concrete slab and is largely covered in moss and pioneer grass species.</li></ul> |

**Figure 3.5:** The roof of the kennels building.

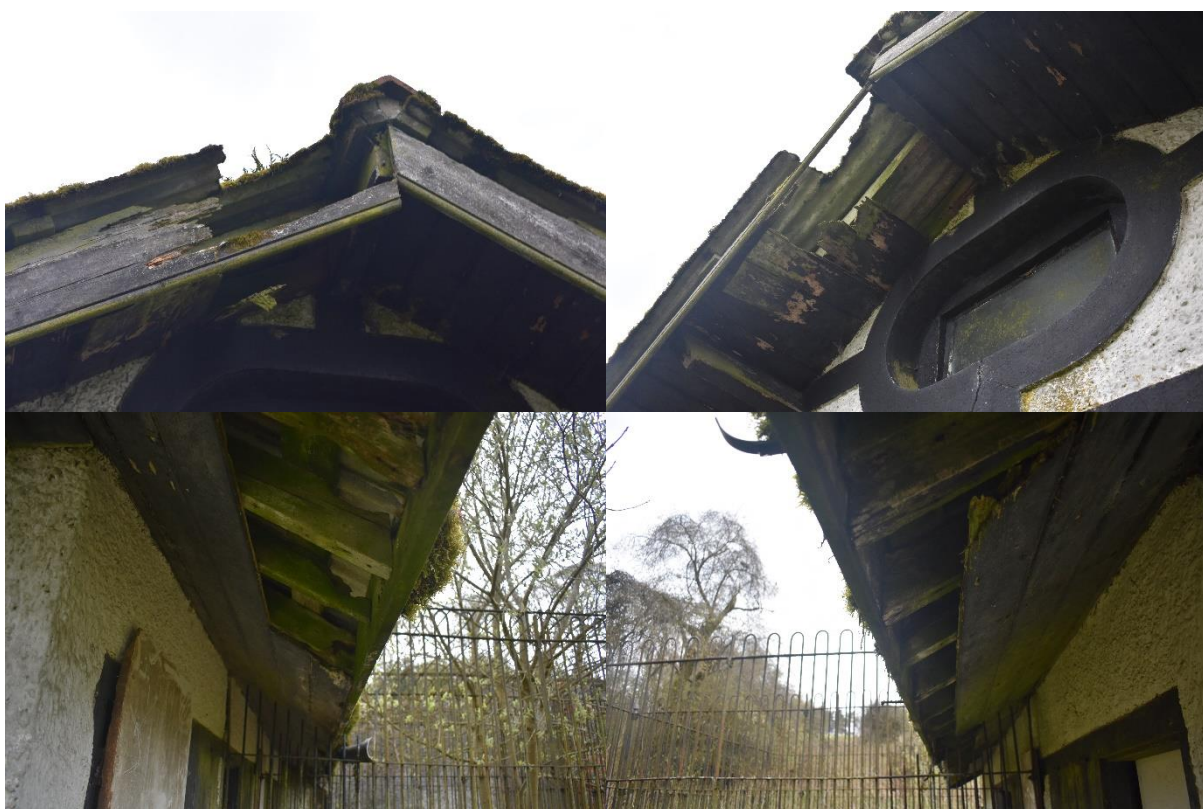
| <b>Exterior Fabric and Features</b> | |
|---|---|
| Soffits, fascias and bargeboards | <ul style="list-style-type: none"><li>• The kennels building features wooden fascias, soffits and bargeboards, all of which are in a poor state of repair, featuring sizeable rot holes in places and having fallen away completely in others.</li><li>• The boiler room is buried within the ground and so does not have any exterior roofline features.</li></ul> |

**Figure 3.6:** The damaged roofline of the kennels building.

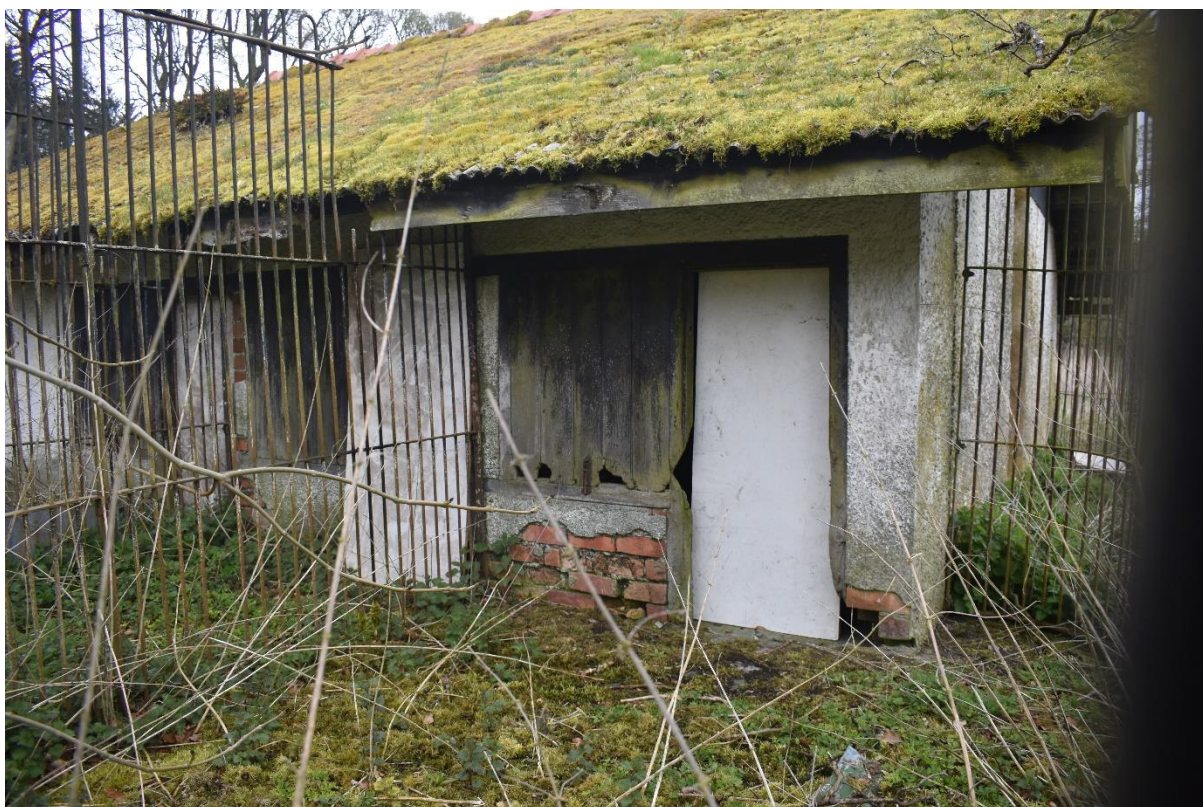
| Windows, doors, and other points of access | <ul style="list-style-type: none"> <li>The doors of the kennels building are made of wood and are in a poor state of repair, with significant gaps present between the doors and their frames and large holes present in places where parts of the doors have rotted away completely. The windows are boarded and in a similar state of repair, with noticeable gaps present.</li> <li>The boiler room is accessible from an open top hatch within its roof and via an open side hatch facing onto the road.</li> </ul> |

**Figure 3.7:** The points of access around the damaged doorways and windows.

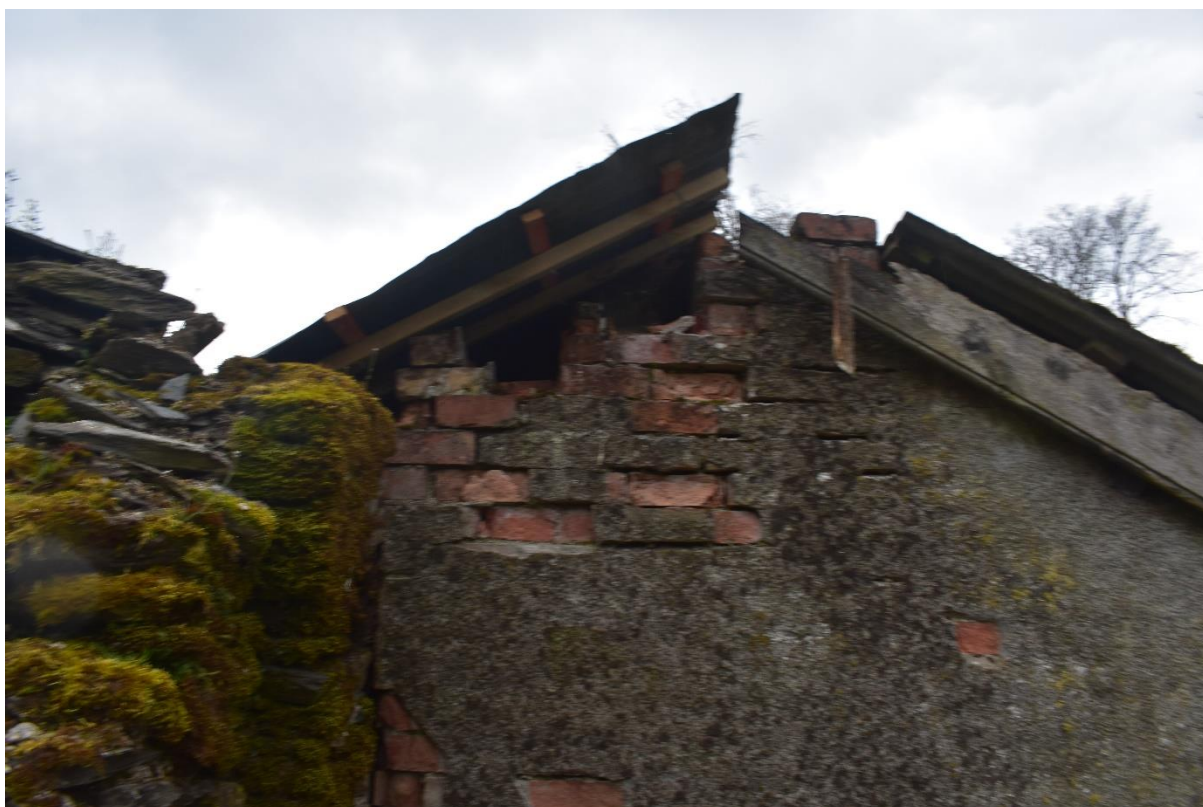
| Walls and Furnishings | <ul style="list-style-type: none"> <li>The interior walls of the kennels building are constructed of exposed brick and are in a fair state of repair, although some damage is clearly visible around the gable wall tops, with some obvious gaps and crevices present within the brickwork where bricks have come away.</li> <li>The interior walls of the boiler room are constructed of exposed random stone, within which gaps and crevices are abundantly present throughout. Towards the front (southeast) end of the room, the walls are noticeably damper, with significant moss and fern growth upon one side, whereas they are noticeably drier towards the rear (northwest) end of the room.</li> </ul> |

**Figure 3.8:** The damage to the rear gable wall of the kennels building.

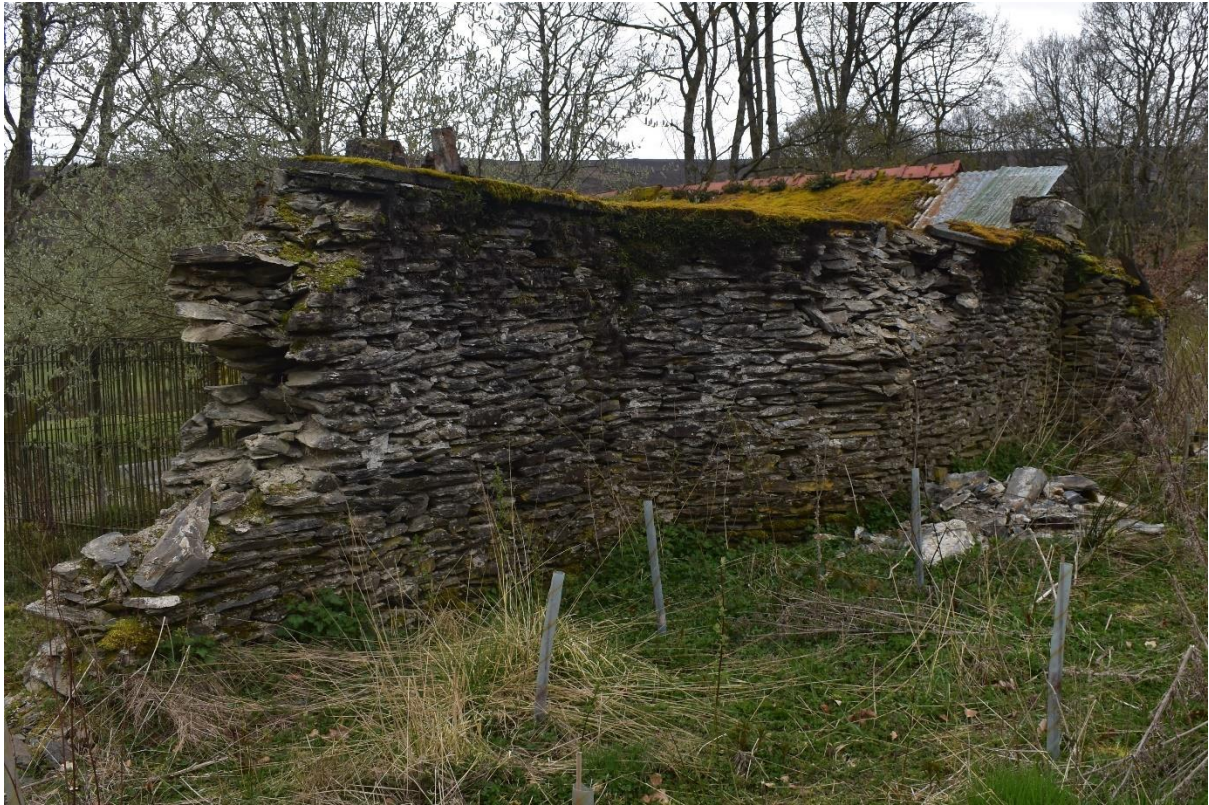
**Figure 3.9:** The stone wall which adjoins the rear of the kennels building.

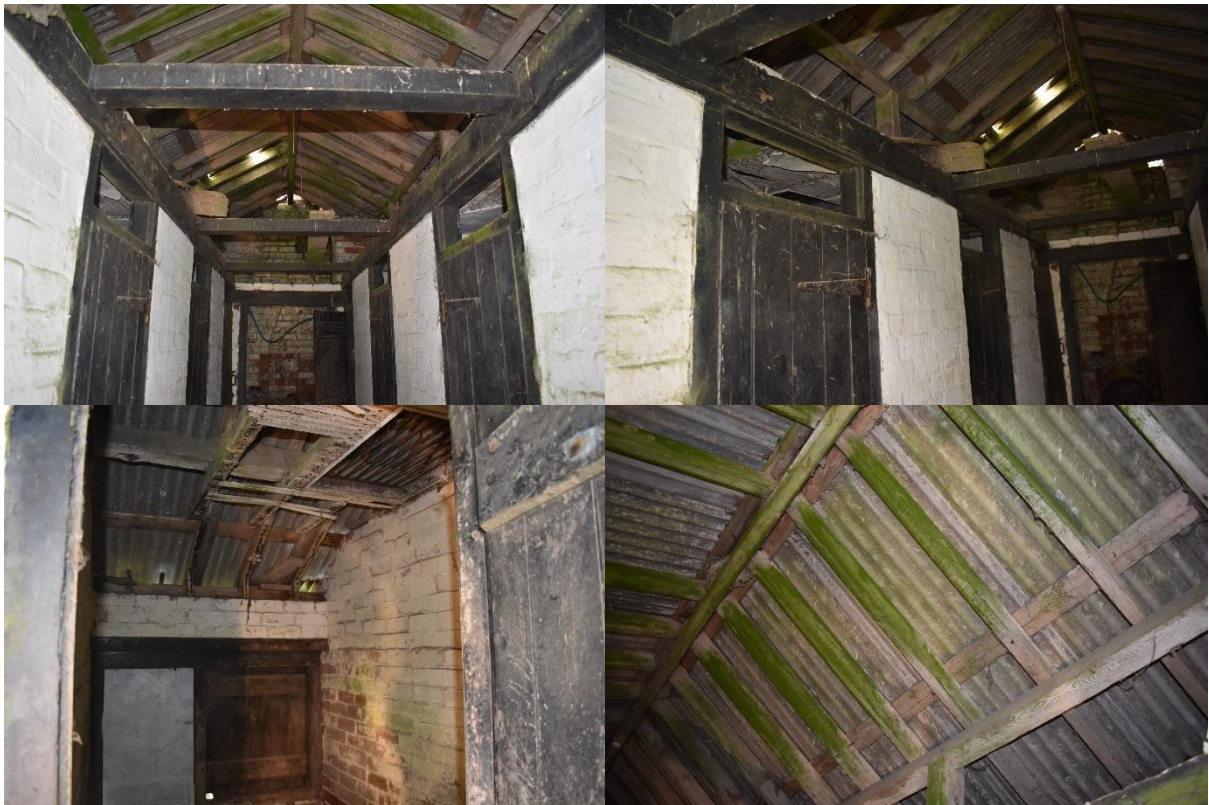
| Structure | <ul style="list-style-type: none"> <li>The interior of the kennels building comprises a single large space which is separated into a central corridor and several individual kennels to each side by brick walls ~2.5m in height. The space is open to the roof of the building, with no separate roof void present.</li> <li>The subterranean boiler room comprises a single open rectangular space.</li> </ul> |

**Figure 3.10:** The interior of the kennels building.

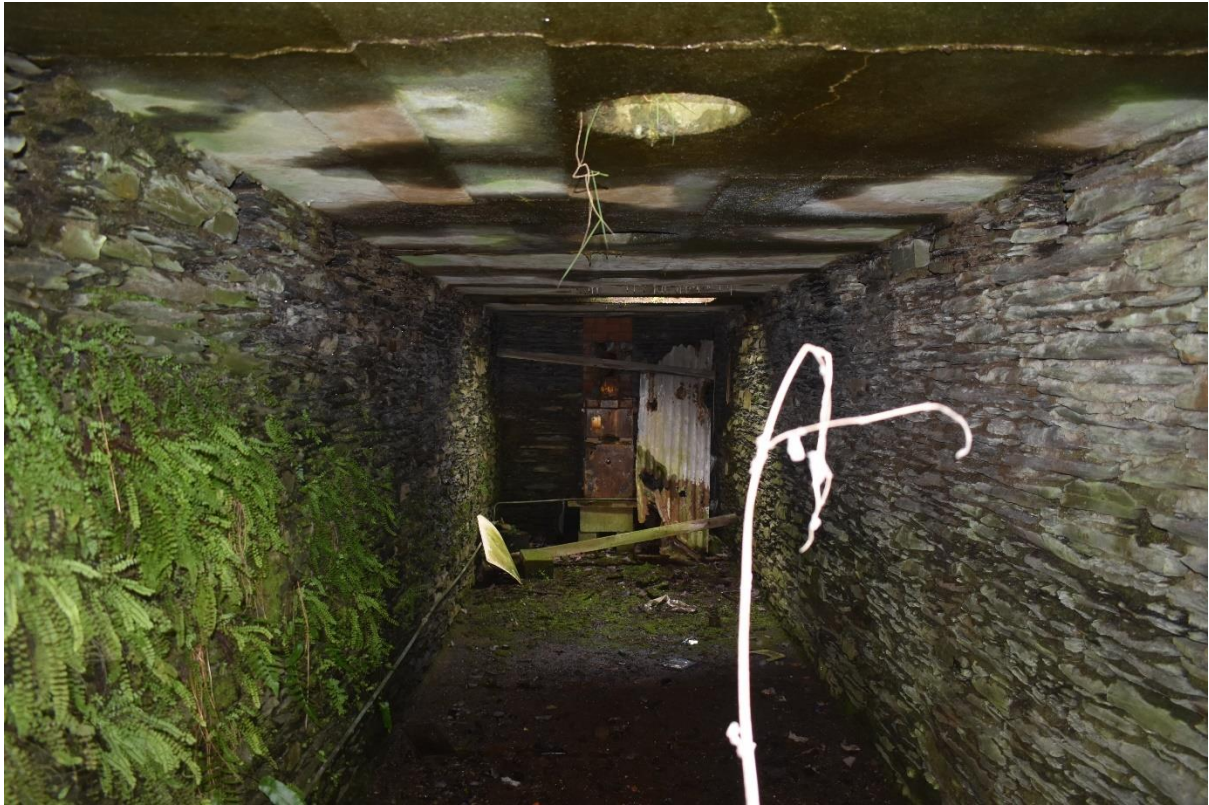
| Evidence of bats or bat roosts | <ul style="list-style-type: none"> <li>No bats or evidence thereof were found during the internal or external inspection of the kennels building.</li> <li>Several scattered droppings, characteristic of <i>Plecotus</i> species of bat, were found within the interior of the boiler room.</li> </ul> |

**Figure 3.11:** The subterranean boiler room.

To make safe the area around the building to be converted, works will need to be undertaken to secure the roof of the boiler room from collapse, and to prevent people from accidentally or intentionally accessing the interior of the room for any purposes other than licensed monitoring activities. These works will constitute a 'roost modification'. Further, in the unlikely situation that any day roosting bats are present at the time of the works (to the boiler room or to the kennels building), they are likely to be disturbed by the noise, vibrations and dust caused thereby.

Advice will be taken from a suitably qualified structural engineer as to what will be the best way to secure the long-term future of the building and roost. Informed by the structural engineer's recommendations, a bat conservation scheme, bespoke to the site and to the project, will be developed by a suitably qualified ecologist and submitted to the local planning authority for approval. The development will then proceed in strict accordance the approved scheme.

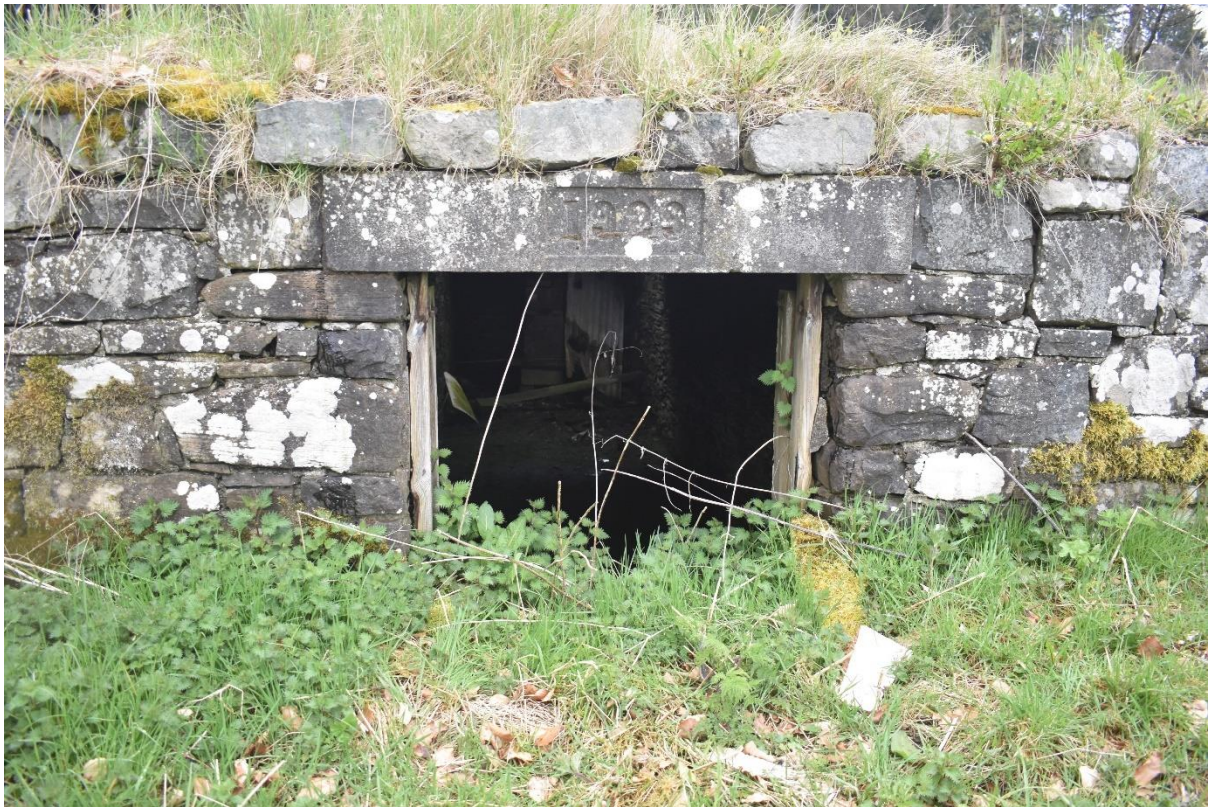
**Figure 3.12:** The roadside access to the boiler room.

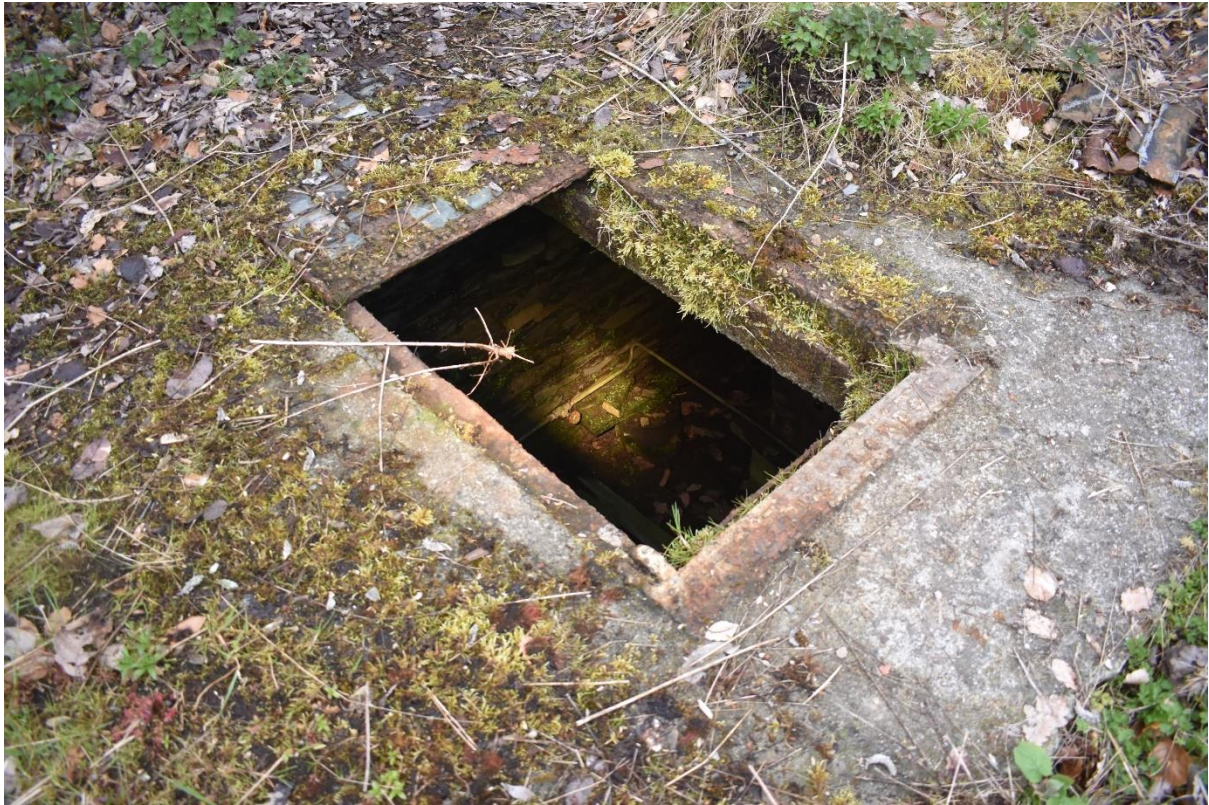
**Figure 3.13:** The top access to the boiler room.

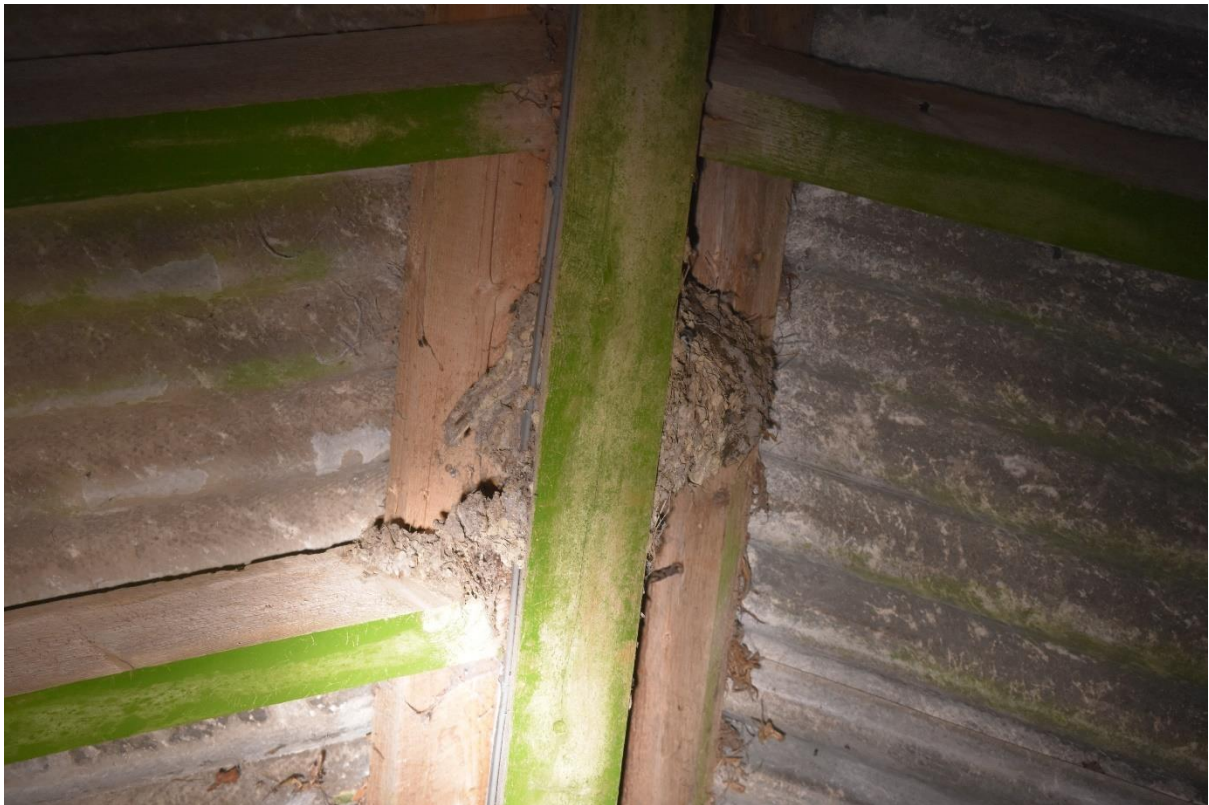
| Evidence of nesting birds | <ul style="list-style-type: none"> <li>Two nests characteristic of barn swallow (<i>Hirundo rustica</i>) and two nests characteristic of wren (<i>Troglodytes troglodytes</i>) were found within the interior of the kennels building.</li> <li>No nesting birds or evidence thereof were found within the boiler room.</li> </ul> |

**Figure 3.14:** One of the swallow nests identified within the kennels building.

Compensatory nesting opportunities for the swallows and wrens will be provided in the form of four Vivara Pro WoodStone Swallow Cups, and two Vivara Pro WoodStone Alicante Nest Boxes, which will be installed in suitable places within the site boundaries. The exact position of these boxes will be shown of the finalised architect's drawings subject to which the development will proceed.

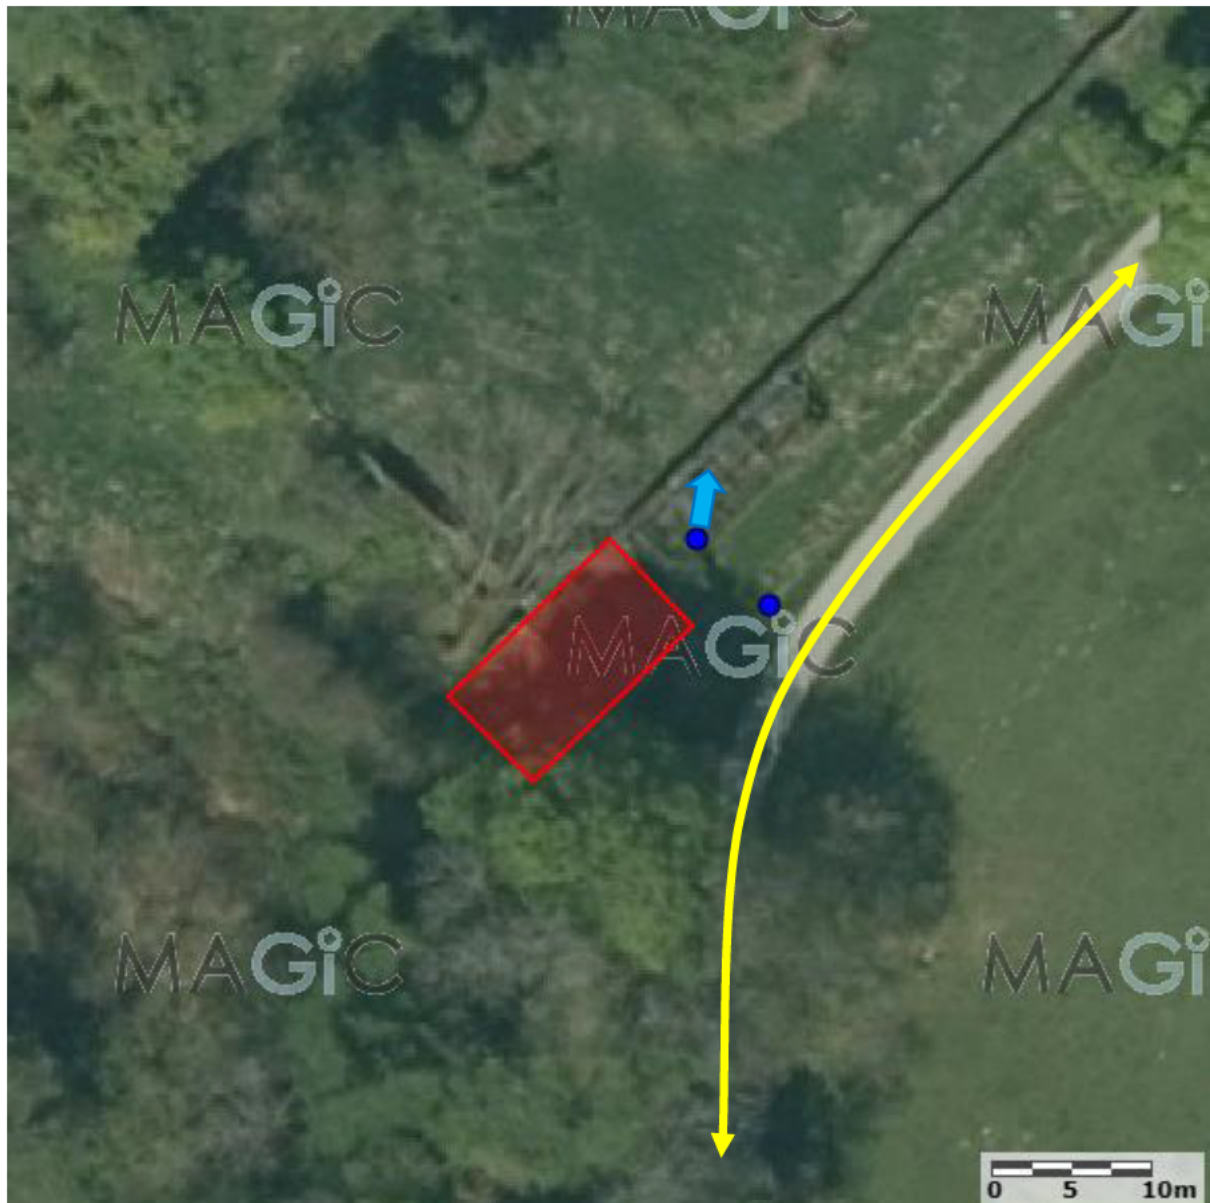
**Figure 3.15:** A plan of the site showing the bat activity recorded. No bats were recorded or observed emerging from or entering the kennels building. However, a single lesser horseshoe bat was briefly observed entering and then re-emerging from the subterranean boiler room (as shown in blue). Additionally, significant commuting activity was recorded and observed along the roadway to the front of the building (as shown in yellow).
