# Site Investigation Report

146497.1.USI

| Brief | Auger were commissioned by Crawford & Co to undertake a site investigation and CCTV inspection of the underground drainage within the area of concern (AOC) at the property. |

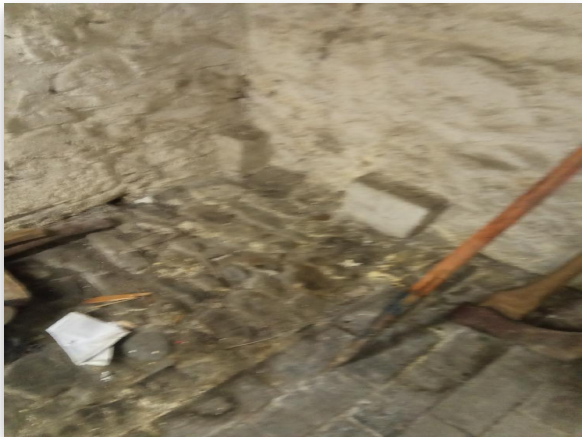
| Fig 1.1: Trial Hole 1 Location | Fig 1.2: Trial Hole 1 Footing |

| Trial Hole Findings | <p>TH1 was moved to <b>the internal rear left hand corner of the cellar</b> because <b>in the proposed location there was a 1.5m deep cellar.</b></p> <p>Within Trial hole 1 we revealed the footing but were unable to auger to the required depth (3m). We were unable to reach the required depth in TH1 because our engineer encountered a hard stone obstruction 1.5m below ground level. We took soil and root samples. These measurements are shown in Trial hole log 1 below.</p> |
