## PROPOSED CONVERSION AND NEW BUILD FOR HOUSING

**Report Title:** Preliminary Ecological Appraisal

**Address:** Gamford Farm, Gamford Lane, Rossett, LL12 0EW

**Issued:** 13<sup>th</sup> December 2018

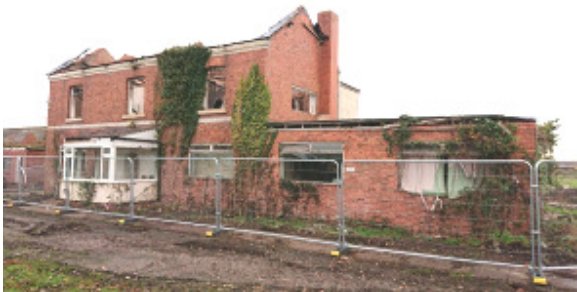
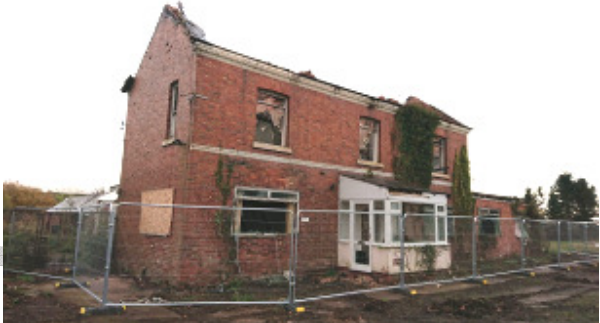
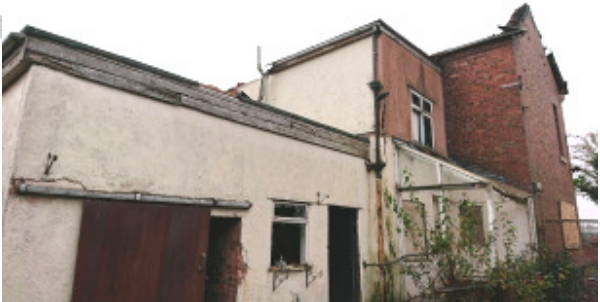
| Building Ref | Description and Roost Potential | Photographs |
|---|---|---|
| 1 | <p><u>Gamford House</u></p> <p>A two-storey brick dwelling with destroyed pitch, slate roof.</p> <p>It has previously been a confirmed Common Pipistrelle maternity roost prior to suffering fire damage on the 5<sup>th</sup> November 2018 (TEP &amp; Arbtech 2015).</p> <p>The roof is now entirely absent, and all that remains are the intact building gable elevations and damaged ground level compartments/extensions.</p> <p>The building is fenced and internal access was prohibited by the client on the considered grounds of health and safety.</p> <p>Considered unsuitable for breeding by Brown Long-eared bats.</p> <p>Potential remains present for roosting by crevice-dwelling bats due to crevices created in brickwork through damage, gaps present in brick at the gable elevation/remaining roofing slate interfaces, gaps beneath timber fascia's adorning the building and ingress potential present due to general dilapidation throughout the structure.</p> <p>Bat roost potential: <b>Moderate</b></p> | |

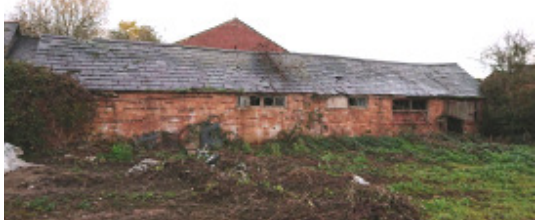
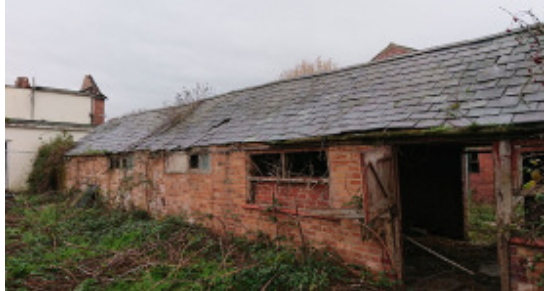
| Building Ref | Description and Roost Potential | Photographs |
|---|---|---|
| 2 | <p><u>Stables</u></p> <p>Dilapidated, single-storey brick building with a pitched slate roof and open wooden window frames. Separated into five independent compartments.</p> <p>No loft present. The south-western compartment has a false ceiling, creating a void space under the tiles; other compartments are open to the ridge, average room height of approx. 3 metres, underlay absent and the interior is draughty and part-illuminated.</p> <p>Unsuitable for breeding by Brown Long-eared bats but could be used for other purposes, such as a day roost / feeding station / hibernation. Potential for roosting by crevice-dwelling bats exists in the form of gaps in slates, brickwork and general dilapidation throughout.</p> <p>Bat roost potential: <b>Moderate</b></p> | |

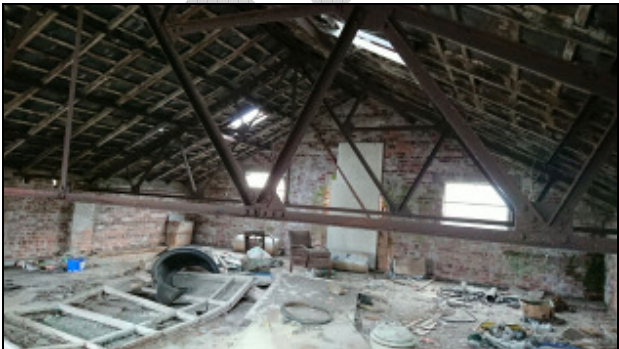
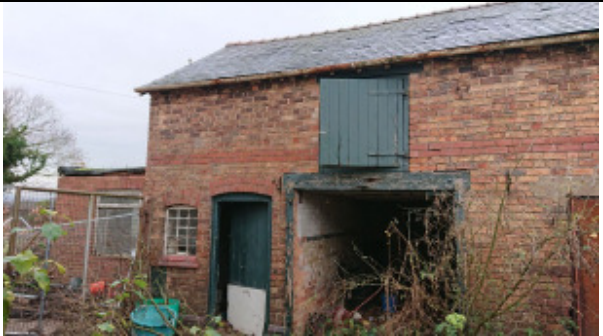
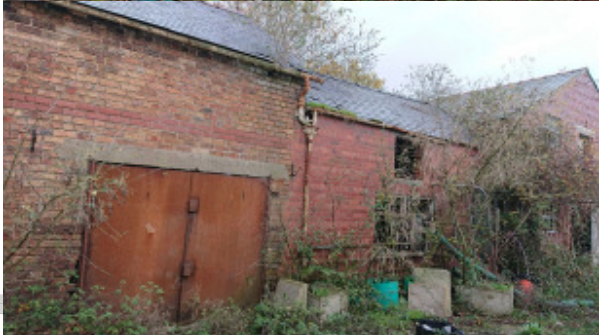
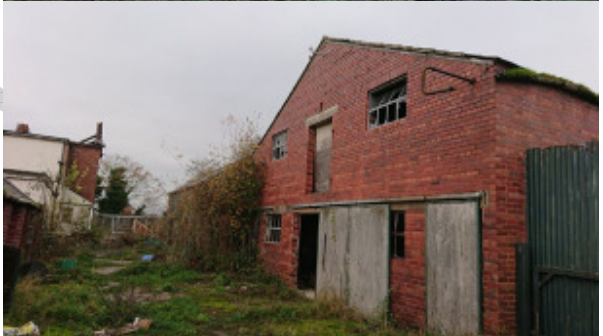
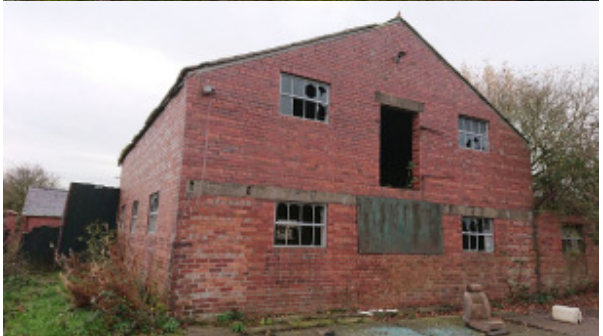
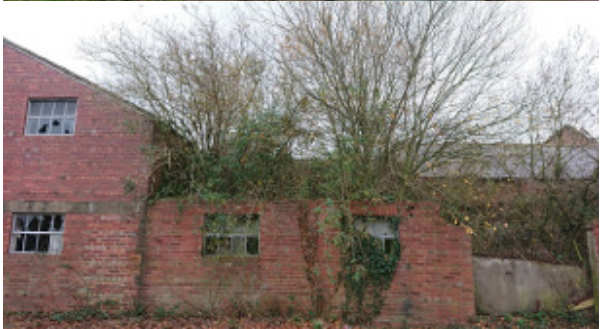
| Building Ref | Description and Roost Potential | Photographs |
|---|---|---|
| 3 | <p><u>Two large two-storey barns with adjoining pen and building ruins</u></p> <p>Dilapidated, brick built with a multi-pitched, slate roof. No underfelt present, though a deteriorating lime and mortar application is noted in visible areas of the roof.</p> <p>South-west section: No loft but a rectangular roof void is present of approx. 2.5 metres high, accessible via ladder in south of the building, conditions are cluttered, part-illuminated and draughty. Unsuitable for breeding by Brown Long-eared bats but could be used for other purposes such as a day/night roost and/or feeding station. There exists an abundance of ingress provision for crevice-dwelling bats at the gable elevation, under eaves, at the ridge and within internal brickwork.</p> <p>Central section: Internal conditions are unknown as access was not gained due to severe structural damage particularly on the north-west elevation, now largely containing dense scrub growth. Gaps otherwise observed under ridge tiles, in roof slate and beneath the eaves.</p> <p>North-east section: No loft, large open barn with flighted stair access to a spacious upper floor; conditions are illuminated and draughty. Considered unsuitable for breeding by Brown long-eared bats but structure could be used for other purposes such as a feeding station. Potential roost features are limited internally though minor crevices are noted at wall plate level, where old beams are missing leaving holes in mortar, and within holes in internal render.</p> <p>Roost potential: <b>Moderate</b></p> | |

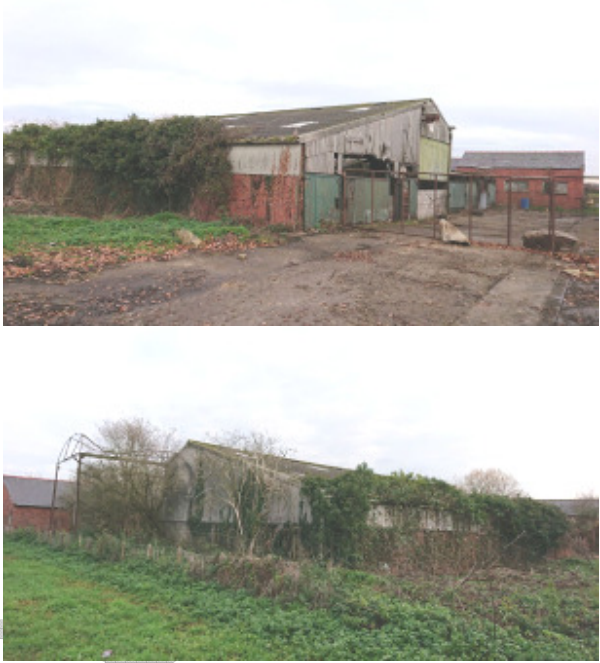
| Building Ref | Description and Roost Potential | Photographs |
|---|---|---|
| 4 | <p><u>Large agricultural structure</u></p> <p>Dilapidated, single-storey, part brick/block/timber built former livestock barn; the roof is made of pre-fabricated corrugated iron and cement asbestos.</p> <p>Largely open to an uneven roof pitch with internal room height of approx. 7.5 metres; screen windows present in roof, conditions are vastly spacious, fully illuminated and significantly draughty. Much of the building west is smothered in climbing Ivy which is also growing internally. The building east is open sided and areas which could be used for roosting by loft dwelling and crevice dwelling bats are absent.</p> <p>With an absence of suitable ingress features, the building is considered generally unsuitable for roosting by both loft-dwelling and crevice dwelling bats, though bats could forage within the structure as access permits.</p> <p>Roost potential: <b>Negligible</b></p> | |

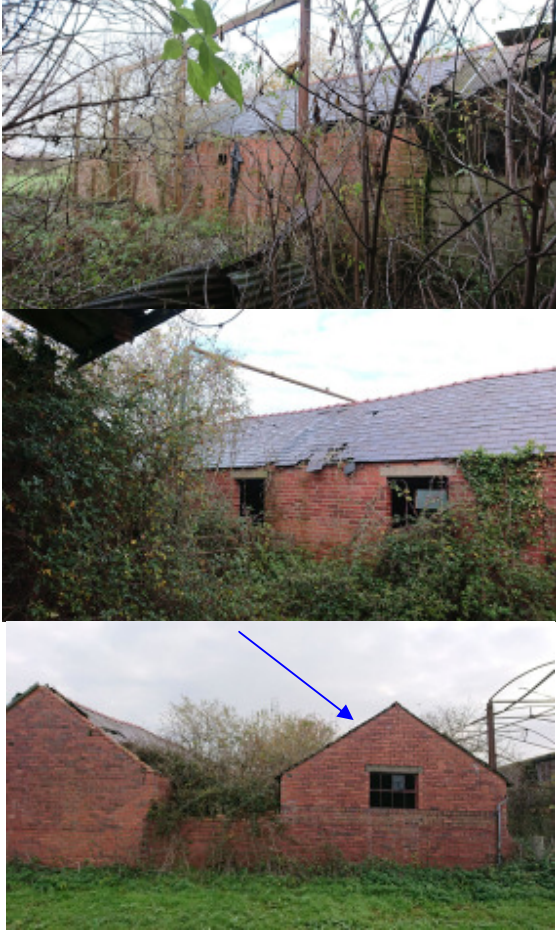
| Building Ref | Description and Roost Potential | Photographs |
|---|---|---|
| 5 | <p><u>Linear Stables A</u></p> <p>Dilapidated, single-storey, brick stables with a pitched, slate roof - four compartments exist internally, half open door/window frames are present. Surrounded by dense scrub reaching roof height in all areas except for the south-facing gable elevation.</p> <p>Internal conditions are part-illuminated and draughty, underfelt is absent and a false ceiling has collapsed revealing a deteriorating lime and mortar application.</p> <p>Unsuitable for breeding by Brown Long-eared bats but could be used for other purposes by BLE such as day/night/feeding/hibernation roost. Potential exists throughout for roosting by crevice-dwelling bats, in the form of gaps at timber joists, loose/missing slates, and general dilapidation throughout the structure.</p> <p>Roost potential: <b>Moderate</b></p> | |

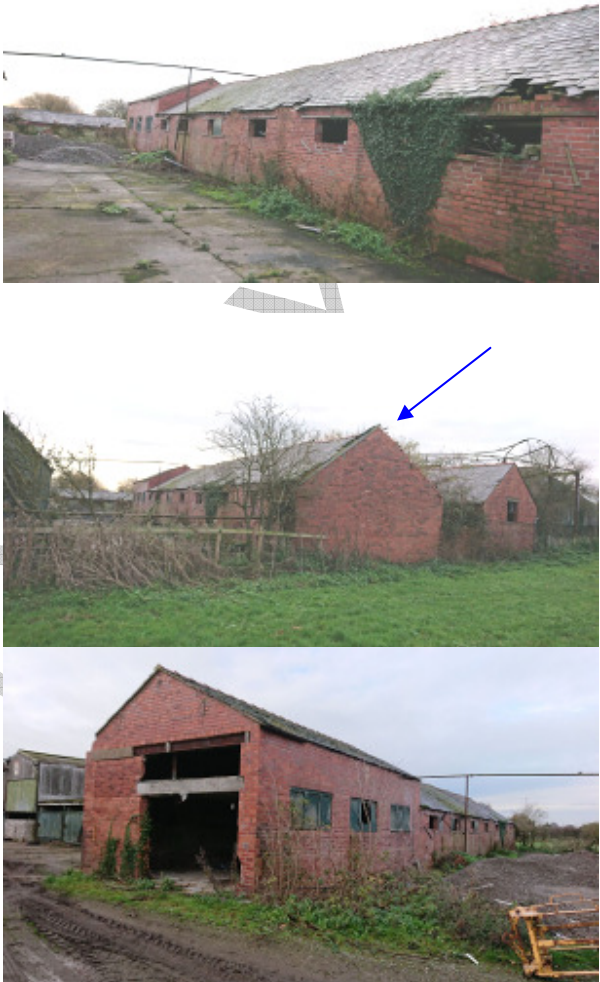
| Building Ref | Description and Roost Potential | Photographs |
|---|---|---|
| <p>6</p> | <p><u>Linear Stables B</u></p> <p>Dilapidated, single-storey brick structure with a dual level pitch, slate roof - seven compartments internally and open door/window frames. Surrounded by dense scrub on its western elevation reaching roof height.</p> <p>Contains a small roof void on its south-eastern section which could not be accessed on the grounds of health and safety but is considered a stable compartment with better shelter than the rest of the structure - internal conditions are spacious, part-illuminated and draughty, underfelt is absent, a deteriorating lime and mortar application is present. The roof has partially collapsed in the north-west of the structure.</p> <p>Unsuitable for breeding by Brown Long-eared bats but could be used for other purposes by BLE. Potential exists for roosting by crevice-dwelling bats, in the form of gaps at ridge tiles, damage in roof, beneath end slates, loose/missing slates, general dilapidation in brick and timber.</p> <p>Roost potential: <b>Moderate</b></p> | |

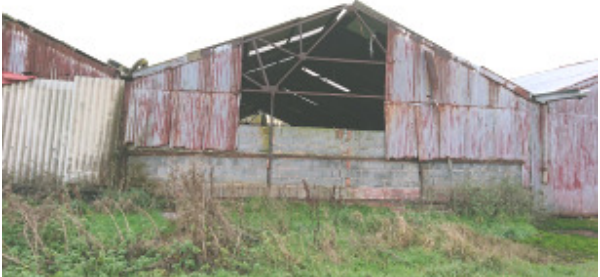
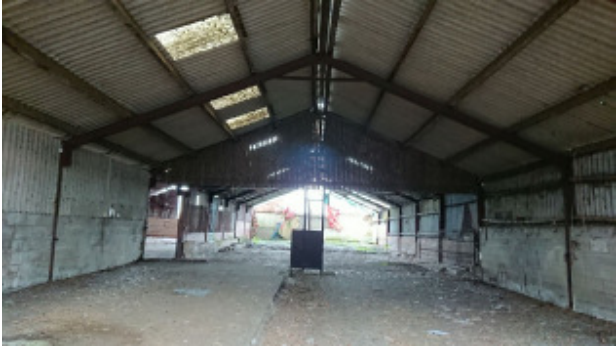
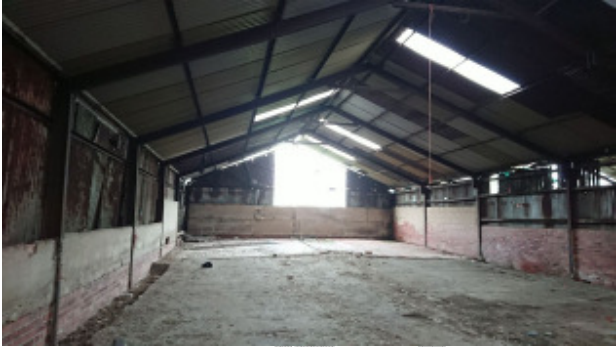
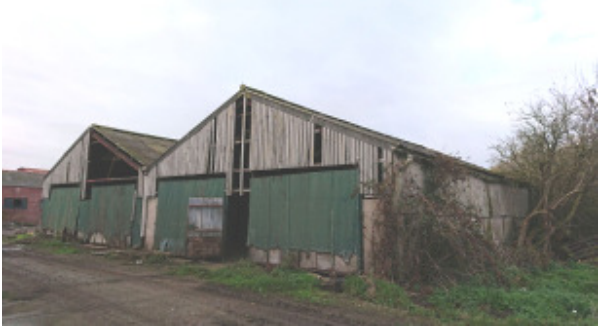
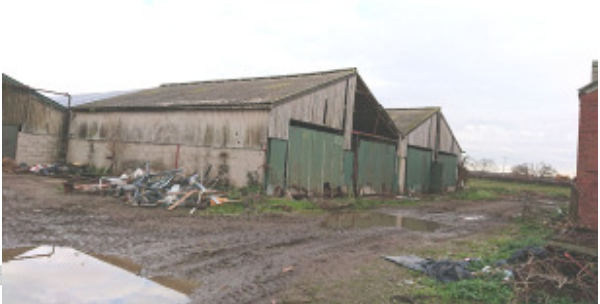
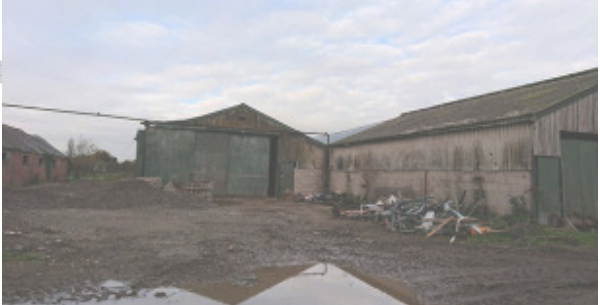
| Building Ref | Description and Roost Potential | Photographs |
|---|---|---|
| <p>7</p> | <p><u>Triple-pitched storage Barns</u></p> <p>x3 adjoined structures, all single-storey, triple-pitched cement asbestos roof. Building is of metal, breeze-blocks and timber construction.</p> <p>No underlay throughout, typical room height of 7.5 metres, screen windows present in cement asbestos and iron sheet roof, lack any loft spaces and is open to the ridge in all compartments. Fully illuminated, draughty and spacious.</p> <p>Open sided in several places, missing timber and sheeting provides ease of internal access to flying animals. Dense, extensive scrub is present along the general north and east of the building.</p> | |

| Building Ref | Description and Roost Potential | Photographs |
|---|---|---|
| 7 cont ... | <p>With an absence of suitable ingress features, the structure is considered unsuitable for roosting by both loft-dwelling and crevice dwelling bats, however, bats could fly in and out of the structure for foraging purposes.</p> <p>Roost potential: <b>Negligible</b></p> | |

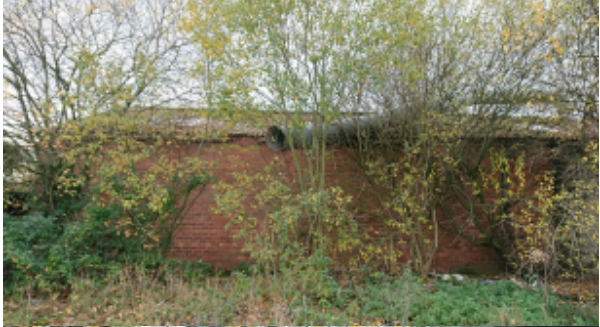
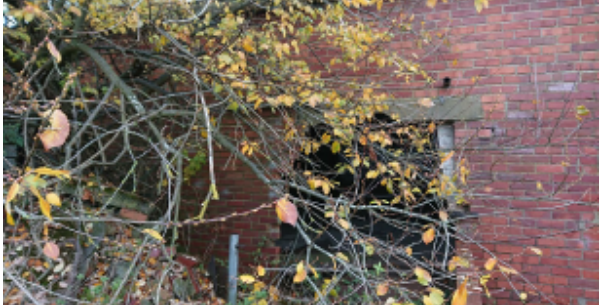
| Building Ref | Description and Roost Potential | Photographs |
|---|---|---|
| 8 | <p><u>Vent-build</u></p> <p>Dilapidated, single-storey, brick and breeze block construct with a cement asbestos, pitched roof. Willow scrub grows high over the northern elevation and the building is attached to a breeze block tower (Building 8a). Access is only possible via doorframe on the south-facing elevation.</p> <p>No lofts present, the interior is illuminated, draughty and spacious.</p> <p>Underfelt is absent and crevice opportunities are lacking internally, though minor gaps exist at wall plate.</p> <p>With an absence of suitable ingress features, the structure is considered, in it's entirely, unsuitable for roosting by both loft-dwelling and crevice dwelling bats.</p> <p>Roost potential: <b>Negligible</b></p> | |

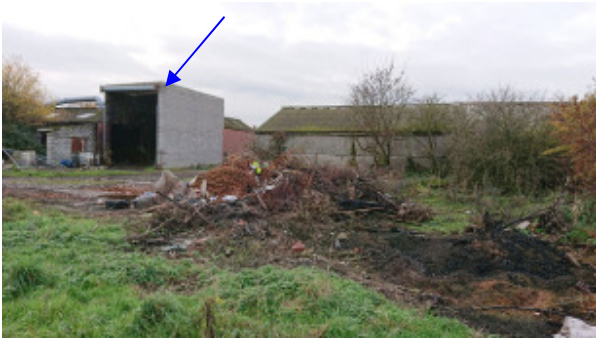
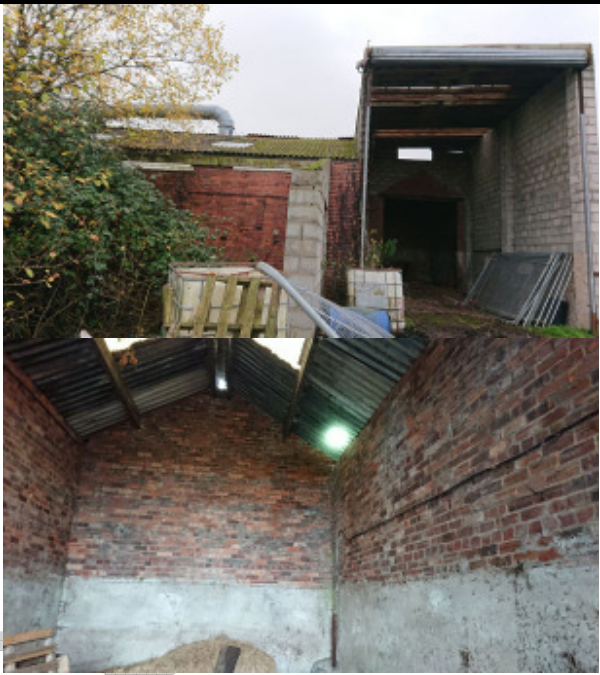
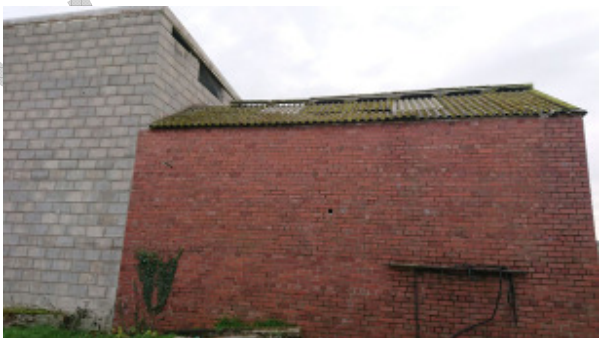
| Building Ref | Description and Roost Potential | Photographs |
|---|---|---|
| 8a | <p><u>Tower construct</u></p> <p>A single-storey brick and breeze-block tower adjoined to Buildings 8 and 9, the brick section contains a pitched, asbestos sheet roof and the tower section contains a flat, asbestos and plastic sheet roof.</p> <p>There are no loft spaces present and roof lining is absent; the interior is fully illuminated, spacious and draughty as the structure is open ended on its north-eastern elevation.</p> <p>Outside of potential hidden opportunities at wall plate height, there are no internal or external cavity features that could be used by bats for ingress or roosting.</p> <p>With a absence of suitable roost features the structure is considered unsuitable for roosting by both loft-dwelling and crevice dwelling bats.</p> <p>Roost potential: <b>Negligible</b></p> | |

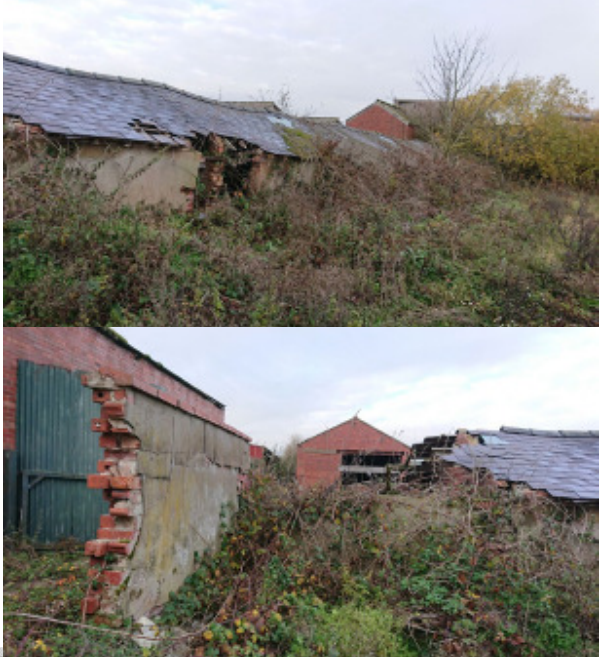
| <p>9</p> | <p><u>Overgrown pig pens</u></p> <p>Dilapidated, single-storey former pig pen made of brick and external render with a pitch, slate roof.</p> <p>Significantly damaged throughout and with dense scrub; inaccessible. Internal conditions are thus unknown though are undoubtedly draughty and part-illuminated.</p> <p>Gaps are evident in the roofing slate; both the centre-east section and the south facing gable elevation are significantly damaged creating large gaps in brick and mortar, including open internal access.</p> <p>Considered unsuitable for loft dwelling bats but could be utilised by crevice-dwelling bats.</p> <p>Roost potential: <b>Low</b></p> | |

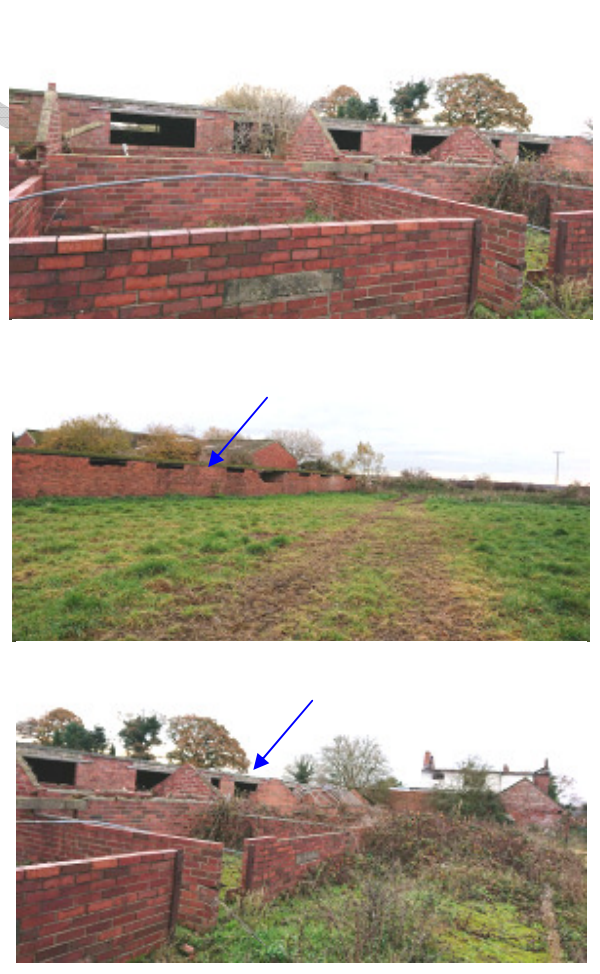
| <p>10</p> | <p><u>Flat damaged pens &amp; foundations</u></p> <p>Single-storey former pens attached to several incomplete building foundations. Dilapidated, flat-roofed and open sided.</p> <p>Multi-compartmental, underlay is absent, internal conditions are cramped, illuminated and draughty. Generally, in good condition and appears to be lacking potential roost features.</p> <p>The structure is considered unsuitable for roosting bats due to an absence of features that could be used for bat roosting or otherwise provide hidden ingress opportunities.</p> <p>Roost potential: <b>Negligible</b></p> | |

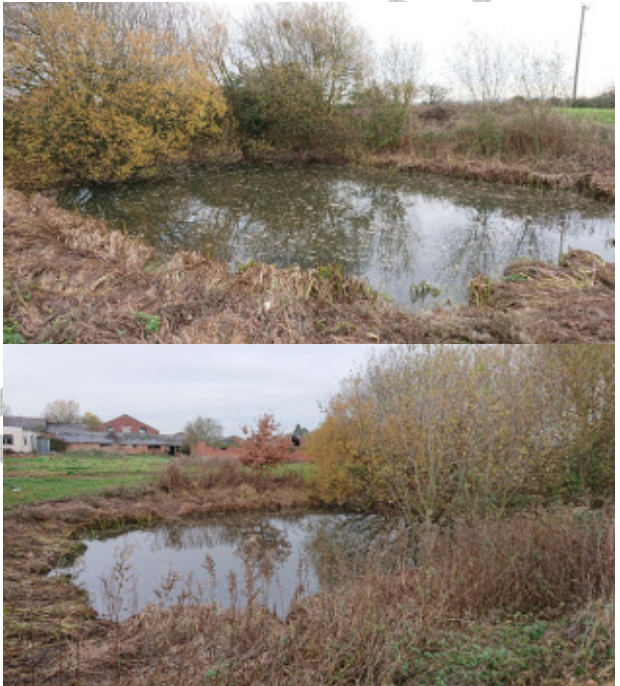
| Pond Ref | National Grid Reference | Pond Suitability | Description |
|---|---|---|---|
| 1 | SJ37845737 | Excellent | <p>Located within the site boundary east. Circular in shape, surrounded by rough grassland, tall ruderal and Willow sp. scrub that affords superb connectivity to nearby scrub and hedgerow. Contains semi-aquatic plants, a thin line of oil/pollution is found on the surface of the water, water turbidity is low/clear (1/5) and the base of the pond contains leaf litter. Banks are moderately inclined and the estimated depth is 1.5ft deep centrally. Proximity to impact development zone is immediate (less than 25 metres west).</p> |

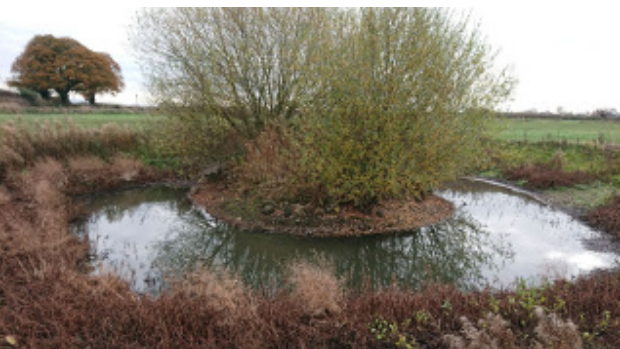
| Pond Ref | National Grid Reference | Pond Suitability | Description |
|---|---|---|---|
| 2 | SJ37715737 | Average | <p>Located 45 metres south-west of site boundary. A circular pond with island, surrounded by tall/ruderal and limited scrub. Good connectivity to nearby hedgerows. Pond contains Fool's Water-cress and a <i>Veronica</i> sp., water turbidity is low/clear (2/5). Banks are shallow, estimated max depth of 2ft in areas Mallard duck pair present during survey, separated from development site.</p> |

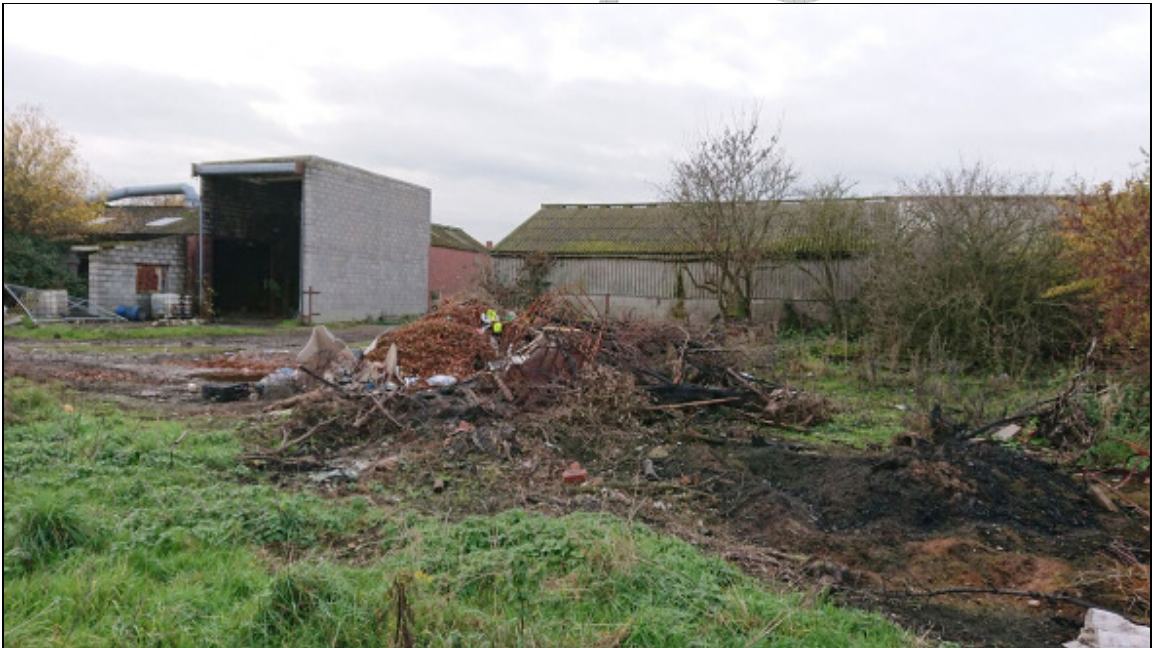
**Plate 4** - Bonfire damage in the north of the site, Target Note 4

Grassland throughout the site is rough and unmanaged; in the boundary north it is significantly disturbed by tyre tracks and bonfire damage (Target Note 4); Ox-eye Daisy and Black Medick are noted; the grassland in the centre and south contains species such as Common Ramping Fumitory, Yorkshire-fog, Red Fescue, Broad-leaved/Curled Dock and Common Sorrel amongst others.

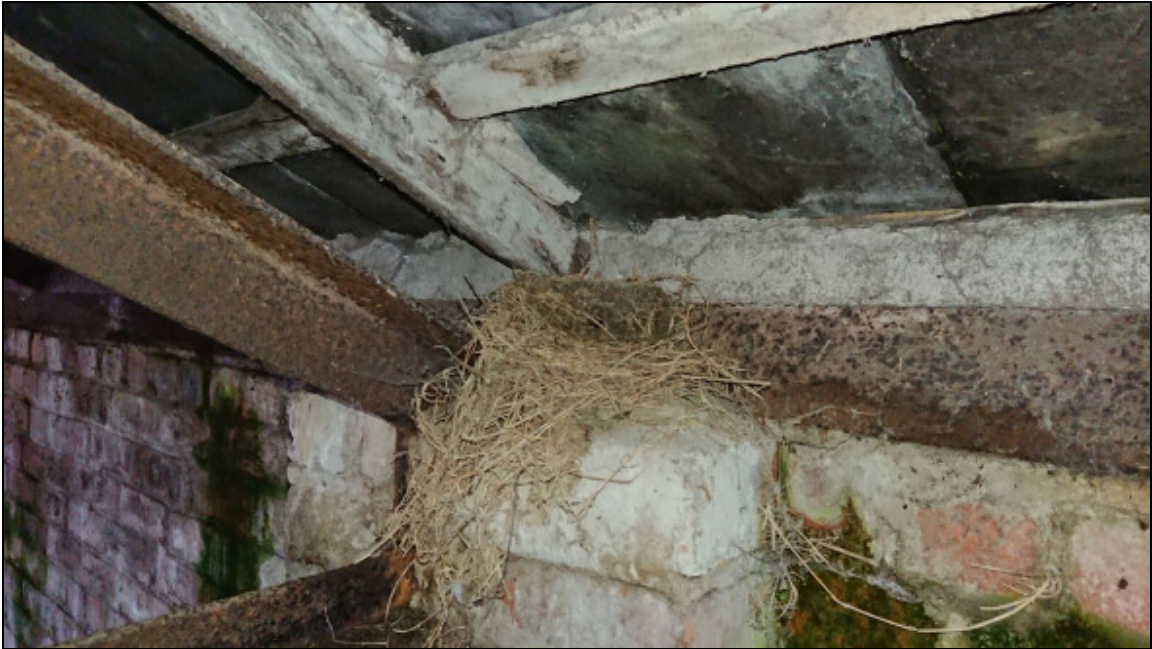
**Plate 5** - Evidence of nesting birds in Building 4

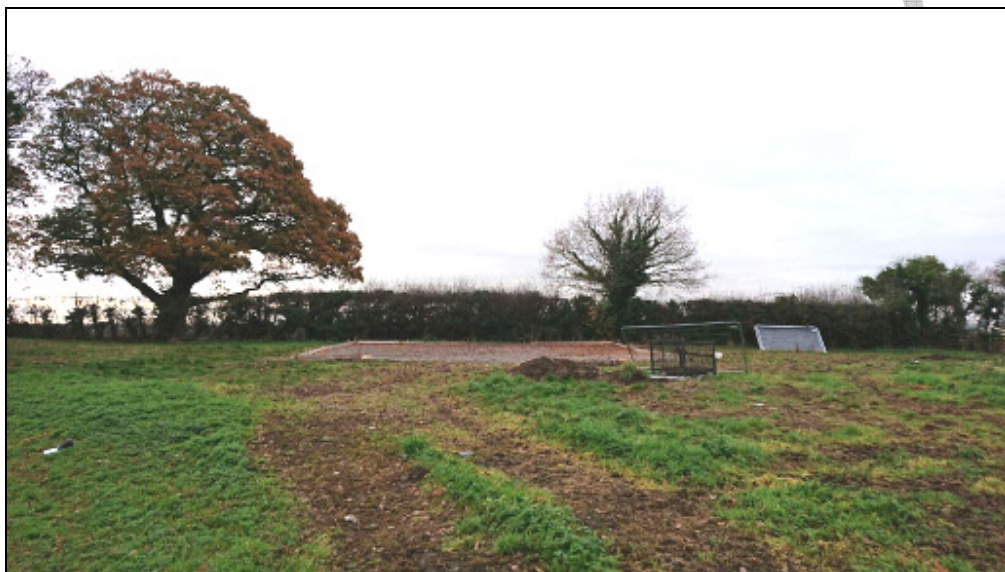
**Plate 10** - Newly built building foundation, Target Note 5

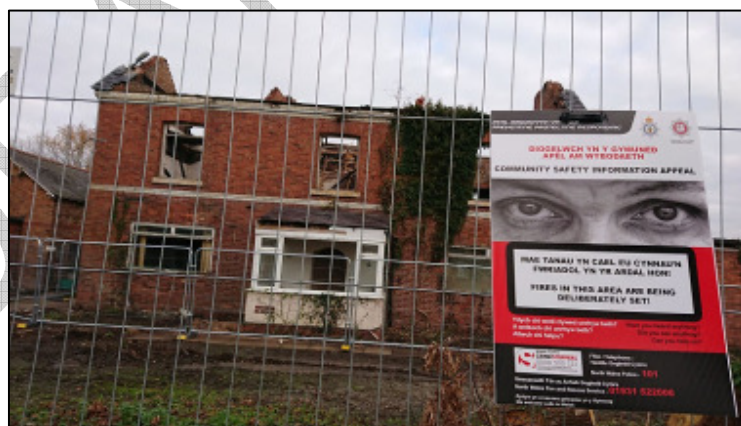
**Plate 11** - Image taken of the former dwelling (B1) now burnt out, taken from outside the site

- 6.1 Gamford House, which is the dwelling on site referred to throughout as Building 1, is understood to have suffered recent fire damage on 5<sup>th</sup> November 2018, destroying the roof and much of the upper floor. The building has previously been confirmed as a Common Pipistrelle maternity roost and it supported an unspecified population of breeding House Sparrow (information sourced from TEP & Arbtech ecological reports, 2015, available on the Wrexham Planning Portal). During the survey access to Building 1 was not permitted on the grounds of health and safety and the building is effectively fenced off. Many buildings on the site are in a considerable state of dilapidation and were similarly not accessible on the grounds of health and safety; building descriptions are given in section 8.4, Table 2, which describes the findings of all structures surveyed in relation to bats.
