Former Victoria Garage, Ruabon  
Proposed Residential Development  
Geoenvironmental Report  
Brenig Construction Ltd

This report presents the findings of the Phase I Desk Study, both phases of trial pitting investigations and the tank validation sampling, and presents risk assessments and conceptual site models for the development. It also provides firm geotechnical recommendations for the development and identifies extra over normal construction costs.

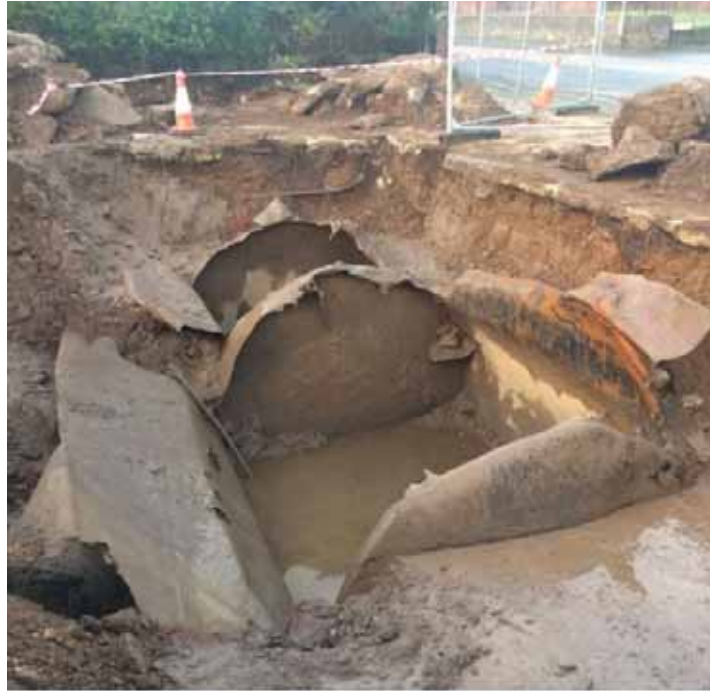
The fuel tank, which was found to be a single tank split into two halves, had been excavated and removed from site prior to GSL site visit; although photographs were supplied by JFL showing the tank being removed, see Photographs 1 and 2 below. JFL reported that the fuel tank was secured to an underlying concrete base, which was being broken out at the time of GSL's visit.

Photograph 1 – Tank (internally divided into two) prior to removal

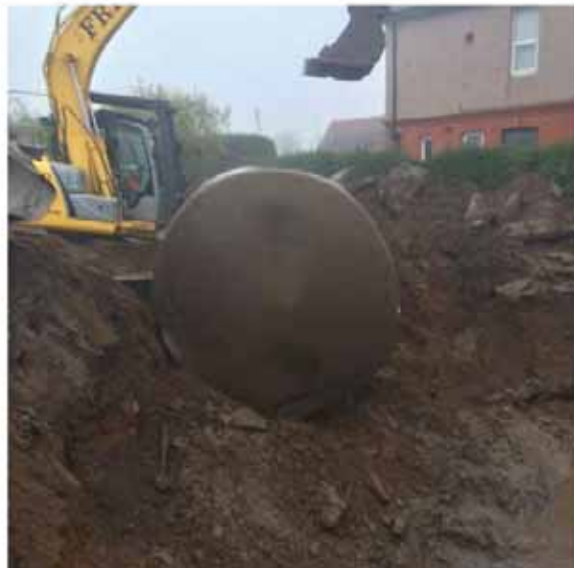
Photograph 2 – Tank being removed from excavation

In GSL experience this is common practice to provide weight to prevent flotation of the tanks when they are empty. It may also limit the potential for any leakage from the tank itself migrating downwards into the surrounding soil.

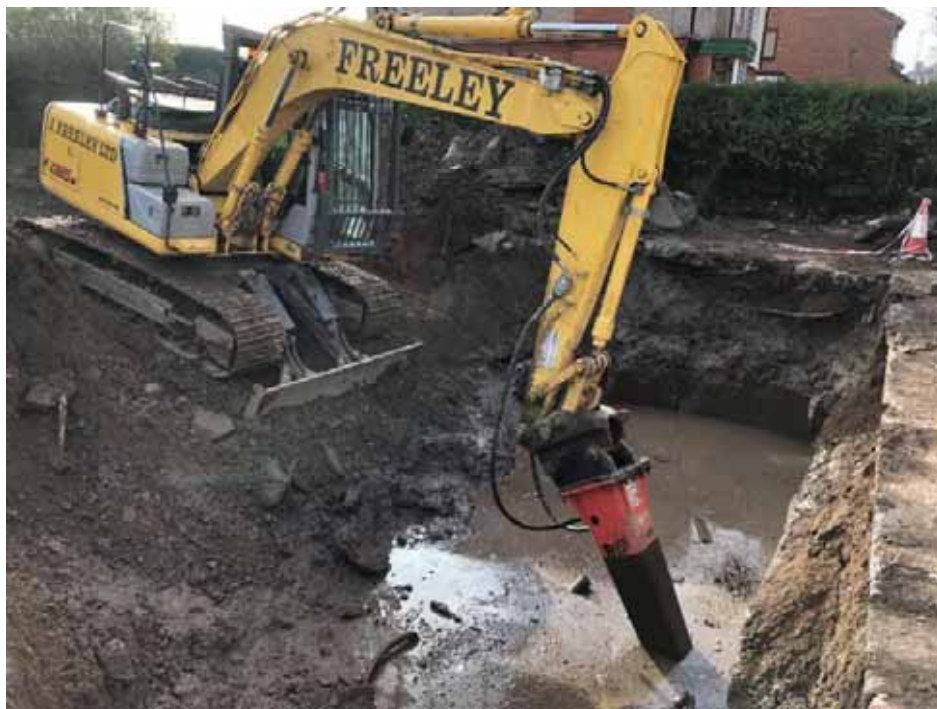
As the tank was found to be full of water, removing it had resulted in around 1m of water sitting above the concrete base, prior to it being broken out, see photograph 3 below. This resulted in difficulty obtaining a clean base to the excavation for sampling purposes. Therefore, a sample was taken from the in-situ soil beneath the slab where it was possible to temporarily exclude the water (sample A), and a sample was also taken of the saturated soil, where the trapped water mixing with the underlying natural soil (sample B).

It should be noted that there was no visible hydrocarbon contamination, sheen, or detectable odour evident on the water or soil.

Photograph 3 – Breaking out underlying concrete slab.

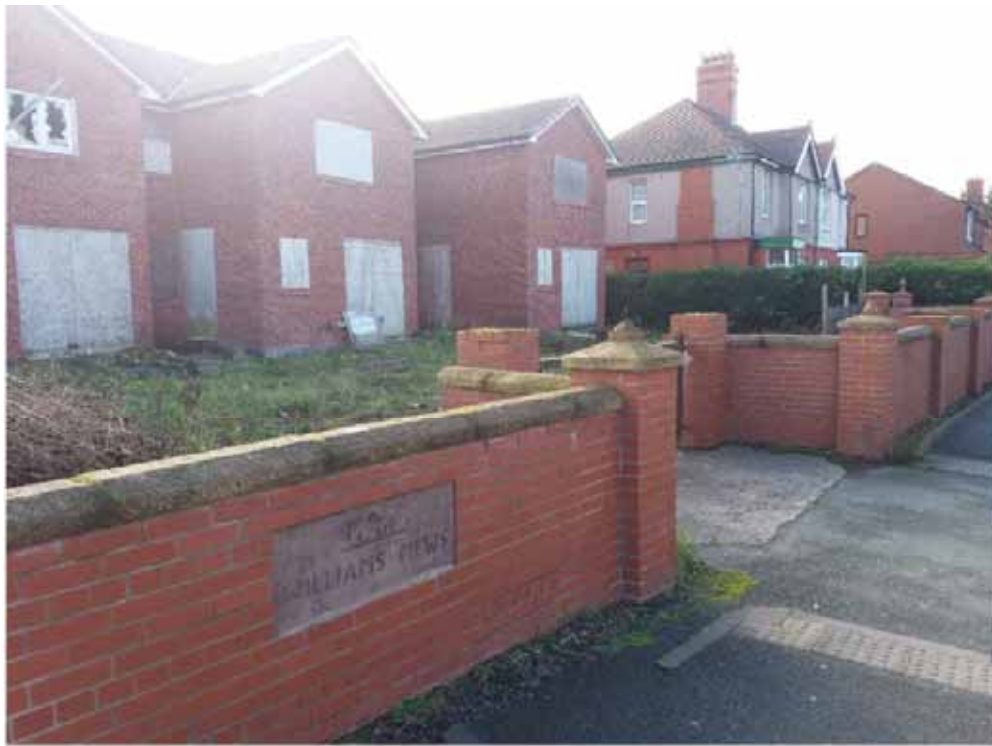
Photograph 1 Site from Ruabon High Street, prior to demolition

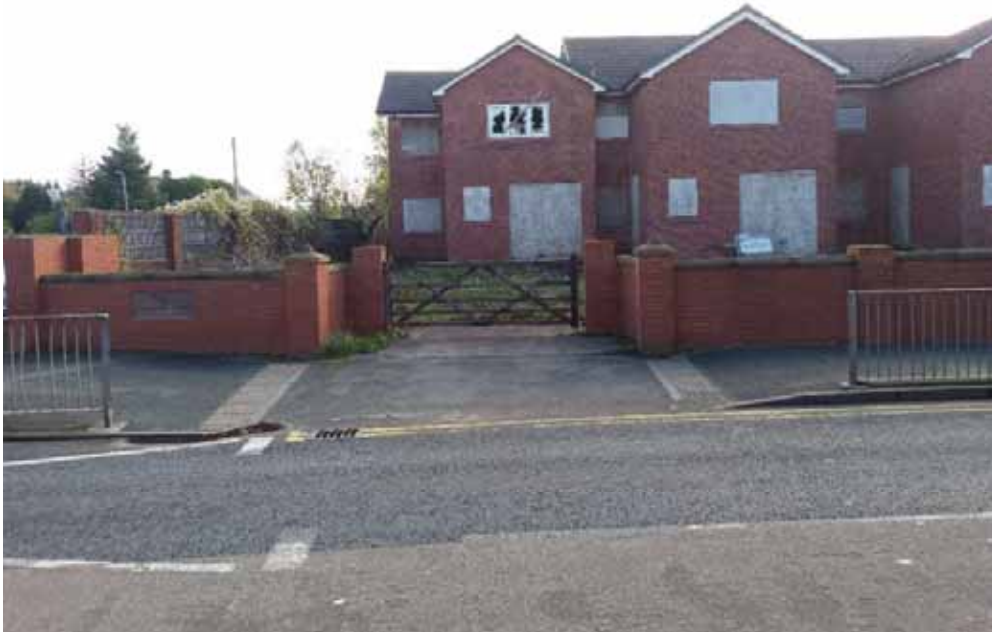
Photograph 2 Site Entrance, prior to demolition

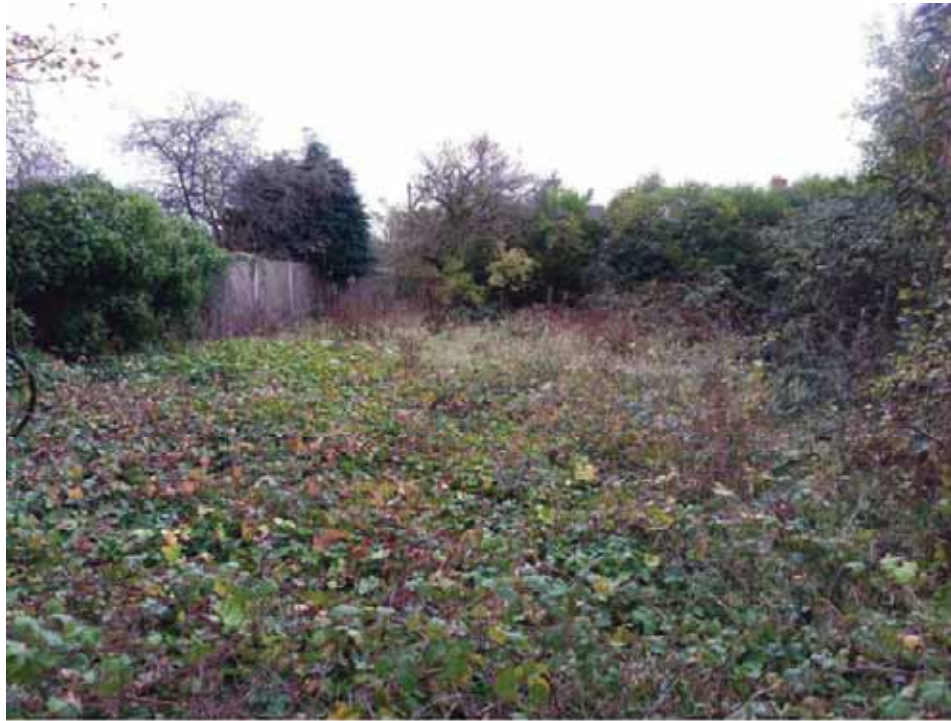
Photograph 3 Garden areas to rear of existing buildings, prior to demolition

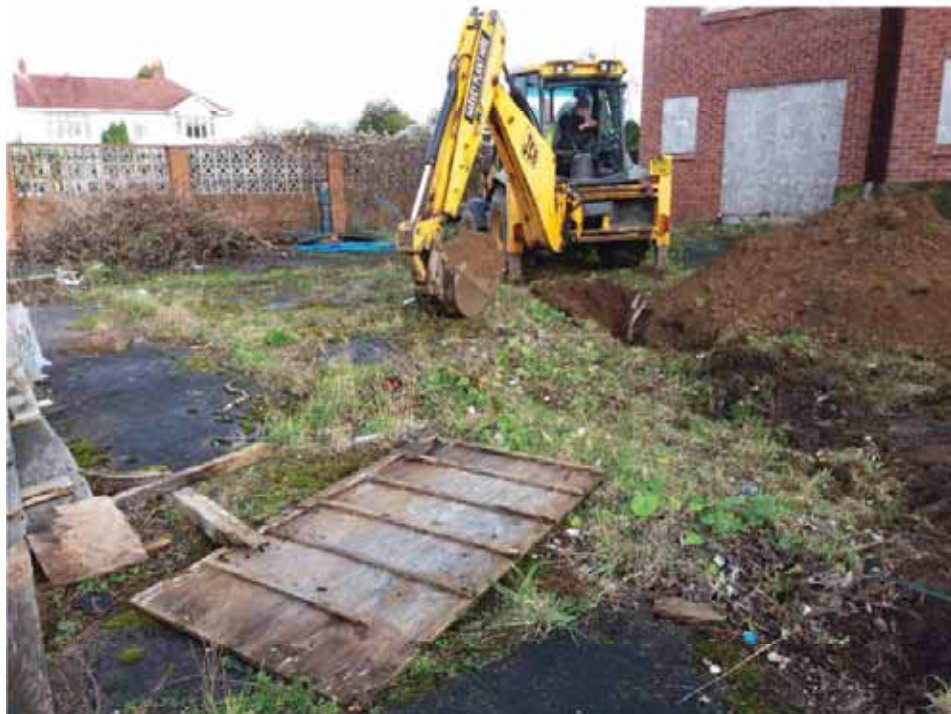
Photograph 4 Concrete and tarmac hardstanding in western part of site, prior to demolition

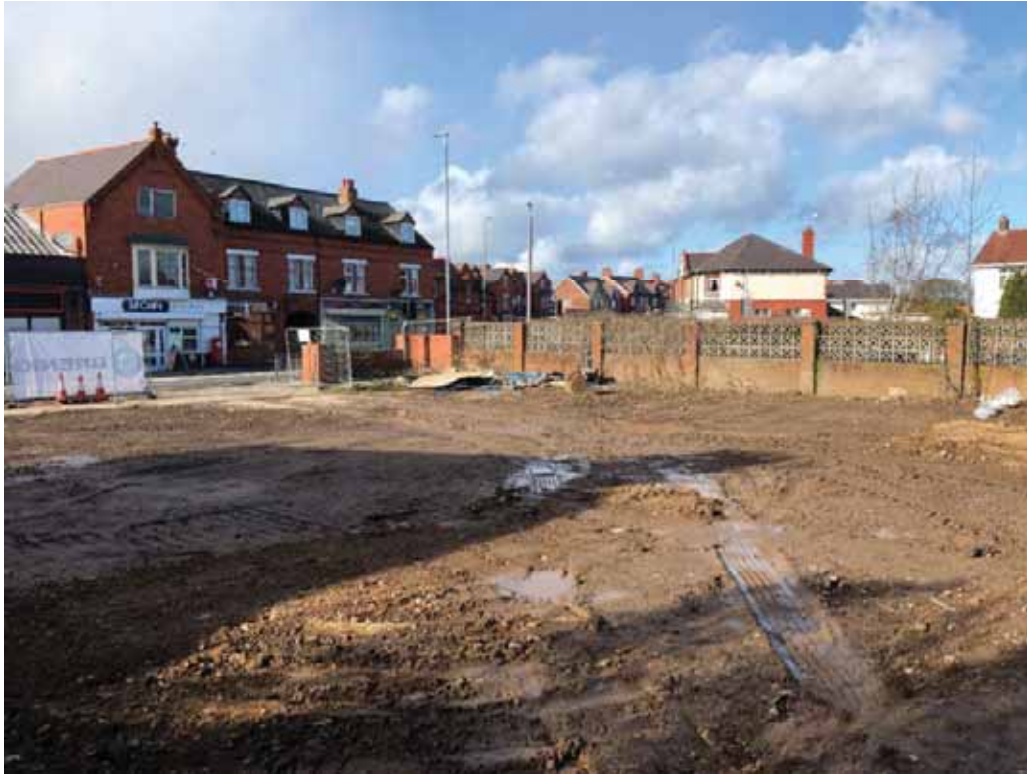
Photograph 5 Site area following demolition of buildings

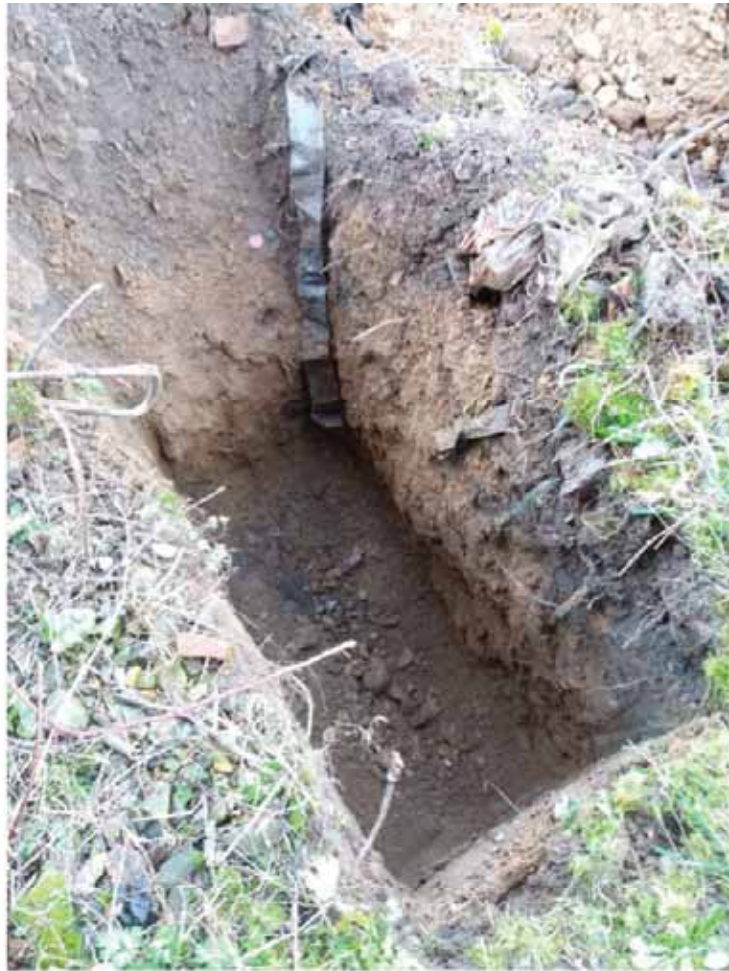
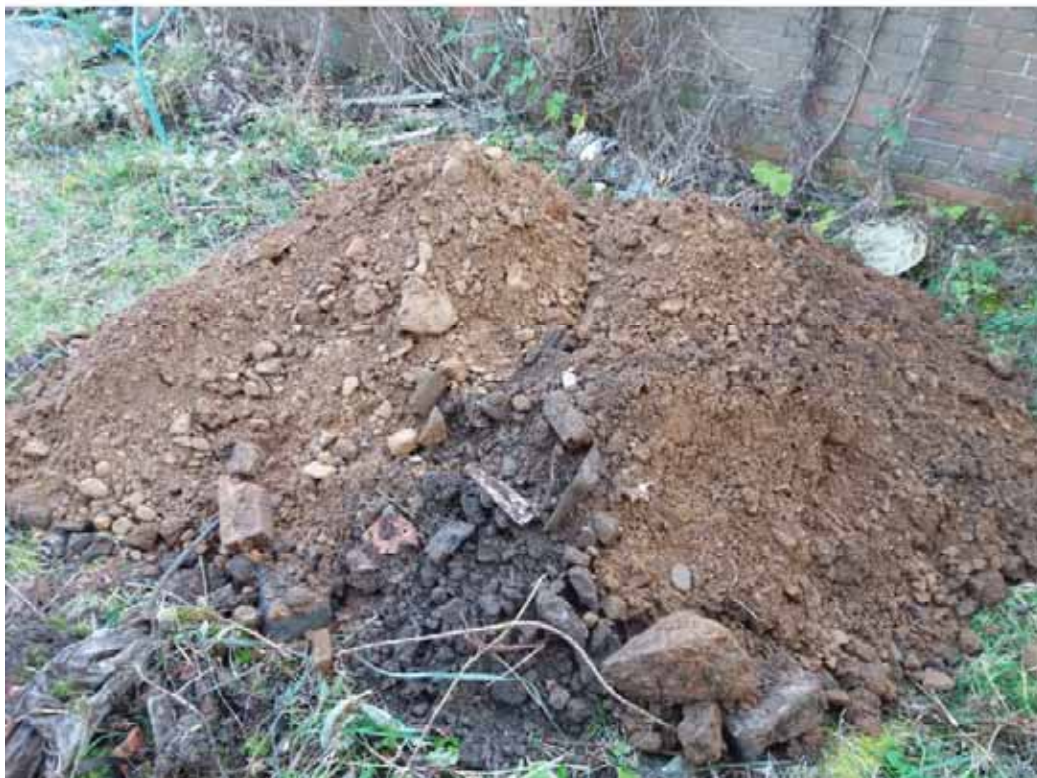
TP1

1. Excavation terminated at 1.9m depth for soakaway testing,
2. Pit dimensions 1.6m x 0.6m,
3. Pit sides were stable,
4. No groundwater encountered.

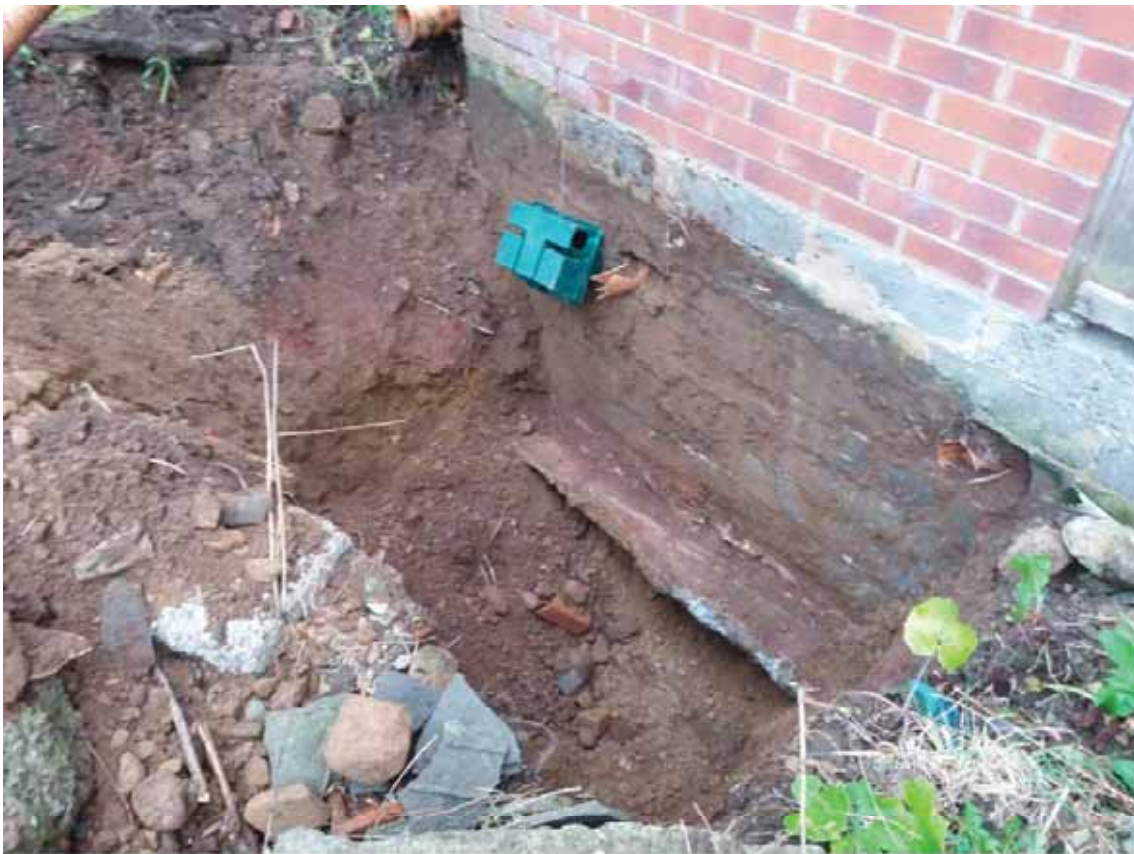
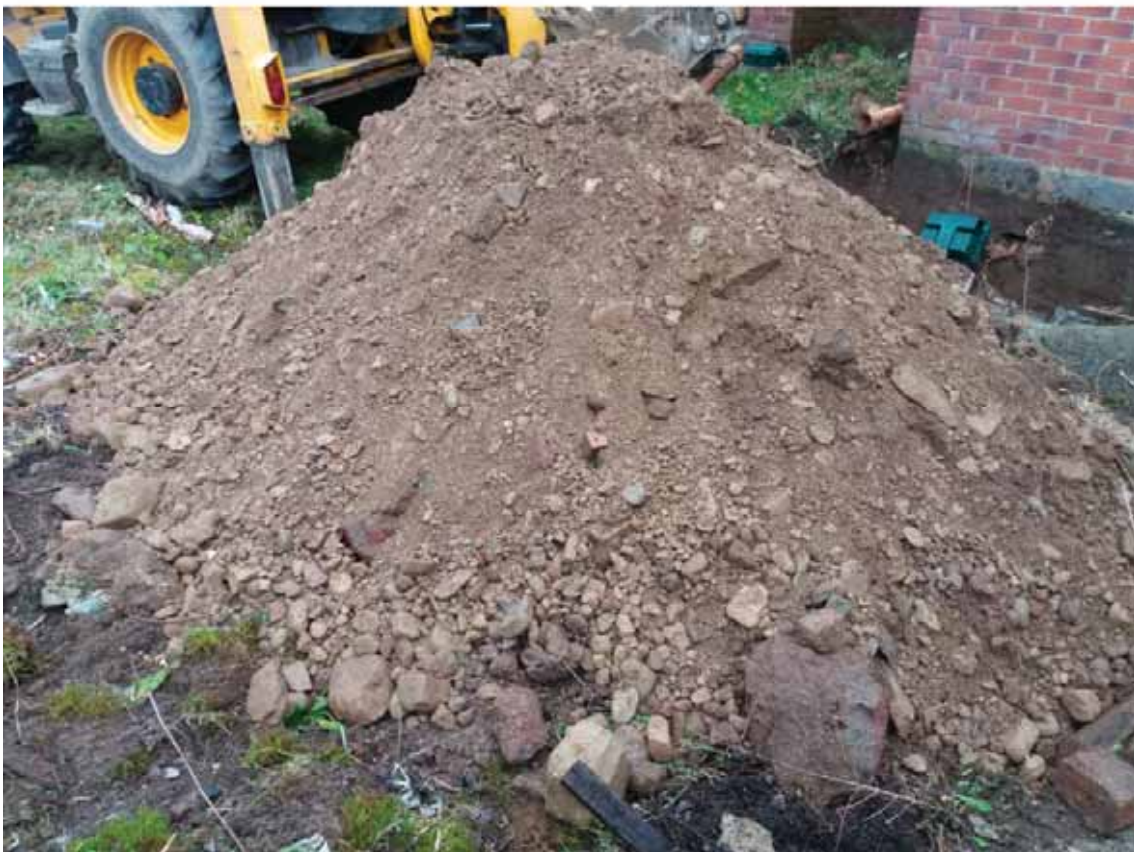
TP2

The trial pit revealed the building to be founded on a shallow strip footing, some 150mm thick and projecting out some 220mm from the building line. The top of the foundation was encountered at 1.1m below existing ground level, and was founded within the glacial sand and gravel.

1. Trial pit excavated alongside existing house foundation, which was encountered at 1.1m depth. The concrete thickness was 150mm, and projected out some 220mm from the brickwork (see following photograph).
2. Excavation terminated at 2.4m depth due to instability of trial pit in sand and gravel.
3. Pit dimensions 2.5m x 2.5m,
4. Pit sides were stable,
5. No groundwater encountered.
6. Jar samples taken at 0.3m and 1.5m depth. Tub sample taken at 1.0m depth.

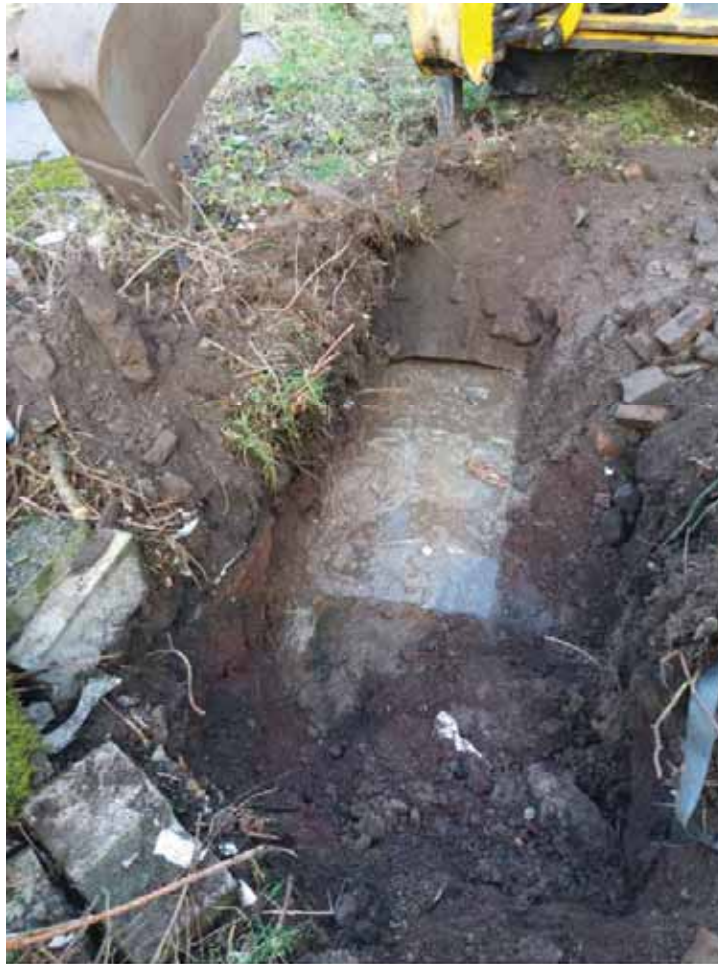
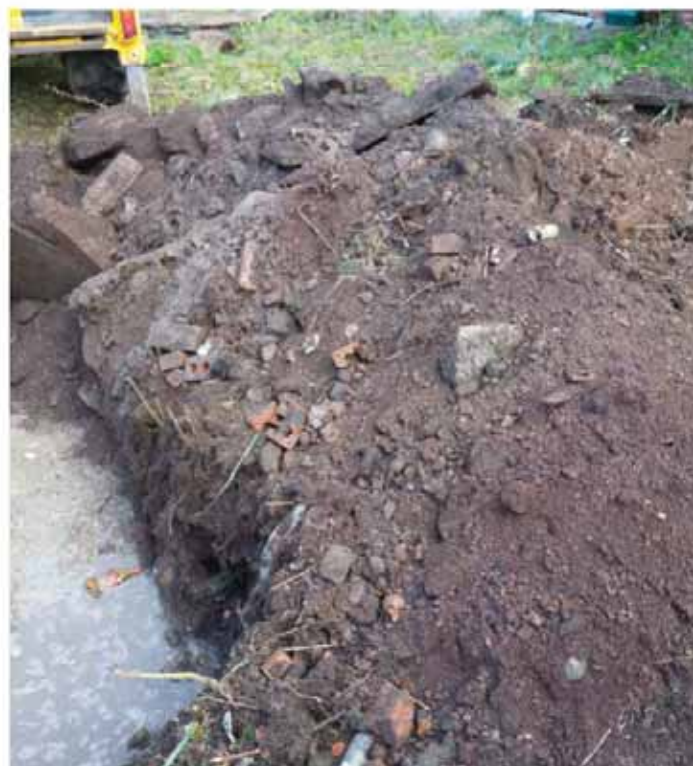
TP3

1. Excavation initially terminated at 0.8m depth on metal obstruction – pit relocated 0.5m to west,
2. Metal tank with rectangular hole (some 1.0x2.0m) cut in top encountered at 0.8m depth, with the tank base at 2.2m depth. Tank was full of water with silty sand and gravel near base.
3. Pit dimensions 2.5m x 2.0m,
4. Pit sides were stable,
5. Strong water inflows when attempting to excavate alongside tank – assumed from water trapped by the tank,
6. Jar samples taken from 2.0m depth (inside tank).

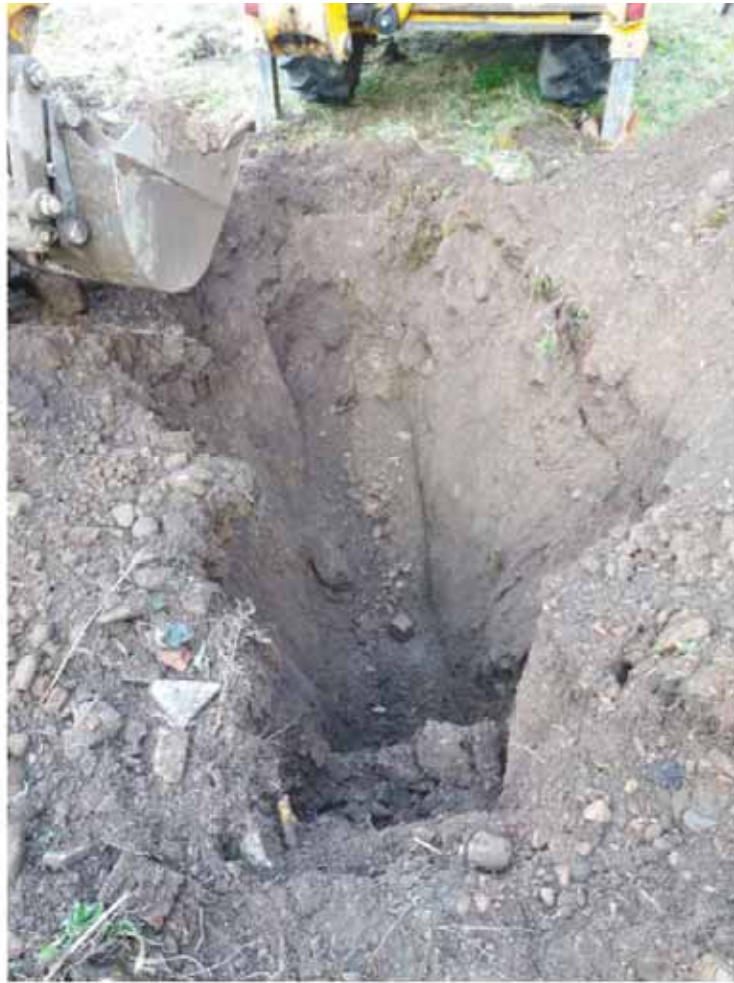
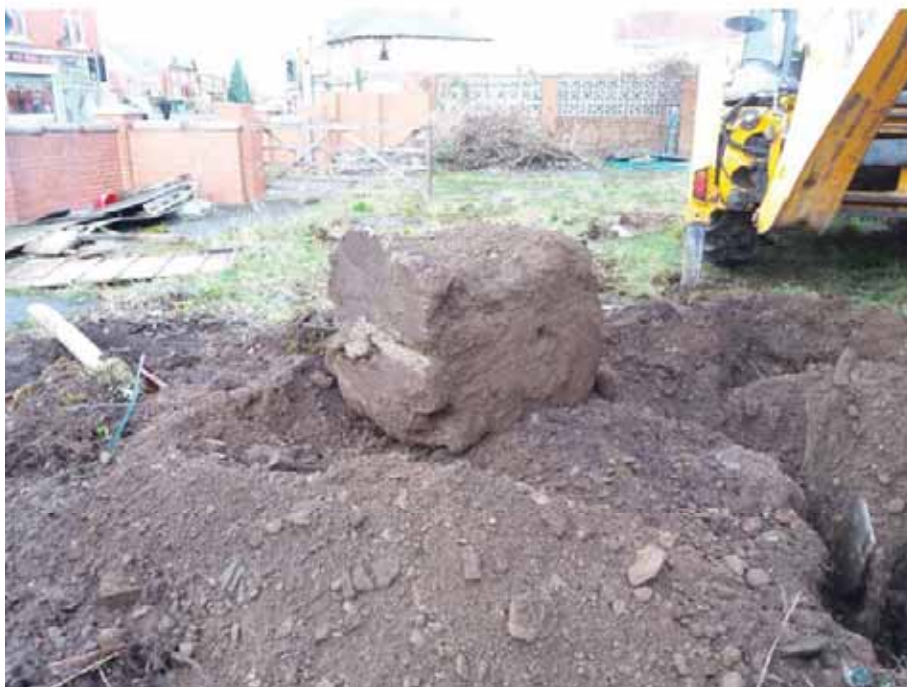
Occasional large concrete boulders, up to 1.2m in diameter, were encountered in TP4 and within the tank removal excavation, and are likely to be old foundations for the former petrol station canopy.

1. Excavation terminated at 1.7m depth due to obstructions,
2. Pit dimensions 2.0m x 0.6m,
3. Pit sides were unstable in sand and gravel strata,
4. No groundwater encountered,
5. Jar samples taken at 1.7m depth, tub sample taken at 1.2m depth.

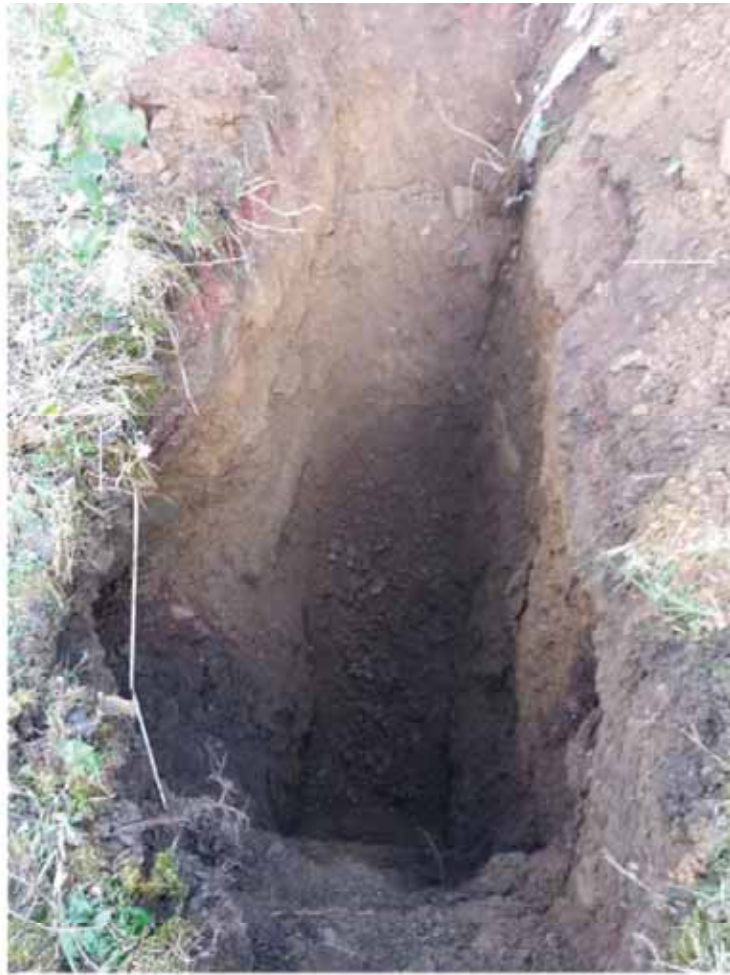
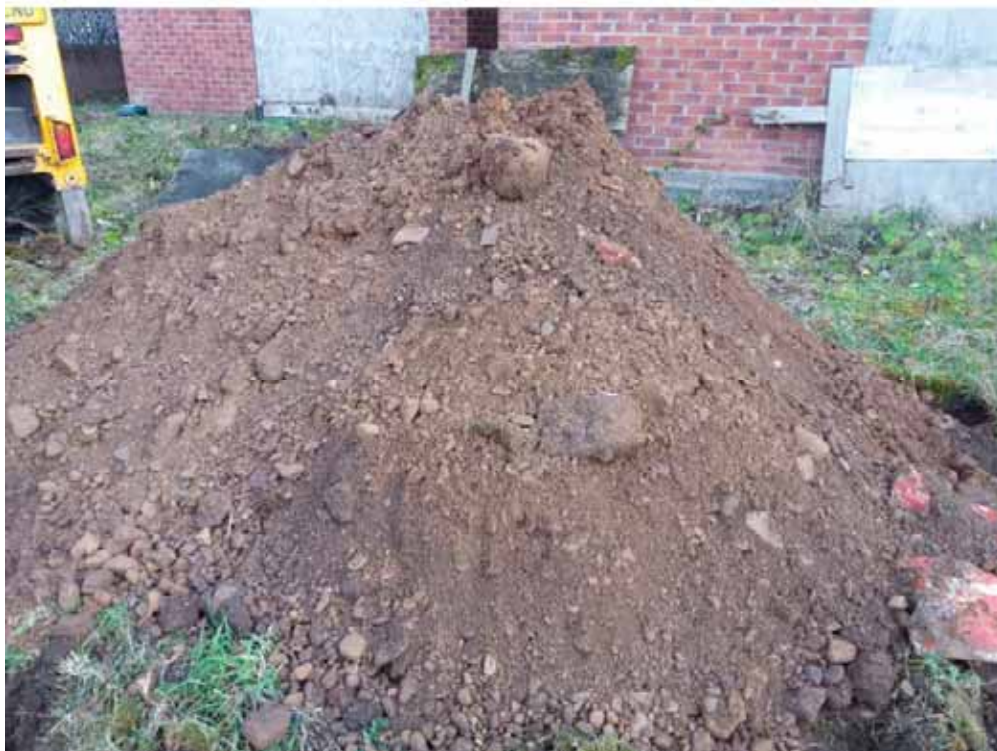
TP5

1. Excavation terminated at 3.0m depth,
2. Boundary with made ground from tank excavations (dark grey SAND AND GRAVEL) visible in southern face of pit,
3. Pit dimensions 2.5m x 1.0m,
4. Pit sides becoming unstable with depth
5. No groundwater encountered.

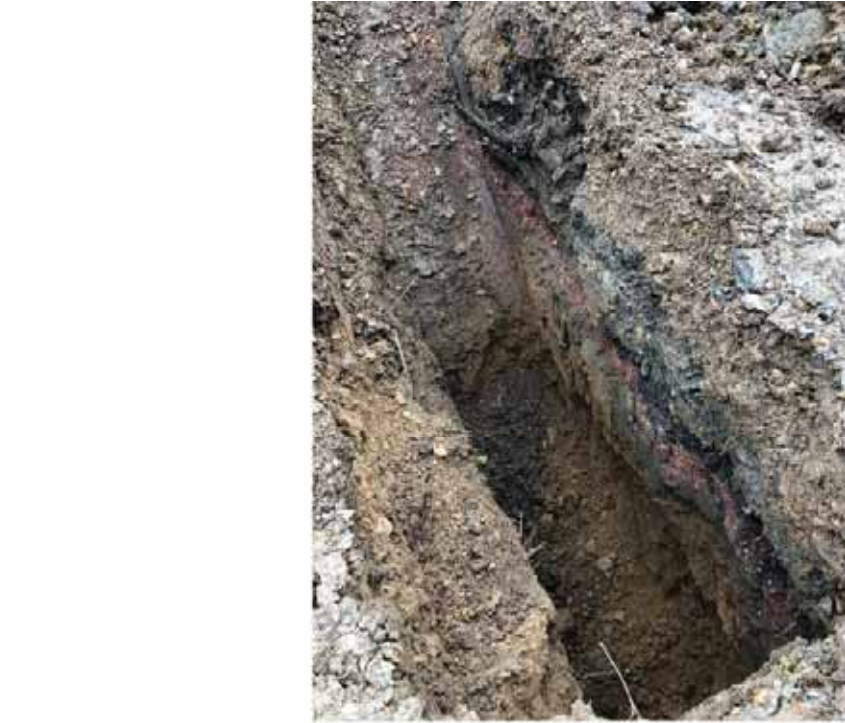
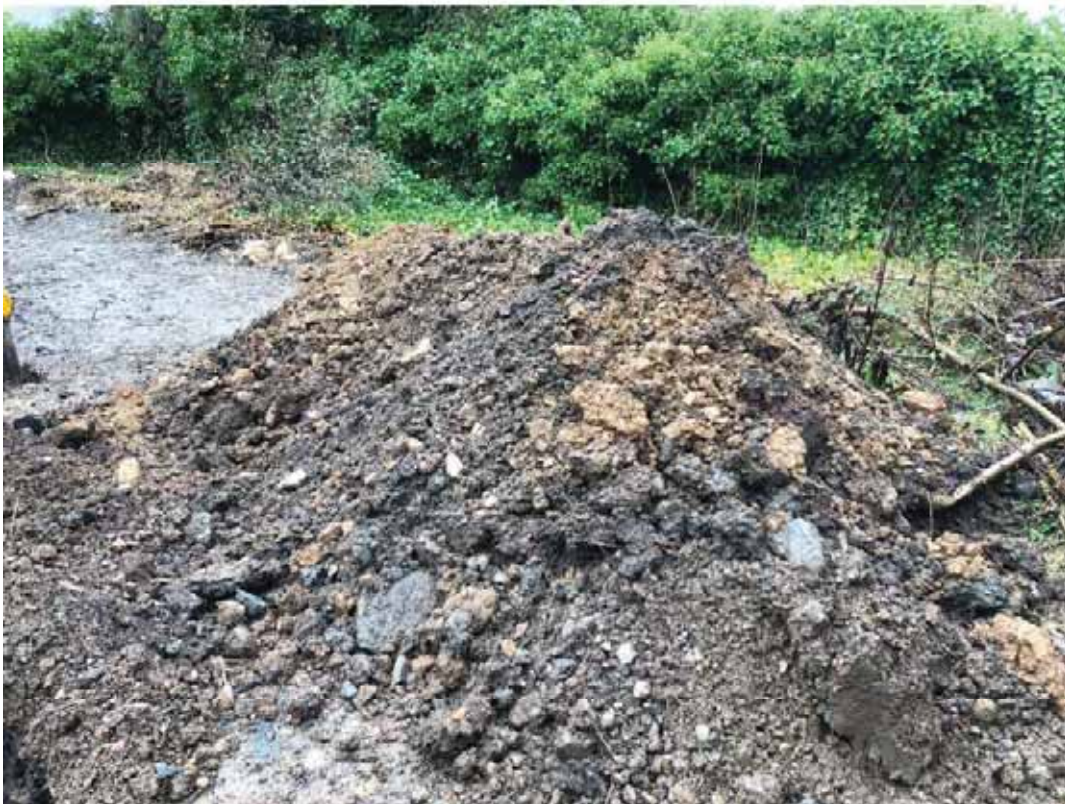
1. Pit dimension 2.20 x 0.70 x 2.10m depth.
2. Pit sides were locally unstable.
3. No groundwater encountered.
4. Soakaway testing carried out.
5. Sample taken at 0.30m depth for chemical testing.
6. Sample taken at 1.00m depth for pH and Sulphate testing.

TP A – Pit walls

TP A – Arising

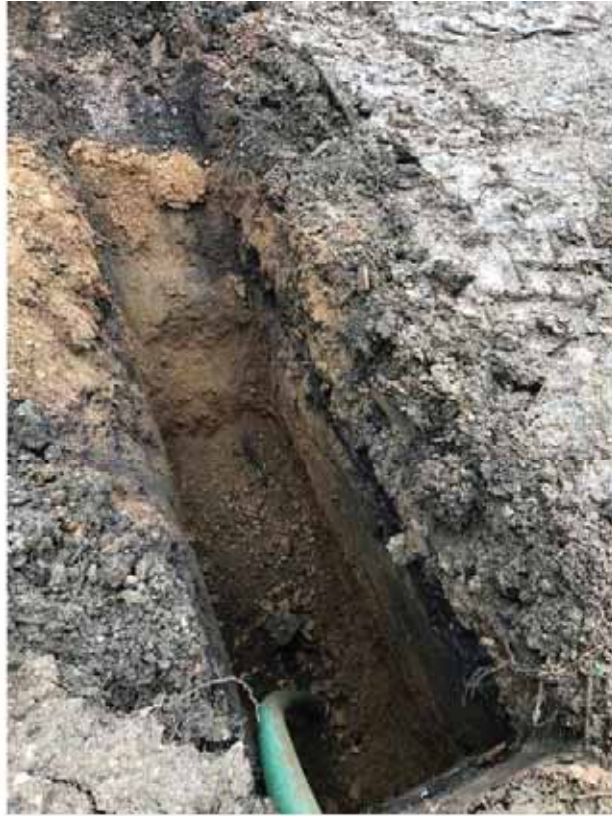
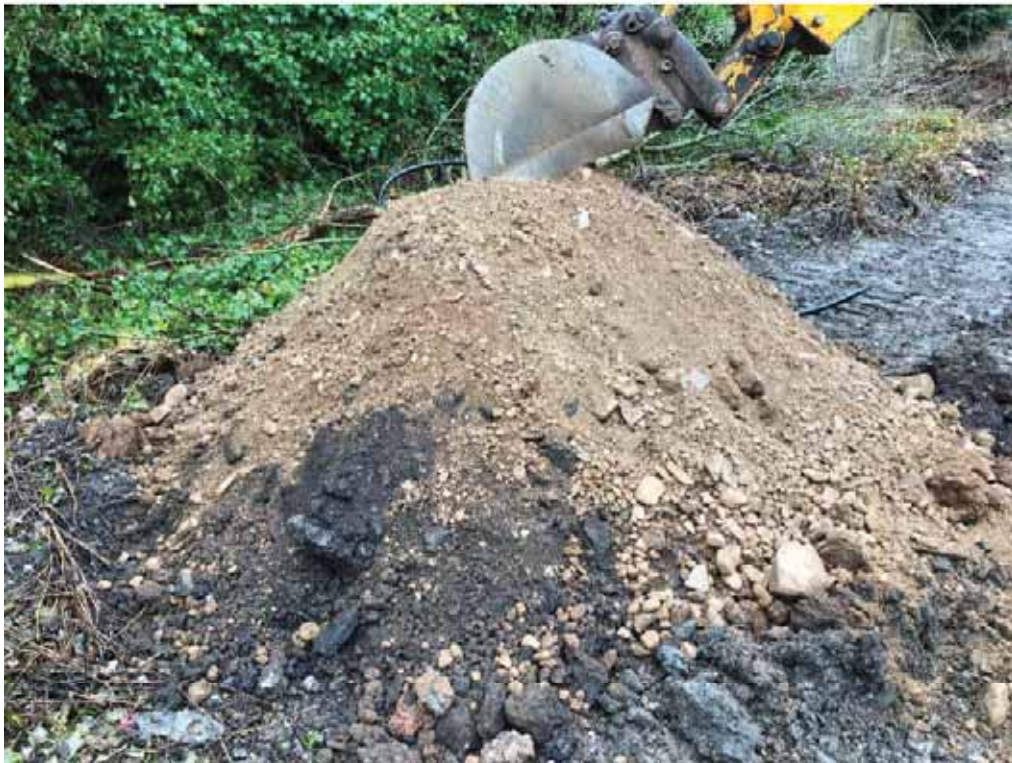
1. Pit dimension 2.30 x 0.70 x 2.10m depth.
2. Pit sides were locally unstable.
3. No groundwater encountered.
4. Soakaway testing carried out.
5. Sample taken at 0.20m depth for chemical testing.
6. Sample taken at 0.90m depth for pH and Sulphate testing.

TP B – Pit walls

TP B – Arising

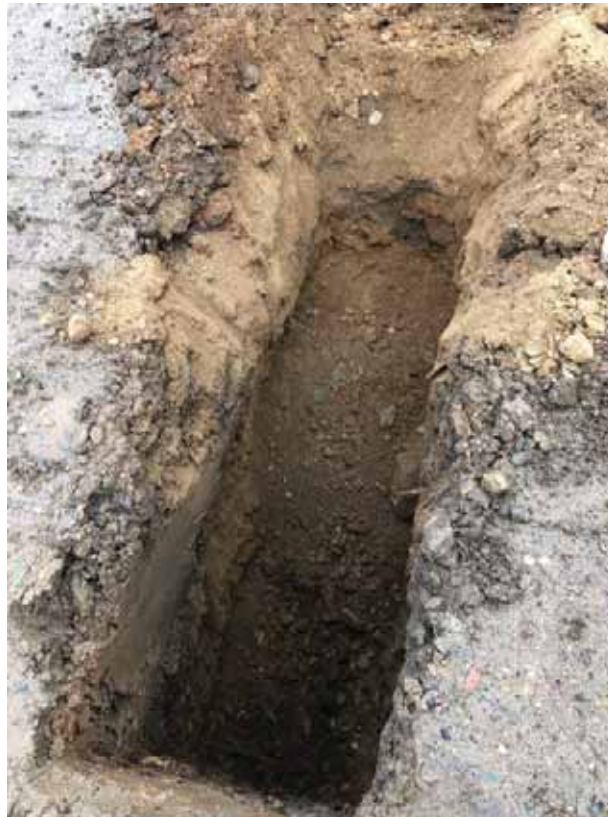
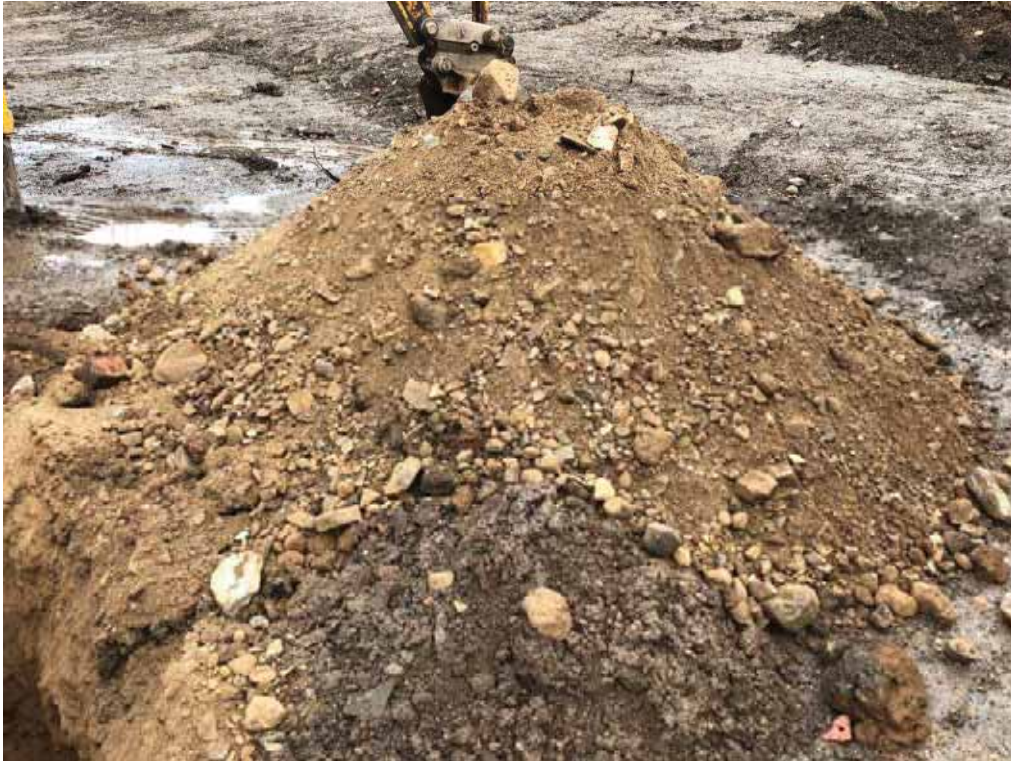
1. Pit dimension 2.50 x 0.70 x 1.80m depth.
2. Pit sides were unstable below 1.10m depth.
3. No groundwater encountered.
4. Sample taken at 1.10m depth for pH and Sulphate testing.

TP C – Arising

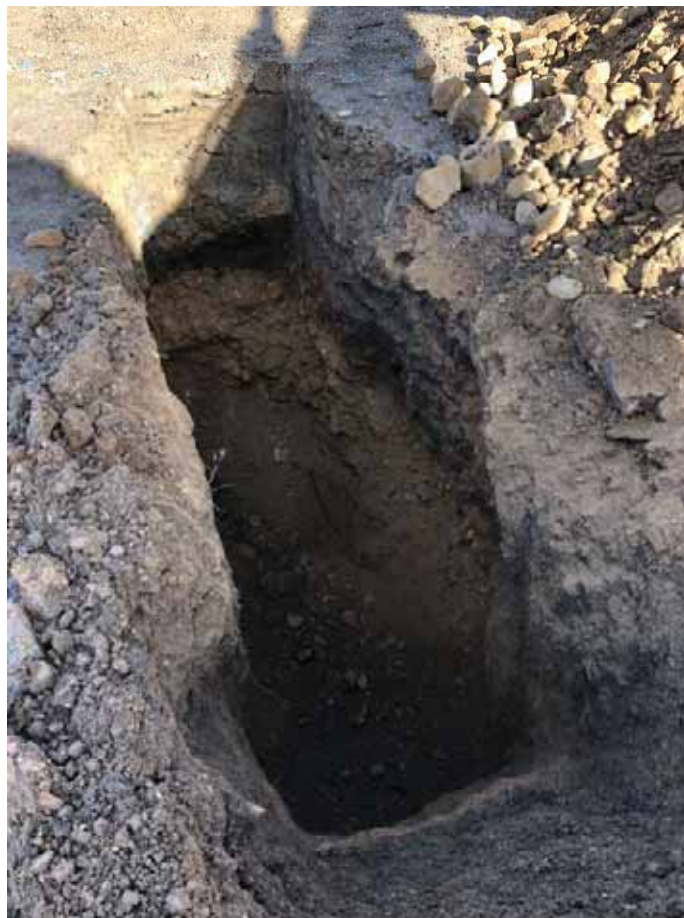
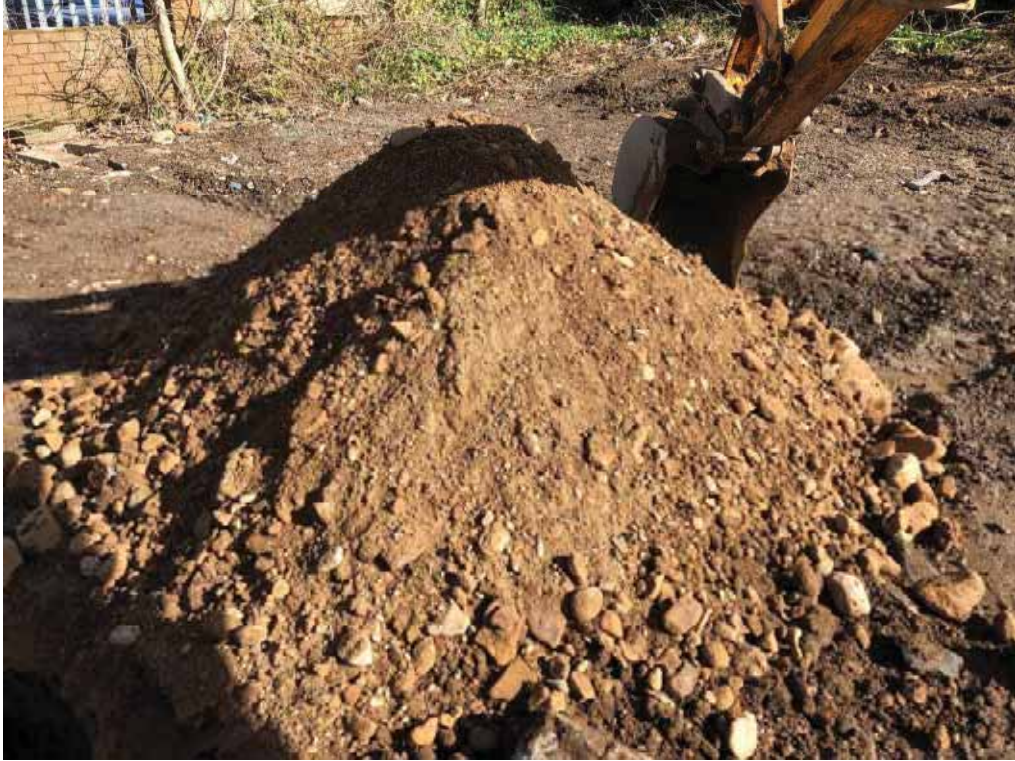
1. Pit dimension 2.50 x 1.00 x 2.00m depth.
2. Pit sides were unstable.
3. No groundwater encountered.
4. Sample taken at 0.50m depth for chemical testing.
5. Sample taken at 1.00m depth for pH and Sulphate testing.

TP D – Pit walls  
GroundSolve Ltd

TP D – Arising
