## Draft Report For Discussion

### 2<sup>nd</sup> CMRA Follow-On Rotary Drilling Investigation

| <b>LOCATION</b> | Terfynfa, 12 Smelt Road, Coedpoeth, Wrexham<br>LL11 3SH |
| <b>OUR REF.</b> | G25382 |

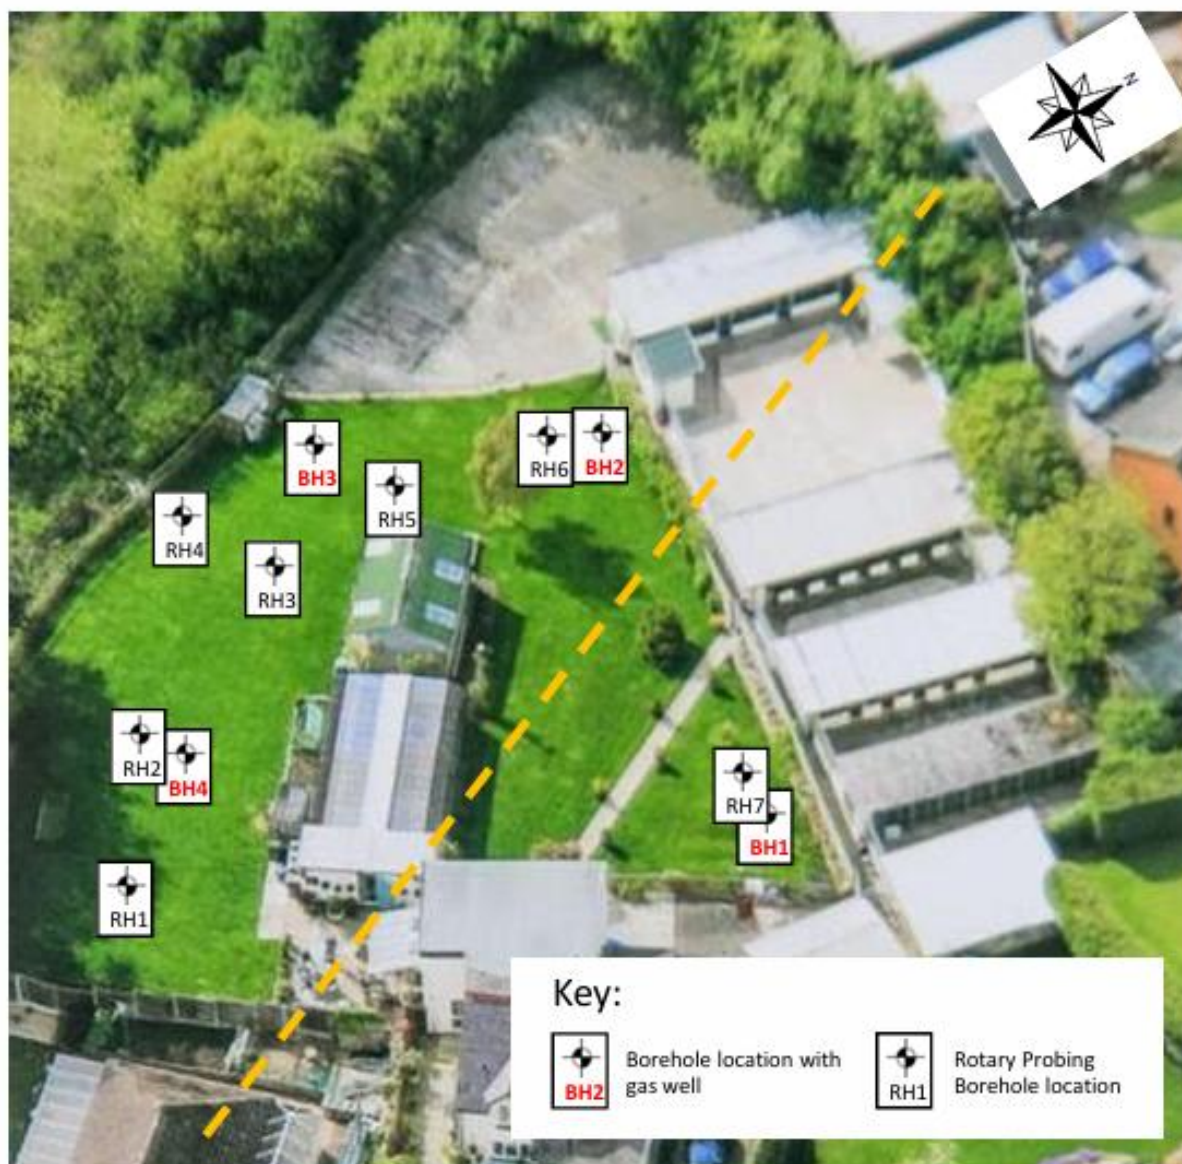
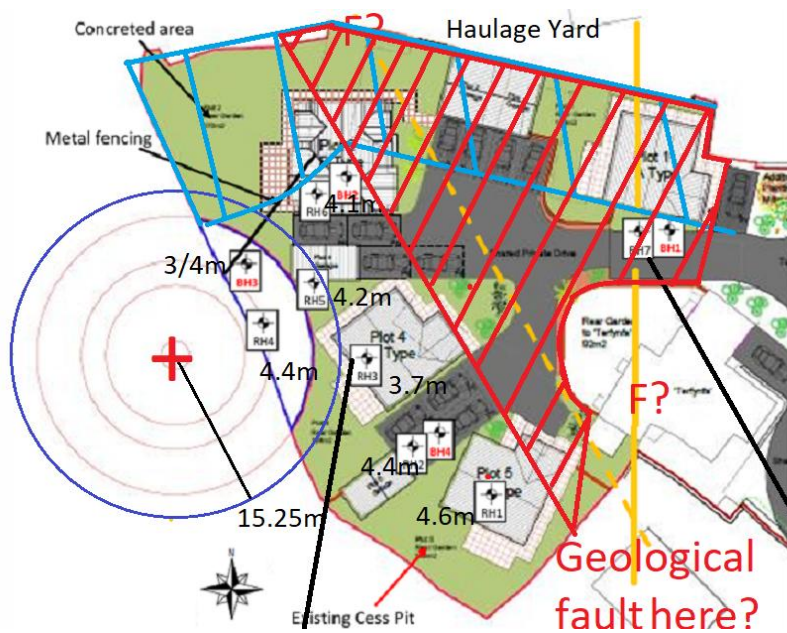
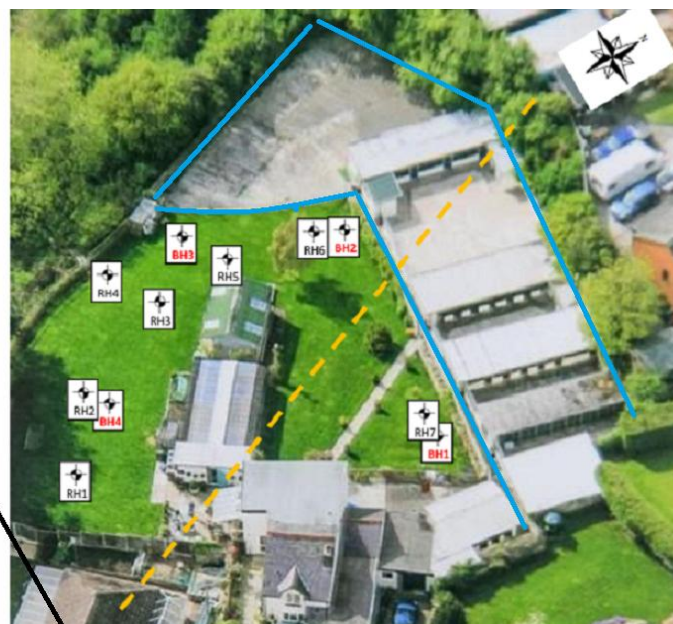
### **1<sup>st</sup> PHASE BOREHOLE LOCATIONS & REVISED ZOI BASED ON 4m BEDROCK DEPTH IN BH3**

On the other hand, given its positional uncertainty of 10m, the shaft could lie on or close to the west site boundary/fence line of Terfynfa, as shown in Appendix 3.

Based on "mechanical" bedrock depth of 4m returned by window sampling borehole BH3 (the closest sampled borehole to the shaft which encountered completely weathered mudstone between 3m to 4m) the calculated zone of influence (ZOI) of the shaft forms a segment of a circle of radius 15.25m extending up to 5.75m east into the development area, potentially impacting the rear of Plots 3 and 4 of the architects 5 Plot layout version of the development plan provided in Appendix 1. It is Geoinvestigate's experience that rotary drilling by nature of its destructive nature typically indicates bedrock position up to 1m deeper and sometimes more than found in cored boreholes.

As a consequence of the increase in ZOI size, the client, Mr D Wardman, had two options: either reduce the development to 4 Plots instead of 5, or drill a line of raking probe holes adjacent to the shaft with the hopeful expectation of confirming that the shaft was located on the slope with sufficient distance from the western site boundary so that its ZOI did not extend within the development area. After lengthy consideration the client chose the drilling option.

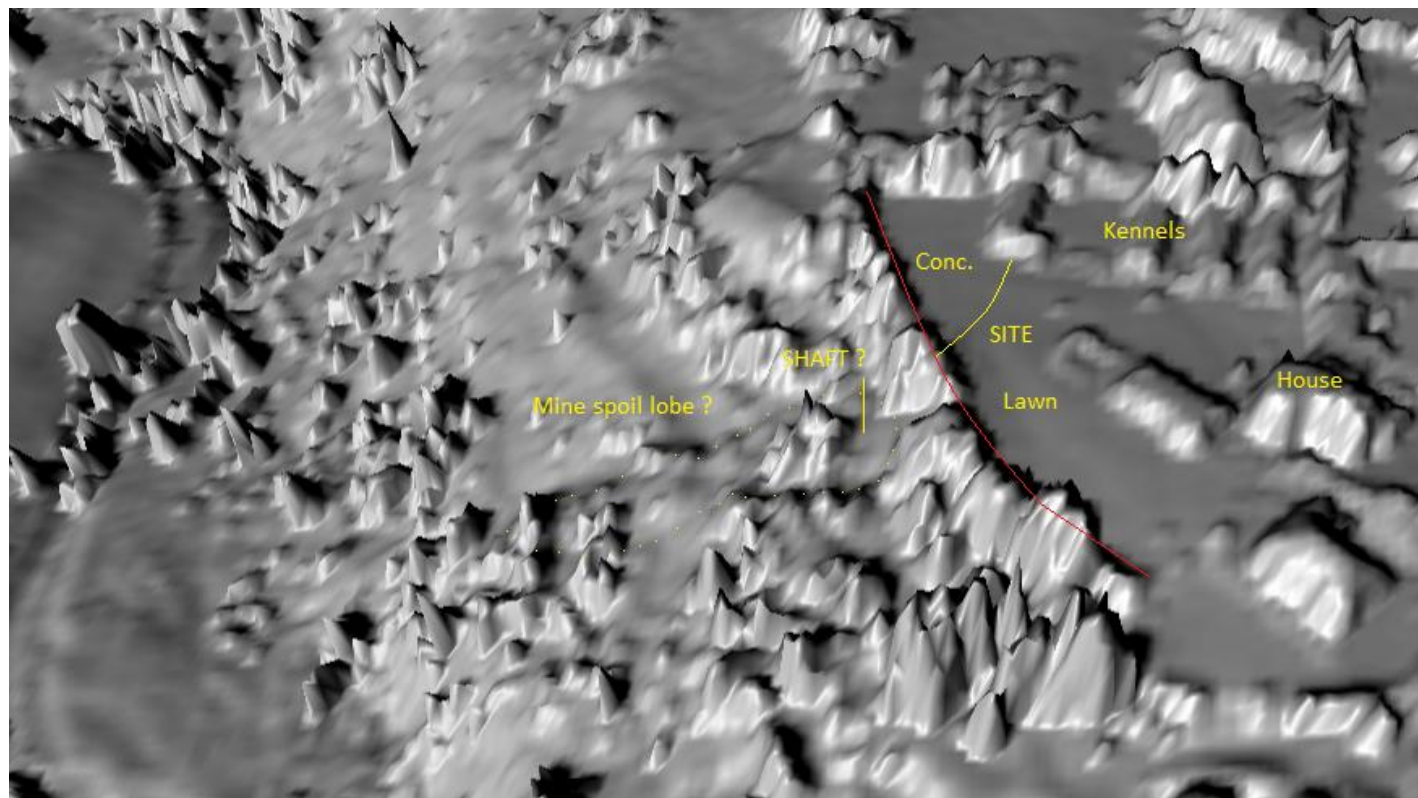
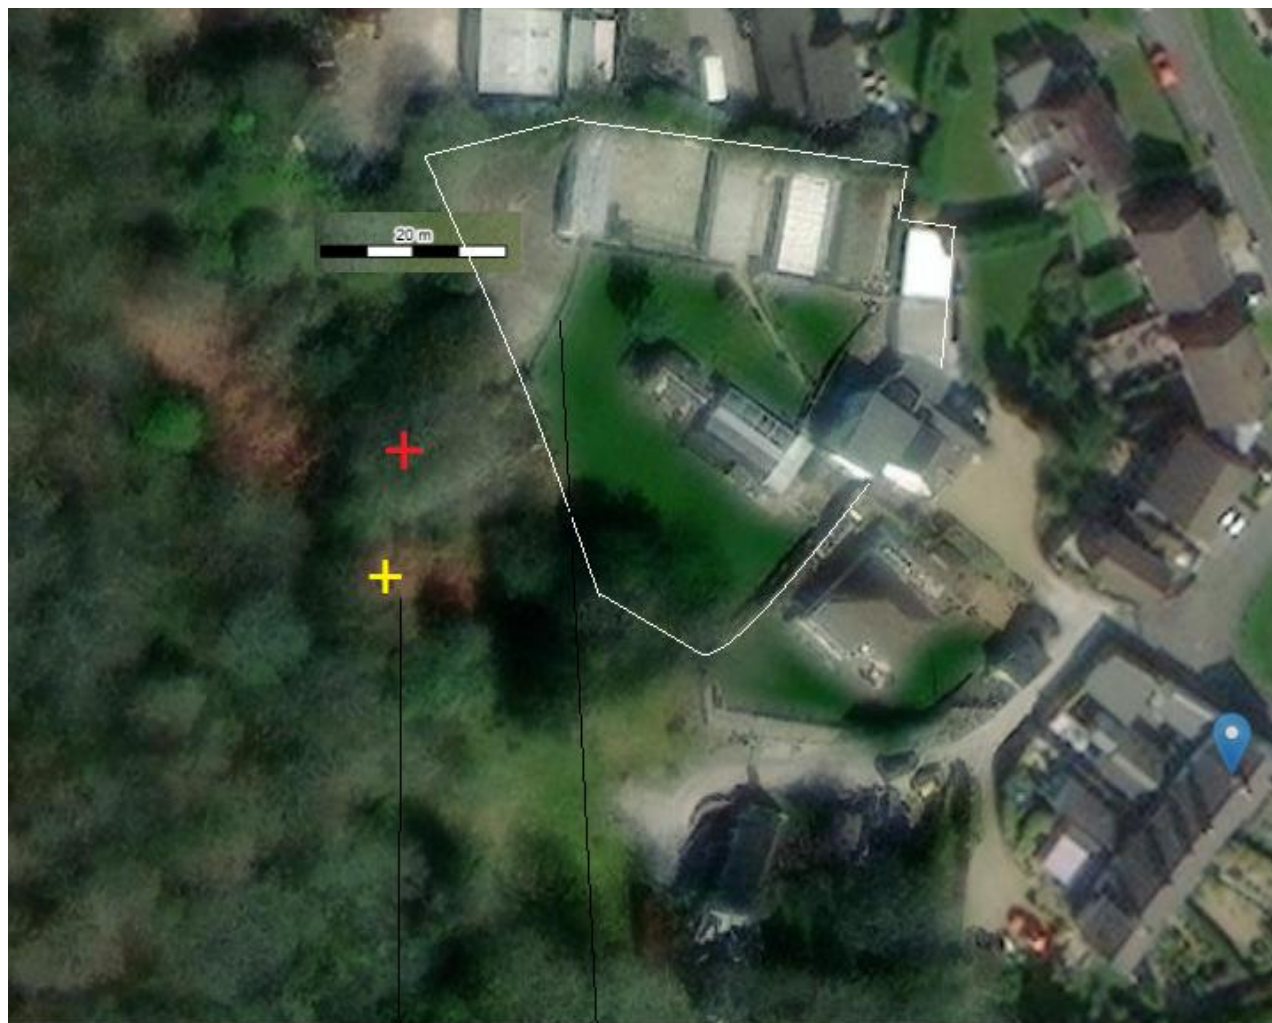
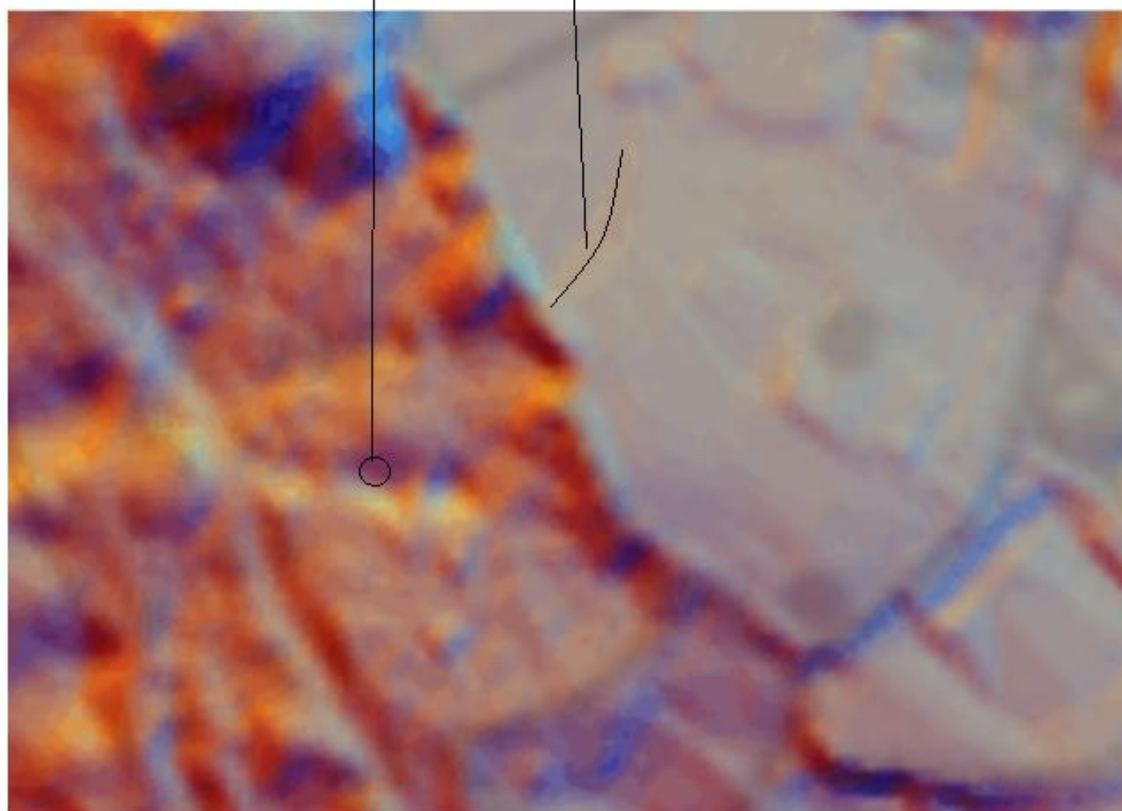
### **LiDAR IMAGERY**

ownership issues and neither was it possible for reasons of safe access to verify its position by walkover inspection, though the LiDAR imagery presented in Appendix 4 might provide evidence of its existence further south on the slope.

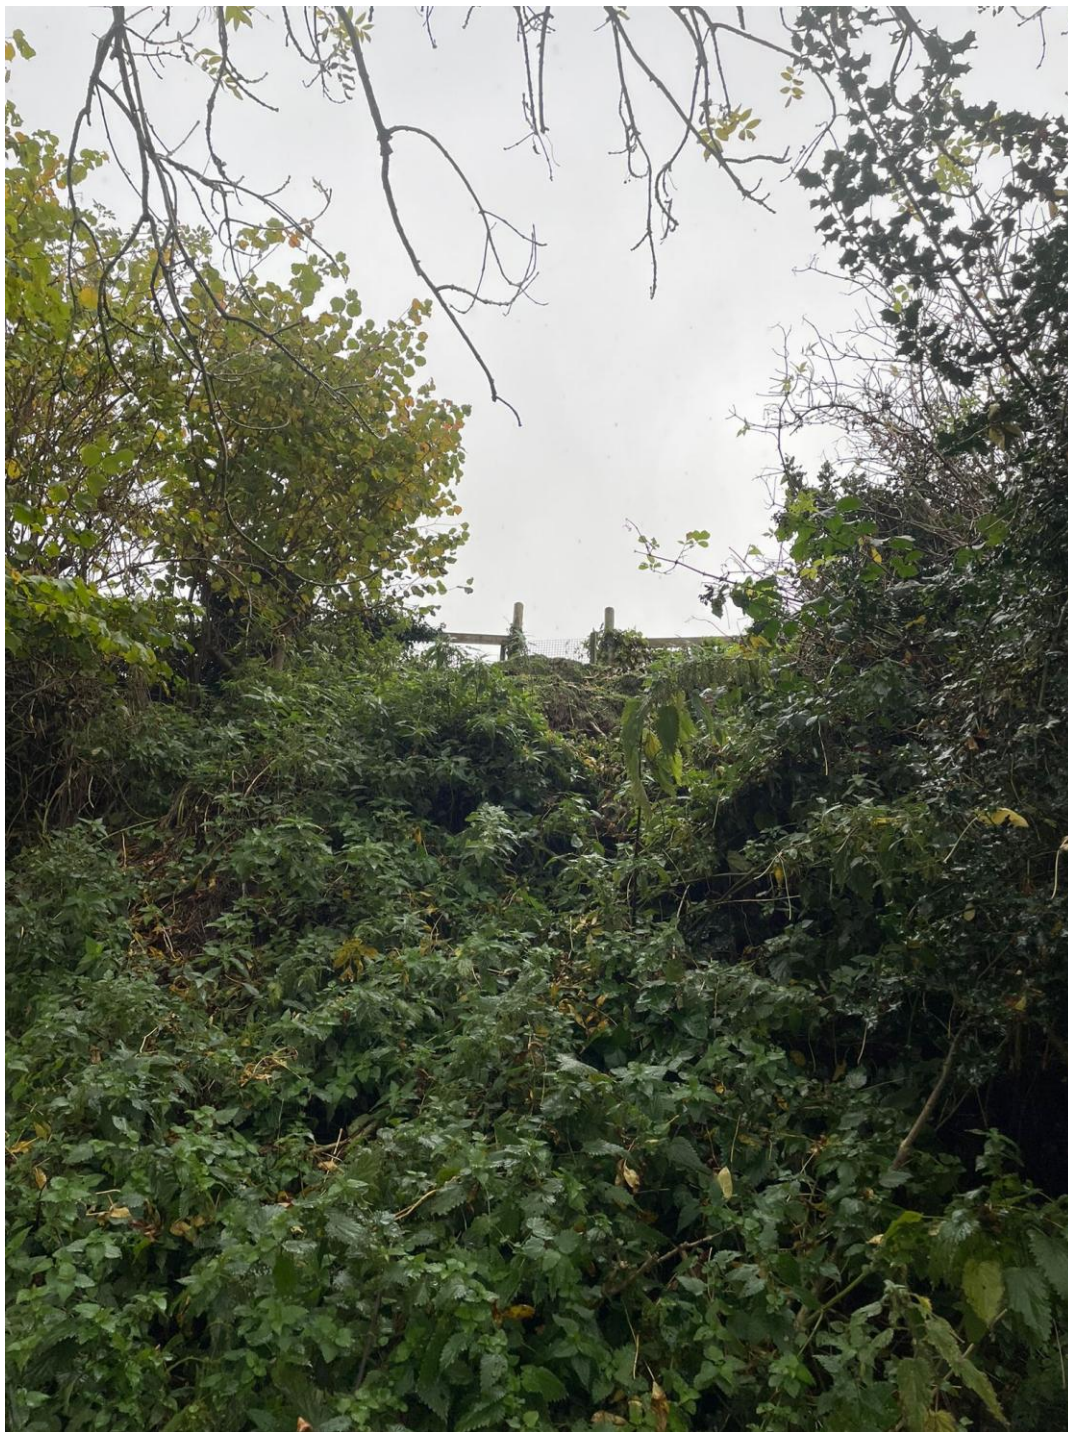
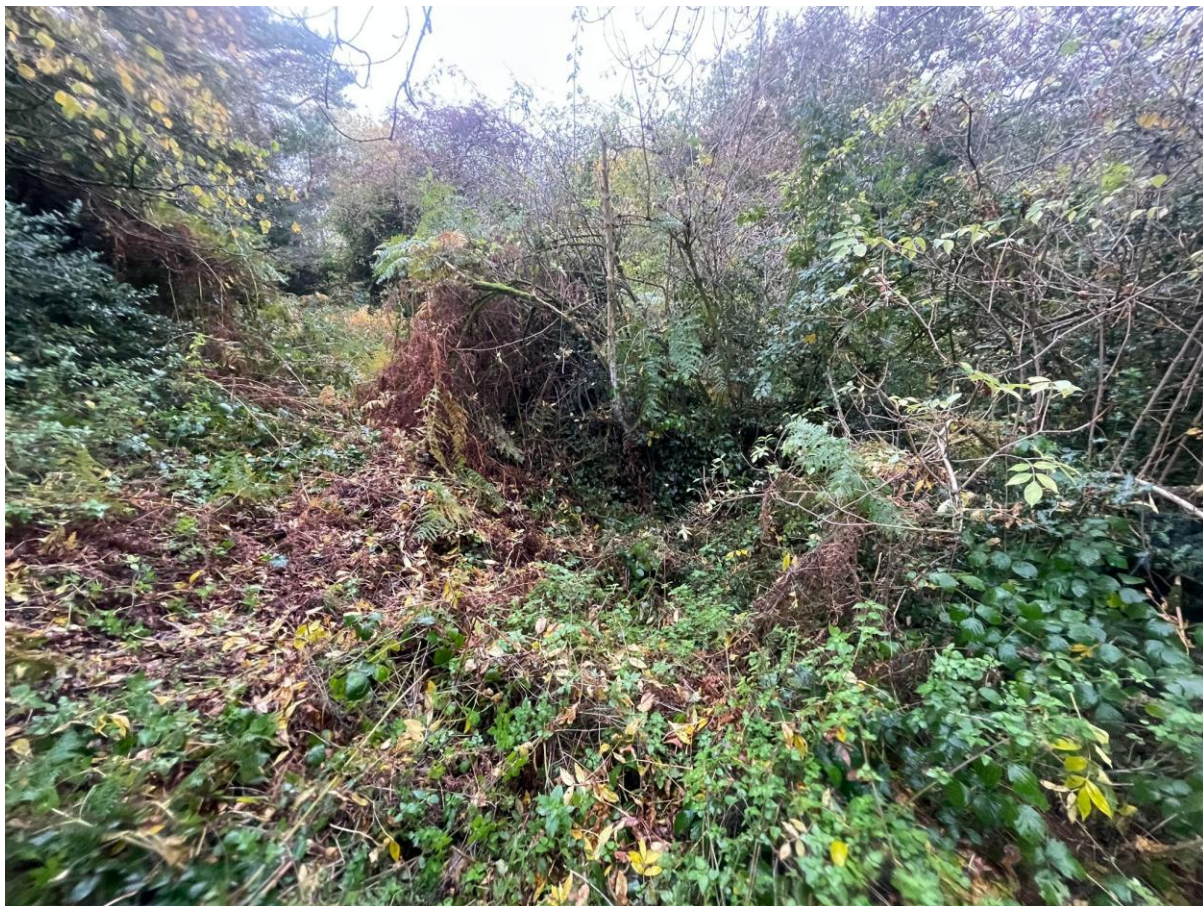
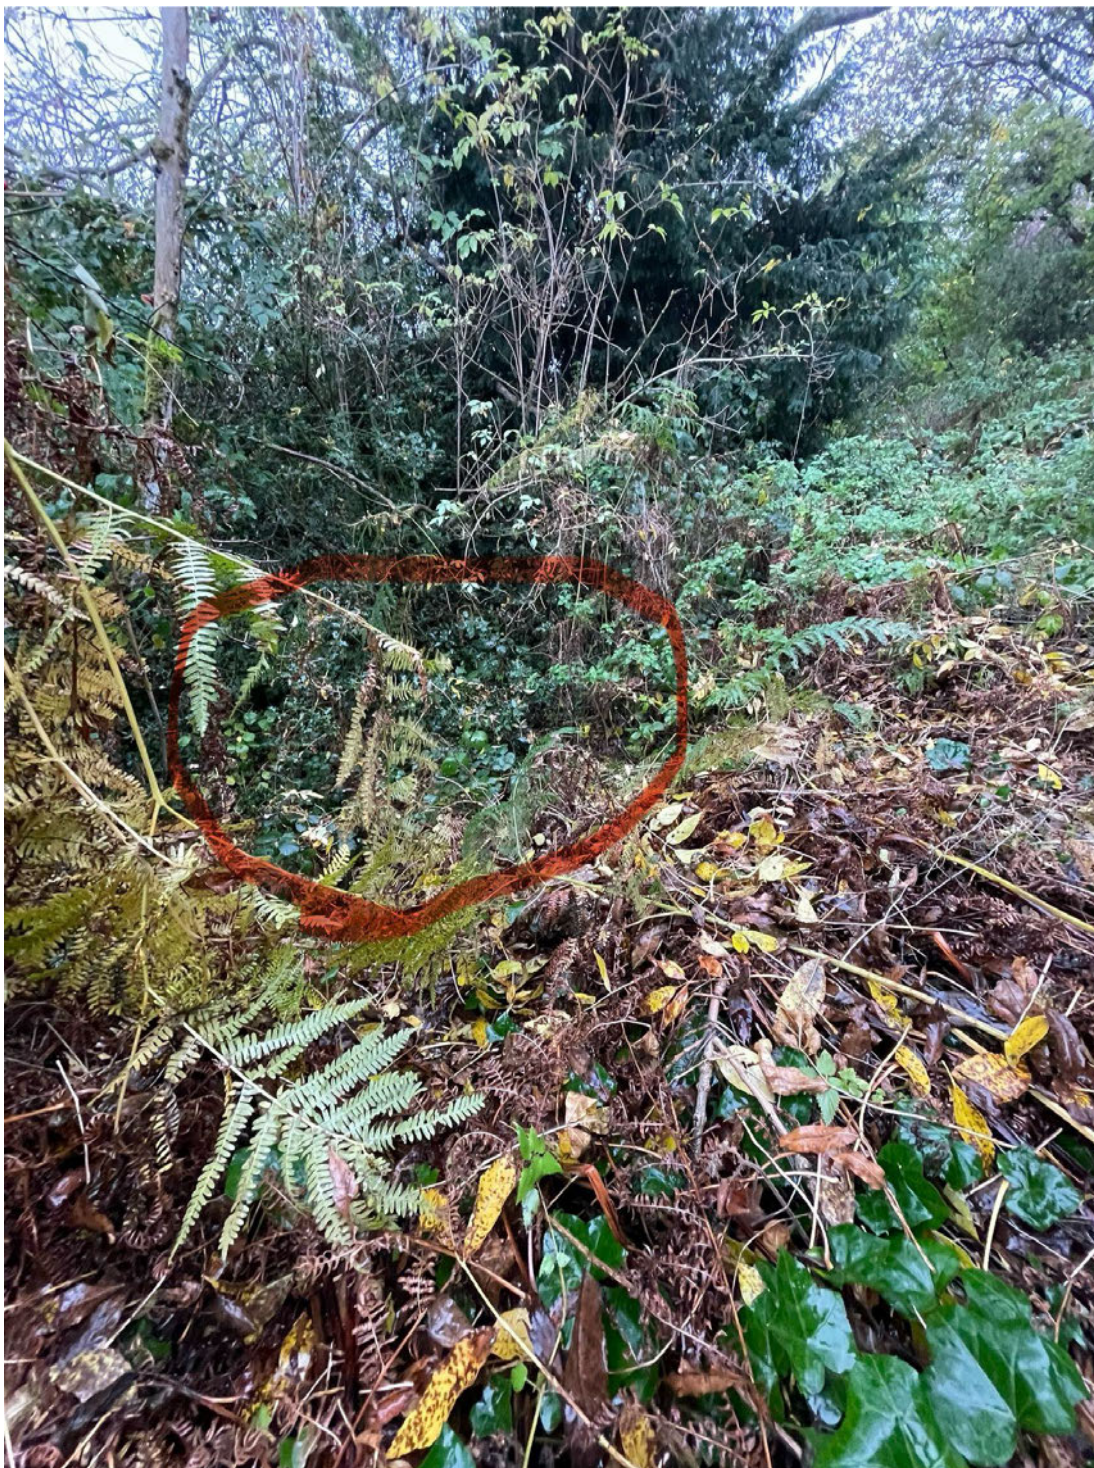
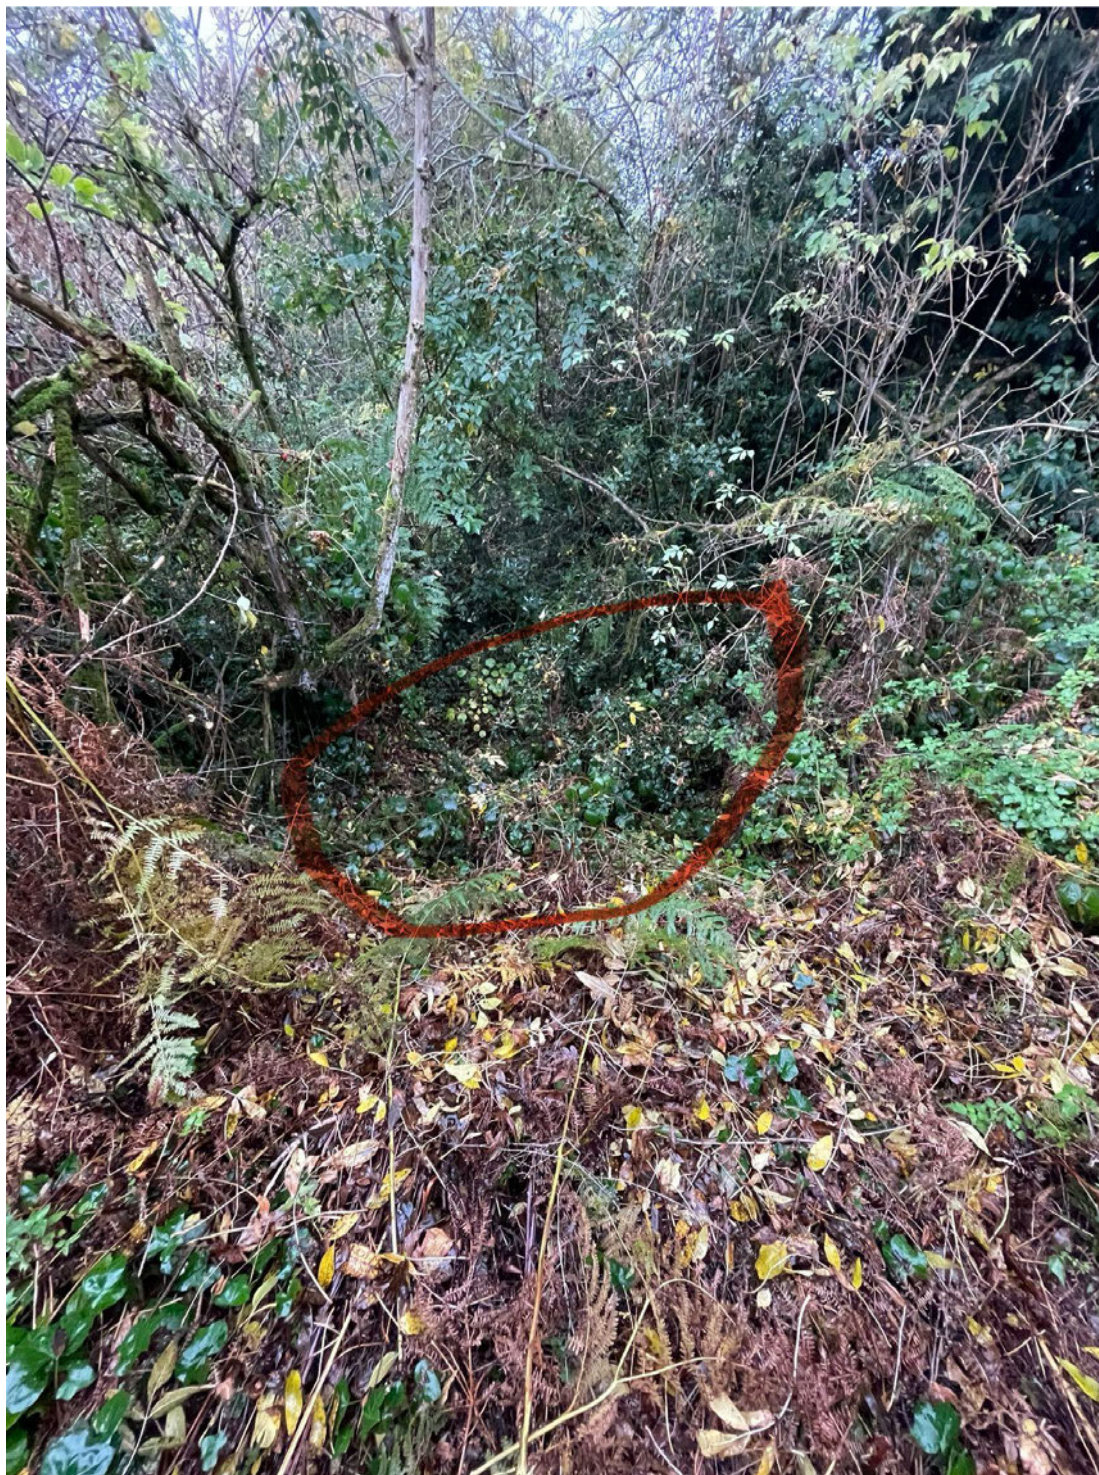
### **WEST SLOPE PHOTOS & POSSIBLE ALTERNATIVE MINE SHAFT LOCATION**

Prior to commencing the shaft drilling search a walkover inspection of the slope by our experienced drilling team led by Geoinvestigate's geotechnician drilling manager, Mr Anthony Montgomery, reported finding a prominent circular "crater like" depression of some 2.5m to 3m in diameter and 1m to 1.5m depth, on the slope perhaps 10 metres south of the position plotted by the CA and 10m to 15m west of the site boundary. This possible partially subsided mine shaft feature lies to the south of a clearing on the slope leading up to the path and gate on the west fence line. Photographs of the feature are provided in Appendix 5. The approximate position of the crater like "depression" is shown on the plan in Appendix 6.

Recent inspection of the slope by Geoinvestigate identified a possible partially subsided mine shaft feature at the location shown to the south of the CAs plotted position. If this is shaft 327351-282 then it is too distant to impact ground stability within the development area.

However, because of uncertainty about the ownership of this lower section of slope and concerns over the safety of our staff scrambling over thickly overgrown, steep, slippery slope, the feature was not investigated further by Geoinvestigate. No fallen tree which might provide an explanation for the crater was observed near it. Whether the "crater" is indeed mine shaft 327351-282 remains unproven however both of Geoinvestigate's experienced geotechnicians who examined the feature were of the strong opinion that it resembled a partially subsided shaft. If so, the feature, which is located some 13m to the west of the site boundary and 10m south of the shafts currently plotted position, lies beyond influencing distance of the development area and therefore has no impact on it.

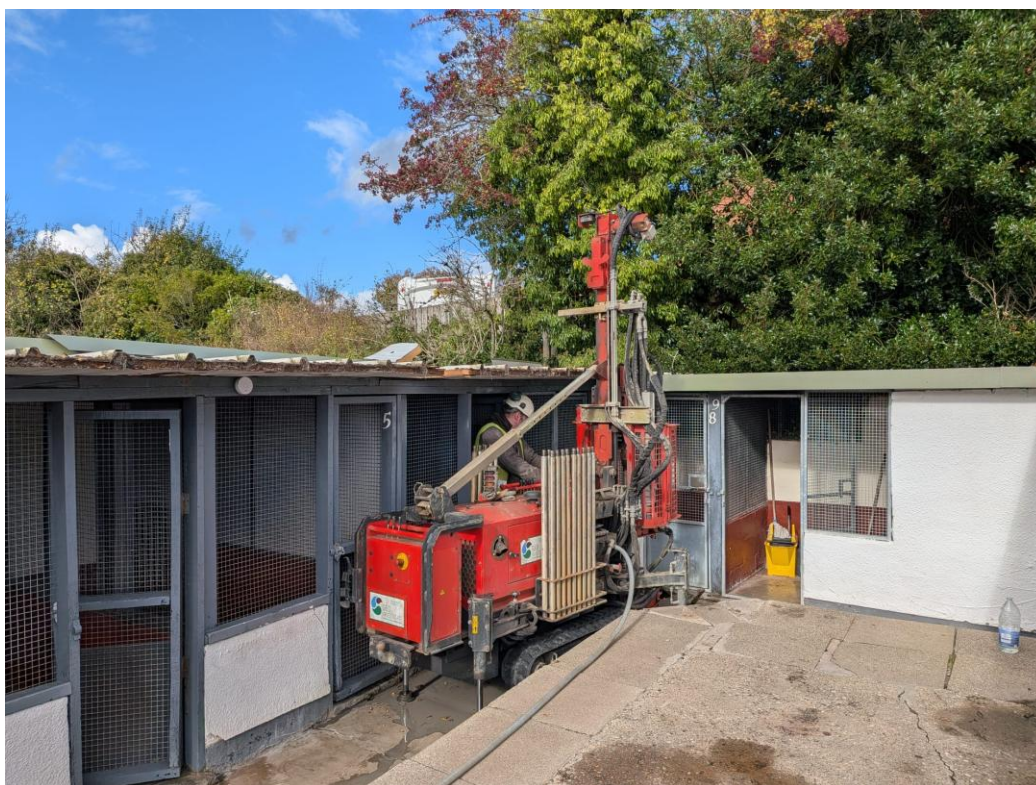
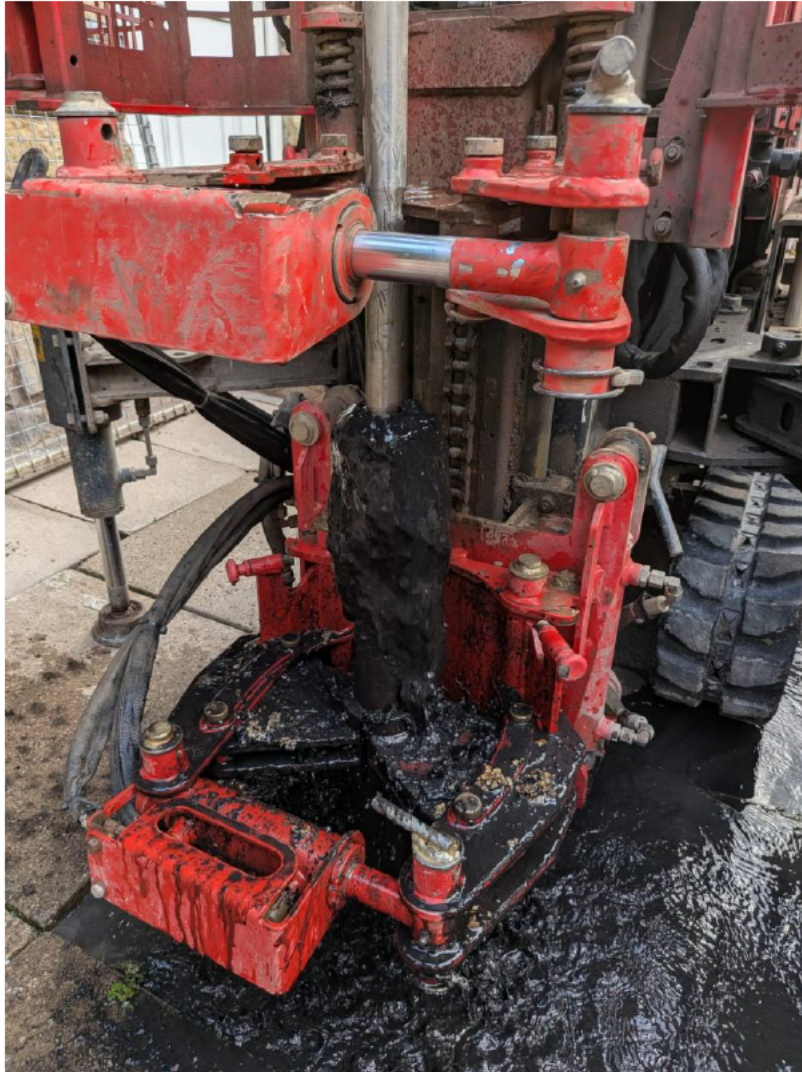
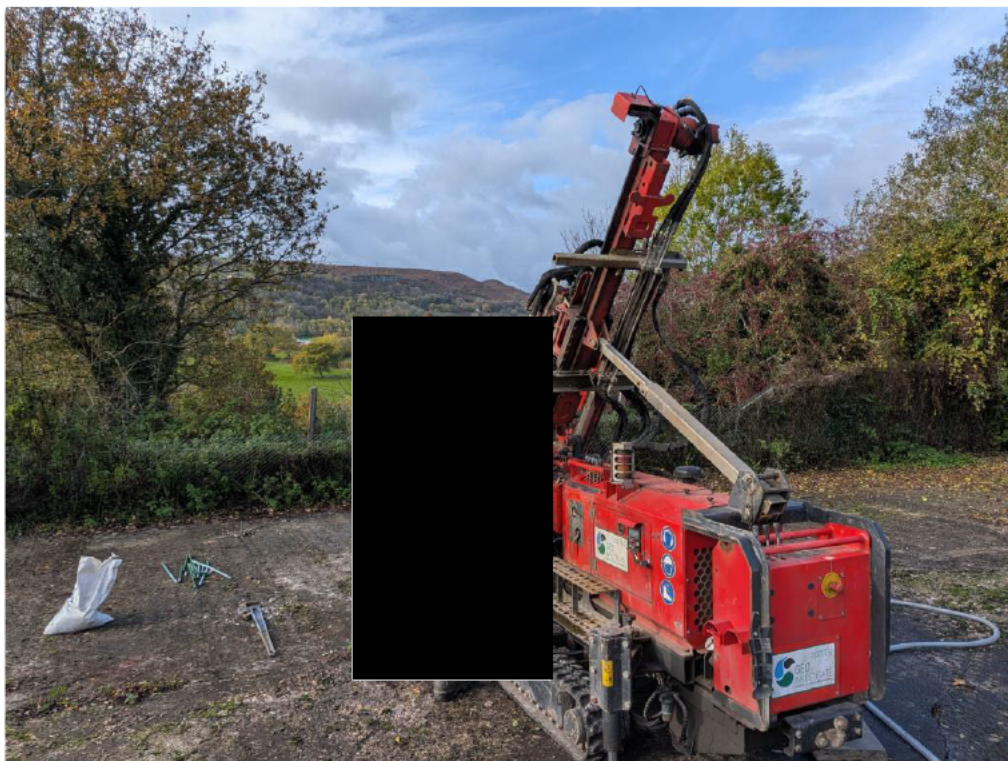
PHASE 1 & 2 BOREHOLE LOCATIONS  
AND ROTARY DRILLING PHOTOS  
RH10 BLACK COAL FLUSH 9.80-10.60m

As with previous holes RH1-RH6 on the west side of the geological fault and the property additional vertical Microdrill holes RH9, 10, 11, 12, 13, 14 and 15 also on the west side encountered a narrow intact coal horizon (0.20-0.50m thick) between 13m to 14.5m bgl followed by shale with occasional ironstone inclusions/bands up to 19m bgl followed by intact coaly mudstone between 23m to 27m. As with the earlier holes on the west side no mine working was found in any of the additional holes.

Like earlier hole RH7 on the east side of the fault additional holes RH8 & 10 on the east side encountered thin (0.4m -0.5m) intact coal around 3.60m bgl followed at 9.5m by thicker (0.80m- 1.20m) intact coal with intact coaly mudstone between 17m to 20.5m. As with RH7 no ironstone was found in either RH8 or RH10.

The approximate position of the fault is shown on the borehole plan. Comparison of the west and east boreholes indicates there has been vertical displacement of the bedrock strata across the fault.
