**STAGE 2 CONTAMINATION  
ASSESSMENT**

**LAND SOUTH OF NANT COTTAGE, LOWER  
ROAD, COEDPOETH, WREXHAM**

**June 2023**

**R3213-R02-v1**

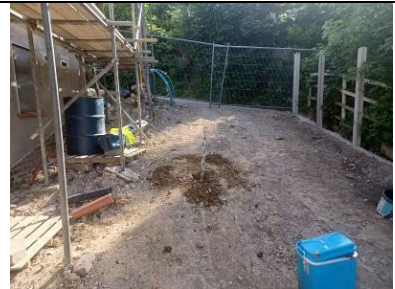
3.4.2. TP1 consisted of light brown, gravelly, sandy clay with occasional cobbles of brick and concrete.

The trial pit could only be extended 0.4m bgl due to the presence of a copper impregnated terram. It is understood this has been placed in relation to Japanese Knotweed treatment works that have previously been undertaken at the site.

| TP1 - Location | TP1 – Trial pit depth | TP1 – Soil type |

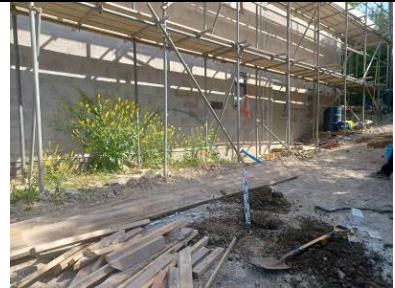
3.4.4. Entries TP2 - TP4 consisted of brown to dark brown gravelly, sandy clay with frequent cobbles of brick and concrete, alongside occasional rootlets. Gravel was fine to coarse, sub rounded to angular with red brick and concrete fragments. Entries extended to 0.6m bgl, the observed ground conditions at each trial pit was consistent with reworked subsoils with occasional building debris present at the surface.

| TP2 – Location | TP2 – Trial pit depth | TP2 – Soil type |
