# Land at Mold Road, Gwersyllt, Wrexham LL1 4AX

Water Vole Survey

*Castle Green Homes*

**P.1626.22**  
July 2026

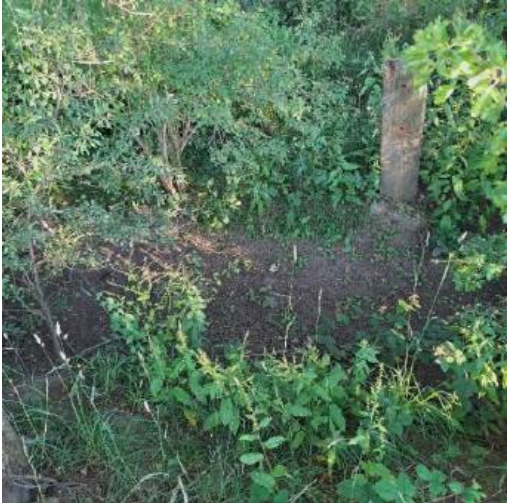
| Watercourse | Photograph / Description | Suitability for water vole |
|---|---|---|
| Wet Ditch 1 (D1) | | <b>Low</b><br>Areas of cover and food resources throughout the watercourse. Earth banks present which are suitable for burrow creation. However, during the surveys conducted in May and July 2026, this ditch was dry and therefore unsuitable for water vole at the time of survey. |

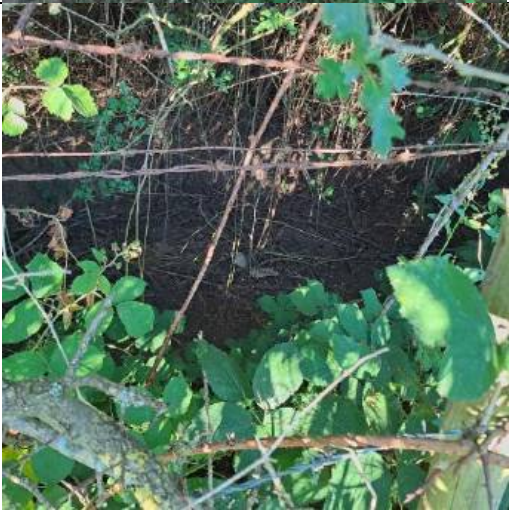
| Watercourse | Photograph / Description | Suitability for water vole |
|---|---|---|
| Wet Ditch 2 (D2) | | <b>Low</b><br>Areas of cover and food resources throughout the watercourse. Earth banks present which are suitable for burrow creation. However, during the survey conducted on 08 July 2026, due to extreme weather conditions in previous weeks, this ditch was dry and therefore unsuitable for water vole at the time of survey. A small amount of water was noted in this ditch during the survey conducted on 21 May 2026. |

Due to access restrictions of dense vegetation growth and that the ditch runs through a dense hedgerow, ditch D2 (see drawing P.1626.22.E01 Preliminary Ecological Appraisal, Appendix 1) was not surveyed in full, however the ditch was dry throughout and access to the ditch at several points within the hedgerow was possible, therefore this is not considered a significant limitation within the conclusions of this report.

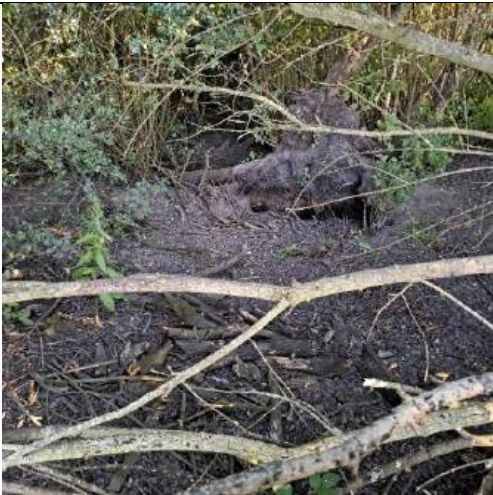
| Pond 1 (P1) | | <p><b>Unsuitable</b></p> <p>Areas of cover and small amounts of food resources are present within the pond. The pond connects directly to the wider ditch network, however, the banks are very shallow and are unsuitable for burrow creation. During both surveys for water vole in May and July 2026, this pond was dry.</p> |

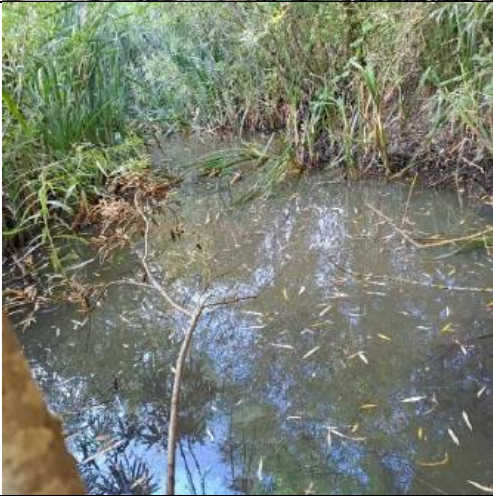
| Pond 2 (P2) | | <p><b>Low</b></p> <p>Areas of cover and food resources are present within the pond and the pond connects directly to the wider ditch network. The pond has banks which may be suitable for burrow creation, however during the surveys conducted in May and July 2026, this pond retained only a small amount of water (less than 30cm) which would greatly reduce the likelihood of this pond being utilised by water vole.</p> |

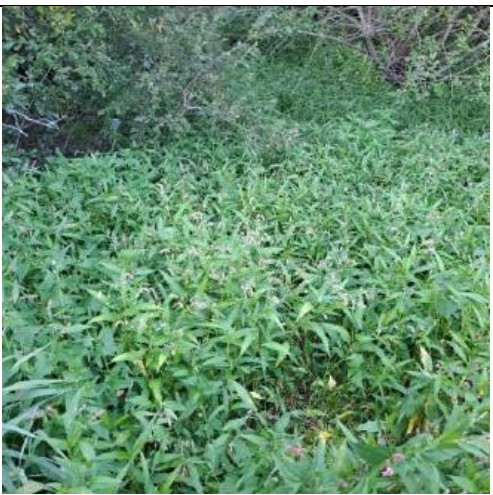
| Pond 4 (P4) | | <p><b>Low</b></p> <p>Areas of cover and food resources are present within the pond and the pond connects directly to the wider ditch network, however, the banks are shallow, and during both surveys for water vole in May and July 2026, this pond was dry.</p> |

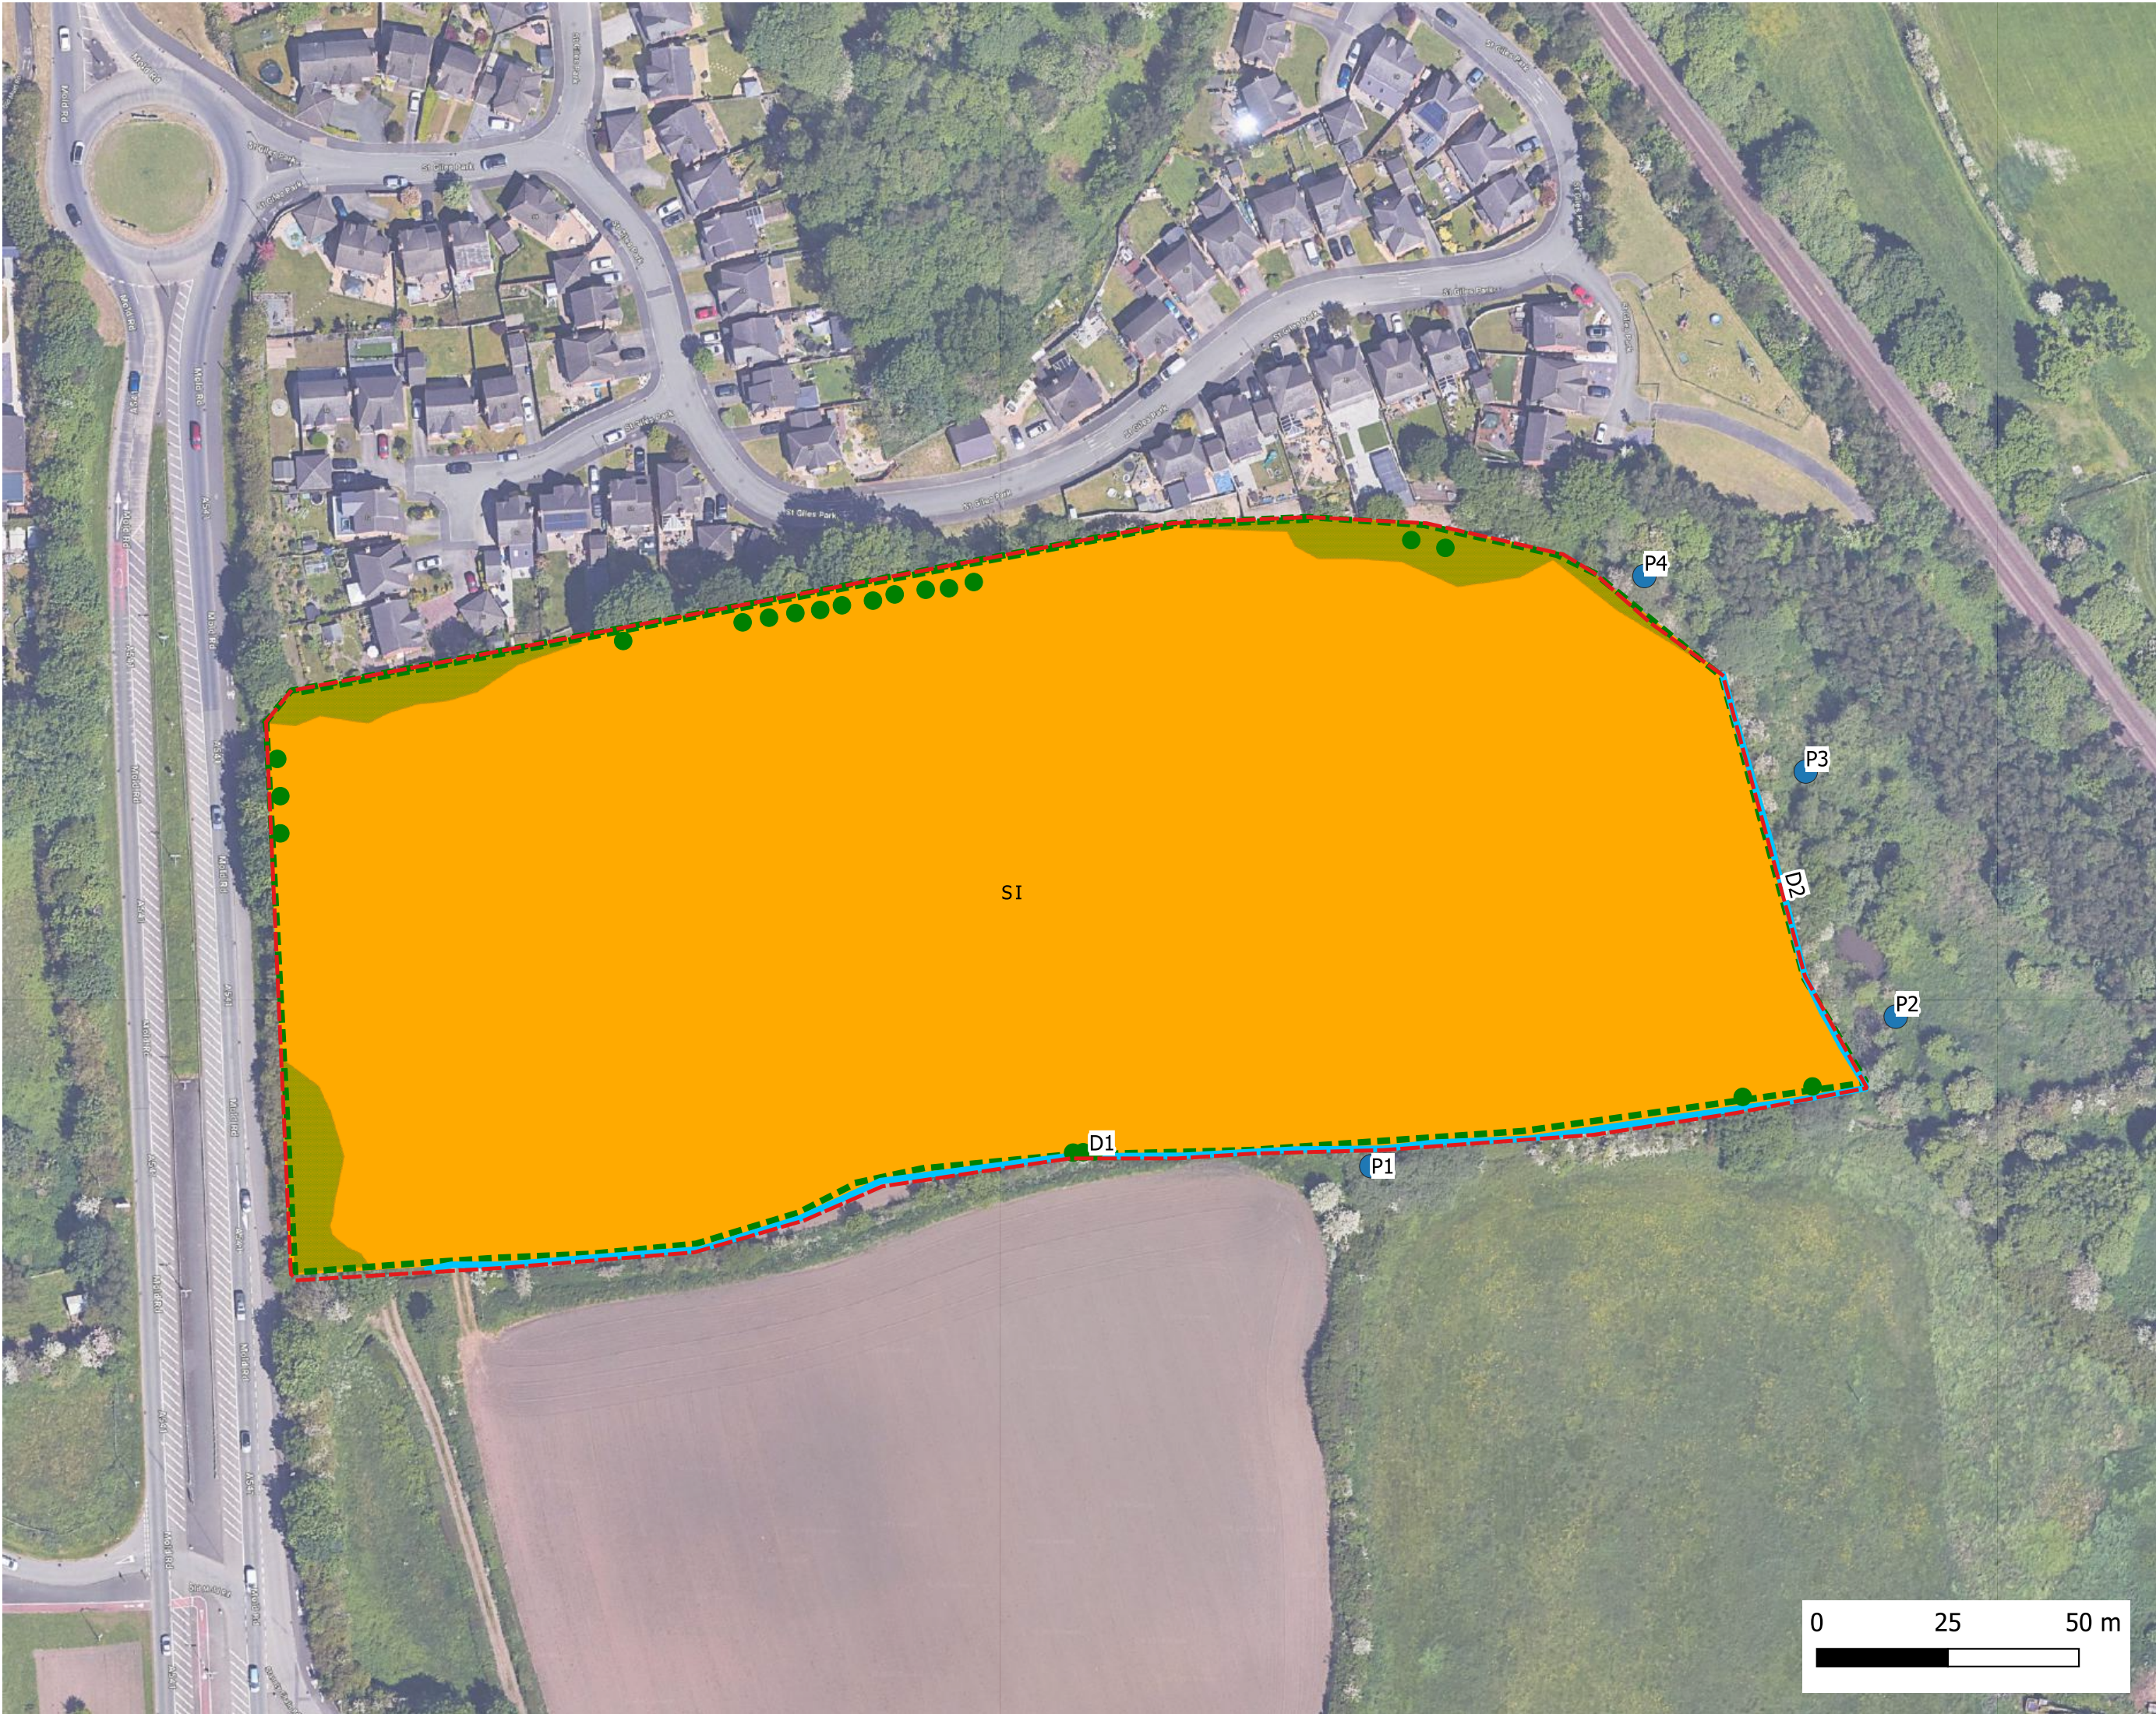
DRAWING TITLE:  
Preliminary Ecological Appraisal

Our client's objectives are to ascertain if water vole are present within ditches D1 and D2 and ponds P1, P2, P3 and P4 within and adjacent to the site (see drawing P.1626.22.E01 Preliminary Ecological Appraisal within Appendix 1) in order to inform measures that will need to be taken to ensure no harm to water vole during and after development.

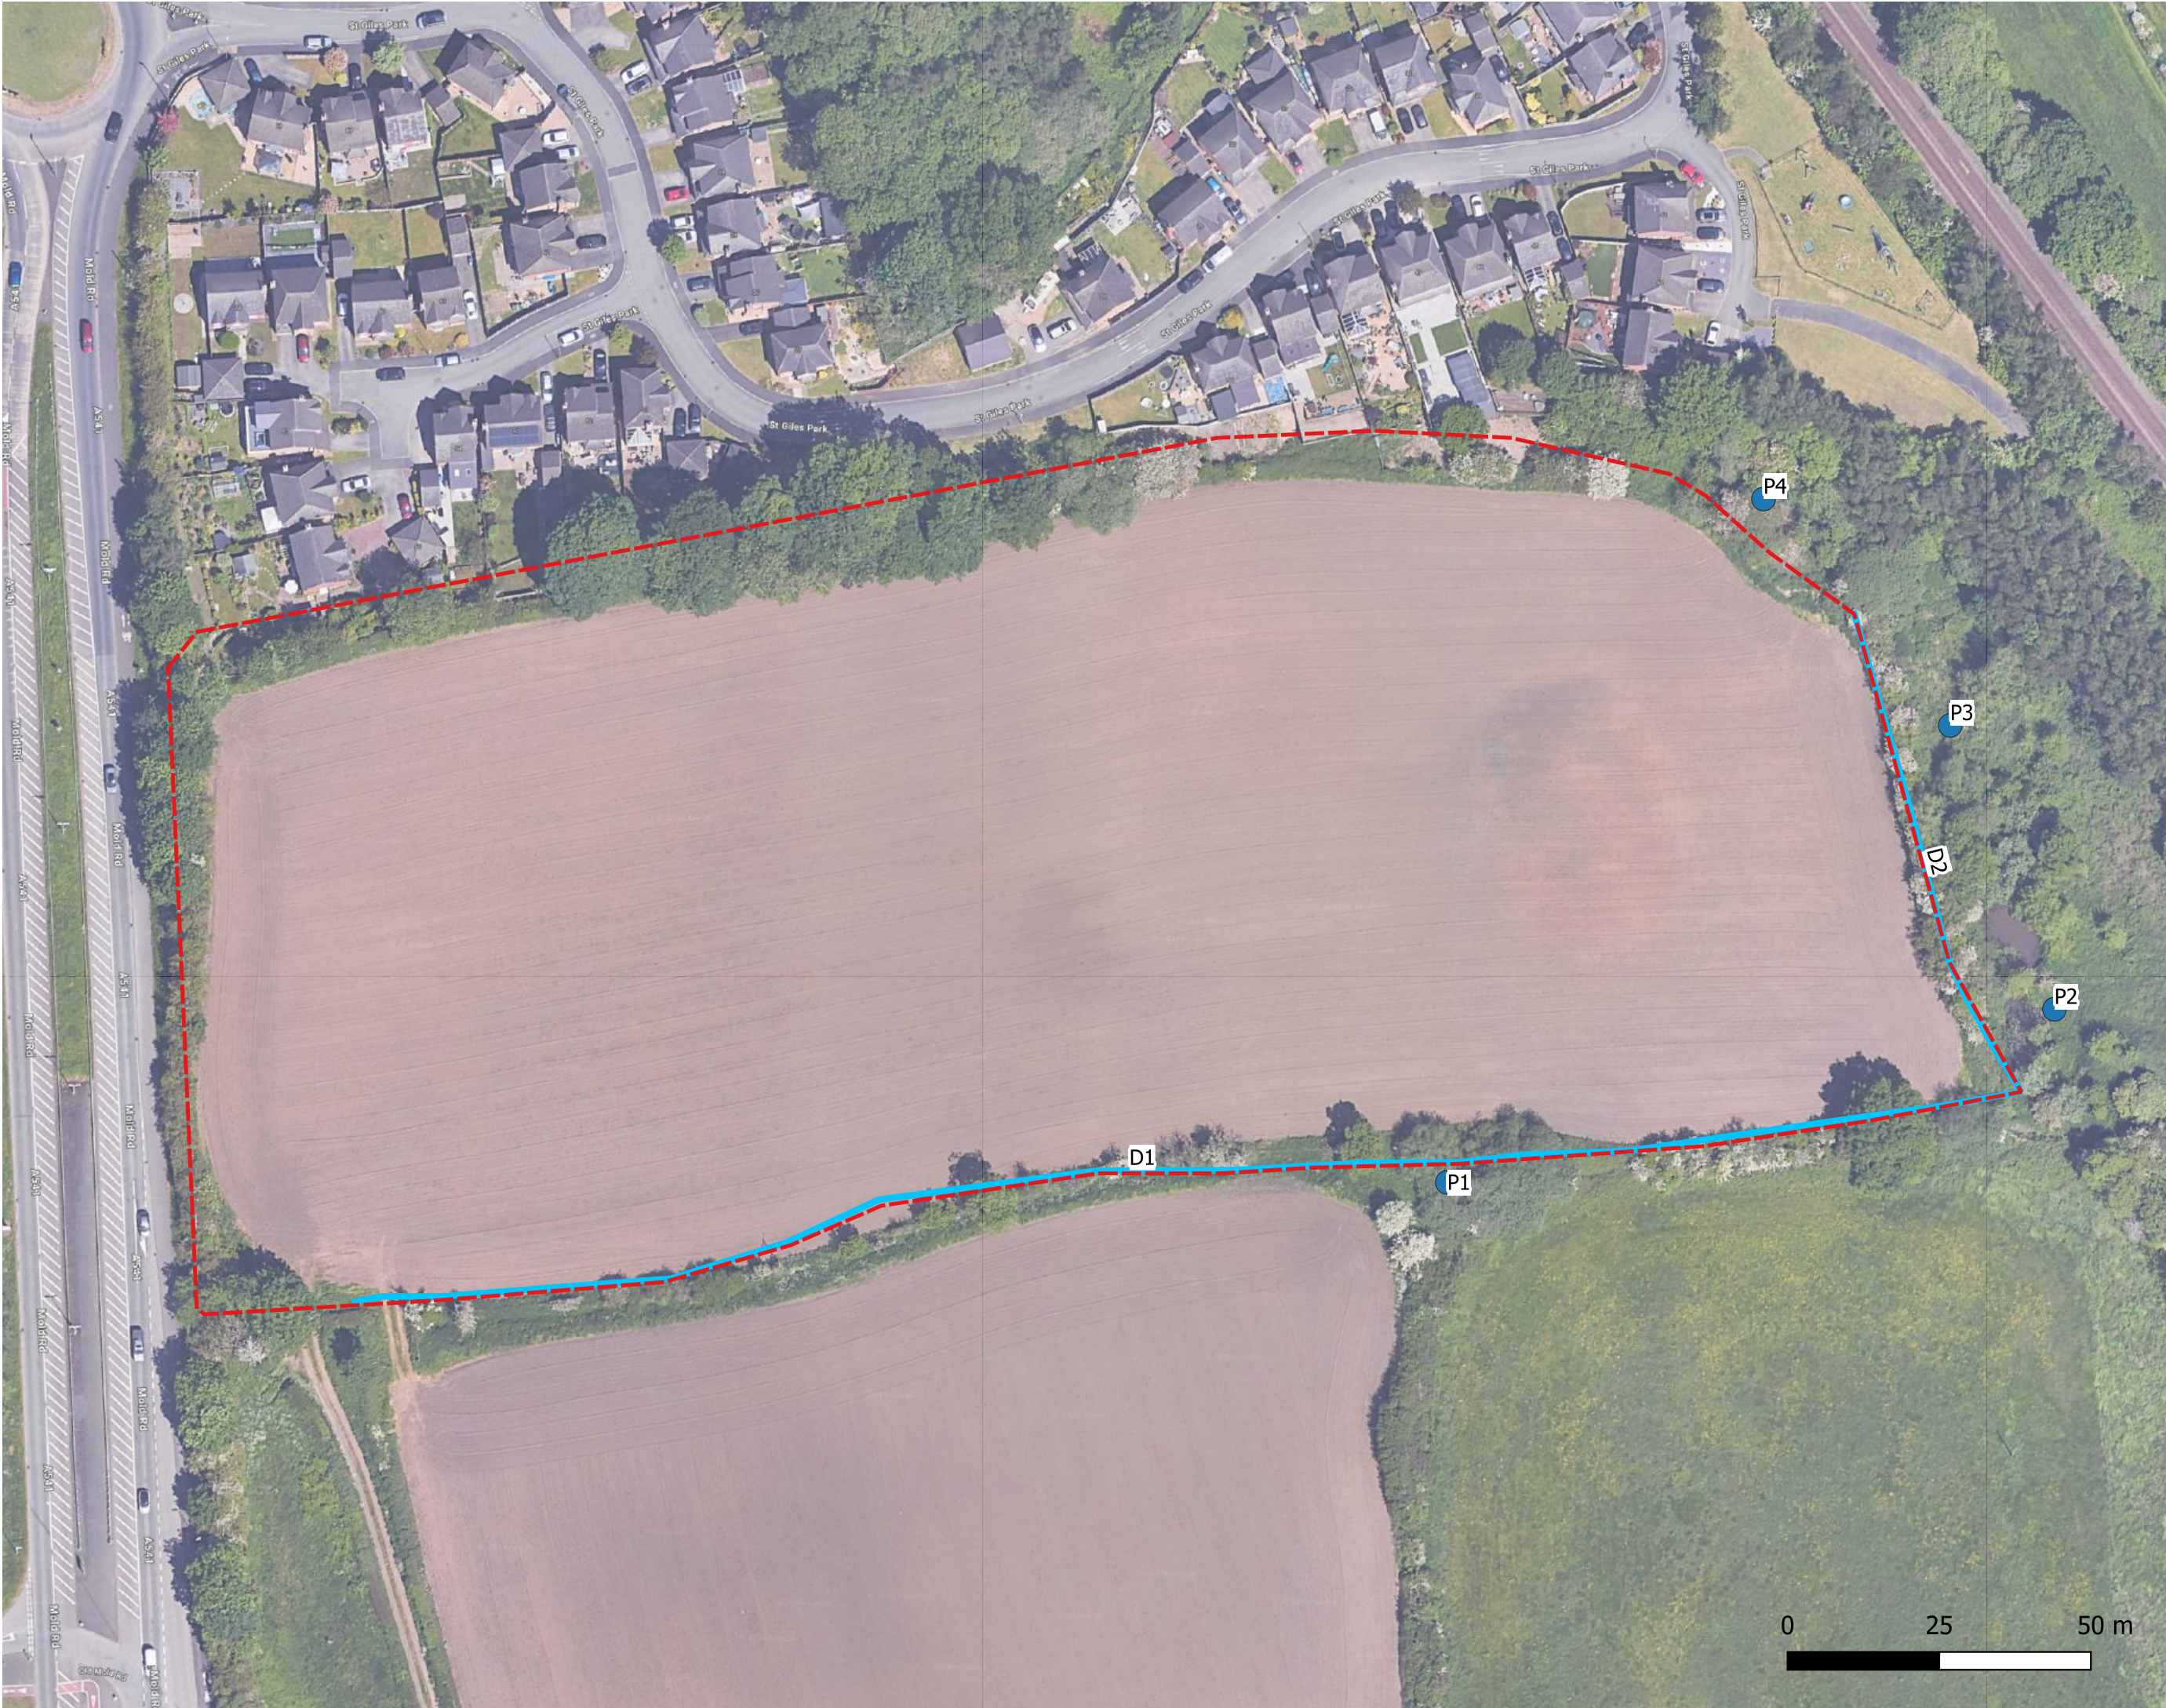
DRAWING TITLE:  
Water Vole Survey

No signs of water vole were found to be present within the survey area during the surveys undertaken on 21 May 2026 and 08 July 2026. The survey areas are present on drawings P.1626.22.E10 Water Vole Survey 21.05.26 and P.1626.22.E13 Water Vole Survey 08.07.26 (Appendix 1).
