P/2025/0409 - CAE COCH, GOLLY, ROSSETT, WREXHAM, LL12 0AL 21.07.2025

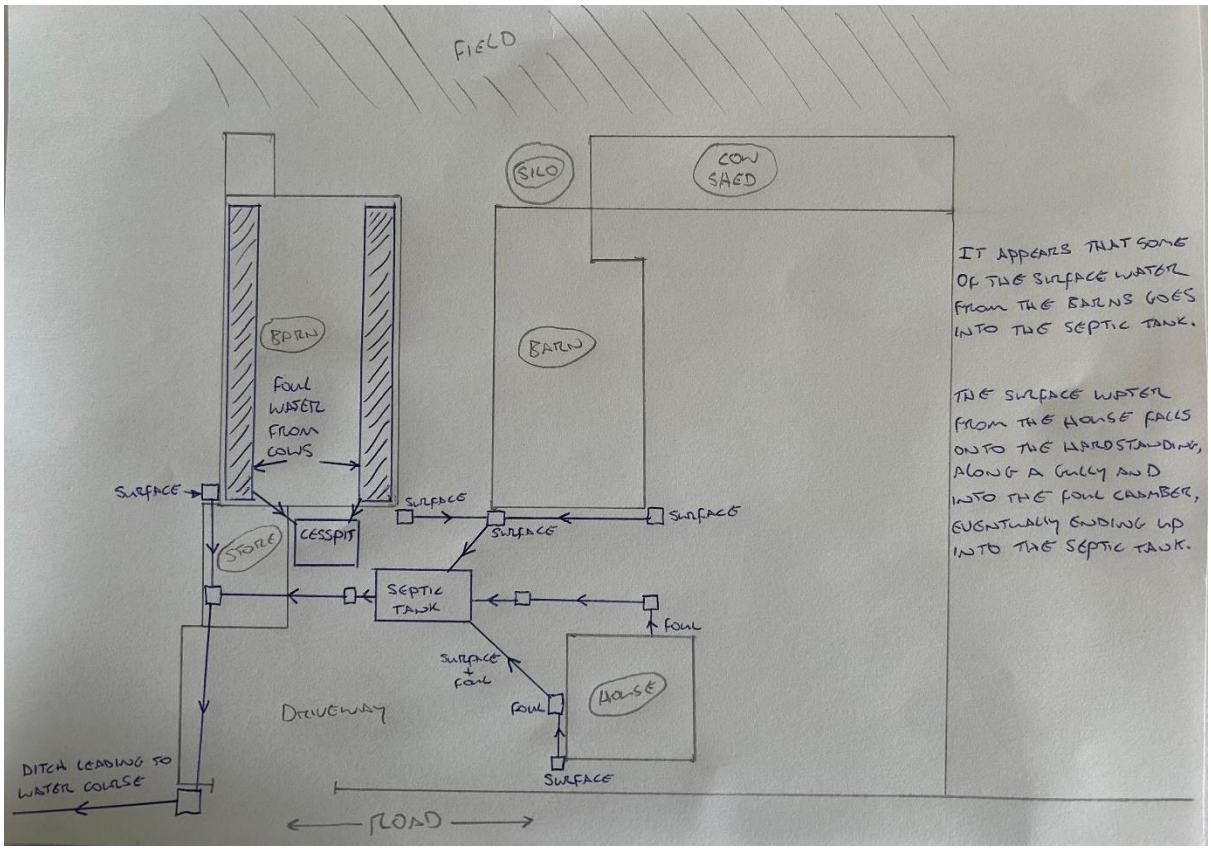
Please see below a basic sketch of the current drainage, there is no evidence of any other drains, manholes or anything that suggests the foul water goes anywhere else other than the ditch

Red arrow - flow direction
Blue arrow - septic tank location
