LLANGOLLEN ROAD, ACREFAIR - GROUND GAS PROTECTION VERIFICATION REPORT,PLOTS 1-3

GSL3116LR02

Gower Homes Ltd

In total 3 No. verification visits have been conducted by GroundSolve Ltd to verify the installation of the protection measures at plots 1, 2 and 3.

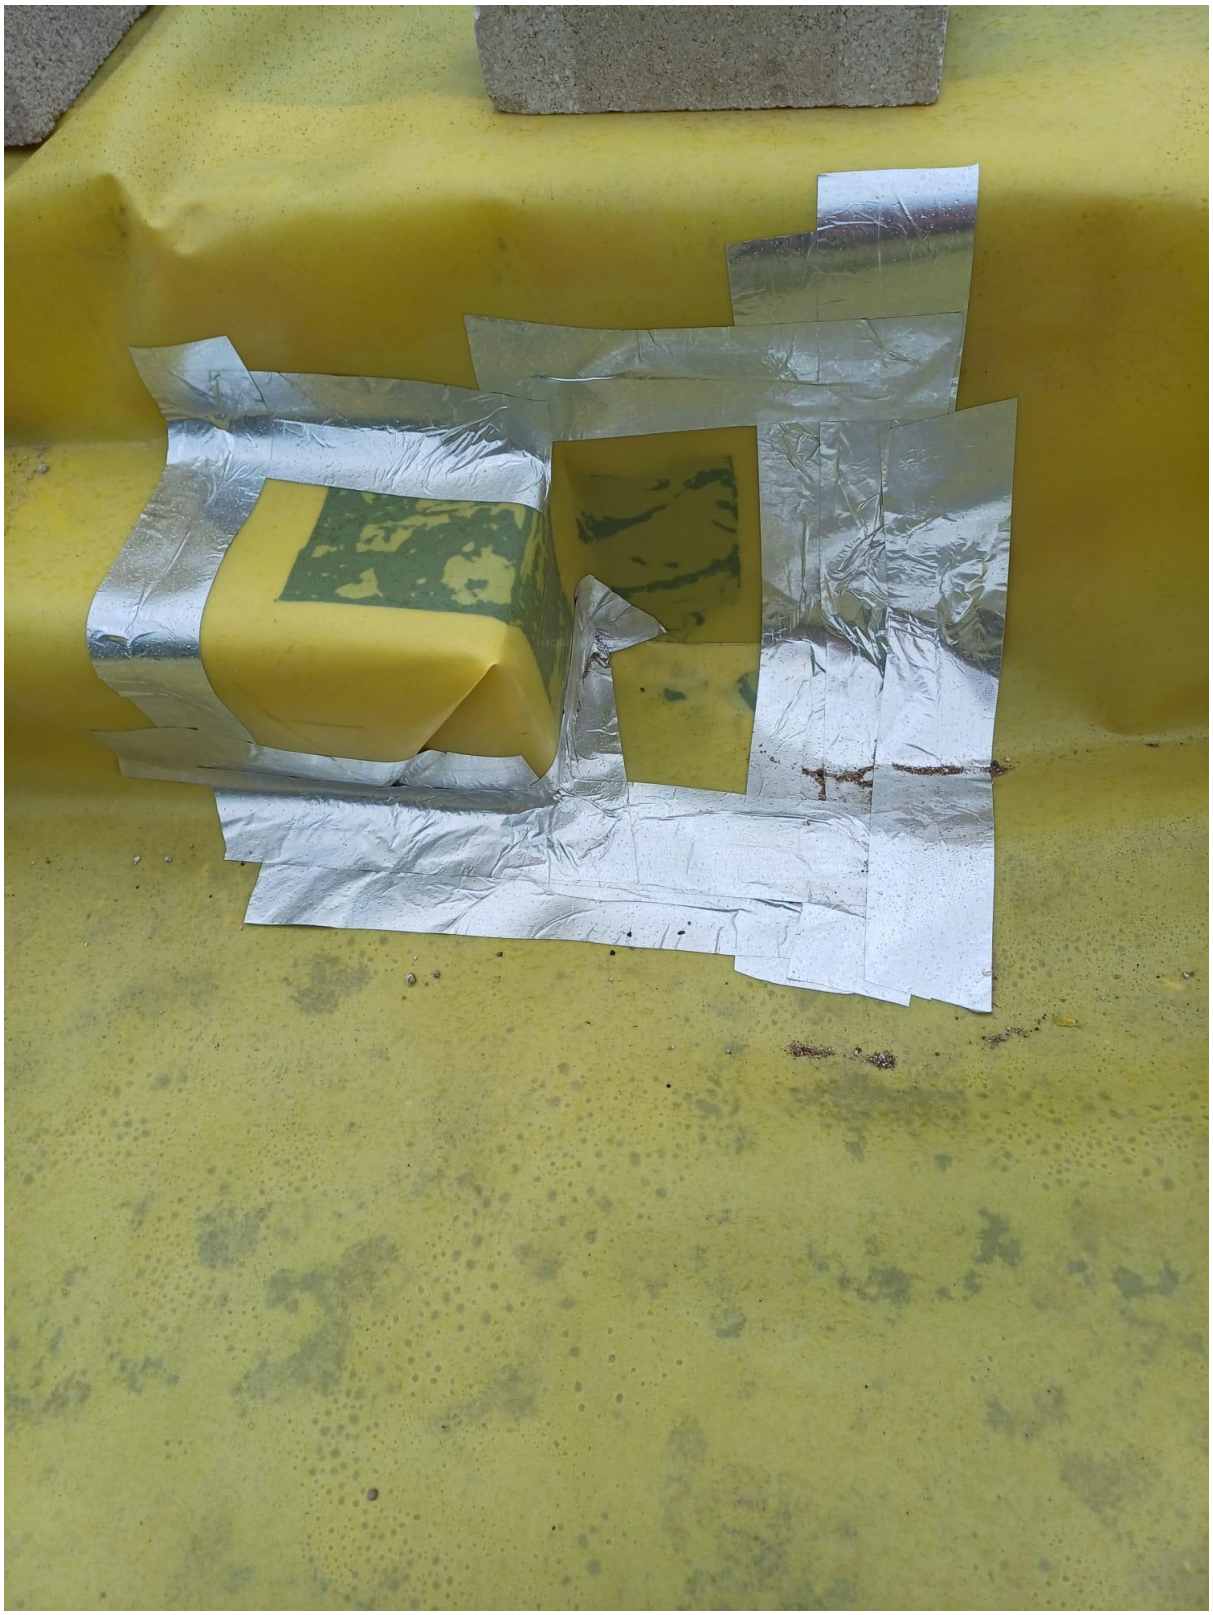
Photograph 1 – Overview of the plot 2 installation.

Photograph 2 – Ducting coming out of the venting layer

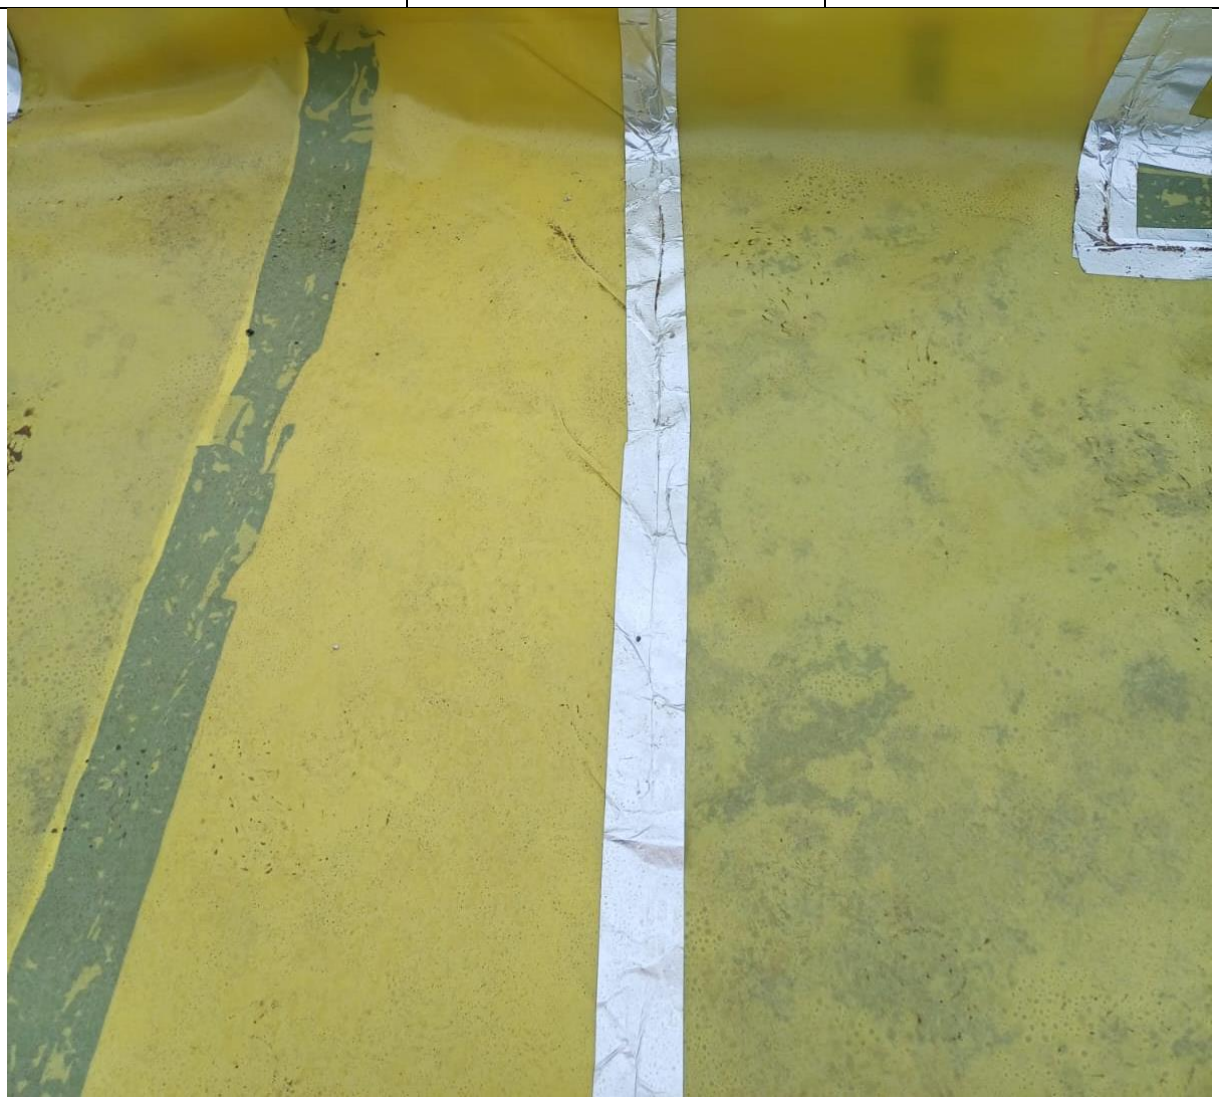
Photograph 3 – Well sealed service entries

Photograph 4 – Well formed and sealed internal corners

Photograph 5.1– lifting edge of tape on formed corner

Photograph 5.2 – Additional taping of corner

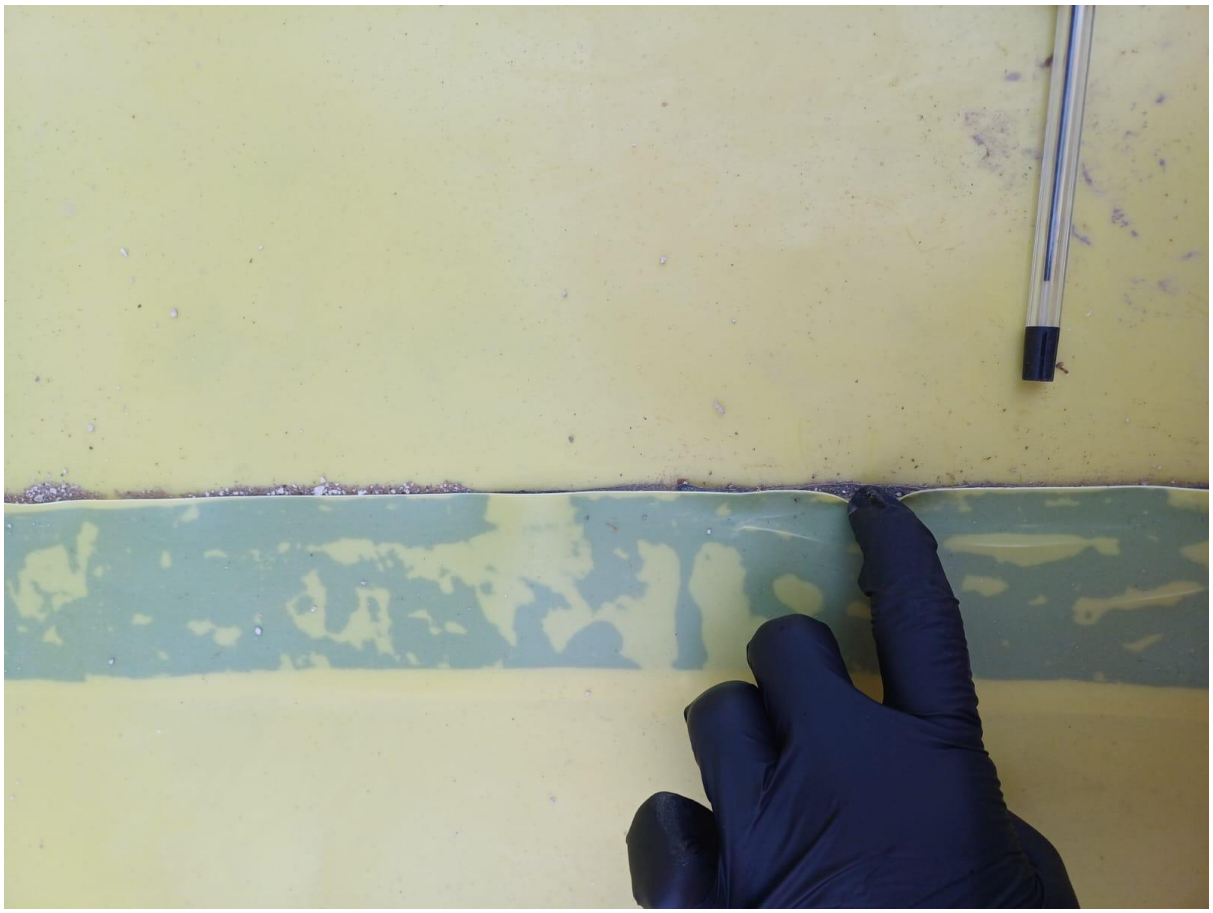
Photograph 5.3 – fully sealed and reverified

Photograph 6 – Double taped lapped endges.

Photograph 7 – Well sealed service entries

Photograph 8 – Fully selaed lapped edge

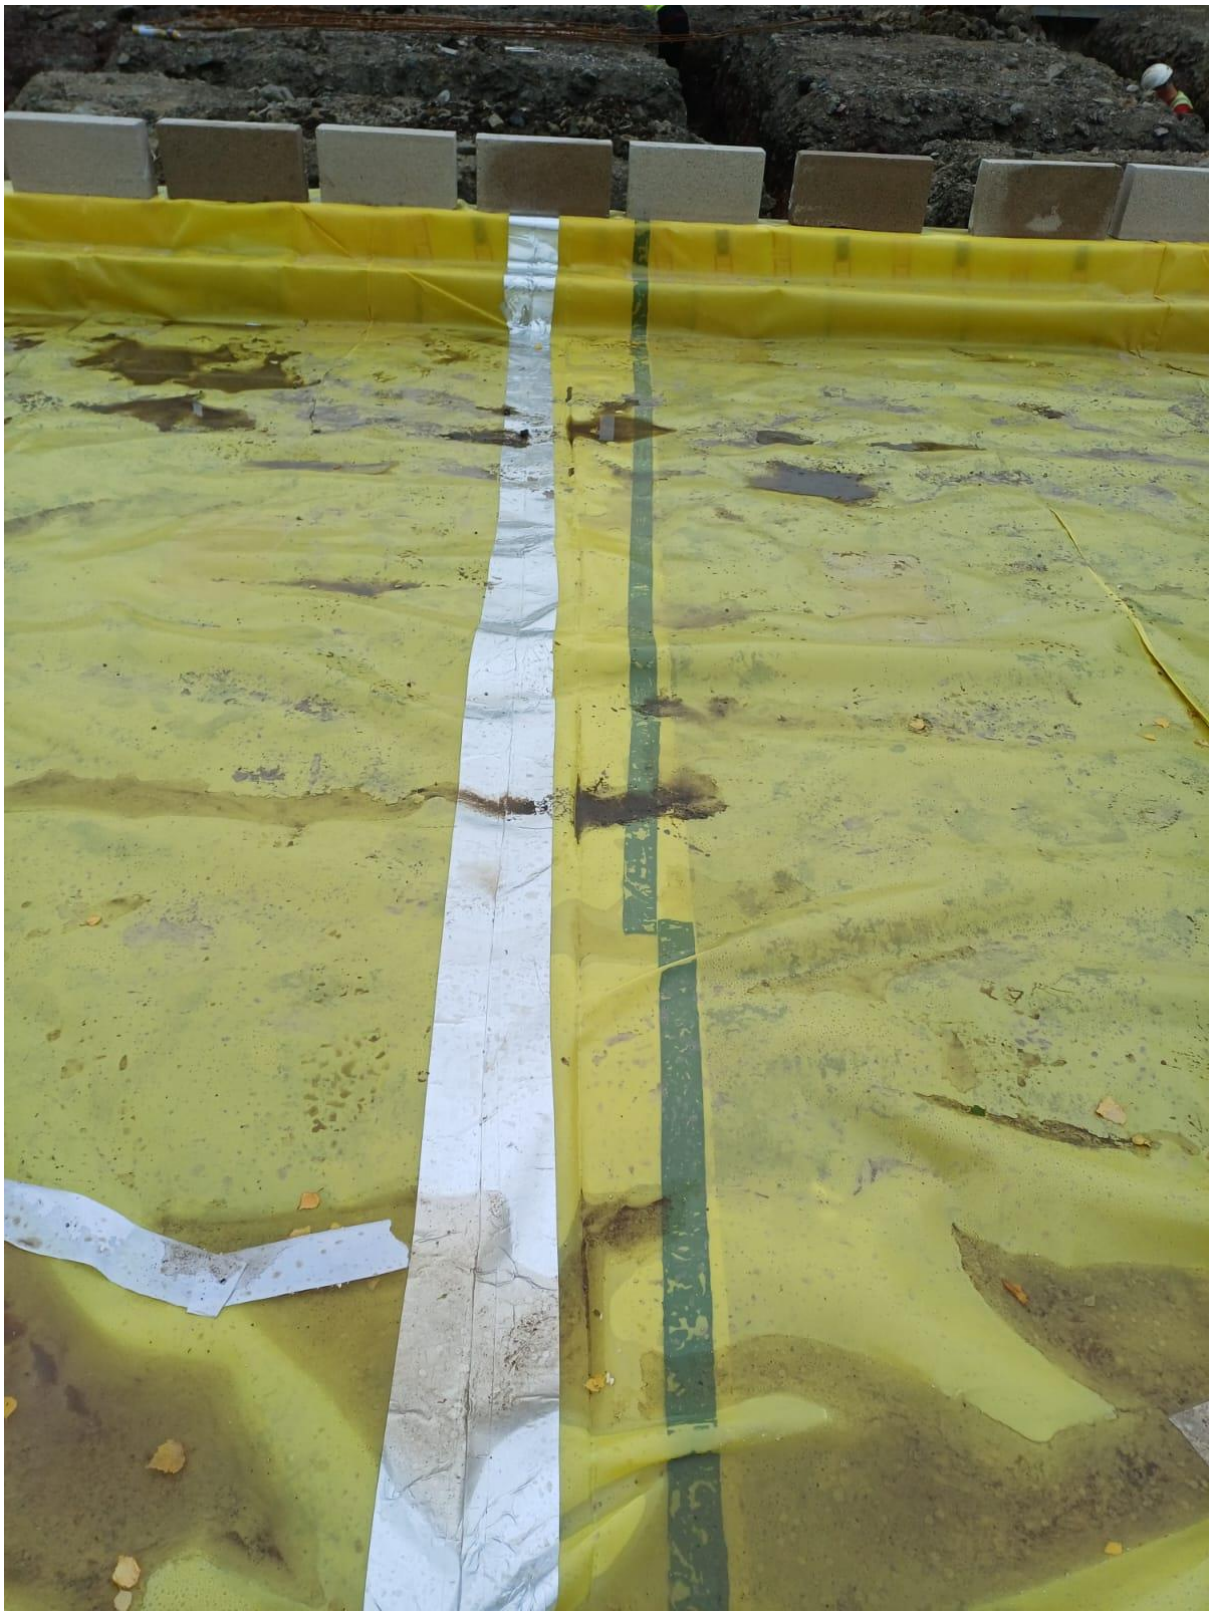
Photograph 1 – Overview of the plot 3 installation.

Photograph 2 – Ducting coming out of the venting layer

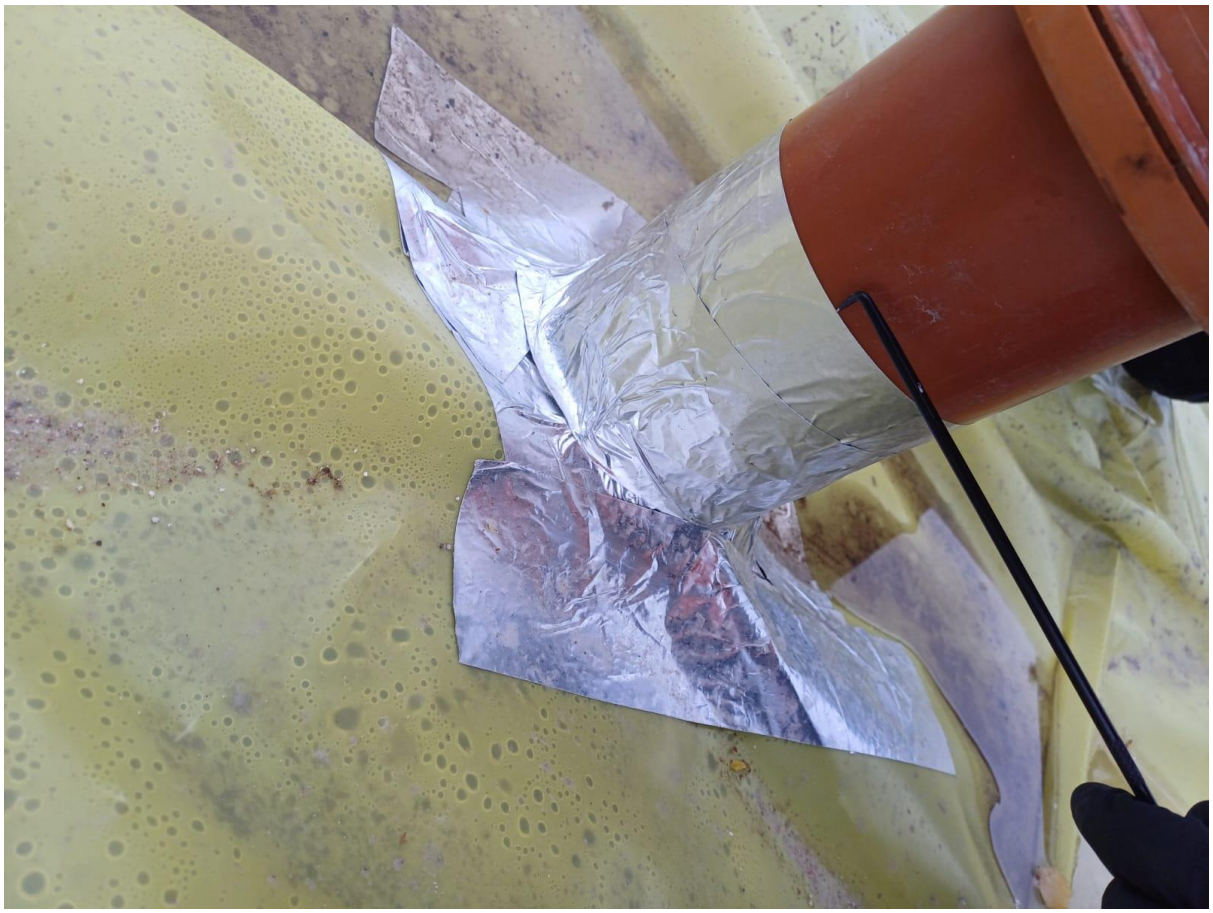
Photograph 3 – double taped seams mechanically picked

Photograph 4 – Well sealed service entries

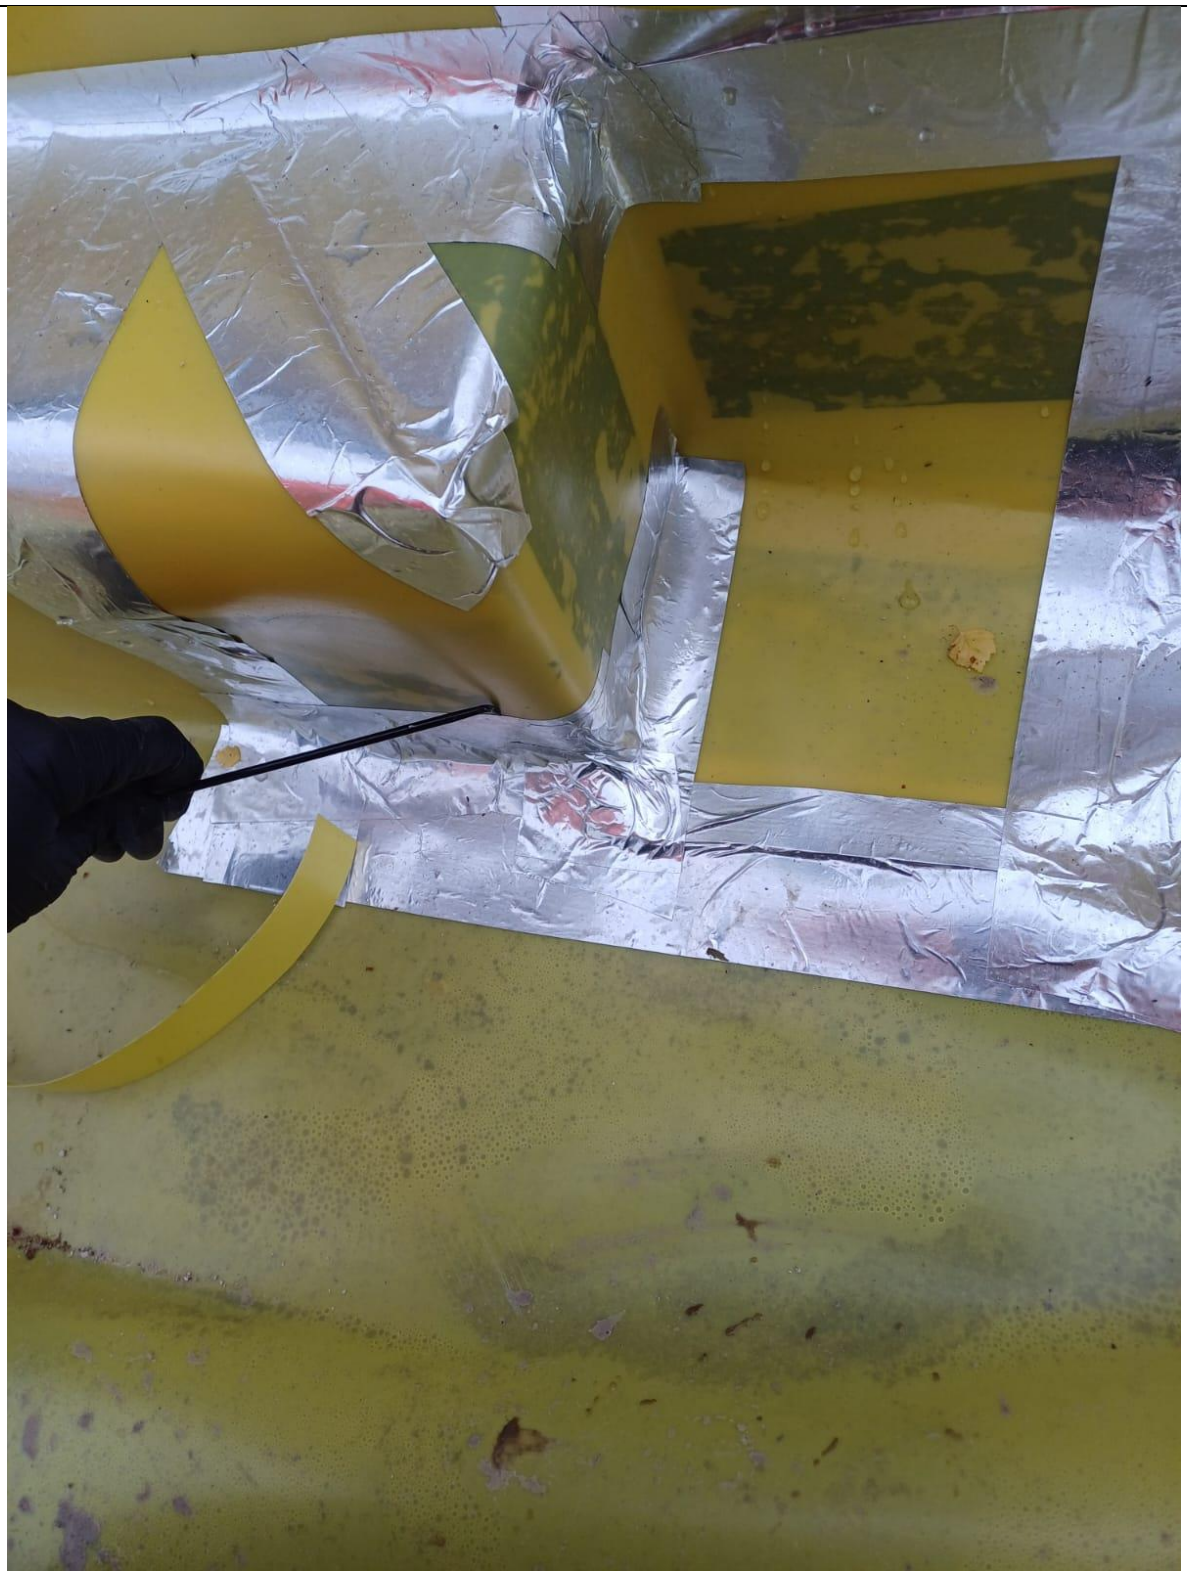
Photograph 5.1– puncture hole identified in corner

Photograph 5.2 – Additional taping of corner

Photograph 5.3 – fully sealed and reverified

Photograph 6 – Garage area yet to have membrane installation

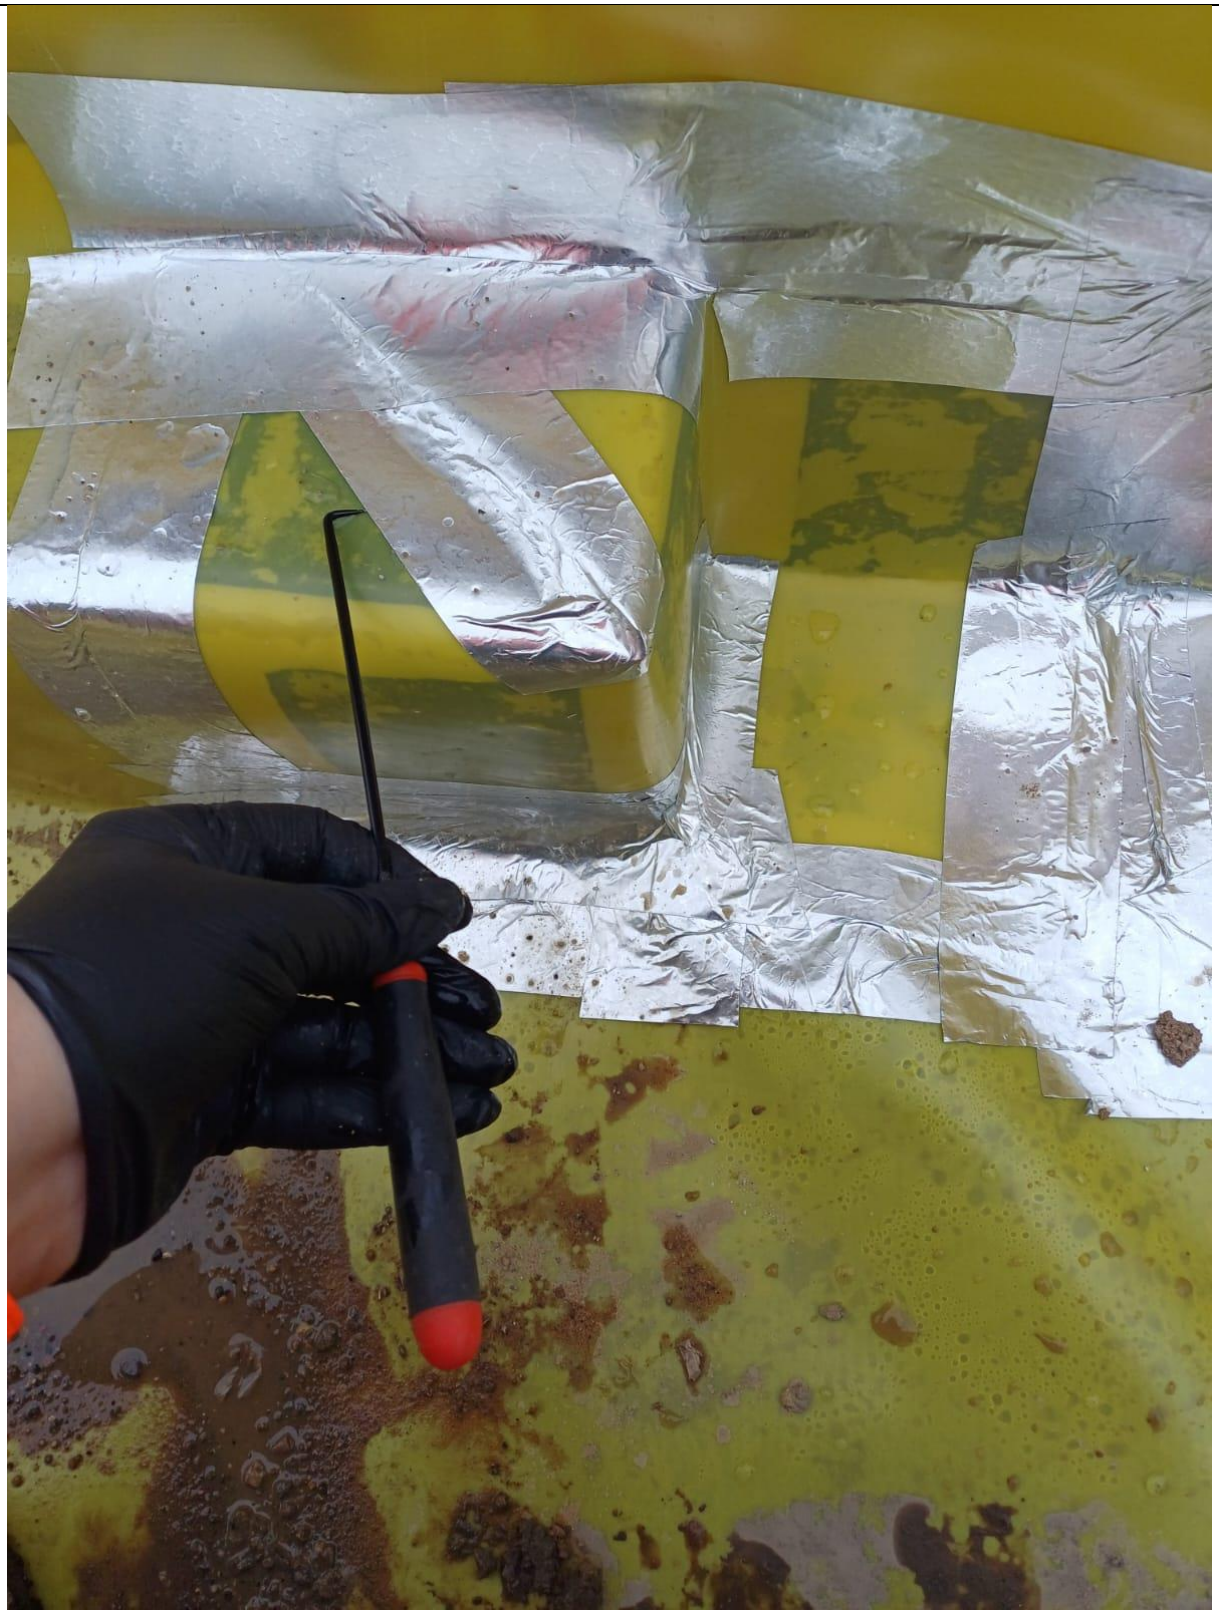
Photograph 5.1– puncture hole identified in corner	Photograph 5.2 – Additional taping of corner	Photograph 5.3 – fully sealed and reverified

Photograph 6 – Formed Corners

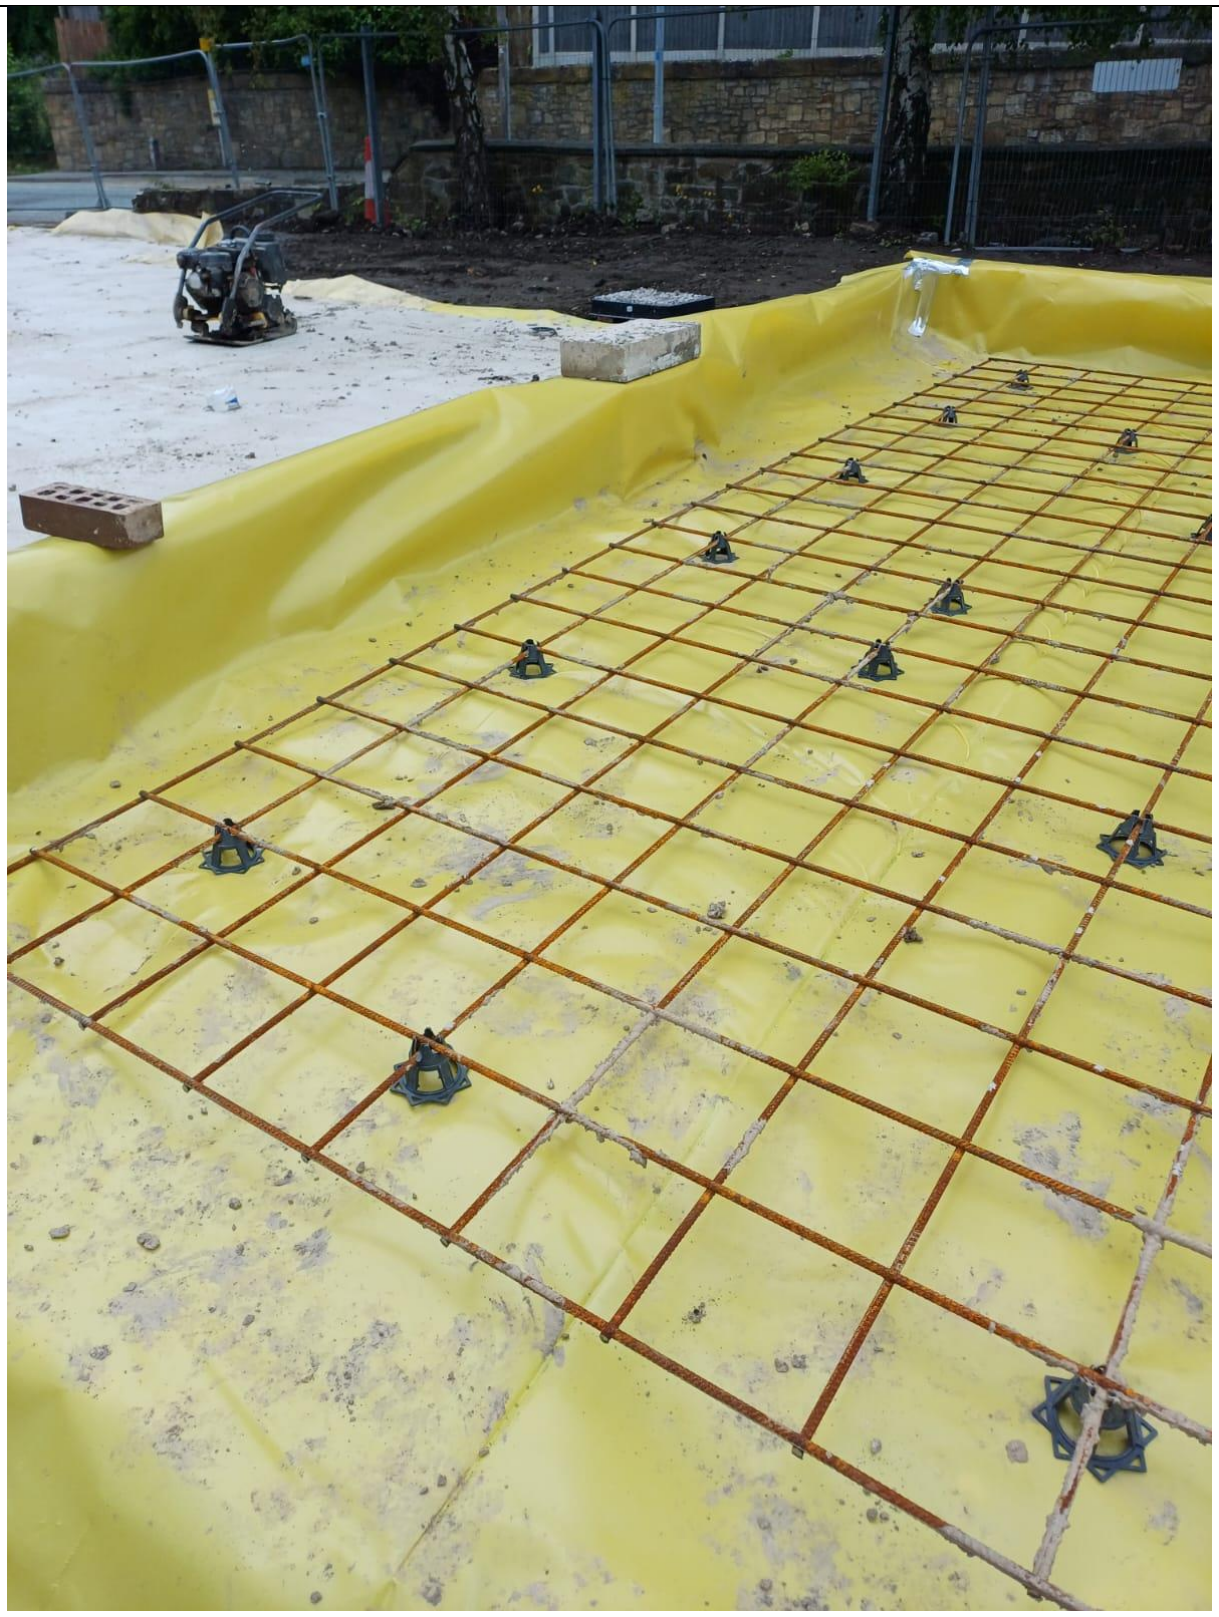
Photograph 7 – Overview of Plot 3 garage area now with membrane installed.
