GroundSolve Ltd
Consulting Geotechnical Engineers

LLANGOLLEN ROAD, ACREFAIR - GROUND GAS PROTECTION VERIFICATION REPORT, PLOTS, 4, 5 AND 7, 8

GSL3116LR03

05 SEPTEMBER 2024

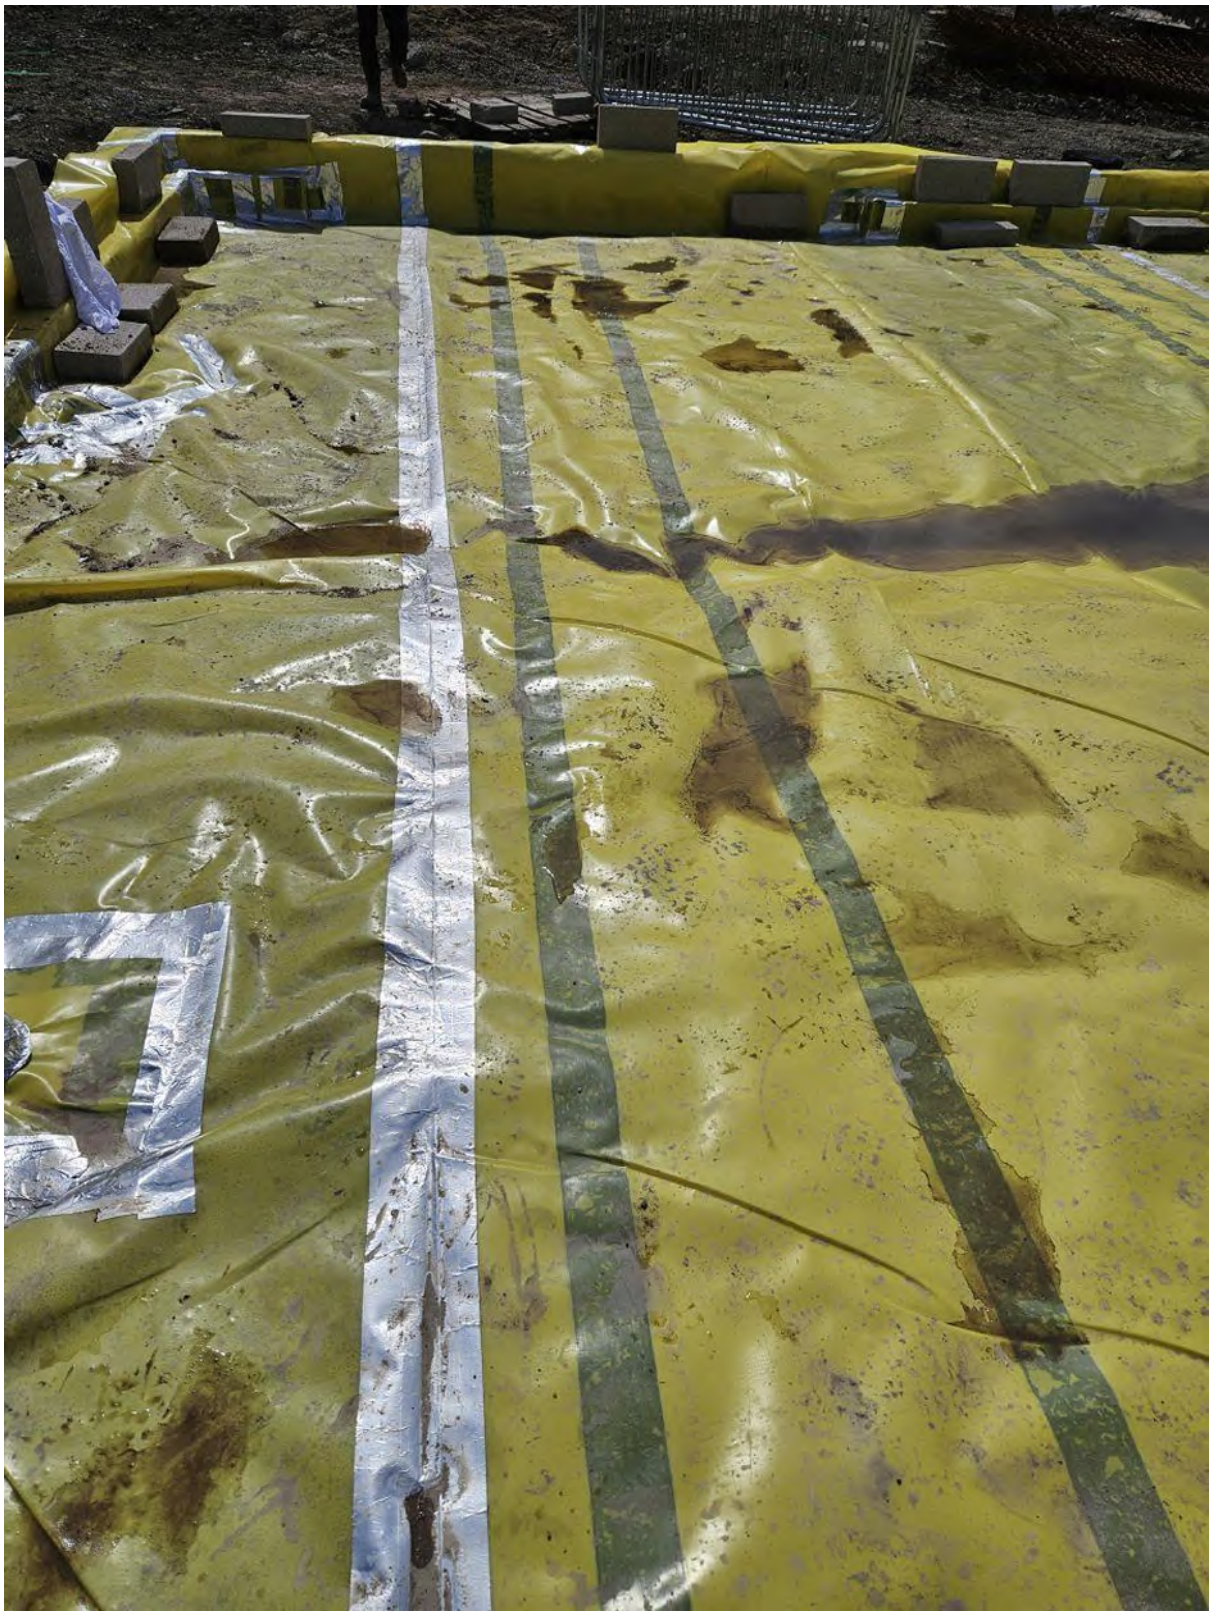
Conclusion
Plot 4 gas protection measured verified, however garage for plot 4 yet to be installed therefore this plot cannot be fully signed off until garage has also been verified on the next visit.

Photograph 1 – Overview of the plot 4 installation.

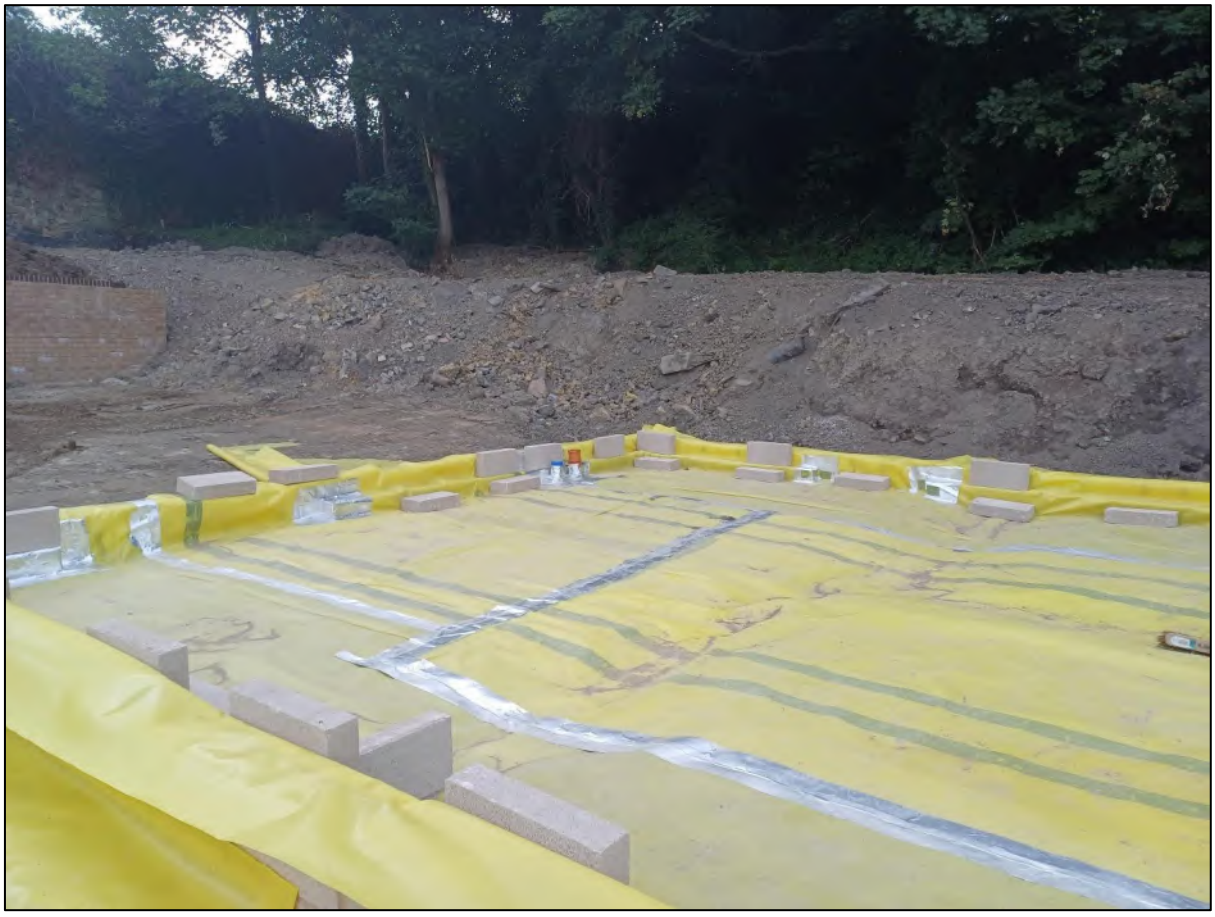
Conclusion
Plot 7 gas protection measured verified, however garage for plot 7 yet to be installed therefore this plot cannot be fully signed off until garage has also been verified on the next visit.

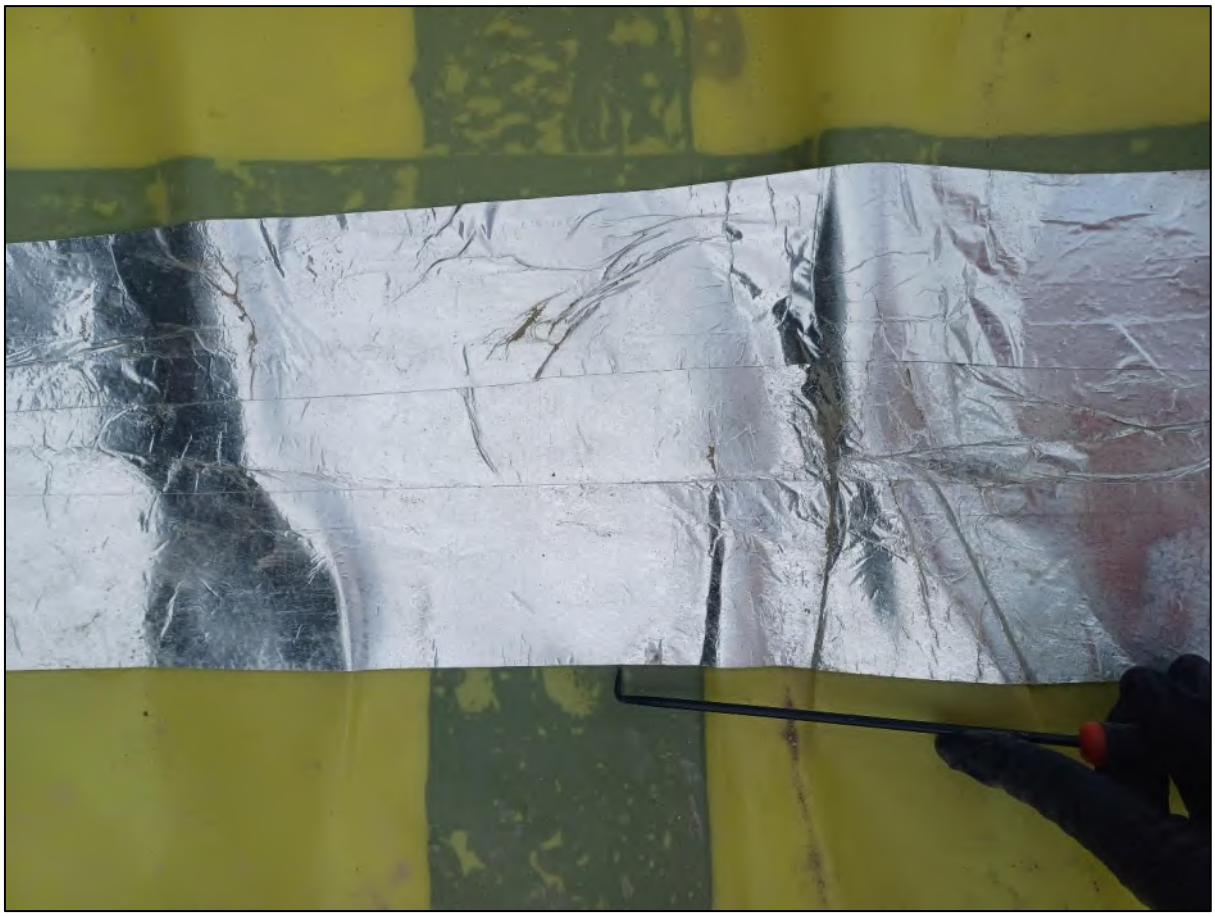
Photograph 1 – Overview of the plot 7 installation.

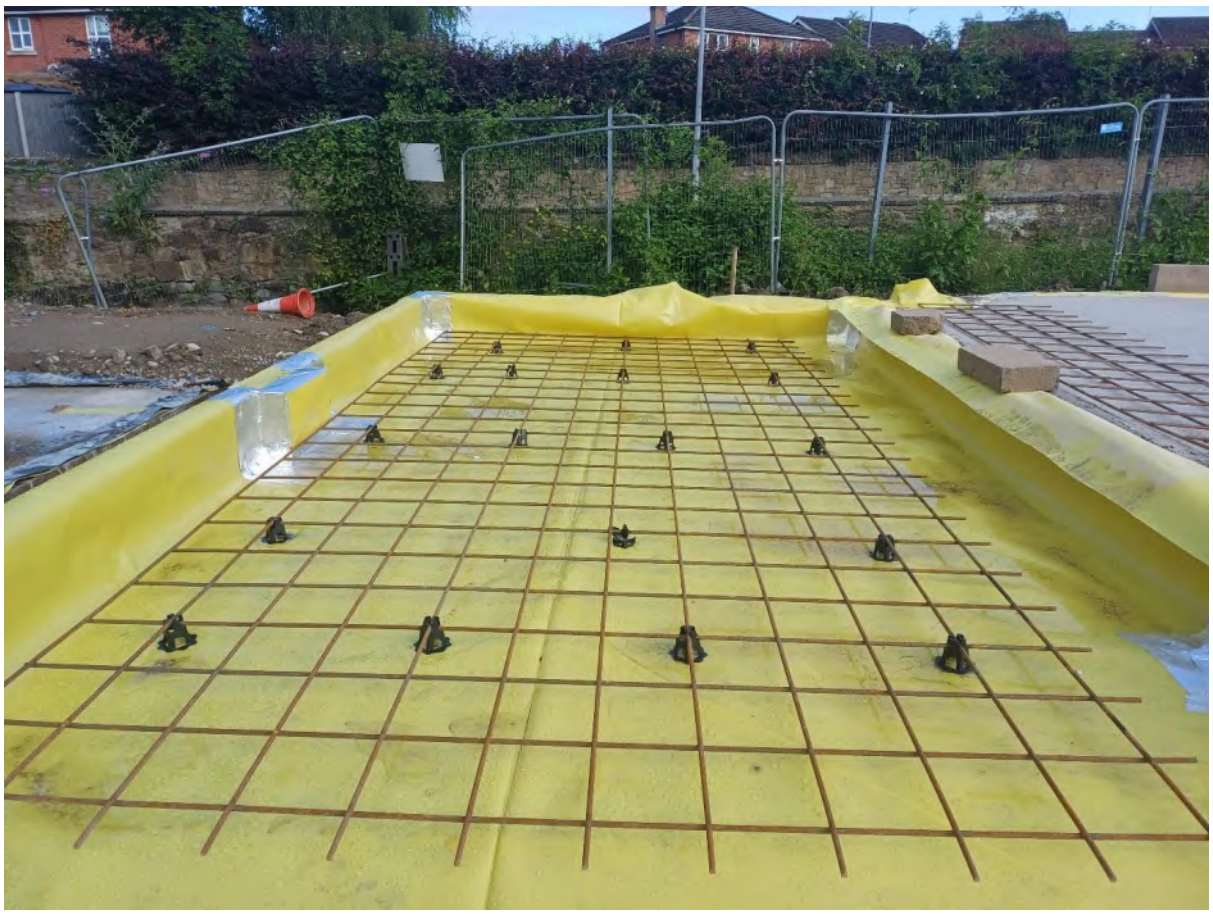
Conclusion
Plot 4 and 7 garage verified; therefore, the full plot 4 development has now been verified and is acceptable and complies with the specification

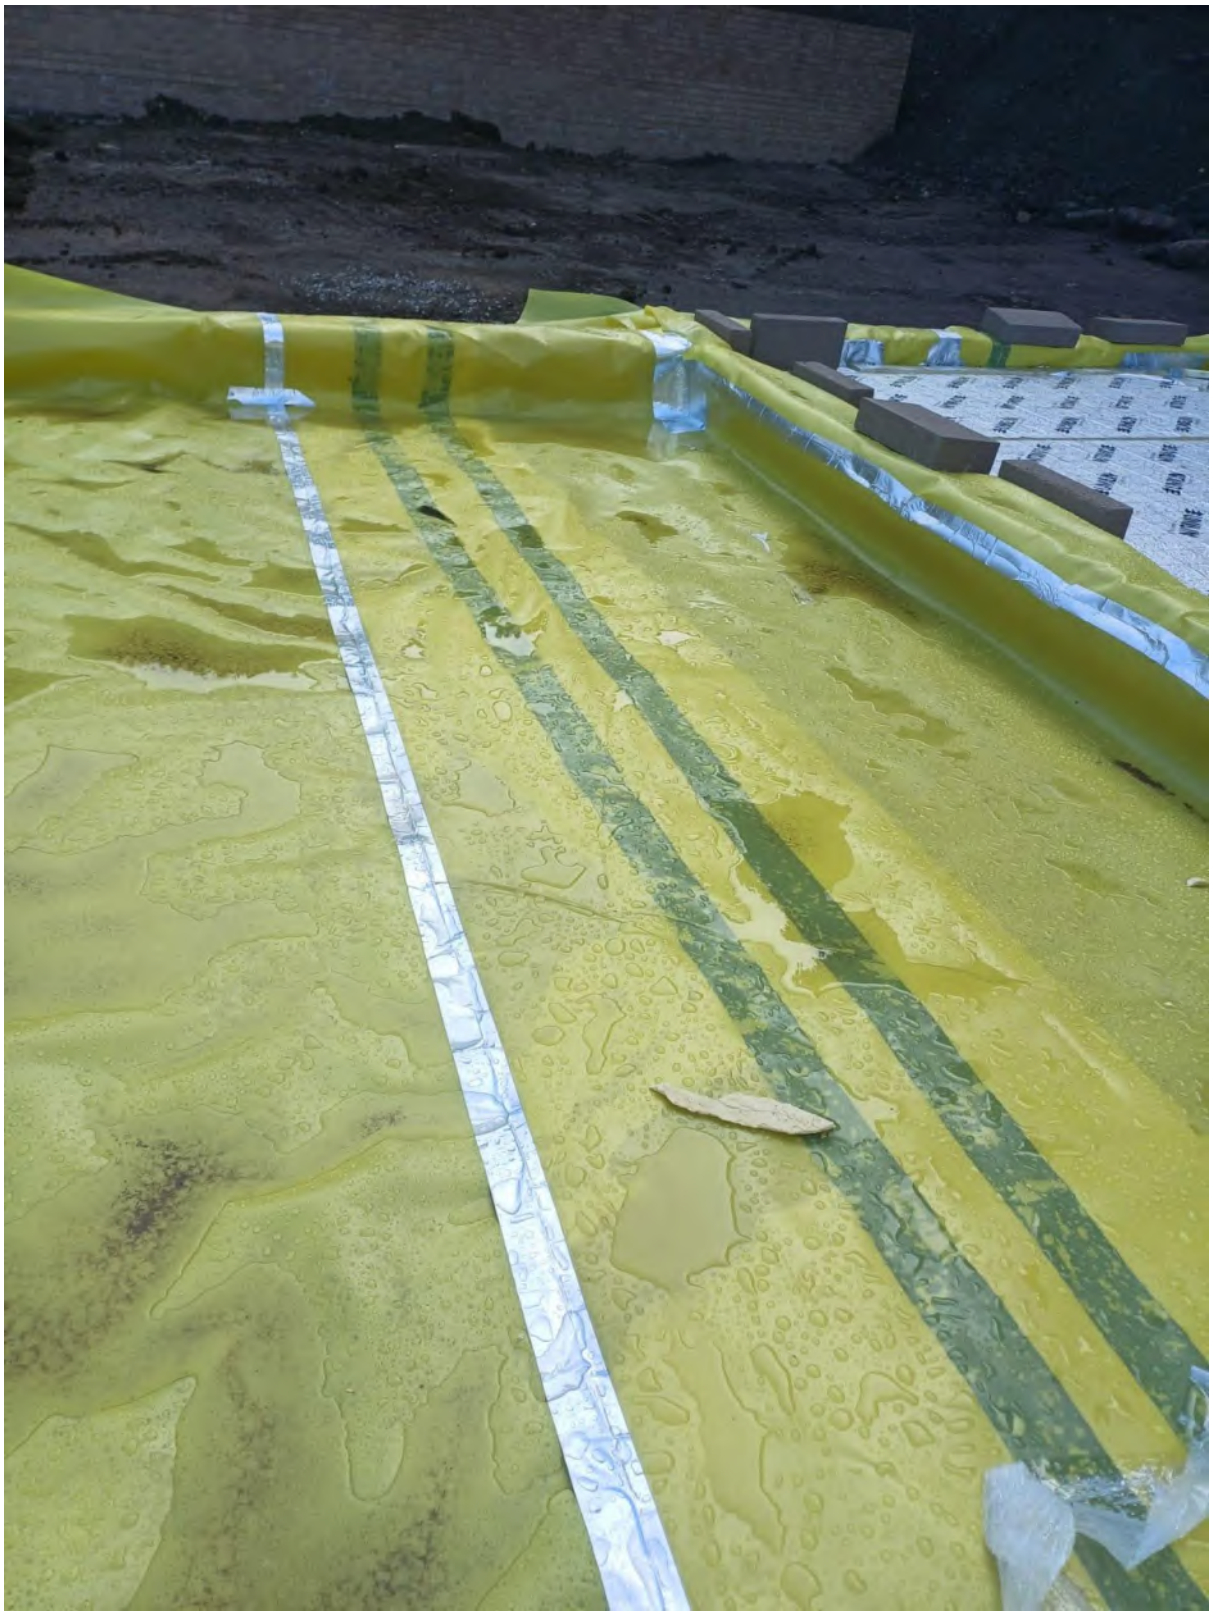
Photograph 1 – Overview of the plot 4 garage installation.

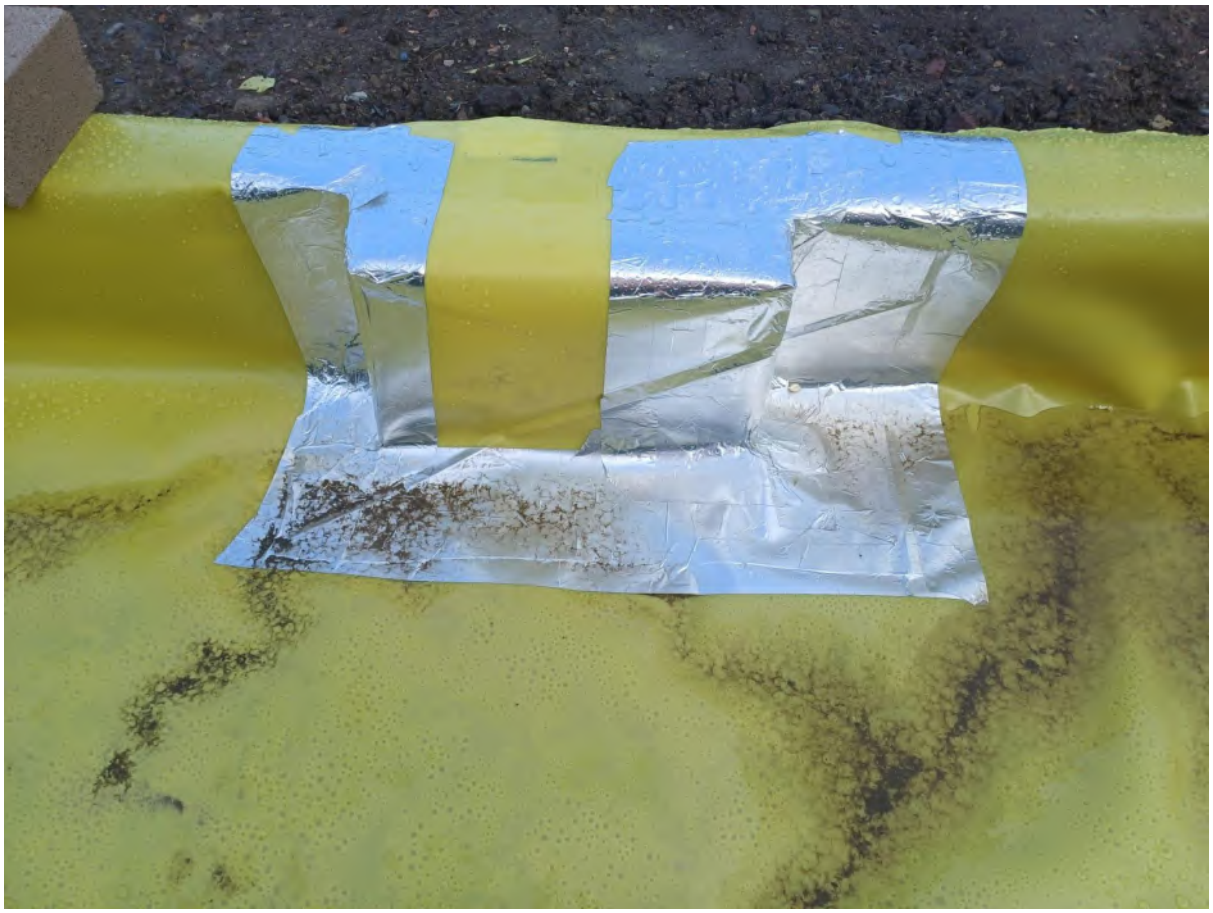
Photograph 3 – Overview of Plot 7 garage

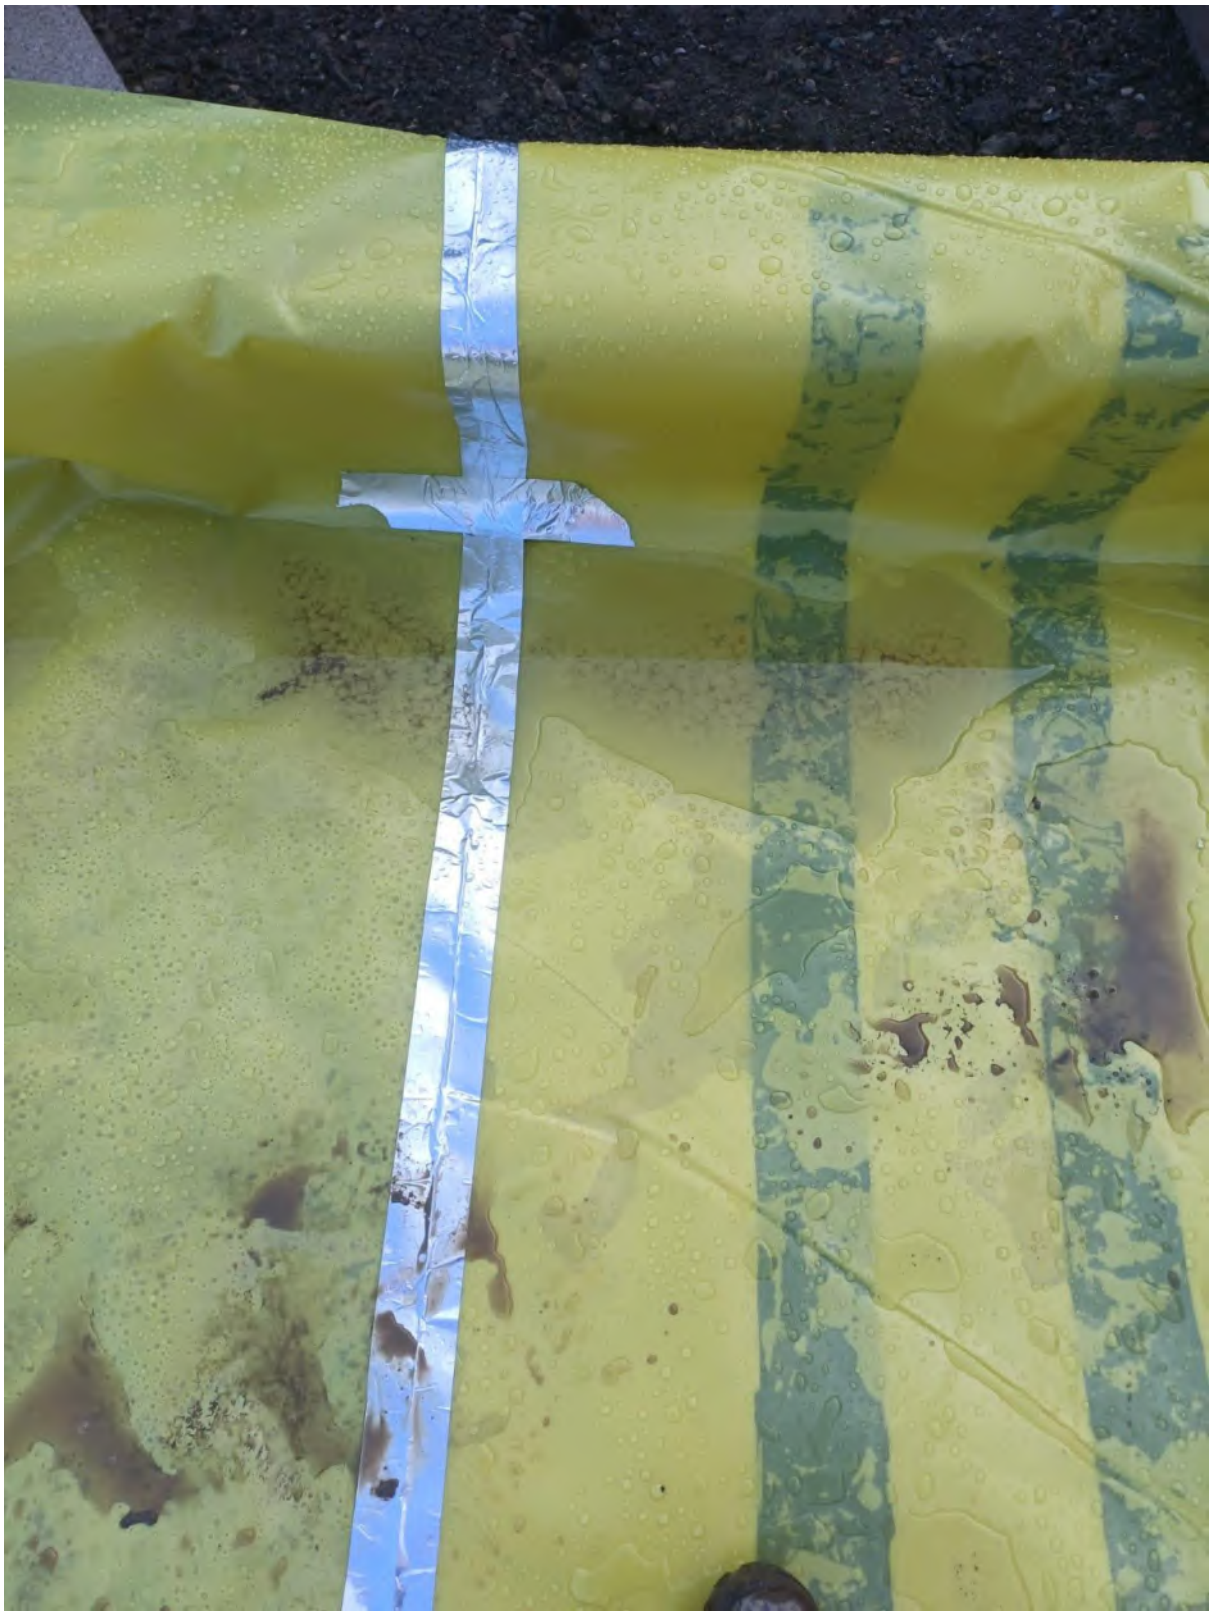
Photograph 4 – Formed and sealed corners in garage 7

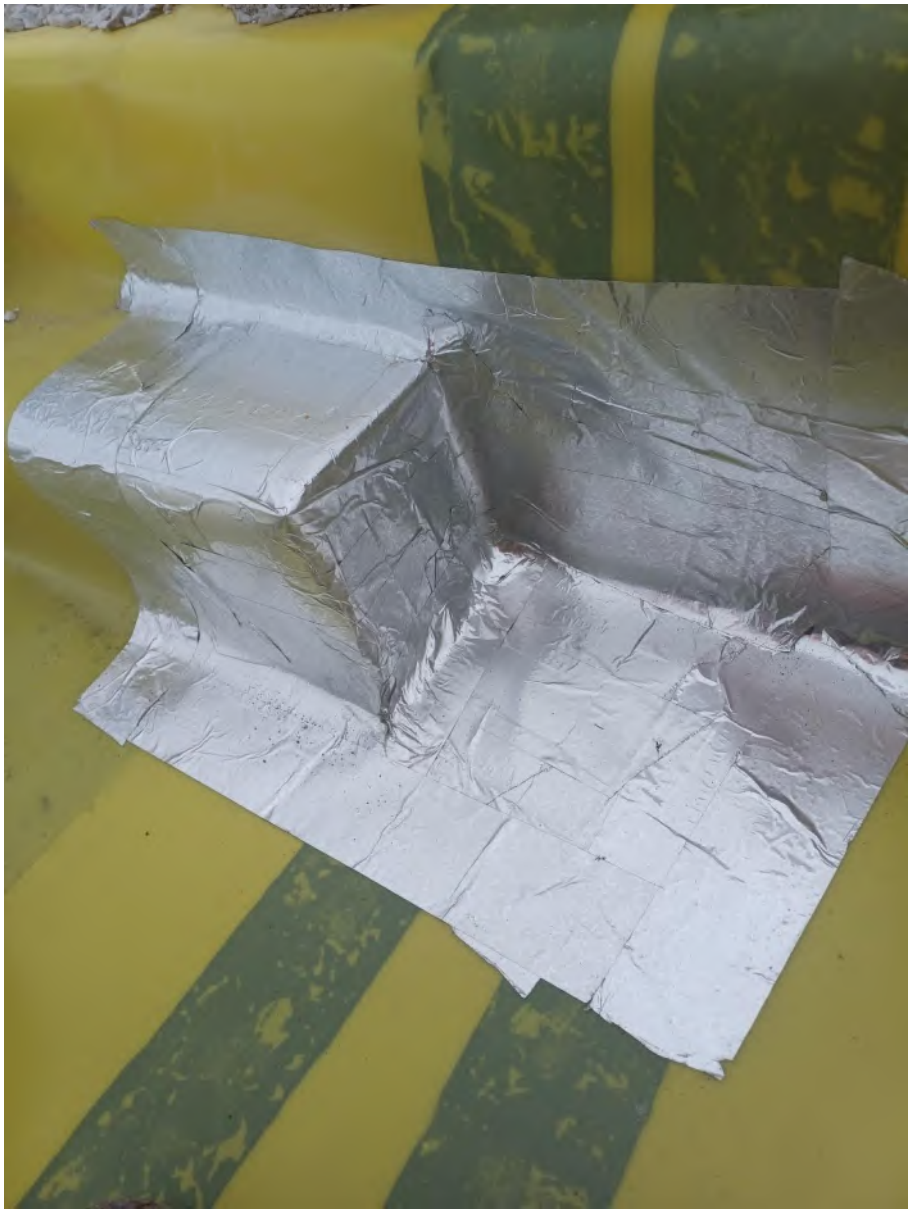
Conclusion
Plot 5 installation verified however garage area is still not complete so cannot be fully signed off.

Photograph 1 – Well sealed service entries

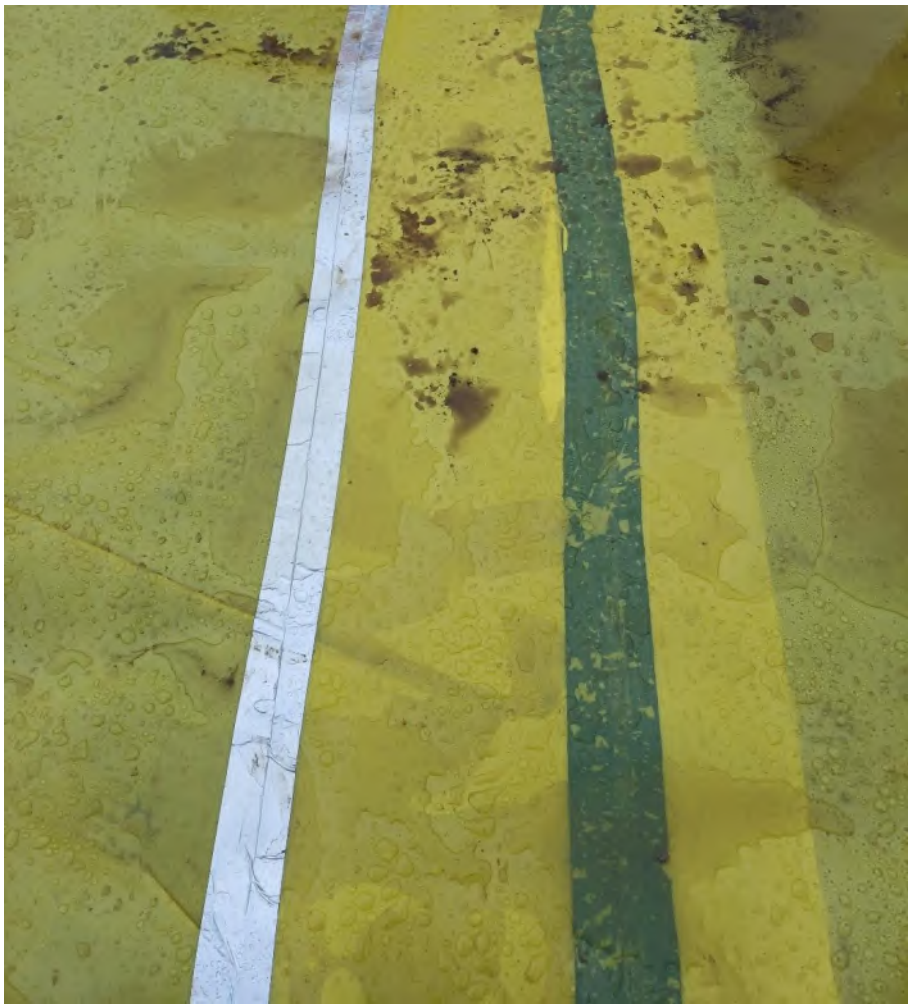
Photogrpah 5 – Well sealed service entires.
