GroundSolve Ltd
Consulting Geotechnical Engineers

LLANGOLLEN ROAD, ACREFAIR - GROUND GAS PROTECTION VERIFICATION REPORT,PLOTS19-21

GSL3116R01

26 JUNE 2024

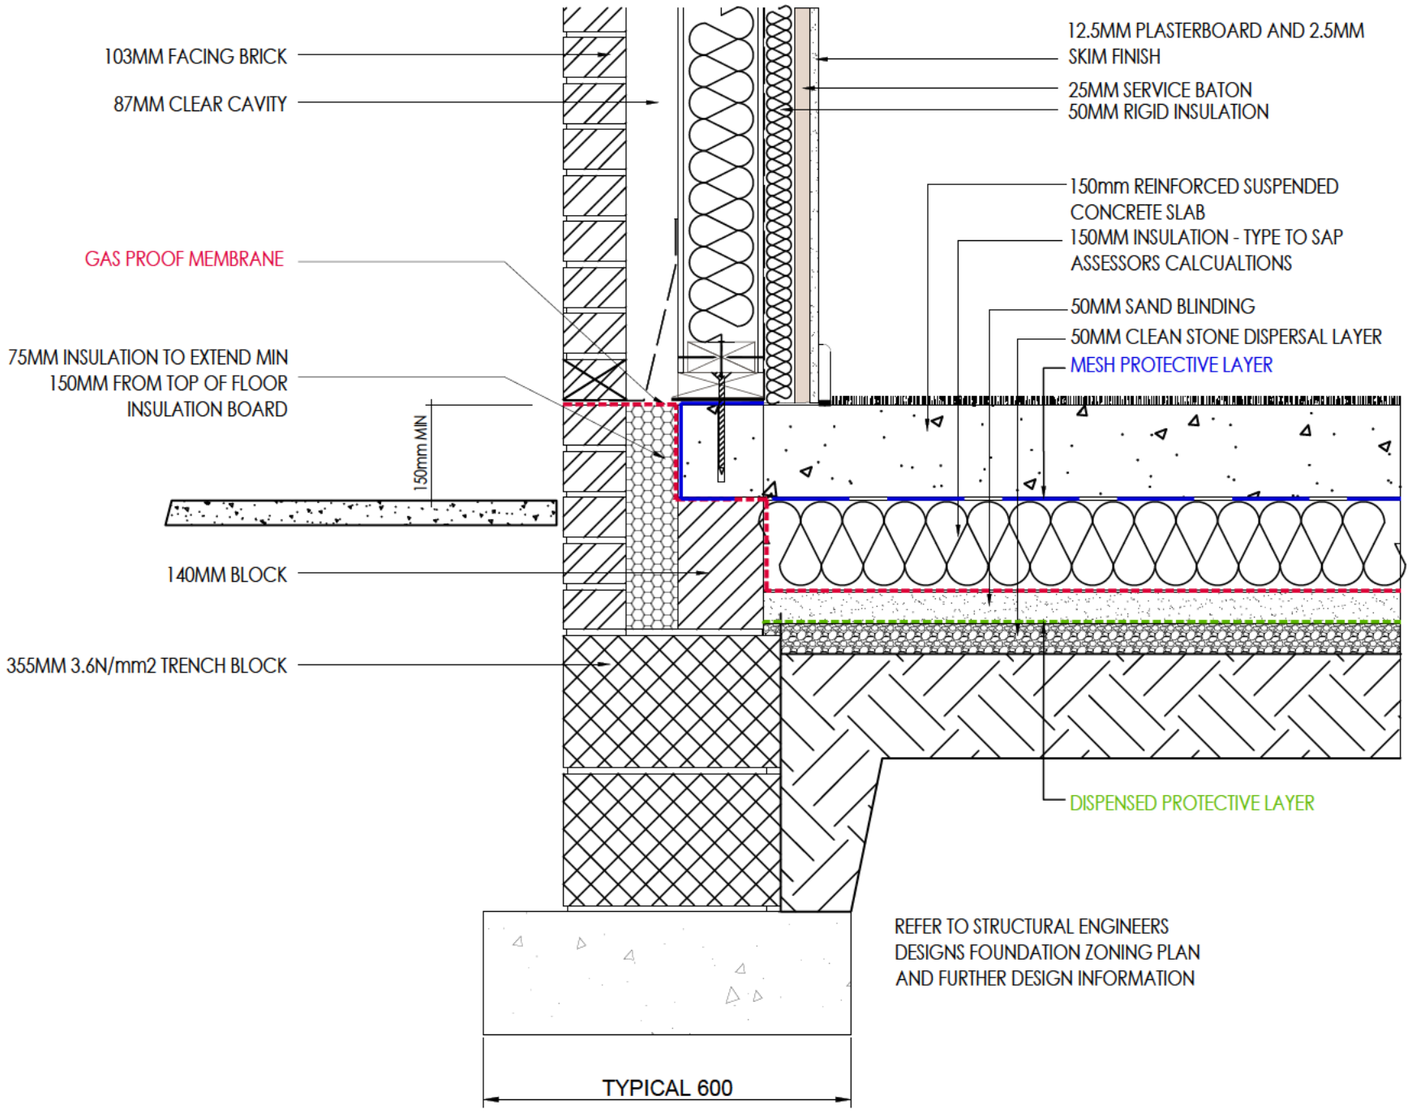
TITLE:
VENTED- GAS MEMBRANE PROTECTION DETAIL

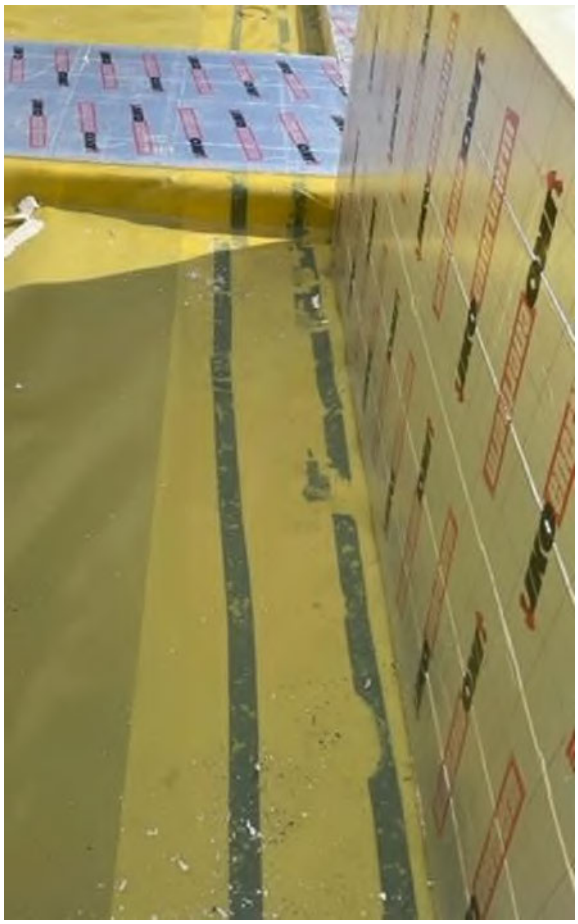
Plot 21 has been verified as acceptable and complies with the specification

Photograph 3 – installed membrane with insulation in place above it

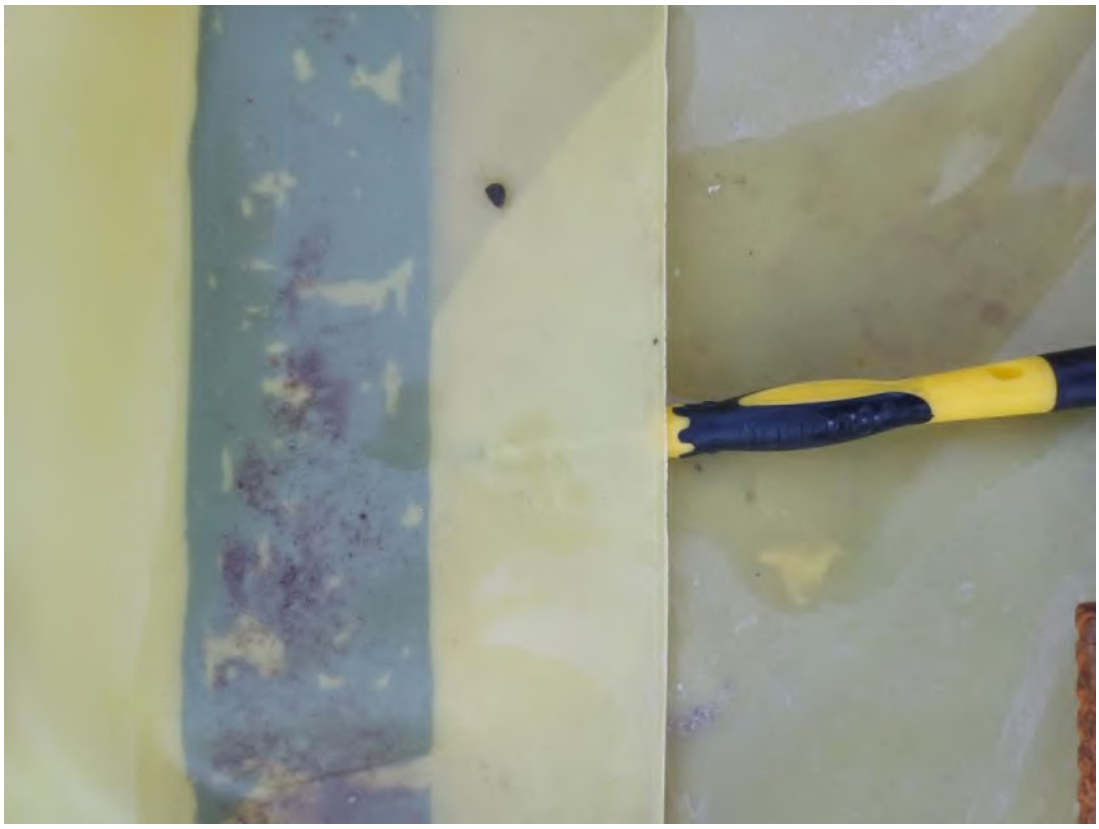
Photograph 1 – Membrane Installation showing membrane in good condition and double taping of 150mm lapped edges.

Discussion was had with site staff about not having tools such as saws on the membrane as this could lead to punctures.

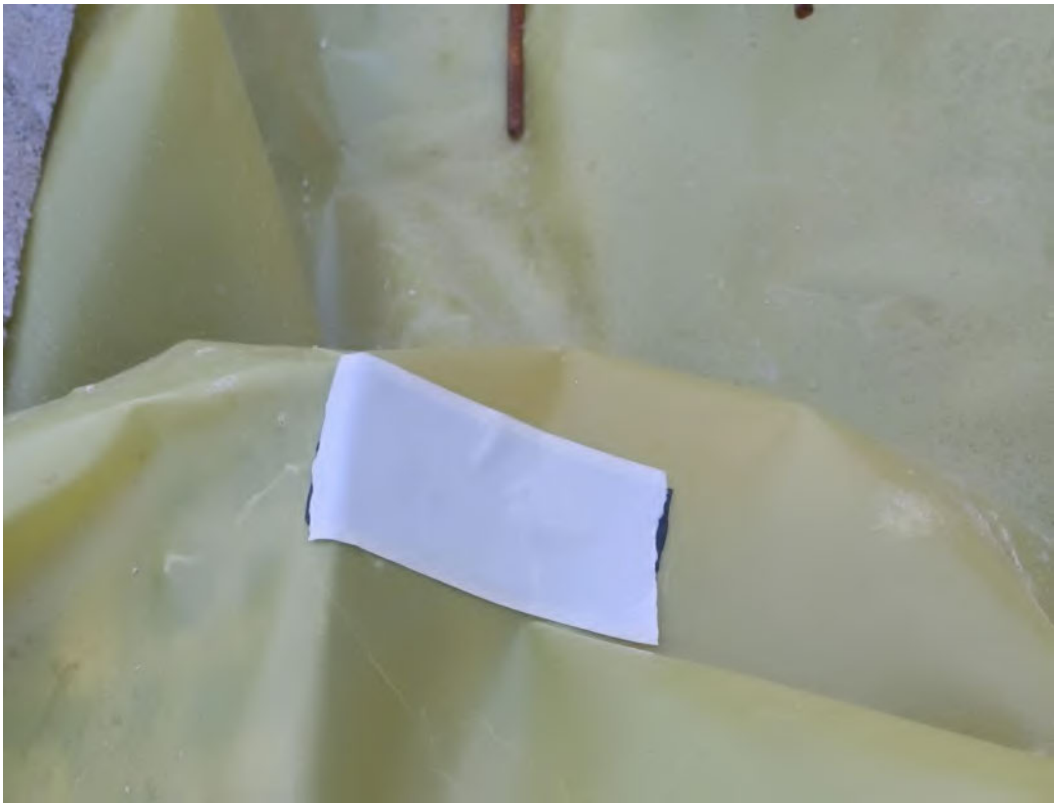
1.2	Gas membrane type	Yellow Visqueen Low Permeability Gas Membrane .
1.3	Gas membrane condition	The membrane was in good condition, with localised areas requiring additional works (i.e identified puncture holes) which were sealed on site and re-verified.

Localised areas were noted during verification that required additional work to ensure a full seal had been formed and/or puncture holes were identified. These were highlighted by the GSL engineer to the site team who then further sealed the areas with additional tape. The newly sealed areas were subsequently re-verified by the GSL engineer to ensure they were fully sealed.

Photograph 6.1 – Puncture holes

Photograph 6.2 – Sealed puncture holes
