Project PD25-107

Report 2158

James Farm, Ruabon

Level One Building Survey

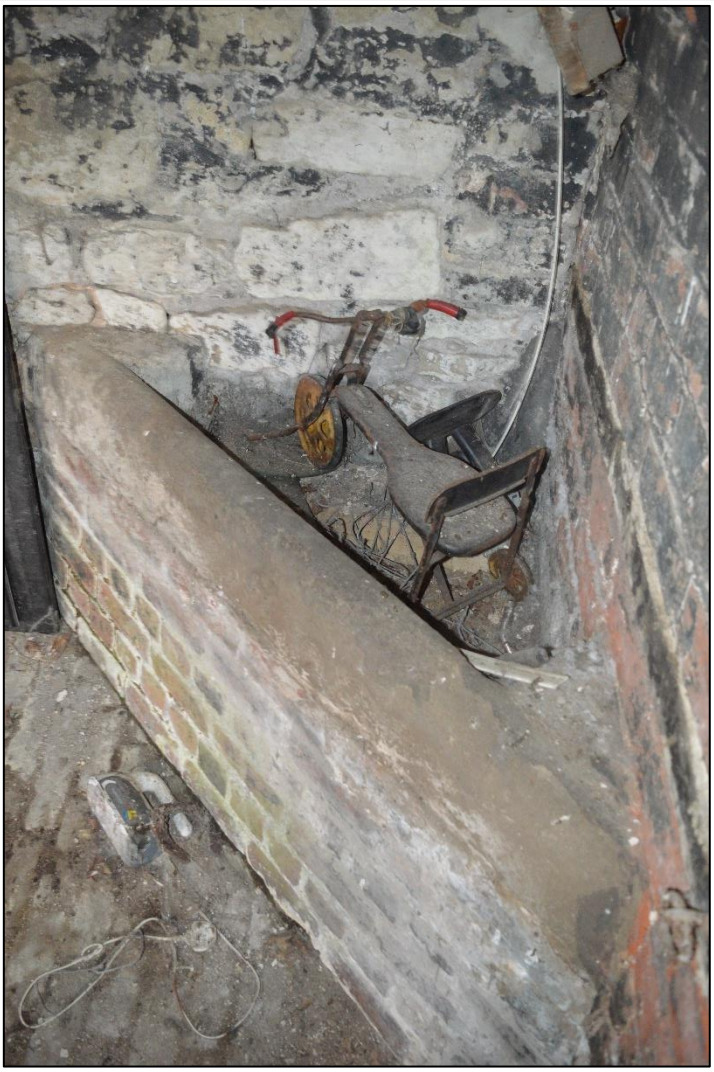
3.4. The two stables on each end of the range still retain their external brick walls facing out into the yard with windows and stable doors (Figure 5), whilst the five in the centre have had these walls removed to form open bays. This change is indicated by the presence of original plinth bricks where the doorways would have been and pivot stones for doors next to these, as well as the remains of wooden latches (Figures 6 and 7).

3.5. Five of these have triangular stone water troughs built into one or other of the rear corners of the stables (Figure 8). Four don't have any remaining signs of troughs, though they may have been removed when doorways were knocked through the partition walls between the stables (Figure 9). One bay shows the possible remains of a food manger in the corner (Figure 10).

Figure 5. East end of building 1 with front wall of stable, window and doorway in situ. Photo: Heneb PD24-107_077

Figure 6. Parts of wooden latches visible protruding from multiple partition walls. Photo: Heneb PD24-107_074

Figure 7. Differences in brickwork and the pivot stone indicate a brick wall has been removed from the fronts of the open bays. Photo: Heneb PD24-107_064

Figure 8. stone water trough in the rear corner of one of the stables in building 1. Photo: Heneb PD24-107_058.

Figure 9. doorway knocked through the rear of the partition walls, possibly removing any water trough. Photo: Heneb PD24-107_068.

Figure 10. Possible remains of food manger in rear corner of one of the stables. Photo: Heneb PD24-107_069.

Figure 11, Thick, Coarse slate roof tiles on building 1. Photo: Heneb PD24-107_051.

Figure 12. The east gable end of building 1 abutting an earlier presumed loading platform. Photo: Heneb PD24-107_083.

Figure 13. East gable end of building 1 with timber lacing. Photo: Heneb PD24-107_082.

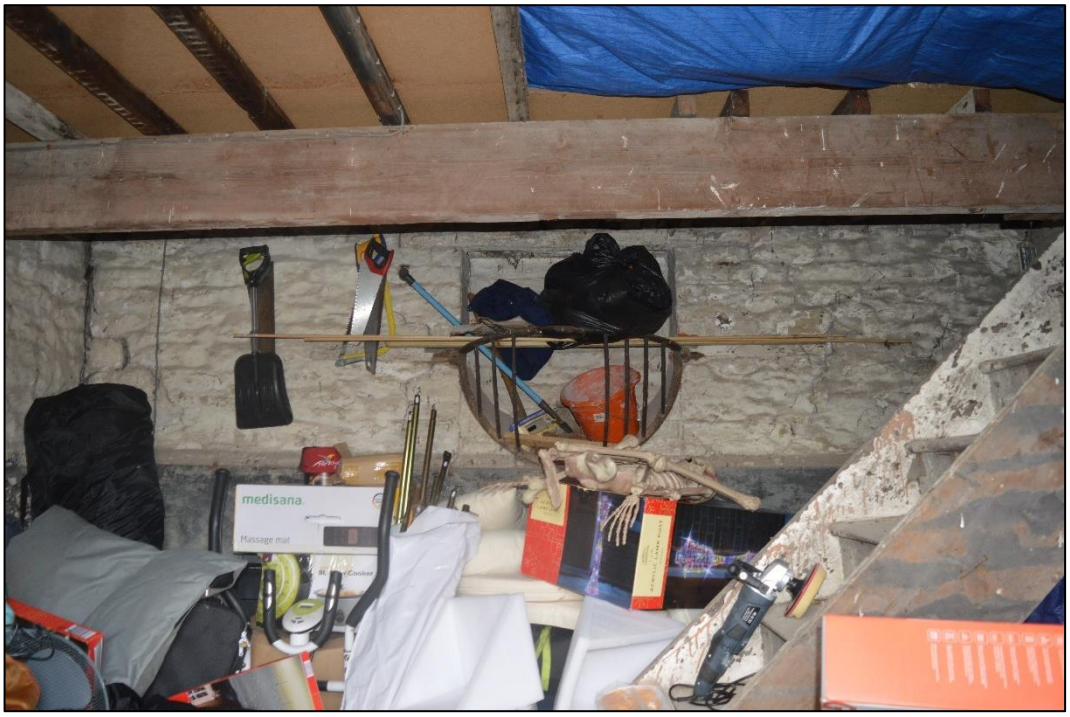
3.9. Each stable is accessed by a large door with overhead light (Figure 15). The stable at the south end still has the metal manger in situ (Figure 16) whilst the other only have the fittings or wall recess present (Figure 17). Triangular brick plinths were located in the rear corners of the central and north stables, these may have once been water troughs or upstands for troughs or they may be structural (Figure 18).

3.10. Above the stables is a loft space accessed via a staircase and ladder in the south stable. The staircase is a later addition, and the primary access was likely the ladder to the right of the door (Figures 20 and 21). The loft space originally had three high level access points on the exterior walls; one, still present and operational, on the south end. One blocked up with stonework on the west side facing into the courtyard, and one on the north end leading out to the loading stage which is now a glazed window (Figures 14, 19 and 23).

3.11. The rear side of building 2 facing the internal courtyard has several small patches of infill where there may have been wooden structures adjoining the side of the building, possibly including a raised floor. The yard has been surfaced with loose gravel so no further signs of these structures were visible during the survey (Figures 22 and 23).

Figure 14. Building 2 viewed from the south-east. Photo: Heneb PD24-107_088.

Figure 15. The central stable in building 2 as viewed from the yard. Photo: Heneb PD24-107_094

Figure 16. wall metal wall mounted manger. Photo: Heneb PD24-107_092.

Figure 17. recess for wall mounted manger in building 2. Photo: Heneb PD24-107_097.

Figure 18. Triangular brick plinth in the north stable. The north gable end of building 2 can be seen to be constructed on top of the stone loading platform. Photo: Heneb PD24-107_102.

Figure 19. Building 2 viewed from the north. Photo: Heneb PD24-107_085.

Figure 20. Ladder leading to the loft in the north stable. Photo: Heneb PD24-107_093.

Figure 21. The loft space in building 2 as viewed through the access on the south gable end. The top of the access ladder in the south stable is visible to the right. Photo: Heneb PD24-107_081.

Figure 22. the rear of building 2 as viewed form the courtyard. Photo: Heneb PD24-107_107,

Figure 23. the rear of Building 2 with detail of the blocked up access, bolts for internal metal wall mounted mangers and various potential putlog spaces. Differences in coursing and wall material can also be seen. Photo: Heneb PD24-107_108.

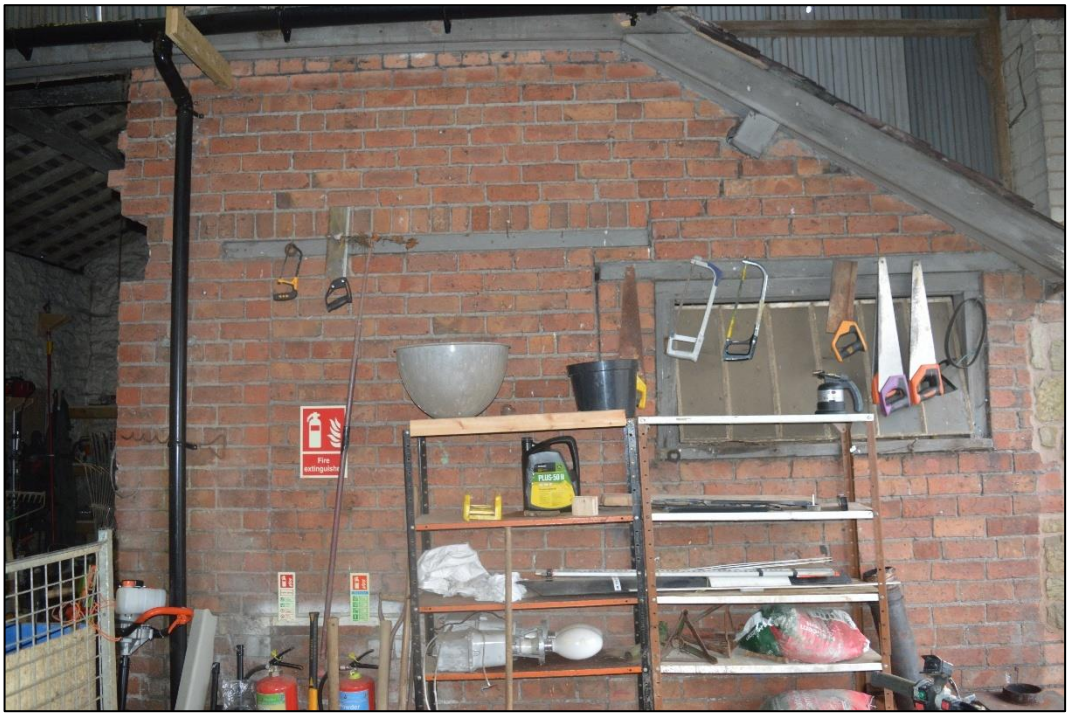
3.16. To the rear of the stables on the inside of the courtyard is a brick-built addition which likely housed implements and equipment (Figure 34). The only access to this from the front of the building is through a small door in the modern workshop and down a small wooden flight of stairs to account for the difference in ground level at this end of the building. This area has been much altered with the addition of brick walls, windows and doorways over time. In the east end of this range is a small office or workshop which houses a staircase along the eastern gable end allowing access to the loft space above the stables (Figures 35, 36 and 38). There is a high level access to the loft area on the east wall which still has some original fittings for lifting gear, at the time of the survey it was obscured by plant growth (Figure 39). In the floor of this workshop are two wooden beams which appear to have once been base plates, possibly for some sort of machinery, engine, boiler or generator (Figure 37).

Figure 24. building 3 viewed from the south-west. Photo: Heneb PD24-107_031.

Figure 25. The east gable end of building 3. Photo: Heneb PD24-107_001.

Figure 26. The three stables at the east end of building 3. Photo: Heneb PD24-107_004.

Figure 27. internal recess for wall mounted manger. Photo: Heneb PD24-107_009.

Figure 28. The central portion of building 3. Photo: Heneb PD24-107_014.

Figure 29. wooden and iron stall fittings in the central portion of building 3. Photo: Heneb PD24-107_016.

Figure 30. the floor in the central stable. Photo: Heneb PD24-107_020.

Figure 31. the west end of building 3 viewed from the south-west. Photo: Heneb PD24-107_031.

Figure 32. what is probably the original west end of the stable block as viewed from inside the workshop/tool store. Photo: Heneb PD24-107_024.

Figure 33. The gable end of the earlier phase of of extension of building 3 at the west end now visible inside the workshop. Photo: Heneb PD24-107_030.

Figure 34. The rear of building 3 facing into the courtyard. Photo: Heneb PD24-107_033.

Figure 35. The workshop at the east end of building 3. Photo: Heneb PD24-107_042.

Figre 36. The stairs leading to the loft space above the stables in building 3. Photo: Heneb PD24-107_046.

Figure 37. the wooden base plates built intot he floor of the workshop. Photo: Heneb PD24-107_045.

Figure 38. the loft space above the stables in building 3. Photo: Heneb PD24-107_047.

Figure 39. the high level access to the loft space in building 3. Photo: Heneb PD24-107_048.
