GroundSolve Ltd
Consulting Geotechnical Engineers

BRYMBO HERITAGE CENTRE - VERIFICATION REPORT

GSL3549

Prepared for: TACP

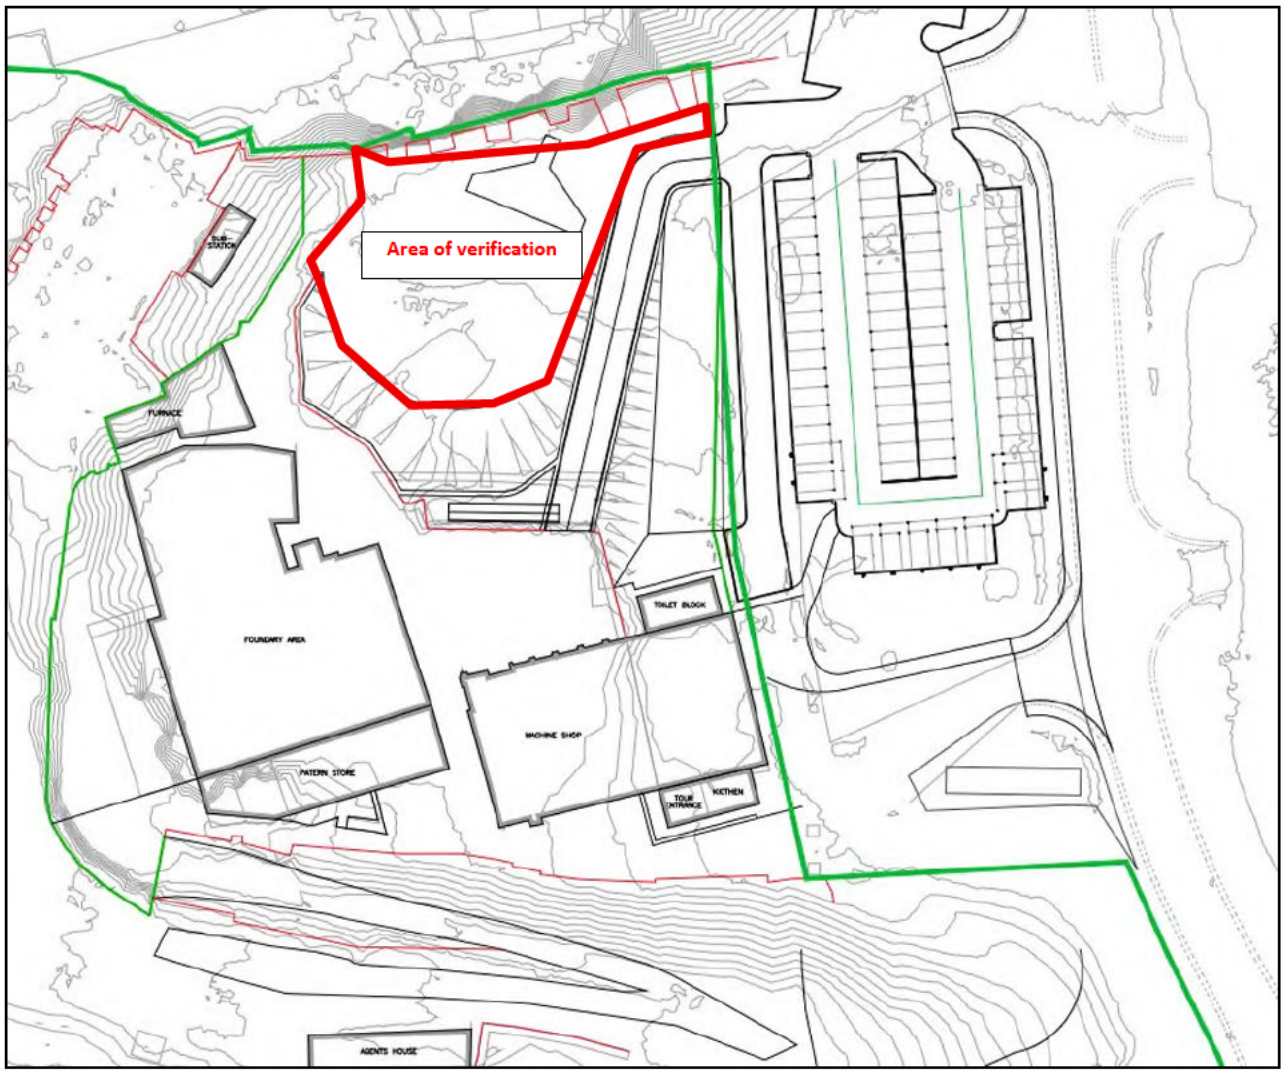
Figure 1: Extract of Development Plan 4866?0002 P01 C01 (Bingham Rawlings Partnership Ltd).

No unexpected contamination has been encountered within the soft landscaped area outlined in **Figure 1.**
