Project Title	"*Coed Issa*" Parc Brymbo, Wrexham
Project Number	7565
Document Title	Gas Membrane Validation Report for Plots 13-15
Document Number	7565gval_plots 13-15
This document is not to be used for contractual or engineering purposes unless the document verification sheet is signed where indicated by the approver of the document.

GAS MEMBRANE VALIDATION REPORT FOR PLOTS 13-15

Developer	Taylor Wimpey North-West
Site Name	"*Coed Issa*" Parc Brymbo, Wrexham
NHBC Site Reference	ENGPROJ/274367
Date of Report:	22nd July 2024

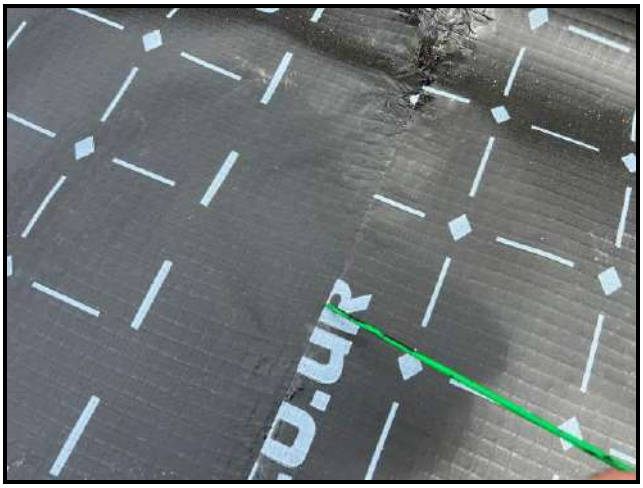
Photograph 1: Showing the general condition of the gas membrane installation on Plots 13-14, as witnessed by Coopers on 26th April 2024.

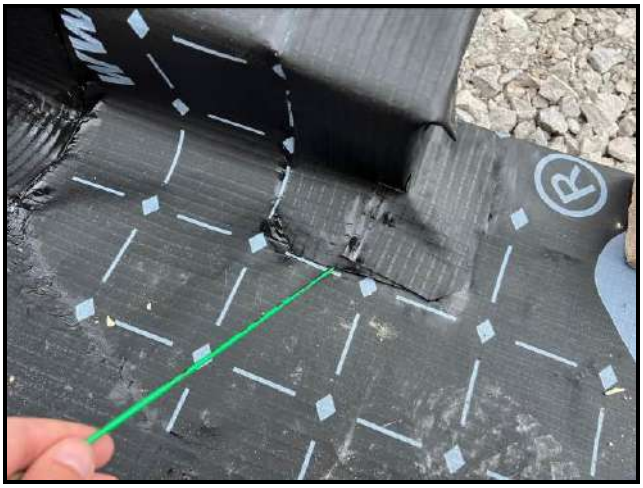
Photograph 6: Showing the formation of the gas membrane around a complex corner section on Plot 16, as witnessed by Coopers on 26th April 2024.
