Fire Safety Report V 4 20.11.22  
The National Trust  
Erddig Hall, Wrexham

Author: Steve Emery CMIFireE  
Heritage Fire Consultancy Limited

24<sup>th</sup> October 2022

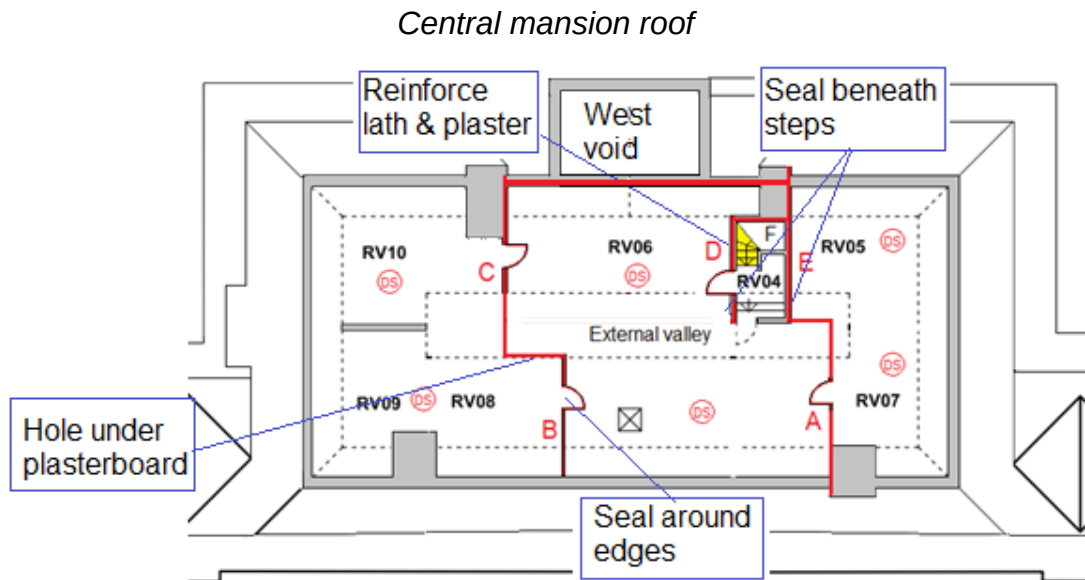
## 1. Central roof void above Mansion

The compartmentation within the central roof void is generally very good with either brick-built partitions or fire-line boards on roof trusses, as shown in red and lettered for identification below. The main issues which should be addressed are shown on the plan below and in the following paragraphs.

- 1.1. Barrier B** should be sealed around the top edges with an intumescent mastic.

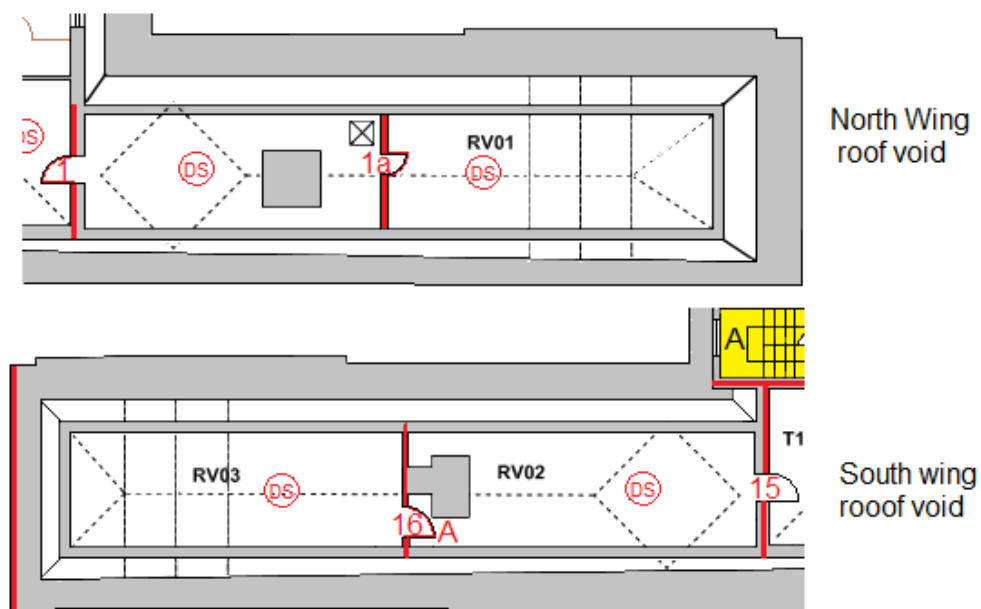
## 2. Roof voids above North and South wings

The two roof voids above the North and South wings are at a lower level than the central roof void and are accessed via hatches in rooms T03 and T14. The compartmentation is very good, but some minor works are required as detailed below. The South roof void RV02/RV03 fire barrier has been created in line with the chimney breast, whilst the North roof void fire barrier is brick-built in line with a masonry wall below (between rooms S05 and S03) rather than the chimney breast, which isn't central.

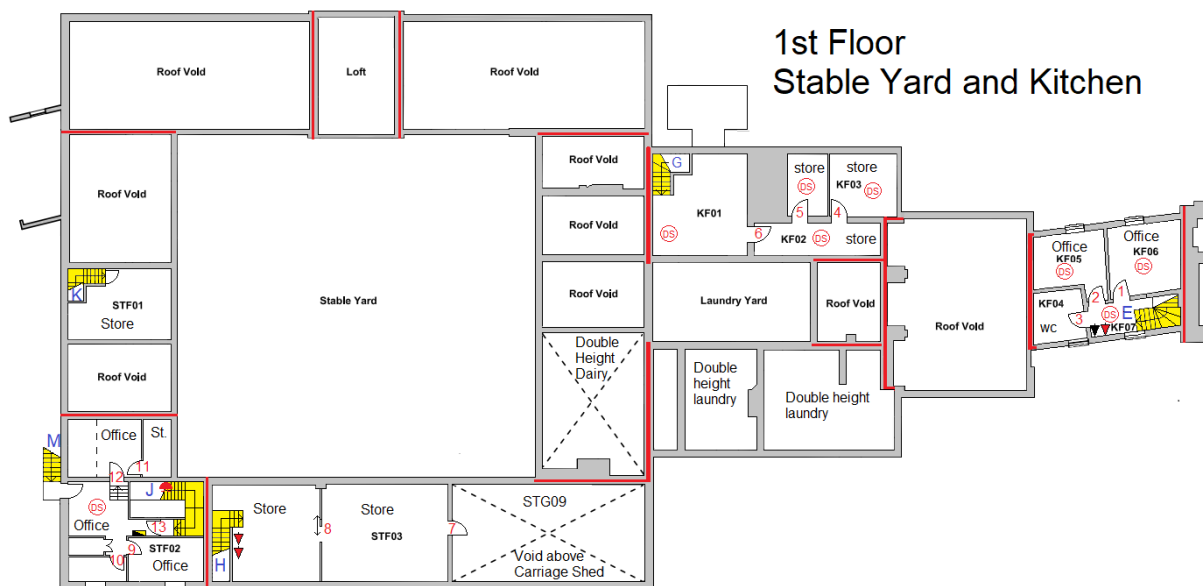
*Plan showing Stable Yard and Kitchen fire compartments in red*

It would be reasonable to assume the roofs are fire separated in the locations shown below in red lines; either because the roof line can be seen internally in double height rooms and stables, or accommodation has been inserted into the roof as seen in the Southeast corner.

The largest compartment is store STF03 which is divided by a flimsy partition with a lightweight sliding door STF8 and is also connected by door STF7 to the void above the carriage shed. Fortunately, stair H is only accessible from outside the building so is fire separated from the rest of the building. As the Carriage shed and store STF03, which is mainly used for agricultural implements have very low fire loads, it would be practical to keep this area STF03 and SRG09 as a single fire compartment.

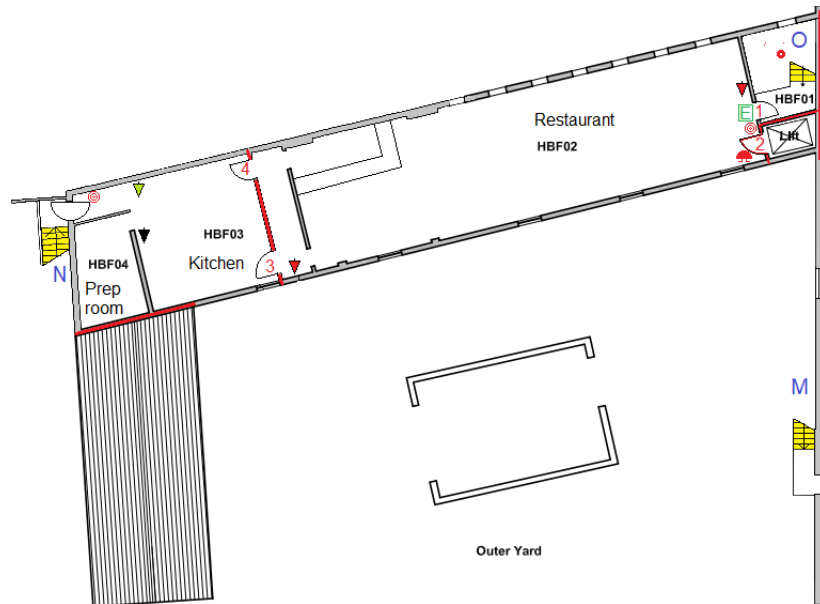
*Plan of the first-floor Outer yard with fire resistance shown in red*

The outer yard only has the first-floor cafe and cafe kitchen which extend up into the roof and the junction with the stable yard can be seen within staircase O. Therefore has satisfactory fire separation. The kitchen and prep room adjoin the South wing which contains cart sheds and storage with adequate fire separation between the two.

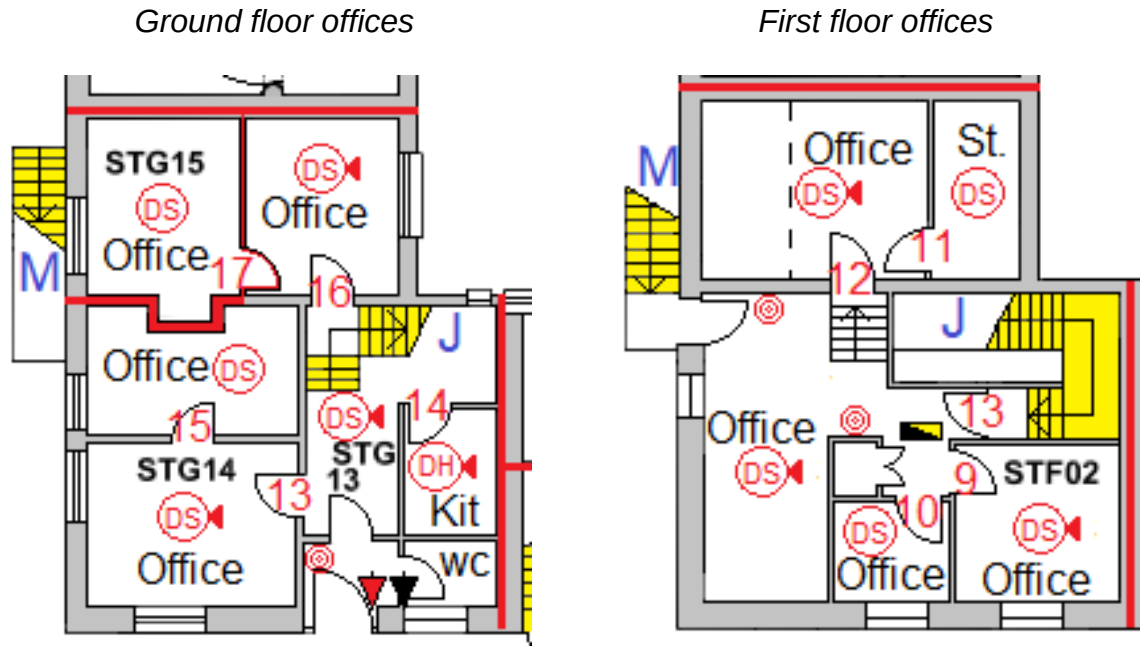
The layout of the Stable Yard offices has changed since the plans were drawn, with new partitions and new offices to the West. The new layout with proposed detection has been used in this report as seen below.

It would be normal practice to make the window next to the stairs fire resisting, but a risk assessed approach shows that if a fire were to occur in office STG15, the internal stair would remain useable, providing the door is fire resisting and self-closing.

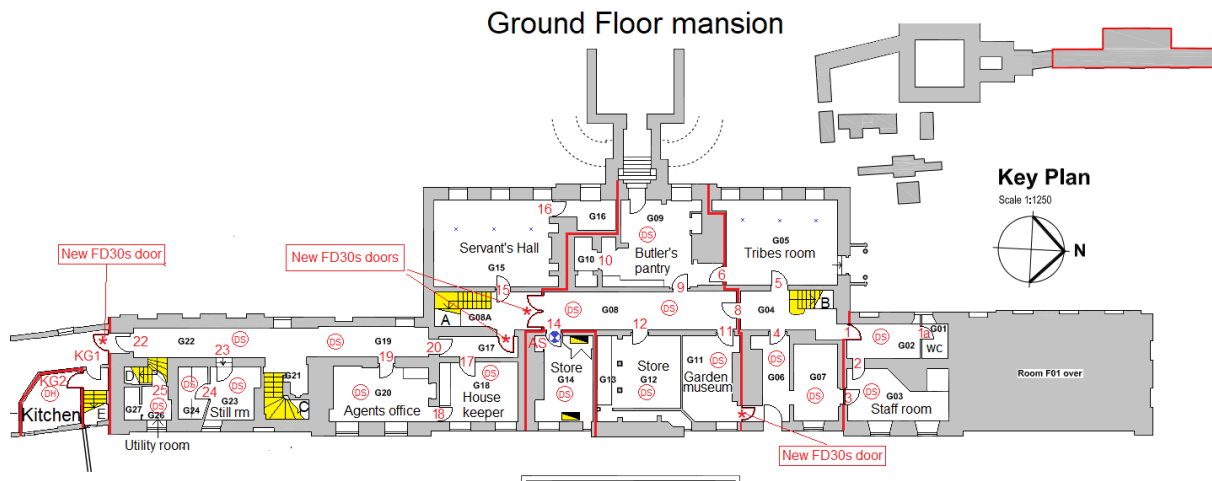
These four sets of doors will protect and fire separate both main staircases and isolate the main house from the Kitchen and Stable yard. If they are not provided doors 10, 17, 14, 12 and 9 will need to be upgraded to FD30s self-closing standard.

- a) Between the Ground floor Garden Museum room G11 and the passage G06. This would create a fire compartment from East to West along the line of the two chimneys, to include doors G6 and G8. This is also a recommendation of the fire risk assessment of January 2022.
- b) More controversial is a new set of double doors across the ground floor main passage G08 to create another compartment line from East to West, also in line with the chimneys. This would allow the door G14 to the electrical intake room, to remain as existing together with Doors G11 and G12, with their ventilation holes.
- c) Between staircase A and corridor G17. This would allow the doors G17, G19 and G20 to remain as existing.
- d) To the South of the original external door G22 all as shown on the plan on the next page marked with red asterisks.

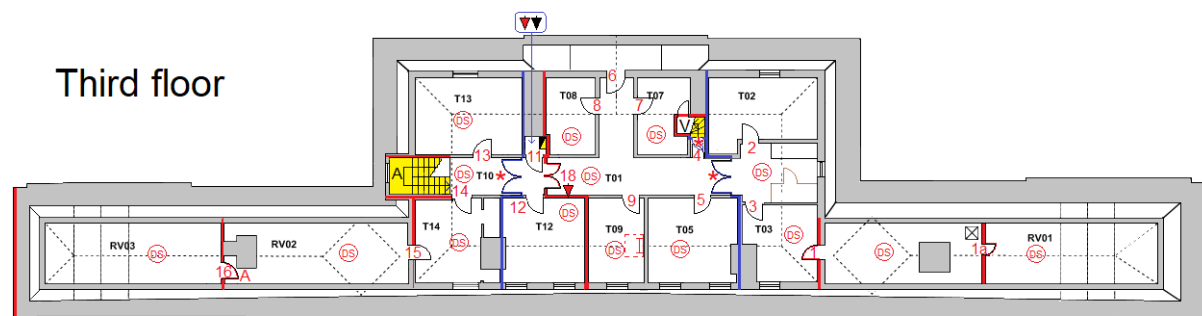
The other locations are across the 3<sup>rd</sup> floor corridor as shown in blue on the plan below and inside the staircase enclosure to the attic. The first set of new cross-corridor doors to the South will protect the third floor from a fire occurring elsewhere in the building and the second set to the North will separate divide the corridor in two to reduce the size of a fire which could start there.
