# Appendix 11.7: Bat Roost Technical Appendix

# LAND NORTH OF BRYN LANE WREXHAM BAT ROOST SURVEY REPORT

| Document Title | Bat Roost Survey Report |
| Document Ref | 9134.005 |

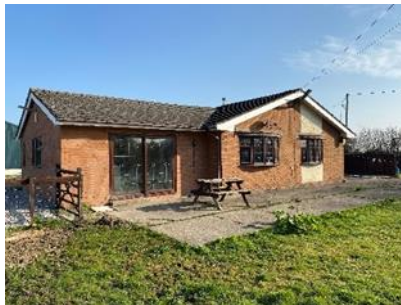
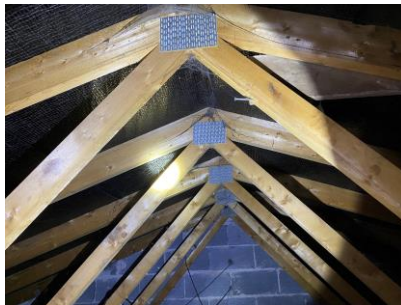
| Building ID | Description and Feature(s) | Photos | BCT Category |
|---|---|---|---|
| B1 | <p>B1 is a single storey brick-built bungalow with a multi-pitched tiled roof. Several gaps are present along the edge of the roof tiles on the gable end where mortar has worn away (west and south elevations), with gaps also present between the external brickwork and wooden soffits on the western aspect and between the brickwork and the head of the window. There is also a large gap in the soffit on the southern aspect. A missing ventilation panel on the northern aspect allows for access into the soffit, where a blue tit was recorded nesting.</p> <p>Internally a single loft space was present. Bitumen felt lining was present throughout and was in good condition, with only minor gaps where the cuts overlap. No evidence of bats was found. However, with the bitumen felt being in good condition and well-sealed the likelihood of finding evidence of bats such as droppings is limited. The main roosting opportunities are therefore between the tiles and bitumen felt lining rather than in the loft space itself. No evidence of roosting bats was found.</p> | | Moderate |

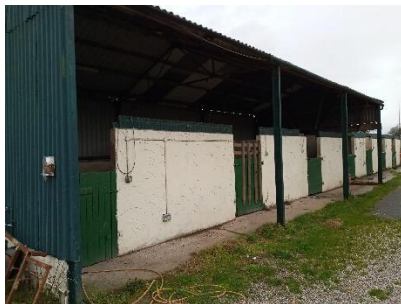
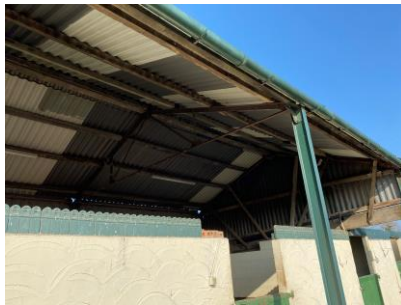
| Building ID | Description and Feature(s) | Photos | BCT Category |
|---|---|---|---|
| B2 | <p>B2 is an open, pitched corrugated metal stable block, with brick walls separating each stable. The building is double height with wood and metal framed. No evidence of roosting bats was found. No suitable roost features are present. The building is open on the eastern aspect and the roof is open to the rest of the building.</p> <p>There was evidence of nesting birds internally.</p> | | Negligible |

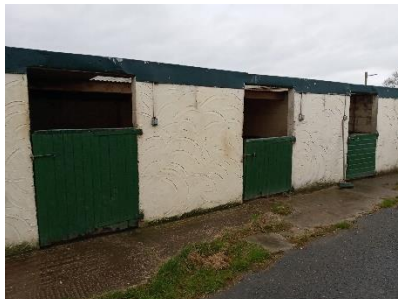
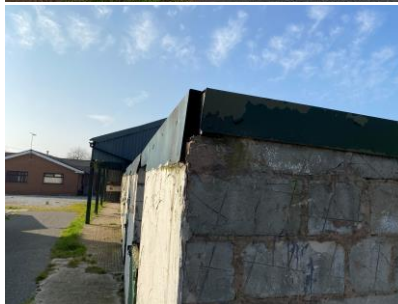
| Building ID | Description and Feature(s) | Photos | BCT Category |
|---|---|---|---|
| B3 | <p>B3 is a single-storey brick-built stable block with flat corrugated plastic roof, adjoined to B2. The edges of the roof are secured with iron. There are gaps between the raised metal edges and the brickwork which could be used opportunistically by individual bats. No evidence of roosting bats was found.</p> <p>Potential for nesting birds due to adequate access.</p> | | Low |

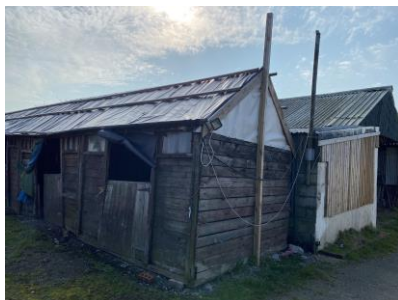
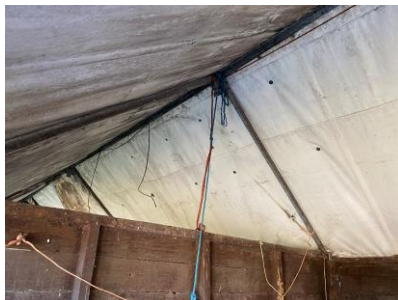
| Building ID | Description and Feature(s) | Photos | BCT Category |
|---|---|---|---|
| B4 | <p>B4 is a wooden stable block with a single pitched roof with the roof membrane exposed. Some of the wooden panels forming the shed structure have fallen away. Internally the roof is lined with tarpaulin. No evidence of roosting bats was found. No suitable roost features are present.</p> <p>Potential for nesting birds due to adequate access.</p> | | Negligible |

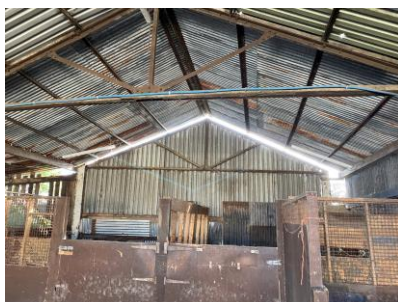
| Building ID | Description and Feature(s) | Photos | BCT Category |
|---|---|---|---|
| B5 | <p>B5 is a large, corrugated metal barn housing horse stables. It is a large open space with a pitched metal roof and exposed beams. It is open fronted on the western aspect. The building is double height and metal framed. No evidence of roosting bats was found. No suitable roost features are present.</p> <p>Potential for nesting birds due to adequate access.</p> | | Negligible |

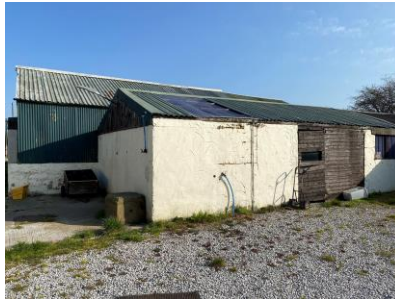
| Building ID | Description and Feature(s) | Photos | BCT Category |
|---|---|---|---|
| B6 | <p>B6 is a single-storey brick-built outbuilding with a pitched corrugated metal roof a small section of which is corrugated uPVC. Occasional wooden panels are present along the walls. Gaps are present between the brick walls and wood panelling, which provide opportunistic roosting opportunities for individual bats. No evidence of roosting bats was found.</p> <p>Potential for nesting birds due to adequate access.</p> | | Low |

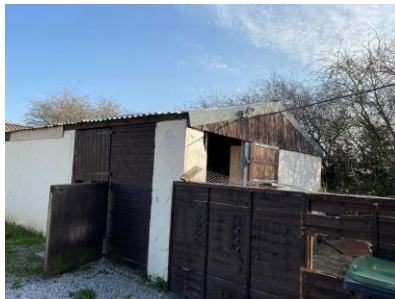
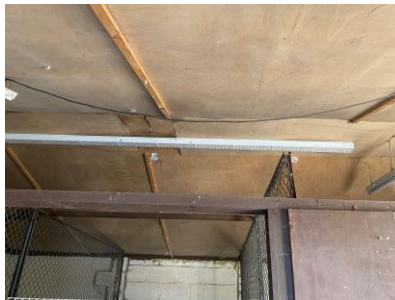
| Building ID | Description and Feature(s) | Photos | BCT Category |
|---|---|---|---|
| B7 | <p>B7 is a single-storey brick-built outbuilding with a pitched corrugated metal roof, of similar construction to B6. The two buildings are adjoining. Internally, the roof is lined with wooden boarding. No evidence of roosting bats were identified. Gaps are present between the brick walls and wood panelling, which provide opportunistic roosting opportunities for individual bats. No evidence of roosting bats was found.</p> <p>Potential for nesting birds due to adequate access.</p> | <br> | Low |

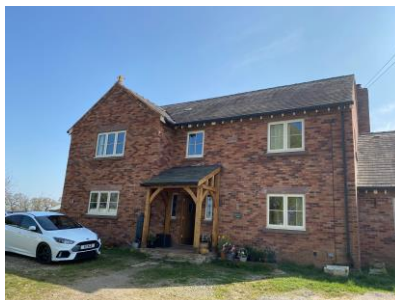
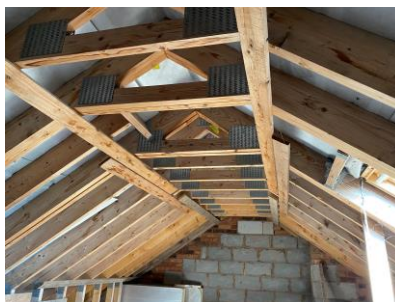
| Building ID | Description and Feature(s) | Photos | BCT Category |
|---|---|---|---|
| B8 | <p>B8 is a two-storey residential dwelling, with adjoining single-storey sections. The brickwork is in good condition with no missing mortar. There are some slipped roof tiles which could allow access between the tiles and lining, suitable for roosting bats.</p> <p>Internally two loft spaces are present, one within the single-storey section and one within the two-storey. The main loft spaces are well insulated and partially converted into additional living space/storage. Windows are present resulting in a well-lit environment. No gaps are present in the internal lining. No evidence of roosting bats was found.</p> | <br> | Moderate |

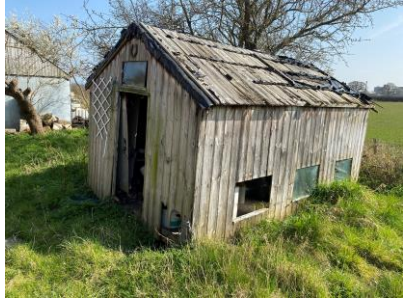
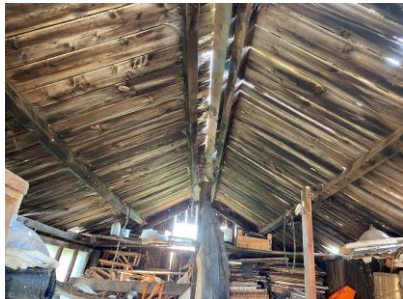
| Building ID | Description and Feature(s) | Photos | BCT Category |
|---|---|---|---|
| B9 | <p>B9 is a wooden garden shed with a pitched wooden roof. The structure is in some disrepair. No roof lining is present. There are gaps between the roof and walls letting plenty of light in and leaving the building exposed to the elements. No evidence of roosting bats was found.</p> <p>Potential for nesting birds due to adequate access.</p> | | Negligible |

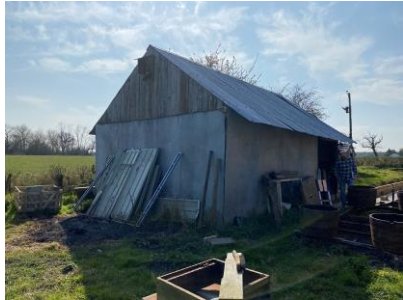
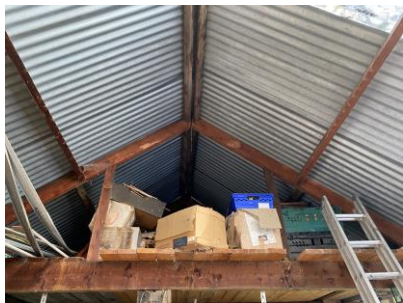
| Building ID | Description and Feature(s) | Photos | BCT Category |
|---|---|---|---|
| B10 | <p>B10 is a single-storey, double height, wooden framed outbuilding with a pitched corrugated iron roof. Wood panelling is present at the gable end walls. Each gable end has a bird box attached, although the eastern box has fallen into disrepair.</p> <p>Internally, the roof void is open to the building and is used as an additional storage space. Timber beams are present. The building is used for as a workshop/garden storage. No evidence of roosting bats was found. No suitable roosting habitat was identified.</p> <p>Potential for nesting birds in western gable bird box and internally due to adequate access.</p> | | Negligible |

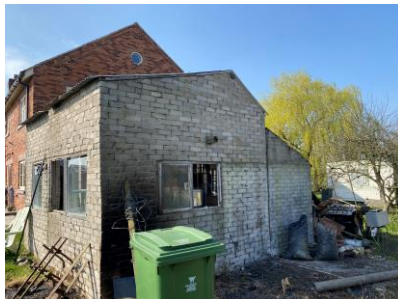
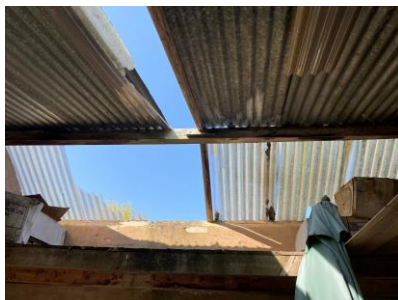
| Building ID | Description and Feature(s) | Photos | BCT Category |
|---|---|---|---|
| B11 | <p>B11 is a single-storey brick outbuilding/shed, with a corrugated iron pitched roof and adjoining mono-pitched roof on the northern aspect. The roof is in disrepair with sections completely missing and parts having been replaced with corrugated plastic. The building is wooden framed, including the windows. Several windows are partially open. Internally, an open roof void with no lining is present leaving the internal space fairly exposed to light and the elements. No evidence of roosting bats was found. No suitable roosting habitat was identified.</p> <p>Potential for nesting birds due to adequate access.</p> | | Negligible |

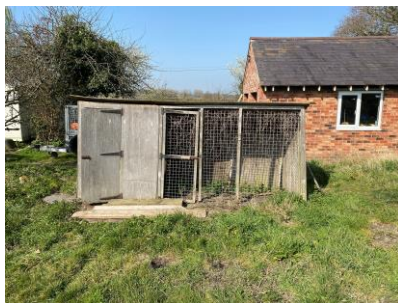
| Building ID | Description and Feature(s) | Photos | BCT Category |
|---|---|---|---|
| B12 | <p>B12 is a small wooden dog kennel with lean-to roof. The western aspect is partially open fronted. The doors are wooden with no frames. No evidence of roosting bats was found. No suitable roosting habitat was identified.</p> <p>Potential for nesting birds due to adequate access.</p> | | Negligible |

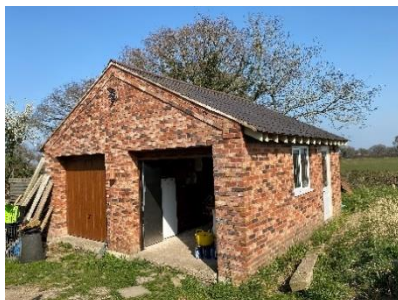
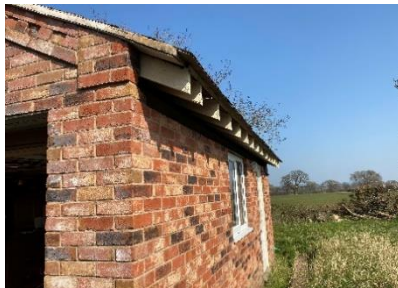
| Building ID | Description and Feature(s) | Photos | BCT Category |
|---|---|---|---|
| B13 | <p>B13 is a single-storey brick garage, with a pitched slate roof. uPVC windows and doors are present. There are large gaps at the top of the walls, below the eaves, where brickwork is unfinished, allowing for access into the cavity walls. Roof tiles are generally in good condition, however there is a missing tile on the western pitch creating access for roosting opportunities between the roof tiles and lining. Internally an open roof void with underfelt is present. No evidence of roosting bats was found.</p> <p>Potential for nesting birds due to adequate access.</p> | | Low |

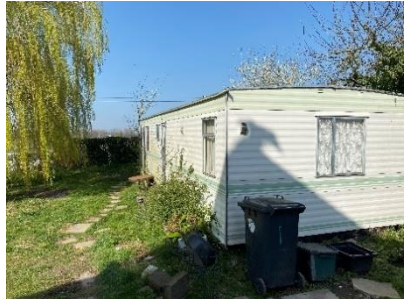
| Building ID | Description and Feature(s) | Photos | BCT Category |
|---|---|---|---|
| B14 | B14 is a static caravan. No roosting features were present. | | Negligible |

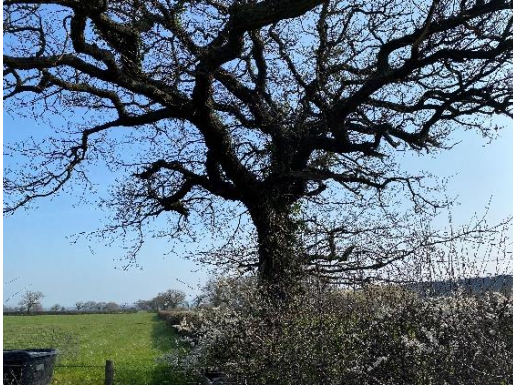
| Tree ID | Description and PRF Characteristics | Roost Suitability based on ground-based assessment | Recommendations if tree is to be impacted |
|---|---|---|---|
| T1 | <p>A middle age pedunculate oak tree situated within the field boundary hedgerow.</p> <p>SJ 38947 50876.</p> <p>A: Desiccated branch and lifted bark on north-west aspect.</p> | Low | No further surveys required. Precautionary soft felling/pruning measures must be adhered to under supervision of a licenced bat ecologist. |

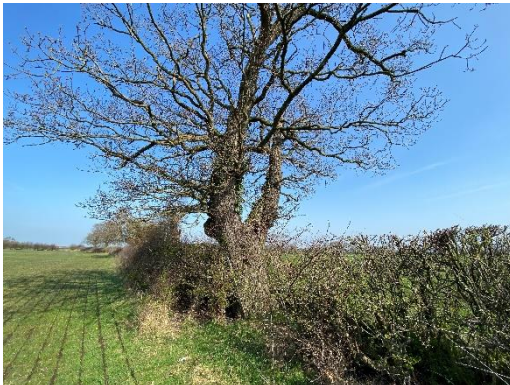
| Tree ID | Description and PRF Characteristics | Roost Suitability based on ground-based assessment | Recommendations if tree is to be impacted |
|---|---|---|---|
| T4 | <p>A mature pedunculate oak tree situated within the field boundary hedgerow (H1).<br/>SJ 38927 50940.</p> <p>PRFs:</p> <p>A: Large south facing cavity in east leading stem at approximately 2 m high.</p> <p>B: Large tear out near top of east leading stem.</p> <p>C: North facing cavity on west leading branch at approximately 2 m.</p> <p>D: North facing knot hole on west leading branch at approximately 5 m.</p> <p>E: Desiccated limb with splits and cavities on east leading branch.</p> | <p>High</p> | <p>Aerial climb and endoscopic inspection to further assess PRFs and tree categorisation.</p> <p>If remains high suitability, three separate nocturnal roost surveys. Including at least one dusk emergence survey and a separate dawn re-entry survey (the third visit being either a dusk emergence or dawn re-entry survey) undertaken between May to September with at least two surveys undertaken between May to August.</p> |

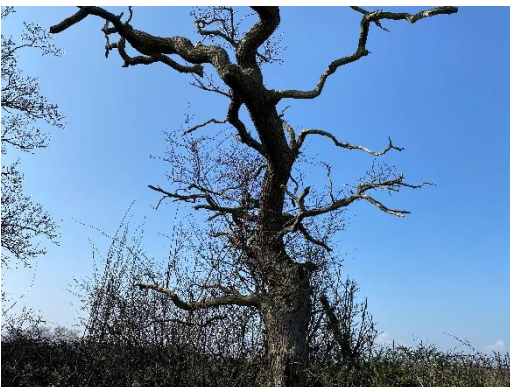
| Tree ID | Description and PRF Characteristics | Roost Suitability based on ground-based assessment | Recommendations if tree is to be impacted |
|---|---|---|---|
| T5 | <p>A middle age pedunculate oak tree situated with the field boundary hedgerow (H1).<br/>SJ 38925 50949.</p> <p>PRFs:</p> <p>A: West facing knot hole on desiccated branch at approximately 4 m.</p> <p>B: East facing knot holes at approximately 3 m and 6 m high.</p> | <p>Moderate</p> | <p>Two separate survey visits. Including one dusk emergence survey and a separate dawn re-entry survey, undertaken between May to September with at least one survey undertaken between May to August.</p> <p>Health and safety: Not suitable for aerial climb due to deadwood.</p> |

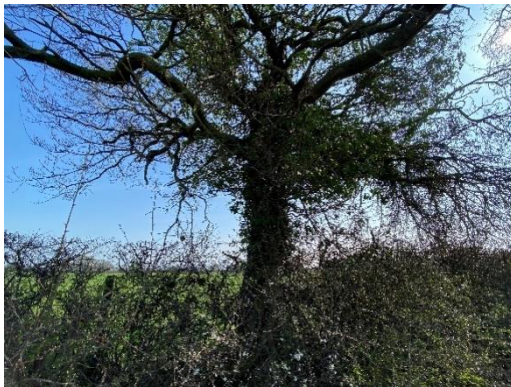
| Tree ID | Description and PRF Characteristics | Roost Suitability based on ground-based assessment | Recommendations if tree is to be impacted |
|---|---|---|---|
| T6 | <p>A middle age pedunculate oak tree situated within the field boundary hedgerow (H1). SJ 38919 50975.</p> <p>PRFs:</p> <p>A: Thick ivy coverage forming plates offering roosting opportunities, particularly on western aspect.</p> <p>B: Transverse snaps and broken limbs in upper canopy.</p> | <p>Moderate</p> | <p>Two separate survey visits. Including one dusk emergence survey and a separate dawn re-entry survey, undertaken between May to September with at least one survey undertaken between May to August.</p> <p>Aerial climb should not be undertaken during active bat season where there is potential to injure bats roosting under ivy.</p> |

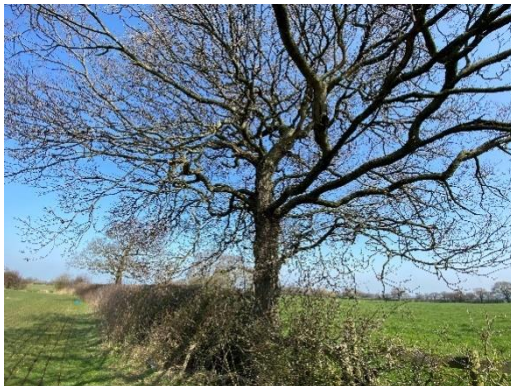
| Tree ID | Description and PRF Characteristics | Roost Suitability based on ground-based assessment | Recommendations if tree is to be impacted |
|---|---|---|---|
| T7 | <p>A middle age pedunculate oak tree situated within the field boundary hedgerow (H7). SJ 38905 51016.</p> <p>PRFs:</p> <p>A: South facing knot hole at approximately 5 m high.</p> <p>B: Desiccated limb with crack, west facing at approximately 5 m high.</p> <p>C: East facing knot hole at approximately 6 m high.</p> | <p>Moderate</p> | <p>Aerial climb and endoscopic inspection to further assess PRFs and tree categorisation.</p> <p>Two separate survey visits. Including one dusk emergence survey and a separate dawn re-entry survey, undertaken between May to September with at least one survey undertaken between May to August.</p> |

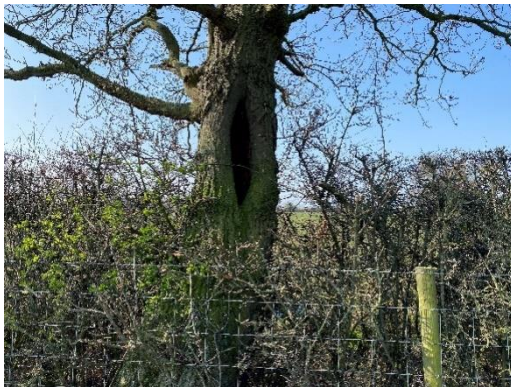
| Tree ID | Description and PRF Characteristics | | Roost Suitability based on ground-based assessment | Recommendations if tree is to be impacted |
|---|---|---|---|---|
| T8 | <p>A middle age pedunculate oak tree situated within the field boundary hedgerow (H1).<br/>SJ 38895 51039.</p> <p>PRFs:</p> <p>A: Large vertical split on stem within upper canopy.</p> <p>B: Large wound on eastern aspect at approximately 1.75 m. Endoscoped during the GLTA. The PRF is approximately 10 cm in depth, as such it does not offer any hibernation potential.</p> | | Moderate | <p>Aerial climb and endoscopic inspection also possible to further assess PRFs and tree categorisation.</p> <p>Two separate survey visits. Including one dusk emergence survey and a separate dawn re-entry survey, undertaken between May to September with at least one survey undertaken between May to August.</p> |

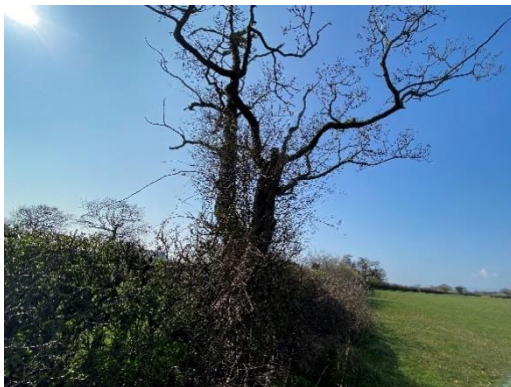
| Tree ID | Description and PRF Characteristics | | Roost Suitability based on ground-based assessment | Recommendations if tree is to be impacted |
|---|---|---|---|---|
| T9 | <p>A middle age pedunculate oak tree situated within the field boundary hedgerow.<br/>SJ 38896 51070.</p> <p>PRFs:</p> <p>A: North facing desiccated limb and a desiccation fissures.</p> | | Low | <p>No further surveys required. Precautionary soft felling/pruning measures must be adhered to under supervision of a licenced bat ecologist.</p> |

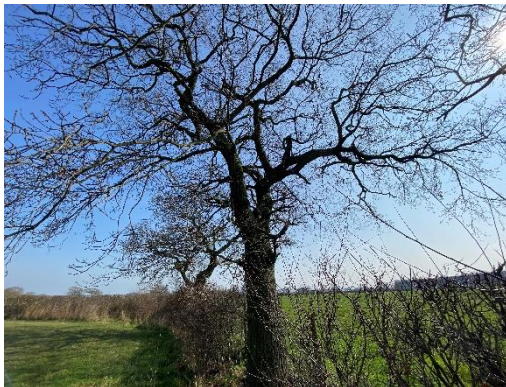
| Tree ID | Description and PRF Characteristics | | Roost Suitability based on ground-based assessment | Recommendations if tree is to be impacted |
|---|---|---|---|---|
| T11 | <p>A middle age pedunculate oak tree situated within the hedgerow. SJ 38914 51076.</p> <p>PRFs:</p> <p>A: South leading branch has decayed and split, at approximately 8 m.</p> <p>B: Knot hole on south-east leading branch at approximately 8 m, with additional cavity just below.</p> | | Moderate | <p>Aerial climb and endoscopic inspection also possible to further assess PRFs and tree categorisation.</p> <p>Two separate survey visits. Including one dusk emergence survey and a separate dawn re-entry survey, undertaken between May to September with at least one survey undertaken between May to August.</p> |

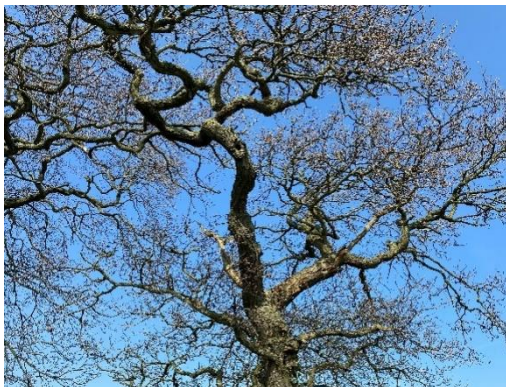
| Tree ID | Description and PRF Characteristics | | Roost Suitability based on ground-based assessment | Recommendations if tree is to be impacted |
|---|---|---|---|---|
| T12 | <p>A middle age pedunculate oak tree situated within the field boundary hedgerow. SJ 38920 51079.</p> <p>PRFs:</p> <p>A: Knot hole, south facing at approximately 6 m, appears to have some depth.</p> | | Moderate | <p>Aerial climb and endoscopic inspection also possible to further assess PRFs and tree categorisation.</p> <p>Two separate survey visits. Including one dusk emergence survey and a separate dawn re-entry survey, undertaken between May to September with at least one survey undertaken between May to August.</p> |

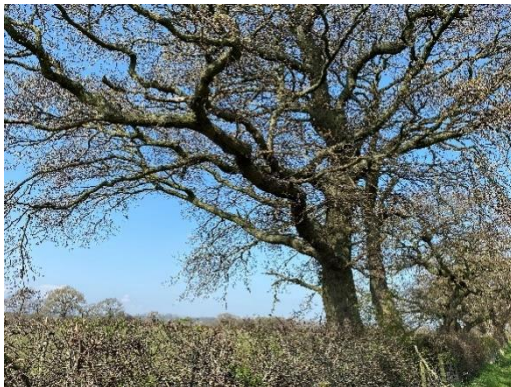
| Tree ID | Description and PRF Characteristics | | Roost Suitability based on ground-based assessment | Recommendations if tree is to be impacted |
|---|---|---|---|---|
| T13 | <p>A large mature pedunculate oak tree situated within the field boundary hedgerow (H2).</p> <p>SJ 38916 51127</p> <p>PRFs:</p> <p>A: Four small cavities in close proximity, east facing on south leading branch at approximately 5 m.</p> <p>B: North facing knot hole at approximately 6 m.</p> <p>C: Small canker on western aspect at approximately 8 m.</p> <p>D: Cavity visible from western aspect on south leading branch at approximately 6 m height.</p> | | Moderate | <p>Aerial climb and endoscopic inspection also possible to further assess PRFs and tree categorisation.</p> <p>Two separate survey visits. Including one dusk emergence survey and a separate dawn re-entry survey, undertaken between May to September with at least one survey undertaken between May to August.</p> |

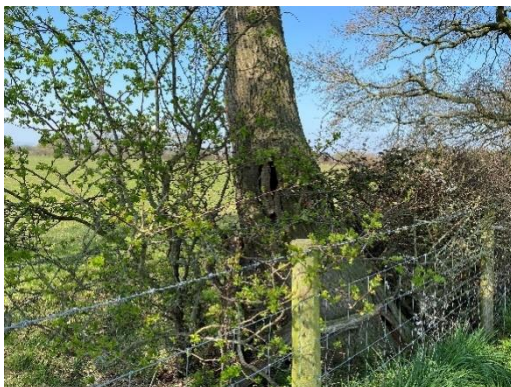
| Tree ID | Description and PRF Characteristics | | Roost Suitability based on ground-based assessment | Recommendations if tree is to be impacted |
|---|---|---|---|---|
| T14 | <p>A large middle age pedunculate oak tree situated within the field boundary hedgerow (H2).</p> <p>SJ 38915 51134.</p> <p>PRFs:</p> <p>A: Large cavity visible from south-east aspect at approximately 1 m.</p> <p>B: Hazard beam visible from north-east aspect at approximately 8 m.</p> <p>C: Knot hole visible from north aspect at approximately 4 m.</p> | | Moderate | <p>Aerial climb and endoscopic inspection also possible to further assess PRFs and tree categorisation.</p> <p>Two separate survey visits. Including one dusk emergence survey and a separate dawn re-entry survey, undertaken between May to September with at least one survey undertaken between May to August.</p> |

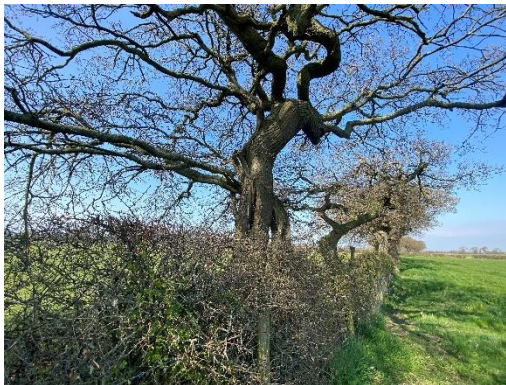
| Tree ID | Description and PRF Characteristics | | Roost Suitability based on ground-based assessment | Recommendations if tree is to be impacted |
|---|---|---|---|---|
| T15 | <p>A twin stemmed, middle age pedunculate oak tree situated within the hedgerow (H2).<br/>SJ 38913 51144.</p> <p>PRFs:<br/>A: Large helical split of one of the main stems. Moderately exposed to the elements with no hibernation potential.</p> | | Moderate | <p>Aerial climb and endoscopic inspection also possible to further assess PRFs and tree categorisation.</p> <p>Two separate survey visits. Including one dusk emergence survey and a separate dawn re-entry survey, undertaken between May to September with at least one survey undertaken between May to August.</p> |

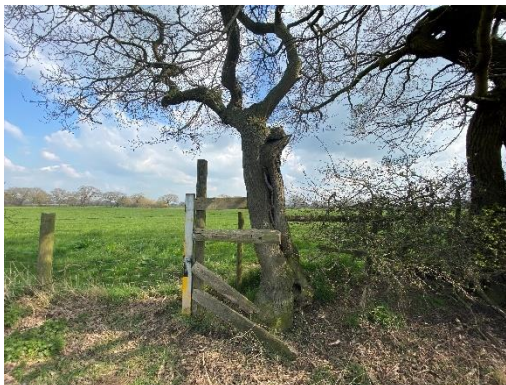
| Tree ID | Description and PRF Characteristics | | Roost Suitability based on ground-based assessment | Recommendations if tree is to be impacted |
|---|---|---|---|---|
| T16 | <p>A middle age pedunculate oak tree situated within the hedgerow (H2).<br/>SJ 38911 51150.</p> <p>A: Large split/wound on main stem from ground level up to 2 m, visible from western aspect. Moderately exposed to the elements, limited roosting suitability.</p> | | Low | <p>No further surveys required. Precautionary soft felling/pruning measures must be adhered to under supervision of a licenced bat ecologist.</p> |

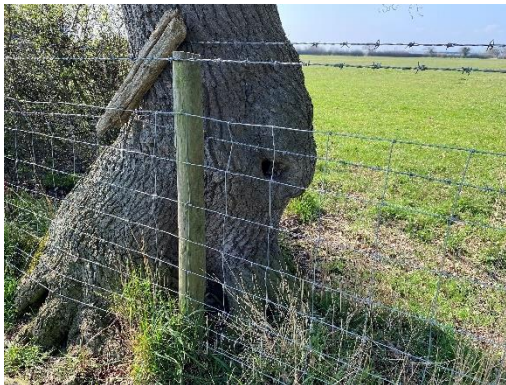
| Tree ID | Description and PRF Characteristics | Roost Suitability based on ground-based assessment | Recommendations if tree is to be impacted |
|---|---|---|---|
| T17 | <p>A middle age pedunculate oak tree situated within the field boundary hedgerow (H2).<br/>SJ 38909 51158.</p> <p>PRFs:</p> <p>A: Cavity on main stem at approximately 1m high, east facing. Narrow opening but opens internally upon endoscope inspection. Has hibernation potential.</p> <p>B: Knot hole visible from north aspect at approximately 5 m.</p> <p>C: Cavity on main stem visible from south-west aspect at approximately 3 m.</p> <p>D: Downward facing cavity on west leading branch.</p> | <p>High</p> | <p>Aerial climb and endoscopic inspection also possible to further assess PRFs and tree categorisation.</p> <p>Three separate survey visits. Including at least one dusk emergence survey and a separate dawn re-entry survey (the third visit being either a dusk emergence or dawn re-entry survey) undertaken between May to September with at least two surveys undertaken between May to August.</p> <p>PRF A has hibernation potential hibernation surveys are required between December and February.</p> |

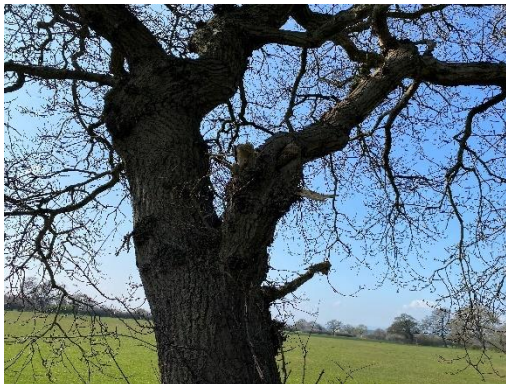
| Tree ID | Description and PRF Characteristics | | Roost Suitability based on ground-based assessment | Recommendations if tree is to be impacted |
|---|---|---|---|---|
| T18 | <p>A middle age pedunculate oak tree situated within the field boundary hedgerow (H2).<br/>SJ 38907 51164.</p> <p>PRFs:</p> <p>A: Small knot hole visible from east aspect appears well occluded from the ground.</p> | | Low | <p>No further surveys required. Precautionary soft felling/pruning measures must be adhered to under supervision of a licenced bat ecologist.</p> |

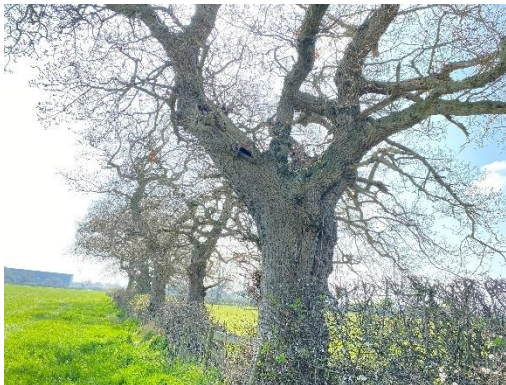
| Tree ID | Description and PRF Characteristics | Roost Suitability based on ground-based assessment | Recommendations if tree is to be impacted |
|---|---|---|---|
| T19 | <p>A large mature pedunculate oak tree situated within the field boundary hedgerow (H2). SJ 38906 51171.</p> <p>PRFs:</p> <p>A: Cavity in upper canopy visible from south-east aspect at approximately 10 m.</p> <p>B: Two cavities in close proximity visible from south aspect at approximately 9 m.</p> <p>C: East leading branch is decayed with cavity present, visible from north aspect.</p> <p>D: West leading branch has a cavity, visible from north aspect.</p> <p>E: Squirrel hole visible from west aspect at approximately 6 m.</p> <p>F: Small cavity present on heavily decayed south-west leading branch.</p> | | <p>High</p> <p>Aerial climb and endoscopic inspection also possible to further assess PRFs and tree categorisation.</p> <p>Three separate survey visits. Including at least one dusk emergence survey and a separate dawn re-entry survey (the third visit being either a dusk emergence or dawn re-entry survey) undertaken between May to September with at least two surveys undertaken between May to August.</p> |

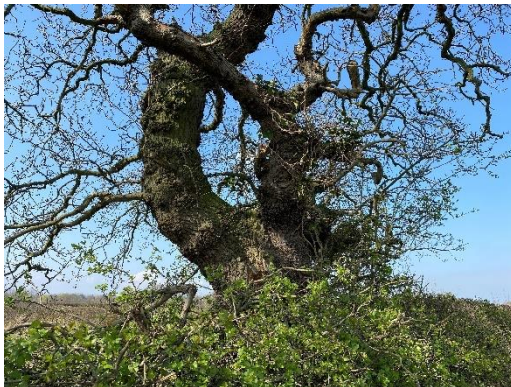
| Tree ID | Description and PRF Characteristics | | Roost Suitability based on ground-based assessment | Recommendations if tree is to be impacted |
|---|---|---|---|---|
| T23 | <p>A squat middle age pedunculate oak tree situated within the hedgerow.</p> <p>SJ 38889 51224</p> <p>PRFs:<br/>A: Pruning cut and desiccation cavity between heartwood and bark. Visible from eastern aspect.</p> | | Low | No further surveys required. Precautionary soft felling/pruning measures must be adhered to under supervision of a licenced bat ecologist. |

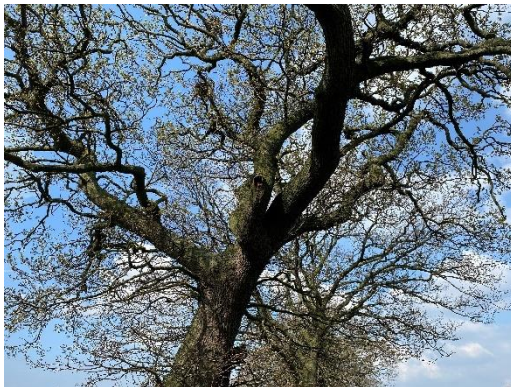
| Tree ID | Description and PRF Characteristics | | Roost Suitability based on ground-based assessment | Recommendations if tree is to be impacted |
|---|---|---|---|---|
| T30 | <p>Large mature pedunculate oak tree situated within hedgerow (H3).<br/>SJ 38855 51416.</p> <p>PRFs:</p> <p>A: Knot hole visible from southern aspect at approximately 7 m. Appears moderately superficial leaving potential for opportunistic roosting by single bats only.</p> <p>B: Cavity visible from eastern aspect at approximately 2.5 m.</p> | | Moderate | <p>Aerial climb and endoscopic inspection also possible to further assess PRFs and tree categorisation.</p> <p>Two separate survey visits. Including one dusk emergence survey and a separate dawn re-entry survey, undertaken between May to September with at least one survey undertaken between May to August.</p> |

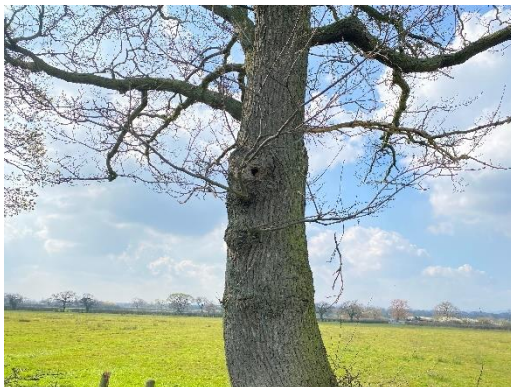
| Tree ID | Description and PRF Characteristics | | Roost Suitability based on ground-based assessment | Recommendations if tree is to be impacted |
|---|---|---|---|---|
| T31 | <p>Middle age pedunculate oak tree situated within the hedgerow. SJ 38851 51429.</p> <p>PRFs:</p> <p>A: Knot hole on eastern aspect at approximately 3 m.</p> | | Moderate | <p>Aerial climb and endoscopic inspection also possible to further assess PRFs and tree categorisation.</p> <p>Two separate survey visits. Including one dusk emergence survey and a separate dawn re-entry survey, undertaken between May to September with at least one survey undertaken between May to August.</p> |

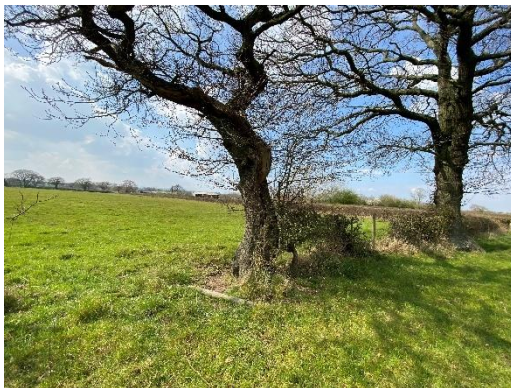
| Tree ID | Description and PRF Characteristics | Roost Suitability based on ground-based assessment | Recommendations if tree is to be impacted |
|---|---|---|---|
| T36 | <p>A middle age pedunculate oak tree situated within the hedgerow</p> <p>SJ 38834 51495.</p> <p>PRFs:</p> <p>A: Longitudinal crack visible from eastern aspect. Moderately exposed.</p> | | <p>Moderate</p> <p>Aerial climb and endoscopic inspection also possible to further assess PRFs and tree categorisation.</p> <p>Two separate survey visits. Including one dusk emergence survey and a separate dawn re-entry survey, undertaken between May to September with at least one survey undertaken between May to August.</p> |

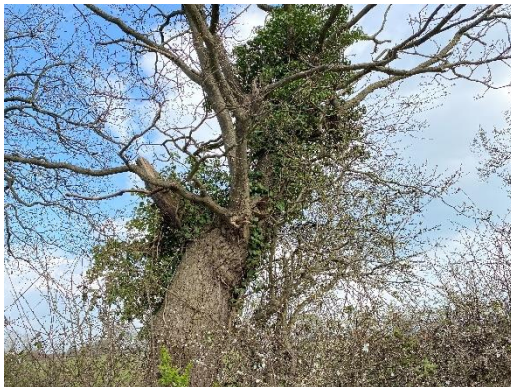
| Tree ID | Description and PRF Characteristics | | Roost Suitability based on ground-based assessment | Recommendations if tree is to be impacted |
|---|---|---|---|---|
| T41 | <p>A middle age pedunculate oak tree situated within the hedgerow (H5). Ivy clad canopy. Ivy does not provide PRF itself.</p> <p>SJ 38666 51381.</p> <p>PRFs:</p> <p>A: Knot hole visible from west aspect at approximately 4 m.</p> <p>B: Tear out in upper stem.</p> <p>C: Large longitudinal crack visible from north-east aspect with multiple cavities within. No hibernation potential due to openness.</p> | | Moderate | <p>Aerial climb and endoscopic inspection also possible to further assess PRFs and tree categorisation.</p> <p>Two separate survey visits. Including one dusk emergence survey and a separate dawn re-entry survey, undertaken between May to September with at least one survey undertaken between May to August.</p> |

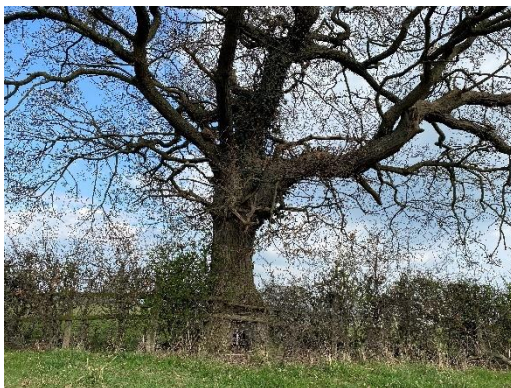
| Tree ID | Description and PRF Characteristics | | Roost Suitability based on ground-based assessment | Recommendations if tree is to be impacted |
|---|---|---|---|---|
| T42 | <p>A middle age pedunculate oak tree situated within the hedgerow (H5).</p> <p>SJ 38672 51369.</p> <p>PRFs:</p> <p>A: Cavity visible from western aspect on south-west leading branch near base.</p> <p>B: Desiccation fissure on upper part of same branch as A.</p> | | Moderate | <p>Aerial climb and endoscopic inspection also possible to further assess PRFs and tree categorisation.</p> <p>Two separate survey visits. Including one dusk emergence survey and a separate dawn re-entry survey, undertaken between May to September with at least one survey undertaken between May to August.</p> |

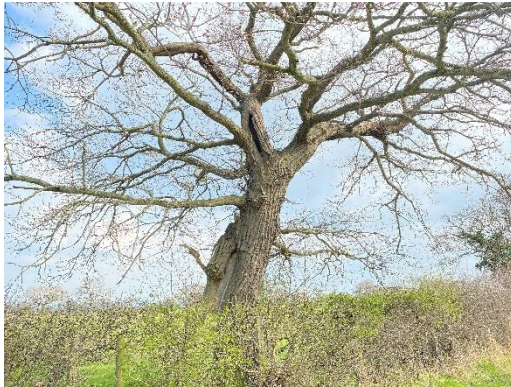
| Tree ID | Description and PRF Characteristics | Roost Suitability based on ground-based assessment | Recommendations if tree is to be impacted |
|---|---|---|---|
| T45 | <p>A mature pedunculate oak tree situated within the hedgerow (H5).<br/>SJ 38715 51302.</p> <p>PRFs:<br/>A: Tear out visible from north-west aspect at approximately 6 m.<br/>B: Knot hole visible from west aspect at approximately 6 m.<br/>C: Large tear out visible from east aspect. Does extend into the stem but the conditions do not appear suitable for hibernation or maternity roosts.</p> | <p>Moderate</p> | <p>Two separate survey visits. Including one dusk emergence survey and a separate dawn re-entry survey, undertaken between May to September with at least one survey undertaken between May to August.</p> <p>Health and safety: Not suitable to climb.</p> |

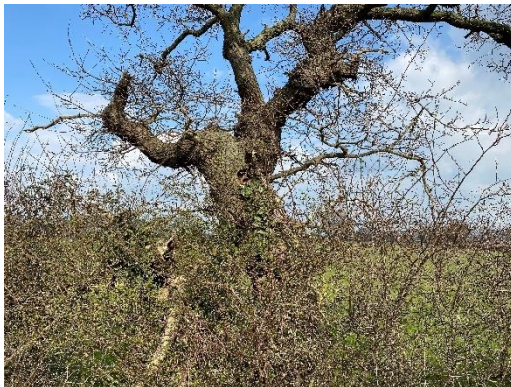
| Tree ID | Description and PRF Characteristics | | Roost Suitability based on ground-based assessment | Recommendations if tree is to be impacted |
|---|---|---|---|---|
| T46 | <p>A mature pedunculate oak tree with heavily burred and twisted main stem. Situated within hedgerow. SJ 38780 51198.</p> <p>PRFs:</p> <p>A: Knot hole visible from west aspect at approximately 2 m.</p> <p>B: Cavity visible from east aspect at approximately 4 m.</p> | | Moderate | <p>Two separate survey visits. Including one dusk emergence survey and a separate dawn re-entry survey, undertaken between May to September with at least one survey undertaken between May to August.</p> <p>Health and safety: Tree unsuitable to climb.</p> |

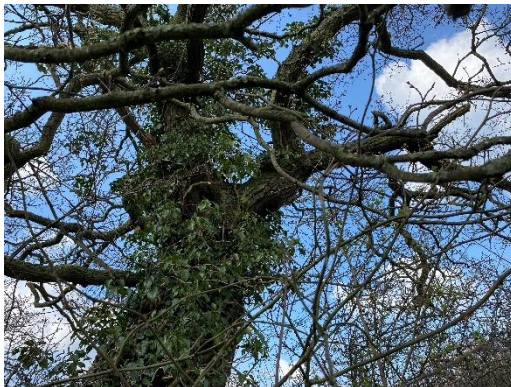
| Tree ID | Description and PRF Characteristics | | Roost Suitability based on ground-based assessment | Recommendations if tree is to be impacted |
|---|---|---|---|---|
| T47 | <p>A middle age pedunculate oak tree clad in ivy. Ivy does not provide suitable PRF itself, but may be obscuring other PRFs. SJ 38790 51179.</p> <p>PRFs:</p> <p>A: Large cavity in main stem partially covered by ivy.</p> <p>B: Knot hole visible from southern aspect at approximately 3 m.</p> | | Moderate | <p>Aerial climb and endoscopic inspection also possible to further assess PRFs and tree categorisation.</p> <p>Two separate survey visits. Including one dusk emergence survey and a separate dawn re-entry survey, undertaken between May to September with at least one survey undertaken between May to August.</p> |

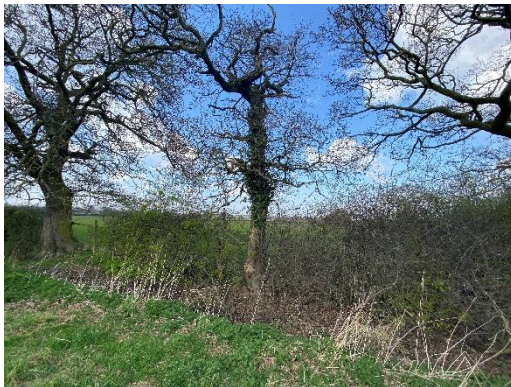
| Tree ID | Description and PRF Characteristics | | Roost Suitability based on ground-based assessment | Recommendations if tree is to be impacted |
|---|---|---|---|---|
| T48 | <p>A small middle age pedunculate oak tree situated within the field boundary hedgerow (H6). SJ 38775 51169.</p> <p>PRFs:</p> <p>A: Main stem has considerable decay with numerous associated cavities throughout.</p> | | Moderate | <p>Two separate survey visits. Including one dusk emergence survey and a separate dawn re-entry survey, undertaken between May to September with at least one survey undertaken between May to August.</p> <p>Health and safety: Not suitable for aerial climb due to amount of deadwood.</p> |

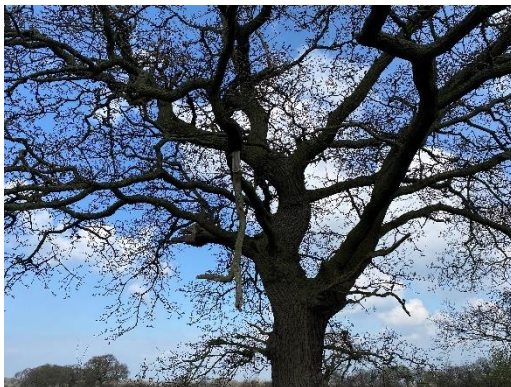
| Tree ID | Description and PRF Characteristics | | Roost Suitability based on ground-based assessment | Recommendations if tree is to be impacted |
|---|---|---|---|---|
| T49 | <p>A large mature pedunculate oak tree situated within the field boundary hedgerow (H6). SJ 38775 51169.</p> <p>PRFs:</p> <p>A: Tear out on underside of branch visible from southern aspect at approximately 6 m.</p> | | Moderate | <p>Aerial climb and endoscopic inspection also possible to further assess PRFs and tree categorisation.</p> <p>Two separate survey visits. Including one dusk emergence survey and a separate dawn re-entry survey, undertaken between May to September with at least one survey undertaken between May to August.</p> |

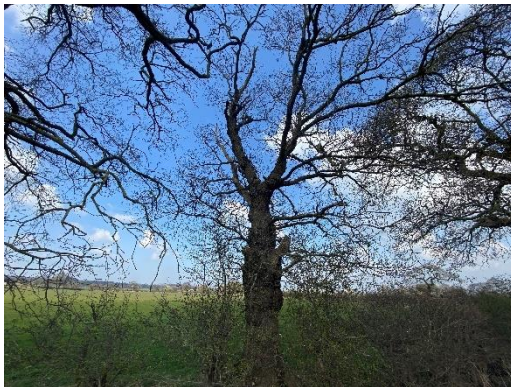
| Tree ID | Description and PRF Characteristics | | Roost Suitability based on ground-based assessment | Recommendations if tree is to be impacted |
|---|---|---|---|---|
| T50 | <p>A middle age pedunculate oak tree situated within the field boundary hedgerow (H6).<br/>SJ 38767 51164.</p> <p>PRFs:</p> <p>A: Canker present where main stem forks, visible from southern aspect at approximately 6 m.</p> <p>B: Cavity associated at pruning cut visible from the south-eastern aspect.</p> <p>C: Desiccated limb with hollowing visible from northern aspect at approximately 6 m.</p> | | Moderate | <p>Two separate survey visits. Including one dusk emergence survey and a separate dawn re-entry survey, undertaken between May to September with at least one survey undertaken between May to August.</p> <p>Health and safety: Not suitable for aerial climb due to amount of deadwood.</p> |

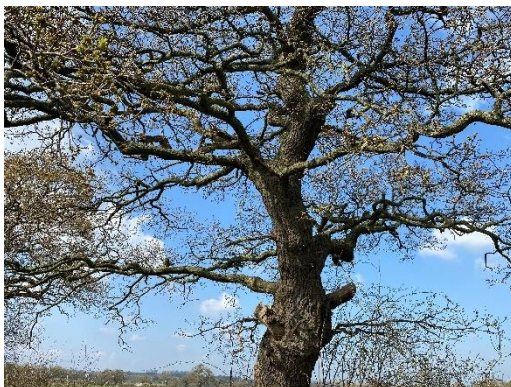
| Tree ID | Description and PRF Characteristics | | Roost Suitability based on ground-based assessment | Recommendations if tree is to be impacted |
|---|---|---|---|---|
| T52 | <p>A middle age pedunculate oak tree situated within the field boundary hedgerow.<br/>SJ 38747 51150.</p> <p>PRFs:</p> <p>A: South-facing knot hole at approximately 4 m.</p> <p>B: South-facing tear out at approximately 8 m.</p> <p>C: North-facing cavity associated with desiccated limb at approximately 4 m.</p> | | Moderate | <p>Aerial climb and endoscopic inspection also possible to further assess PRFs and tree categorisation.</p> <p>Two separate survey visits. Including one dusk emergence survey and a separate dawn re-entry survey, undertaken between May to September with at least one survey undertaken between May to August.</p> |

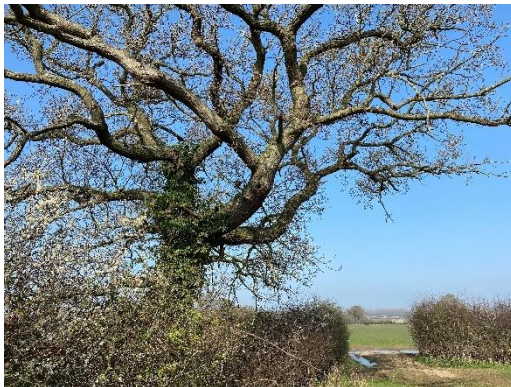
| Tree ID | Description and PRF Characteristics | Roost Suitability based on ground-based assessment | Recommendations if tree is to be impacted |
|---|---|---|---|
| T56 | <p>A large mature pedunculate oak tree situated within the field boundary hedgerow (H7). SJ 38615 51084.</p> <p>PRFs:</p> <p>A: Woodpecker hole visible on south-east aspect at approximately 5 m.</p> <p>B: Desiccated limb with associated cavity and lifted bark. Visible from north-west aspect at approximately 4 m.</p> <p>C: Small cavity visible from north-west aspect on west leading branch at approximately 7 m.</p> | | <p>High</p> <p>Aerial climb and endoscopic inspection also possible to further assess PRFs and tree categorisation.</p> <p>Three separate survey visits. Including at least one dusk emergence survey and a separate dawn re-entry survey (the third visit being either a dusk emergence or dawn re-entry survey) undertaken between May to September with at least two surveys undertaken between May to August.</p> |

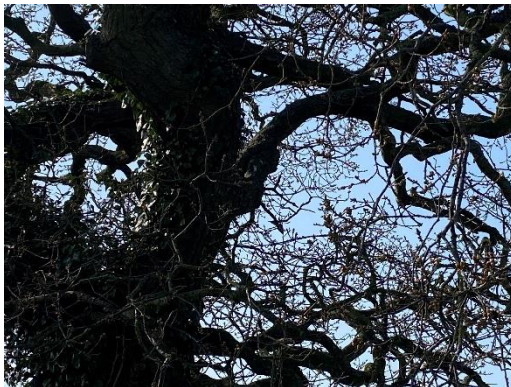
| Tree ID | Description and PRF Characteristics | | Roost Suitability based on ground-based assessment | Recommendations if tree is to be impacted |
|---|---|---|---|---|
| T59 | <p>A middle age pedunculate oak tree situated within the field boundary hedgerow.</p> <p>SJ 38646 50982.</p> <p>PRFs:</p> <p>A: Upward facing cavity on west leading branch visible from east aspect at approximately 5 m.</p> | | Moderate. | <p>Aerial climb and endoscopic inspection also possible to further assess PRFs and tree categorisation.</p> <p>Two separate survey visits. Including one dusk emergence survey and a separate dawn re-entry survey, undertaken between May to September with at least one survey undertaken between May to August.</p> |

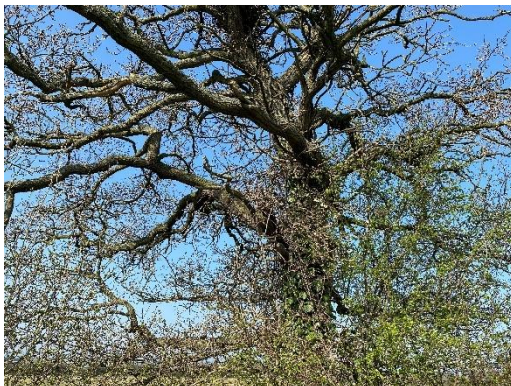
| Tree ID | Description and PRF Characteristics | | Roost Suitability based on ground-based assessment | Recommendations if tree is to be impacted |
|---|---|---|---|---|
| T61 | <p>A middle age pedunculate oak tree situated within the field boundary hedgerow.</p> <p>SJ 38662 50907.</p> <p>PRFs:</p> <p>A: Broken limb that is split from main stem, visible from south-east aspect.</p> | | Low | No further surveys required. Precautionary soft felling/pruning measures must be adhered to under supervision of a licenced bat ecologist. |

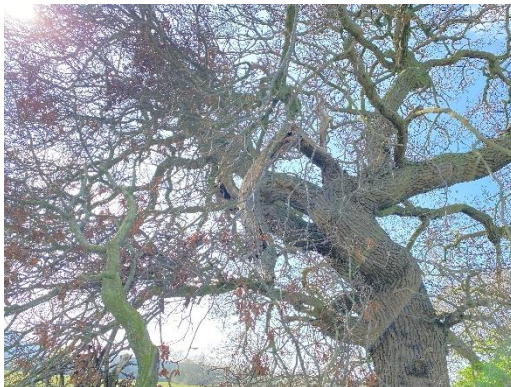
| Tree ID | Description and PRF Characteristics | | Roost Suitability based on ground-based assessment | Recommendations if tree is to be impacted |
|---|---|---|---|---|
| T62 | <p>A mature pedunculate oak tree situated within the field boundary hedgerow.</p> <p>SJ 38817 51039.</p> <p>PRFs:</p> <p>A: Large cavity visible on south leading branch.</p> <p>B: Transverse snap with associated cavities on east leading branch.</p> | | Moderate | <p>Aerial climb and endoscopic inspection also possible to further assess PRFs and tree categorisation.</p> <p>Two separate survey visits. Including one dusk emergence survey and a separate dawn re-entry survey, undertaken between May to September with at least one survey undertaken between May to August.</p> |

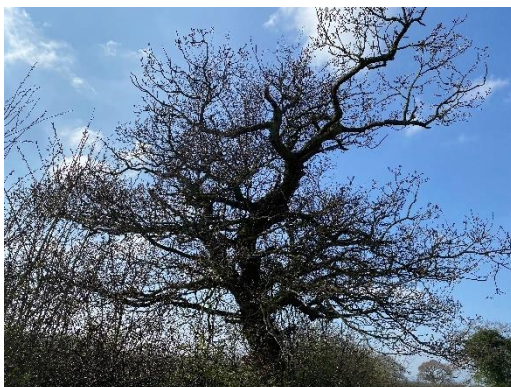
| Tree ID | Description and PRF Characteristics | | Roost Suitability based on ground-based assessment | Recommendations if tree is to be impacted |
|---|---|---|---|---|
| T64 | <p>A middle age pedunculate oak tree with scrubby appearance.</p> <p>SJ 38663 51038.</p> <p>PRFs</p> <p>A: Knot hole visible on desiccated branch from eastern aspect at approximately 5 m.</p> <p>B: Upward facing cavity on same branch as PRF A, visible from northern aspect.</p> | | Moderate | <p>Aerial climb and endoscopic inspection also possible to further assess PRFs and tree categorisation.</p> <p>Two separate survey visits. Including one dusk emergence survey and a separate dawn re-entry survey, undertaken between May to September with at least one survey undertaken between May to August.</p> |

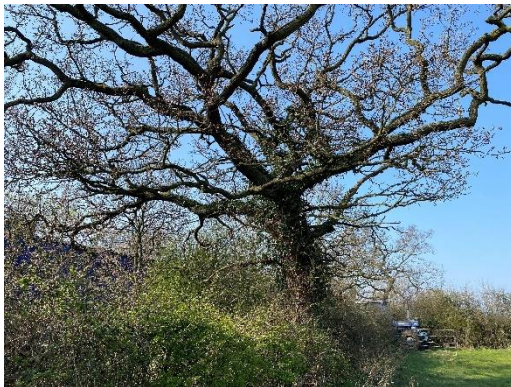
| Tree ID | Description and PRF Characteristics | | Roost Suitability based on ground-based assessment | Recommendations if tree is to be impacted |
|---|---|---|---|---|
| T67 | <p>A mature pedunculate oak tree growing out of hedgerow and ditch.</p> <p>SJ 38689 50869.</p> <p>PRFs:</p> <p>A: North-west leading branch is desiccated with associated lifted bark and cavities.</p> | | Low | No further surveys required. Precautionary soft felling/pruning measures must be adhered to under supervision of a licenced bat ecologist. |

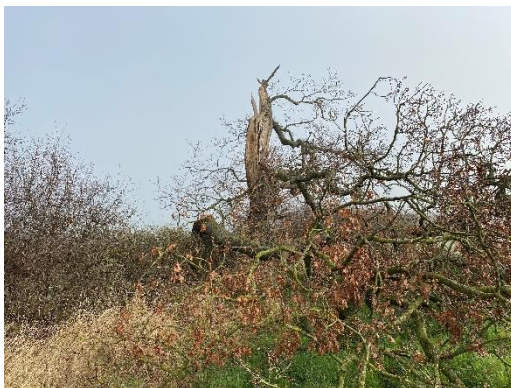
| Tree ID | Description and PRF Characteristics | | Roost Suitability based on ground-based assessment | Recommendations if tree is to be impacted |
|---|---|---|---|---|
| T69 | <p>A large mature oak tree that has had a recent total stem failure.</p> <p>SJ 38556 51066.</p> <p>PRFs: Multiple features associated with tear out/stem failure resulting in large cavity and splits. Conditions not suited to hibernation/maternity roosts due to openness.</p> | | Moderate | <p>Two separate survey visits. Including one dusk emergence survey and a separate dawn re-entry survey, undertaken between May to September with at least one survey undertaken between May to August.</p> <p>Health and safety: Not suitable for aerial climb.</p> |

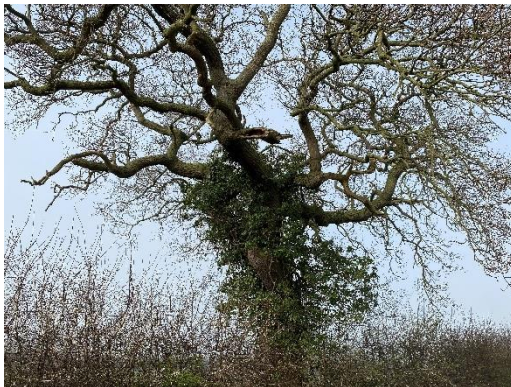
| Tree ID | Description and PRF Characteristics | | Roost Suitability based on ground-based assessment | Recommendations if tree is to be impacted |
|---|---|---|---|---|
| T70 | <p>A mature pedunculate oak tree with sparse ivy cladding situated within the field boundary hedgerow (H22). Ivy does not provide suitable PRF itself. SJ 38536 51076.</p> <p>PRFs:</p> <p>A: East-facing cavity on limb at approximately 6m.</p> <p>B: Snapped branch with associated west-facing cavity at approximately 6 m.</p> <p>C: Desiccated limb with associated lifted bark visible from western aspect.</p> | | Moderate | <p>Aerial climb and endoscopic inspection also possible to further assess PRFs and tree categorisation.</p> <p>Two separate survey visits. Including one dusk emergence survey and a separate dawn re-entry survey, undertaken between May to September with at least one survey undertaken between May to August.</p> |

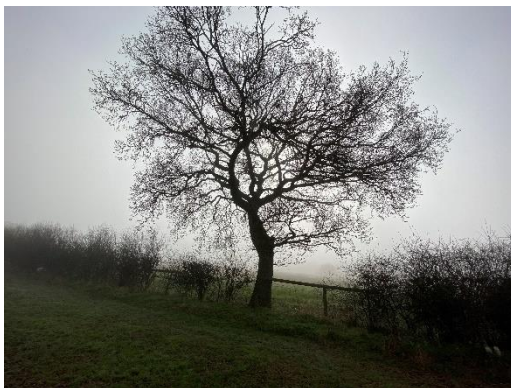
| Tree ID | Description and PRF Characteristics | | Roost Suitability based on ground-based assessment | Recommendations if tree is to be impacted |
|---|---|---|---|---|
| T71 | <p>A middle age pedunculate oak tree situated within the field boundary hedgerow. SJ 38511 51033.</p> <p>PRFs:</p> <p>A: Transverse snap at approximately 6 m, north-facing. Appears exposed to the elements.</p> <p>B: Pruning cut with associated lifted bark, south-facing at approximately 3 m. Appears exposed to the elements.</p> | | Low | <p>No further surveys required. Precautionary soft felling/pruning measures must be adhered to under supervision of a licenced bat ecologist.</p> |

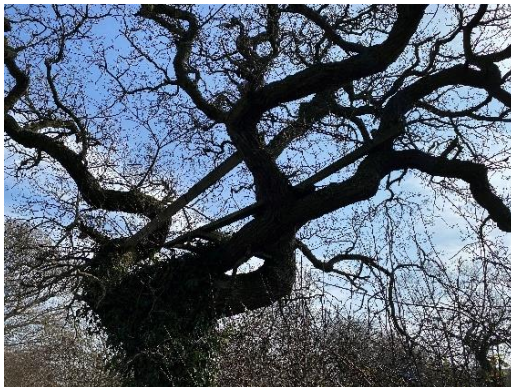
| Tree ID | Description and PRF Characteristics | | Roost Suitability based on ground-based assessment | Recommendations if tree is to be impacted |
|---|---|---|---|---|
| T73 | <p>A middle age pedunculate oak tree situated within field boundary hedgerow (H13) with remnants of tree house attached. Ivy cladding of stem. SJ 38461 51003.</p> <p>PRF features: Various due to tree house.</p> <p>A: Potential crevices where the tree house remnants are attached to the trunk and branches.</p> | | Low | No further surveys required. Precautionary soft felling/pruning measures must be adhered to under supervision of a licenced bat ecologist. |

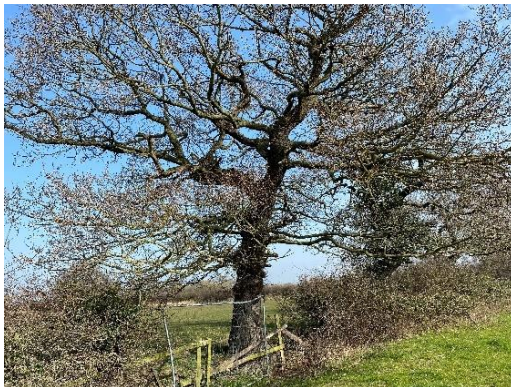
| Tree ID | Description and PRF Characteristics | Roost Suitability based on ground-based assessment | Recommendations if tree is to be impacted |
|---|---|---|---|
| T75 | <p>A mature pedunculate oak tree with considerable deadwood, situated within hedgerow and ditch. SJ 38442 50994.</p> <p>PRF features:</p> <p>A: Large desiccation fissure/cavity south-west facing at approximately 5 m.</p> <p>B: Lifted bark south-west facing on north-west leading branch, at approximately 4.5 m.</p> <p>C: Transverse snap/crack south-east facing at approximately 6 m.</p> <p>D: Potential cavity on desiccated branch/ram's horns north-west facing at approximately 6 m.</p> <p>E: Lifted bark, potential cavity, north-facing at approximately 4 m.</p> | <p>High</p> | <p>Aerial climb and endoscopic inspection also possible to further assess PRFs and tree categorisation.</p> <p>Three separate survey visits. Including at least one dusk emergence survey and a separate dawn re-entry survey (the third visit being either a dusk emergence or dawn re-entry survey) undertaken between May to September with at least two surveys undertaken between May to August.</p> |
