# Appendix 11.7: Bat Roost Technical Appendix

# LAND NORTH OF BRYN LANE WREXHAM BAT ROOST SURVEY REPORT

| Document Title | Bat Roost Survey Report |
| Document Ref | 9134.005 |

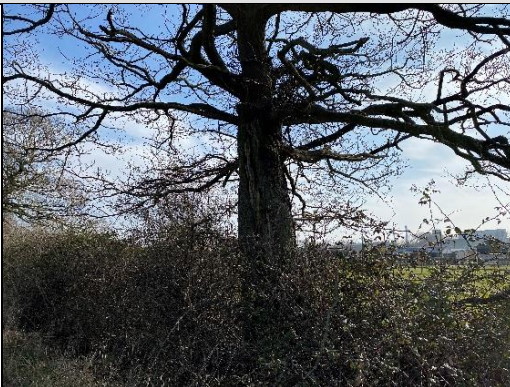
| Tree ID | Description and PRF Characteristics | Roost Suitability based on ground-based assessment | Recommendations if tree is to be impacted |
|---|---|---|---|
| T76 | <p>A middle age pedunculate oak tree situated in hedgerow (H13), bramble covering base.<br/>SJ 38421 50981.</p> <p>PRF features:</p> <p>A: Cavity caused by desiccation fissure and lifted bark. South-facing at approximately 3 m.</p> <p>B: Long longitudinal crack, north facing running up main stem to approximately 4.5 m. Appears superficial.</p> | | <p>Moderate</p> <p>Aerial climb and endoscopic inspection also possible to further assess PRFs and tree categorisation.</p> <p>Two separate survey visits. Including one dusk emergence survey and a separate dawn re-entry survey, undertaken between May to September with at least one survey undertaken between May to August.</p> |

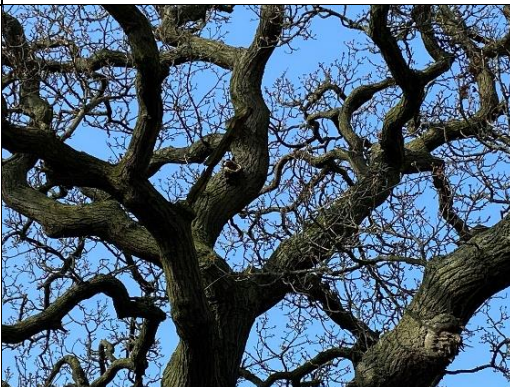
| Tree ID | Description and PRF Characteristics | Roost Suitability based on ground-based assessment | Recommendations if tree is to be impacted |
|---|---|---|---|
| T77 | <p>A mature pedunculate oak tree situated within the field. SJ 38389 50974.</p> <p>PRFs:</p> <p>A: Knot hole south-east aspect, central branch, at approximately 7 m. Unable to rule out from ground level.</p> | | <p>Moderate</p> <p>Aerial climb and endoscopic inspection also possible to further assess PRFs and tree categorisation.</p> <p>Two separate survey visits. Including one dusk emergence survey and a separate dawn re-entry survey, undertaken between May to September with at least one survey undertaken between May to August.</p> |

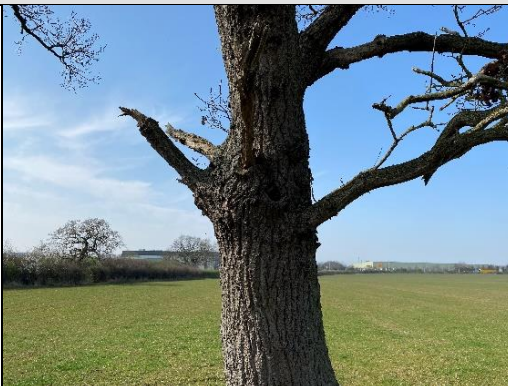
| Tree ID | Description and PRF Characteristics | | Roost Suitability based on ground-based assessment | Recommendations if tree is to be impacted |
|---|---|---|---|---|
| T78 | <p>A middle age pedunculate oak tree situated within the field. SJ 38381 50987.</p> <p>PRFs:</p> <p>A: Knot hole on south-eastern aspect of main stem at head height. Endoscoped during GLTA. Shallow feature offering limited opportunistic roosting only.</p> <p>B: Transverse snap offering shallow activity on south-west aspect at approximately 3 m. Shallow feature with limited opportunistic roosting potential.</p> | | Low | No further surveys required. Precautionary soft felling/pruning measures must be adhered to under supervision of a licenced bat ecologist. |

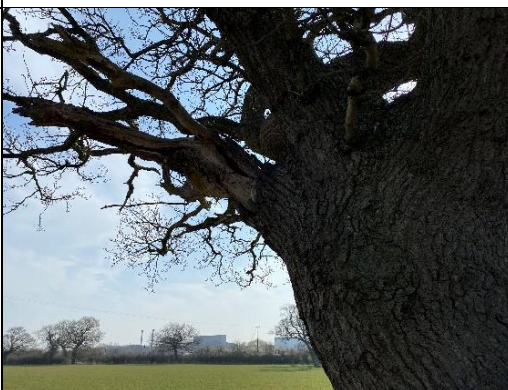
| Tree ID | Description and PRF Characteristics | | Roost Suitability based on ground-based assessment | Recommendations if tree is to be impacted |
|---|---|---|---|---|
| T79 | <p>A mature pedunculate oak tree situated within field. SJ 38346 51040.</p> <p>A: Desiccation fissure on north-east aspect of east leading branch at approximately 2.5 m.</p> | | Moderate. | <p>Aerial climb and endoscopic inspection also possible to further assess PRFs and tree categorisation.</p> <p>Two separate survey visits. Including one dusk emergence survey and a separate dawn re-entry survey, undertaken between May to September with at least one survey undertaken between May to August.</p> |

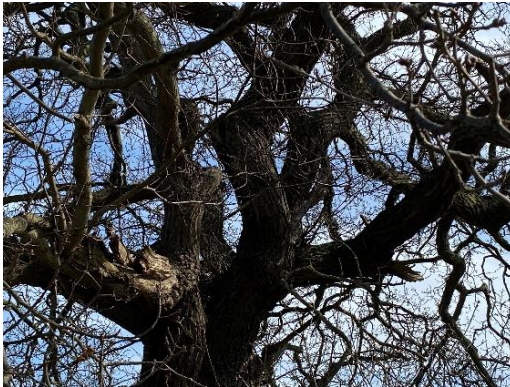
| Tree ID | Description and PRF Characteristics | | Roost Suitability based on ground-based assessment | Recommendations if tree is to be impacted |
|---|---|---|---|---|
| T85 | <p>A middle aged pedunculate oak tree situated with the field boundary hedgerow (H21).<br/>SJ 38441 51086.</p> <p>PRFs:</p> <p>A: Multiple potential upward facing cavities visible due to decayed branch.</p> <p>B: Knot hole on western aspect of central branch at approximately 6 – 7 m.</p> | | Moderate | <p>Aerial climb and endoscopic inspection also possible to further assess PRFs and tree categorisation.</p> <p>Two separate survey visits. Including one dusk emergence survey and a separate dawn re-entry survey, undertaken between May to September with at least one survey undertaken between May to August.</p> |

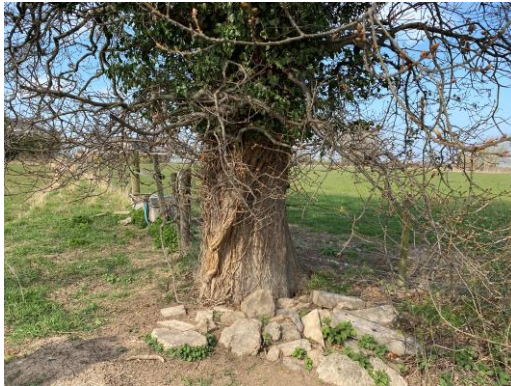
| Tree ID | Description and PRF Characteristics | | Roost Suitability based on ground-based assessment | Recommendations if tree is to be impacted |
|---|---|---|---|---|
| T86 | <p>A mature pedunculate oak tree situated within central field boundary hedgerow H14).<br/>SJ 38105 51040.</p> <p>PRFs:</p> <p>A: Thick ivy cladding obscuring view of tree. Thick branches creating potential roosting pockets on southern aspect at chest height.</p> <p>B: Longitudinal crack on north aspect at approximately 2 m. Endoscope revealed that cavity runs deep.</p> | | Moderate | <p>Two separate survey visits. Including one dusk emergence survey and a separate dawn re-entry survey, undertaken between May to September with at least one survey undertaken between May to August.</p> <p>Aerial climb should not be undertaken where there is potential to injure bats roosting under ivy.</p> |

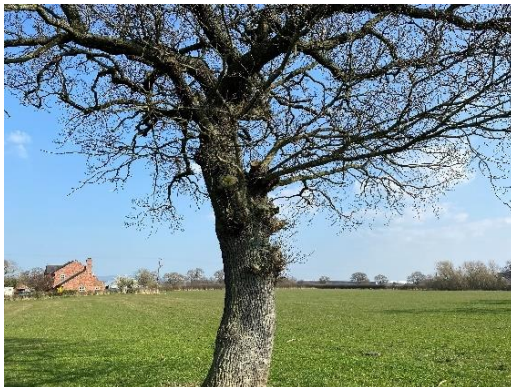
| Tree ID | Description and PRF Characteristics | | Roost Suitability based on ground-based assessment | Recommendations if tree is to be impacted |
|---|---|---|---|---|
| T88 | <p>A mature pedunculate oak situated within the north-western field. SJ 38201 51204.</p> <p>PRFs:</p> <p>A: Lifted bark around pruning cut.</p> | | Low | No further surveys required. Precautionary soft felling/pruning measures must be adhered to under supervision of a licenced bat ecologist. |

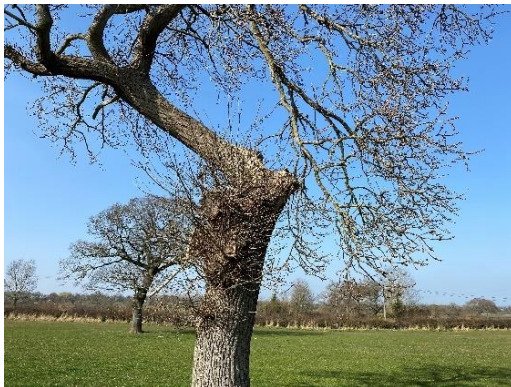
| Tree ID | Description and PRF Characteristics | | Roost Suitability based on ground-based assessment | Recommendations if tree is to be impacted |
|---|---|---|---|---|
| T89 | <p>A middle age pedunculate oak tree situated within the north-western field.</p> <p>SJ 38214 51178.</p> <p>PRFs:</p> <p>A: Tear out on southern aspect of main stem with numerous potential cavities.</p> <p>B: Lifted bark/hazard beam on western aspect.</p> | | Moderate | <p>Aerial/ladder climb and endoscopic inspection also possible to further assess PRFs and tree categorisation.</p> <p>Two separate survey visits. Including one dusk emergence survey and a separate dawn re-entry survey, undertaken between May to September with at least one survey undertaken between May to August.</p> |

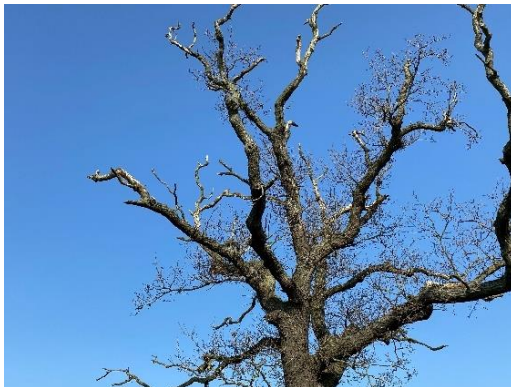
| Tree ID | Description and PRF Characteristics | | Roost Suitability based on ground-based assessment | Recommendations if tree is to be impacted |
|---|---|---|---|---|
| T90 | <p>A mature pedunculate oak tree situated within the north-western field. SJ 38222 51164.</p> <p>PRFs:</p> <p>A: Two knot holes on south-west aspect branch at approximately 8 m.</p> <p>B: pruning cut on north-east aspect at approximately 2 m.</p> <p>C: Knot hole on north aspect at approximately 2m high.</p> | | Moderate | <p>Aerial climb and endoscopic inspection also possible to further assess PRFs and tree categorisation.</p> <p>Two separate survey visits. Including one dusk emergence survey and a separate dawn re-entry survey, undertaken between May to September with at least one survey undertaken between May to August.</p> |

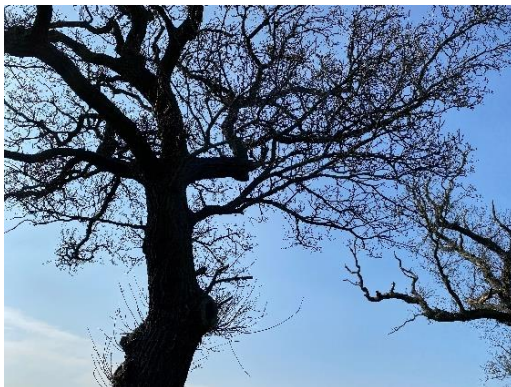
| Tree ID | Description and PRF Characteristics | | Roost Suitability based on ground-based assessment | Recommendations if tree is to be impacted |
|---|---|---|---|---|
| T91 | <p>A middle age pedunculate oak situated within the north-western field. SJ 38227 51155</p> <p>PRFs:</p> <p>A: Desiccation fissure on north-east aspect at approximately 4 m.</p> | | Moderate | <p>Aerial climb and endoscopic inspection also possible to further assess PRFs and tree categorisation.</p> <p>Two separate survey visits. Including one dusk emergence survey and a separate dawn re-entry survey, undertaken between May to September with at least one survey undertaken between May to August.</p> |

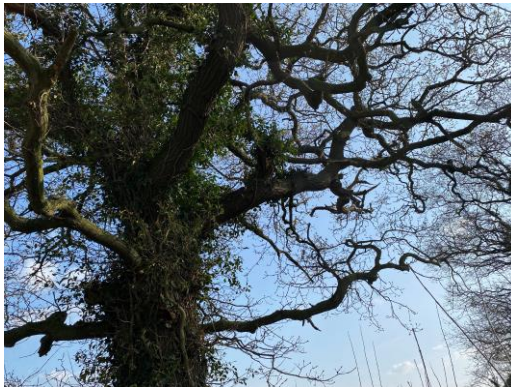
| Tree ID | Description and PRF Characteristics | Roost Suitability based on ground-based assessment | Recommendations if tree is to be impacted |
|---|---|---|---|
| T96 | <p>A mature pedunculate oak tree situated within the residential/field boundary hedgerow (H16) with large tree house. SJ 38327 51261.</p> <p>Ivy cladding may be obscuring additional features, but does not provide suitable PRF itself.</p> <p>PRFs:</p> <p>A: Heavily ivy clad, potentially hiding features within remnants of tree house.</p> <p>B: Desiccated south-east facing branch with cavity at approximately 4 m.</p> | <p>Moderate.</p> | <p>Aerial climb and endoscopic inspection also possible to further assess PRFs and tree categorisation.</p> <p>Two separate survey visits. Including one dusk emergence survey and a separate dawn re-entry survey, undertaken between May to September with at least one survey undertaken between May to August.</p> |

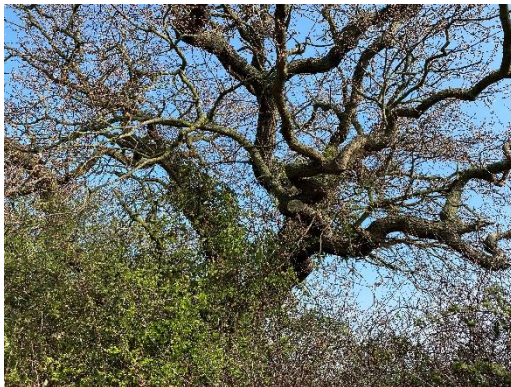
| Tree ID | Description and PRF Characteristics | Roost Suitability based on ground-based assessment | Recommendations if tree is to be impacted |
|---|---|---|---|
| T100 | <p>A mature pedunculate oak tree situated within the hedgerow (H22). SJ 38499 51125.</p> <p>PRFs</p> <p>A: South leading branch has desiccated limb with associated downward facing cavity just above the top of hedgerow at approximately 3m.</p> <p>B: Knot hole visible on west aspect at approximately 7 m.</p> <p>C: North leading stem has desiccated features with cavity. Cluttered entrance due to hedgerow vegetation.</p> <p>D: Tear out on south-east aspect within upper canopy at approximately 8 m.</p> <p>E: Woodpecker hole on east aspect at approximately 6.</p> <p>F: Cavity on north-leading branch, located where branch meets main stem at approximately 4 m. Visible from eastern aspect.</p> <p>G: Same branch as PRF E. Desiccated limb with ram's horns. Visible from eastern aspect at approximately 8 m.</p> | <p>High</p> | <p>Aerial climb and endoscopic inspection also possible to further assess PRFs and tree categorisation.</p> <p>Three separate survey visits. Including at least one dusk emergence survey and a separate dawn re-entry survey (the third visit being either a dusk emergence or dawn re-entry survey) undertaken between May to September with at least two surveys undertaken between May to August.</p> |

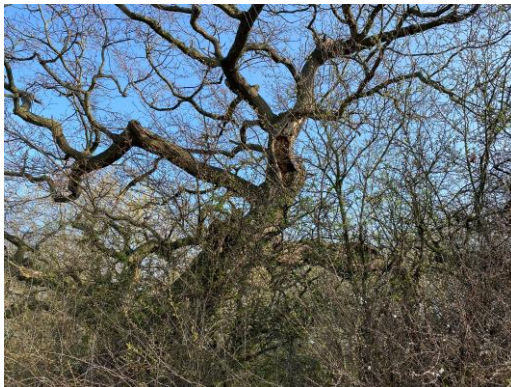
| Tree ID | Description and PRF Characteristics | | Roost Suitability based on ground-based assessment | Recommendations if tree is to be impacted |
|---|---|---|---|---|
| T101 | <p>A veteran pedunculate oak tree closely associated with group of trees G13.</p> <p>SJ 38470 51133.</p> <p>PRFs:</p> <p>A: Large cavity on northern aspect from base of main stem running upwards. Additional access points on western aspect. Very open and exposed but contains associated desiccation fissures suitable for crevice dwelling species.</p> <p>B: Branch overhanging water on eastern aspect has transverse snap with suitable features.</p> <p>C: Tear out on limb attached to north-west leading branch.</p> | | High | <p>Three separate survey visits. Including at least one dusk emergence survey and a separate dawn re-entry survey (the third visit being either a dusk emergence or dawn re-entry survey) undertaken between May to September with at least two surveys undertaken between May to August.</p> <p>Health and safety: Not suitable for aerial climb due to hollow stem.</p> |

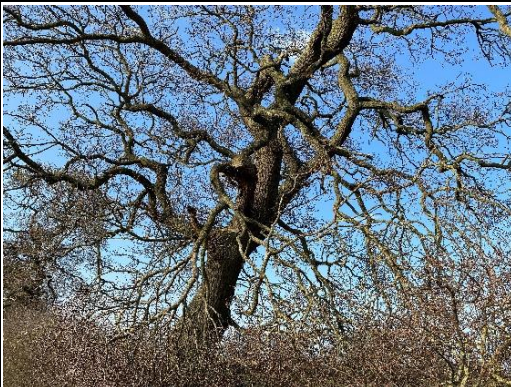
| Tree ID | Description and PRF Characteristics | | Roost Suitability based on ground-based assessment | Recommendations if tree is to be impacted |
|---|---|---|---|---|
| T102 | <p>A mature pedunculate oak tree situated within the hedgerow (H22). SJ 38468 51175.</p> <p>PRFs:</p> <p>A: Transverse snap on south-west aspect at approximately 8 m.</p> <p>B: Lifted bark and cavities around pruning cut on south-west facing branch at approximately 6 m.</p> <p>C: Woodpecker hole visible from eastern side of hedgerow on main north-leading branch that forks east. PRF at approximately 9 m.</p> <p>D: Longitudinal crack desiccated branch with wound at base, north leading branch within eastern canopy at approximately 5 m.</p> | | High | <p>Aerial climb and endoscopic inspection also possible to further assess PRFs and tree categorisation.</p> <p>Three separate survey visits. Including at least one dusk emergence survey and a separate dawn re-entry survey (the third visit being either a dusk emergence or dawn re-entry survey) undertaken between May to September with at least two surveys undertaken between May to August.</p> |

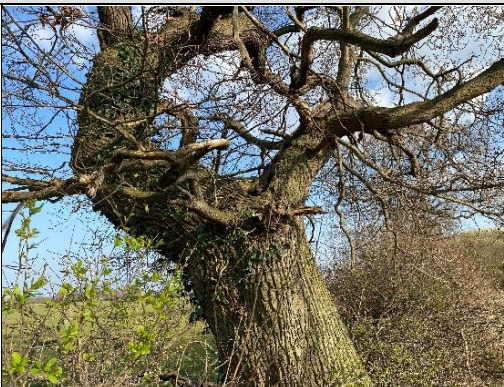
| Tree ID | Description and PRF Characteristics | | Roost Suitability based on ground-based assessment | Recommendations if tree is to be impacted |
|---|---|---|---|---|
| T103 | <p>A mature pedunculate oak tree situated within the hedgerow (H22). SJ 38453 51196.</p> <p>PRFs:</p> <p>A: Large desiccated branch that forks from main stem at 2 – 3 m with multiple cavities from large tear out.</p> <p>B: Woodpecker hole on southern aspect at approximately 8 m.</p> <p>C: Possible hazard beam within mid canopy on eastern most upright branch, approximately 1 m above woodpecker hole (B).</p> <p>D: Possible hazard beam with potential cavity on southernmost branch, at approximately 6.5 m.</p> | | High | <p>Aerial climb and endoscopic inspection also possible to further assess PRFs and tree categorisation.</p> <p>Three separate survey visits. Including at least one dusk emergence survey and a separate dawn re-entry survey (the third visit being either a dusk emergence or dawn re-entry survey) undertaken between May to September with at least two surveys undertaken between May to August.</p> |

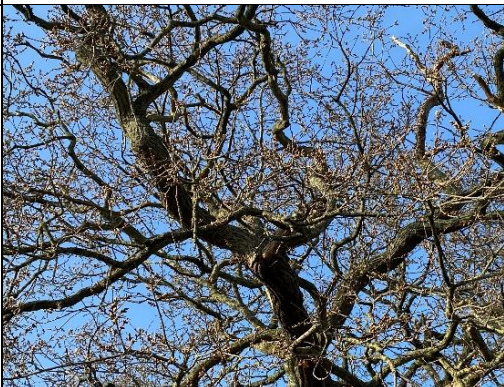
| Tree ID | Description and PRF Characteristics | | Roost Suitability based on ground-based assessment | Recommendations if tree is to be impacted |
|---|---|---|---|---|
| T104 | <p>A mature pedunculate oak tree situated within the hedgerow (H22). SJ 38445 51208.</p> <p>PRFs:</p> <p>A: Wound on desiccated branch on south-west aspect at approximately 8 m.</p> <p>B: Knot hole forming at base of desiccated central south-west leading branch at approximately 4 m.</p> <p>C: Knot hole on southern aspect at base of desiccated branch at approximately 8 m.</p> | | Moderate | <p>Aerial climb and endoscopic inspection also possible to further assess PRFs and tree categorisation.</p> <p>Two separate survey visits. Including one dusk emergence survey and a separate dawn re-entry survey, undertaken between May to September with at least one survey undertaken between May to August.</p> |

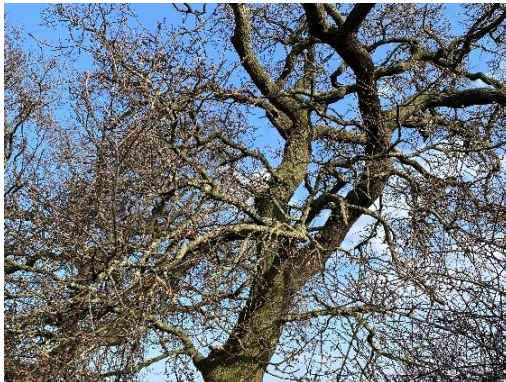
| Tree ID | Description and PRF Characteristics | Roost Suitability based on ground-based assessment | Recommendations if tree is to be impacted |
|---|---|---|---|
| T106 | <p>A middle age pedunculate oak tree immediately adjacent to T107. SJ 38471 51262.</p> <p>PRFs:</p> <p>A: Branch cavity on north-west aspect at approximately 8 m.</p> <p>B: Two knot holes on south-facing desiccated branch at approximately 3 m.</p> | <p>Moderate</p> | <p>Aerial climb and endoscopic inspection also possible to further assess PRFs and tree categorisation.</p> <p>Two separate survey visits. Including one dusk emergence survey and a separate dawn re-entry survey, undertaken between May to September with at least one survey undertaken between May to August.</p> |

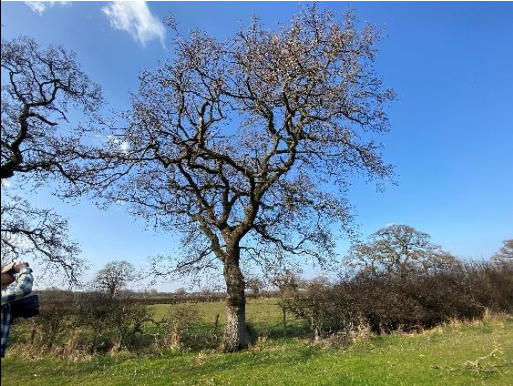
| Tree ID | Description and PRF Characteristics | Roost Suitability based on ground-based assessment | Recommendations if tree is to be impacted |
|---|---|---|---|
| T107 | <p>A middle age pedunculate oak tree situated within the hedgerow (H20). SJ 38479 51264.</p> <p>PRFs:</p> <p>A: Wound at 1.5 m on southern aspect. Unable to inspect due to wasps' nest in feature.</p> <p>B: Dead branch with cavities on southern aspect at approximately 6 m.</p> <p>C: Longitudinal crack on southern aspect at approximately 6 m.</p> <p>D: Desiccated branch with dropped section on western aspect.</p> <p>E: Woodpecker hole on dead branch on western aspect at approximately 8 m.</p> <p>F: Hazard beam on northern aspect at approximately 6 m.</p> <p>G: Desiccation fissure on desiccated branch on northern aspect at approximately 6 m.</p> | <p>High</p> | <p>Aerial climb and endoscopic inspection also possible to further assess PRFs and tree categorisation.</p> <p>Three separate survey visits. Including at least one dusk emergence survey and a separate dawn re-entry survey (the third visit being either a dusk emergence or dawn re-entry survey) undertaken between May to September with at least two surveys undertaken between May to August.</p> <p>Health and safety: Wasps' nest present at the time of ground-based assessment in feature A.</p> |

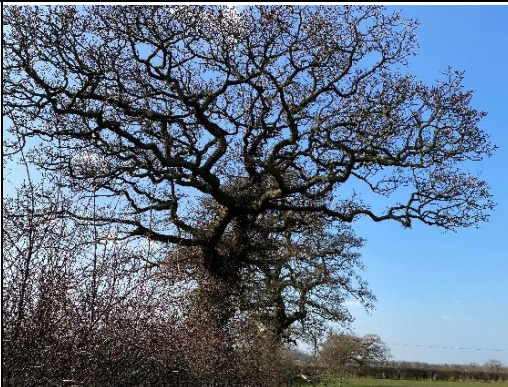
| Tree ID | Description and PRF Characteristics | | Roost Suitability based on ground-based assessment | Recommendations if tree is to be impacted |
|---|---|---|---|---|
| T108 | <p>A middle age pedunculate oak tree situated within the hedgerow (H20). SJ 38525 51288.</p> <p>PRFs:</p> <p>A: Lifted bark on desiccated branch on south-eastern aspect at approximately 5 m high.</p> <p>B: Lifted bark on desiccated branch on southern aspect at approximately 6 m high.</p> | | Low | No further surveys required. Precautionary soft felling/pruning measures must be adhered to under supervision of a licenced bat ecologist. |

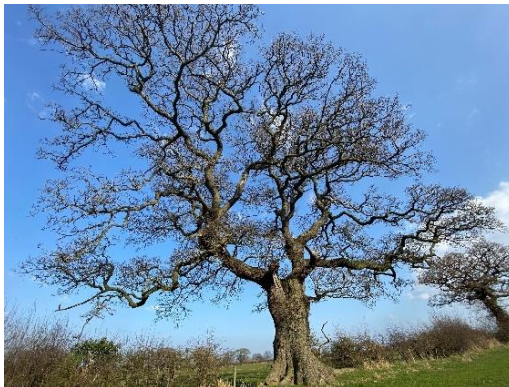
| Tree ID | Description and PRF Characteristics | | Roost Suitability based on ground-based assessment | Recommendations if tree is to be impacted |
|---|---|---|---|---|
| T109 | <p>A large mature pedunculate oak tree situated in the hedgerow (H20). SJ 38513 51309.</p> <p>PRFs:</p> <p>A: Large tear out on south-west aspect at approximately 8 m, appears to provide access internally.</p> <p>B: Cavity formed due to dropped branch on southern aspect at approximately 2 m.</p> <p>C: Cavity formed due to dropped branch on northern aspect at approximately 7 m.</p> <p>D: Lifted bark and cavities located on southern aspect branch at approximately 5 m.</p> <p>E: Transverse snap or broken branch on western aspect at approximately 5 m.</p> | | High | <p>Aerial climb and endoscopic inspection also possible to further assess PRFs and tree categorisation.</p> <p>Three separate survey visits. Including at least one dusk emergence survey and a separate dawn re-entry survey (the third visit being either a dusk emergence or dawn re-entry survey) undertaken between May to September with at least two surveys undertaken between May to August.</p> |

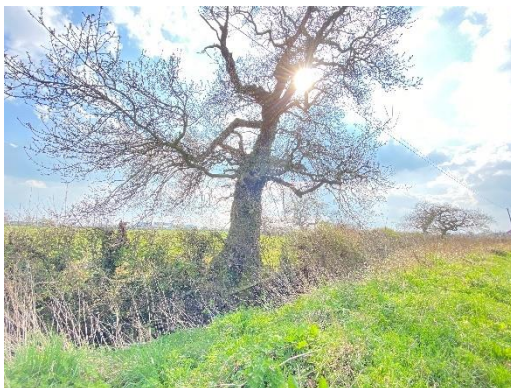
| Tree ID | Description and PRF Characteristics | | Roost Suitability based on ground-based assessment | Recommendations if tree is to be impacted |
|---|---|---|---|---|
| T111 | <p>Large mature pedunculate oak tree situated within the field boundary hedgerow (H23). SJ 38537 51374.</p> <p>PRFs:</p> <p>A: Knot hole and desiccated branch on northern aspect at approximately 6 m.</p> <p>B: Tear out on southern aspect with associated desiccation fissure and cavities.</p> | | Moderate | <p>Aerial climb and endoscopic inspection also possible to further assess PRFs and tree categorisation.</p> <p>Two separate survey visits. Including one dusk emergence survey and a separate dawn re-entry survey, undertaken between May to September with at least one survey undertaken between May to August.</p> |

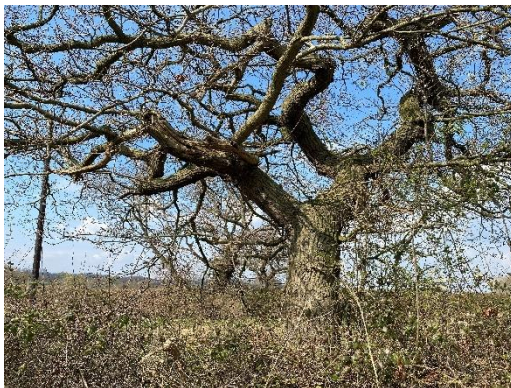
| Tree ID | Description and PRF Characteristics | | Roost Suitability based on ground-based assessment | Recommendations if tree is to be impacted |
|---|---|---|---|---|
| T112 | <p>A middle aged pedunculate oak tree situated within the field boundary hedgerow SJ 38501 51350.</p> <p>PRFs:</p> <p>A: Tear out with associated desiccation fissure and lifted bark on southern aspect at approximately 3.5 m.</p> <p>B: East facing knot hole visible from southern aspect at approximately 4 m.</p> | | Moderate | <p>Aerial climb and endoscopic inspection also possible to further assess PRFs and tree categorisation.</p> <p>Two separate survey visits. Including one dusk emergence survey and a separate dawn re-entry survey, undertaken between May to September with at least one survey undertaken between May to August.</p> |

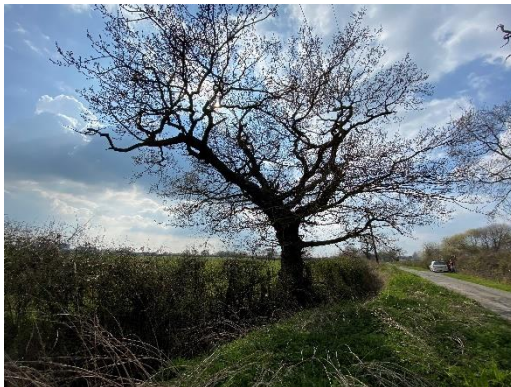
| Tree ID | Description and PRF Characteristics | | Roost Suitability based on ground-based assessment | Recommendations if tree is to be impacted |
|---|---|---|---|---|
| T113 | <p>A large mature pedunculate oak tree growing out of ditch within field boundary. SJ 38612 51416.</p> <p>PRFs:</p> <p>A: Knot hole visible on eastern aspect at approximately 6 m.</p> <p>B: Desiccation fissure on east leading branch at approximately 5 m.</p> <p>C: Knot hole and bark damage on northern aspect at approximately 6 m.</p> <p>D: Upward facing cavity on east leading branch.</p> <p>E: Knot hole and desiccated branch on southern aspect.</p> | | Moderate | Two separate survey visits. Including one dusk emergence survey and a separate dawn re-entry survey, undertaken between May to September with at least one survey undertaken between May to August. Aerial climb and endoscopic inspection also possible to further assess PRFs and tree categorisation. |

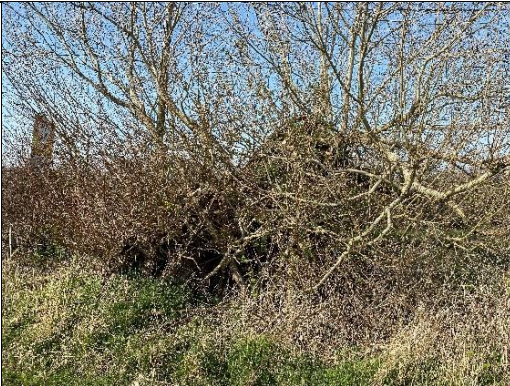
| Tree ID | Description and PRF Characteristics | | Roost Suitability based on ground-based assessment | Recommendations if tree is to be impacted |
|---|---|---|---|---|
| T115 | <p>Failed white willow with newer regrowth. The twisted, cracked, and shattered remnants of the old tree provide numerous PRFs throughout. SJ 38111 51210.</p> <p>Too many features to adequately inspect and regrowth prevents access.</p> | | Moderate | <p>Two separate survey visits. Including one dusk emergence survey and a separate dawn re-entry survey, undertaken between May to September with at least one survey undertaken between May to August.</p> <p>Health and safety: Hi vis PPE required due to roadside.</p> |

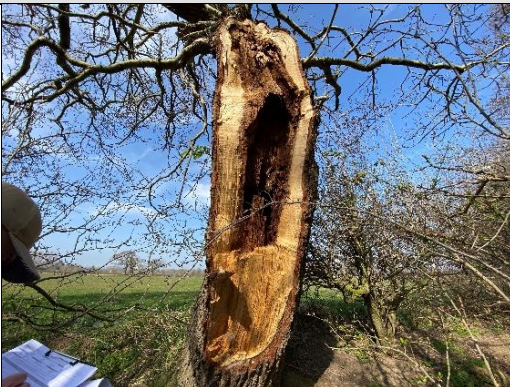
| Tree ID | Description and PRF Characteristics | Roost Suitability based on ground-based assessment | Recommendations if tree is to be impacted |
|---|---|---|---|
| T116 | <p>A mature pedunculate oak tree with large tear out/failure that has fallen over the pond. Situated adjacent to the G10 group of trees.</p> <p>SJ 38303 51085.</p> <p>PRFs:</p> <p>A: Tear out on southern aspect, at approximately 2 m. Endoscoped during GLTA. No evidence of bats, however, feature offers moderate potential.</p> <p>B: Tear out (as above) but detached section. Endoscoped during GLTA. No evidence of bats, however, feature offers low potential.</p> | | <p>Moderate</p> <p>Two separate survey visits. Including one dusk emergence survey and a separate dawn re-entry survey, undertaken between May to September with at least one survey undertaken between May to August.</p> <p>Unsuitable to climb due to health and safety.</p> |

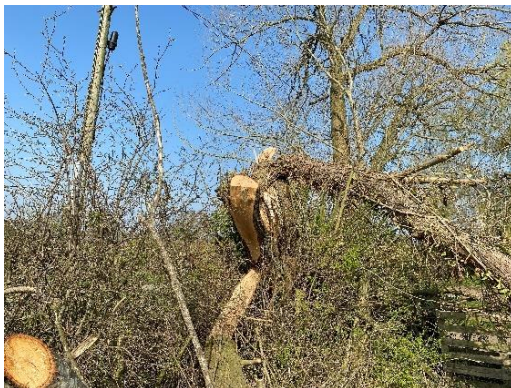
| Tree ID | Description and PRF Characteristics | Roost Suitability based on ground-based assessment | Recommendations if tree is to be impacted |
|---|---|---|---|
| T118 | <p>A recently failed/fallen mature crack willow within hedgerow associated with residential boundary. Debris within adjacent field. SJ 38277 51253.</p> <p>PRF features: Present throughout due to tears/splits but limited value due to exposure. Conditions are suitable for opportunistic use only.</p> | | <p>Low</p> <p>No further surveys required. Precautionary soft felling/pruning measures must be adhered to under supervision of a licenced bat ecologist.</p> |

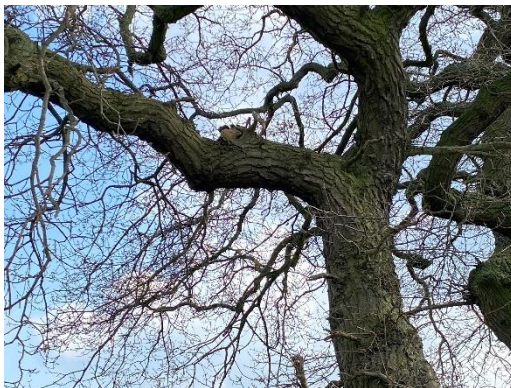
| Tree ID | Description and PRF Characteristics | | Roost Suitability based on ground-based assessment | Recommendations if tree is to be impacted |
|---|---|---|---|---|
| G1.2 | Middle age pedunculate oak tree situated within hedgerow within a group of similar four trees. Second tree within the group, from the south. SJ 38876 51295.<br><br>A: Pruning cut cavity between heartwood and bark visible from western aspect at approximately 6 m. | | Low. | No further surveys required. Precautionary soft felling/pruning measures must be adhered to under supervision of a licenced bat ecologist. |

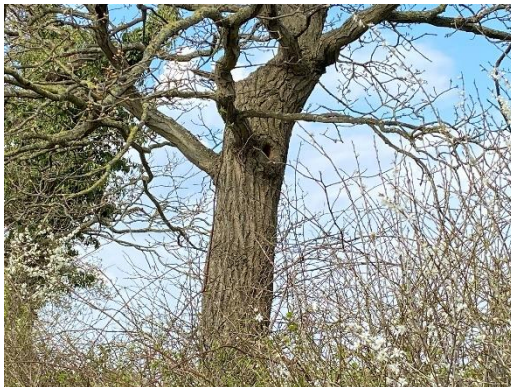
| Tree ID | Description and PRF Characteristics | | Roost Suitability based on ground-based assessment | Recommendations if tree is to be impacted |
|---|---|---|---|---|
| G4.2 | <p>A middle aged pedunculate oak. Second tree in the group starting from the north.</p> <p>SJ 38683 51357</p> <p>PRFs:</p> <p>A: Knot hole visible from west aspect at approximately 3.5 m.</p> <p>B: Woodpecker hole on southern aspect.</p> | | High | <p>Aerial climb and endoscopic inspection also possible to further assess PRFs and tree categorisation.</p> <p>Three separate survey visits. Including at least one dusk emergence survey and a separate dawn re-entry survey (the third visit being either a dusk emergence or dawn re-entry survey) undertaken between May to September with at least two surveys undertaken between May to August.</p> |

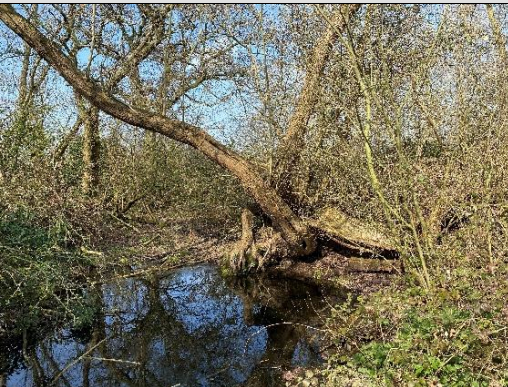
| Tree ID | Description and PRF Characteristics | Roost Suitability based on ground-based assessment | Recommendations if tree is to be impacted |
|---|---|---|---|
| G10.1 | <p>Willow tree overhanging pond with multiple PRFs visible with features potentially suited to high value roosts. SJ 38331 51079.</p> <p>PRFs:</p> <p>A: Large longitudinal crack in main stem which is hollowed out.</p> | High | <p>Three separate survey visits. Including at least one dusk emergence survey and a separate dawn re-entry survey (the third visit being either a dusk emergence or dawn re-entry survey) undertaken between May to September with at least two surveys undertaken between May to August.</p> <p>Health and safety: Close inspection not possible due to water. Aerial climb not recommended due to health and safety..</p> |

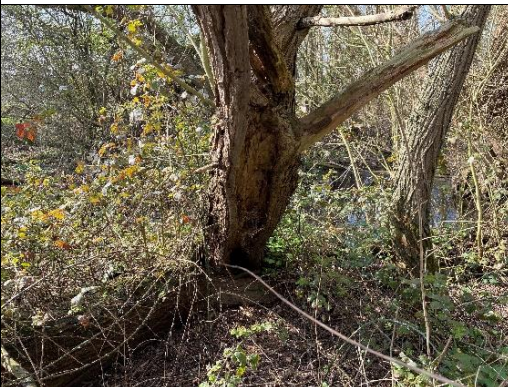
| Tree ID | Description and PRF Characteristics | Roost Suitability based on ground-based assessment | Recommendations if tree is to be impacted |
|---|---|---|---|
| G10.2 | <p>Partially fallen willow tree with hollowed out stem at base adjacent to pond. SJ 38333 51085.</p> <p>PRFs:</p> <p>A: Downward facing longitudinal crack in stem, would provide opportunistic roosting habitat.</p> | Low | <p>No further surveys required. Precautionary soft felling/pruning measures must be adhered to under supervision of a licenced bat ecologist.</p> |

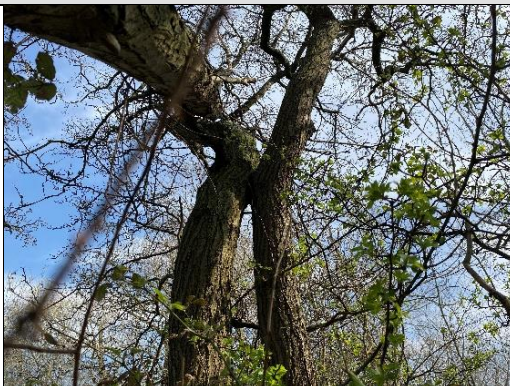
| Tree ID | Description and PRF Characteristics | | Roost Suitability based on ground-based assessment | Recommendations if tree is to be impacted |
|---|---|---|---|---|
| G10.3 | <p>A multi-stem willow tree within scrub area adjacent to pond. SJ 383319 51086.</p> <p>PRF:</p> <p>A: Compression fork where two stems meet may offer limited roosting potential.</p> | | Low | No further surveys required. Precautionary soft felling/pruning measures must be adhered to under supervision of a licenced bat ecologist. |

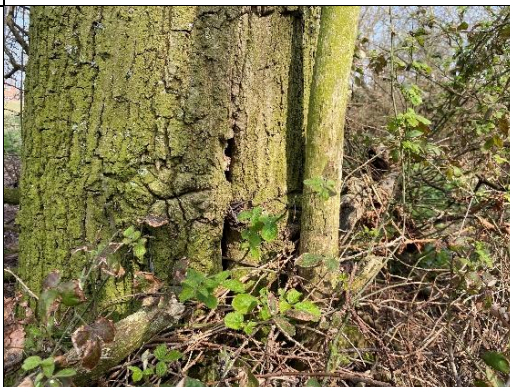
| Tree ID | Description and PRF Characteristics | | Roost Suitability based on ground-based assessment | Recommendations if tree is to be impacted |
|---|---|---|---|---|
| G10.4 | <p>A mature pedunculate oak tree situated within the group of trees within scrub area near to pond. SJ 38317 51087.</p> <p>PRFs:</p> <p>A: PRFs consisting of fluting at waist height on the southern aspect of the main stem. Attempted endoscope survey during GLTA but unsuccessful.</p> | | Moderate | <p>Two separate survey visits. Including one dusk emergence survey and a separate dawn re-entry survey, undertaken between May to September with at least one survey undertaken between May to August. Aerial climb and endoscopic inspection also possible to further assess PRFs and tree categorisation.</p> <p>Health and safety: Adjacent to water.</p> |

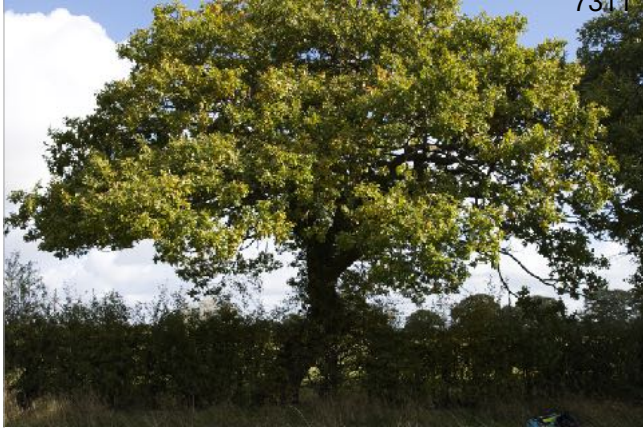
| Tree / feature number | Species | Height | DBH / Aspect | JPEG | Description | Comments | Can it be fully checked ? | Suitability | Further survey? |
|---|---|---|---|---|---|---|---|---|---|
| T39 | Oak | 10 | 70 | 7311 | Mature oak tree in field hedgerow boundary. Light ivy clad from base to 8m, deadwood in crown | | Yes | Negligible | No |

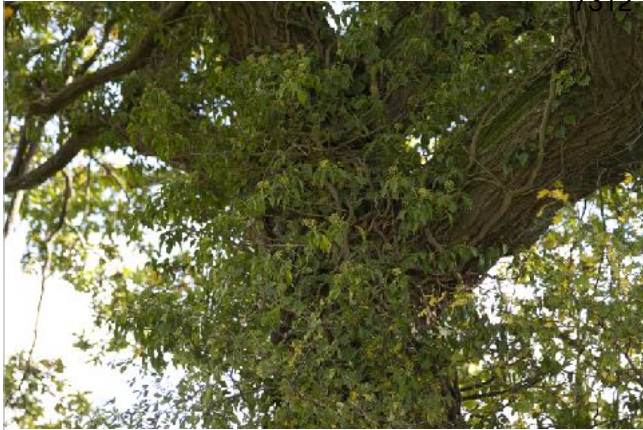
| Tree / feature number | Species | Height | DBH / Aspect | JPEG | Description | Comments | Can it be fully checked ? | Suitability | Further survey? |
|---|---|---|---|---|---|---|---|---|---|
| T39.1 | PRF1 | All | All | 7312 | Light ivy cladding from ground to 8m right against the bark. Does not provide suitable roosting feature at present. Is not obscuring any other PRFS | Ivy does not make PRF | Yes | Negligible | No |

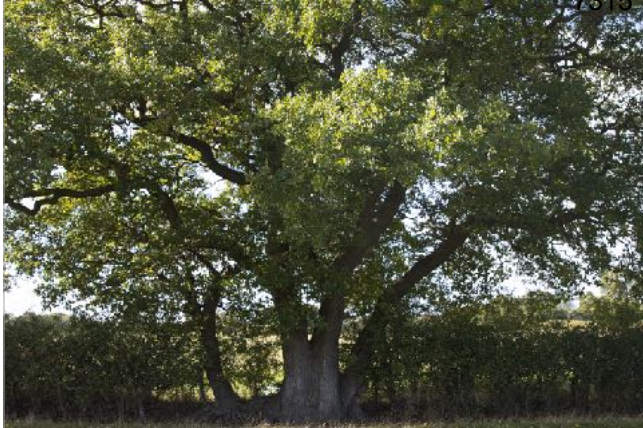
| Tree / feature number | Species | Height | DBH / Aspect | JPEG | Description | Comments | Can it be fully checked ? | Suitability | Further survey? |
|---|---|---|---|---|---|---|---|---|---|
| T40 | Oak | 12 | 1.2 | 7315 | Mature oak tree in field hedgerow boundary. Deadwood in the crown. | | Yes | Low | No |

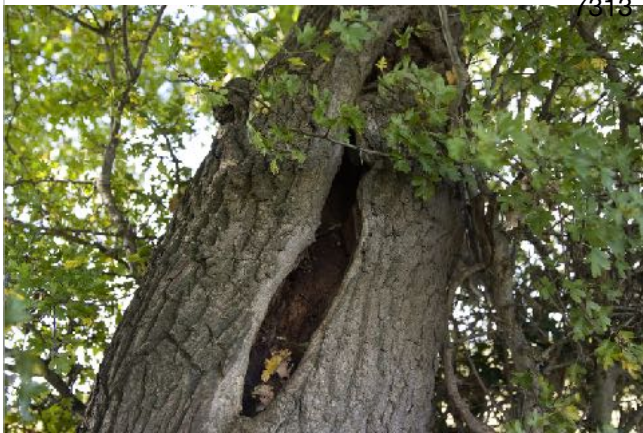
| Tree / feature number | Species | Height | DBH / Aspect | JPEG | Description | Comments | Can it be fully checked ? | Suitability | Further survey? |
|---|---|---|---|---|---|---|---|---|---|
| T40.1 | PRF1 | 2m | E | 7313 | Tear out on North leading limb visible on the eastern aspect at 2m. 1m x 7cm entrance with 10cm of downward travel and 10cm upward travel. Dry inside, more suitable to nesting birds. | Use torch to check before felling | Yes | Low | No |

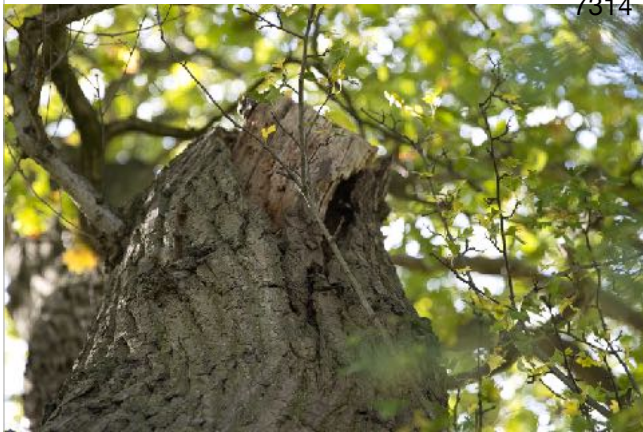
| Tree / feature number | Species | Height | DBH / Aspect | JPEG | Description | Comments | Can it be fully checked ? | Suitability | Further survey? |
|---|---|---|---|---|---|---|---|---|---|
| T40.2 | PRF2 | 4m | N | 7314 | Pruning wound at 4m with small cavity at base. Entrance is 10cm x 5cm. 10cm of upwards travel into rotting deadwood. Open to the elements | Use torch to check before felling | Yes | Low | No |

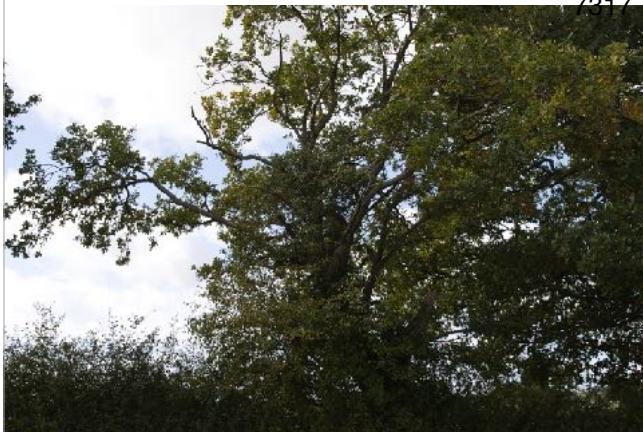
| Tree / feature number | Species | Height | DBH / Aspect | JPEG | Description | Comments | Can it be fully checked ? | Suitability | Further survey? |
|---|---|---|---|---|---|---|---|---|---|
| T41 | Oak | 9 | 60 | 7317 | Middle aged oak tree in field hedgerow boundary. Significant deadwood with the crown and ivy clad from base to 6m. Heavy foliage at base of tree | | No | Moderate | Yes |

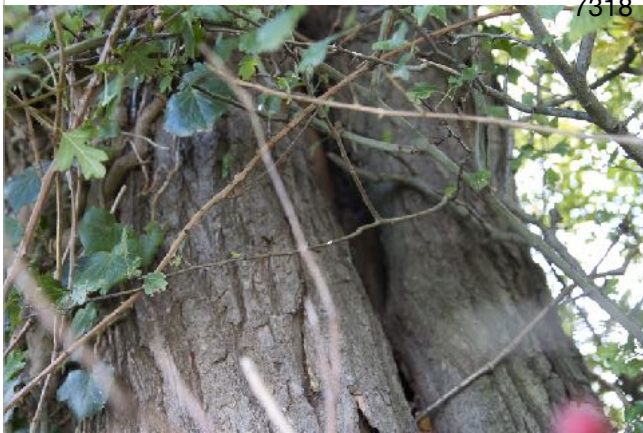
| Tree / feature number | Species | Height | DBH / Aspect | JPEG | Description | Comments | Can it be fully checked ? | Suitability | Further survey? |
|---|---|---|---|---|---|---|---|---|---|
| T41.1 | PRF1 | 1m | N | 7318 | Tear out with main stem cavity from 1m to 6m. Entrance 1m x 7cm with more than 1m of upward travel. The cavity itself is approx 10cm wide, open at top. Leaf debris and twigs (nesting birds/squirrels) at base. | Check prior to felling | No | Moderate | Yes |

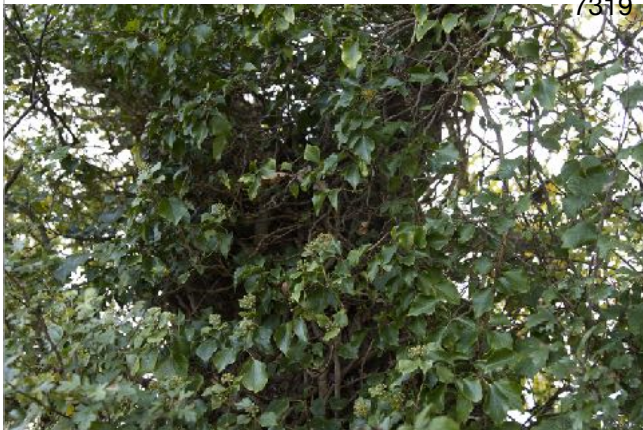
| Tree / feature number | Species | Height | DBH / Aspect | JPEG | Description | Comments | Can it be fully checked ? | Suitability | Further survey? |
|---|---|---|---|---|---|---|---|---|---|
| T41.2 | PRF2 | Base to 6m | All | 7319 | Ivy clad from base to 6m. At 4m ivy is thick and has slight come away from the tree creating PRF. Also obscures other entrances into main stem cavity. | Check prior to felling | Yes | Low | No |

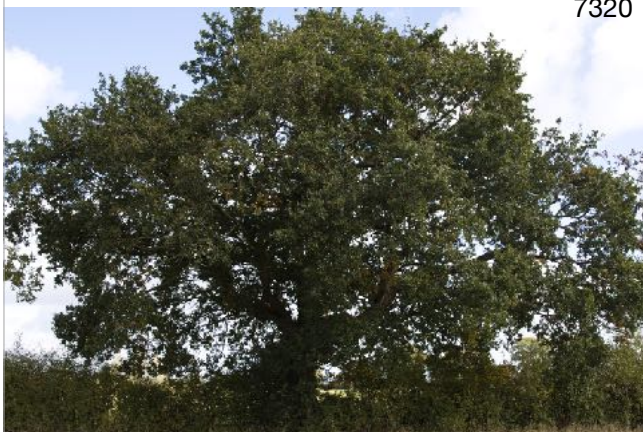
| Tree / feature number | Species | Height | DBH / Aspect | JPEG | Description | Comments | Can it be fully checked ? | Suitability | Further survey? |
|---|---|---|---|---|---|---|---|---|---|
| T42 | Oak | 12 | 90 | 7320 | Mature oak tree in field hedgerow boundary. Some deadwood in crown. Heavily foliage at base and very light ivy clad. | Ivy does not make PRF | Yes | Negligible | No |

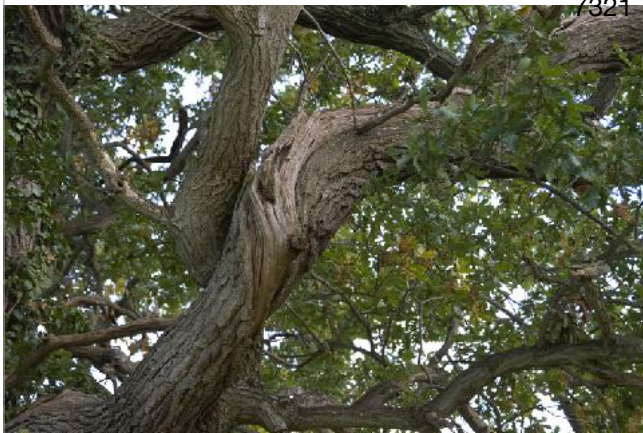
| Tree / feature number | Species | Height | DBH / Aspect | JPEG | Description | Comments | Can it be fully checked ? | Suitability | Further survey? |
|---|---|---|---|---|---|---|---|---|---|
| T42.1 | PRF1 | 3m | W | 7321<br> | Exposed heartwood throughout whole of southern limb. 4m in length. Callus is tight to the exposed heartwood and creates no cavity. | | Yes | Negligible | No |

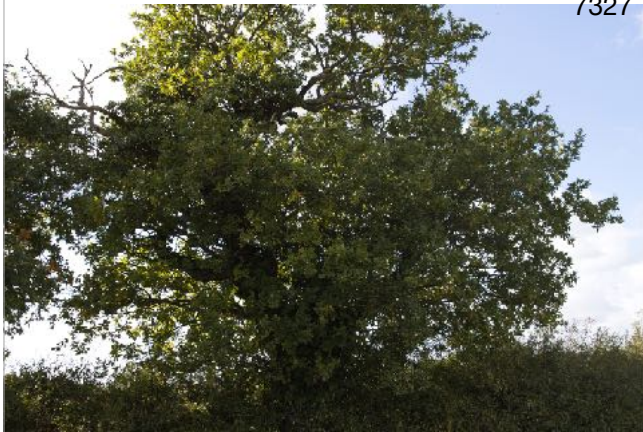
| Tree / feature number | Species | Height | DBH / Aspect | JPEG | Description | Comments | Can it be fully checked ? | Suitability | Further survey? |
|---|---|---|---|---|---|---|---|---|---|
| T44 | Oak | 8 | 90 | 7327<br> | Middle aged oak tree in field hedgerow boundary. Main stem cavity from ground to top. Heavy foliage at base. Ivy clad from ground to 7m | | No | Moderate | Yes |

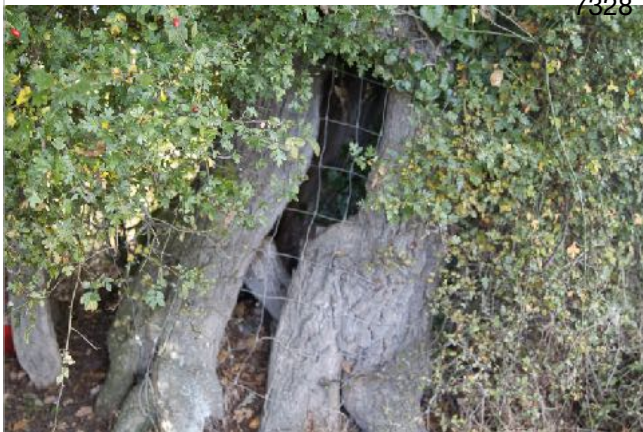
| Tree / feature number | Species | Height | DBH / Aspect | JPEG | Description | Comments | Can it be fully checked ? | Suitability | Further survey? |
|---|---|---|---|---|---|---|---|---|---|
| T44.1 | PRF1 | 1m | S | 7328<br> | Main stem cavity at base of tree. Entrance 1m x 30cm with more than 1m of upward travel. Cavity dimensions are 50cm wide tapering down to 30cm. Entrance obscured by barbed wire fence. Dry and smooth inside. Open to predators. Nesting bird material | Suitable for single bats day roost. | No | Moderate | Yes |

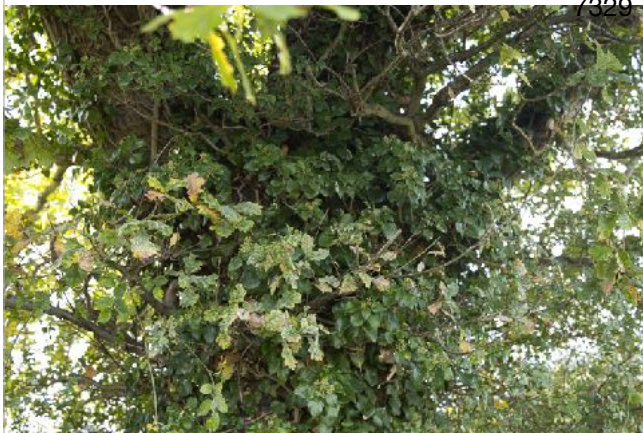
| Tree / feature number | Species | Height | DBH / Aspect | JPEG | Description | Comments | Can it be fully checked ? | Suitability | Further survey? |
|---|---|---|---|---|---|---|---|---|---|
| T44.2 | PRF2 | All | All | 7329 | Moderate ivy clad through the crown. Some ivy starting to come away. Possible small cavities for single bats behind ivy. Can be checked with torch. | Check with torch before felling | Yes | Low | No |

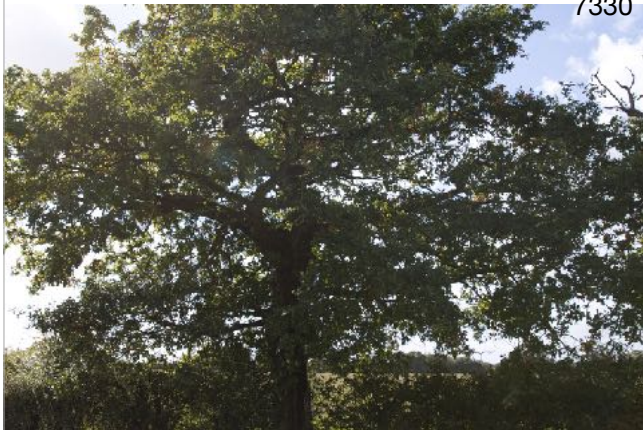
| Tree / feature number | Species | Height | DBH / Aspect | JPEG | Description | Comments | Can it be fully checked ? | Suitability | Further survey? |
|---|---|---|---|---|---|---|---|---|---|
| T45 | Oak | 11 | 70 | 7330 | Mature oak tree in field hedgerow boundary. Large lightening struck tree with scorch marks. Exposed heart wood with complex main stem cavity | | No | High | Yes |

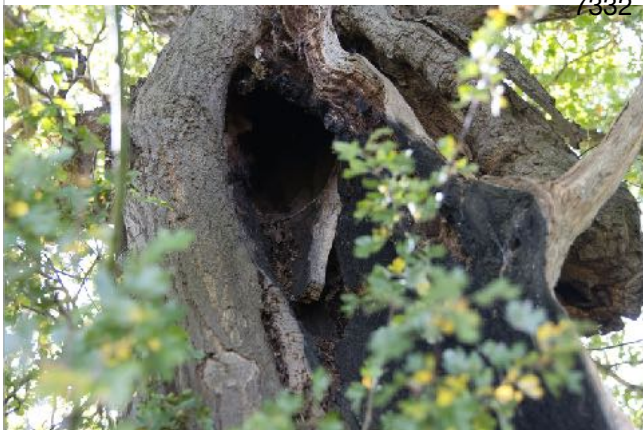
| Tree / feature number | Species | Height | DBH / Aspect | JPEG | Description | Comments | Can it be fully checked ? | Suitability | Further survey? |
|---|---|---|---|---|---|---|---|---|---|
| T45.1 | PRF1 | 1m | E | 7332 | Lightening strike on eastern aspect. Entrance 4m x 40cm leading to an upward cavity with more than 1m of upward travel. Dry inside. Cavity is 40cm wide through. More suitable to nesting birds. Looks to be open above. | cannot be fully inspected with endoscope due to size of cavities | No | Moderate | Yes |

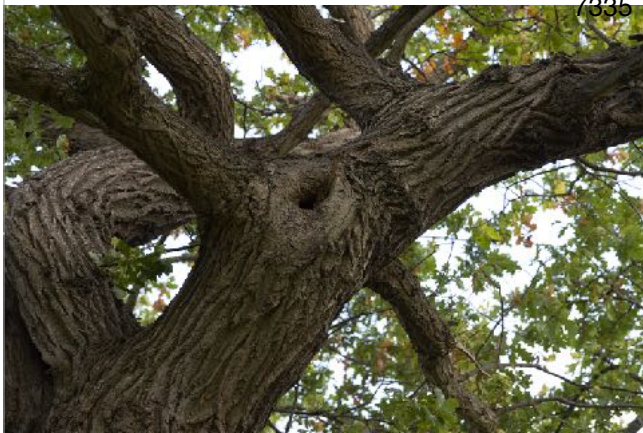
| Tree / feature number | Species | Height | DBH / Aspect | JPEG | Description | Comments | Can it be fully checked ? | Suitability | Further survey? |
|---|---|---|---|---|---|---|---|---|---|
| T45.2 | PRF2 | 5m | W | 7335 | Knot hole on the western aspect. Entrance 7cm x 5cm. Leads into a cavity 15cm wide with more than 1m of downward travel linking up to PRF1. Cavity could not be fully inspected due to nesting squirrel inside cavity at time of survey. | cannot be fully inspected with endoscope due to size of cavities | No | Moderate | Yes |

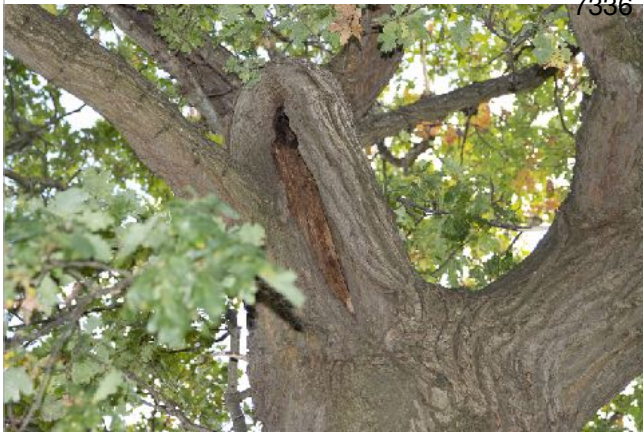
| Tree / feature number | Species | Height | DBH / Aspect | JPEG | Description | Comments | Can it be fully checked ? | Suitability | Further survey? |
|---|---|---|---|---|---|---|---|---|---|
| T45.3 | PRF3 | 5m | W | 7336 | Continuation of lightning strike from PRF1 on the western aspect. Entrance 1m x 7cm. Multiple cavities with more than 1m of upward, downward and horizontal travel into multiple limbs. Cavity is 10cm wide inside. | cannot be fully inspected with endoscope due to size of cavities | No | High | Yes |

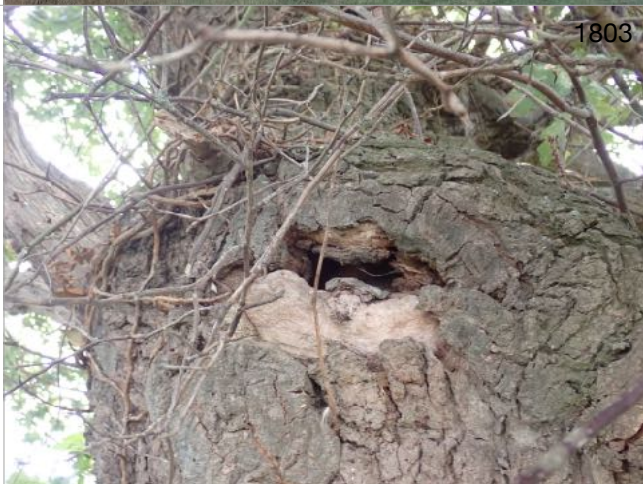
| Tree / feature number | Species | Height | DBH / Aspect | JPEG | Description | Comments | Can it be fully checked ? | Suitability | Further survey? |
|---|---|---|---|---|---|---|---|---|---|
| T54.1 | PRF1 | 3 | N | 1803 | Healing tear out at 3m on north side of main stem, with 10cm x 5cm opening into 5cm deep dry cavity, potentially suitable for single or lower numbers of bats, but more likely to be used by nesting birds. | | Yes | Low | No |

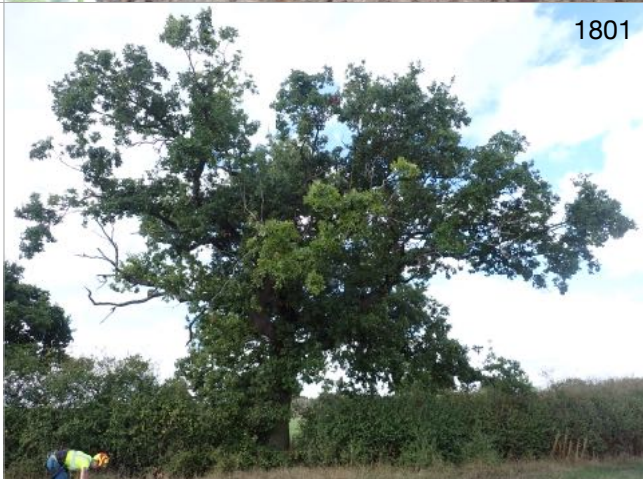
| Tree / feature number | Species | Height | DBH / Aspect | JPEG | Description | Comments | Can it be fully checked ? | Suitability | Further survey? |
|---|---|---|---|---|---|---|---|---|---|
| T56 | Oak | 8 | 60 | 1801 | Mature oak tree in field hedgerow boundary with deadwood woodpecker holes, knot holes, and exposed heartwood in the crown. | | Yes | High | Yes |

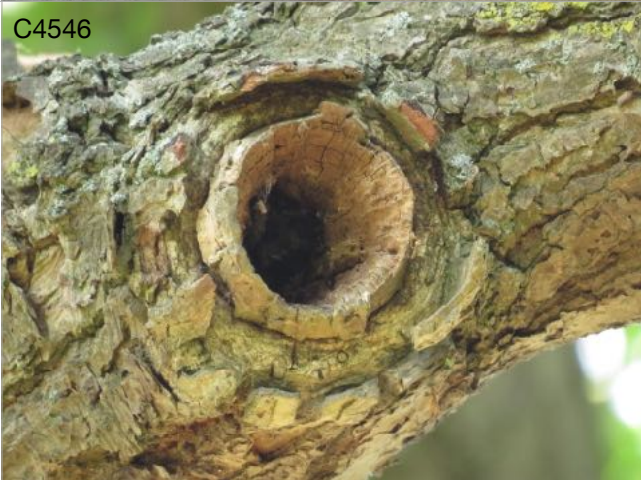
| Tree / feature number | Species | Height | DBH / Aspect | JPEG | Description | Comments | Can it be fully checked ? | Suitability | Further survey? |
|---|---|---|---|---|---|---|---|---|---|
| T77.1 | PRF1 | 4 | S | C4546 | Knot hole on end of horizontal limb on south side of canopy, 5cm diameter entrance with 7cm horizontal travel in dry tapering cavity. | | Yes | Negligible | No |
