# Appendix 11.7: Bat Roost Technical Appendix

# LAND NORTH OF BRYN LANE WREXHAM BAT ROOST SURVEY REPORT

| Document Title | Bat Roost Survey Report |
| Document Ref | 9134.005 |

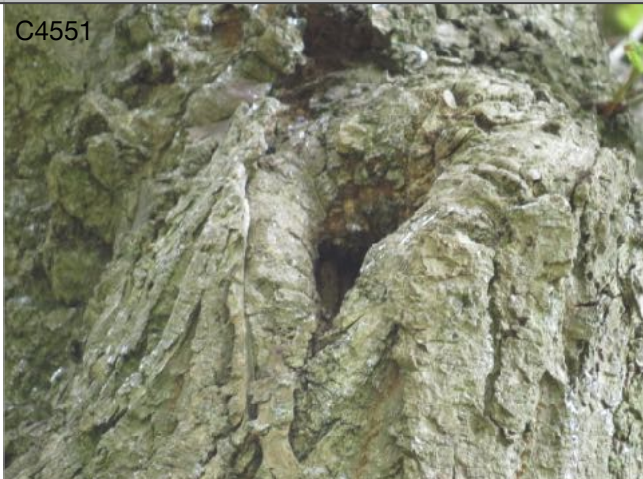
| Tree / feature number | Species | Height | DBH / Aspect | JPEG | Description | Comments | Can it be fully checked ? | Suitability | Further survey? |
|---|---|---|---|---|---|---|---|---|---|
| T85.1 | PRF1 | 7 | W | <div>C4551</div> | Knot hole at 7m on west side of vertical limb. 7cm diameter entrance with no upward travel and <5cm downward travel in tapering cavity. Open to the elements, not suitable for roosting bats. | | Yes | Negligible | No |

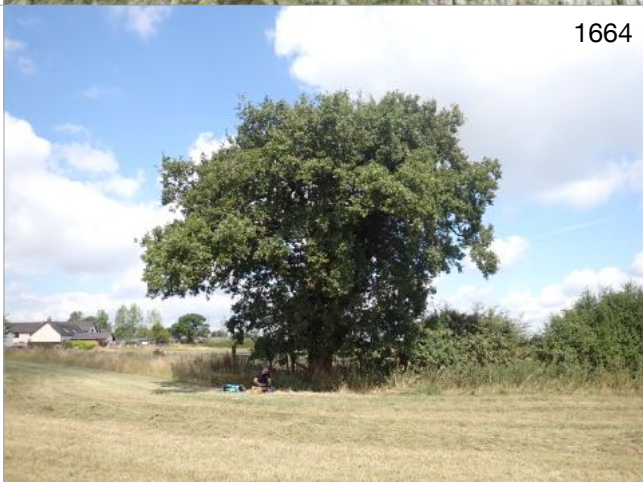
| Tree / feature number | Species | Height | DBH / Aspect | JPEG | Description | Comments | Can it be fully checked ? | Suitability | Further survey? |
|---|---|---|---|---|---|---|---|---|---|
| T86 | Oak | 8 | 90 | <div>1664</div> | Mature oak on field boundary hedgerow dead branches and limbs in the crown ivy from base to top of crown | Precautionary moderate as cannot be fully checked. | | Moderate | |

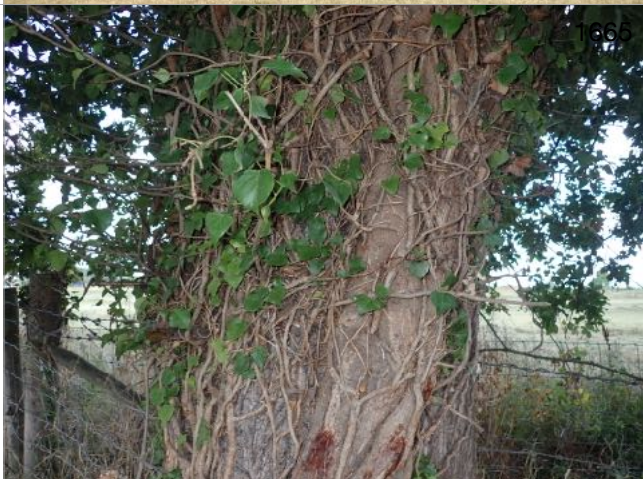
| Tree / feature number | Species | Height | DBH / Aspect | JPEG | Description | Comments | Can it be fully checked ? | Suitability | Further survey? |
|---|---|---|---|---|---|---|---|---|---|
| T86.1 | PRF1 | All | All | <div>1666</div> | Ivy from base to top of crown with pockets behind the thicker stems towards the base | | Yes | Low | No |

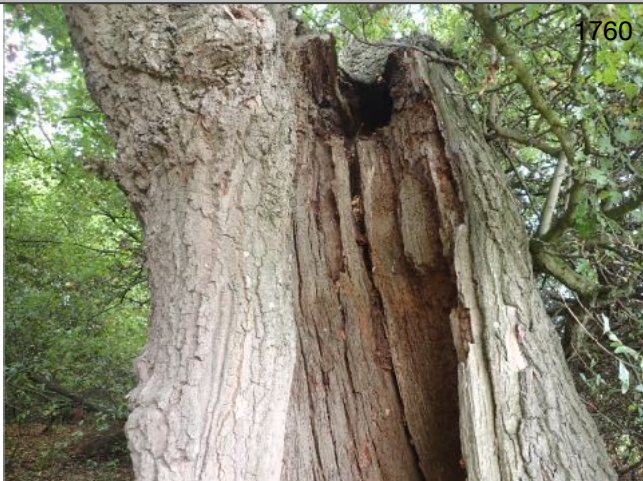
| Tree / feature number | Species | Height | DBH / Aspect | JPEG | Description | Comments | Can it be fully checked ? | Suitability | Further survey? |
|---|---|---|---|---|---|---|---|---|---|
| T101.1 | PRF1 | Base | N | 1760 | Large open main stem cavity from base to which leads upward, open at base, enclosed above 3m, 40cm diameter cavity, with at least 1m of upward travel, could not be checked, but likely to be suitable for use by roosting bats. | | No | High | Yes |

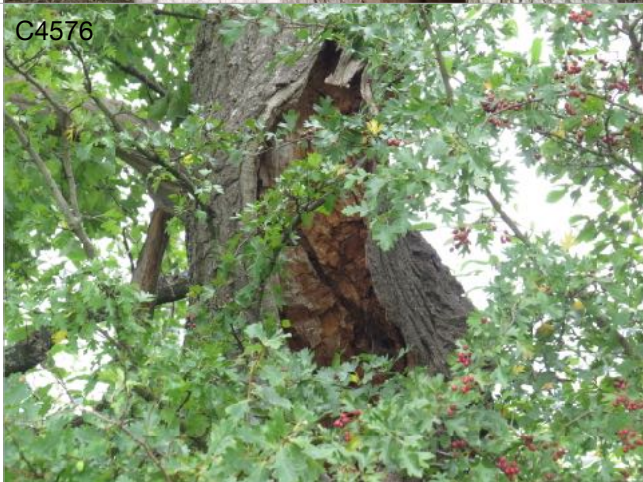
| Tree / feature number | Species | Height | DBH / Aspect | JPEG | Description | Comments | Can it be fully checked ? | Suitability | Further survey? |
|---|---|---|---|---|---|---|---|---|---|
| T101.2 | PRF2 | 5 | W | C4576 | Tear out on west side of main stem with split above, 30 x 60cm of exposed heartwood with cavity potentially travelling upward, and possibly downward linking to PRF1. | | No | High | Yes |

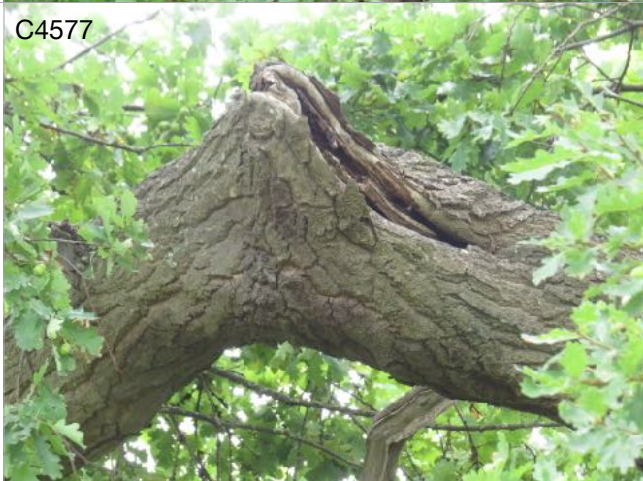
| Tree / feature number | Species | Height | DBH / Aspect | JPEG | Description | Comments | Can it be fully checked ? | Suitability | Further survey? |
|---|---|---|---|---|---|---|---|---|---|
| T101.3 | PRF3 | 5 | W | C4577 | Tear out on west side of horizontal limb in the north of the crown. 40cm x 10cm with some deadwood inside, cavity potentially leads down the limb. | | No | High | Yes |

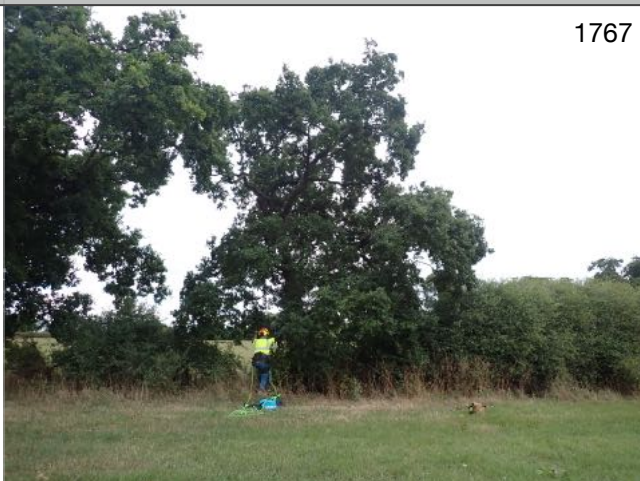
| Tree / feature number | Species | Height | DBH / Aspect | JPEG | Description | Comments | Can it be fully checked ? | Suitability | Further survey? |
|---|---|---|---|---|---|---|---|---|---|
| T106 | Oak | 8 | 40 | 1767 | Oak tree in field boundary hedgerow with knot holes and dead branches in the crown. | | Yes | Negligible | No |

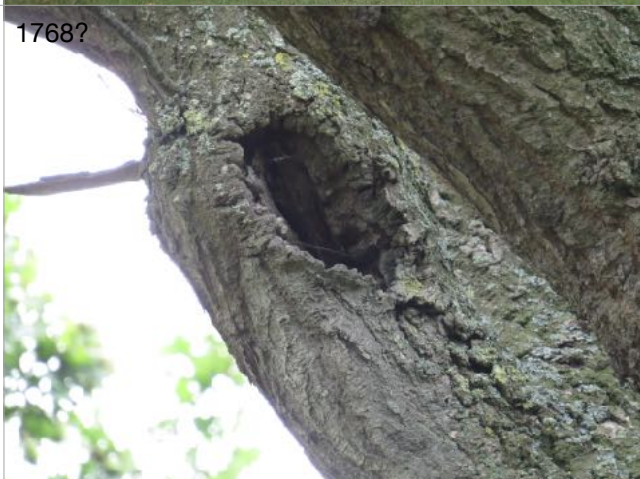
| Tree / feature number | Species | Height | DBH / Aspect | JPEG | Description | Comments | Can it be fully checked ? | Suitability | Further survey? |
|---|---|---|---|---|---|---|---|---|---|
| T106.1 | PRF1 | 6 | NW | 1768? | Tear out at 6m on the northwest side of vertical limb, no suitable cavity. | | Yes | Negligible | No |

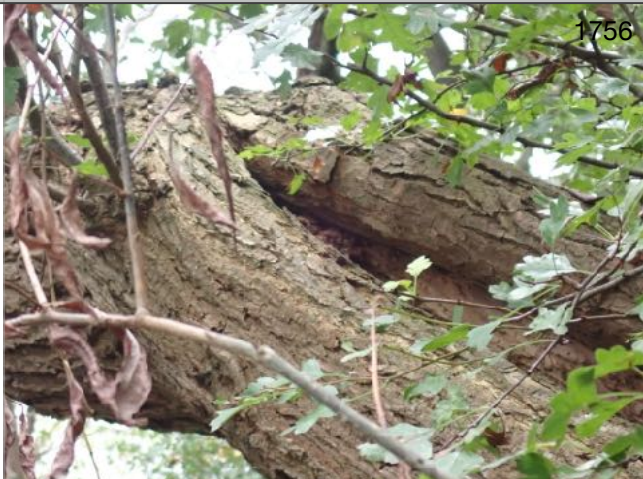
| Tree / feature number | Species | Height | DBH / Aspect | JPEG | Description | Comments | Can it be fully checked ? | Suitability | Further survey? |
|---|---|---|---|---|---|---|---|---|---|
| G10.1.1 | PRF1 | Base to 3m | NE | | 1756 Tear out on north east side of leaning limb from base to 3m with 20cm of exposed heartwood. Callus rolls tight against heartwood and 10 enclosed cavities at the top of the feature. Open to the elements more suitable for nesting birds | | Yes | Low | No |

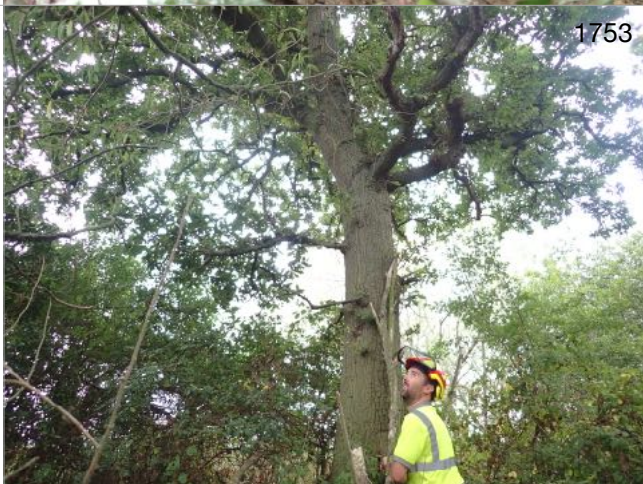
| Tree / feature number | Species | Height | DBH / Aspect | JPEG | Description | Comments | Can it be fully checked ? | Suitability | Further survey? |
|---|---|---|---|---|---|---|---|---|---|
| G10.4 | Oak | 10 | 50 | | 1753 Oak tree on edge of pond with split in bark at 1m on south side of mai. Stem. | | No | Moderate | Yes |

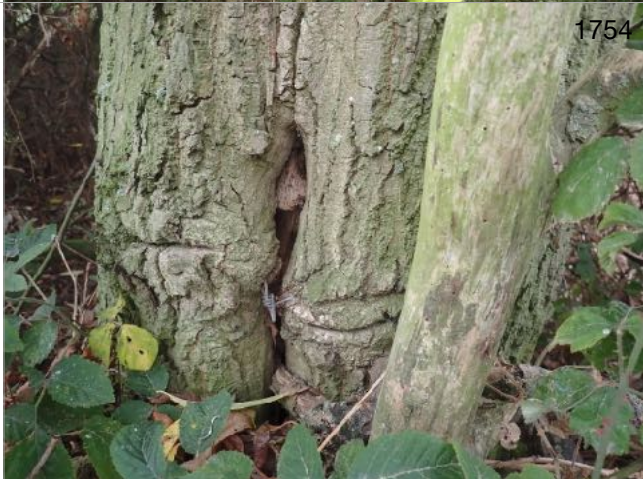
| Tree / feature number | Species | Height | DBH / Aspect | JPEG | Description | Comments | Can it be fully checked ? | Suitability | Further survey? |
|---|---|---|---|---|---|---|---|---|---|
| G10.4.1 | PRF1 | 1 | S | | 1754 Split in bark at 1m on south side of main stem 10cm x 3cm with more than 30cm upward travel in dry smooth cavity, multiple chambers which can't be fully checked. | Likely to be more suitable for winter use than summer as entrance is cluttered and low to the ground. | No | Moderate | |

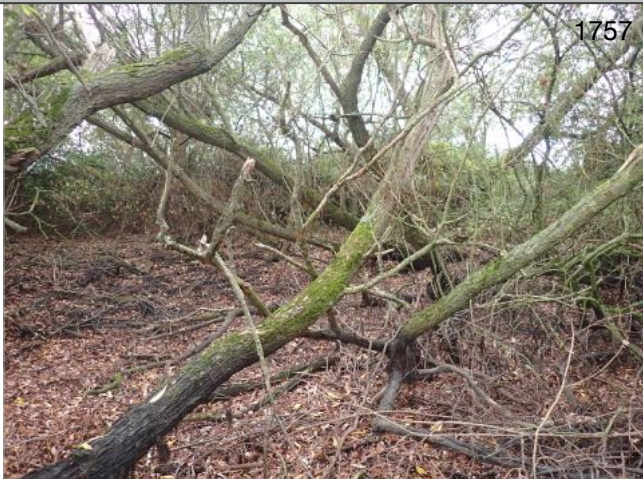
| Tree / feature number | Species | Height | DBH / Aspect | JPEG | Description | Comments | Can it be fully checked ? | Suitability | Further survey? |
|---|---|---|---|---|---|---|---|---|---|
| G10.5 | Willow | 7 | 20 | 1757<br> | Multi stemmed willow in pond, with tear out on southern stem. | Check before felling. | Yes | Low | No |

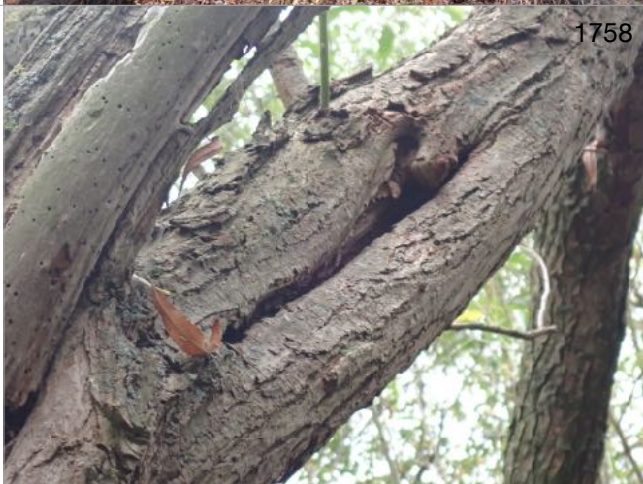
| Tree / feature number | Species | Height | DBH / Aspect | JPEG | Description | Comments | Can it be fully checked ? | Suitability | Further survey? |
|---|---|---|---|---|---|---|---|---|---|
| G10.5.1 | PRF1 | | | 1758<br> | Tear out at 2m on west side of stem leaning south into the pond. 5cm x am of exposed heartwood with 2cm x 20cm cavity at top of feature. Packed with woodlice, dry and smooth inside. | Suitable for use by single or low numbers of bats. | Yes | Low | No |

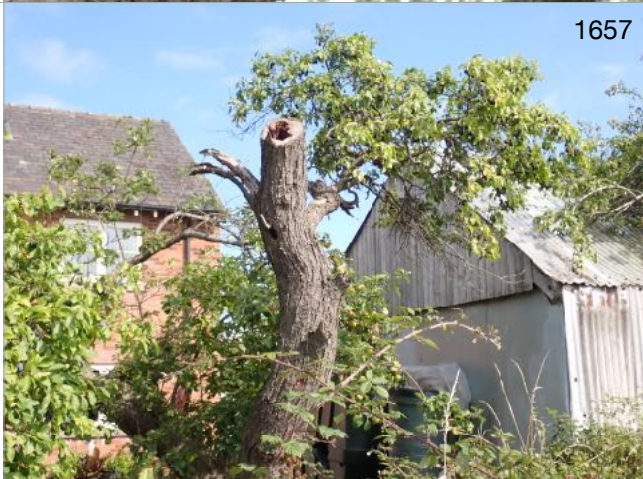
| Tree / feature number | Species | Height | DBH / Aspect | JPEG | Description | Comments | Can it be fully checked ? | Suitability | Further survey? |
|---|---|---|---|---|---|---|---|---|---|
| G11.1 | Damson, not Apple | 3 | 15 | 1657<br> | Damson tree in residential garden adjacent tin shed and field boundary hedgerow. Top has been cut off, revealing a main stem cavity with a woodpecker hole 40cm below the cut. | Open to the elements, no suitable shelter in main stem cavity or splits in bark on north side of main stem. | Yes | Negligible | No |

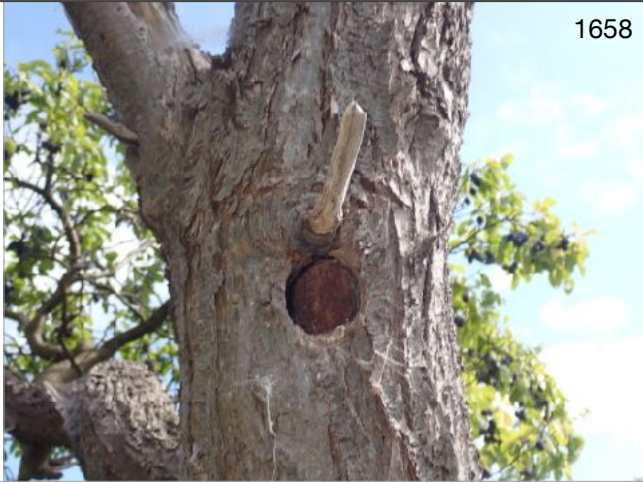
| Tree / feature number | Species | Height | DBH / Aspect | JPEG | Description | Comments | Can it be fully checked ? | Suitability | Further survey? |
|---|---|---|---|---|---|---|---|---|---|
| G11.1-1 | PRF1 | 2.5 | W | | 1658<br>Woodpecker hole at 2.5m on west side of main stem, 5cm diameter with 10cm downward travel in open cavity with 40cm upward travel to open top of stem. | Does not offer suitable shelter for roosting bats. | Yes | Negligible | No |
