Stori Brymbo Project  
Mining Report  
HF Machine Shop  
Brymbo Heritage Trust

## **1.0 INTRODUCTION**

Job Number: 2326  
Mining Report  
Issue January 2020

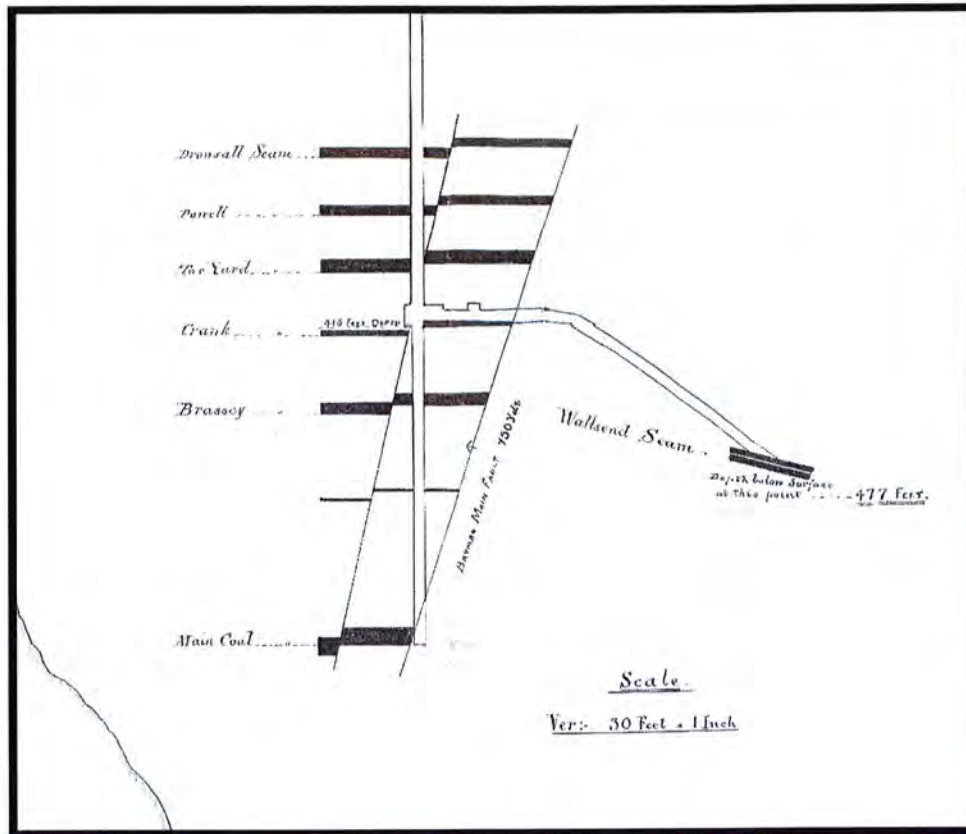
### Bye Pit showing Brymbo fault

Mine plan 5973, dated 1910, showing recorded workings in the Wallsend seam presents a shaft section of the Bye Pit at the Brymbo colliery, see below. This shows the shaft going through the Drowsell, Powell, Two Yard and Crank seams before entering the Brymbo Fault at the level of the Crank seam at 418 feet depth (127m). A roadway is shown going to the Wallsend seam on the east side of the fault at a depth of 477 feet (145m), See below.

The downthrown on the fault is shown as 150 yards in a westerly direction.

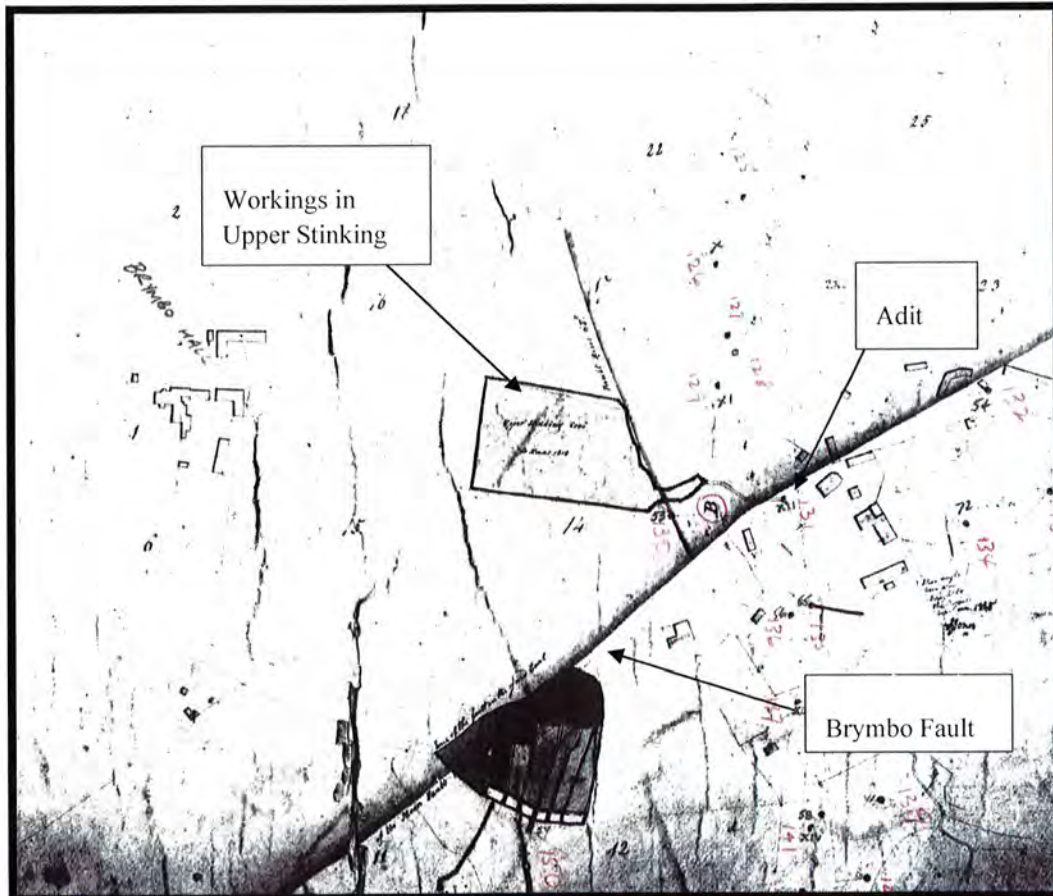
### Workings in Upper Stinking Seam from Adit on site

Separate mine plans under the same number show workings in the Drowsell, Yard and Upper Stinking coal seams. The workings in the Upper Stinking seam are shown below and dated 1818, they appear to have been pursued from the adit seen on site and crossed the Brymbo Fault close to the entrance, these are shown below and in Figure 3.

The workings on this side of the fault are considered to be sufficiently deep as not to carry a risk to the development, with the exception of the workings in the Upper Stinking seam, which were pursued from the adit (131) on site. This adit crossed the Brymbo Fault, before entering the workings, see Figure 3.

It is likely that the only voids which could influence the site would be the main roadways accessing the Upper Stinking seam. However, the adit is open to tours by the Heritage Trust and the condition of the adit beneath the site can be inspected regularly.

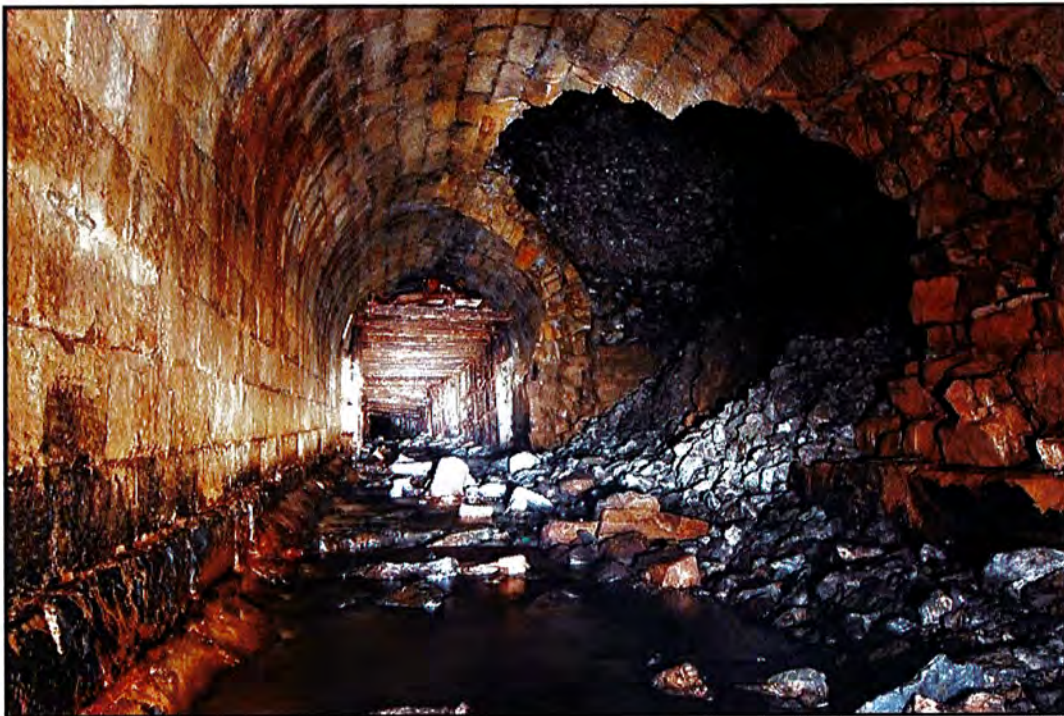
An example of a well-constructed roadway, typical of ironstone workings, but which has collapsed is presented below.

**Well-constructed roadway with collapse**

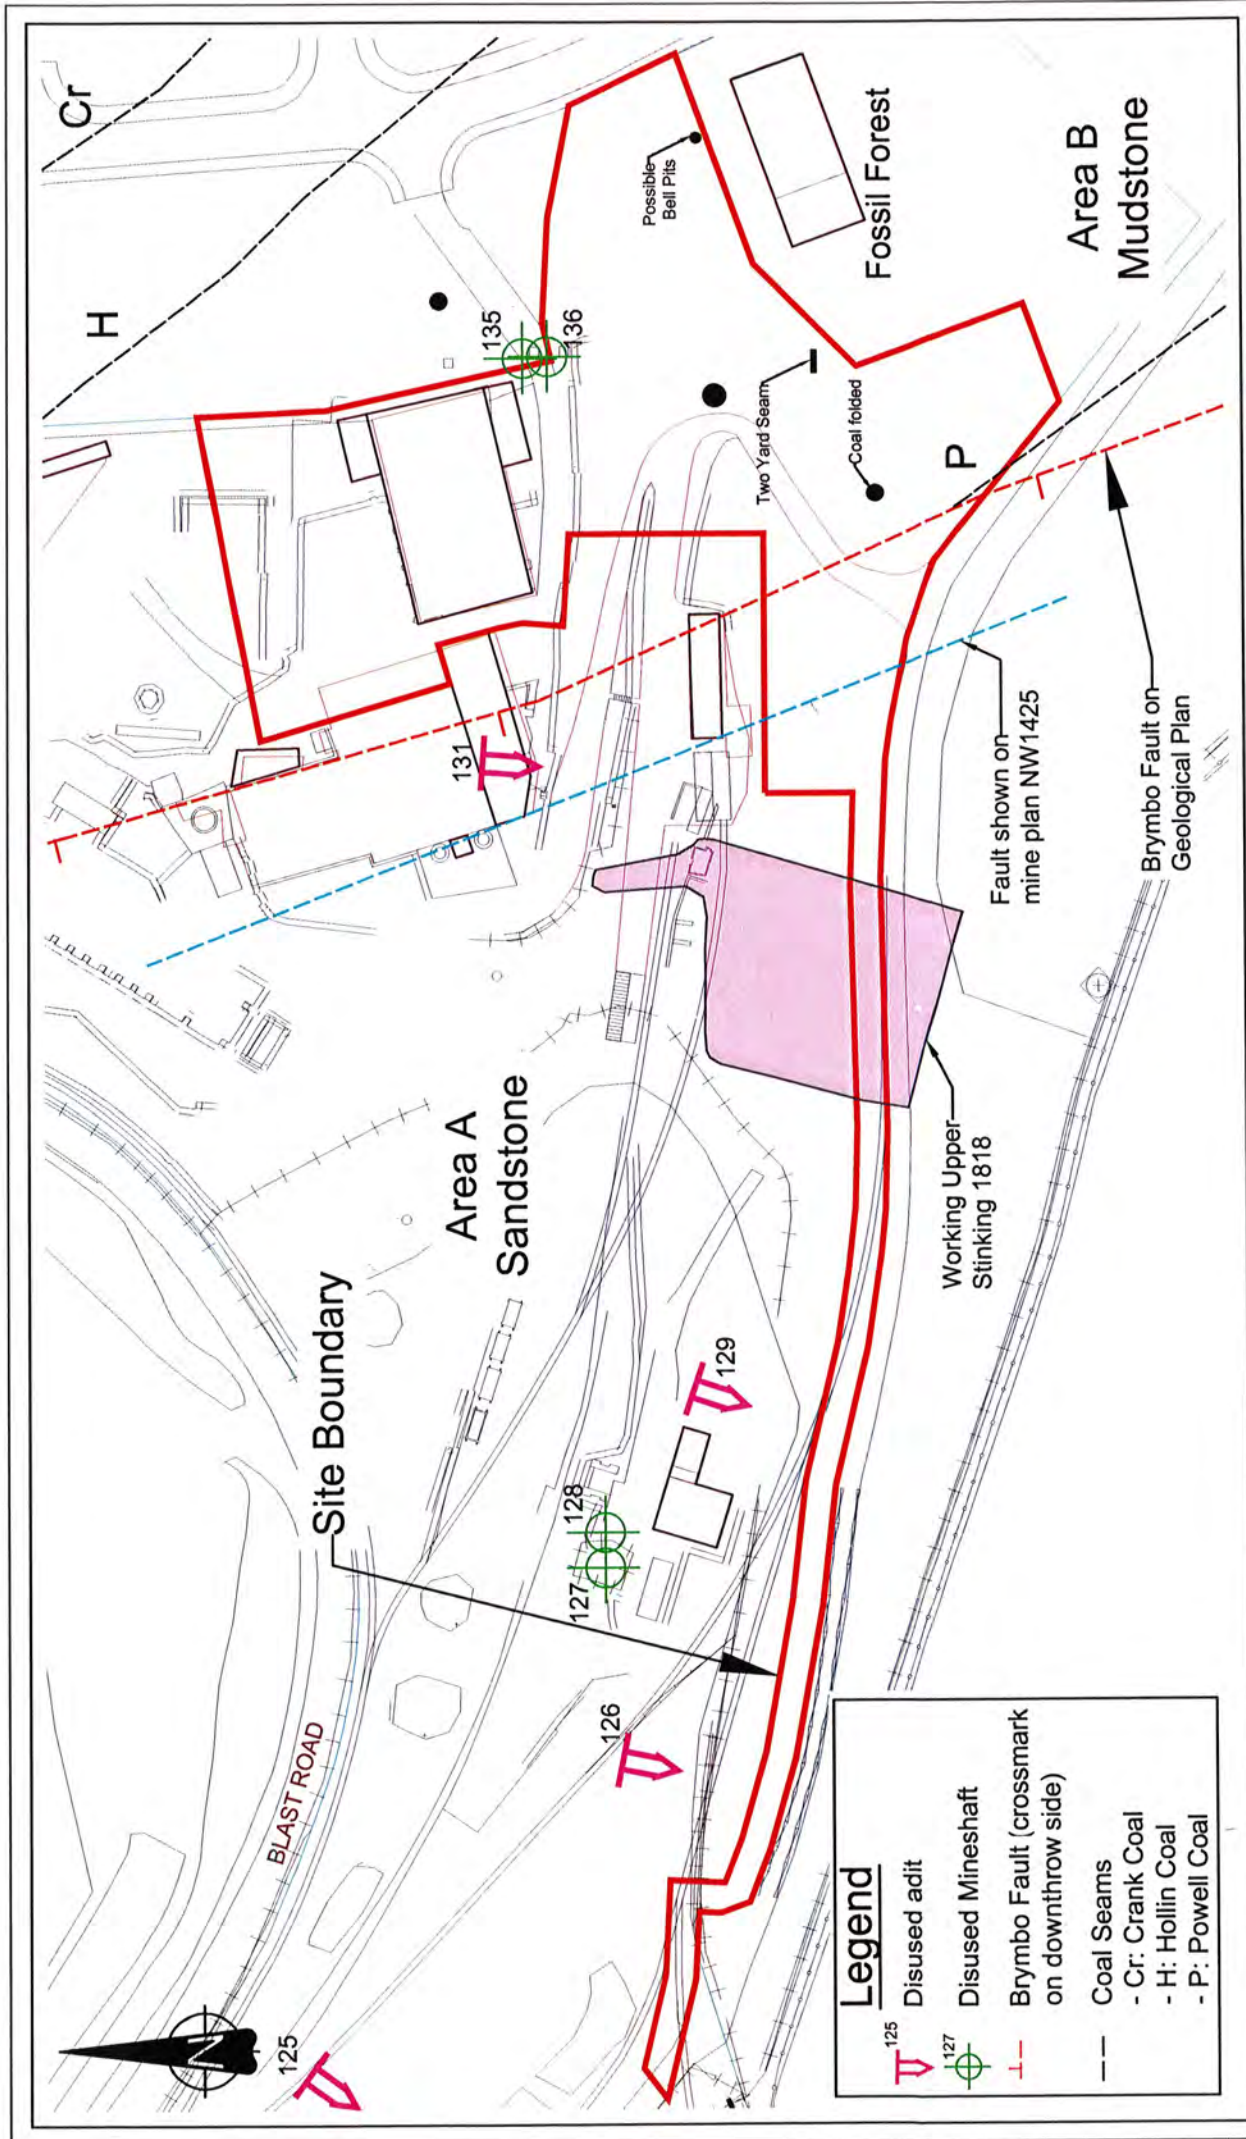
FIGURE 3

In addition, previous open casting immediately south of the site exposed a coal seam, thought to be the Two-Yard seam, which was dipping gently in an easterly direction. However, immediately west of this outcrop, further coal was exposed dipping steeply to the west, probably indicating it was in the vicinity of the main Brymbo Fault, see Figure 3.

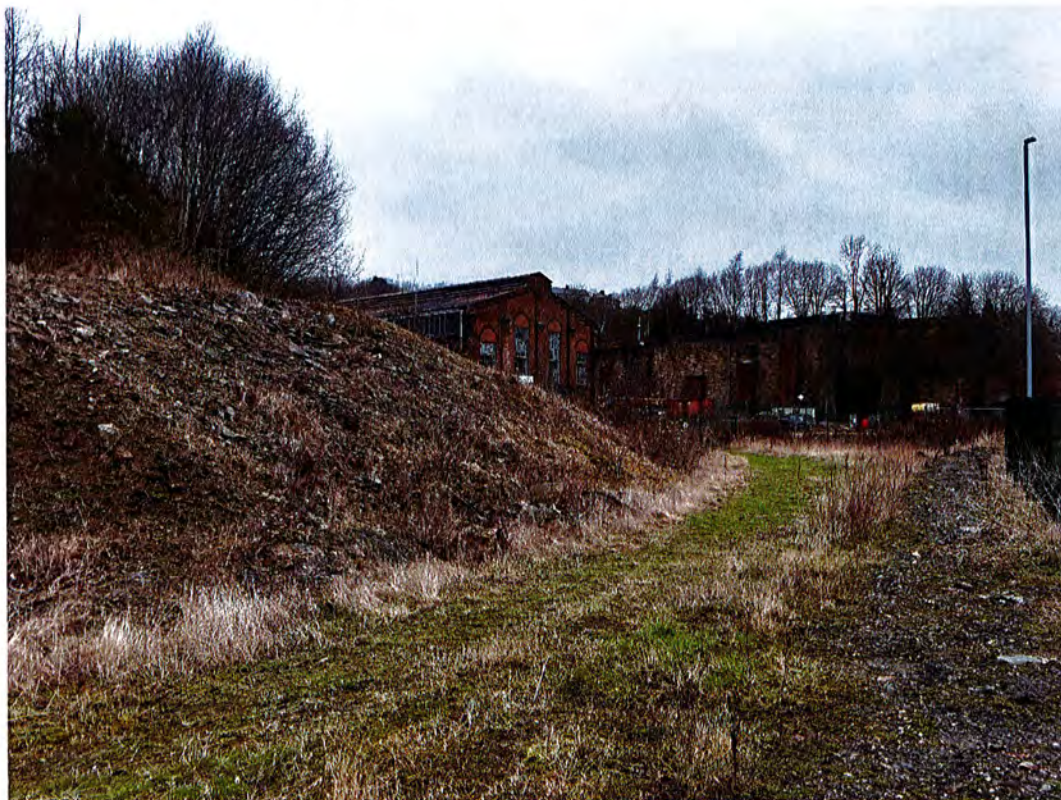
Photograph 22 Showing relationship with site
