# Heritage Impact Statement

Cintra, 39 Salop Road, Overton. LL13 0EH

## Repair & Restore

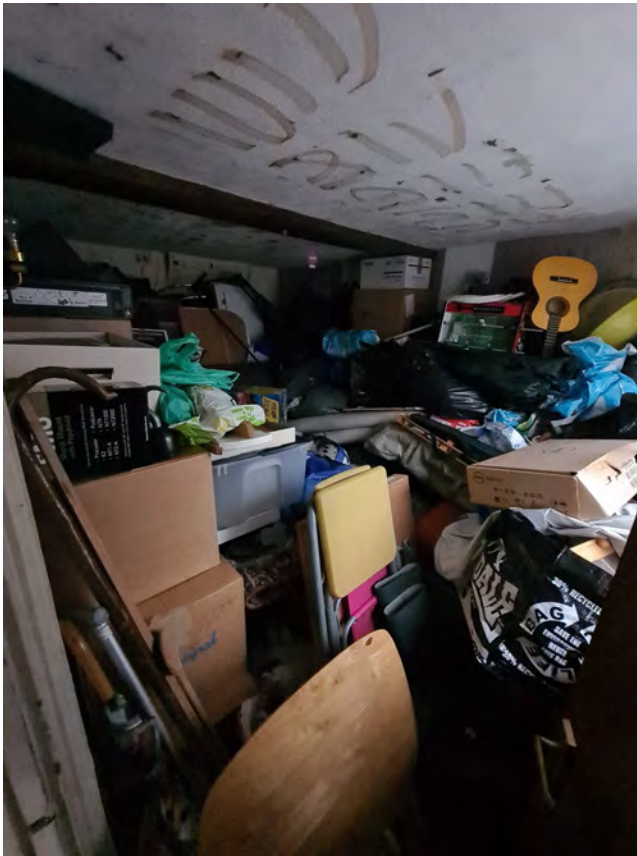
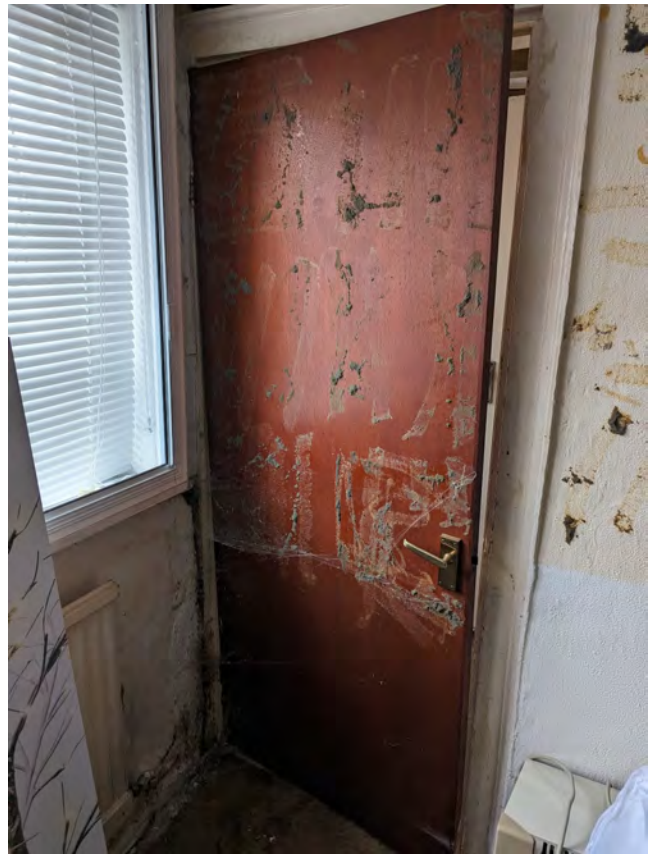
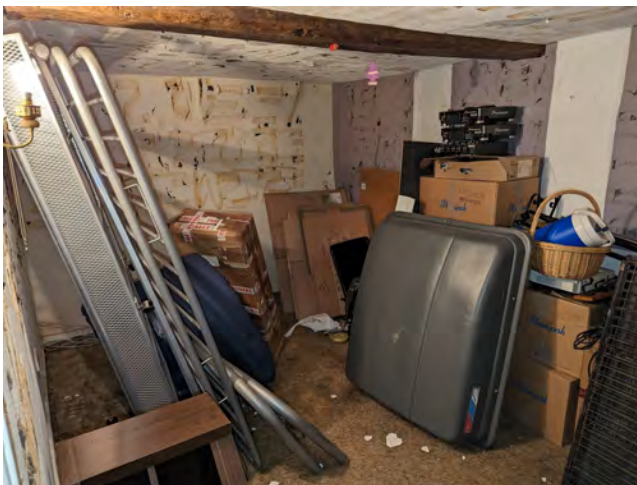
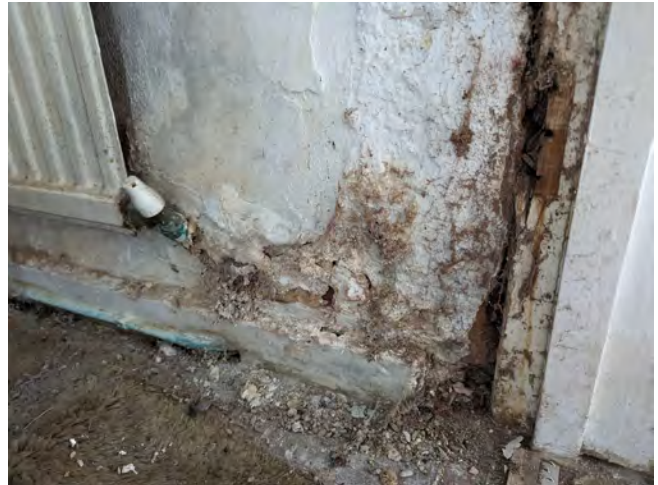
## OFFICE -

The walls were damp and soft, you could push your fingers into them with no force. The plasterboard on the ceiling had a large swell to the right of the room which unfortunately you can't see in this photo.

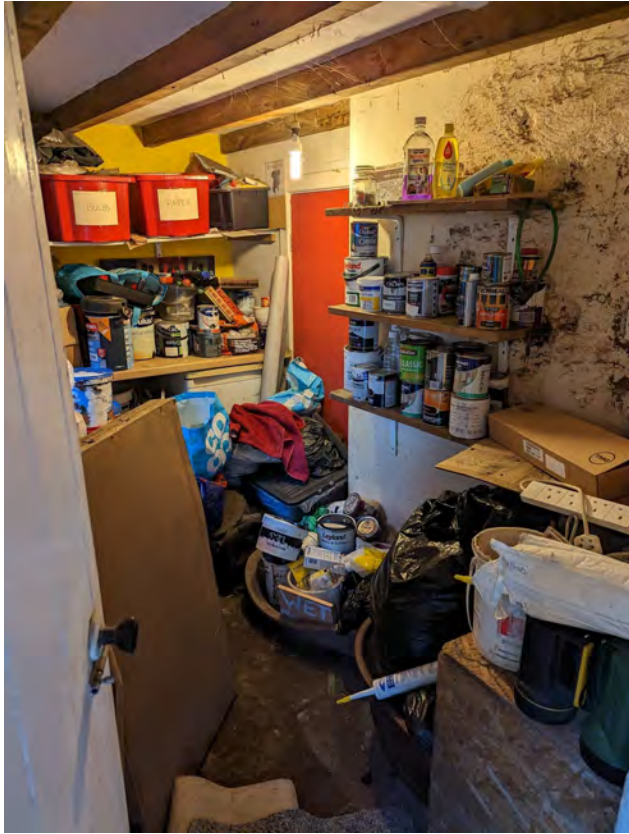
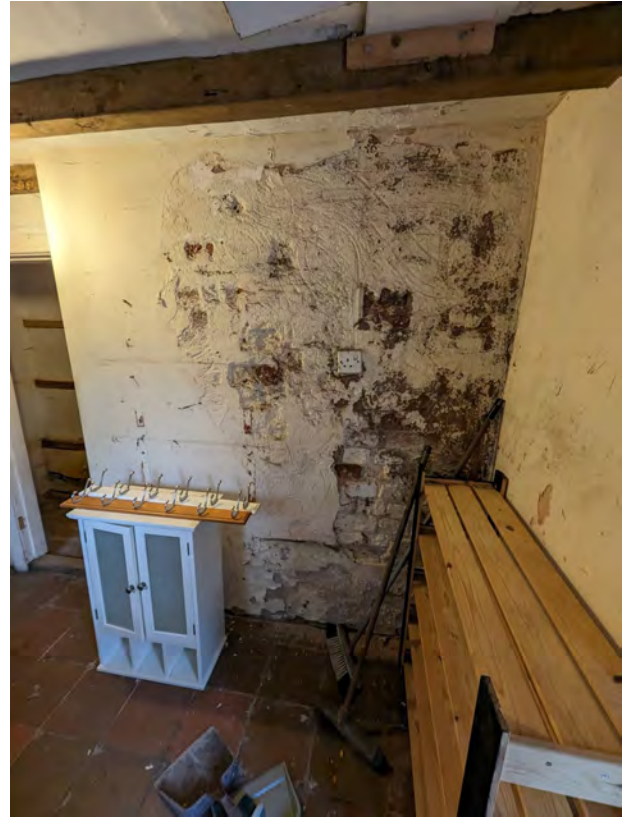
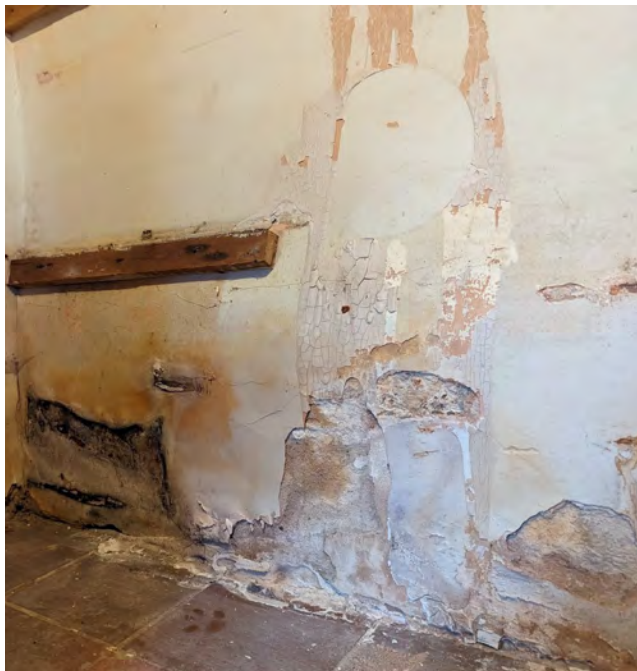
## UTILITY ROOM -

The photo to the left shows the wall inside the built-in cupboard. This wall was so wet you could pull lumps out of it. It had been filled with stuff and kept closed for who knows how many years and the smell was awful.

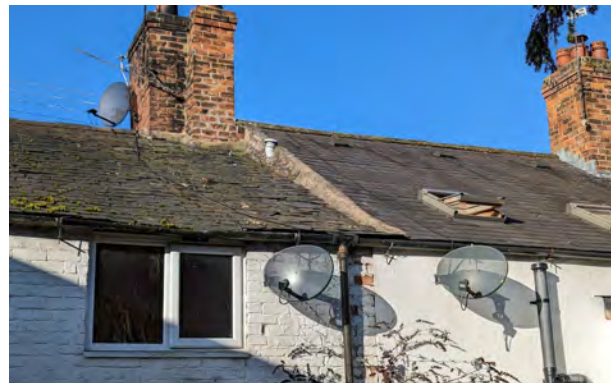
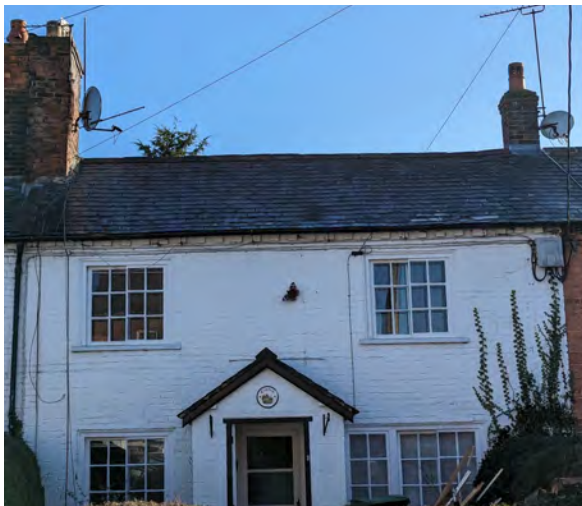
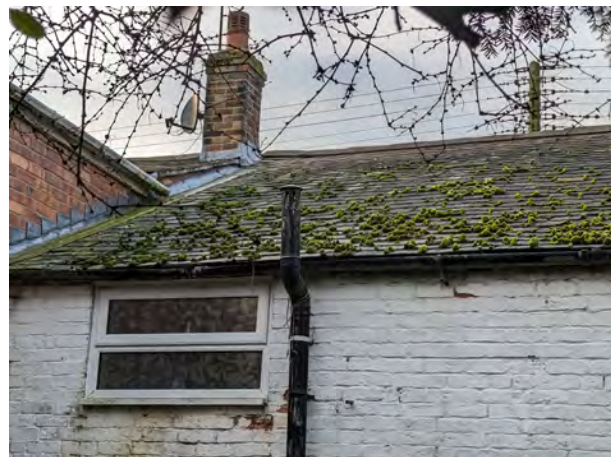
The roof was one of the most important areas to tackle in the beginning because until we had it watertight we were unable to dry out the inside and at this point it was the height of winter so it was imperative that we stop further damage from happening. The front and the back roofs both leaked but the back was by far in the worst condition. It was deformed, had broken slates throughout and it's own little forest growing within.

- Scaffolding was erected
- Tiles were removed saving any that could be reused.
- Roof was stripped of rotten battens front & back
- The rotten rafter in the back bedroom was replaced with new air dried oak.
- The rotten oak wall plate in the bathroom was replaced with a new air dried oak wall plate.
- New tandalised roofing battens were fitted
- Breathable felt was fitted to the roof battens
- The roof was re-tiled using the slates that were saved and the rest were reclaimed welsh slate which matched the original slates

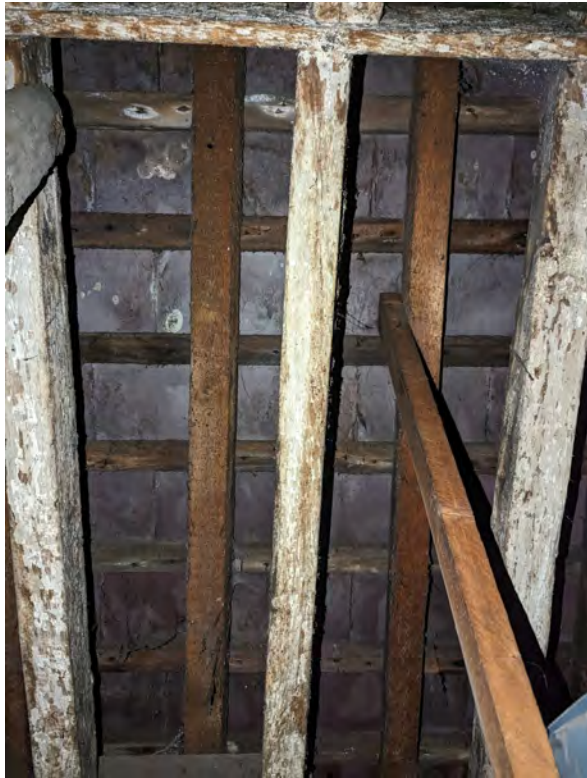
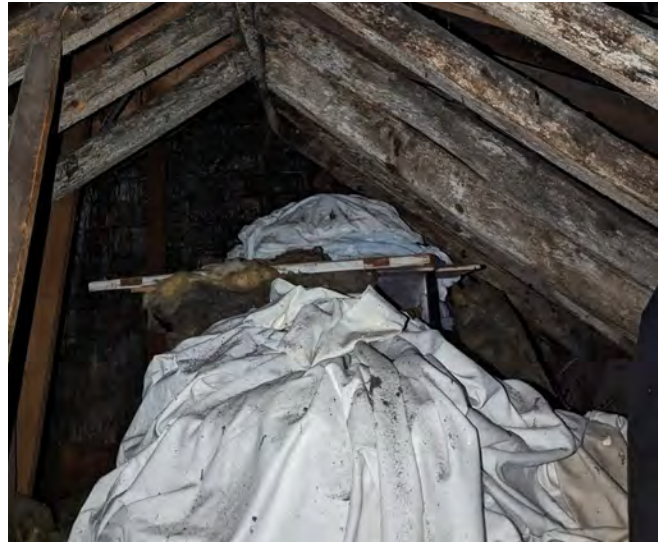
Several roofing contractors surveyed the job and all of them gave the same report that there was possibly 60% salvageable tiles on the front and virtually nothing from the back. On inspection inside the attic of the front of the roof it showed soaking wet timbers, rotten roof battens and dripping wet chimney breast.

It's quite hard to see the full extent in these images but the far wall is the chimney breast and it was so wet and black and slimy like it had been under a waterfall for years.

In the photo above you can see the old white rafters that are the pitch of the first roof of the original 1800s building and the dark brown wet timbers from the current pitched roof.

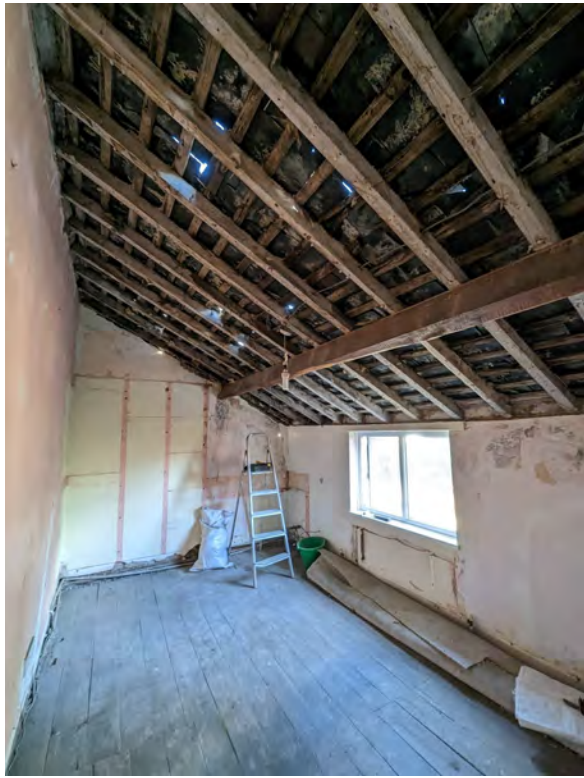
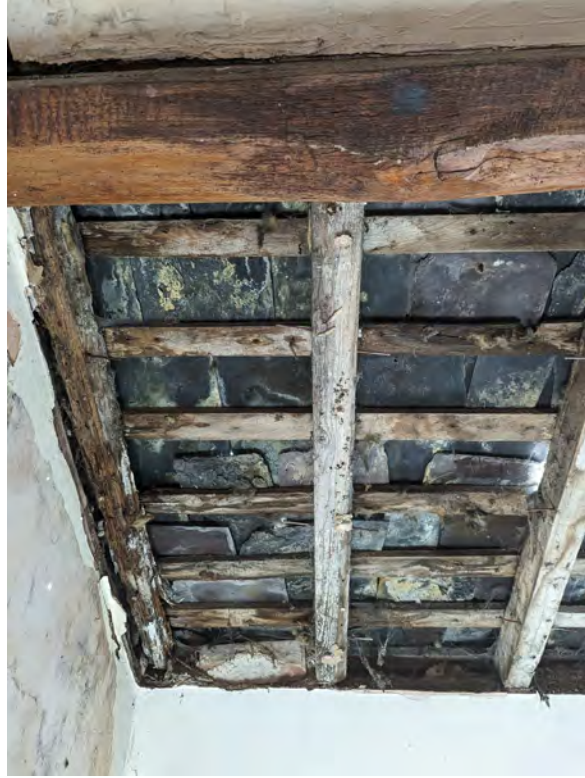
The vaulted ceiling in the back bedroom (photo to the right) and bathroom had visible holes through the plasterboard ceiling where water ran/dripped through every time it rained. The full extent of leaking areas was revealed when the ceiling was removed and revealed more holes than I could count.

All of the roof battens were visibly sodden and rotten along with one of the roof rafters to the far left of the room (shown in the image above) which was crumbling away.

It was a similar story in the bathroom, all of the battens were rotten as well as the oak beam wall plate which was so soft it came away in your fingers and was offering no support to the roof.

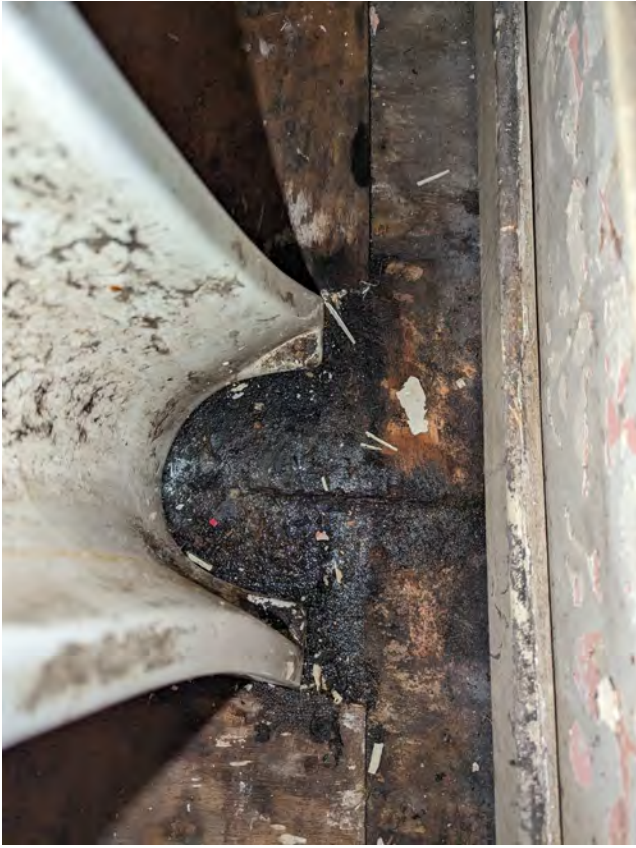
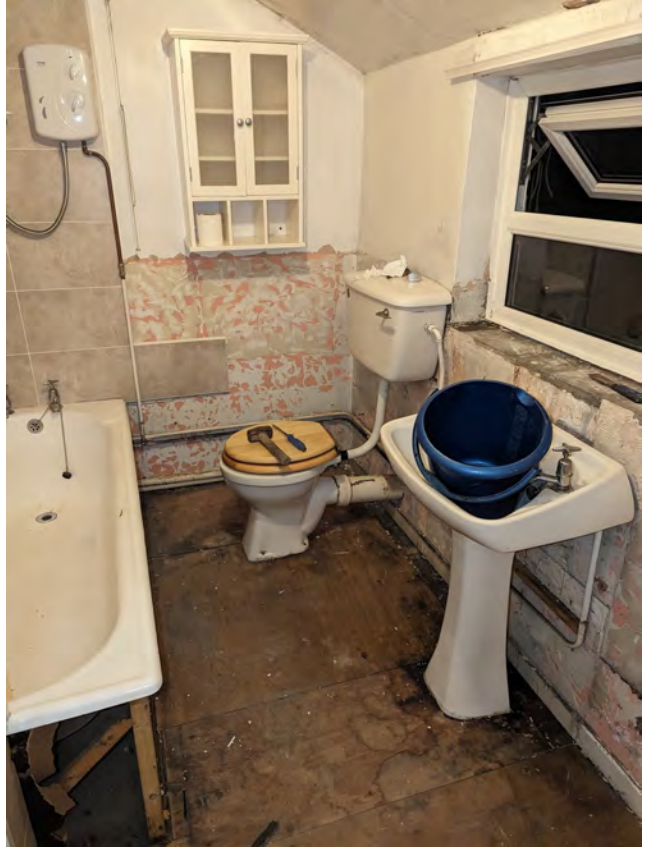
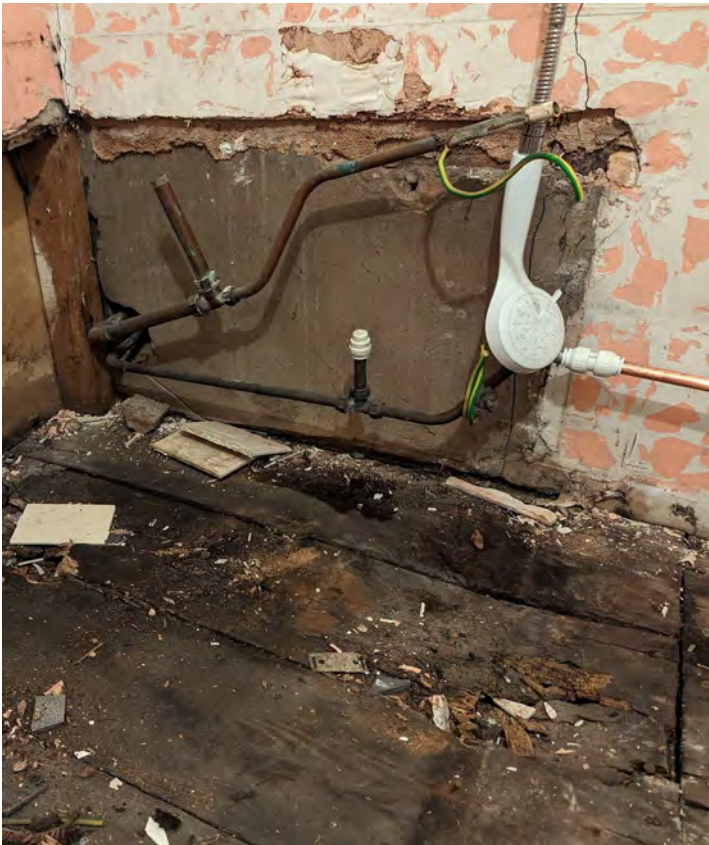
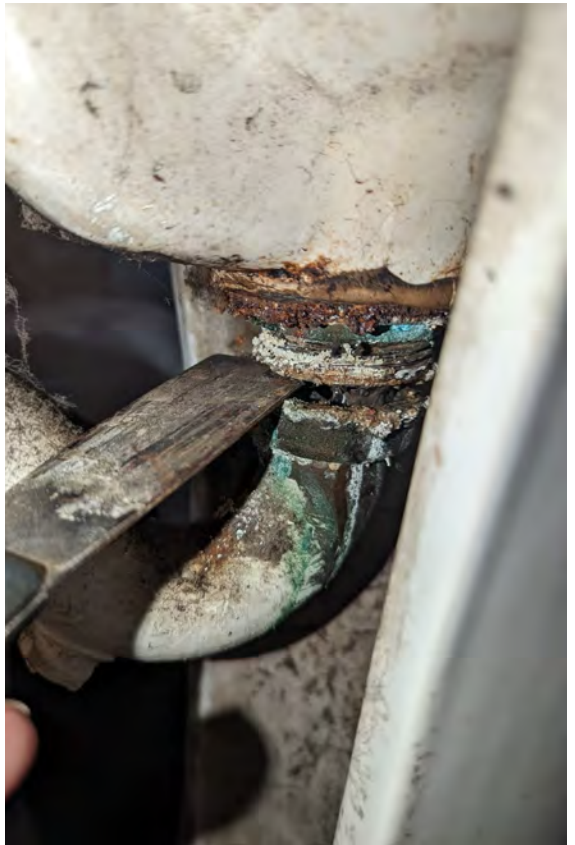
Once the carpet was lifted the extent of the water damage was clear and all the leaking pipes were located. The damaged areas had been subjected to water for a long time causing areas of floorboards to turn completely black, soft and slimy to the touch, and the worst area was under the bath, when pressed my arm almost went through it.

Once all the wall tiles were removed, any damp area on the walls were cleaned with bleach and left to dry out. There was no lime plaster present, only gypsum plaster which was firmly adhered to the walls and plasterboard stud wall around the door and bath.

| ROOM | PROBLEM AREAS | POSSIBLE CAUSES | REMEDY |
|---|---|---|---|
| | <ul style="list-style-type: none"> <li>- Floor, wet, soft cracking and crumbling (Mixed Wood Floorboards)</li> </ul> | <ul style="list-style-type: none"> <li>- Leaking sink</li> <li>- Leaking toilet</li> <li>- Leaking bath</li> <li>- Leaking pipework</li> </ul> | <ul style="list-style-type: none"> <li>- Replace all defective items/pipework then allow the wooden floor to dry out completely. Once dry assess the safety of the water damaged boards and replace any that are no longer weight bearing.</li> </ul> |

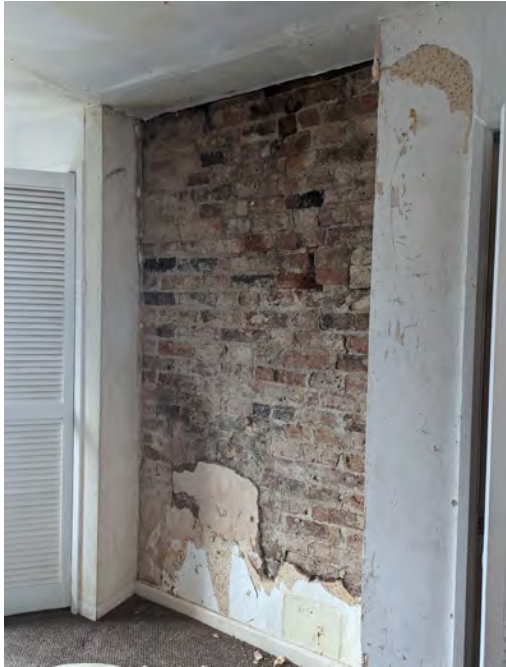
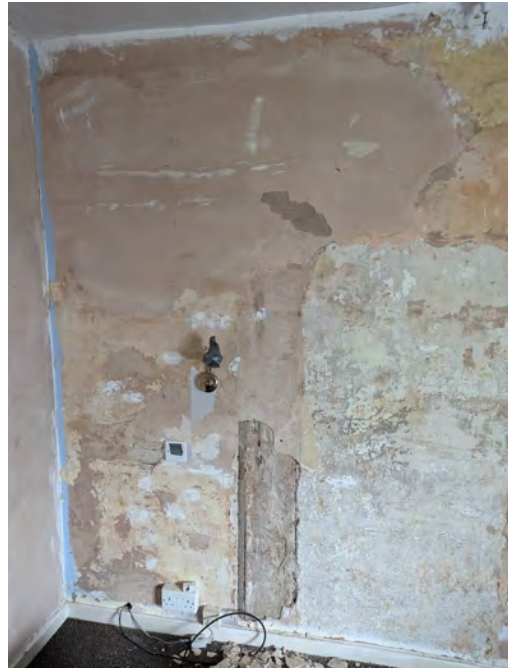
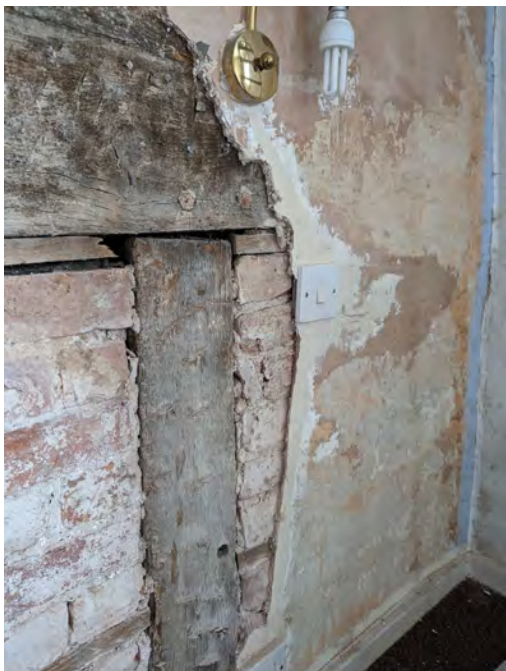
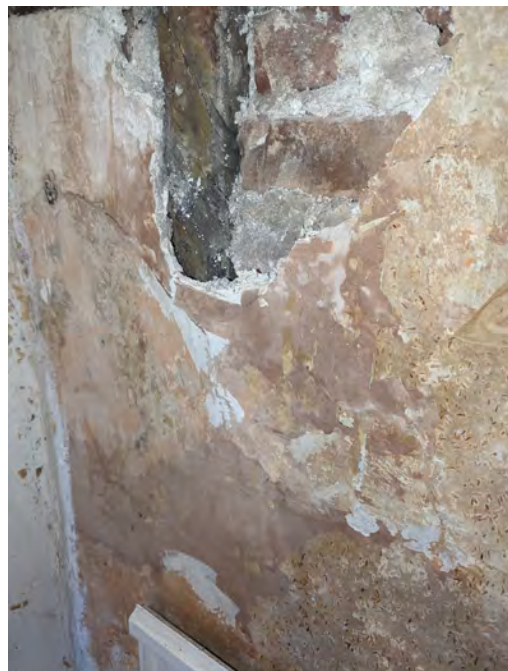
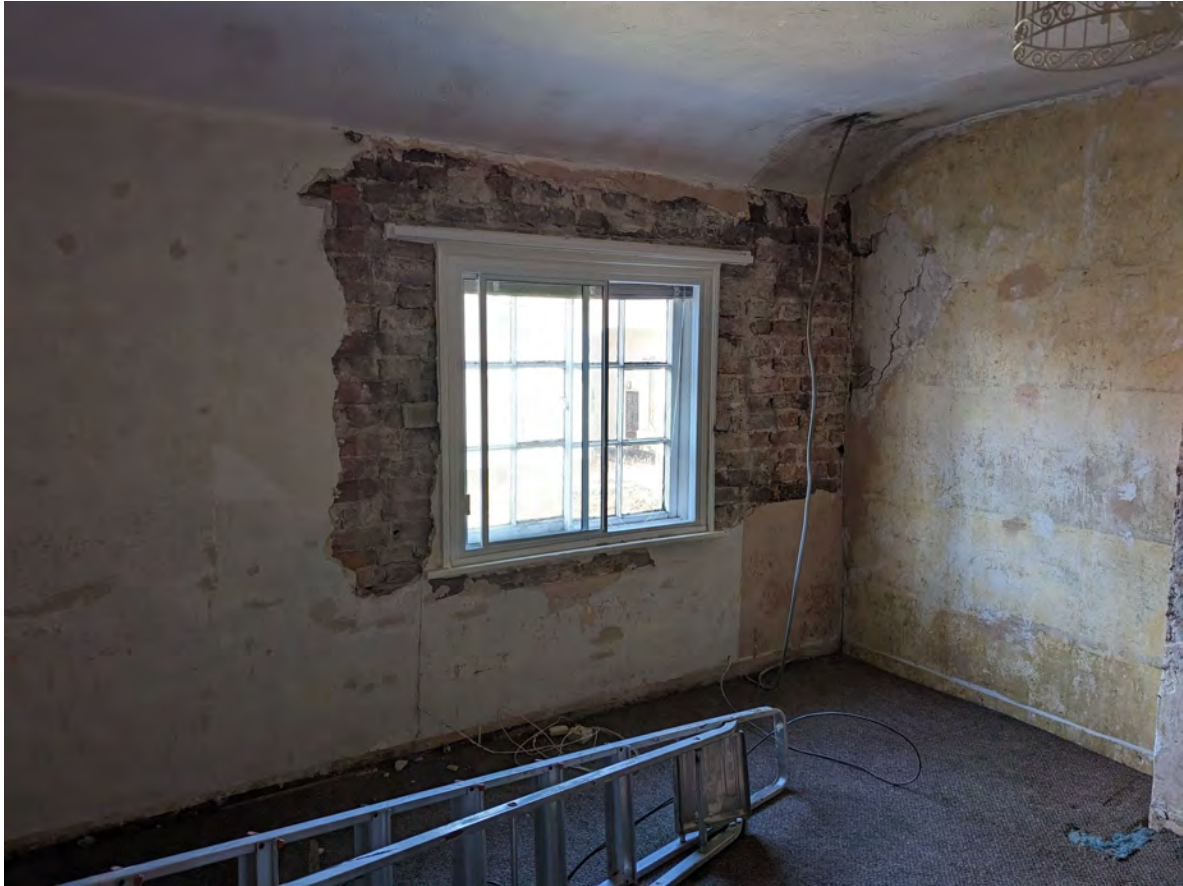
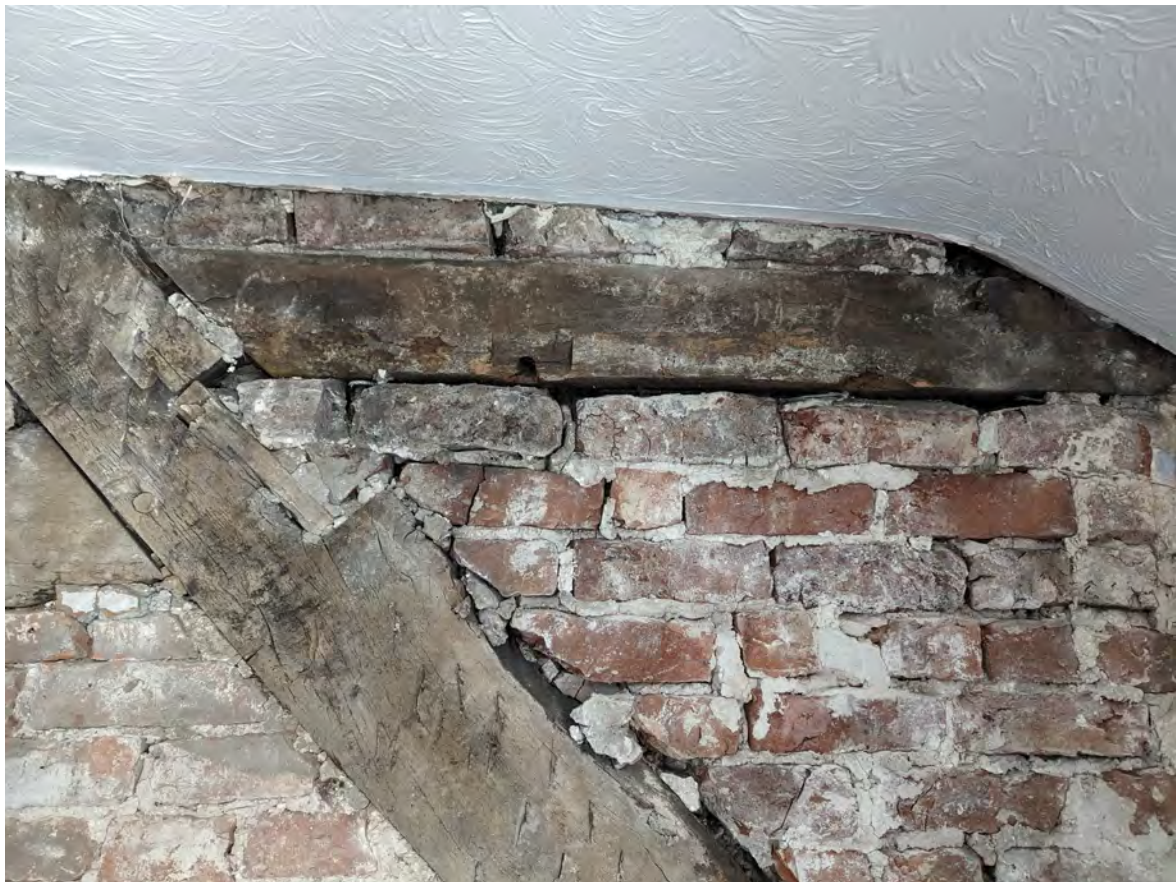
It's quite difficult to see in the photos but the lime plaster was no longer attached to the brickwork on almost all of the walls in the front 2 bedrooms and some of the hallway,, a lot of it had gypsum and cement layers on top of the lime which I'm assuming would have removed its breathability and possibly caused the lime plaster to sweat because there was nowhere for the dampness to release.

- Carefully remove damaged plaster by hand using a scraper as leverage, make sure no further damage is caused to surrounding materials.

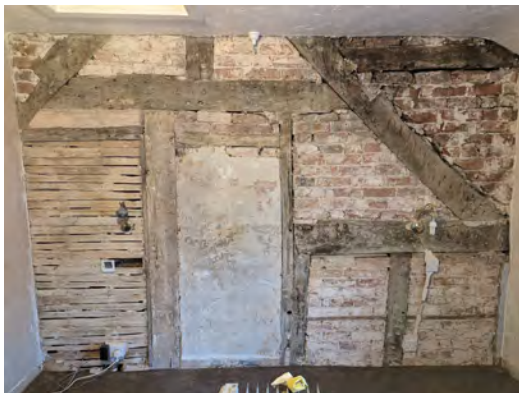
**Front main bedroom**

LEFT: The bricks and the wood in the top right corner of the wall and the wood that lead to it was all very damp, wood rot and wood worm.

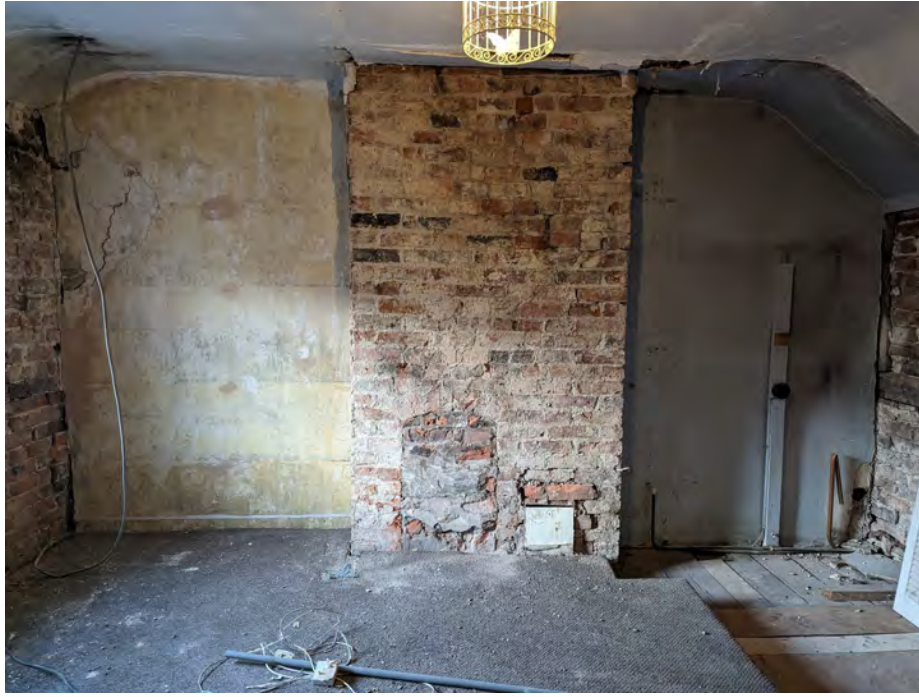
LEFT: The chimney breast was one of the worst areas on this wall, it was so wet that the lime plaster was just falling away from it.

RIGHT: This wall which is now an internal wall would have been the original back of the house. You can see the roof slopes down to meet it and from inside the attic you see where the original roof comes down to meet this wall. At first this was a mystery as to why it was so wet, it was general only the external walls upstairs that had the damp issues. As you can see in the photo, the top half of the wall was very damp, there were also areas of white and dark spores. It was because water had been leaking down from the roof/attic timbers and into this wall.

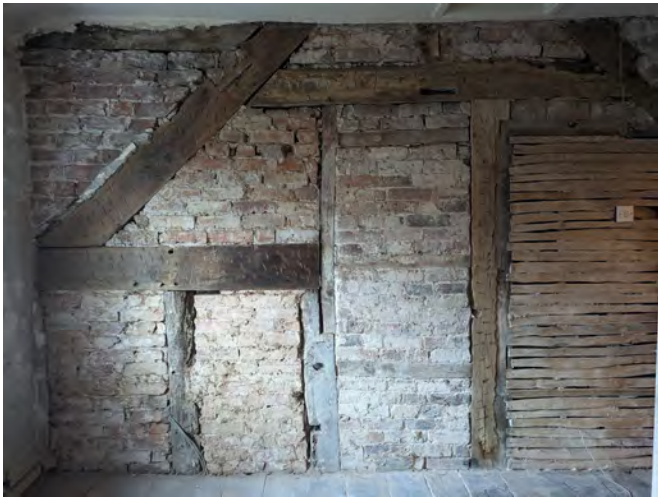
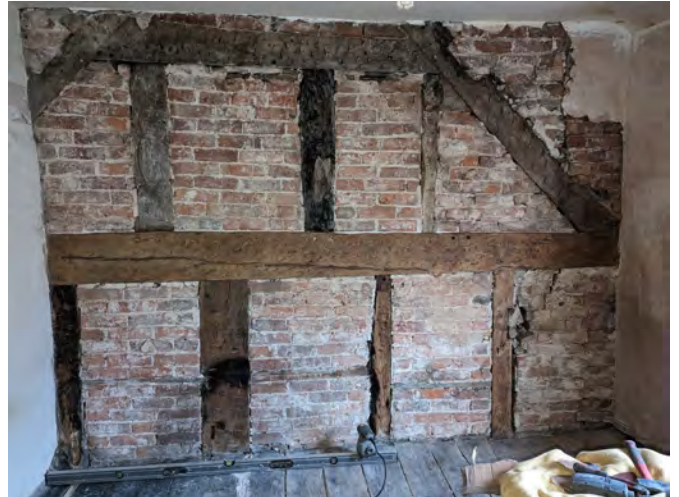
## Front Small Bedroom

Same issues as main front bedroom

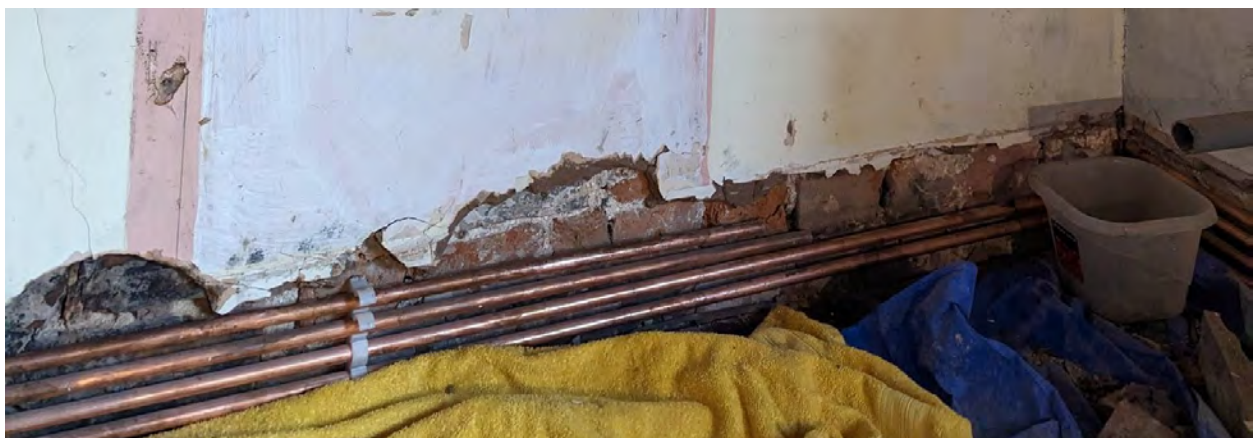
## Back Bedroom

The back of the house was the extension, the date of this unknown but the materials different to the front of the house. The back bedroom, bathroom, kitchen and utility room didn't have the same issues as the front of the house, the plaster wasn't falling off the walls, there was no lime plaster evident, only gypsum on brick and plasterboard in areas.

The dampness on these walls, caused by condensation, but predominantly coming from the badly leaking roof which I evidenced earlier in this document.

Despite all the damp, the plaster itself was all firmly adhered to the walls, there was no need for removal. The walls were cleaned down with bleach and left to dry out.

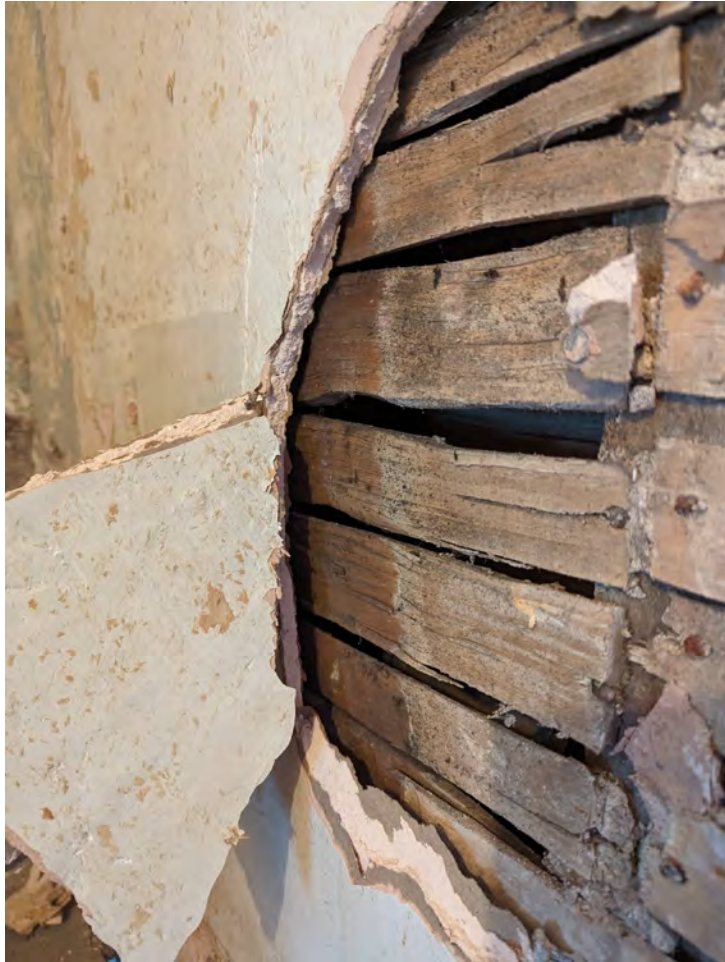
## Upstairs Hallway

This was the situation with the wall in the hallway which backed onto the small front bedroom. The lime plaster had been skimmed over with gypsum and in some areas plasterboard was attached on top. There was no attachment of the original lime to the wooden laths beneath anymore and the lime plaster was billowing from the wall and splitting in areas.

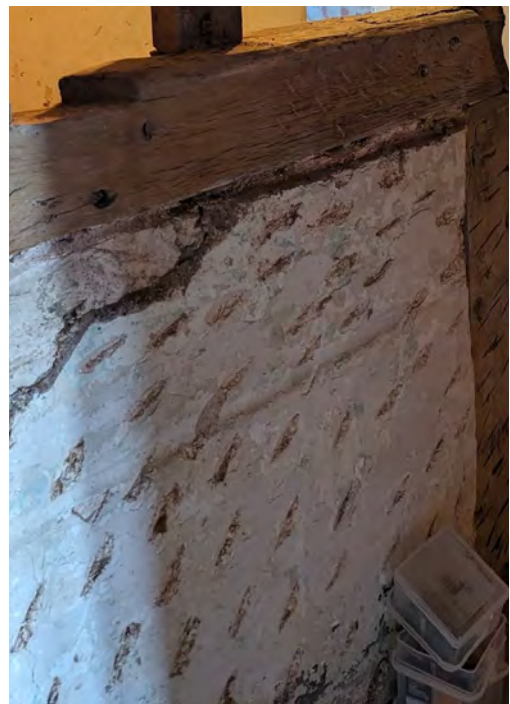
RIGHT - Here is the other side of the hallway which backs onto the staircase. The top layer of plaster was coming away but the base/scratch coat seemed fairly attached to the bricks underneath and we planned to keep any areas like this and when the lime plastering was done they would be floated and skimmed preserving the original underneath.

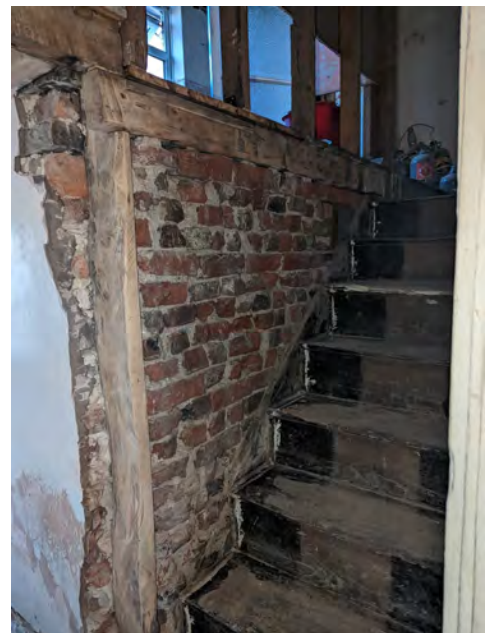
LEFT - This is the opposite side of the staircase, the wall was extremely wet and you can see the dampness in the wood. Which had no reason to be so wet, there was no leaky water pipes above it, the wall was drier the higher up you went so it had to be coming from below or from something that was attached to it.

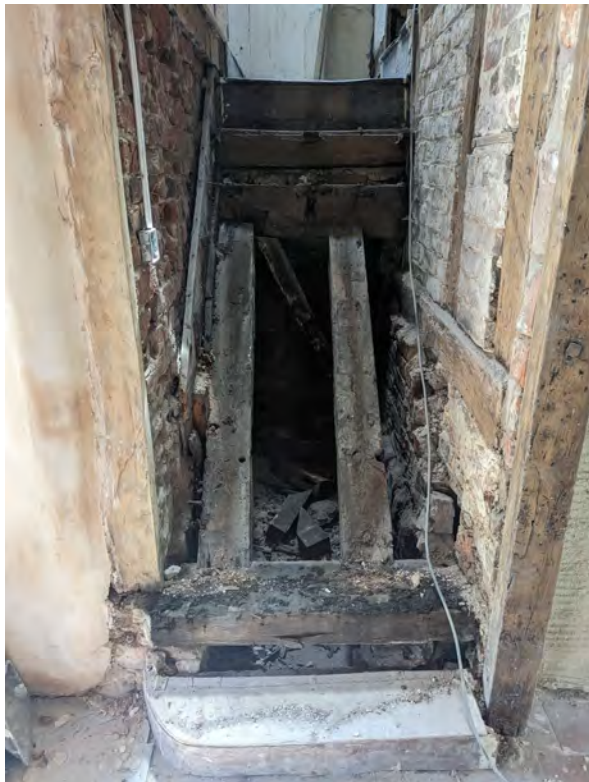
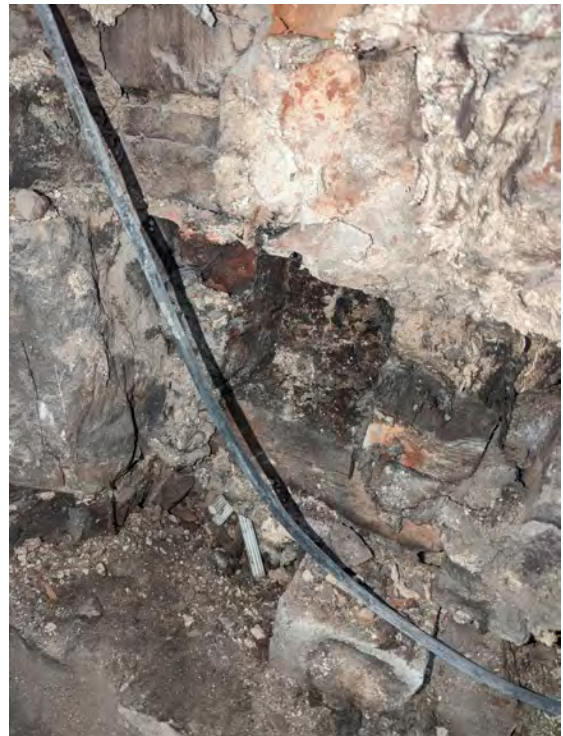
It was soaking wet under there, perhaps difficult to see the extent in these photos because the removal kicked up a lot of dust but it was so wet. The floor, the brickwork and all the wood you could break bits away in your hands and there was a lot of fungus.

After a couple of months drying out, the broken areas of wall were repaired using loose bricks that were found under the staircase

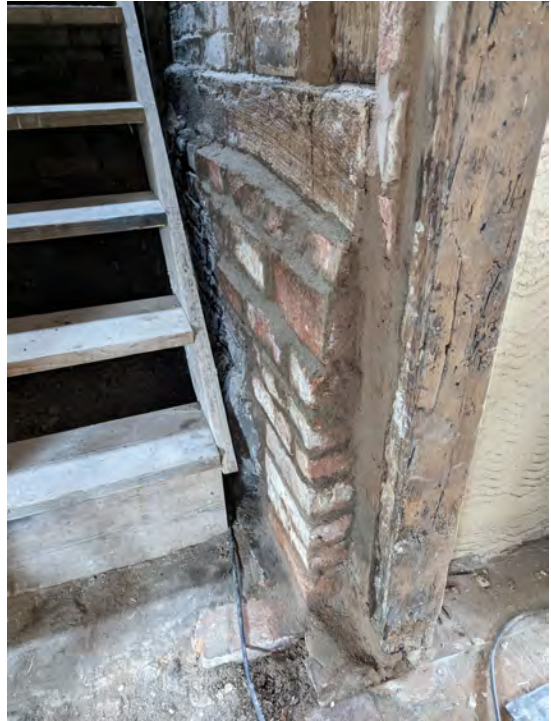
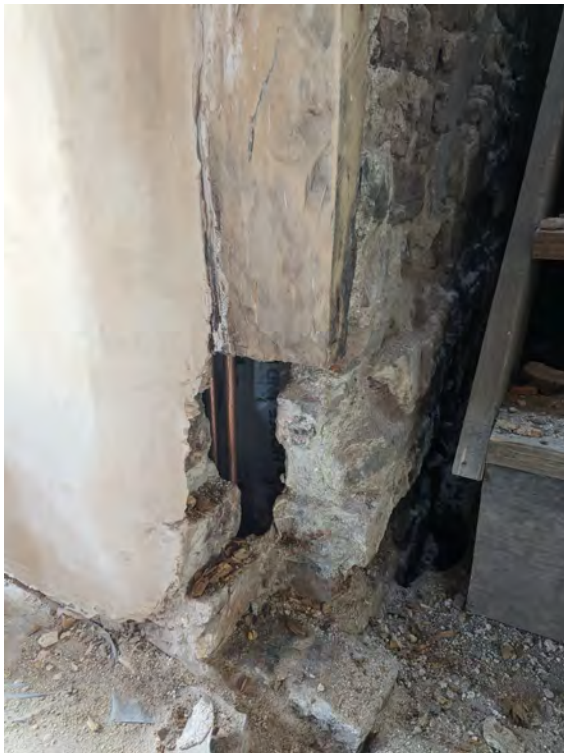
ABOVE - A before and after of the repaired brickwork during the drying out process, the lime mortar lightens in colour as it dries.

RIGHT - Brickwork freshly repaired.

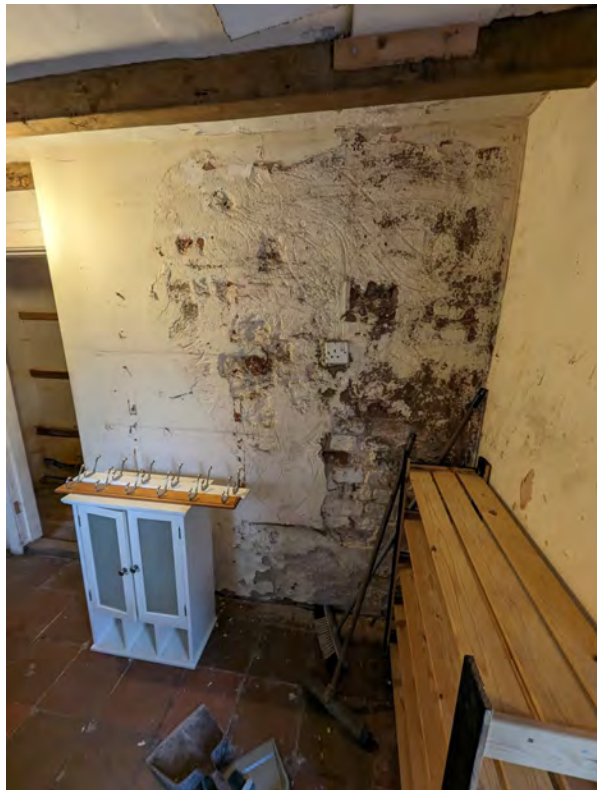
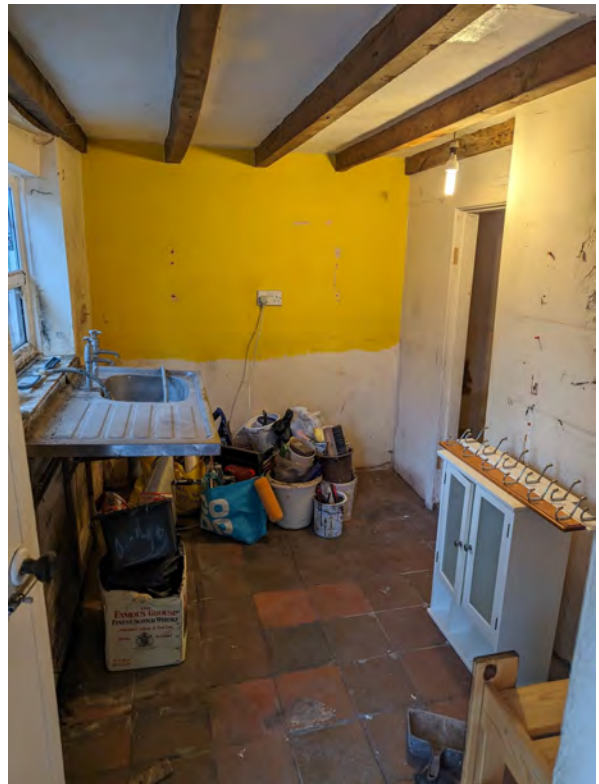
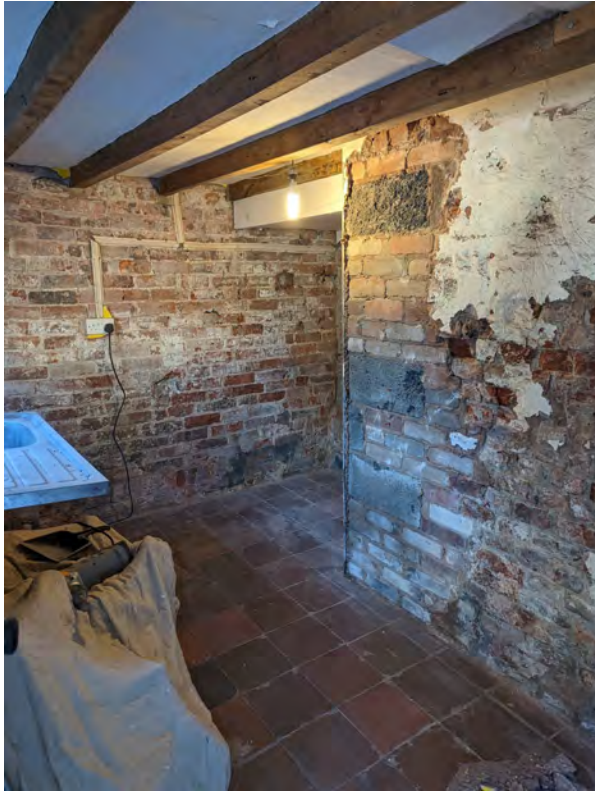
## UTILITY ROOM

This room was a major concern, every wall was wet, almost from top to bottom. The walls were black with mould, which isn't visible in these photos because these were taken after I'd bleached all the walls down. At that stage I was hoping that the plaster wouldn't need to be removed but we soon realised that they were beyond touching up so the gypsum render was removed and the corner cupboard removed to help that corner dry out. I couldn't understand why it was so wet in there, poor ventilation wouldn't have helped but after the discover of what was under the staircase we realised it was a continuation of the spread of water damage coming from the bathroom and down the staircase for a long period of time that had caused such a build up of moisture.

All of the render was removed and the walls began to dry out after the staircase was also removed. All apart from the external wall, which remained unchanged -

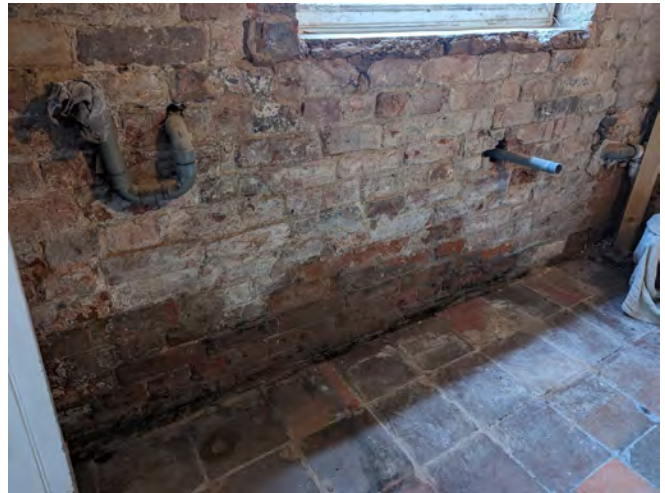
Once the concrete was removed and the ground level lowered outside, it began to dry out a little but not a lot.

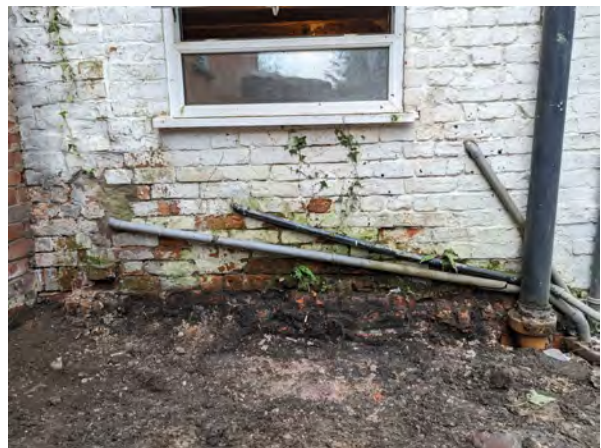
ABOVE - This was after the concrete was removed, it revealed that there was some strange brickwork, bricks were sticking out of the wall and they were in the exact same shape as the damp patch inside.

We left it to dry out for about a month using heat and dehumidifiers but there was little change and every time it rained the damp patch was back to square one so I knew the next stage was to do something about the protruding brickwork outside which was obviously drawing water in.

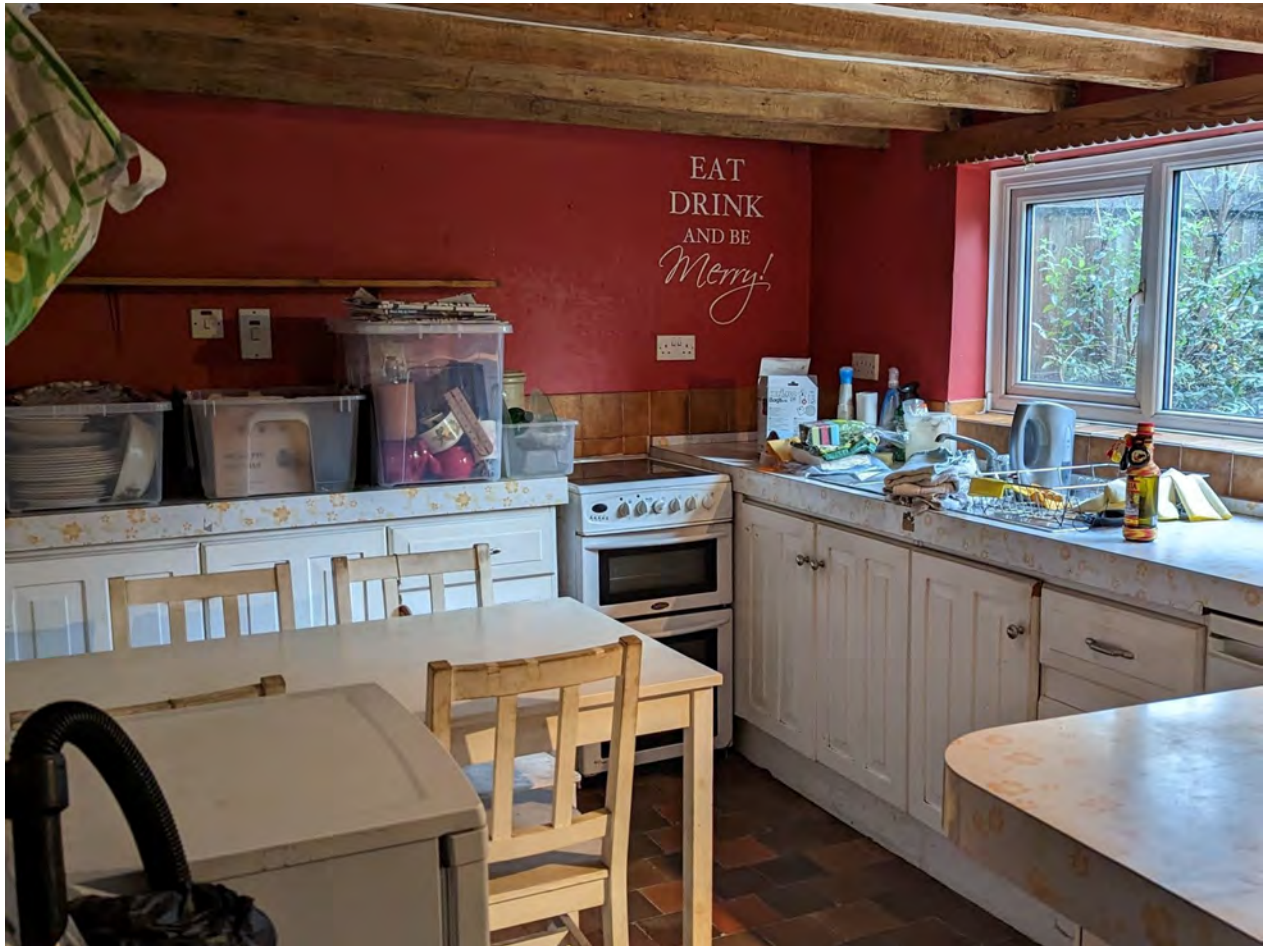
## KITCHEN

This is the only photo of the kitchen I have from the beginning, but like the utility room, I'd forgotten to take a photo before I cleaned all the mould from the walls, cupboards and floor, I was initially hoping to spruce up the kitchen units and keep them but that was before I realised how much damp there was behind them.

It was one of the least problematic rooms overall, but the kitchen units were extremely outdated, fitted in the late 1970's by the previous owner and were now rotten with mould coming from the back of them. So they had to be removed, mould cleaned off them and then left to dry out before skimming over the walls to tidy them up and then fit new kitchen units in a similar layout to what was there before. Again, we weren't going for any dramatic changes, our sole intention was to tackle the damp, restore anything we could and end up with an energy efficient warm family home.
