# Heritage Impact Statement

Cintra, 39 Salop Road, Overton. LL13 0EH

## Repair & Restore

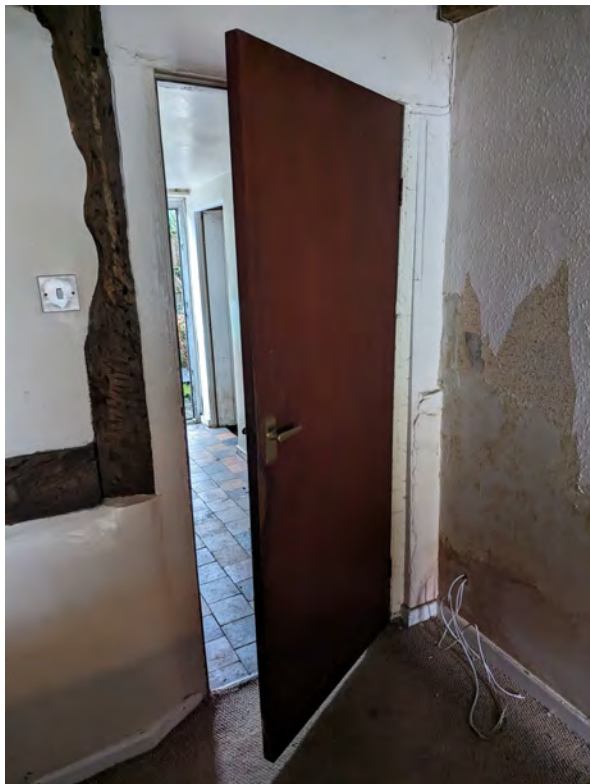
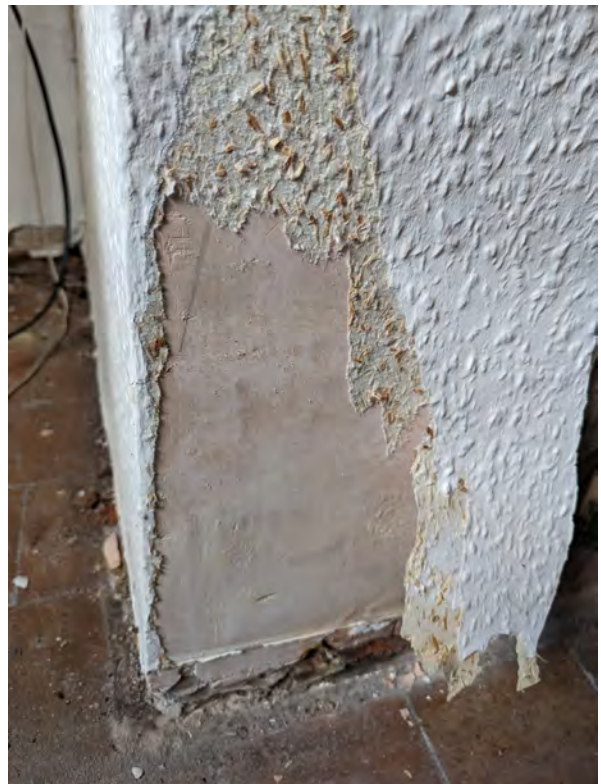
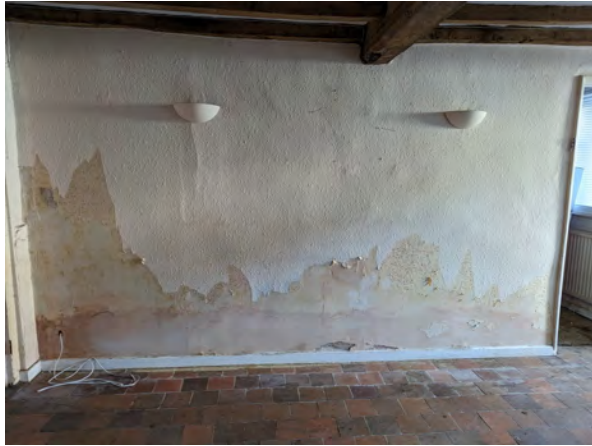
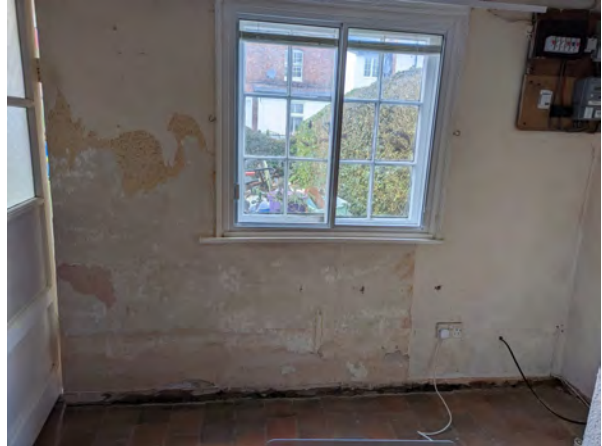
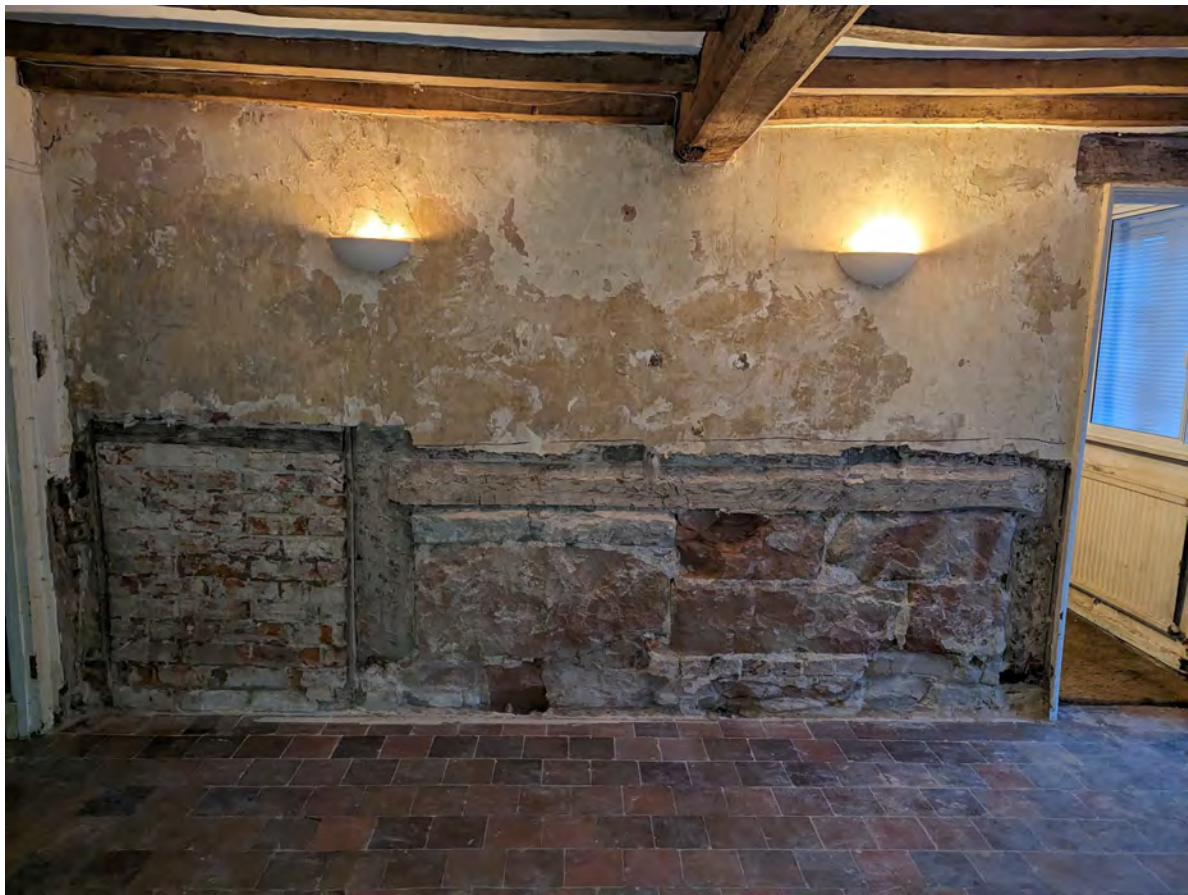
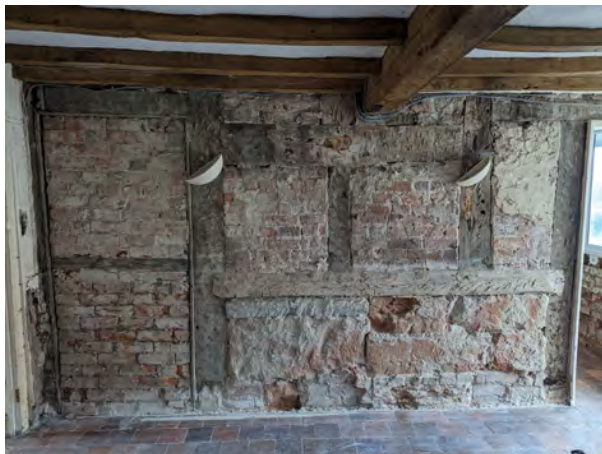
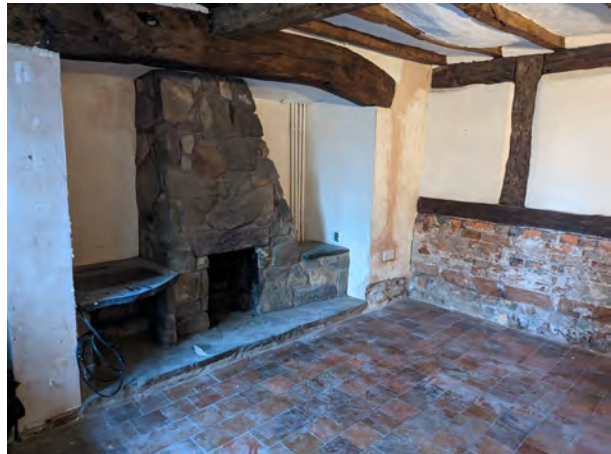
This was a very damp room, the smell was putrid, we thought this was just coming from the carpet and soft furnishings but even with those removed it didn't improve.

Woodchip and plaster was bubbling and crumbling.

The loose and crumbling plasters were all removed along with areas of modern plasters that had been used by previous owners during re-wiring and repairs. We also removed the hollow late 1970's doors and doorframes which were all rotting away at the bottoms to create a more open-plan layout, following the same design as Kew Cottage next door.

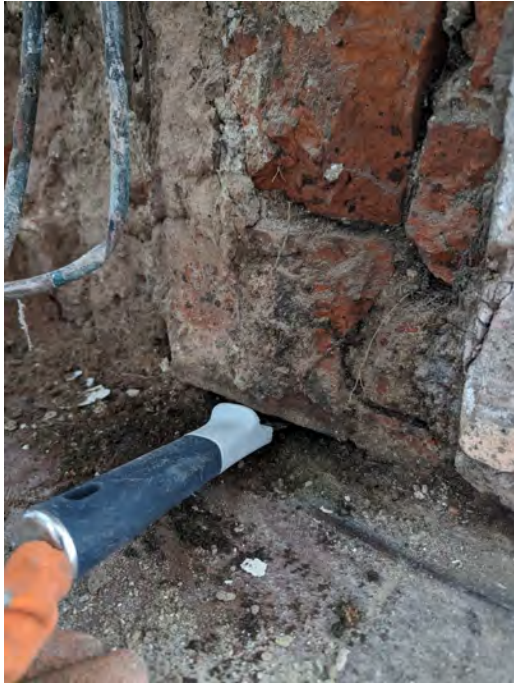
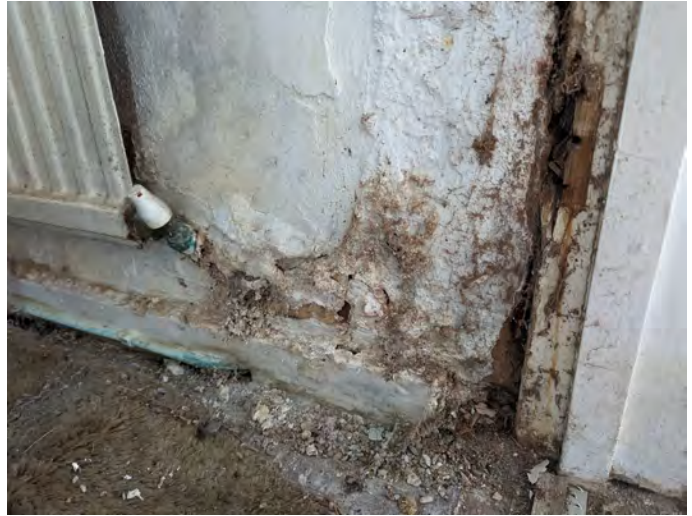
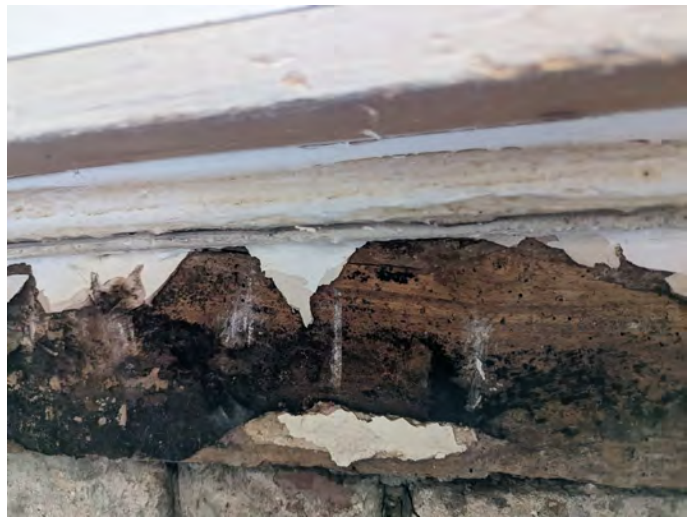
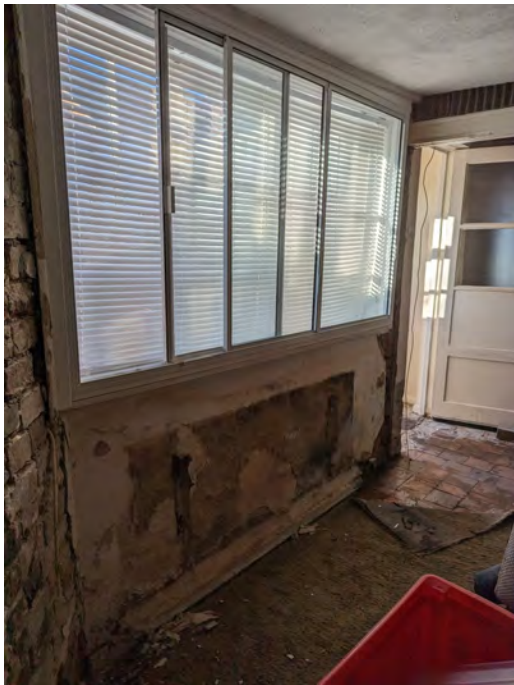
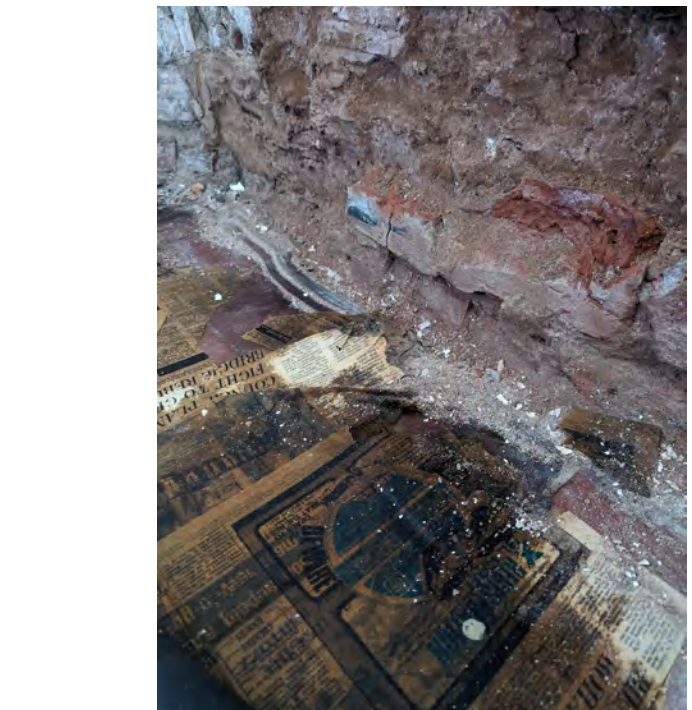
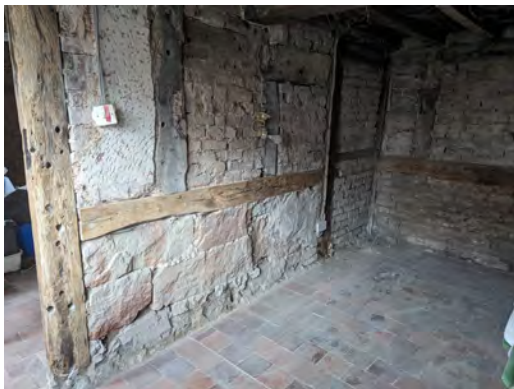
The office was in real bad shape, the previous owner had used it for practising on his drums and had installed a stud wall as soundproofing so this had to all be removed as well as the sagging plasterboard ceiling which had 2 layers of plasterboard as well as a skim and then the stipple paint and it just fell away when we pressed it.

In the photo above of the office, if you look at the far wall, apart from the window wall, this was the wettest part of the room. You can see all the dark patches on the wood and brickwork. Again, a mystery to begin with because it was the centre of the house and nowhere near any outside walls or leaky pipes. But after the issue with the staircase was discovered we were able to follow the path of dampness along the connecting timbers as it travelled into the adjoining rooms. And once the staircase was removed and that area dried out, so did everywhere else.

The window wall didn't dry out when all the damp plaster was removed, it wasn't until the ground level at the front of the house was lowered, the broken render that was trapping moisture behind it and allowing plant roots to penetrate through was removed and all the deteriorated mortar joints repaired, then the wall began to dry.

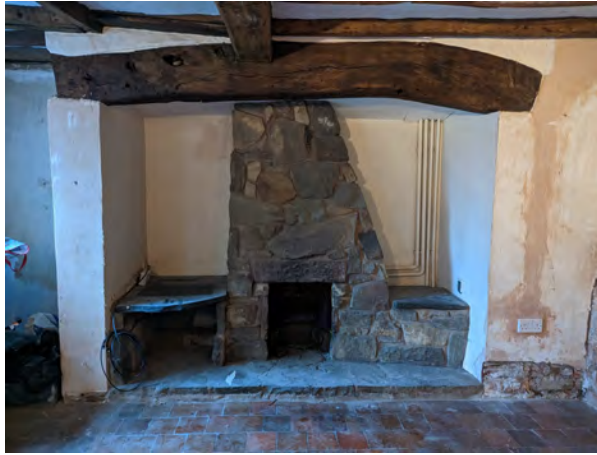
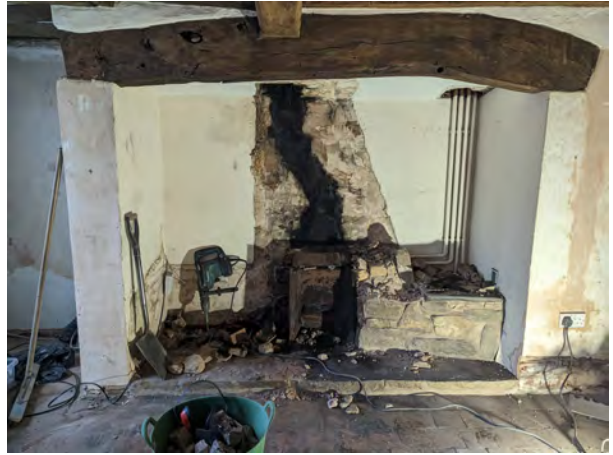
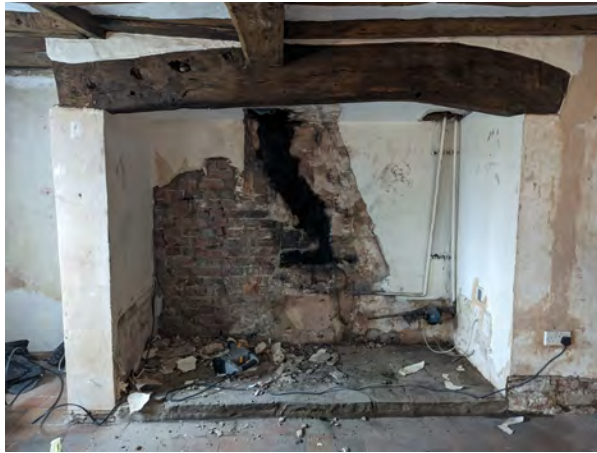
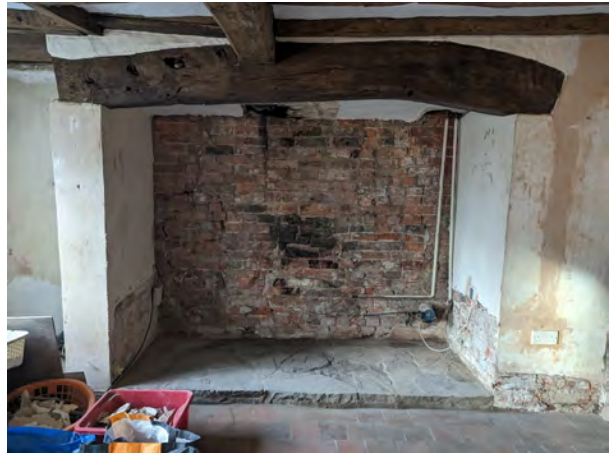
Lee Wright Plumbing & Heating were hired to remove the stone chimney in preparation for the log burner to be installed. It was a careful procedure of chiselling to removing each piece of stone and break it down.

Originally we'd hoped that we could keep the brick exposed but it was in such bad shape that we decided to lime render over the top and then attach Tudor brick slips and finish by pointing it in lime.
