## WHEN EVERYTHING HAD DRIED OUT

## **INSULATING THE EXTERIOR WALLS PRIOR TO PLASTERING & REPLACING PLASTERBOARD WITH WOOD WOOL BOARDS IN THE LIVINGROOM / OFFICE / FRONT BEDROOMS / HALLWAY & STAIRCASE**

## INSULATING THE EXTERIOR WALLS & PREPARING THE WALLS READY FOR PLASTERING IN THE KITCHEN / UTILITY ROOM / BACK BEDROOM & BATHROOM

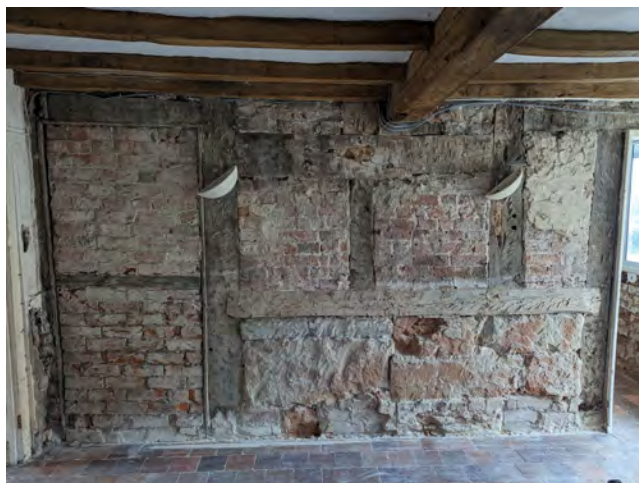
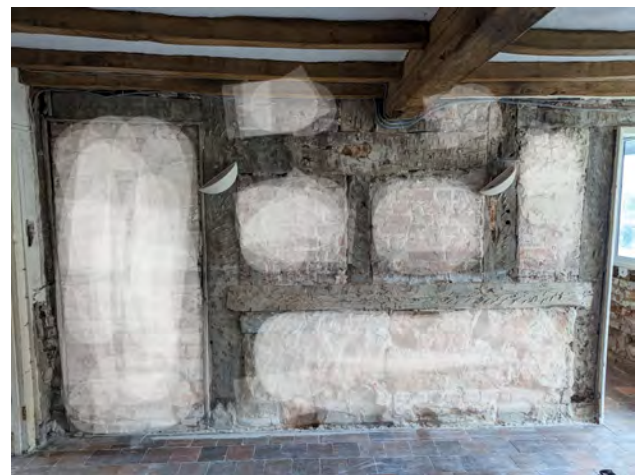
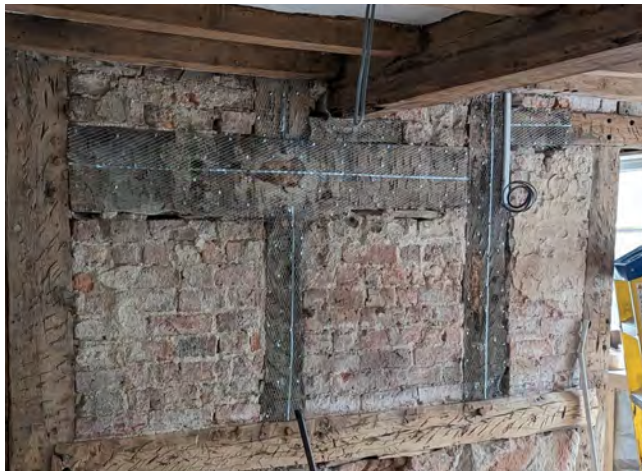
In each room we discussed what areas were to be plastered, some of the wood was going to be plastered over but I wanted to keep a lot of it exposed, I felt it would be such a shame to hide those fascinating details. Each piece of oak could tell it's own story and was full of gnarly character that I felt I would be doing it a disservice if it was to be covered up. I also knew that the areas where the lime plaster had been put on top of the wood were the worst areas for the plaster having absolutely no attachment to the wood, there had been air gaps between all of it through the house. Some of the walls were straight forward but for the complicated ones I took a photo of them and painted different ways (on my phone) that it could be plastered, it made it easier to visualise the final look.

Any of the oak that was plastered over, first had to have a steel mesh attached to it, so that the plaster has something to key to and to prevent the same detachment that had happened previously.

Hemp lime plaster was used for the whole project, horse hair was only added to the scratch coat then there was a second float coat and the final top coat.

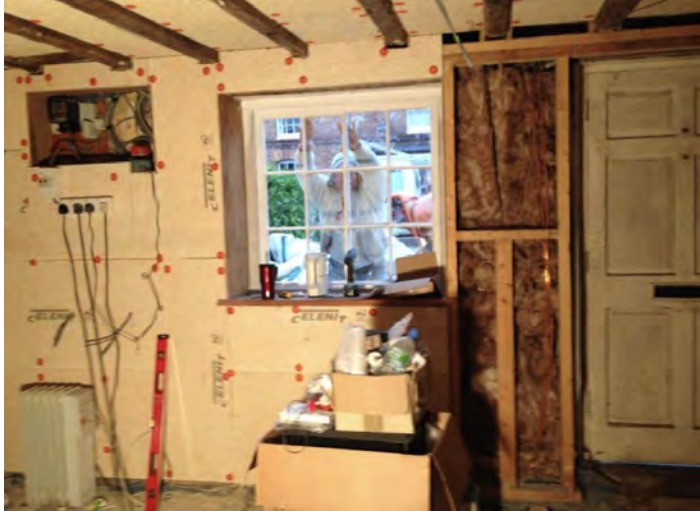
LEFT - This was taken during the renovations at Kew Cottage and shows the materials mentioned above

This consisted of building a stud framework, wool insulation, wood wool celenit boards & lime plaster finish.

Having the stud framework there also allowed for electrical cables, radiator and water pipes to all be hidden within that.

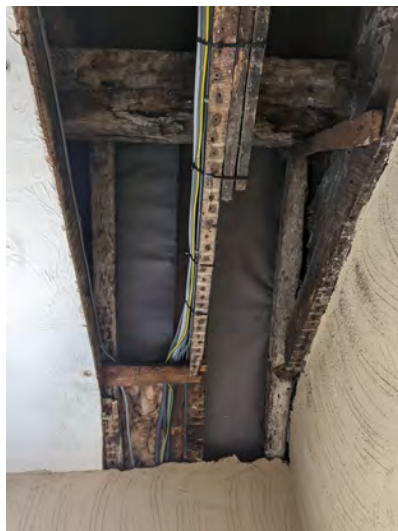
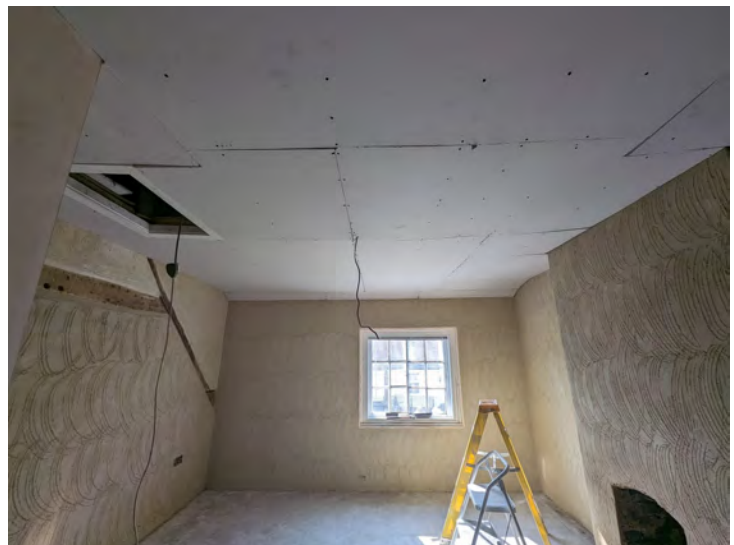
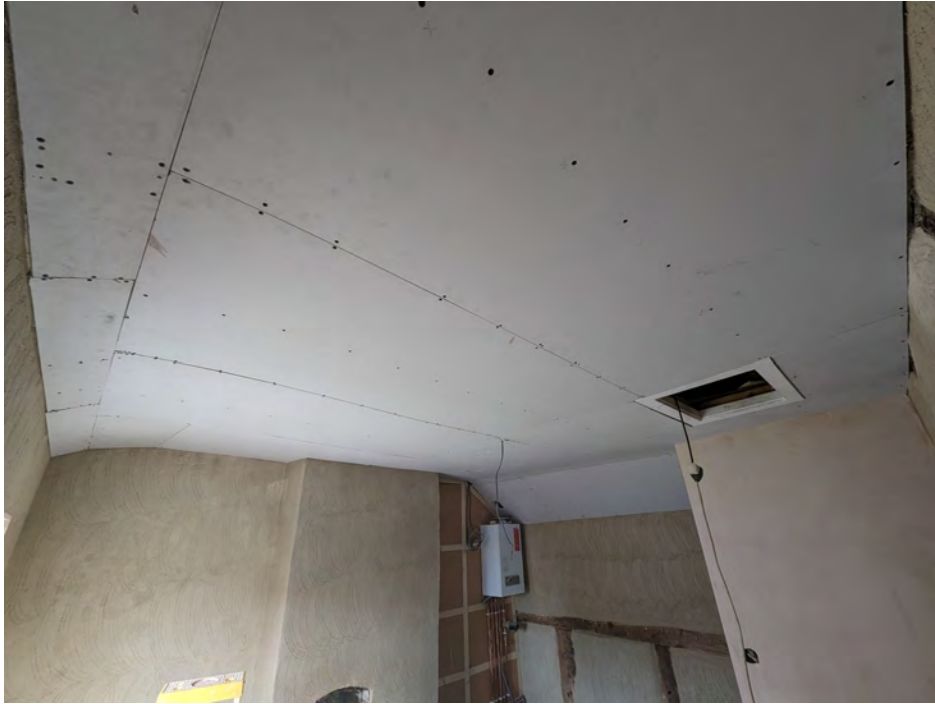
The ceiling had damaged areas from a water tank that had once leaked and been repaired very badly. These areas were cut away and then it was over boarded ready to be skimmed, Rather than pull down the whole ceiling, over boarding was the least destructive and safest option. My plaster said there might be a very small chance of asbestos in the artex due to the age of it so we decided to avoid disturbing it as much as possible.

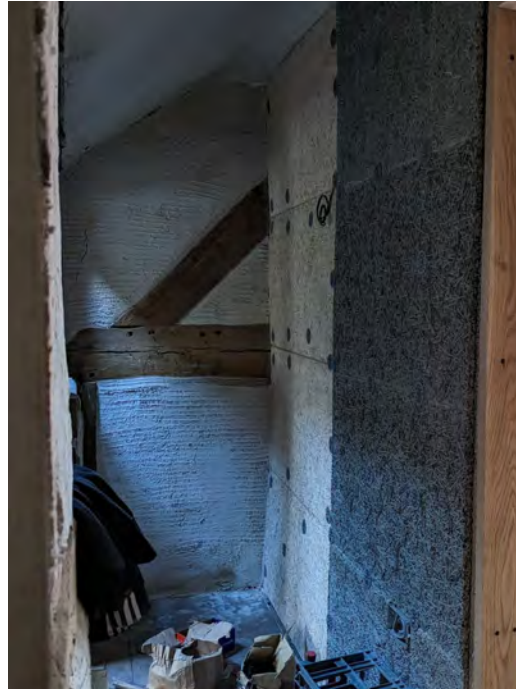
**TOP RIGHT** - This wall which backed onto the small front bedroom had previously had plasterboard on top of the wooden laths and plasterboard on top of some areas of lime plus gypsum skim on top all causing the materials to pull away from the laths underneath (as detailed earlier), these were all removed and the wood wool boards were attached on top of the laths.

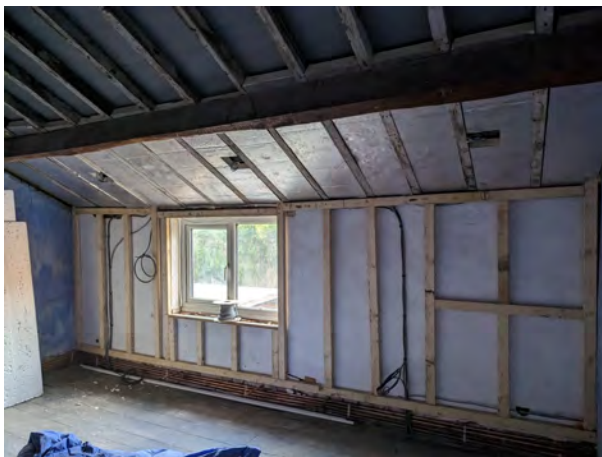
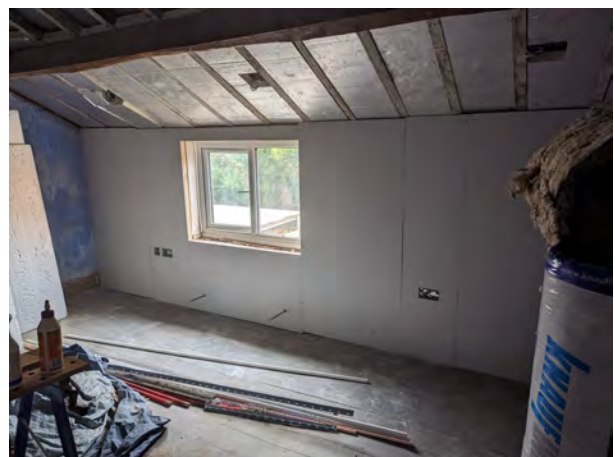
## BACK BEDROOM

The render in these rooms was solid, a few big cracks here and there but firmly attached to the walls, it hadn't been badly affected by the leaking roof and the mould spores had been removed and hadn't returned once there was heat and ventilation. So we had no intention of disturbing the render and used a product recommended by our plasterer to allow a fresh coat of gypsum skim to be applied over the top.

- Blue grit, a bonding solution, was painted on the walls to give the skim a good surface to adhere to.

A stud framework was built on the exterior wall of the back bedroom, with wool insulation and plasterboard on top. The ceiling was insulated with Celotex insulation boards and plasterboard.

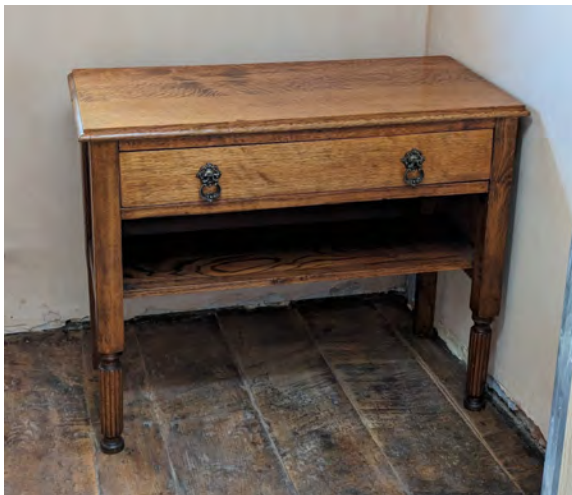
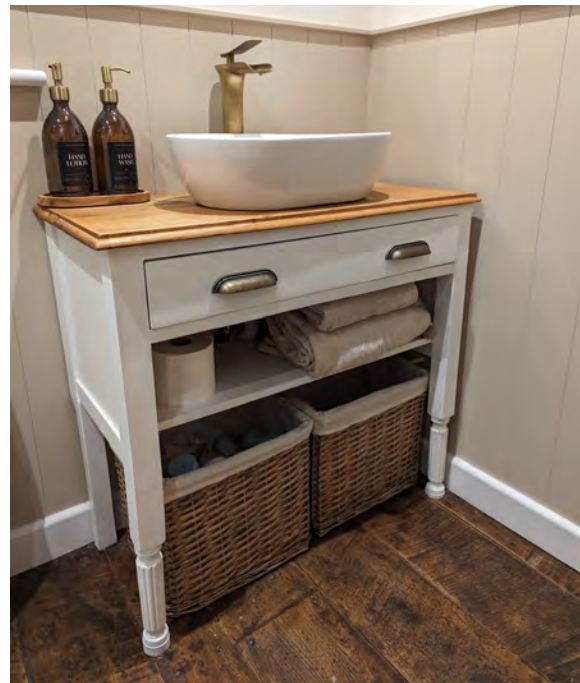
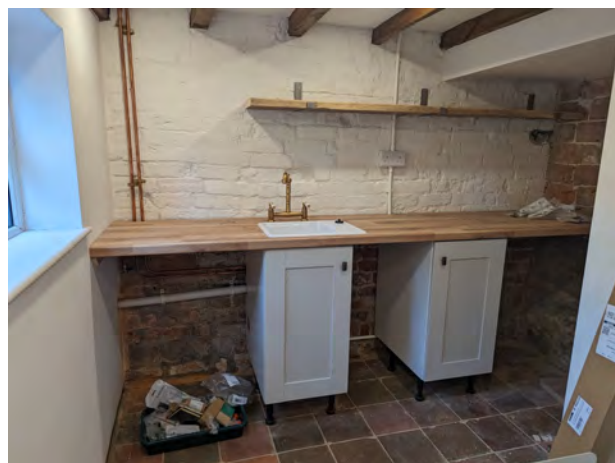
The original sink in the utility room was under the window, but the room was already narrow and this made it even narrower so I decided to put it on the back wall to utilise the space better,

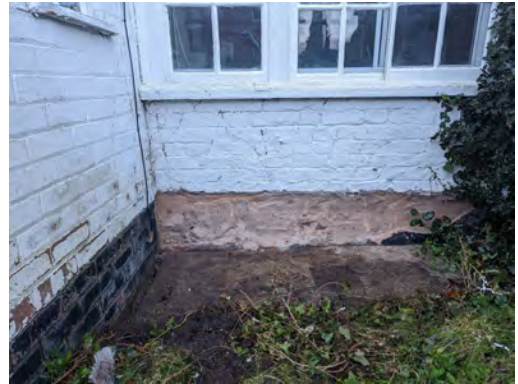
RIGHT - This is before it was lowered at the front, it's hard to see in the photo but the lawn was 2 big bulges either side of the porch which sloped down to a concreted area underneath each window. This concrete was slightly higher than the floor inside.

The concrete was removed and the ground dug away and levelled out at a height of 150mm lower than the floor inside.

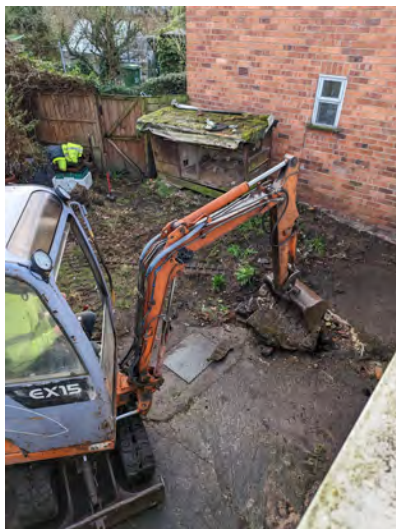
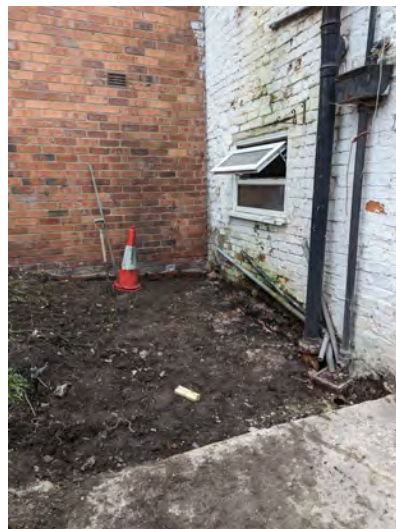
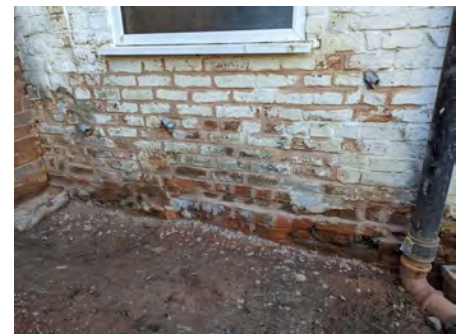
The groundworker had done some temporary repairs on the leaking drain early on in the project just to tide us over until he was able to come back and replace the full drainage system and manholes.

The rest of the concrete was removed from the back of the house and the earth dug away to reach the pipes. The garden itself was about a metre higher than the ground floor and it sloped down to the house and when it rained the water would just fill up the concrete area with nowhere to go except sit against the house. So the main objective with lowering the ground level at the back was so that there could be a drainage channel next to the house

and the new patio was going to be angled so that water rain away from the house instead of towards it and it would run into eco drains that would then filter into a soakaway.

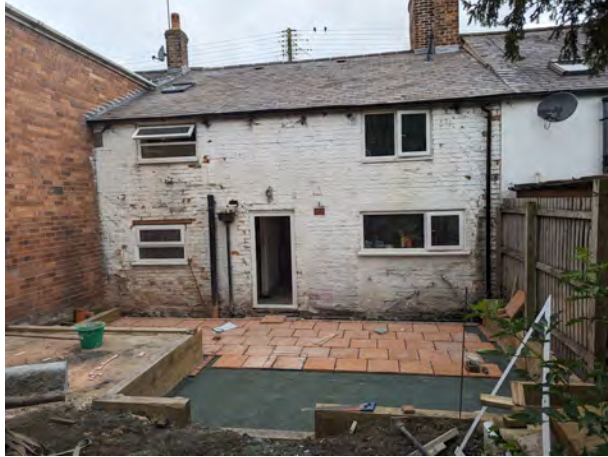
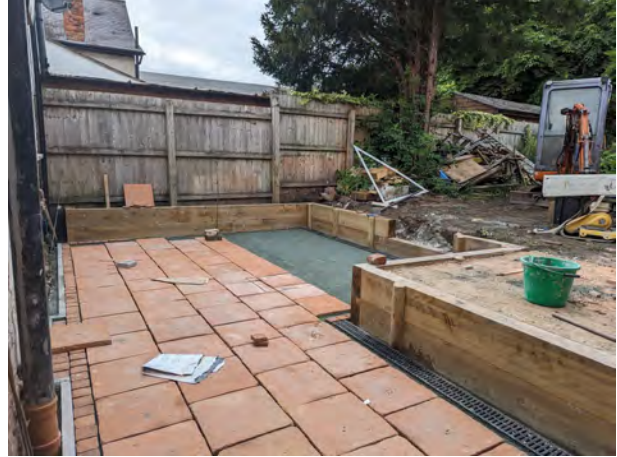
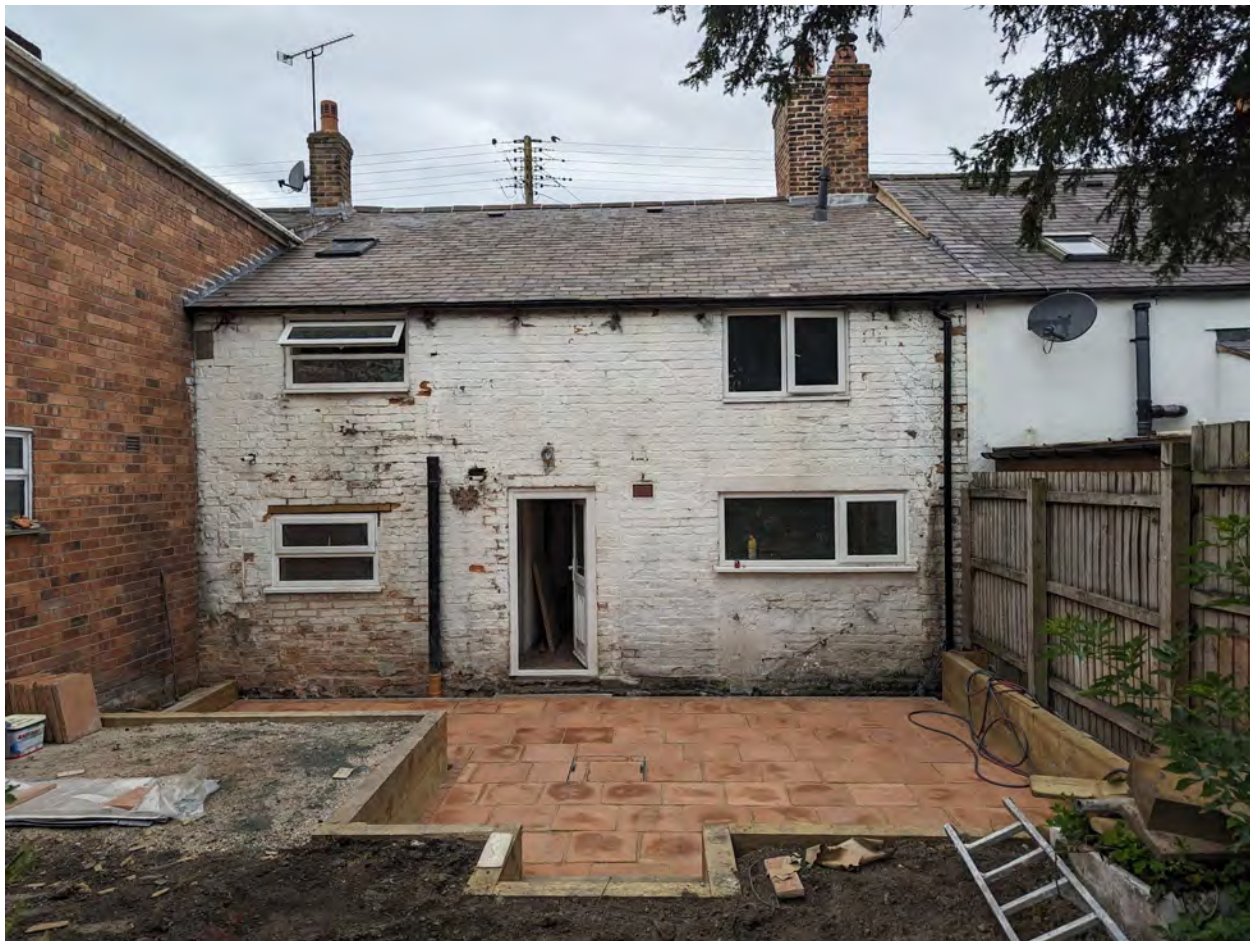
Combining the 2 rectangular manholes into one square one made such a difference once the patio was laid because we were able to use a recessed manhole cover and disguise it completely.

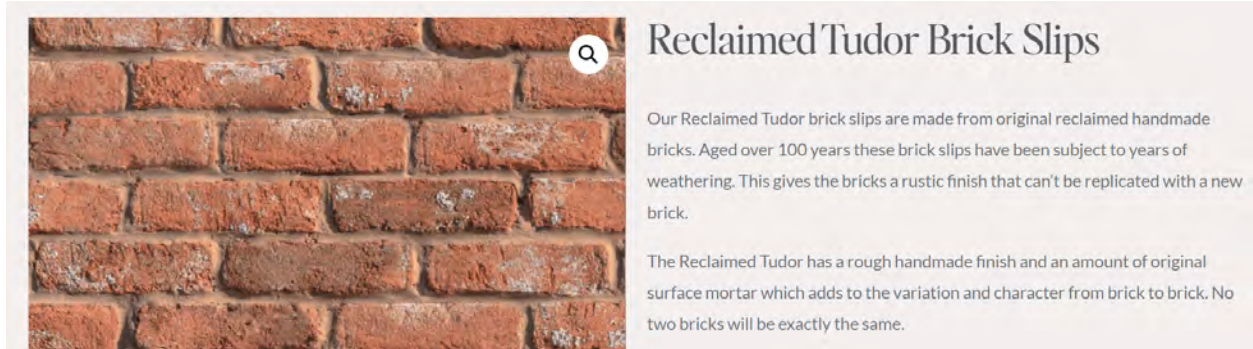
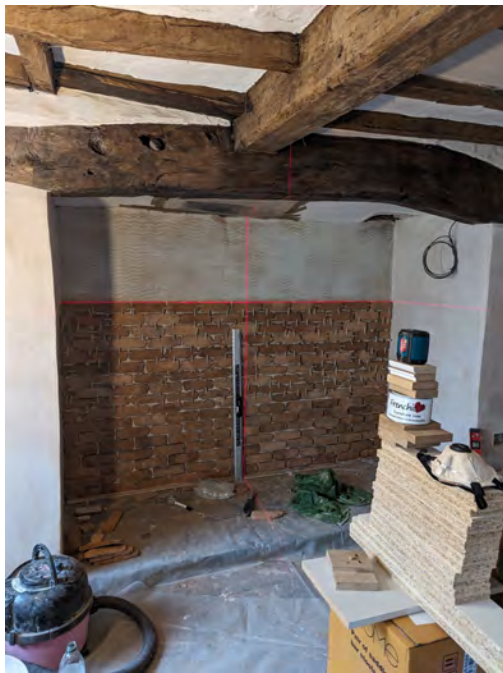
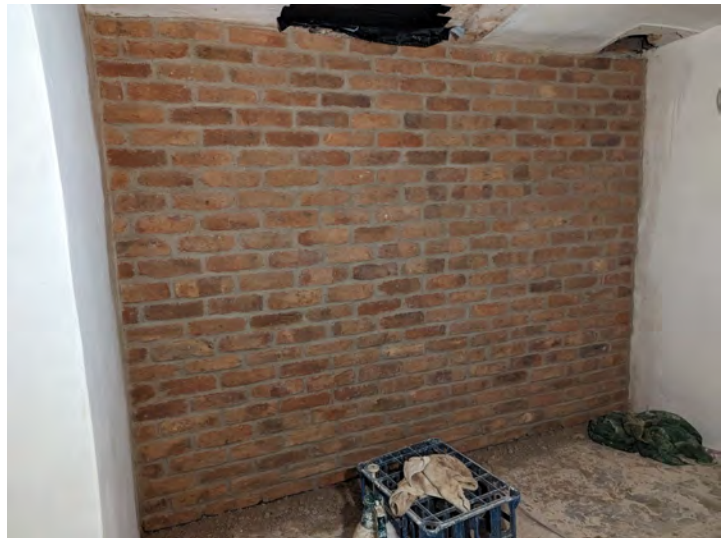
The brick slips that I used for the fireplace with from [www.reclaimedbricktile.com](http://www.reclaimedbricktile.com). I chose the Tudor brick slips because they were over 100 years old, they were long and thin like the old bricks that were used to build the house so I thought they would suit the age and character of the building.

Conserv gunlime in Oatmeal was used to point the bricks and with what brick slips I had left over I used in the little fireplace in the Front main bedroom.

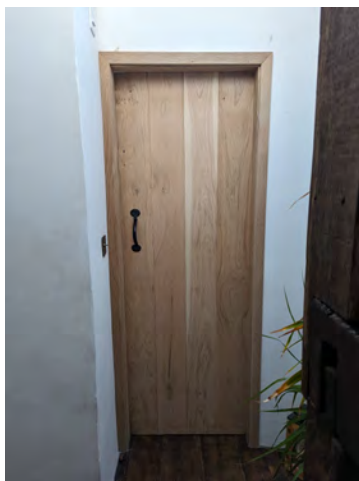
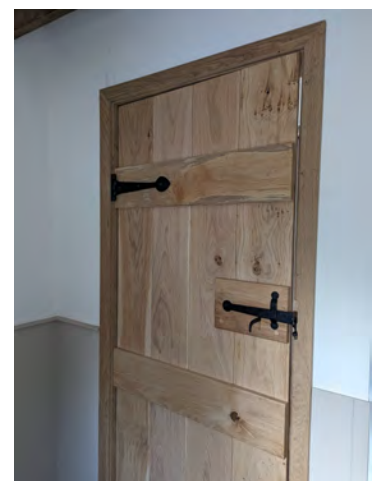
I don't have any photos of the old ones but they were the same as the downstairs ones, hollow and in bad condition. These were removed and replaced with oak framed doors with wrought iron furnishings.

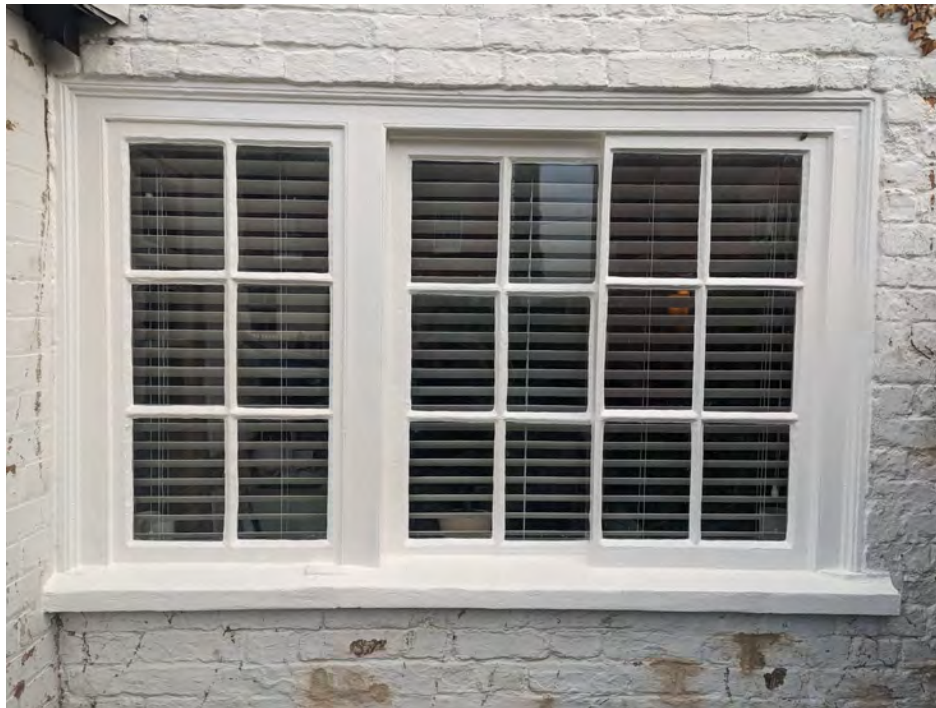
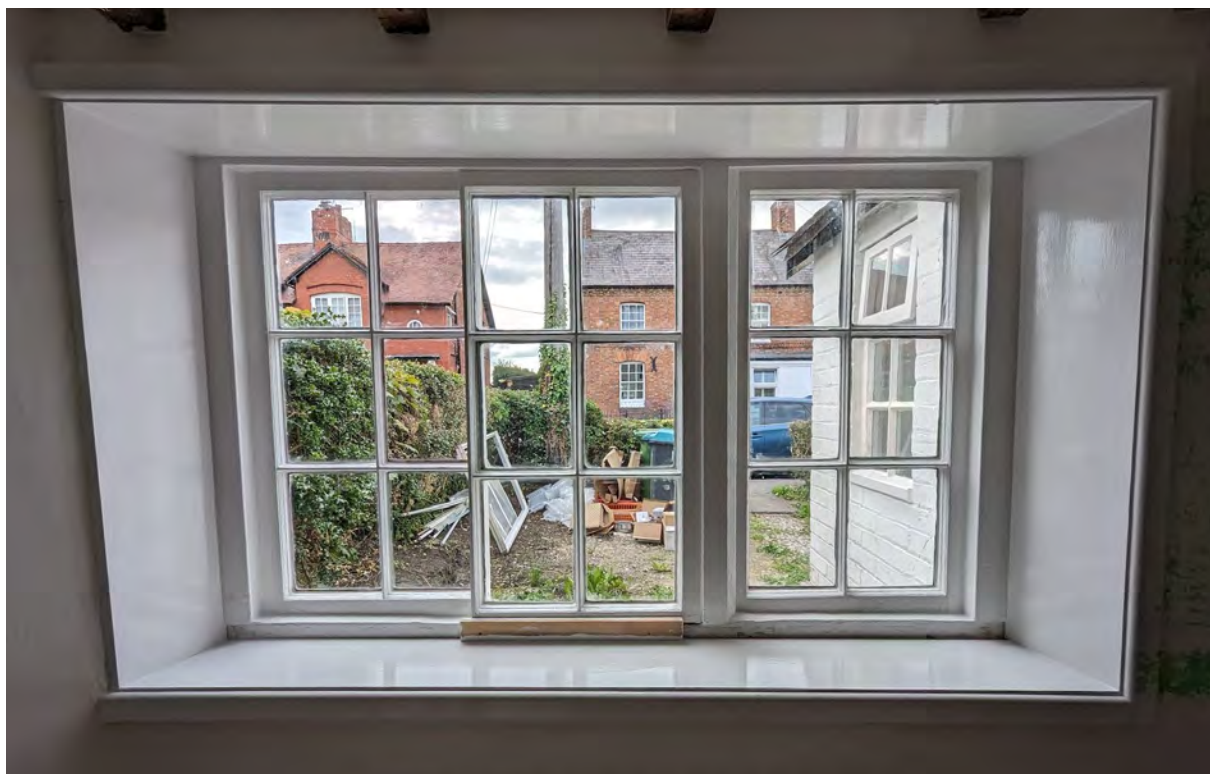
These are the original single glazed sash windows, quite unsafe, major heat loss source and unable to be opened because the frames are so fragile. They were sanded down and wood filler applied where needed and then painted, they are also sealed shut now so to stop the water penetrating inside.

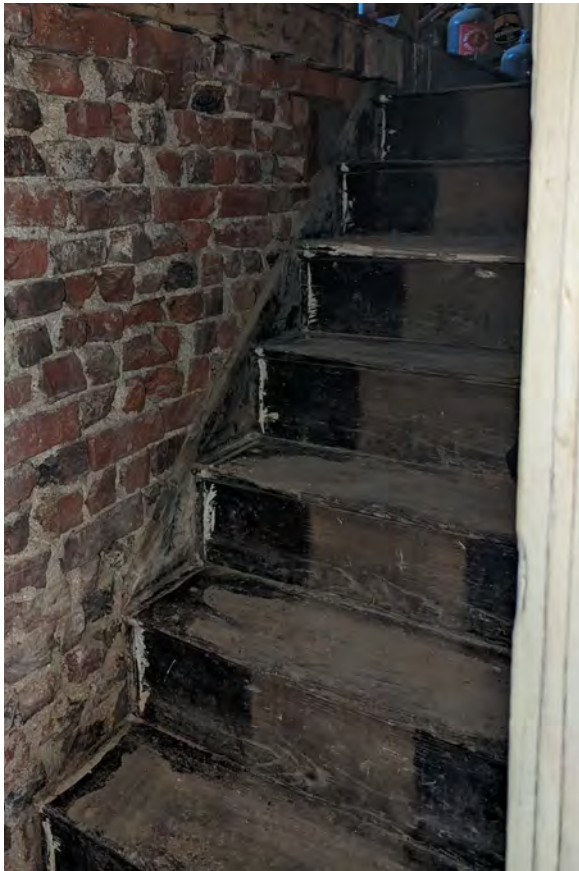
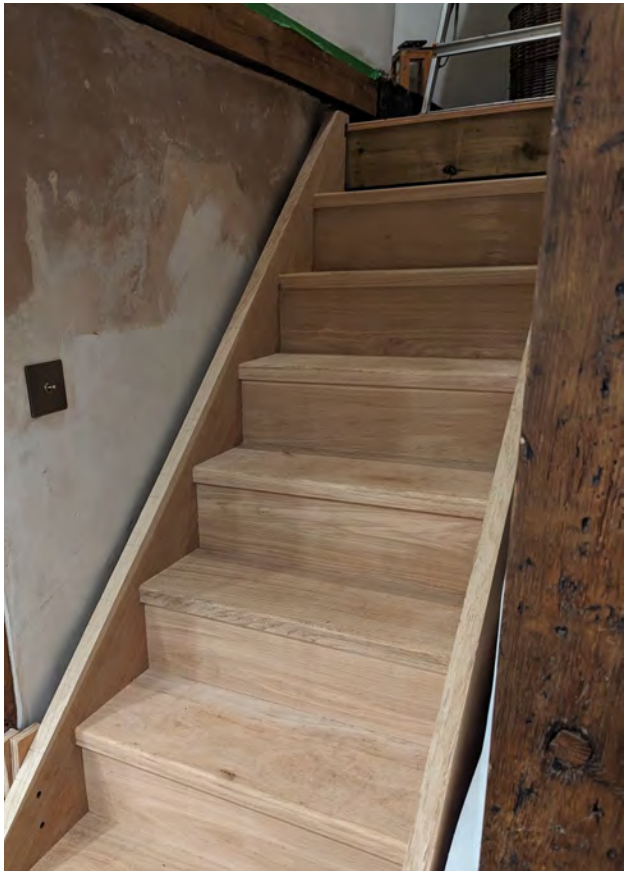
The old one had 9 steps and the new one has the same, it's waiting on the bottom bullnose step being made and the oak strips to fill the edges either side of the staircase and then i'll use the Fiddes Hard Wax Oil in English Oak on it to protect it and match it in colour to the rest of the wood through the building.

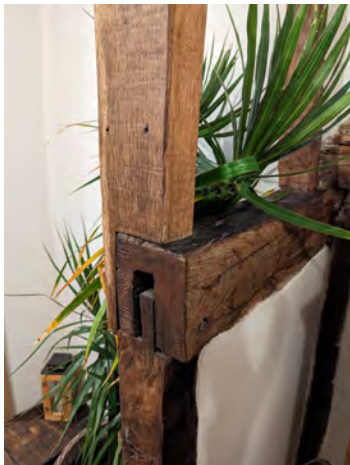
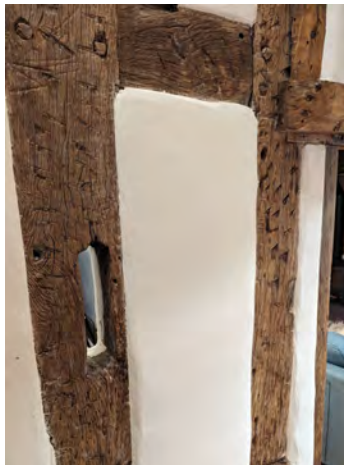
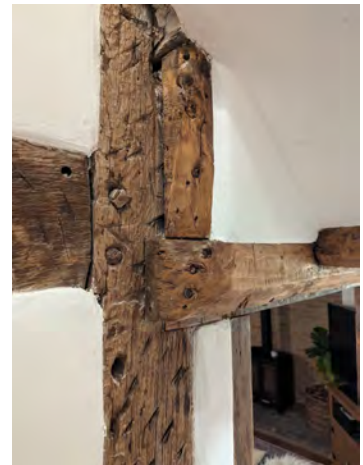
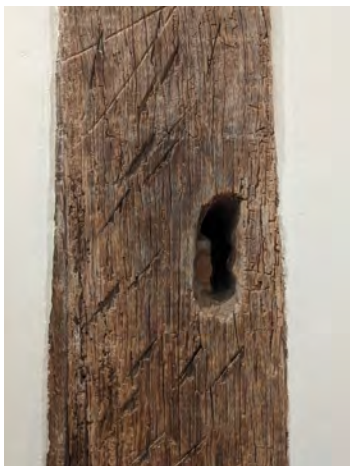
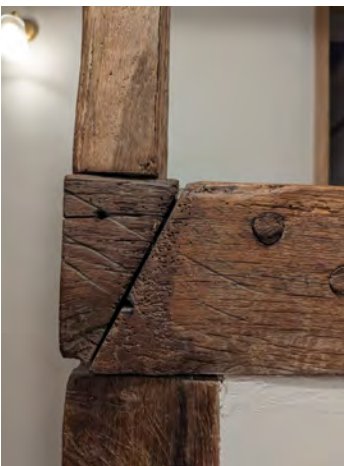
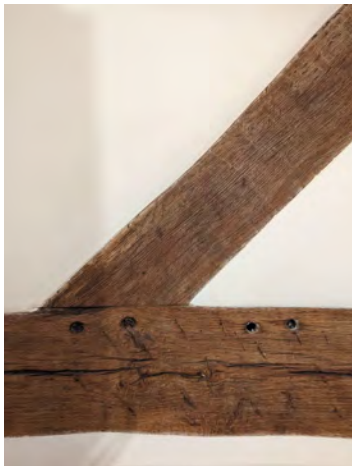
## The oak!

I'm obsessed with all the old oak, some of it was on show but so much was hidden under layers of lime/gypsum plaster all these years. It's absolutely stunning, full of character and history. I'd love to know its origins and the events it's been a part of before ending up here. We've got some quirky little features throughout the house where you can see into each room through the various holes in the wood from where old pegged tenon joints of other timbers once were.
