## **McDonald's Restaurant, Land at Plas Coch Retail Park, Wrexham**

### **Road Safety Audit Stage 1**

**TMS reference no: 15932**  
**Date: 26<sup>th</sup> October 2020**

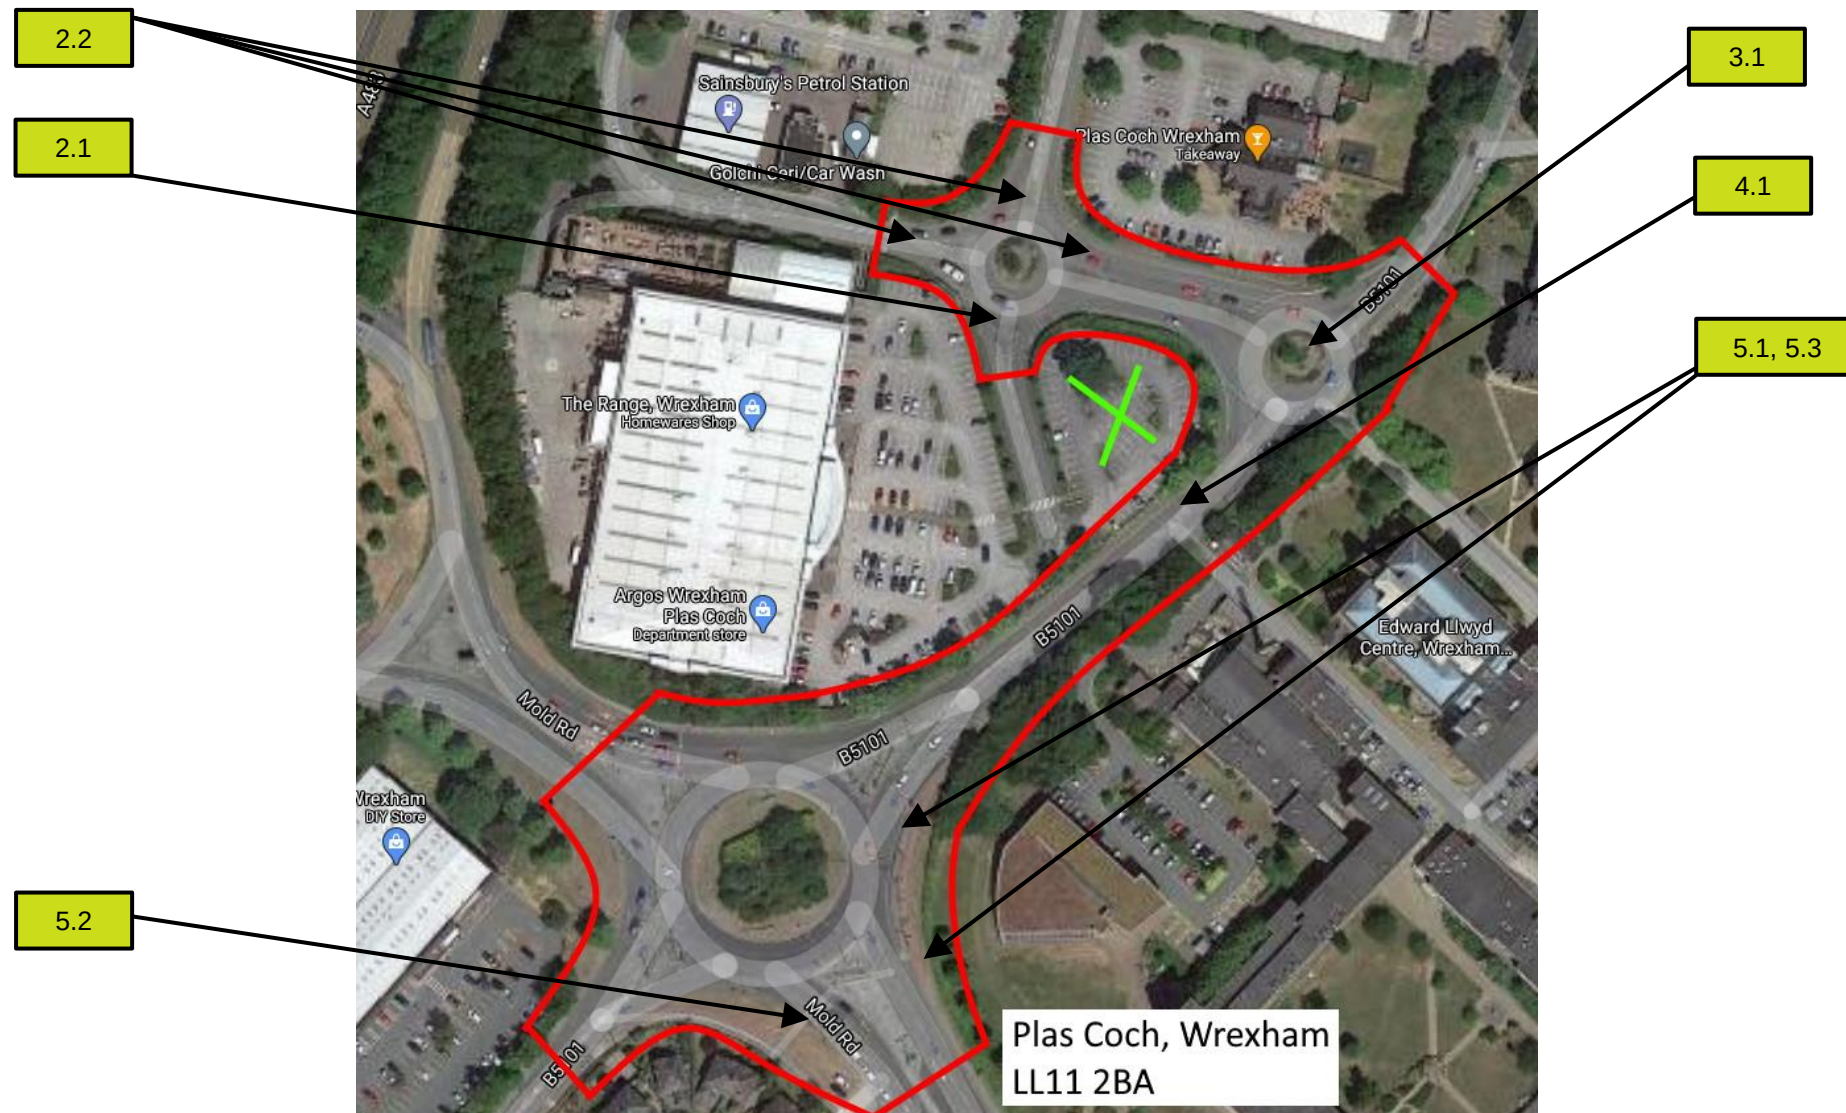
Please refer to the following page for a plan illustrating the locations of the problems identified as part of this audit (location numbers refer to paragraph numbers in the report).
