# **BRYMBO HERITAGE PROJECT**

## **STRUCTURAL CONDITION ASSESSMENT**

**August 2023**  
**Suitability S2**  
**Revision P02**

**By:**  
Bingham Rawlings Partnership Ltd.

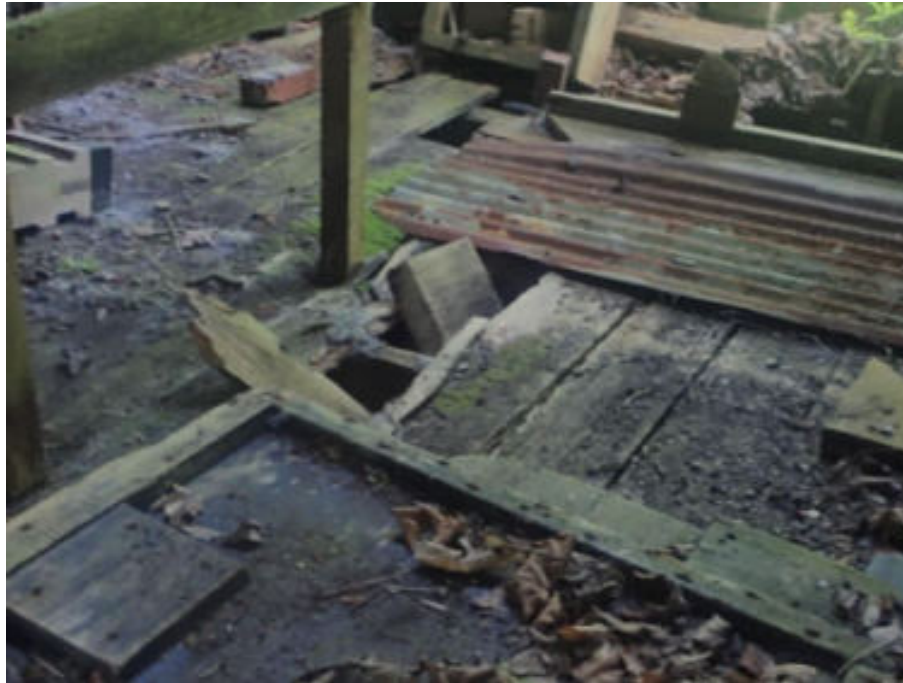
- 3.2.2 BA2 – Timber floor joists exhibiting signs of wet rot due to prolonged exposure to environmental factors, particularly within their supports in the walls.

*Figure 2. Typical deteriorated floor joists*

- 3.7.1 Remove all floor coverings and replace with suitable moisture resistant board or treated timber boards.
- 3.7.2 Remove and replace all deteriorated timber floor joists. Make allowance at this stage for 50% removal.

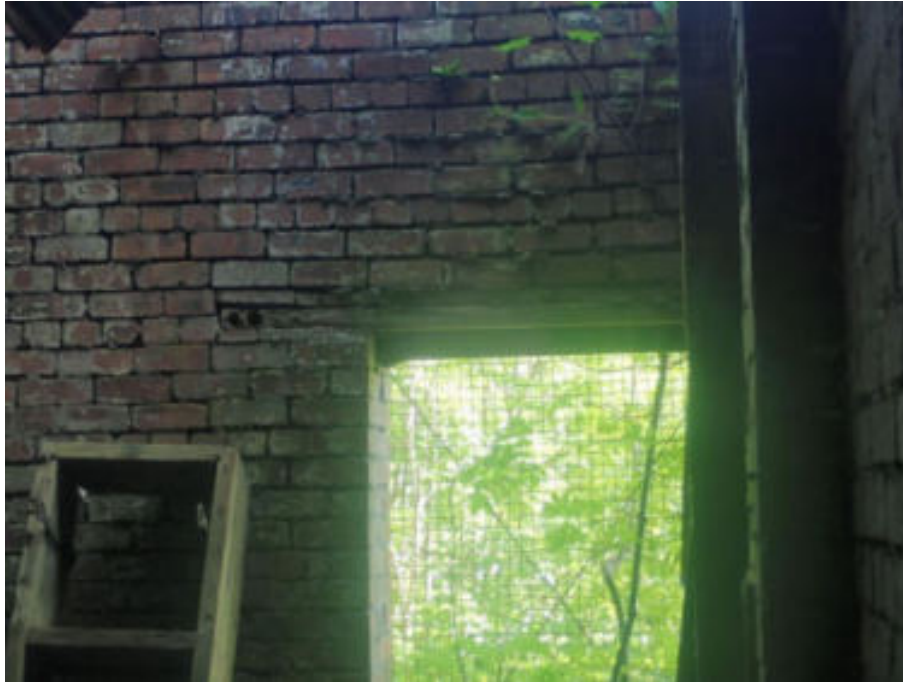
- 3.2.4 BA4 – Deteriorated timber lintels to front façade windows through exposure and wet rot. Refer to defect BA4 in Defect Sketch in **Appendix D – Defect Sketches**.

*Figure 4. Typical deteriorated timber lintel*

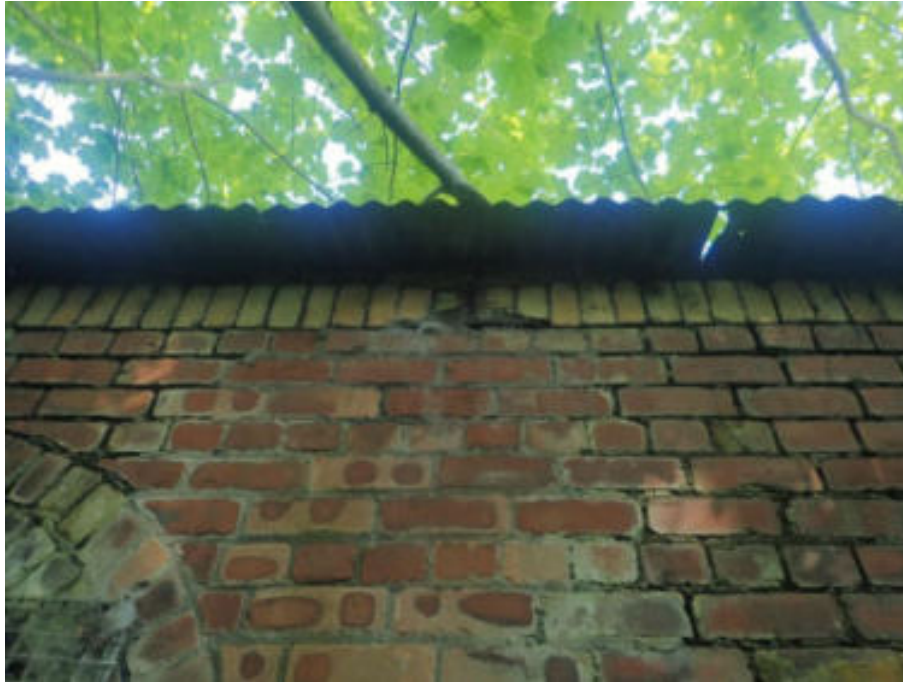
- 3.2.6 BA6 – De-bonded brick coping along eaves at truss bearing locations. Deteriorated timber lintels to front façade windows through exposure and wet rot. Refer to defect BA6 in Defect Sketch in **Appendix D – Defect Sketches**.

*Figure 6. Typical de-bonded brick coping*

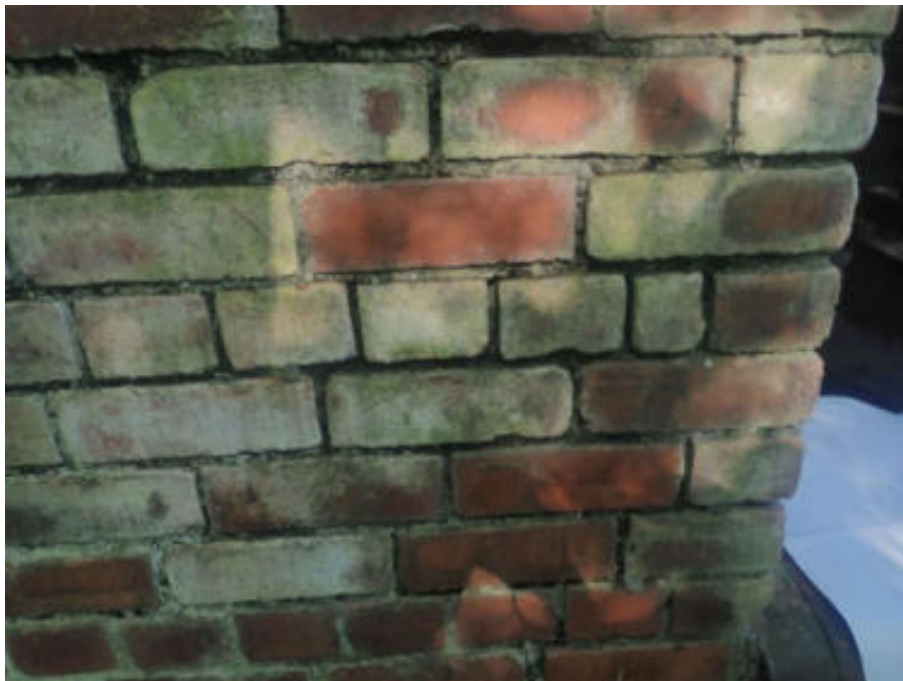
- 3.2.7 BA7 – Desiccated mortar pointing throughout.

*Figure 7. Typical desiccated mortar pointing*

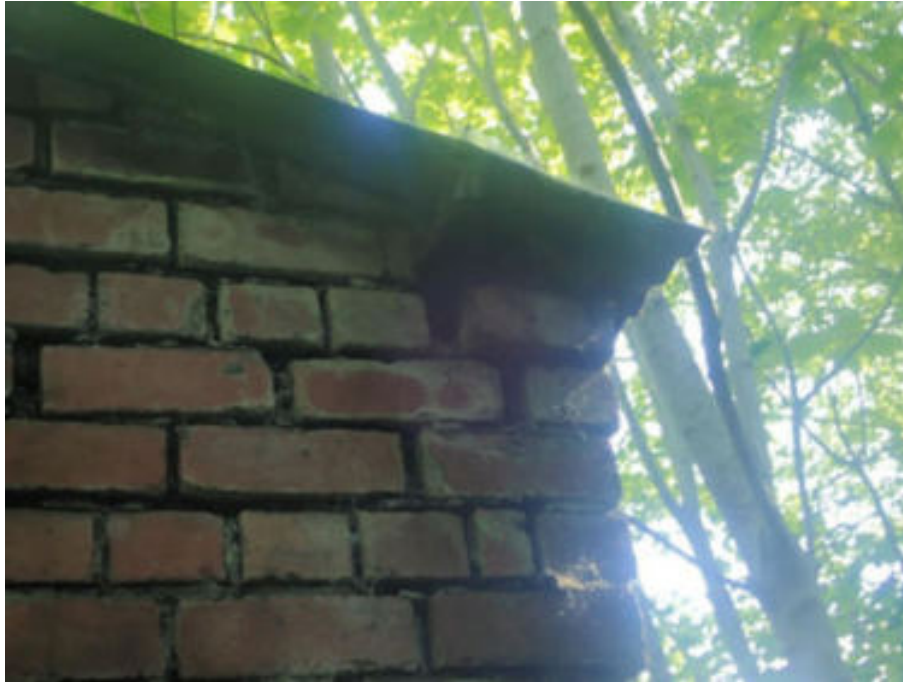
- 3.2.8 BA8 – Dislodged brickwork to all four corners of the building at eaves level due to rotation of RSA canted purlins within brickwork. Refer to defect BA8 in Defect Sketch in **Appendix D – Defect Sketches**.

*Figure 8. Typical dislodged brickwork on corner*

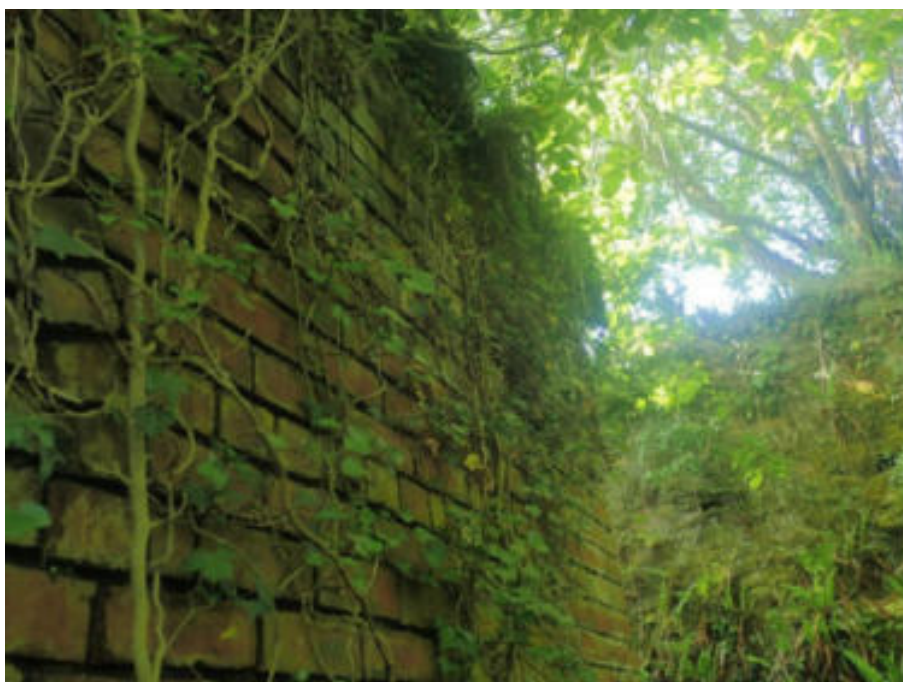
- 3.2.9 BA9 – Area of vegetation growth on external wall. Refer to defect BA9 in Defect Sketch in **Appendix D – Defect Sketches**.

*Figure 9. Vegetation growth on wall*

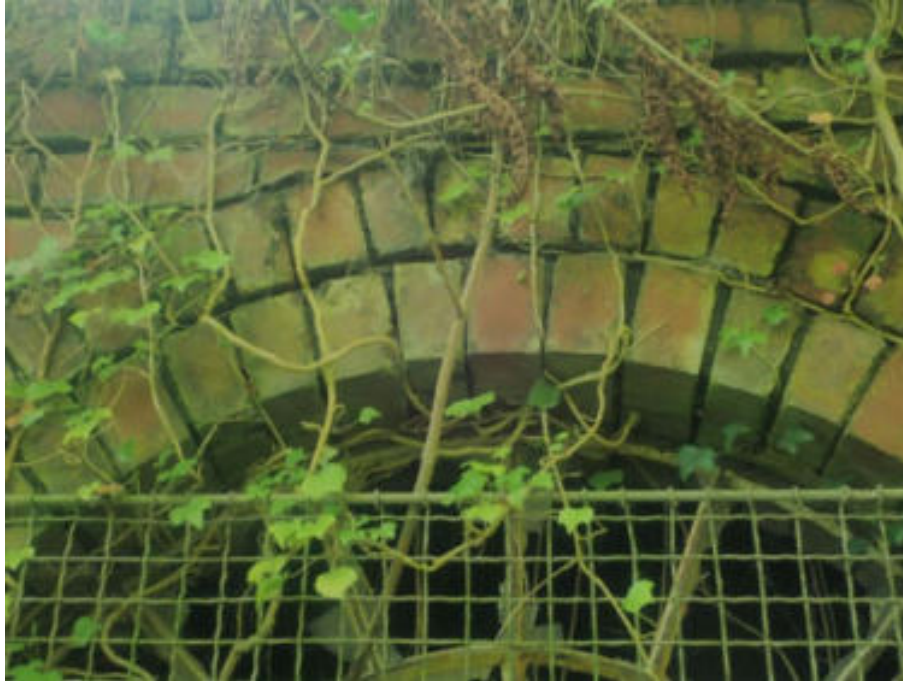
**3.2.10 BA10 – Displacement in arch keystone. Refer to defect BA10 in Defect Sketch in Appendix D – Defect Sketches.**

*Figure 10. Displaced arch keystone*

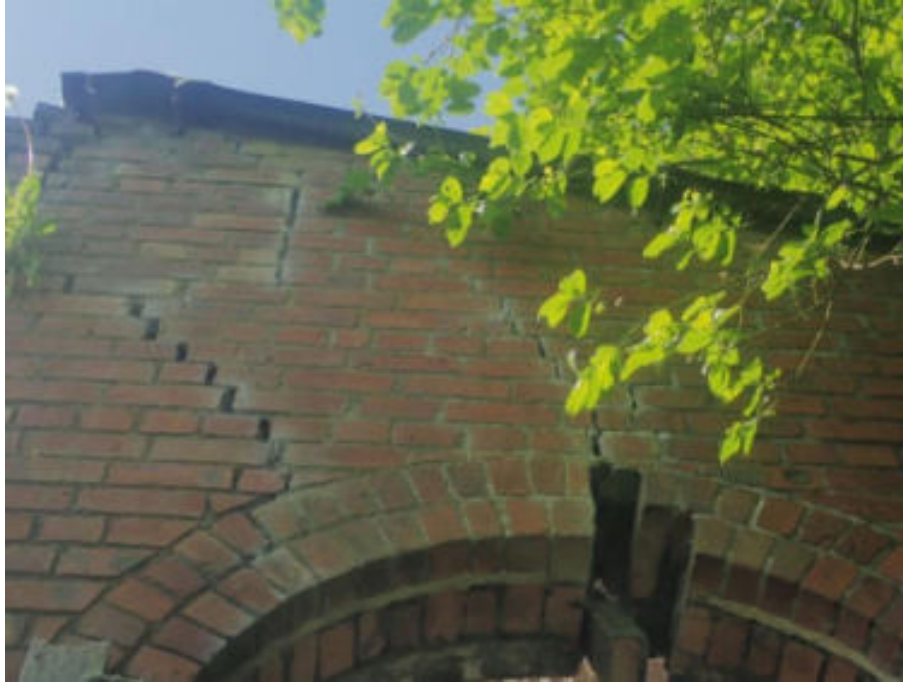
3.2.12 BA12 – Failed masonry arch due to displaced / dislodged keystone coupled with significant vertical and diagonal cracking (15mm width) from head of arch in masonry panel above. Refer to defect BA12 in Defect Sketch in **Appendix D – Defect Sketches**.

*Figure 12. Failed masonry arch*

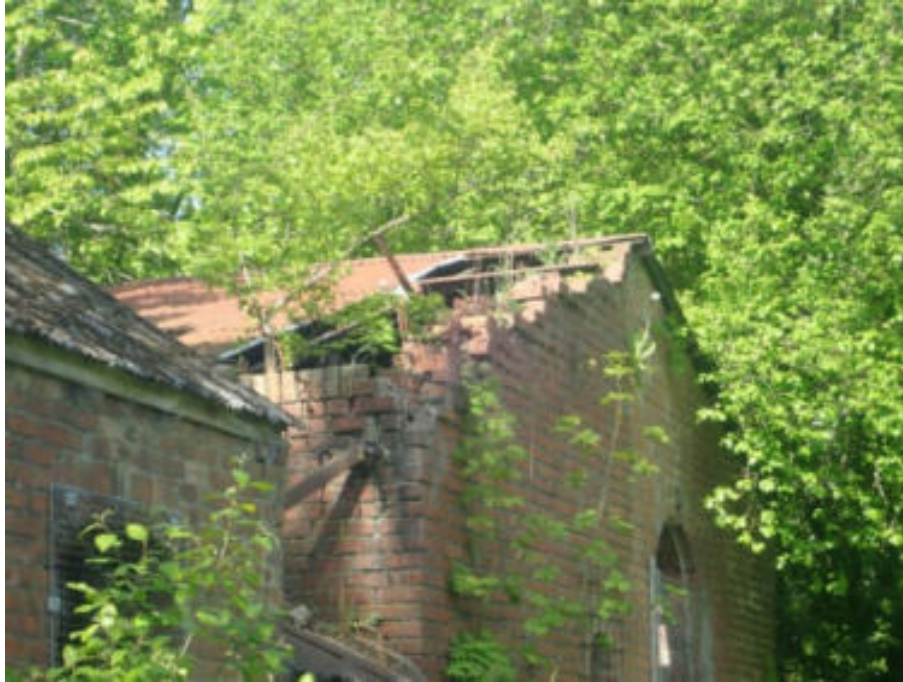
- 3.2.13 BA13 – Failed section of roof, missing steel RSA purlins (2 No.) and significant area of disturbed masonry at the roof line of the front gable spandrel due to tree growth internally. Refer to defect BA13 in Defect Sketch in **Appendix D – Defect Sketches**.

*Figure 13. Failed section of roof*

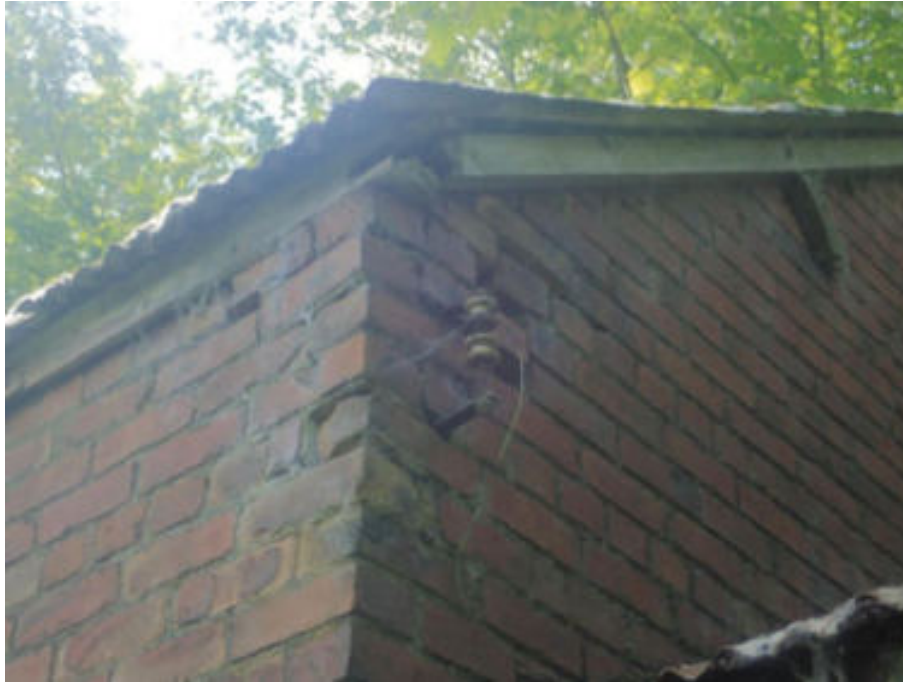
3.2.14 BA14 – Loose / dislodged masonry at eaves of gable wall due to expansive corrosion of historical electricity line bracket embedded in wall. Refer to defect BA14 in Defect Sketch in **Appendix D – Defect Sketches**.

*Figure 14. Loose/dislodged masonry*

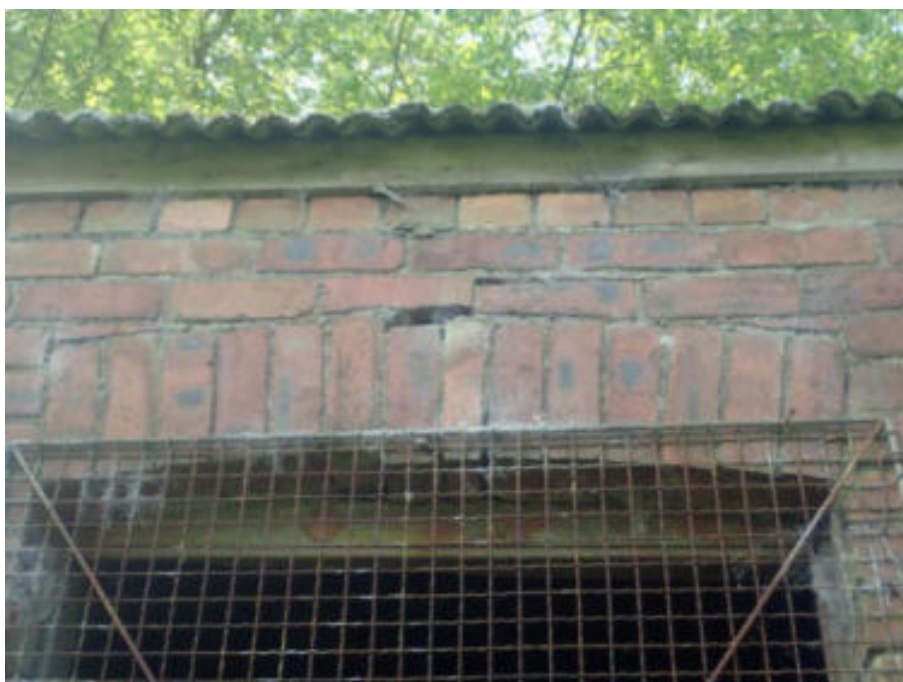
3.2.15 BA15 – Failed masonry arch due to displaced / dislodged keystone. Refer to defect BA15 in Defect Sketch in **Appendix D – Defect Sketches**.

*Figure 15. Failed masonry arch*

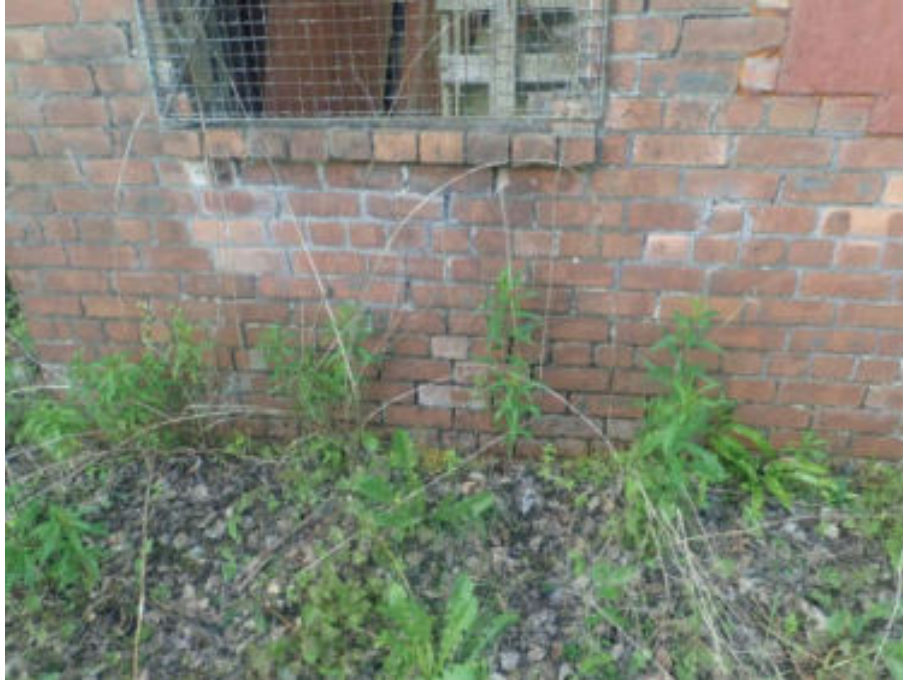
- 3.2.16 BA16 – Diagonal cracking emanating from the enlarged door opening in the front elevation and terminating at the base of the wall, suggestive of historical impact damage. Refer to defect BA16 in Defect Sketch in **Appendix D – Defect Sketches**.

*Figure 16. Diagonal cracking*

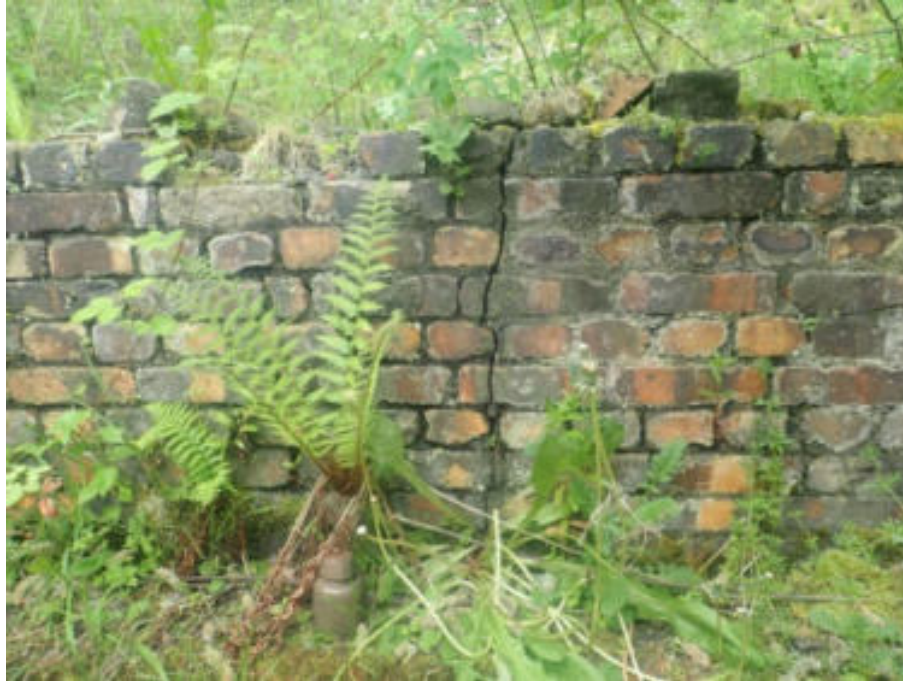
**4.2.2 BB2 – Vertical crack recorded in upper section of rear wall attributed by the growth of vegetation.**

***Figure 18. Vertical crack***

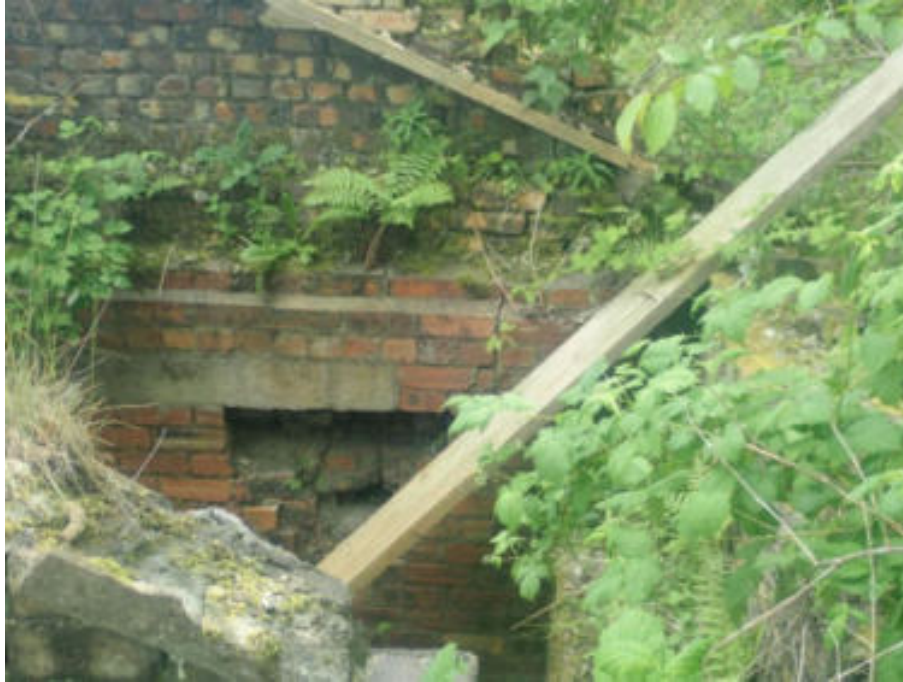
- 4.2.3 BB3 – Historically, due to failure of natural stone lintel, a reinforced concrete lintel has been installed over the former fireplace. The lintel cantilevers due to localised failure of the internal wall at the bearing and as such contains vertical stress fractures due to excessive deflection.

*Figure 19. Vertical stress fracture*

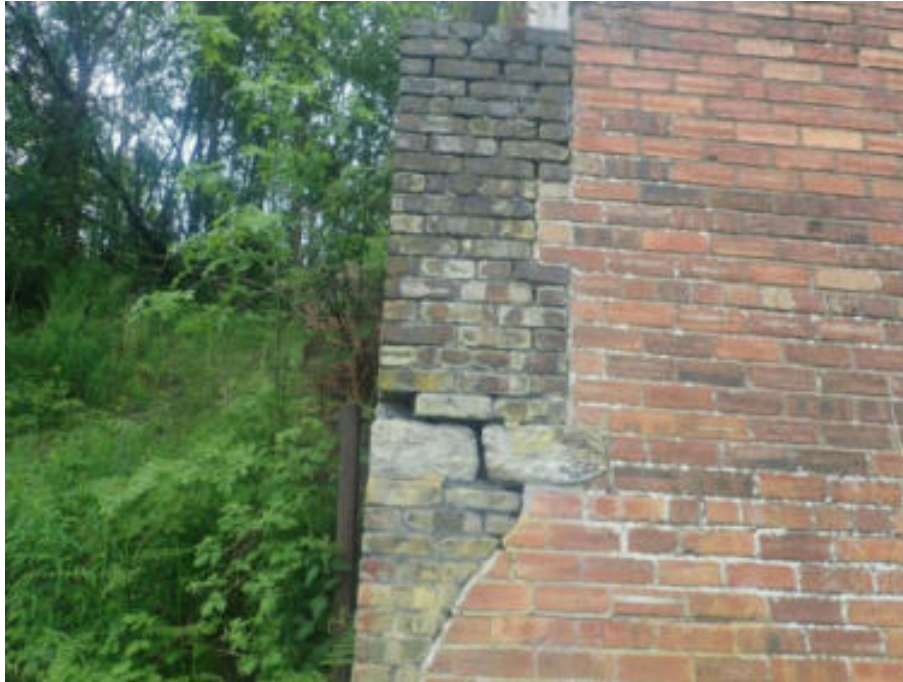
- 4.2.4 BB4 – The front wall panel is an infill panel in part and is not adequately tied to its return walls. Inappropriate horizontal support has left to vertical hairline cracking within the panel.

*Figure 20. Insufficiently tied in infill panel*

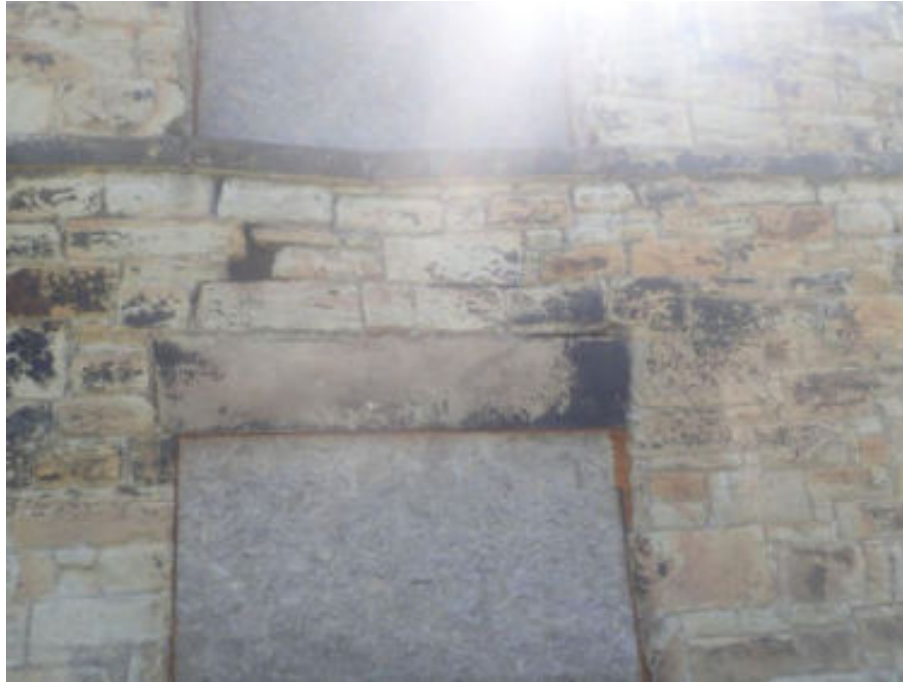
- 5.2.2 BC2 – Failed external wall panel due to dislodged natural stone lintel to window at ground floor of front elevation. Refer to defect BC2 in Defect Sketch in **Appendix D – Defect Sketches.**

***Figure 23. Failed wall panel***

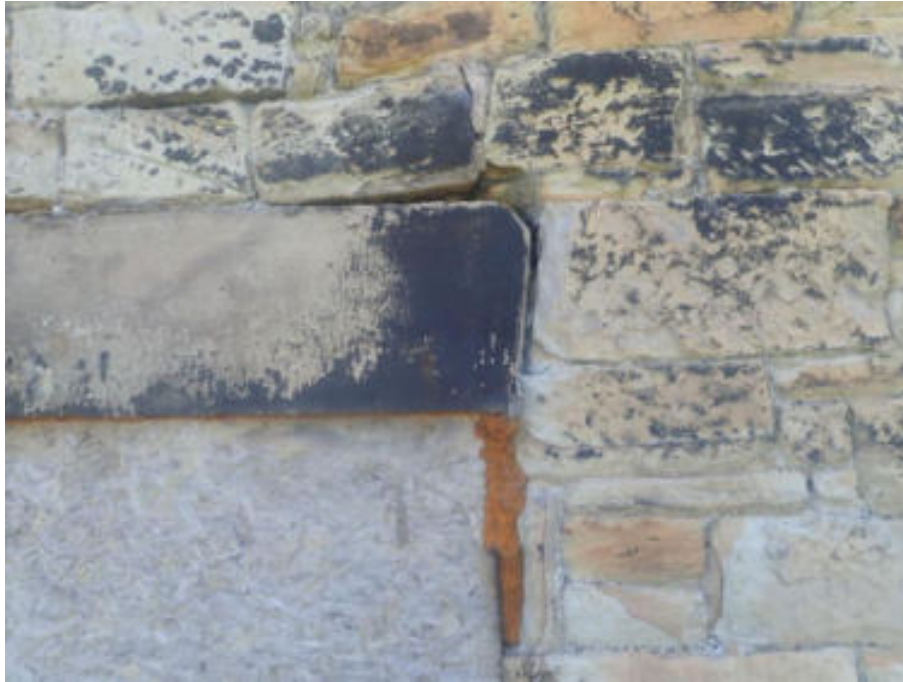
- 5.2.3 BC3 – Failed bearing at window jam to ground floor front elevation opening. Natural stone compression lintel has dropped. Refer to defect BC3 in Defect Sketch in **Appendix D – Defect Sketches**.

*Figure 24. Failed lintel bearing*

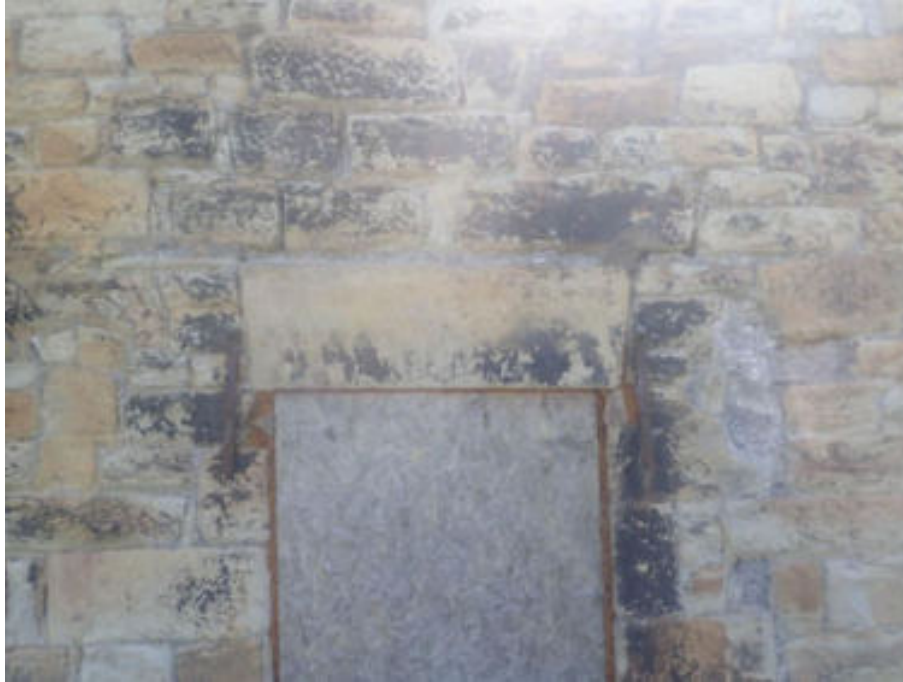
- 5.2.4 BC4 – Historical failure to bearing of natural stone compression lintel above door opening to ground floor front elevation. Historical repair has been undertaken, but it was not carried out in a sympathetic or appropriate manner. Refer to defect BC4 in Defect Sketch in **Appendix D – Defect Sketches**.

*Figure 25. Historical failure to lintel bearing*

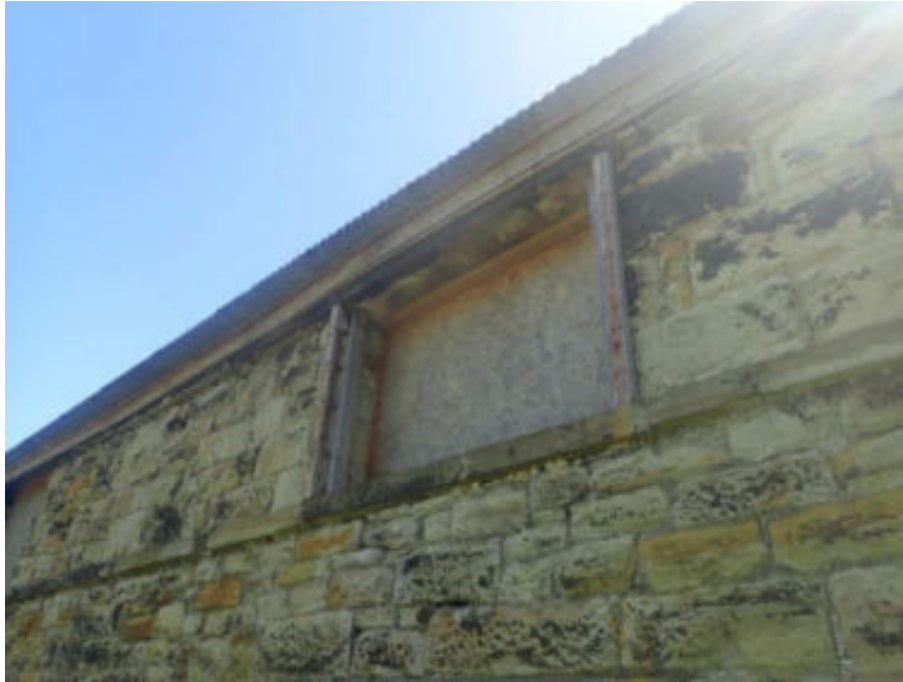
- 5.2.5 BC5 – Natural stone eaves beam joint directly over opening and is currently propped by temporary timber props. Refer to defect BC5 in Defect Sketch in **Appendix D – Defect Sketches.**

**Figure 26.** *Propped stone eaves beam*

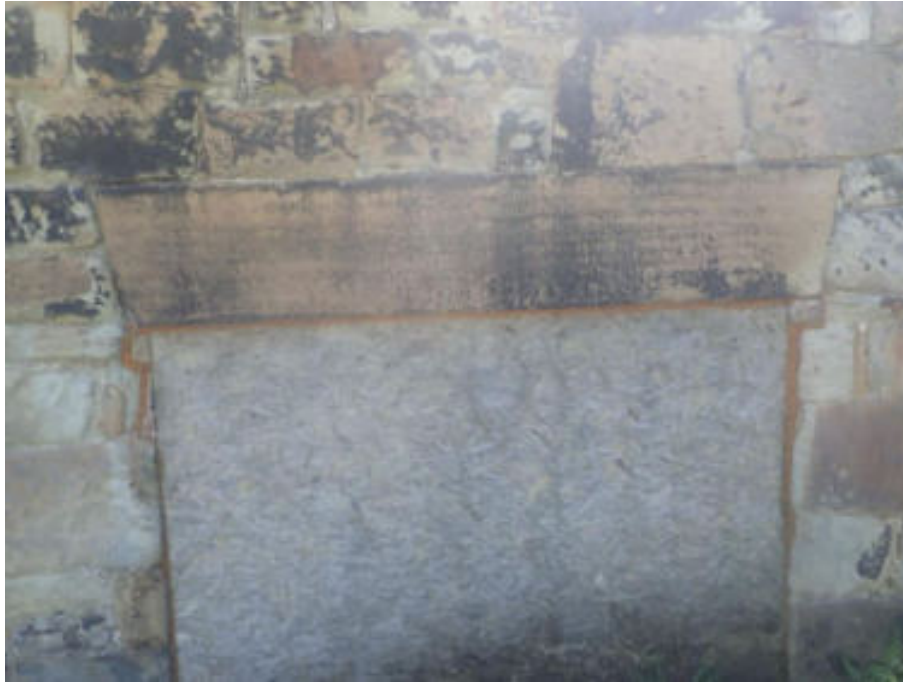
- 5.2.7 BC7 – Failed bearing at window jam to ground floor front elevation opening. Natural stone compression lintel has dropped. Refer to defect BC7 in Defect Sketch in **Appendix D – Defect Sketches**.

**Figure 28.** *Failed lintel bearing*

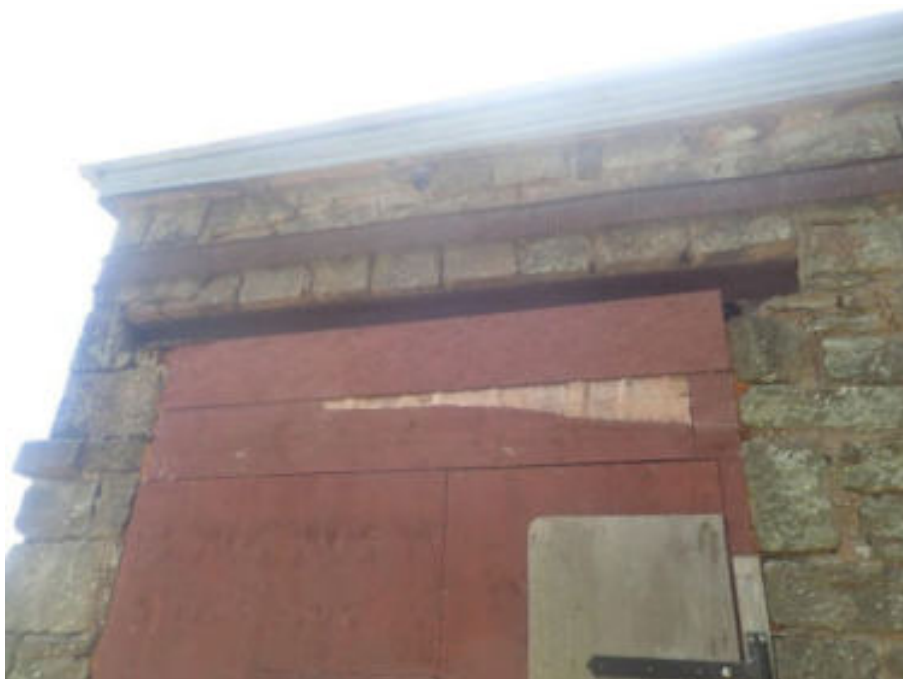
- 5.2.8 BC8 – Existing steel UB forming full height opening to gable wall currently provides bearing to approximately 50% width of supported stonework above. Refer to defect BC8 in Defect Sketch in **Appendix D – Defect Sketches**.

**Figure 29.** *Insufficient bearing to stonework above lintel*

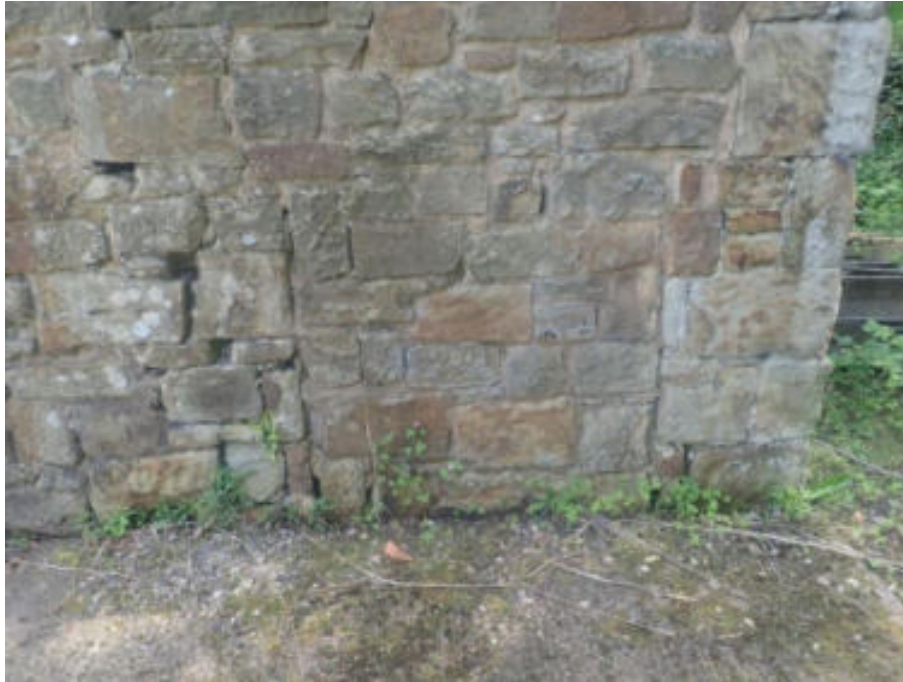
- 5.2.9 BC9 – Historical infill masonry panel to gable wall contains loose individual masonry at its base. Refer to defect BC9 in Defect Sketch in **Appendix D – Defect Sketches**.

*Figure 30. Loose masonry*

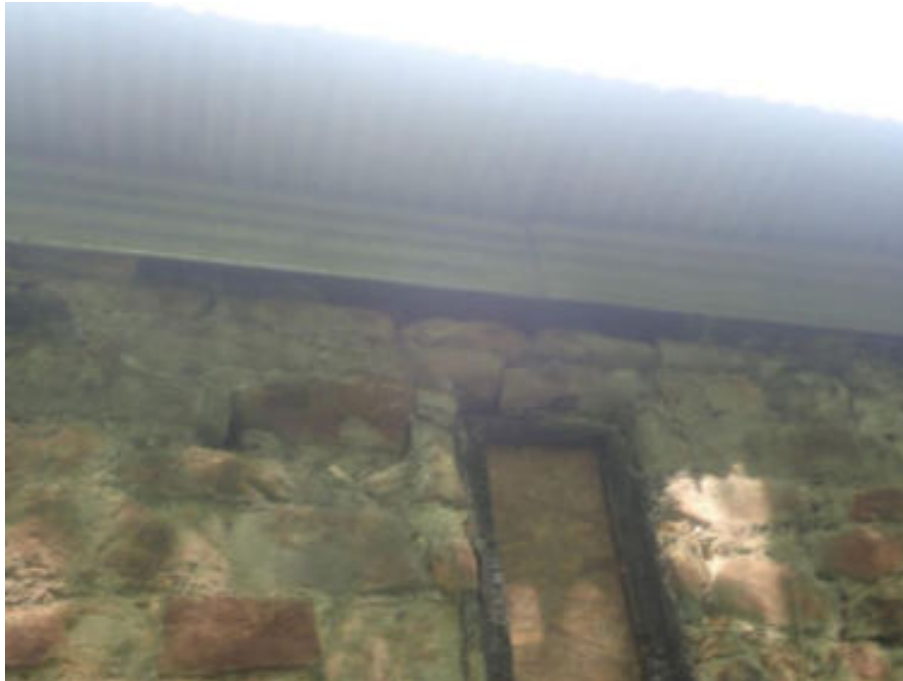
5.2.11 BC11 – Natural stone eaves member has been removed resulting in a void beneath the roof line. Refer to defect BC11 in Defect Sketch in **Appendix D – Defect Sketches**.

*Figure 32. Removed eaves member*

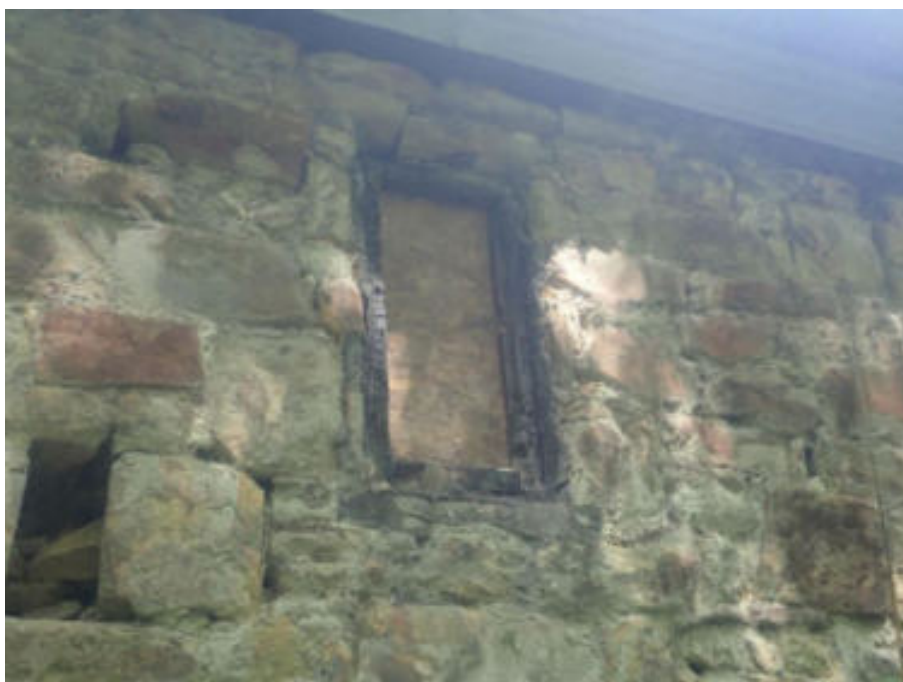
5.2.12 BC12 – Fire damage noted to external first floor window frame. Refer to defect BC12 in Defect Sketch in **Appendix D – Defect Sketches**.

*Figure 33. Fire damaged window frame*

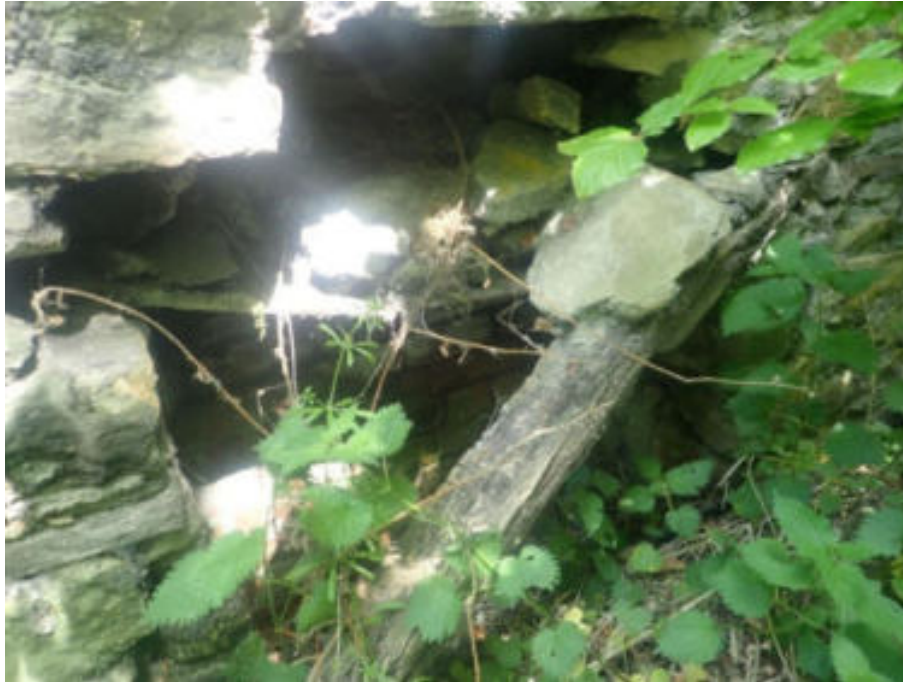
5.2.13 BC13 – Failed external timber lintel and prying action through evasive root growth has resulted in external wall panel failure and localised collapse. Refer to defect BC13 in Defect Sketch in **Appendix D – Defect Sketches**.

*Figure 34. Failed lintel and localised collapse*

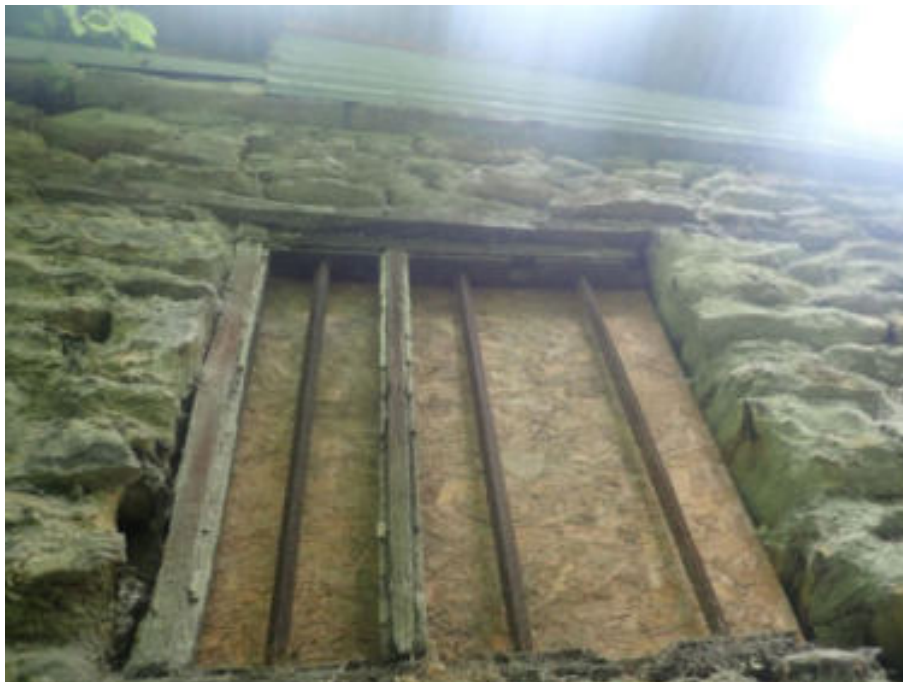
5.2.14 BC14 – Failed external timber lintel to rear elevation first floor opening. Refer to defect BC14 in Defect Sketch in **Appendix D – Defect Sketches**.

*Figure 35. Failed timber lintel*

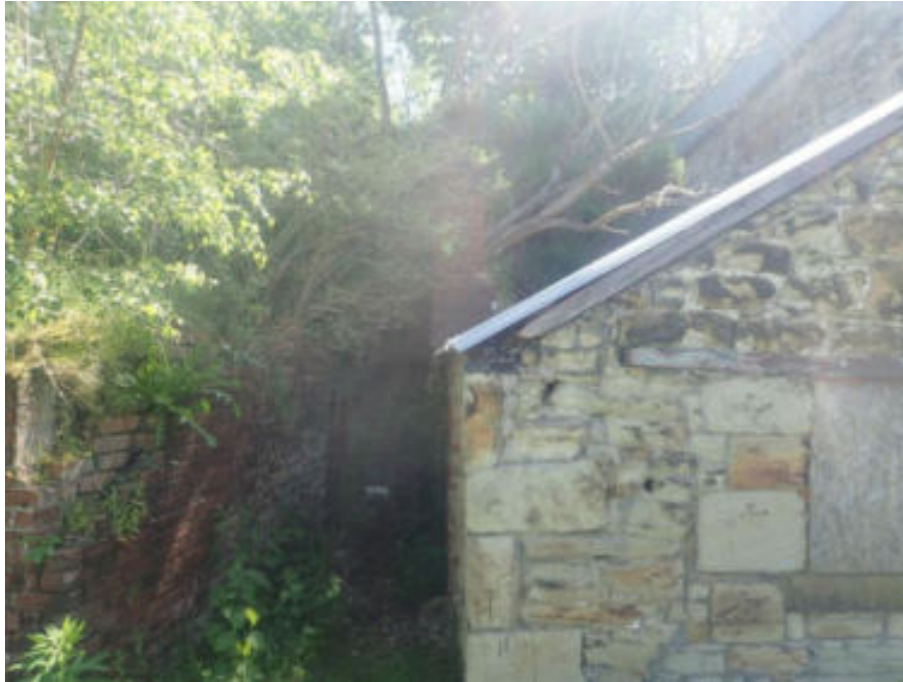
5.2.18 BC18 – Significant outward lean in external stack from its base resulting in various fractures between the panel and its abutting panels. Refer to defect BC18 in Defect Sketch in **Appendix D – Defect Sketches**.

*Figure 39. Significant outward lean in stack*

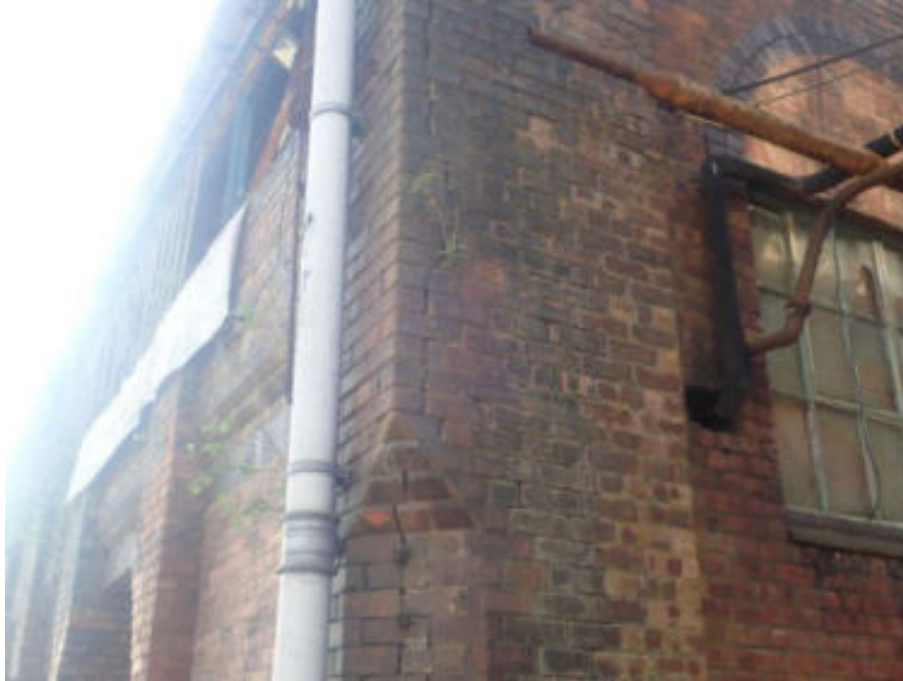
- 6.2.6 BD6 – Vertical fractures up to 10mm in width noted on all 4 external corners of building.

*Figure 47. Typical corner fracture*

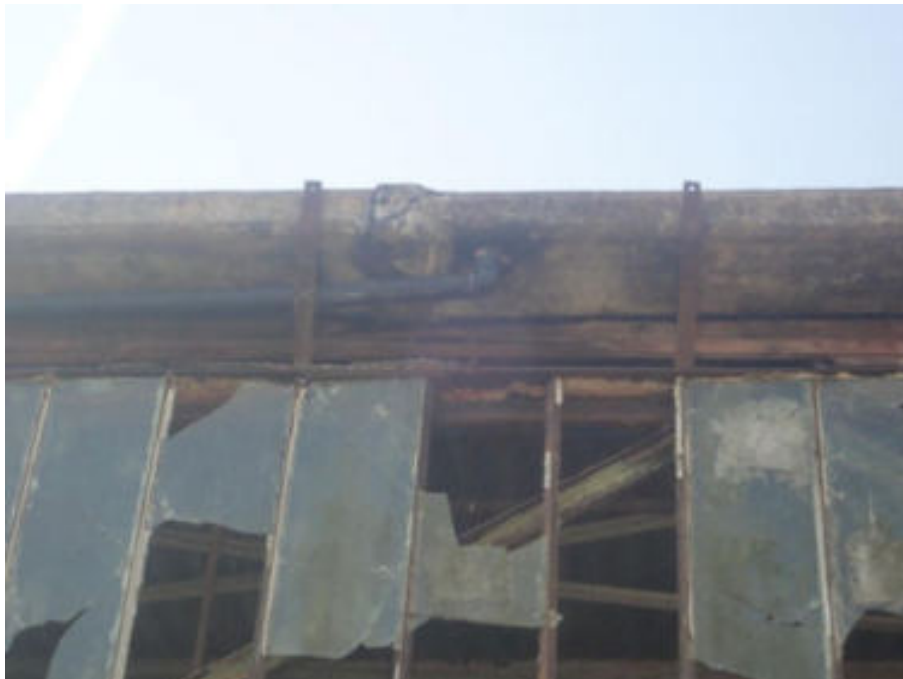
- 6.2.7 BD7 – Deterioration of timber fascia and broken windows.

*Figure 48. Typical deterioration to fascia*

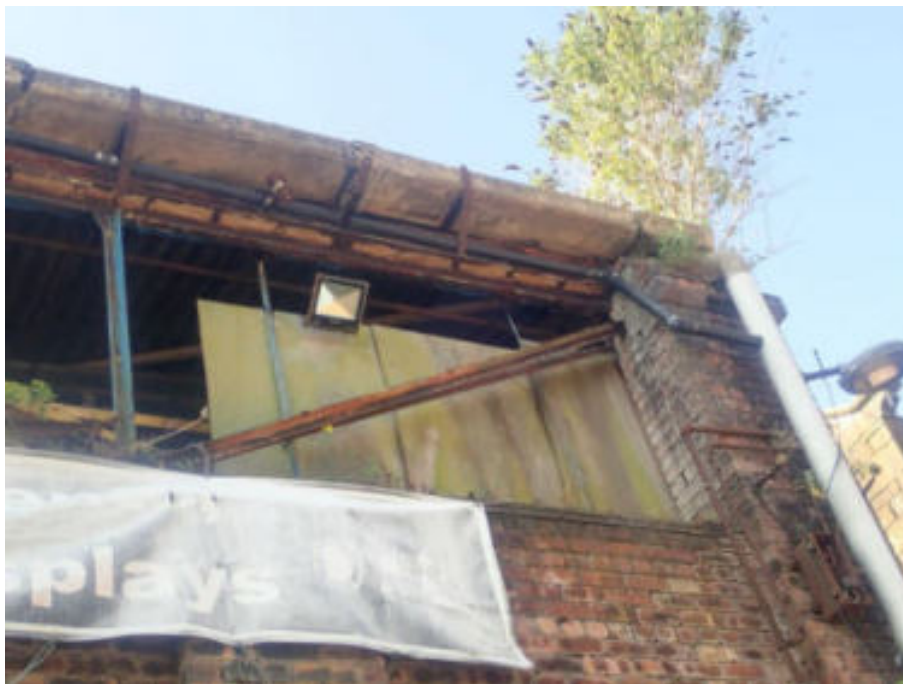
**6.2.11 BD11 – Angles on windows above main entrance have sheared.**

*Figure 52. Sheared angle*

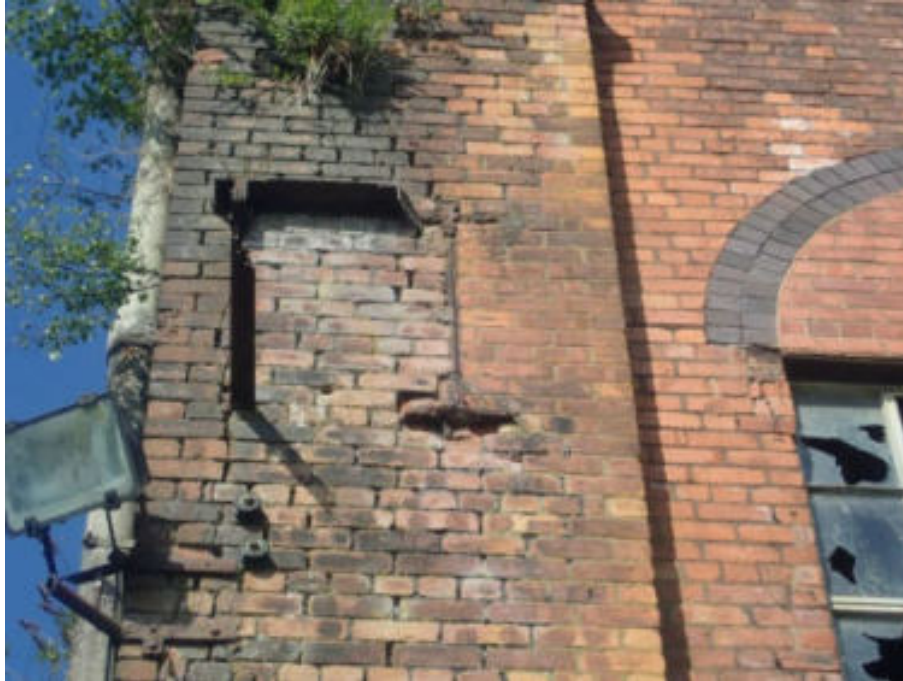
6.2.12 BD12 – Significant expansive corrosion noted on cantilevered crane beam to the front.

*Figure 53. Corrosion to crane beam*

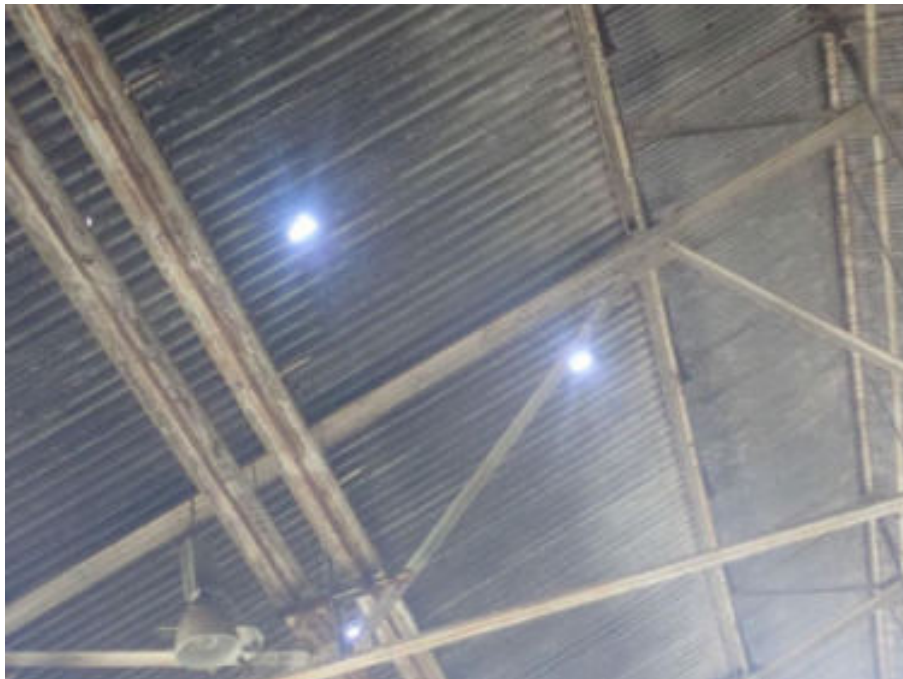
6.2.13 BD14 – Roof covering requires replacing.

*Figure 54. Typical deterioration of roof covering*

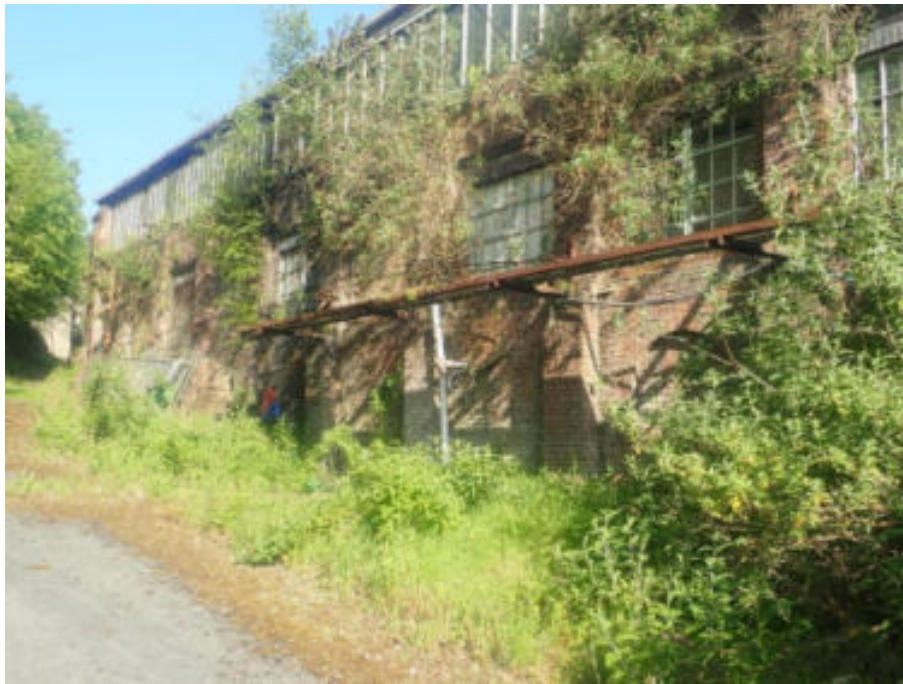
**6.2.14 BD17 – Area of vegetation growth on external wall.**

*Figure 55. Vegetation growth*

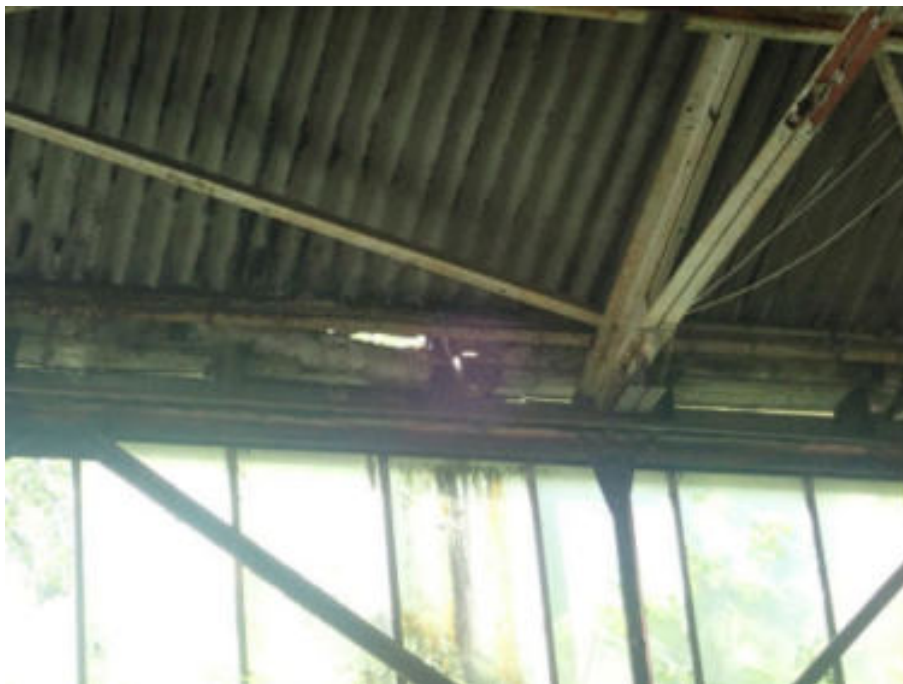
**6.2.15 BD18 – Minor surface corrosion to bottom cord of truss.**

*Figure 56. Typical corrosion to truss*
