# **BRYMBO HERITAGE PROJECT**

## **STRUCTURAL CONDITION ASSESSMENT**

**August 2023**  
**Suitability S2**  
**Revision P02**

**By:**  
Bingham Rawlings Partnership Ltd.

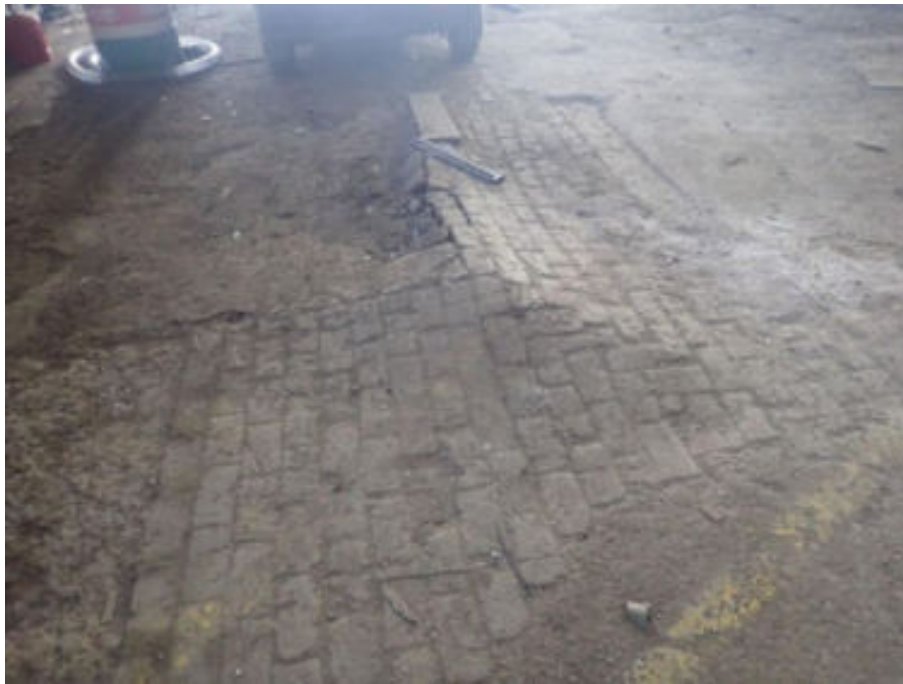
#### 6.2.16 BD10 – Deformed floor due to use of expansive slag.

*Figure 57. Deformed floor*

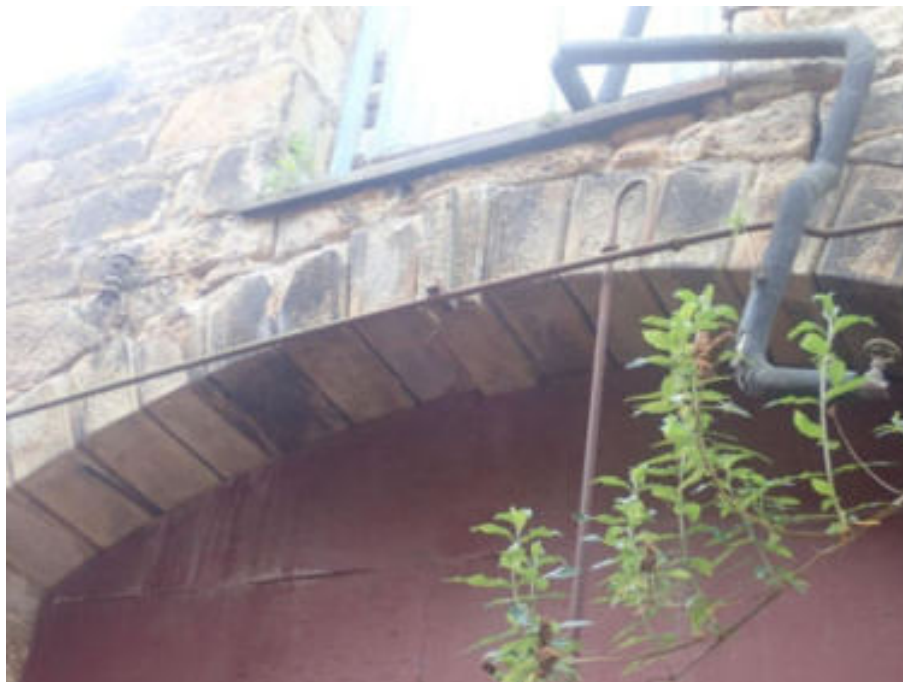
- 7.2.1 BE1 – Deteriorated masonry leading to the stones in the arch above the main doorway dropping. Refer to Defect Sketch in **Appendix D – Defect Sketches**.

*Figure 58. Dropped arch*

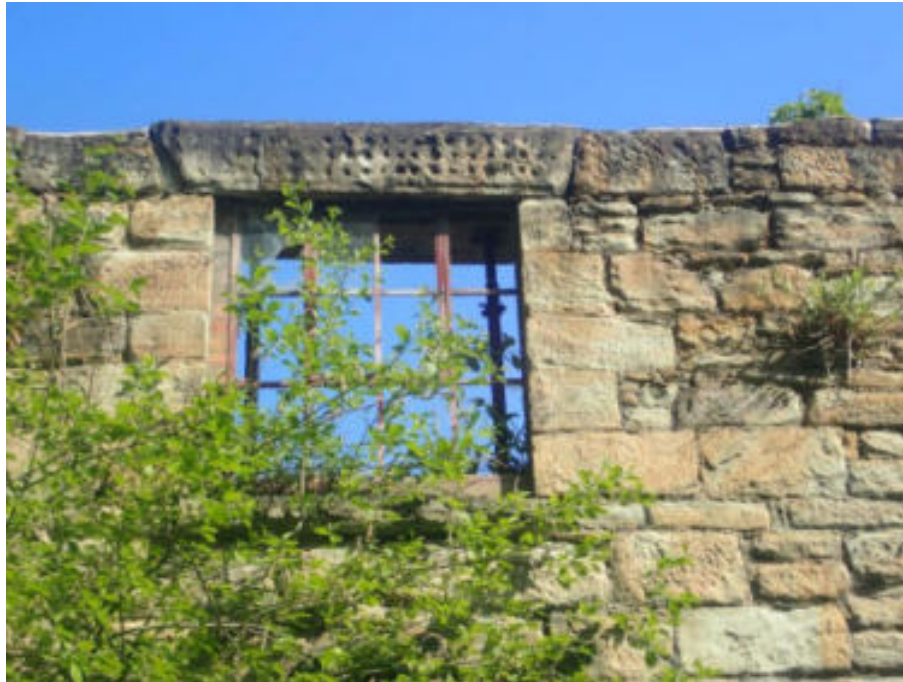
- 7.2.2 BE2 – Failed stone jam to 2nd floor south elevation windows. This has resulted in a slight drop to one side of the lintels. Sufficient bearing is still currently provided by the stone below. Refer to Defect Sketch in **Appendix D – Defect Sketches**.

*Figure 59. Typical failed stone jam*

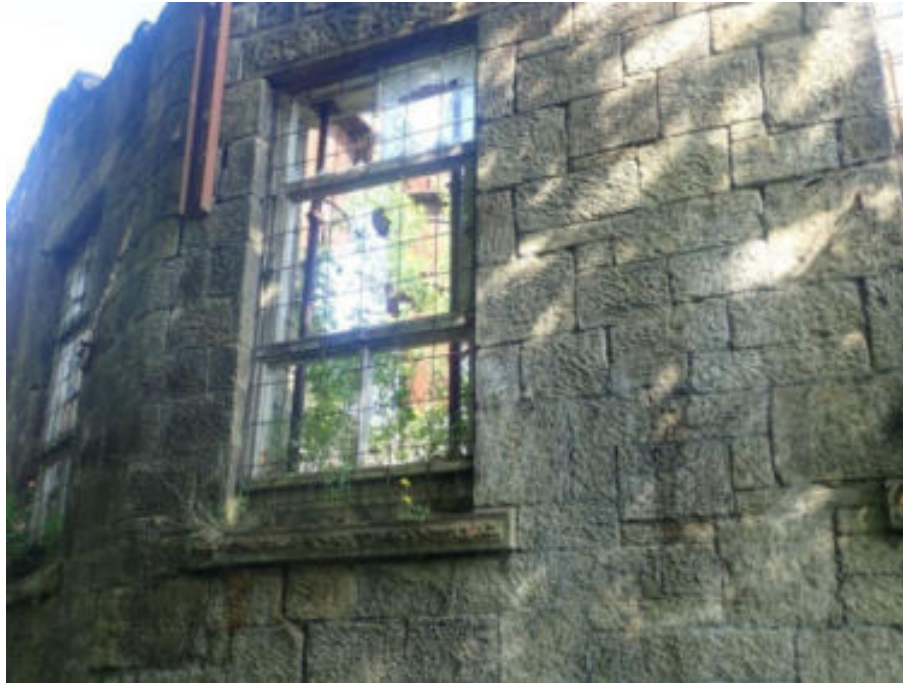
- 7.2.3 BE3 – Propped window lintels on the 2<sup>nd</sup> floor south elevation. Refer to Defect Sketch in **Appendix D – Defect Sketches**.

*Figure 60. Typical propped lintel*

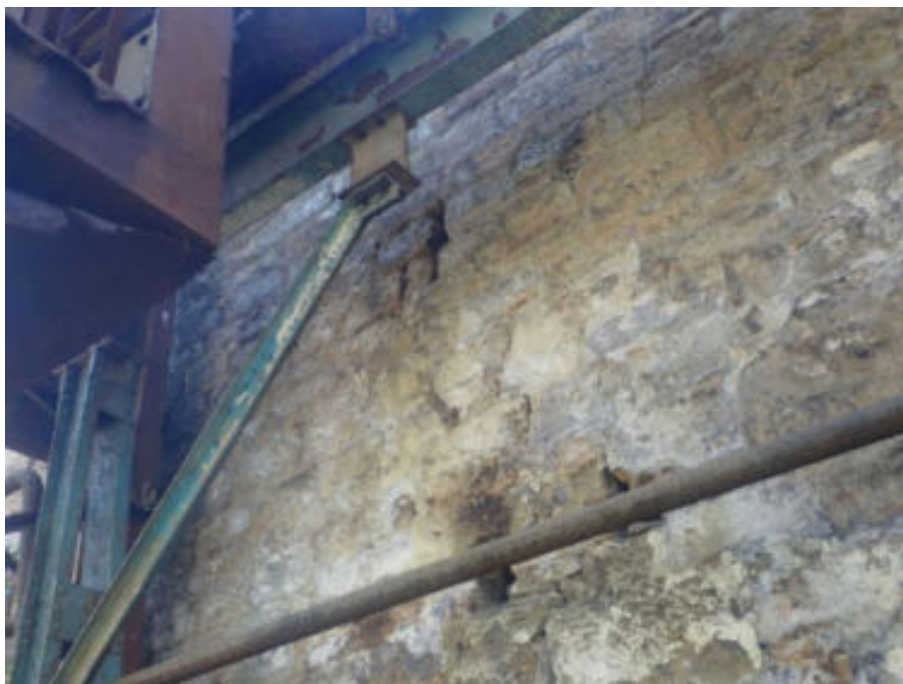
- 7.2.4 BE4 – Minor missing masonry and mortar loss on the north elevation. Refer to Defect Sketch in **Appendix D – Defect Sketches**.

*Figure 61. Typical missing masonry*

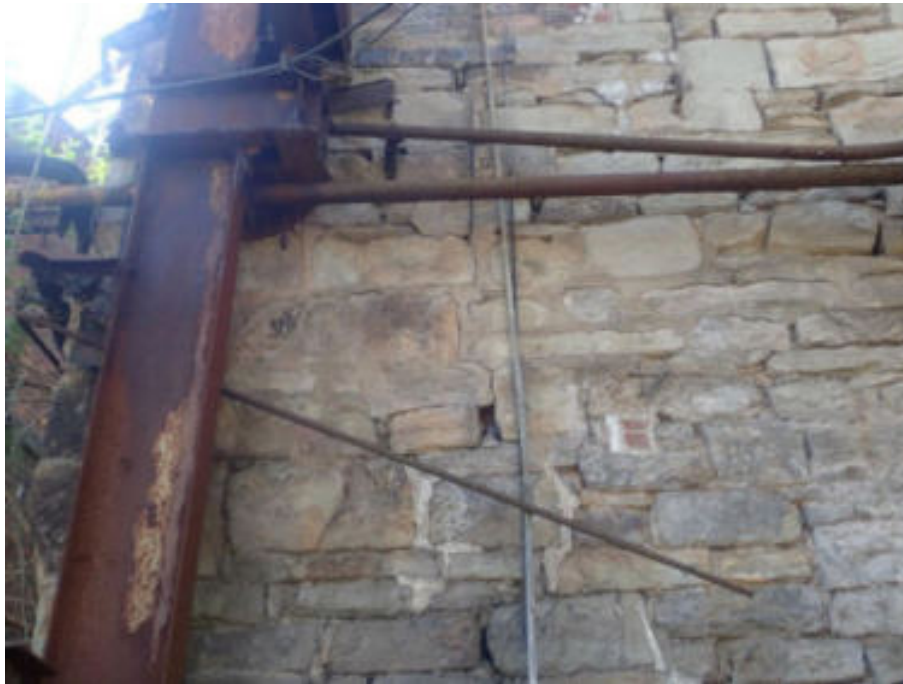
*Figure 62. Typical mortar loss*

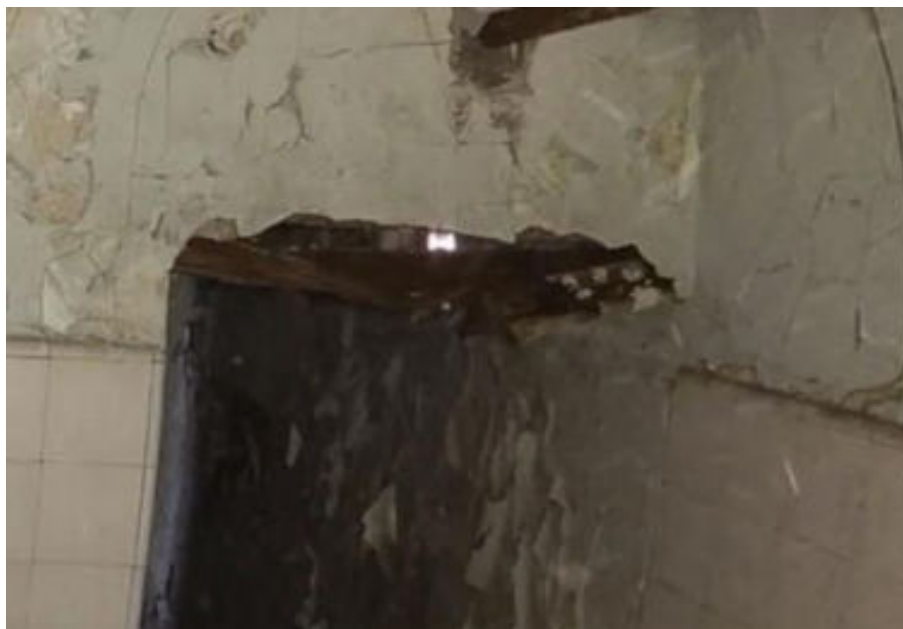
**7.2.5 BE5 – Failed timber lintels above the door internally on the ground floor. Refer to Defect Sketch in Appendix D – Defect Sketches.**

*Figure 63. Typical failed lintel*

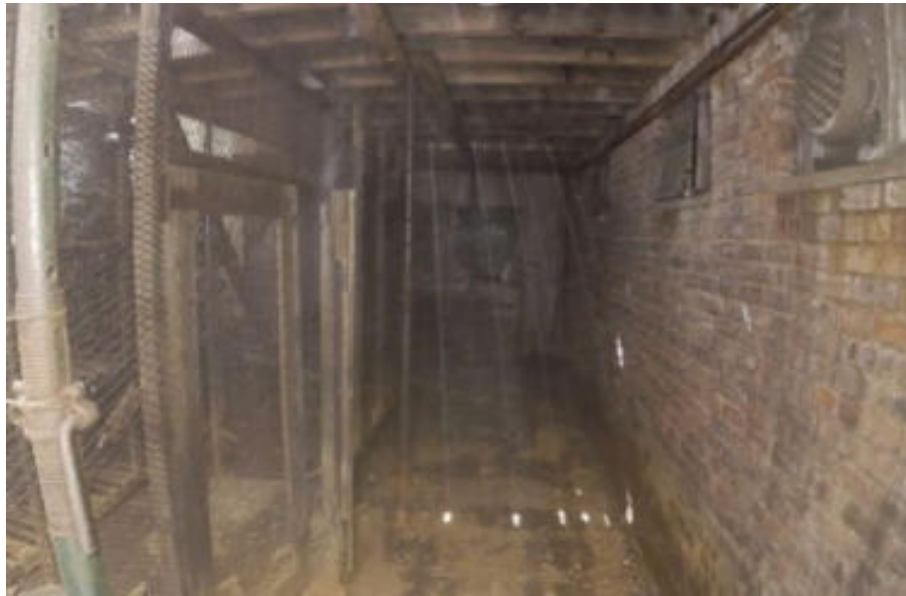
- 7.2.6 BE6 – Acrow props supporting the floor joists above. Internal first and second floor structure are generally in very poor condition with temporary props holding it up. Total collapse of section of 2nd floor noted due to failed bearing of timber joist. However, the temporary propping appears to be functioning adequately in preventing further instability or collapse of the internal structure. Refer to Defect Sketch in **Appendix D – Defect Sketches**.

*Figure 64. Typical acrow prop*

- 7.7.14 Monitor condition of temporary props. If functioning adequately keep in place until full remediation has been designed and implemented.
- 7.7.15 Due to lack of intrusive at hand access and based on failure through sheer at supports, allowance to be made for splicing of each joist.

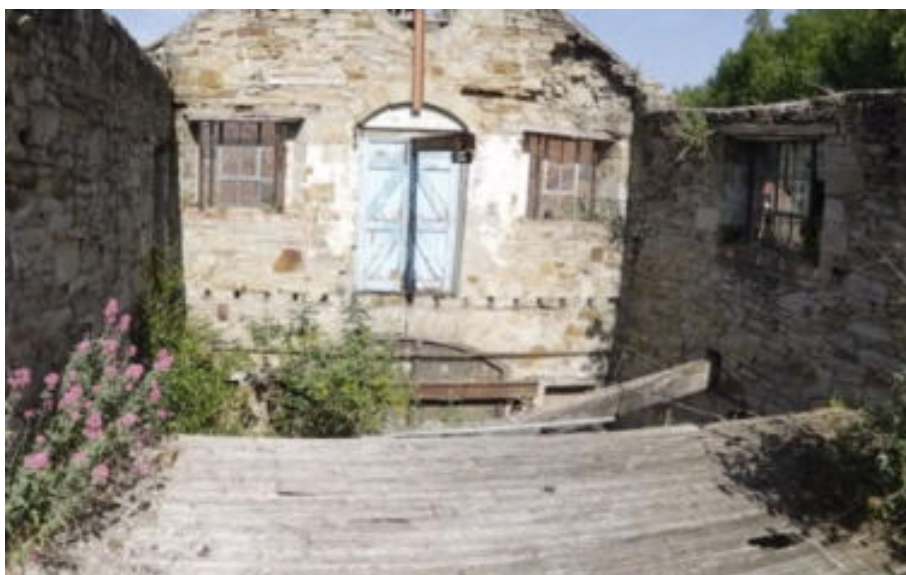
- 7.2.7 BE6 – Failed floor joist on 2<sup>nd</sup> floor. Refer to Defect Sketch in **Appendix D – Defect Sketches**.

*Figure 65. Failed section of 2<sup>nd</sup> floor*

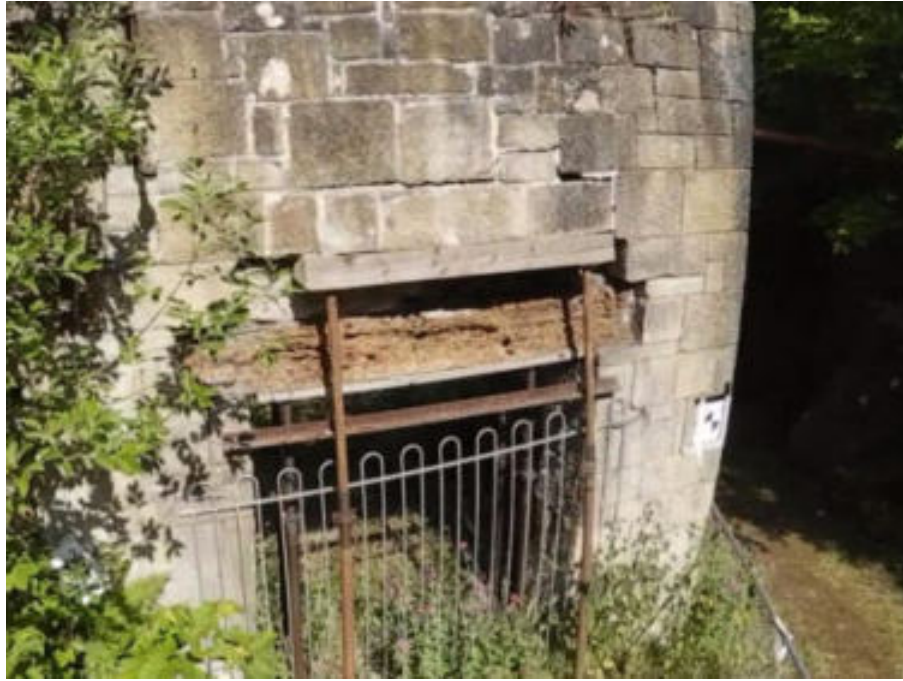
- 7.2.8 BE7 – Failed timber lintel on exterior west elevation with temporary propping. Refer to Defect Sketch in **Appendix D – Defect Sketches**.

*Figure 66. Failed lintel*

- 7.7.10 Replace propped lintel on west elevation with suitably designed member ensuring adequate bearing.
- 7.7.11 Replace deflected lintel with suitably designed member ensuring adequate bearing.

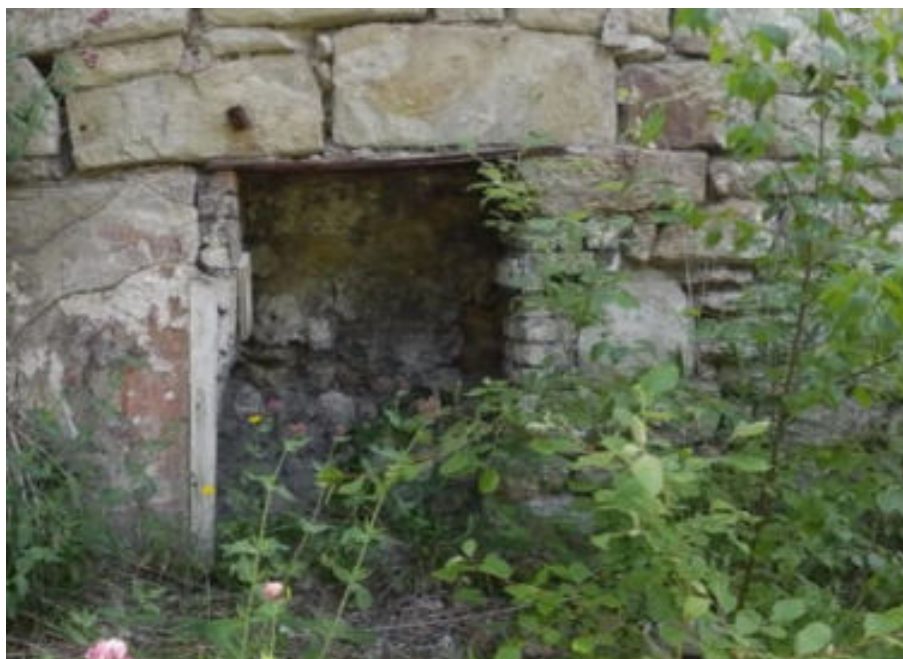
- 7.2.9 BE8 – Significant deflection to steel lintel internally at the west of the building. Member is insufficient size for applied load. Refer to Defect Sketch in **Appendix D – Defect Sketches**.

*Figure 67. Deflection to lintel*

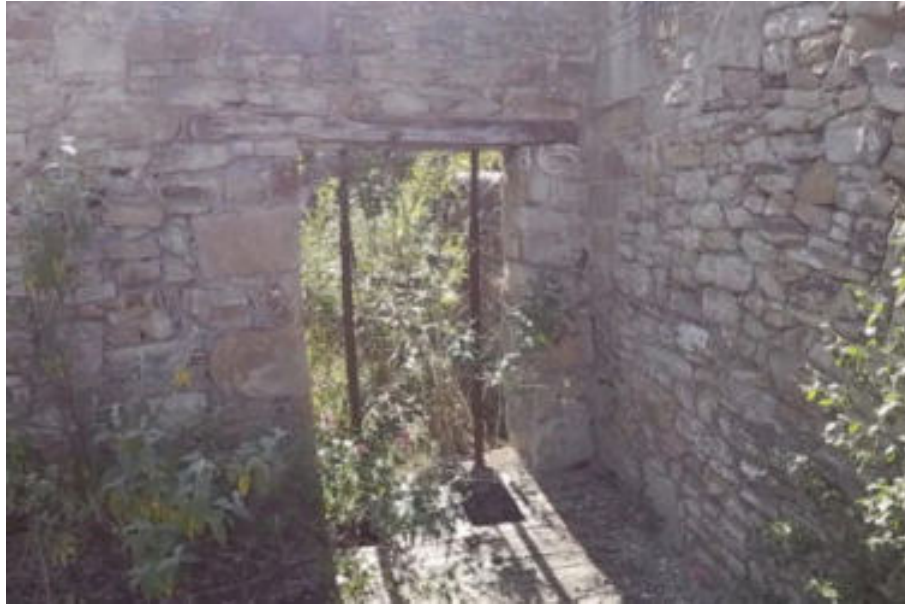
7.2.10 BE9 – Propped timber lintel internally on 2nd floor. Refer to Defect Sketch in **Appendix D – Defect Sketches**.

*Figure 68. Propped timber lintel*

- 7.7.12 Replace propped lintel on 2<sup>nd</sup> floor with suitably designed member ensuring adequate bearing.
- 7.7.13 Masonry repair works are recommended to the collapsed section of inner leaf on the gable end.

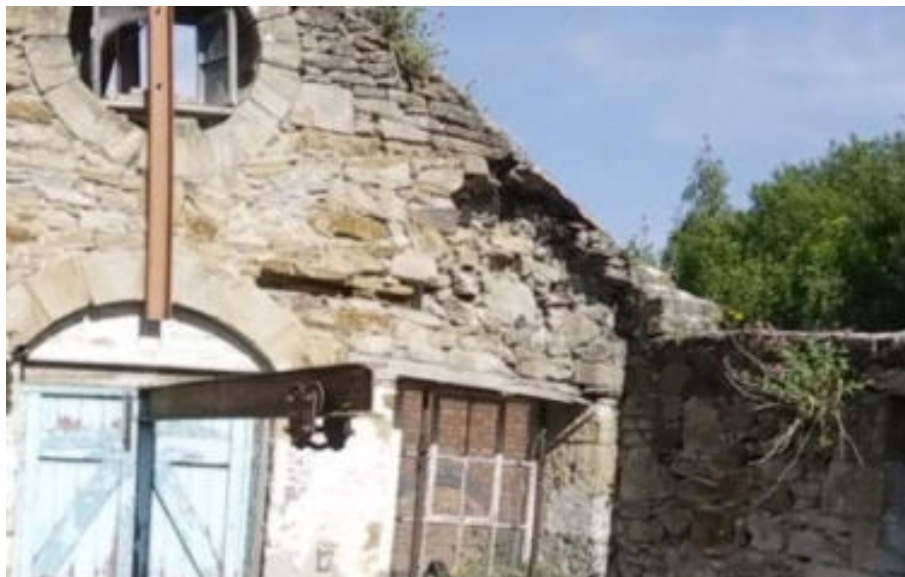
7.2.11 BE10 – Localised collapse to inner leaf of stone masonry wall internally on gable end. Refer to Defect Sketch in **Appendix D – Defect Sketches**.

*Figure 69. Localised collapse of inner leaf*

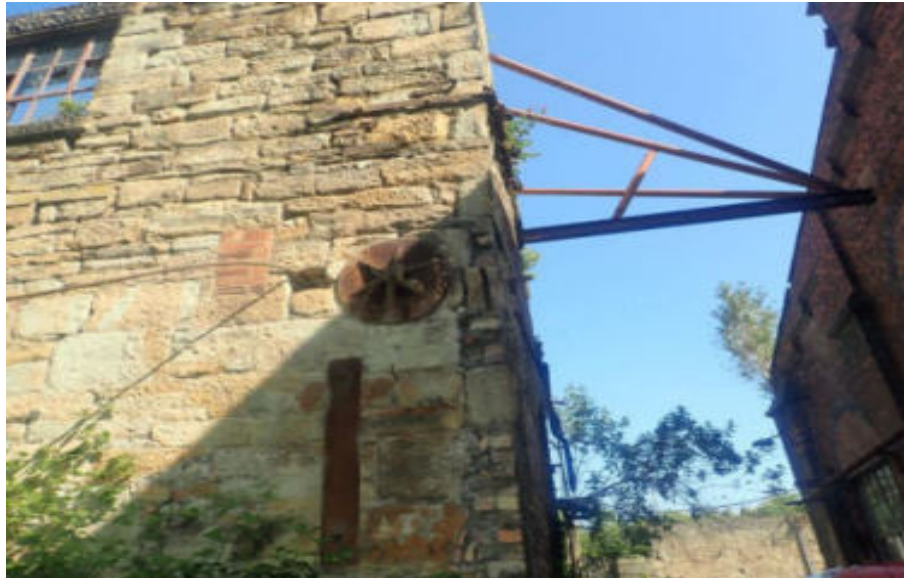
**7.2.12 BE11 – Steel prop on gable end. Refer to Defect Sketch in Appendix D – Defect Sketches.**

*Figure 70. Steel prop*

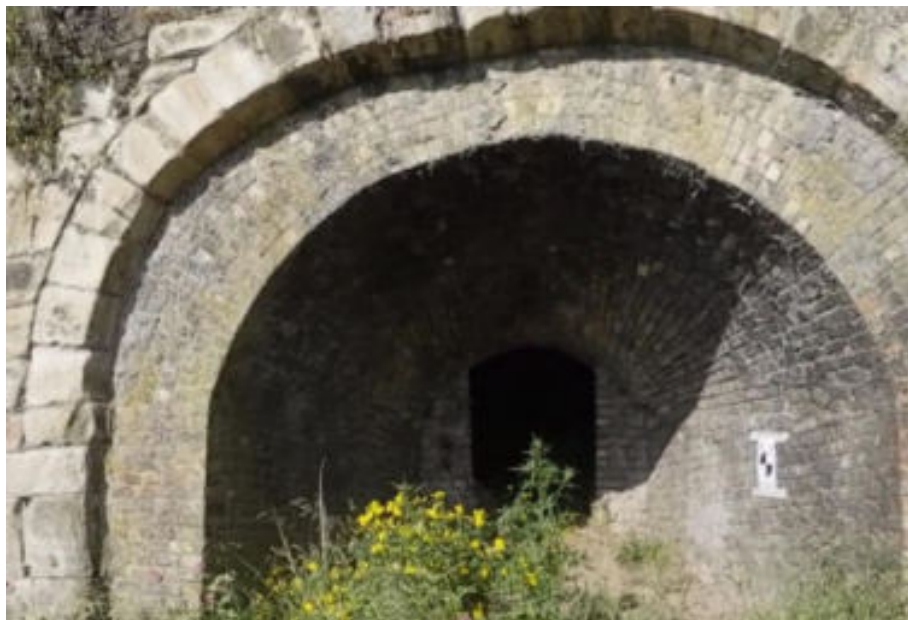
- 8.2.1 BF1 – Keystone to original stone arch has dropped, and as a measure to address this, an additional arch has been constructed beneath it. The newly added arch seems to be structurally stable and secure.

*Figure 71. Additional arch*

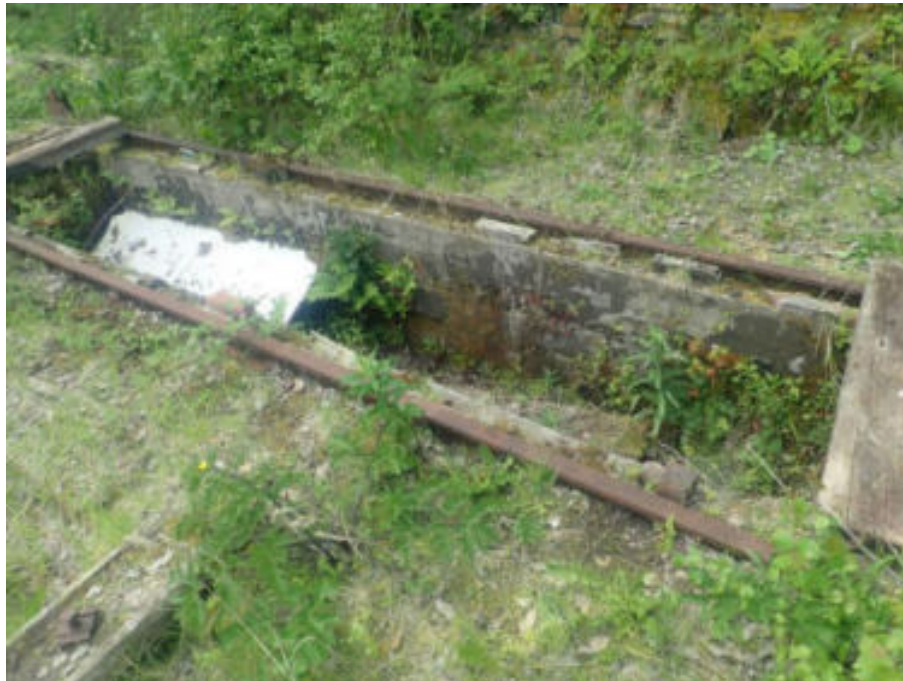
11.2.2 Vegetation growth was noted.

*Figure 78. Vegetation growth*

11.4.1 Remove vegetation to prevent damage to structure.

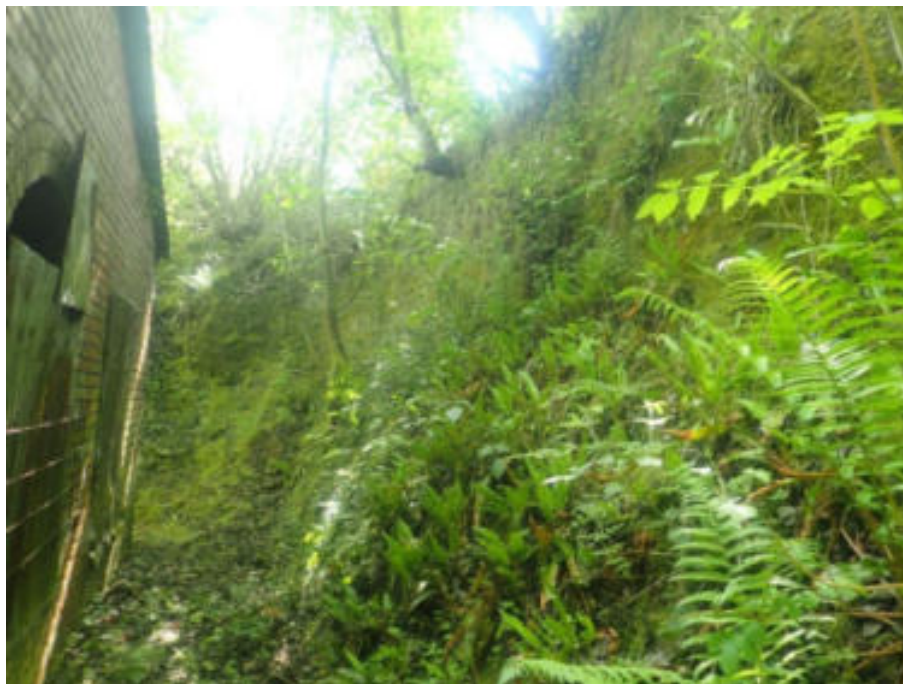
12.2.1 RWA1 – Significant vegetation growth and moss growth on face of wall and at base.

*Figure 79. Typical vegetation growth*

12.6.1 Implement a long term maintenance and inspection regime. For this type of structure, recommend annual vegetation removal with annual general inspection.

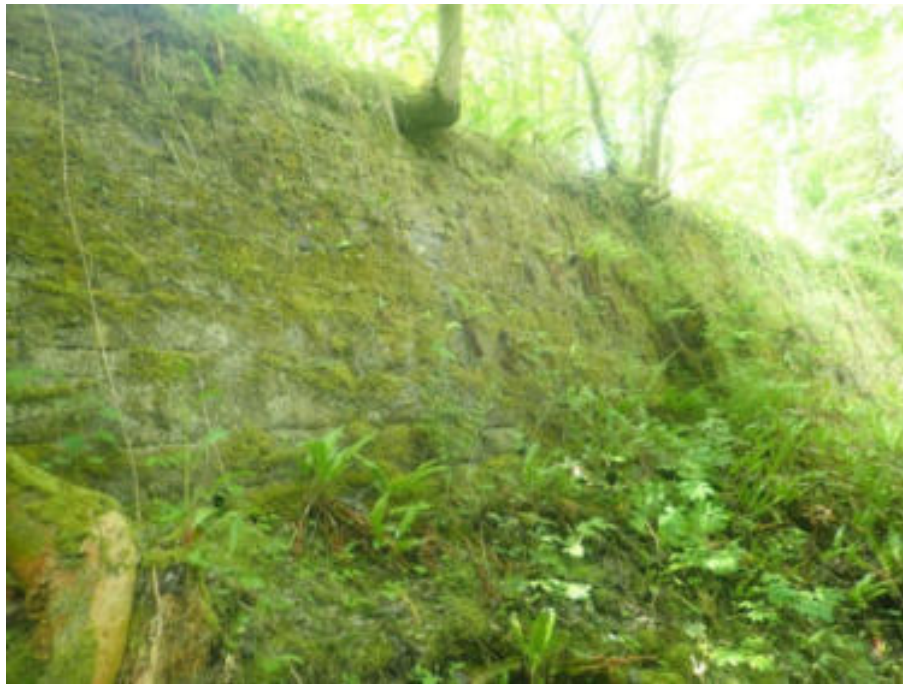
#### 12.2.2 RWA2 – Sapling and mature tree growth in retained areas above retaining wall.

*Figure 80. Typical sapling and mature tree growth*

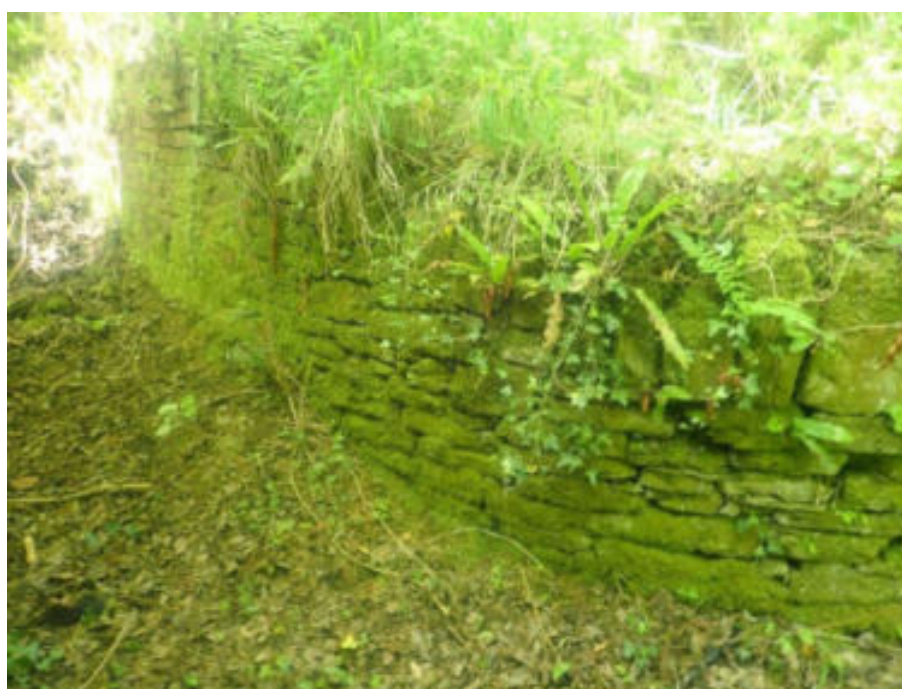
- 13.2.1 RWB1 – Significant vegetation growth and moss growth on face of wall and at base.

*Figure 81. Typical moss and vegetation growth*

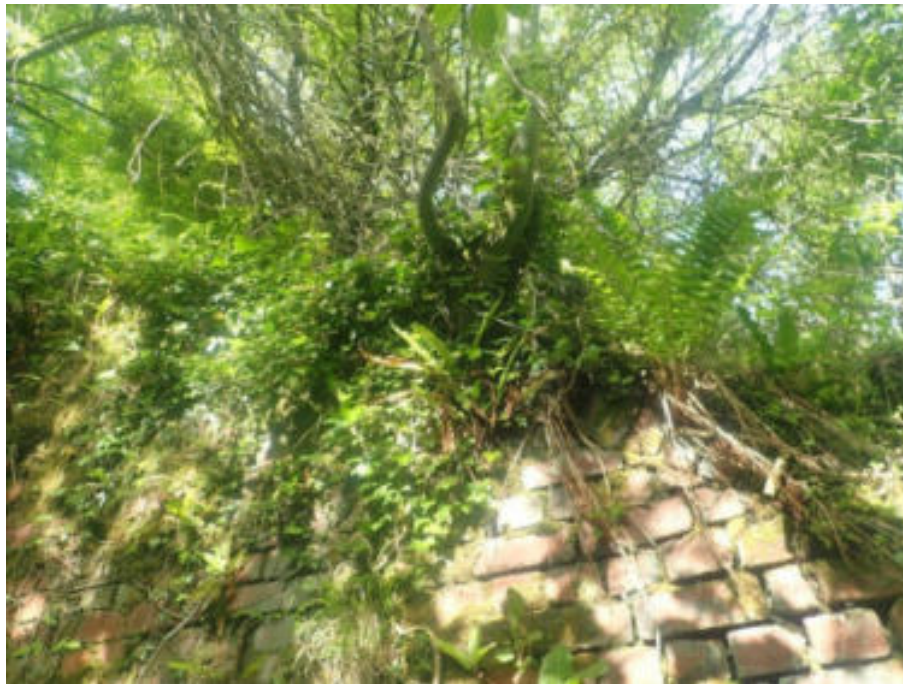
### 13.2.2 RWB2 – Sapling and mature tree growth in retained areas above retaining wall.

*Figure 82. Sapling and mature tree growth*

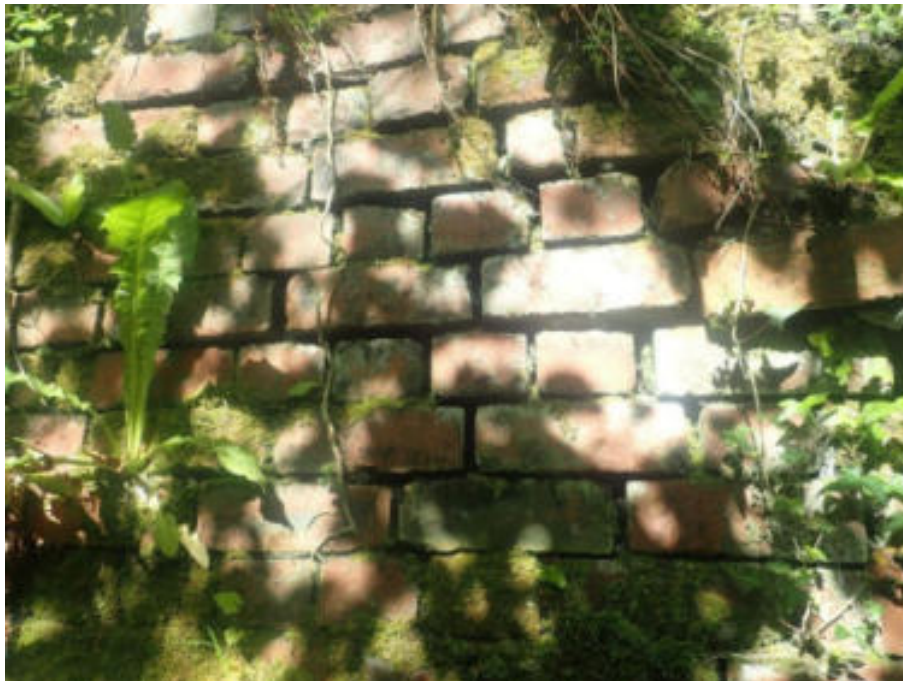
### 13.2.3 RWB3 – Deterioration and desiccation of the mortar pointing.

*Figure 83. Typical deterioration and desiccation to pointing*

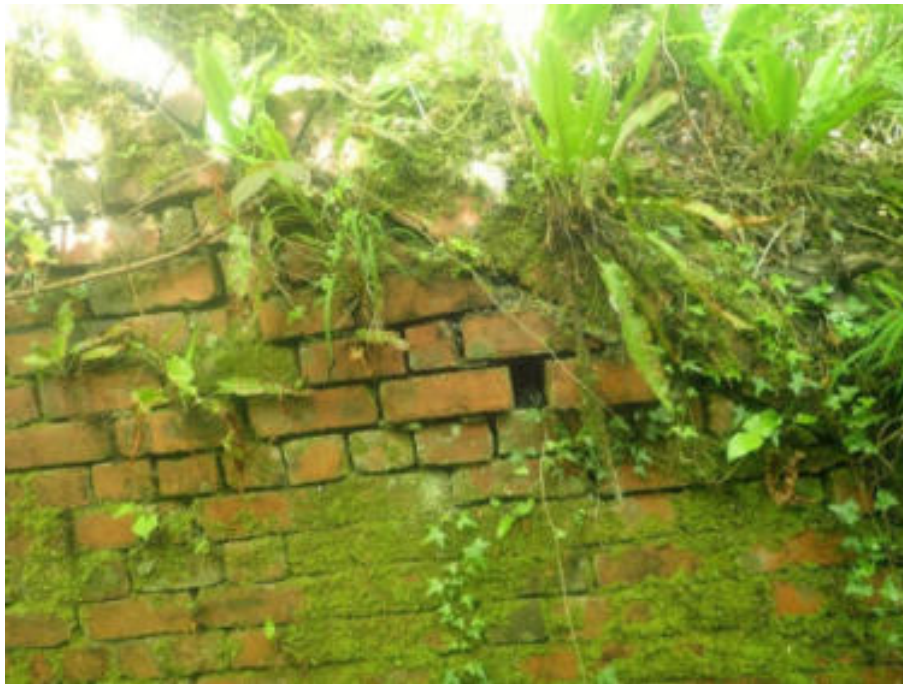
#### 13.2.4 RWB4 – Localised area of dislodged brickwork due to vegetation growth.

*Figure 84. Area of dislodged brickwork*

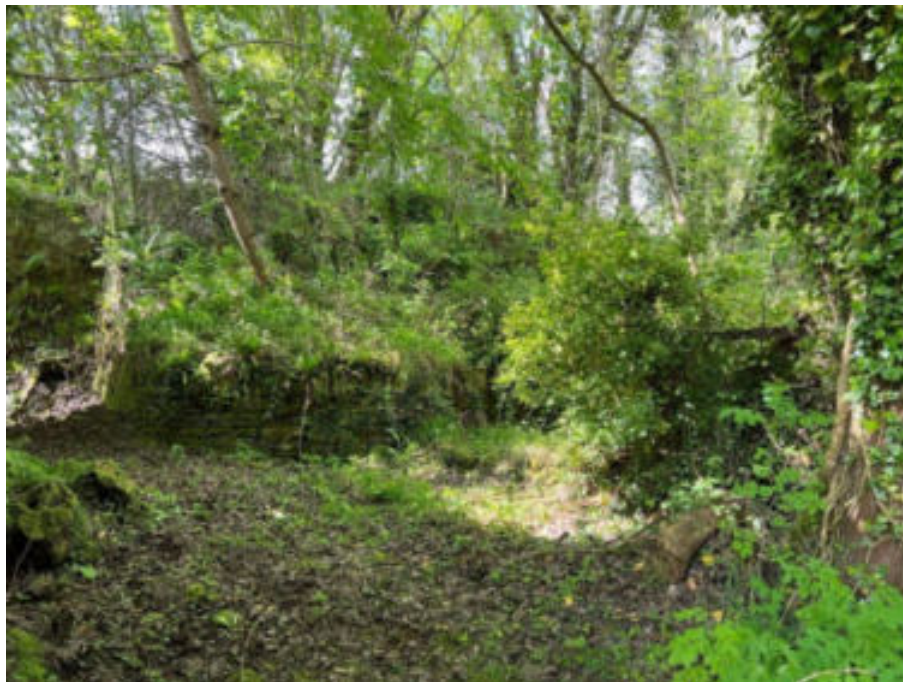
14.2.1 RWC1 – Significant vegetation growth and moss growth on face of wall and at base.

*Figure 85. Vegetation growth*

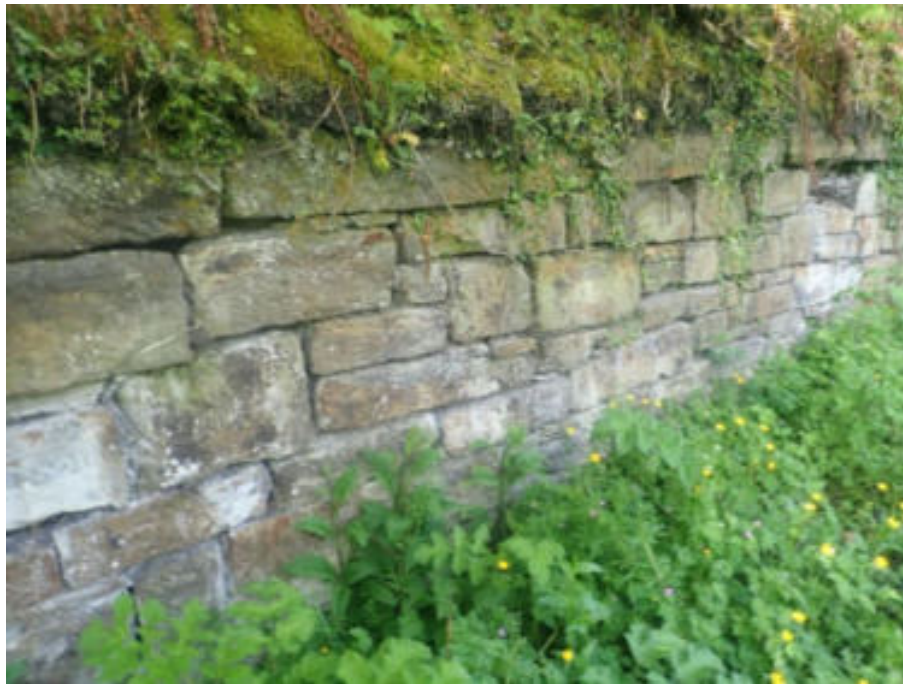
**15.2.2 RW1B – Mortar loss noted along the wall, approx. 10-20% of total area.**

***Figure 89. Typical mortar loss***

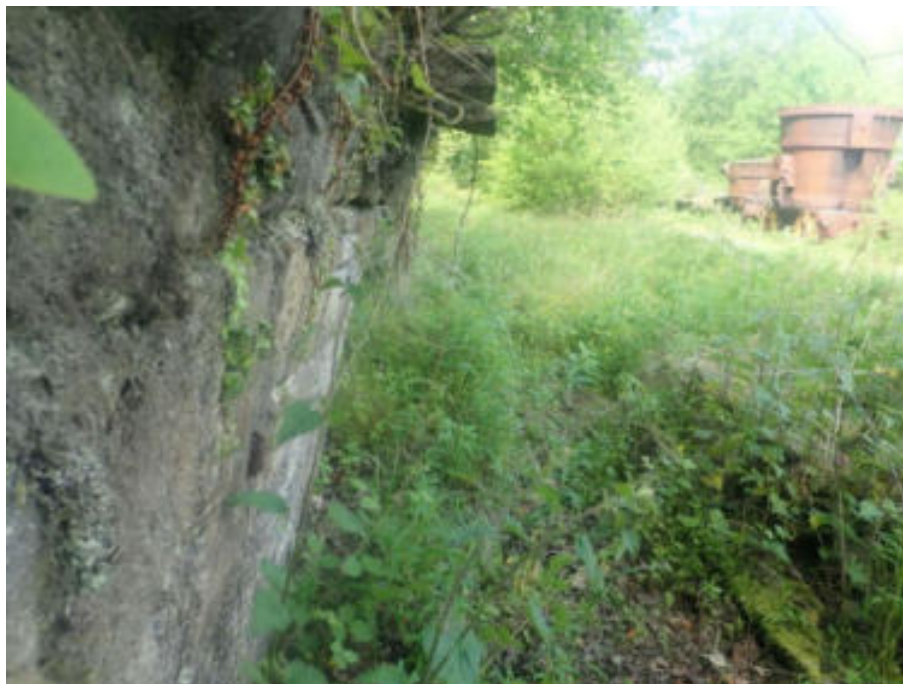
**15.2.3 RW1C – 300m lateral displacement resulting the wall entering a mode of failure.**

***Figure 90. Lateral displacement***

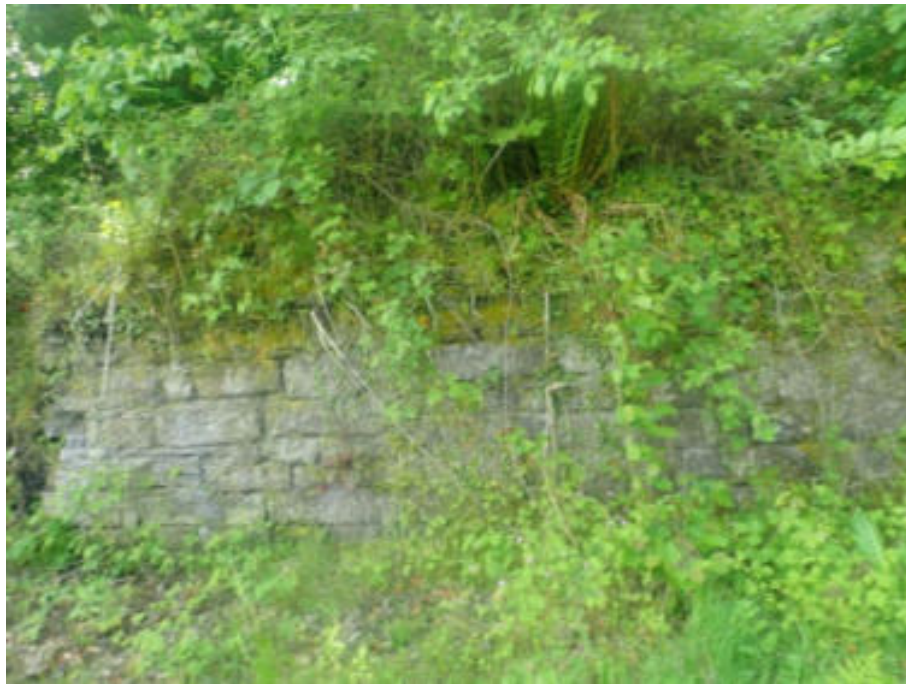
#### 15.2.4 RW1D – Vegetation growth.

*Figure 91. Typical vegetation growth*

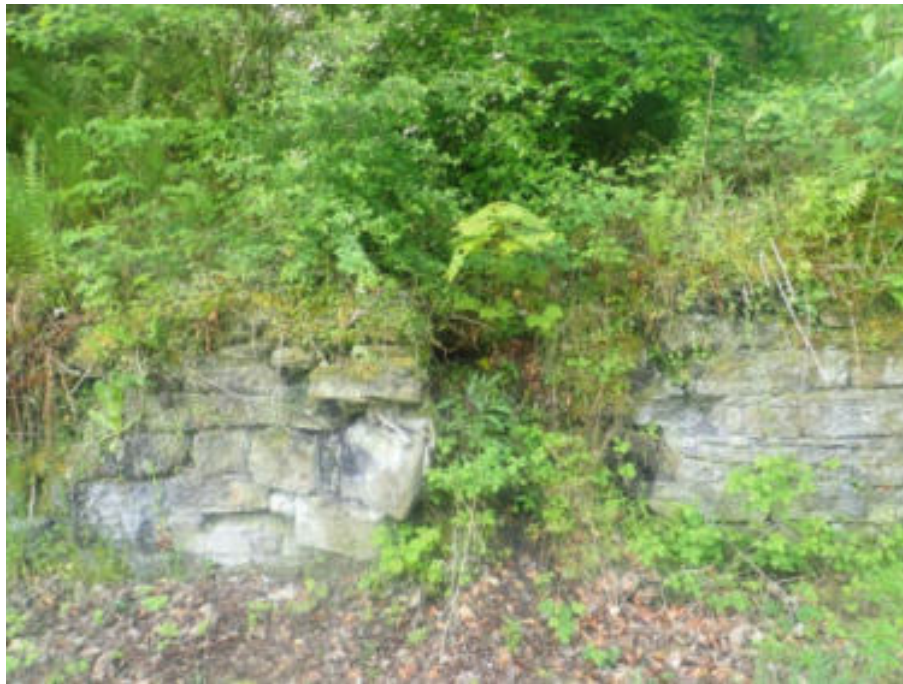
#### 15.2.6 RW1F – Section of wall has failed.

*Figure 93. Failed section of wall*

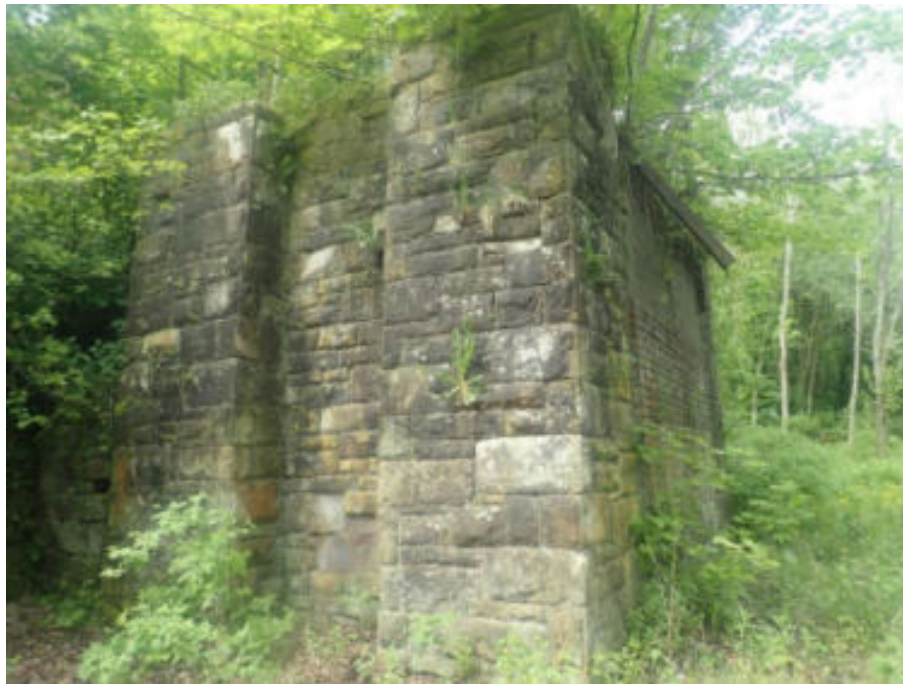
### 16.2.3 RW2C – Lateral displacement.

*Figure 96. Lateral displacement*

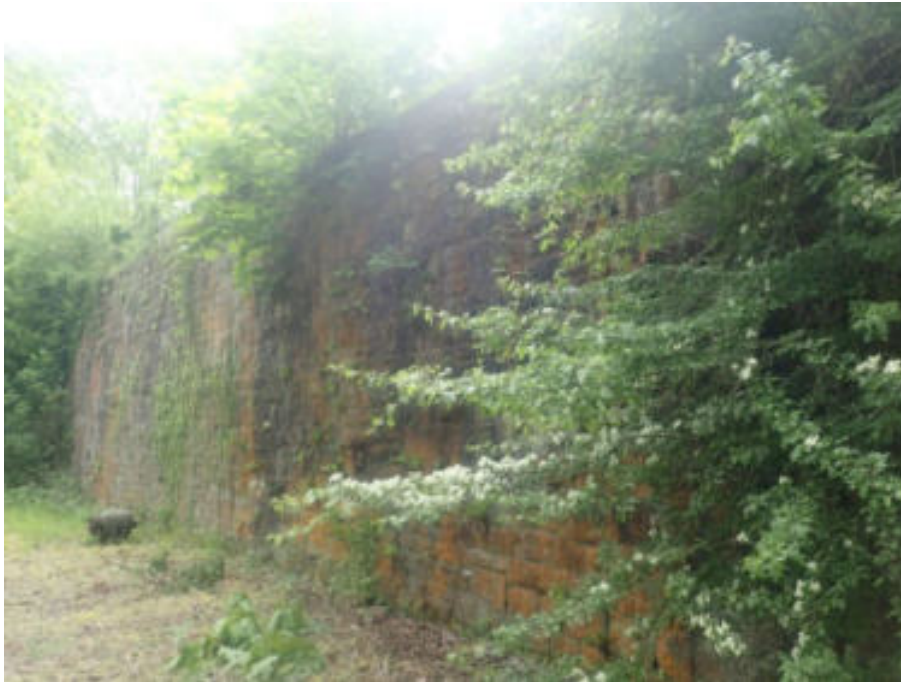
### 16.2.5 RW2E – Vegetation growth.

*Figure 98. Typical vegetation growth*

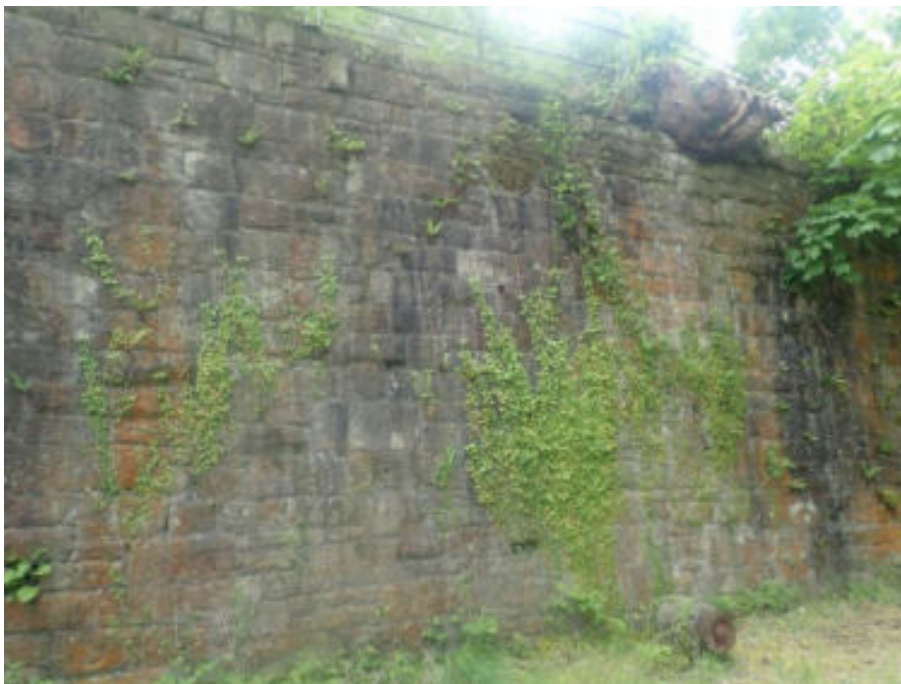
### 16.2.6 RW2F – Remains of tree.

*Figure 99. Tree*

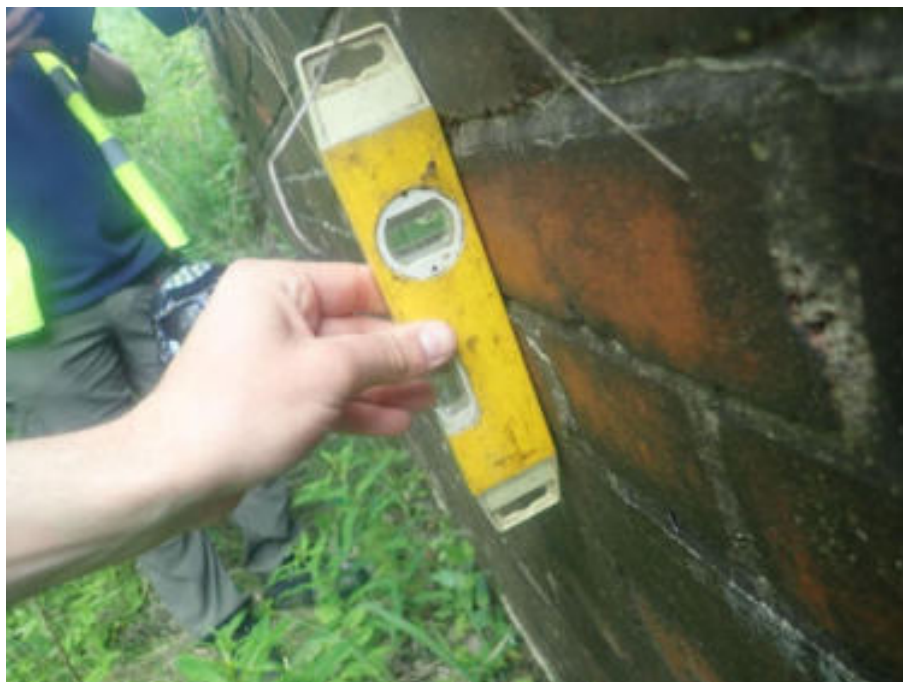
- 17.2.1 RW3-1 – There is a consistent lean of approximately 3 degrees from the vertical towards the rail track. The lean is visibly noticeable but the wall's centre of gravity is still contained within its middle third.

*Figure 100. Leaning wall*

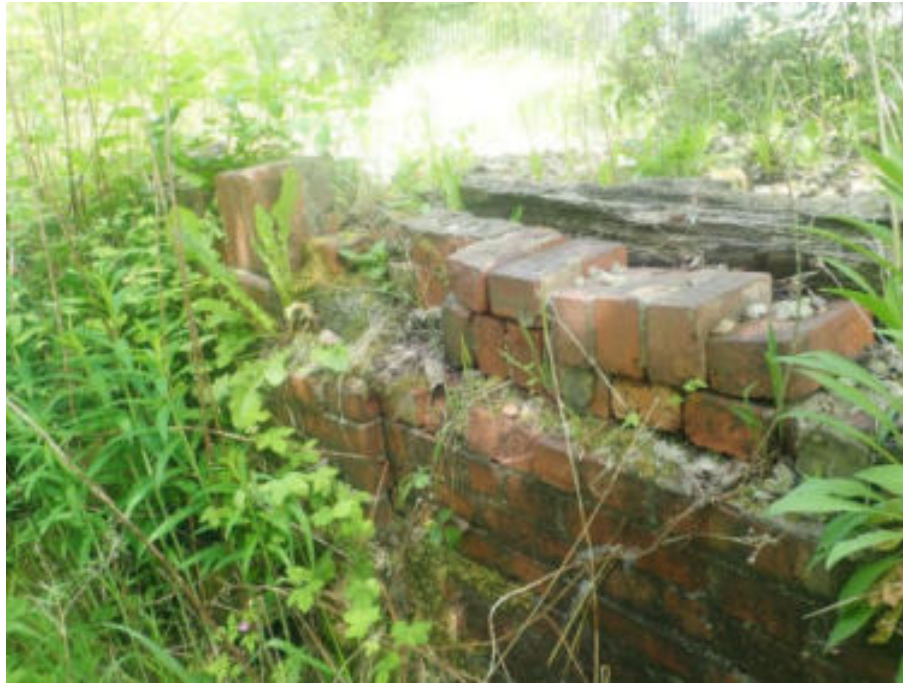
17.2.2 RW3-2 – Dislodged coping in localised areas due to vegetation growth both on the wall, in front of the wall and within the retained platform above.

*Figure 101. Typical dislodged coping*

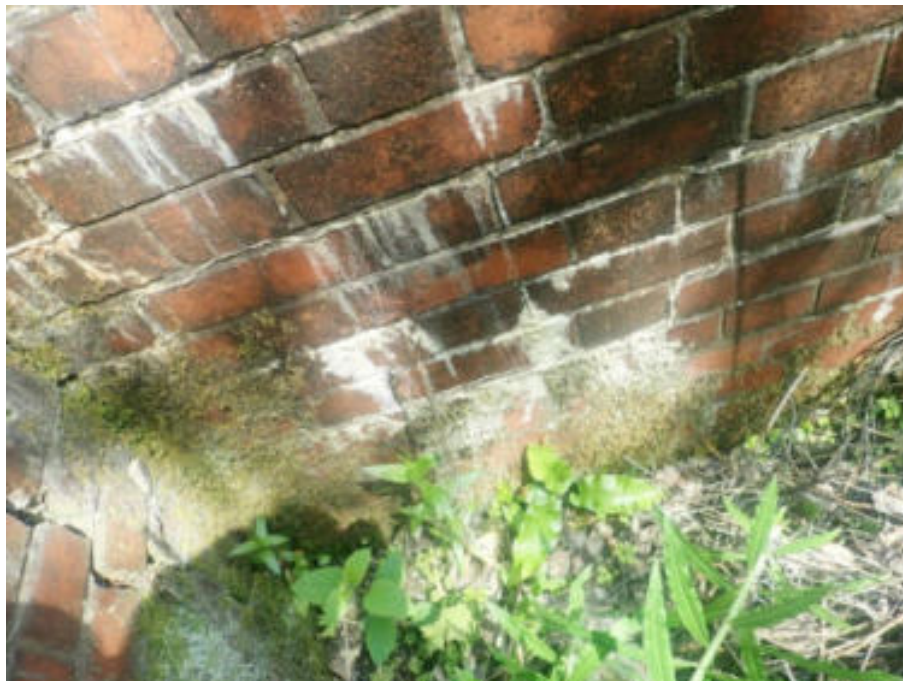
17.2.3 RW3-3 – Evidence of effervescent at lower level of the exposed wall face indicative of sulphate leaching as a result of a lack of weep holes.

*Figure 102. Typical effervescent*

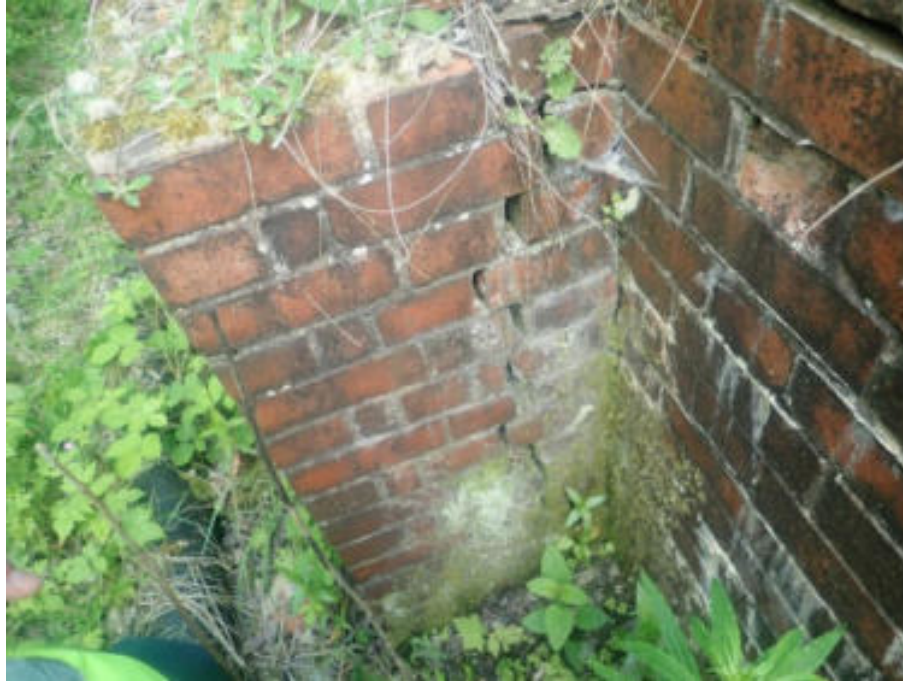
17.2.4 RW3-4 – Vertical crack measuring between 15mm - 25mm at wall return location as a result of the leaning action of the wall.

*Figure 103. Vertical crack*

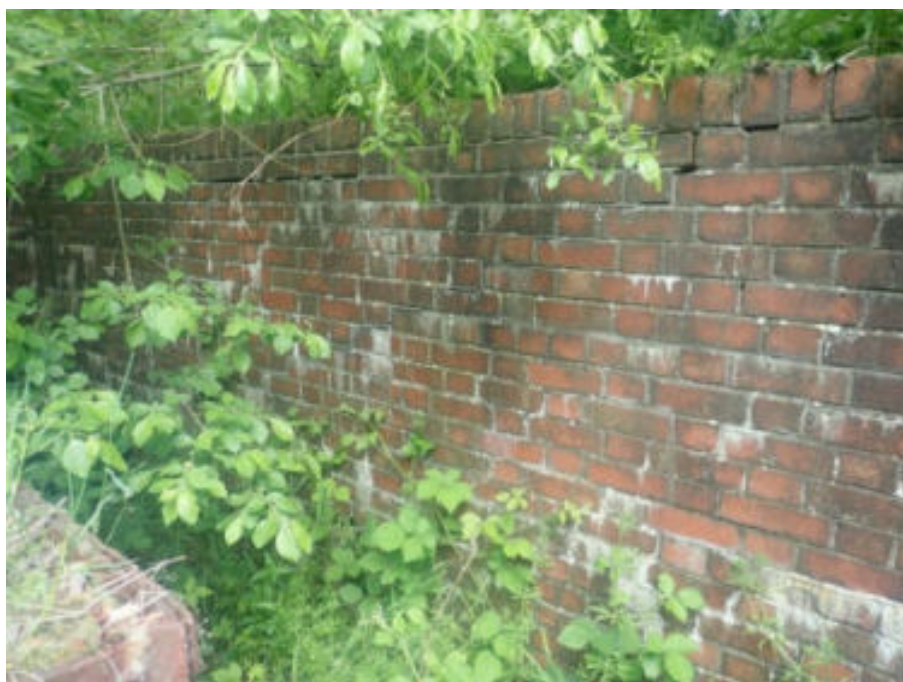
17.2.5 RW3-5 – Full height diagonal crack in mortar joints as a direct result of a mature tree directly behind the wall at high level and as a result of no formal movement joints being constructed within the wall to counter thermal movement.

*Figure 104. Diagonal crack*
