# **BRYMBO HERITAGE PROJECT**

## **STRUCTURAL CONDITION ASSESSMENT**

**August 2023**  
**Suitability S2**  
**Revision P02**

**By:**  
Bingham Rawlings Partnership Ltd.

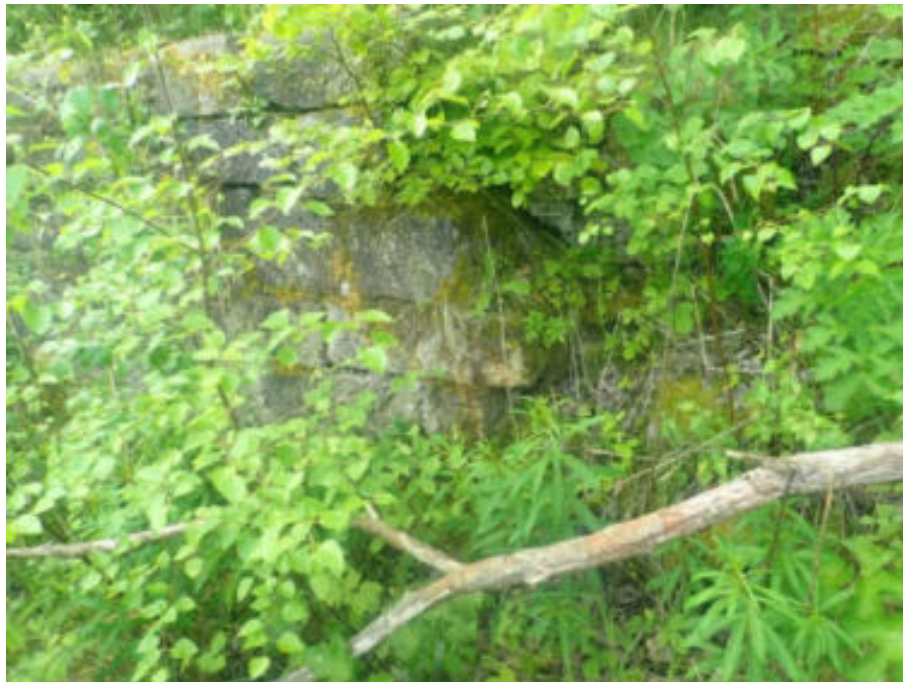
18.2.1 RW4A – Displaced and loose masonry to localised areas as a result of vegetation growth.

*Figure 105. Typical displaced and loose masonry*

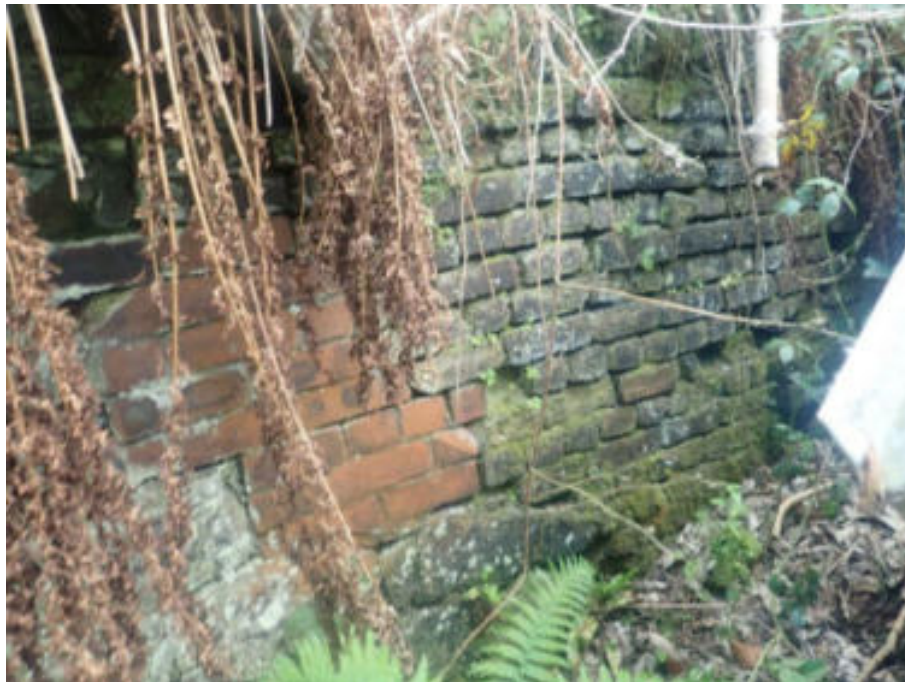
20.2.1 RW6A – Historic brick repair.

*Figure 109. Historic brick repair*

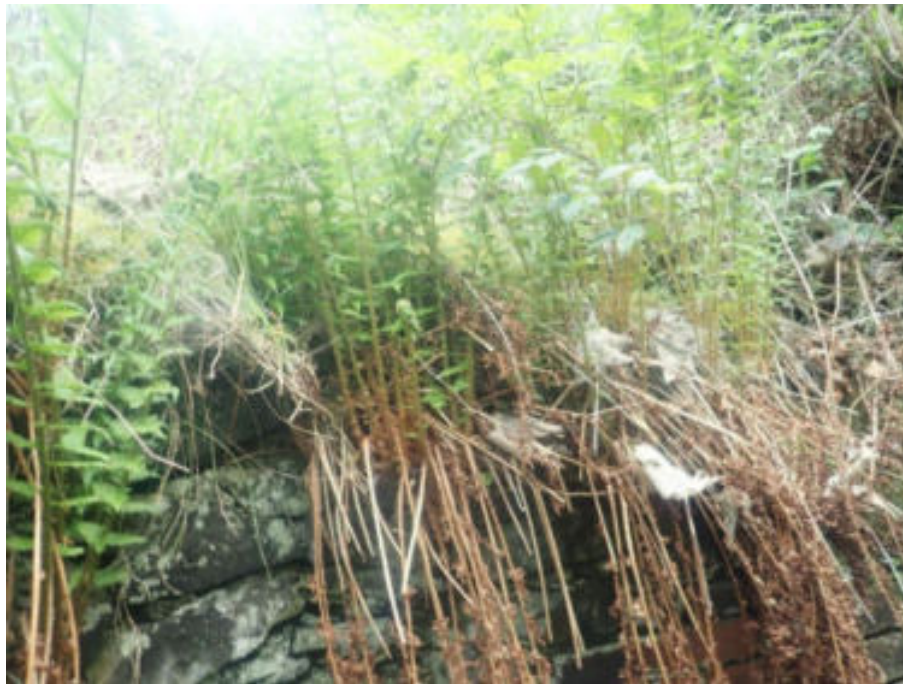
### 20.2.2 RW6B – Vegetation growth.

*Figure 110. Typical vegetation growth*

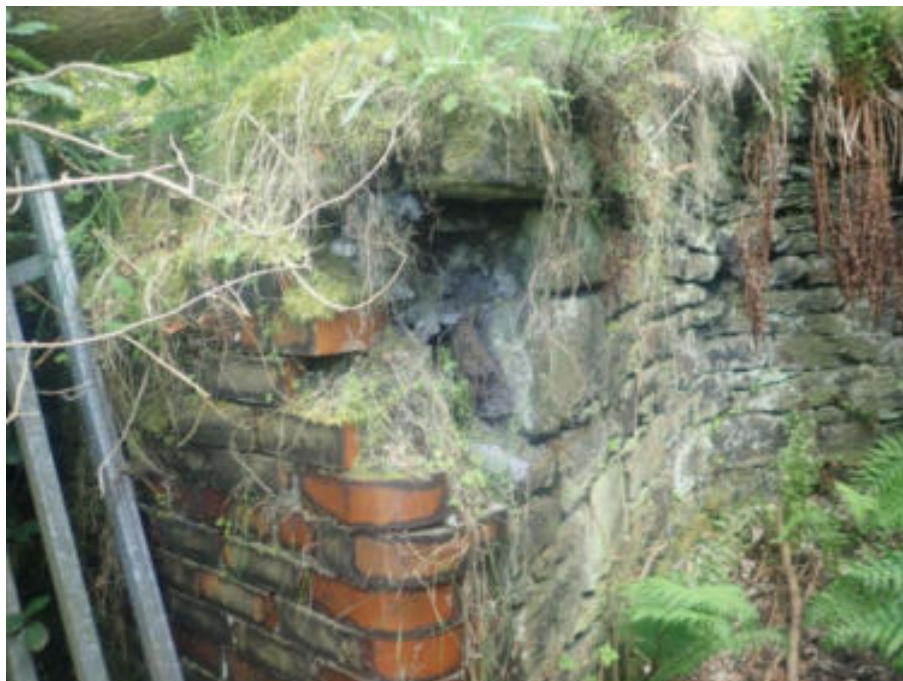
### 20.2.3 RW6C – Misaligned and partially collapsed area of natural stone retaining wall to rear of the Agent's House due to vegetation growth.

*Figure 111. Partially collapsed wall*

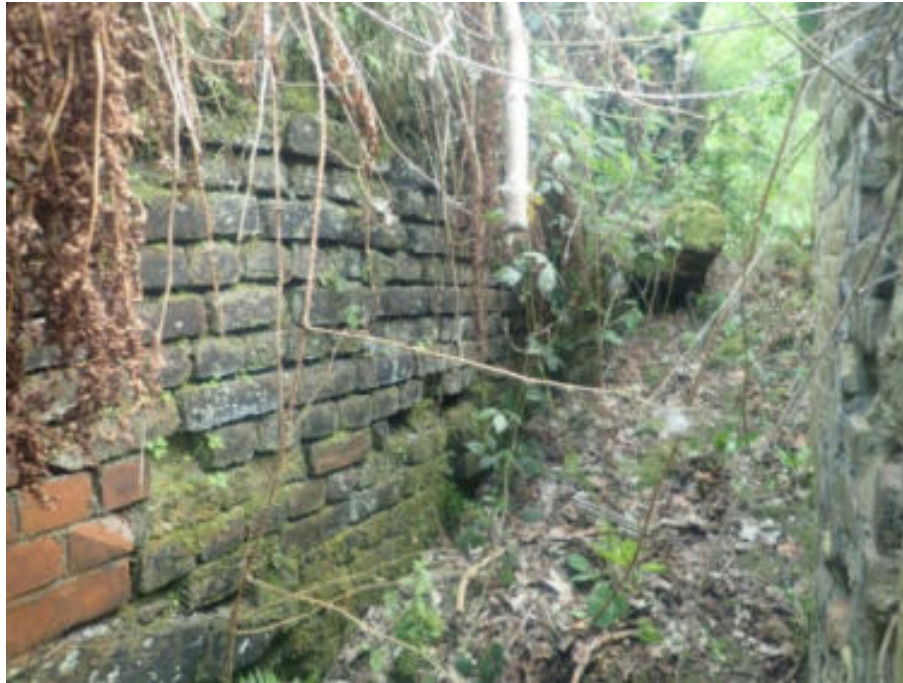
**20.2.4 RW6D – Debonded and dislodged brickwork due to vegetation growth on face of wall and at head of wall.**

*Figure 112. Debonded and dislodged brickwork*

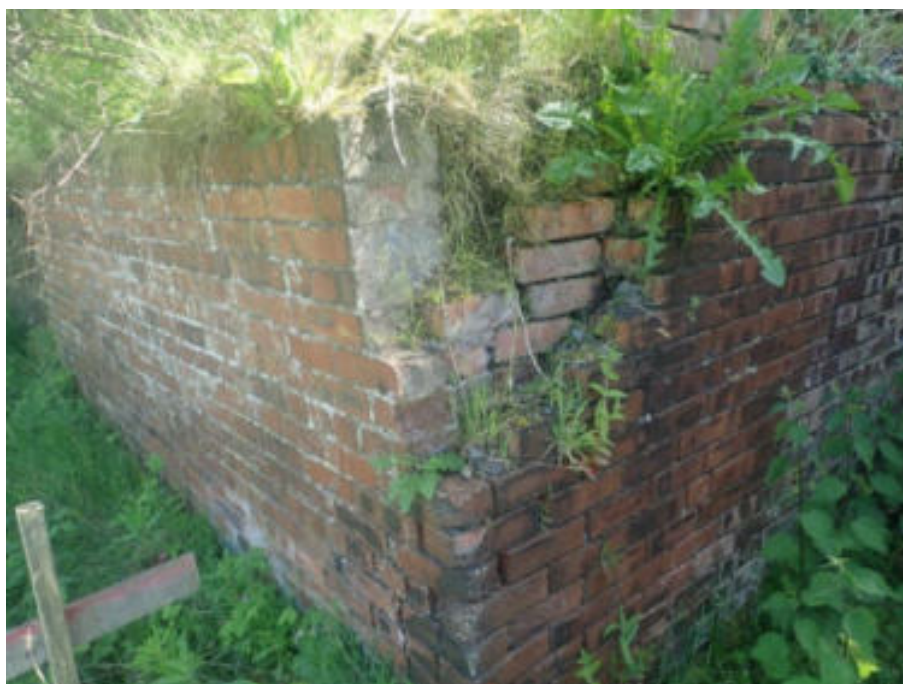
**20.2.5 RW6E – Section of brick retaining wall which abuts Retaining Wall 7 vertically leans outward by approximately 7 degrees. This lean is attributed to the growth of a mature tree located behind the wall.**

*Figure 113. Leaning section of wall*

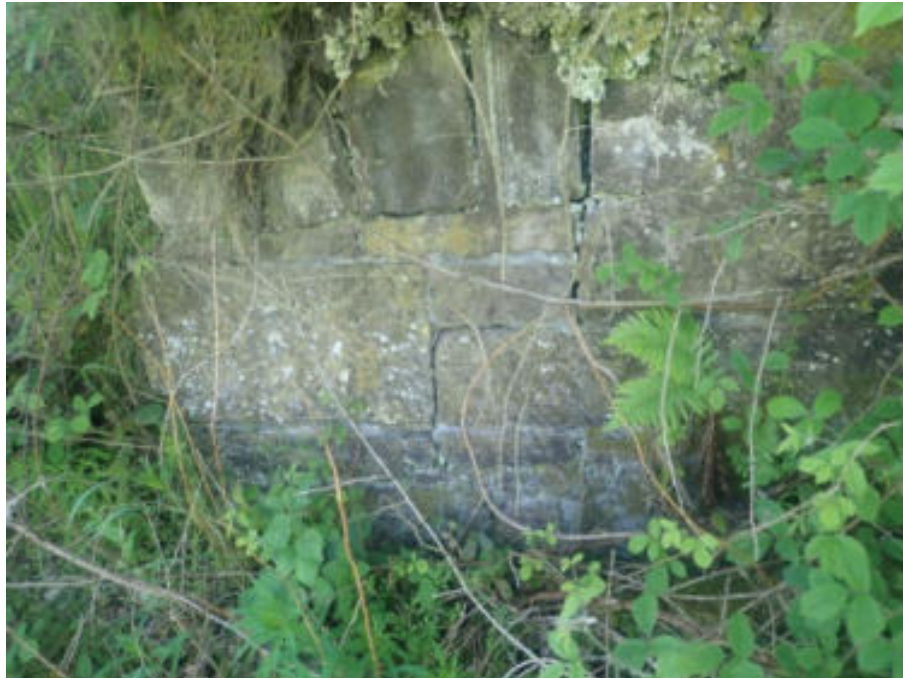
21.2.1 RW7A – Diagonal fracture within mortar joints.

*Figure 114. Diagonal fracture*

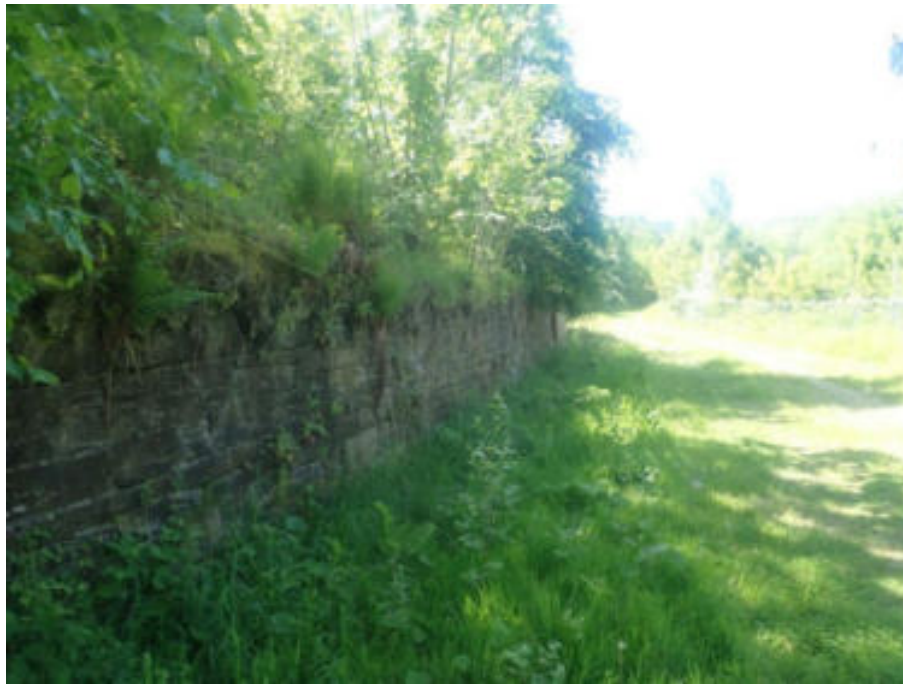
### 21.2.2 RW7B – Vegetation growth.

*Figure 115. Typical vegetation growth*

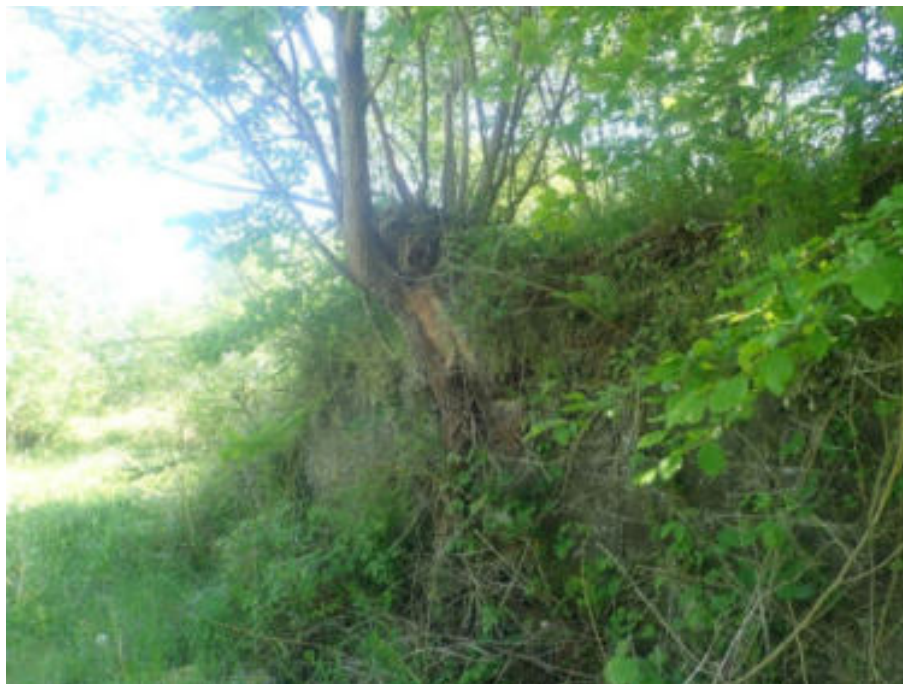
### 21.2.3 RW7C – Mature tree.

*Figure 116. Mature tree*

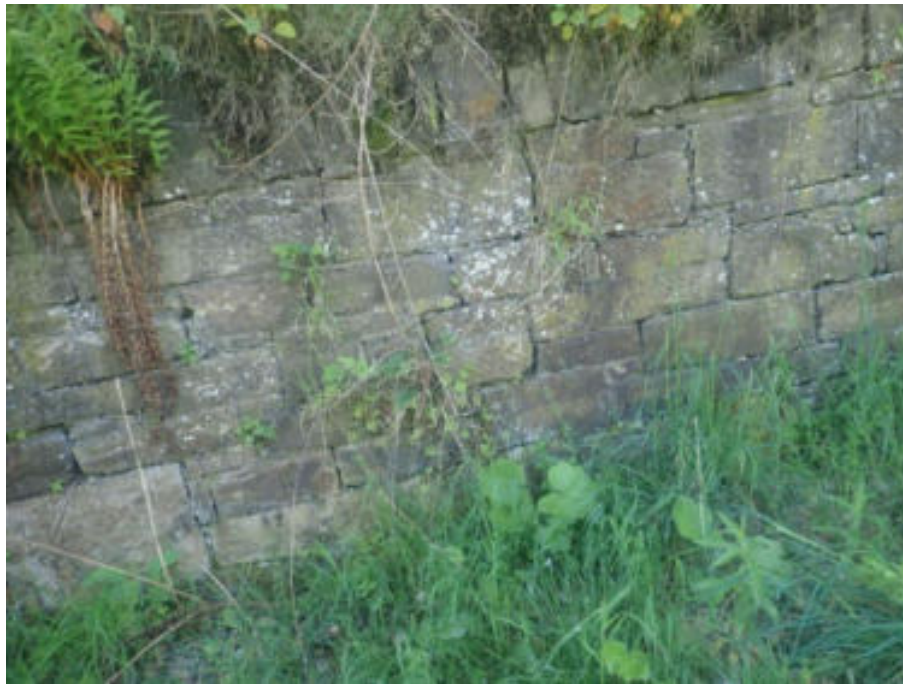
**21.2.4 RW7D – Missing mortar 5-10% of total area.**

*Figure 117. Typical mortar loss*

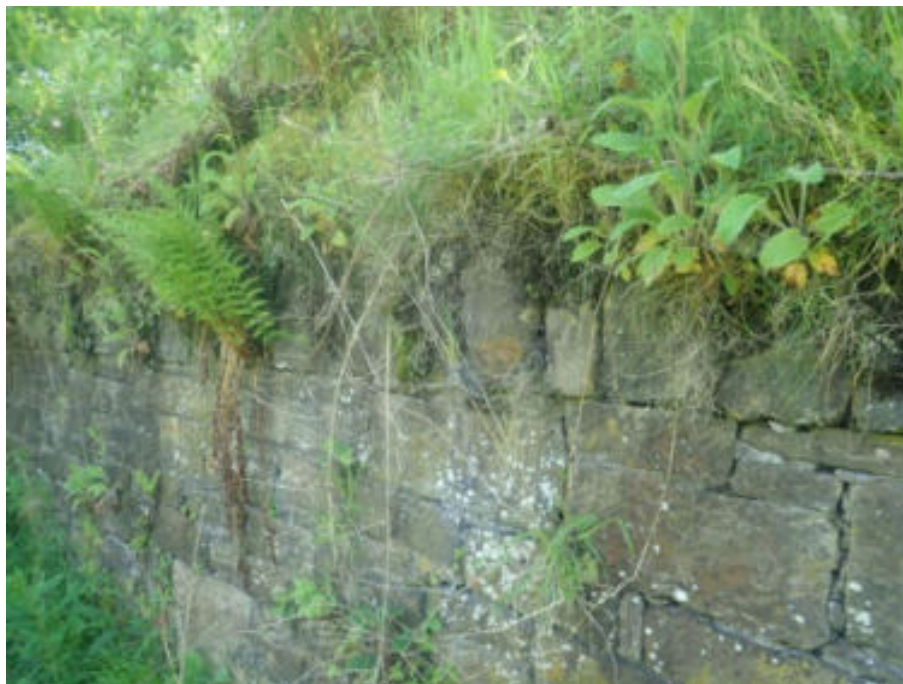
**21.2.5 RW7E – Loose copings.**

*Figure 118. Typical loose copings*

21.5.3 Undertake repair work on copings.

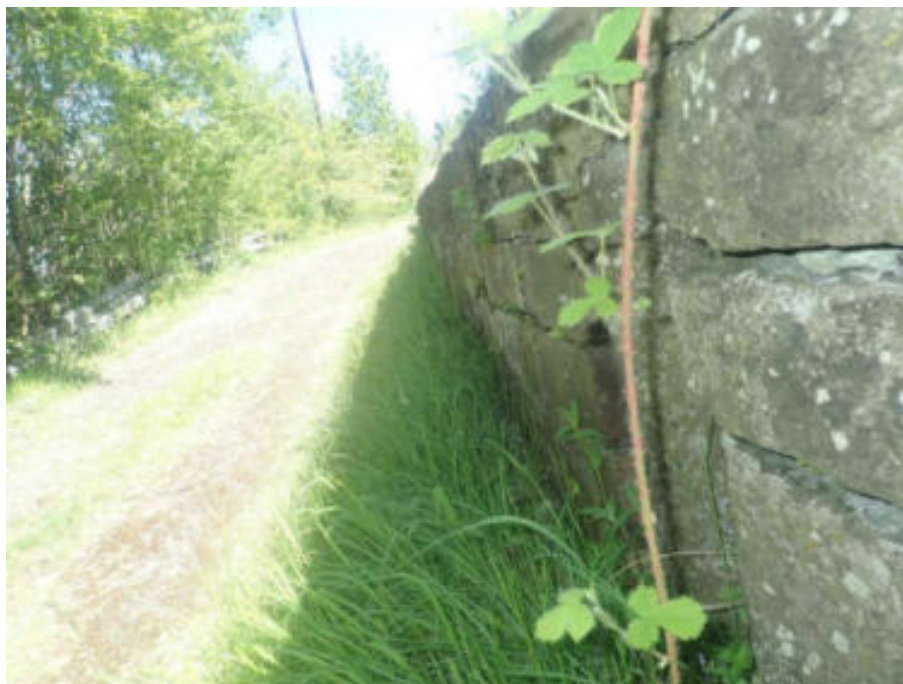
22.2.1 RW8A – The first 6m has displaced horizontally at mid height by approx. 60mm. This section of wall is considered to have failed.

*Figure 119. Displaced wall*

22.5.1 Demolish and replace wall. Alternatively, remove wall and grade back on retaining soil.

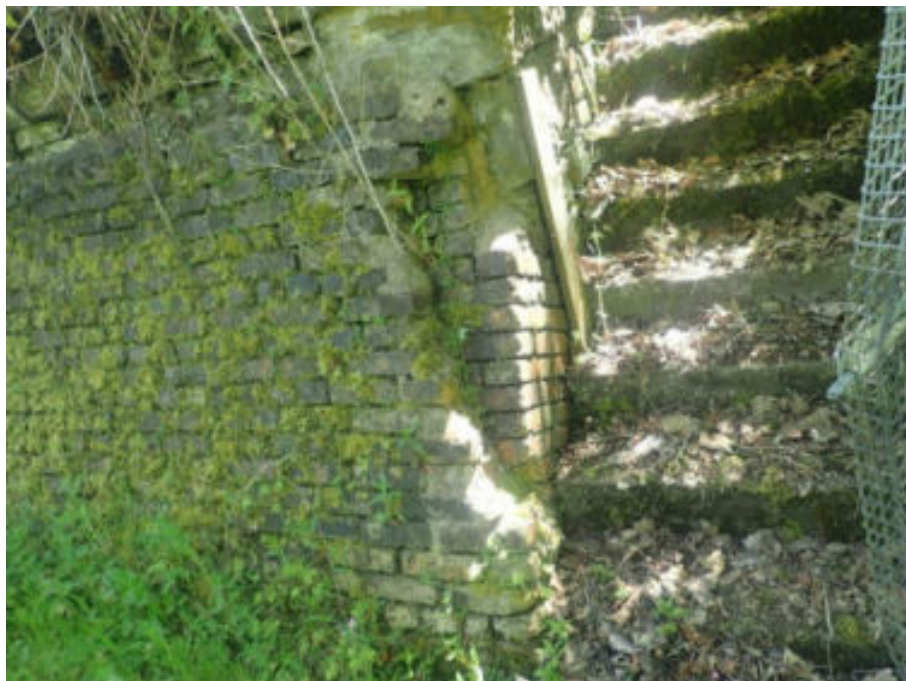
**22.2.3 RW8C – Missing masonry at base of access steps.**

*Figure 121. Missing masonry*

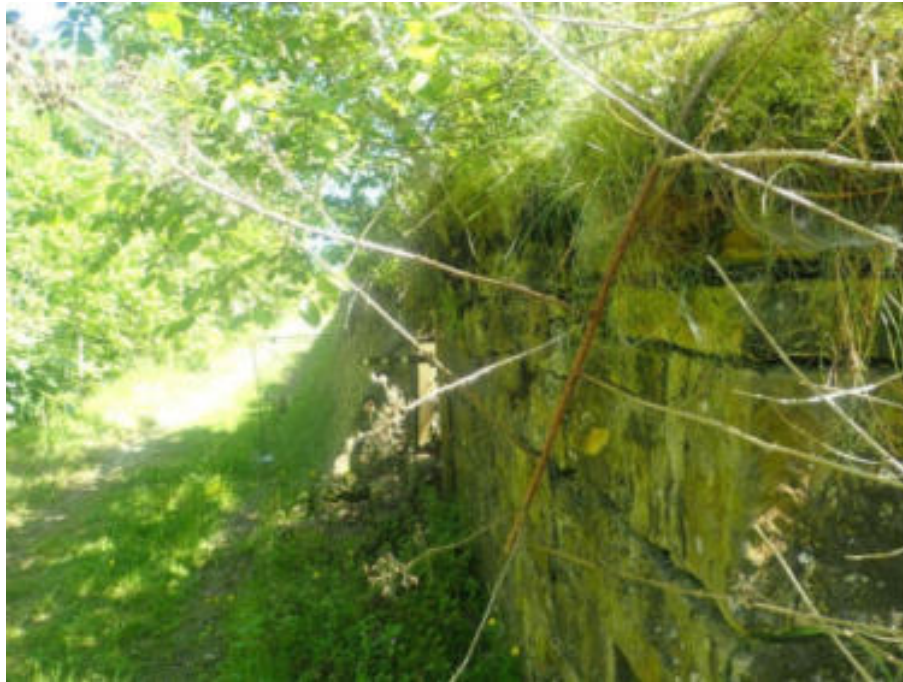
### 23.2.2 RW9B – Vegetation growth.

*Figure 123. Vegetation growth*

23.6.1 Implement a long term maintenance and inspection regime. For this type of structure, recommend annual vegetation removal with annual general inspection.

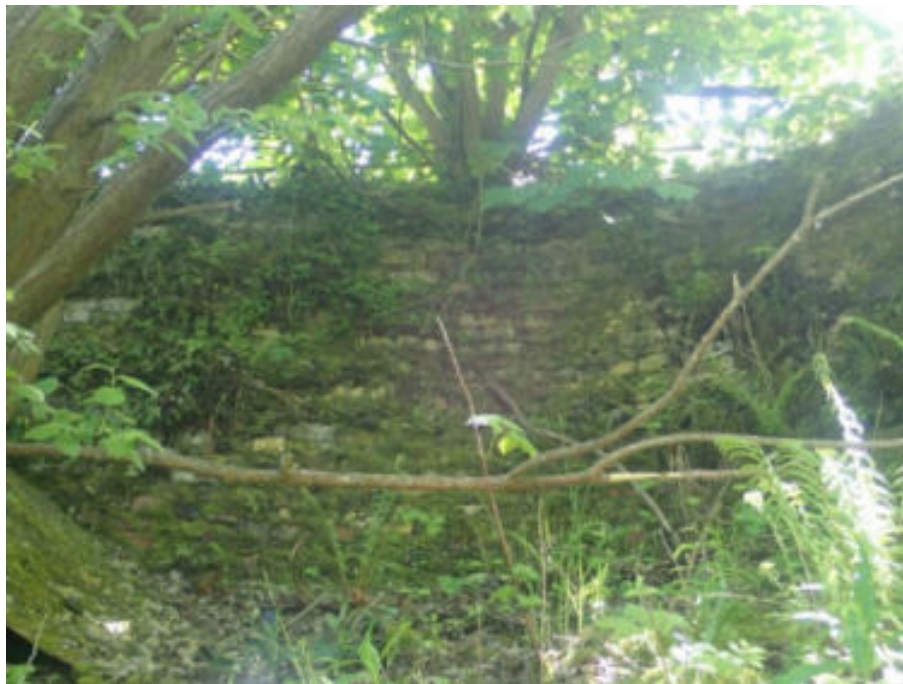
24.2.1 RW10A – Mortar loss 10-20% of total area.

24.2.2 RW10B and RW10C – Vegetation growth and remains of tree noted on wall

*Figure 124. General view of wall showing mortar loss, vegetation growth and tree*

24.5.2 Remove remains of tree and repair wall.

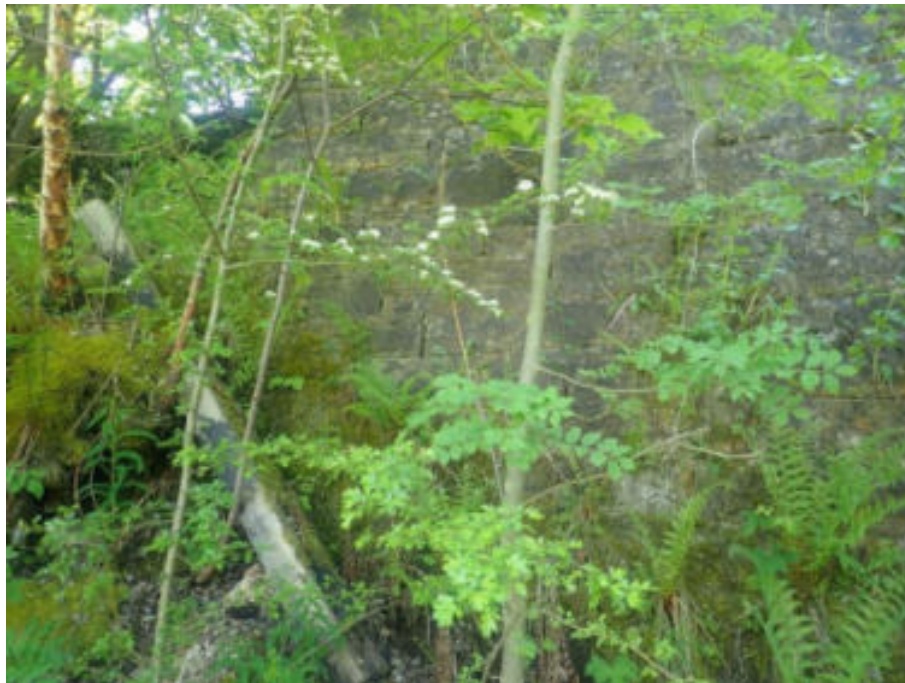
25.2.1 RW11A – Mortar loss 10-20% of total area.

*Figure 125. Typical mortar loss*

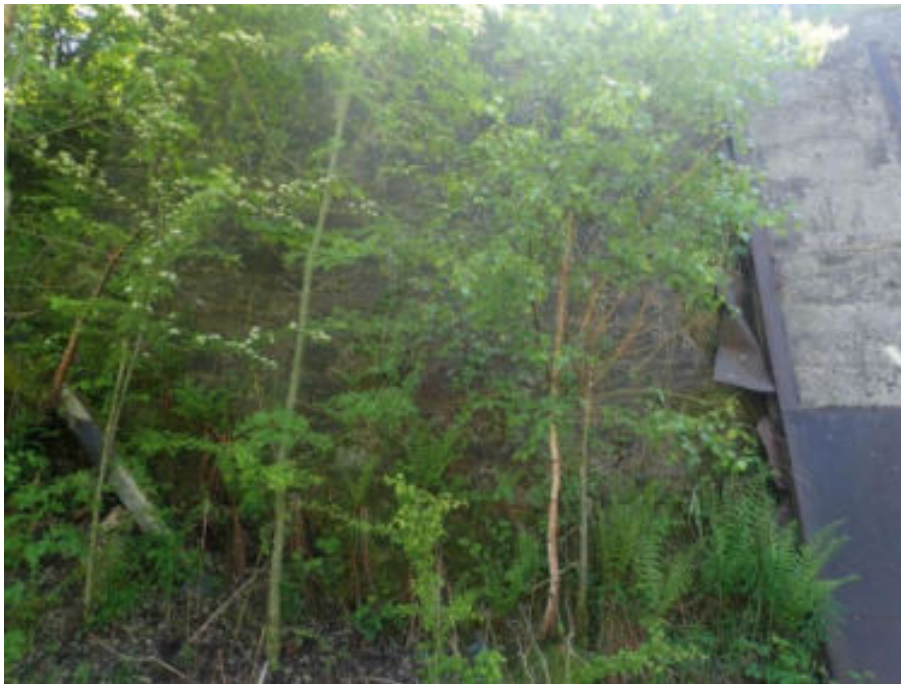
### 25.2.2 RW11B – Vegetation growth.

*Figure 126. Typical vegetation growth*

25.7.2 Implement a long term maintenance and inspection regime. For this type of structure, recommend annual vegetation removal with annual general inspection.

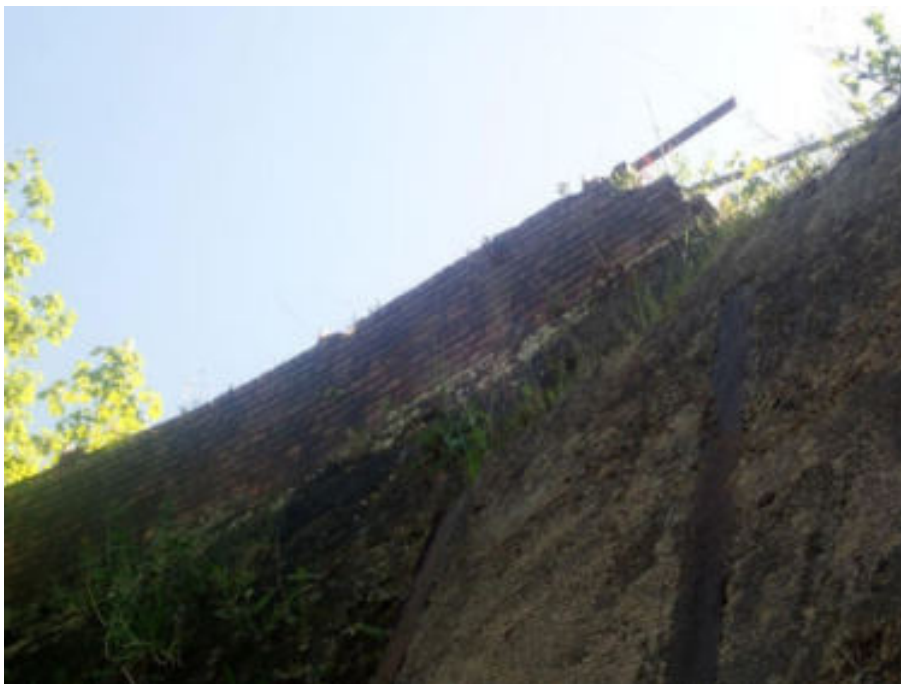
### 25.2.3 RW11C – Missing masonry noted on upper section.

*Figure 127. Missing masonry*

25.6.2 Undertake masonry repair work on upper section of wall, approx. 2m<sup>2</sup>.

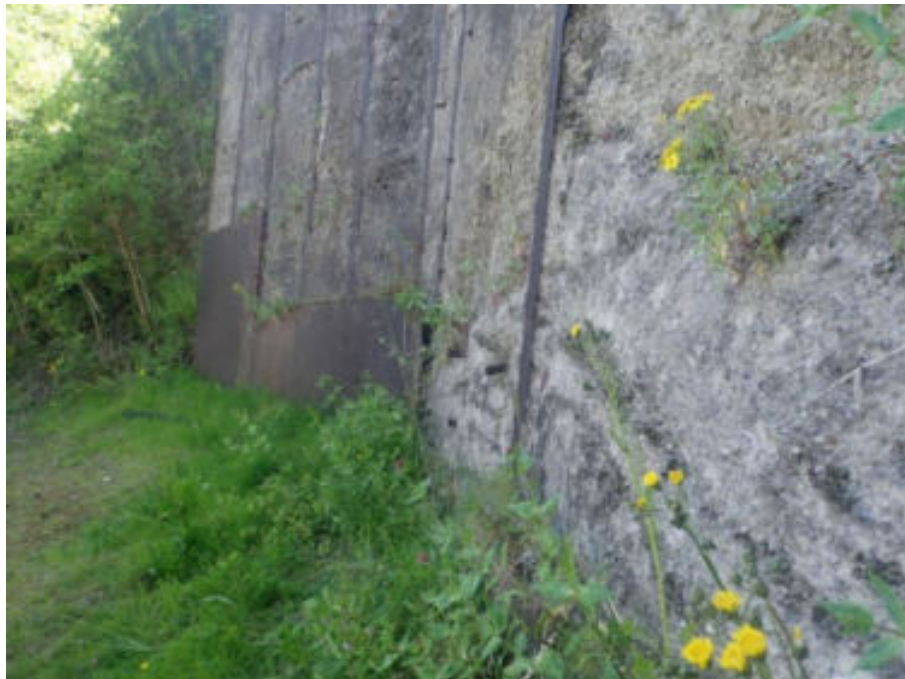
26.2.3 RW12D – Vegetation growth.

*Figure 130. Typical vegetation growth*

26.7.1 Implement a long term maintenance and inspection regime. For this type of structure, recommend annual vegetation removal with annual general inspection.

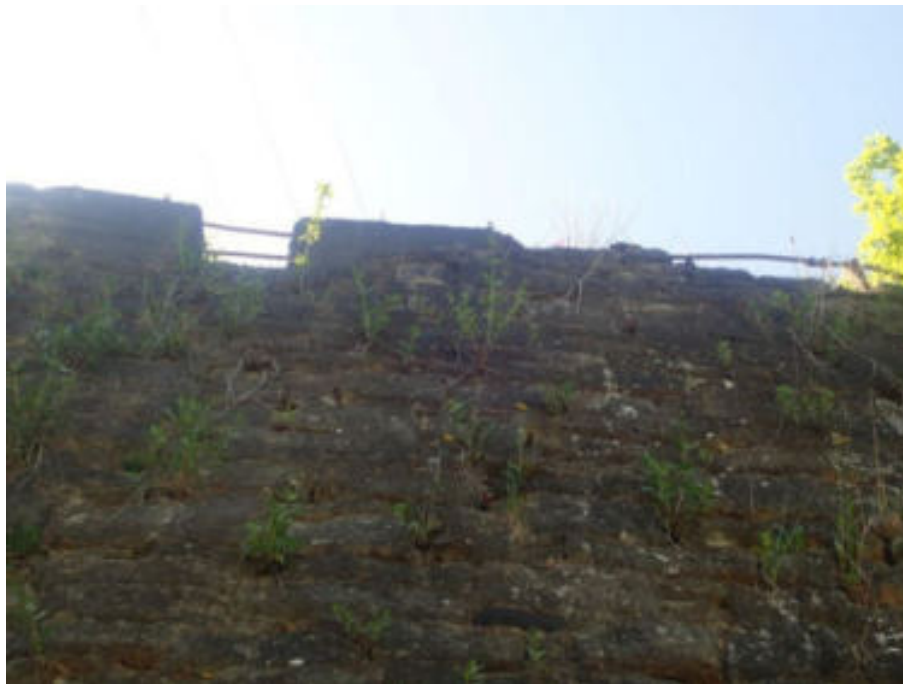
27.2.1 RW13A – Mortar loss 10-20%.

*Figure 131. Typical mortar loss*

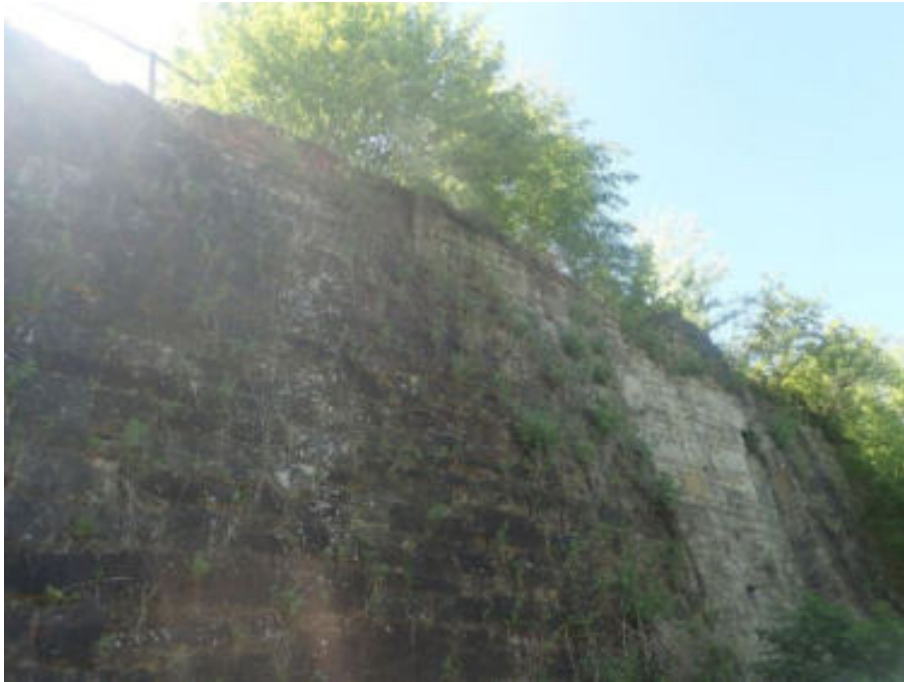
### 27.2.2 RW13 – Vegetation growth.

*Figure 132. Typical vegetation growth*

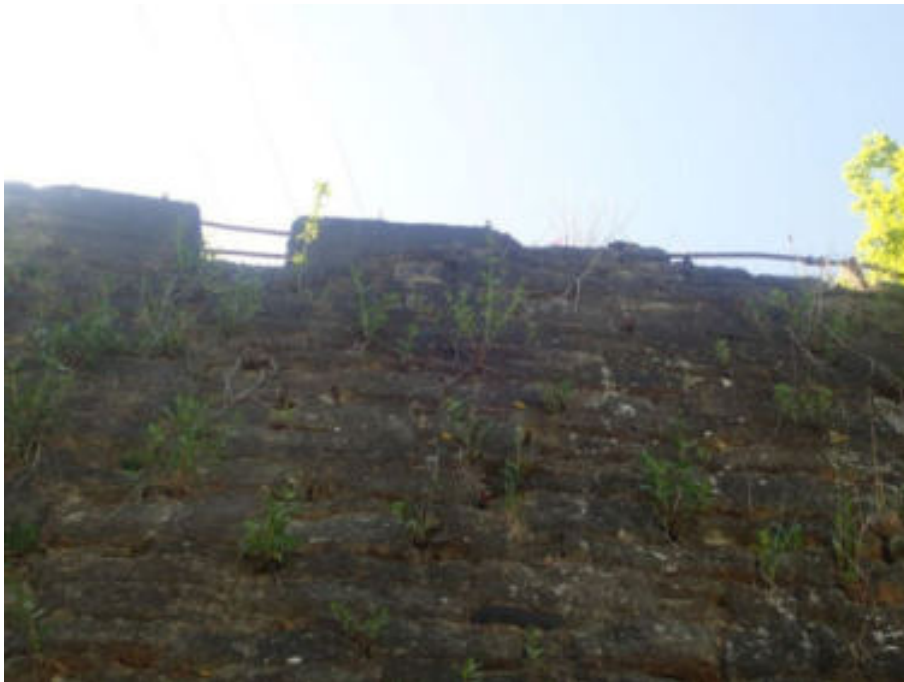
### 27.2.3 RW13C – Dislodged and missing masonry noted on upper parapet section of the wall due to historical vegetation growth and instability within the parapet.

*Figure 133. Dislodged and missing masonry*

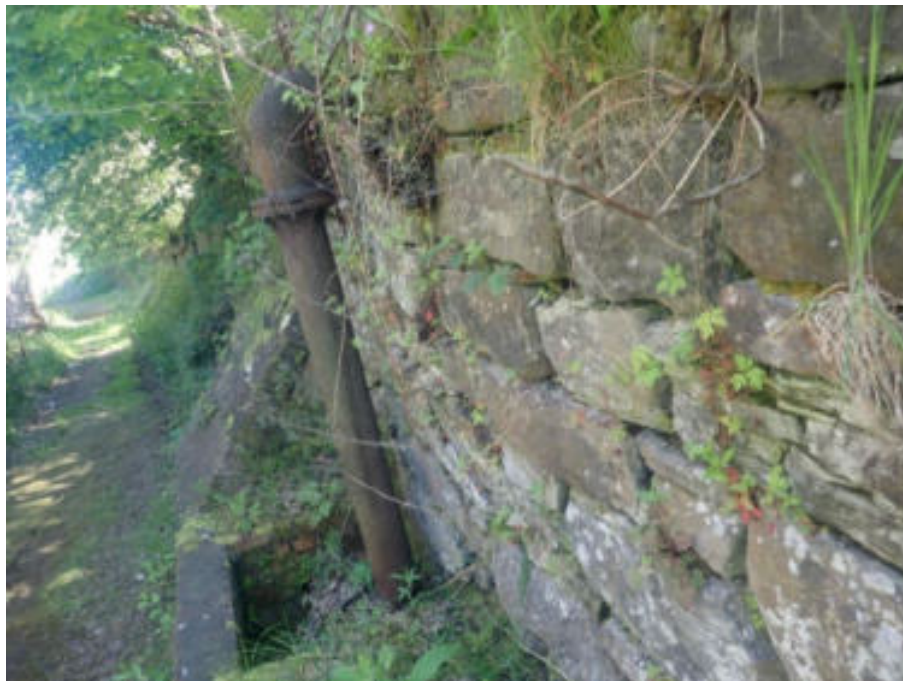
28.2.1 RW14A – In the vicinity of the drainage channel at Ch10m, there is an area with slight bulging and leaning observed. Additionally, loose masonry units and masonry unit fractures have been noted. The movement in this area is assessed as historical and not considered to be currently progressing.

*Figure 134. Bulging and leaning wall*

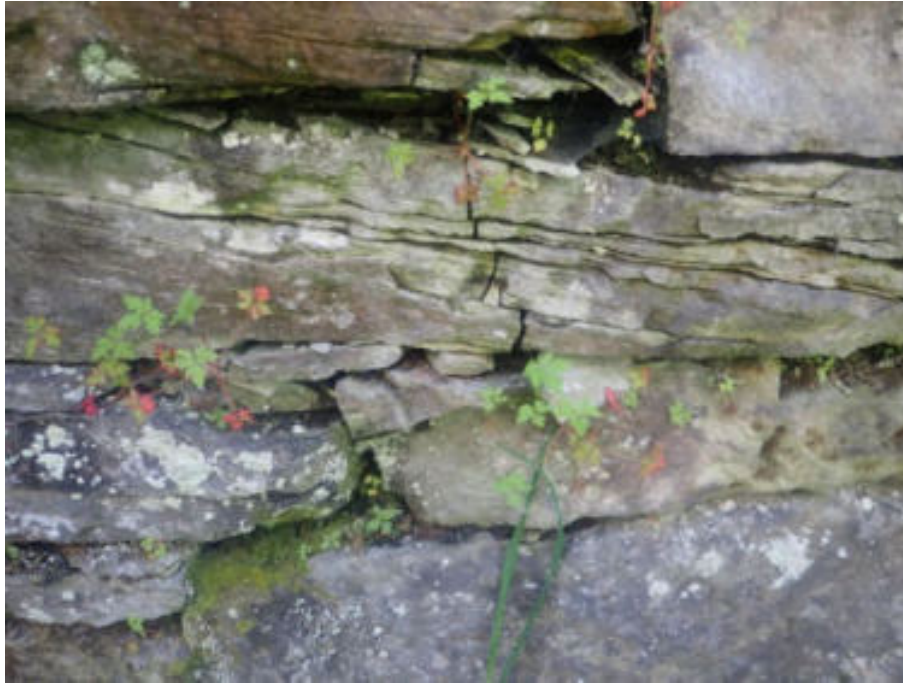
*Figure 135. Typical masonry fracture*

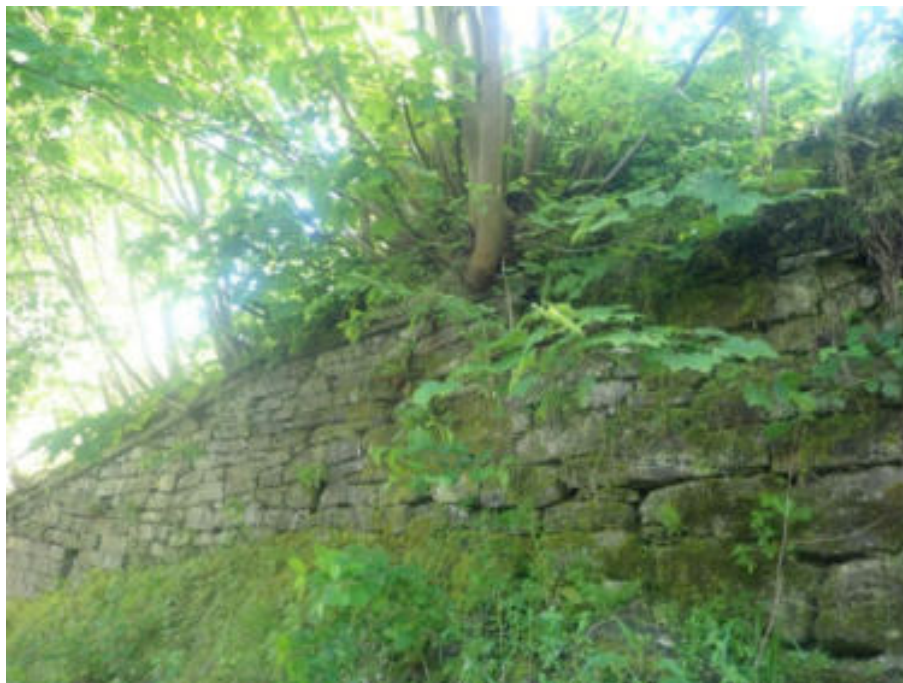
**28.2.2 RW14B – Vegetation growth. Vegetation causing movement in the wall.**

*Figure 136. Typical vegetation growth*

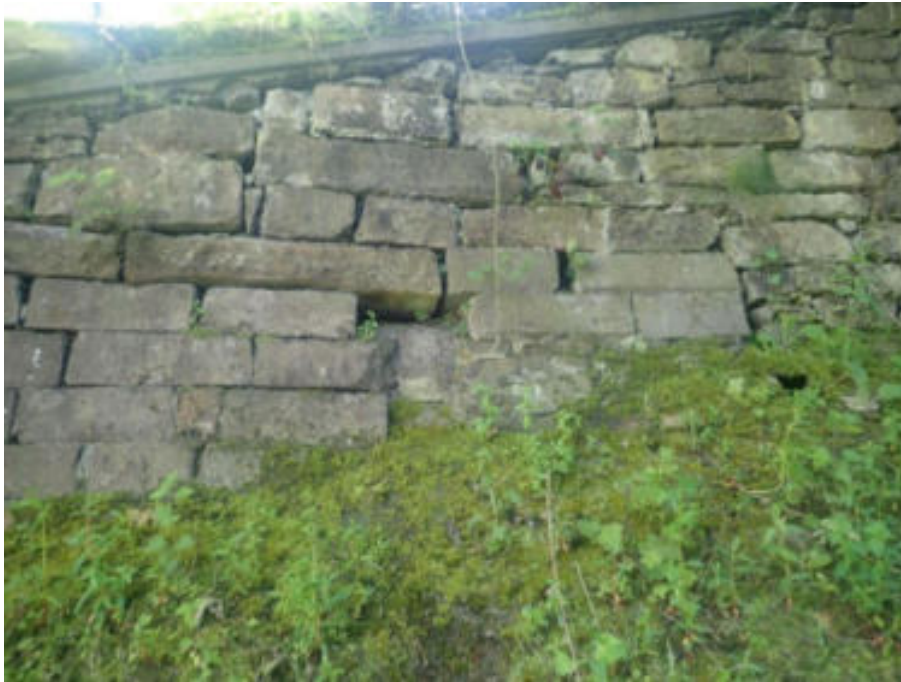
### 28.2.3 RW14C – Missing and loose masonry.

*Figure 137. Dislodged and missing masonry*

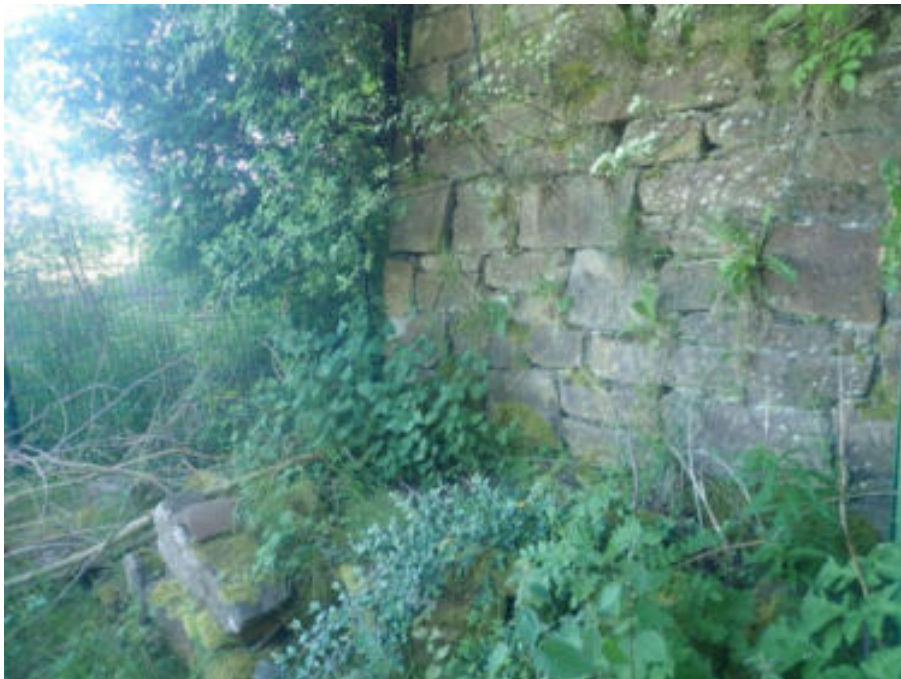
### 28.2.4 RW14D – Fractures units at corner of wall, approx. 1m above G.L. Units have also displaced.

*Figure 138. Fractured and displaced units*

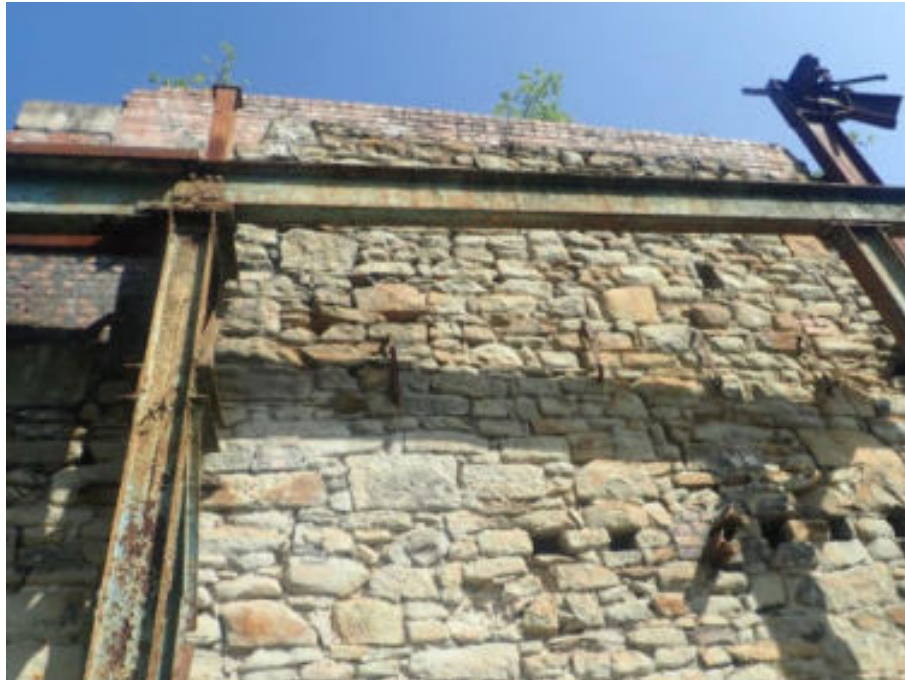
29.2.1 RW15A – Missing mortar 50%.

*Figure 139. Typical mortar loss*

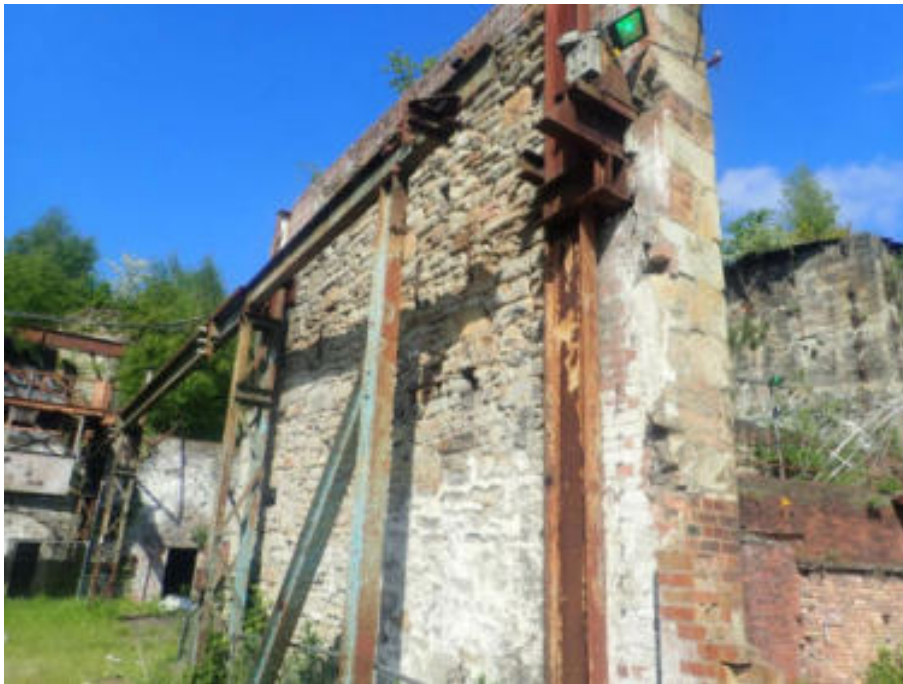
**29.2.4 RW15D – Spalling noted on brick work.**

*Figure 142. Spalling to brickwork*

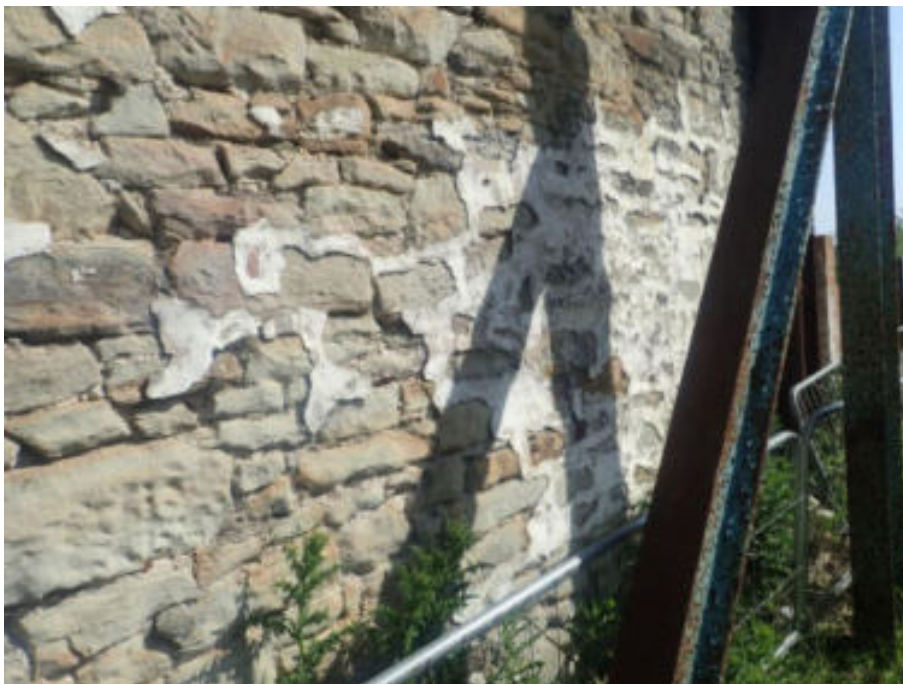
**29.2.5 RW15F – Perished render 90%.**

*Figure 143. Perished render*

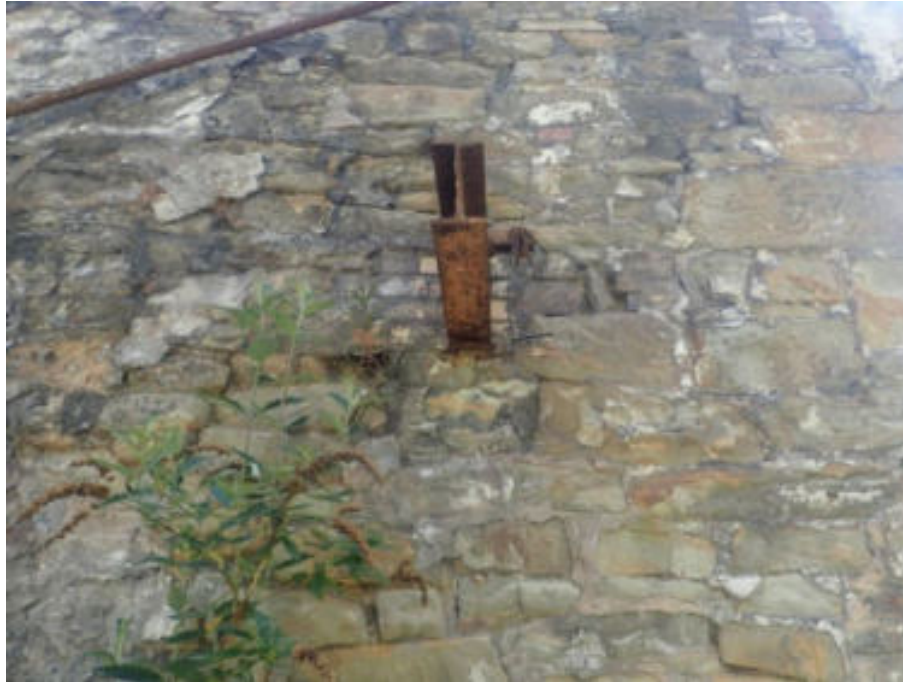
30.2.2 RW16B – Various corroded historical steel members embedded in wall associated with previous building including structural steel members, service ducts etc.

*Figure 145. Typical corrosion to steel*

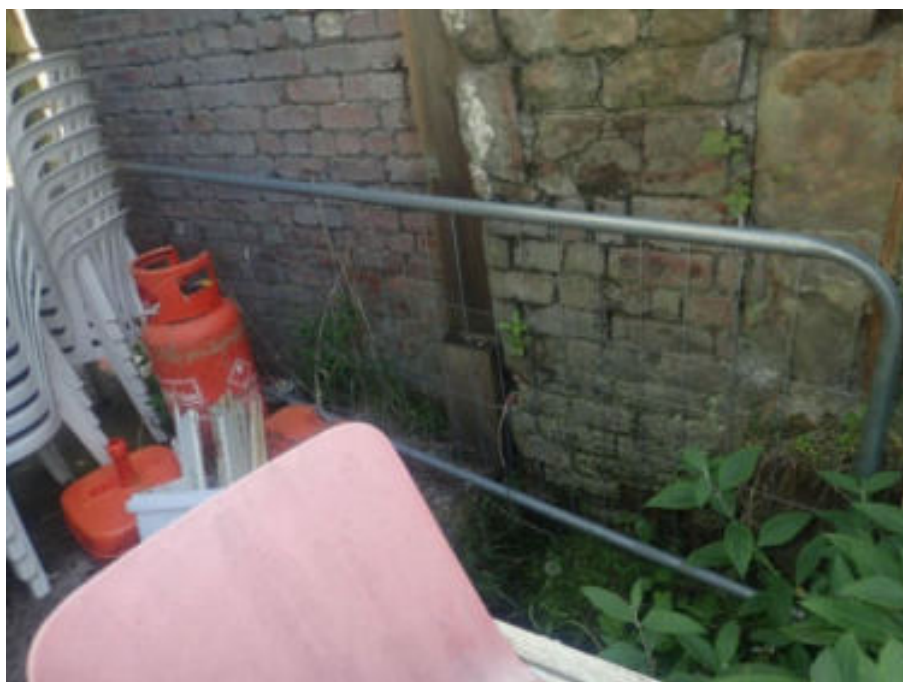
30.2.3 RW16C – Localised areas of spalling noted on brick work infill panels and high level parapet.

*Figure 146. Typical spalling to brickwork*

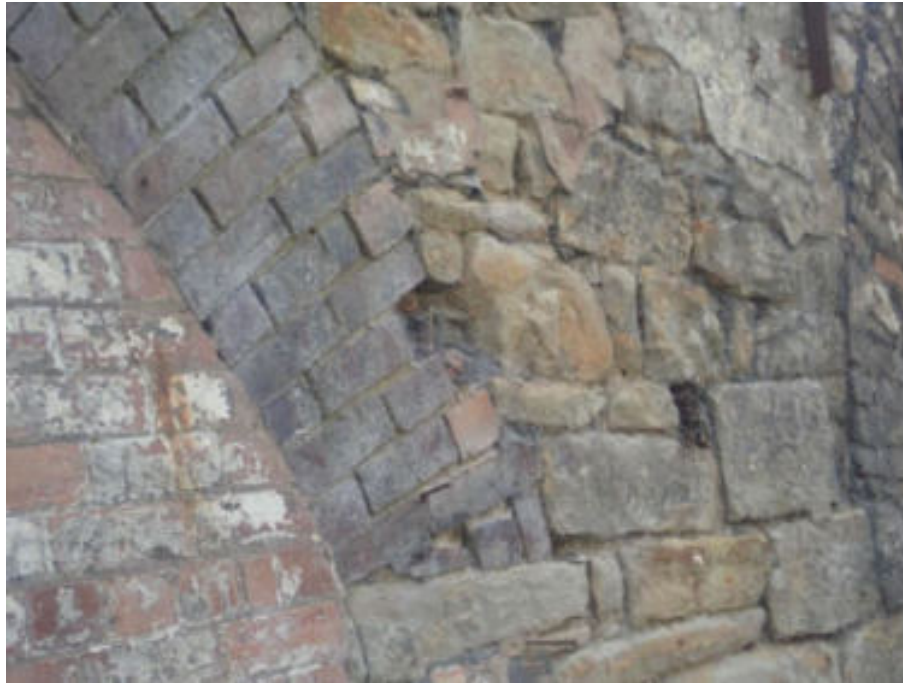
30.2.5 RW16G – Localised areas of missing masonry units, expected with a historic wall of this nature.

*Figure 149. Typical missing masonry*

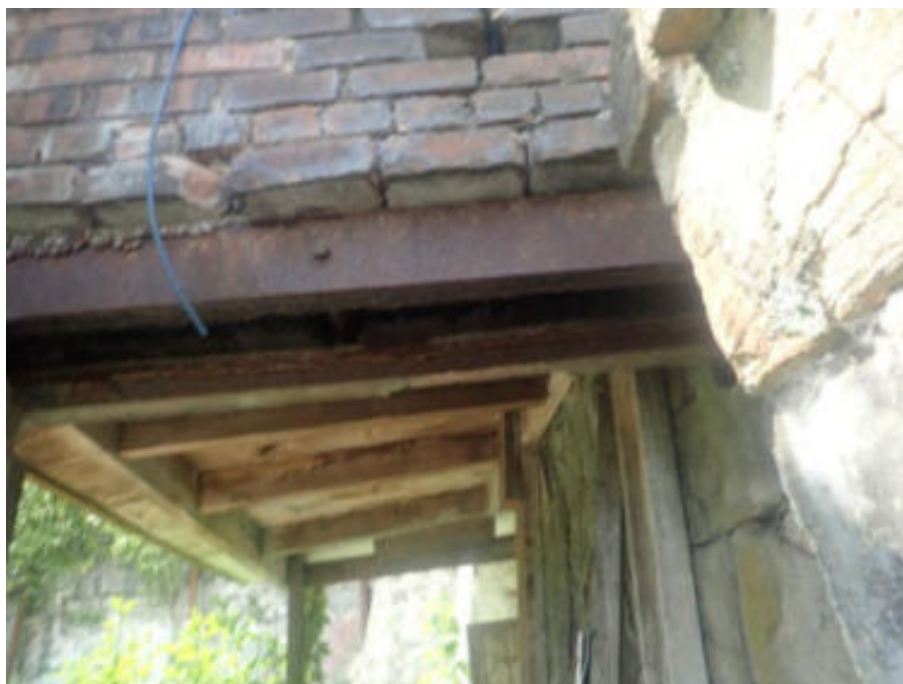
30.2.6 RW16H – Fragile timber temporary mezzanine. Deteriorated timber joists and posts which form part of a temporary mezzanine abutting the furnace.

*Figure 150. General view of temporary mezzanine*

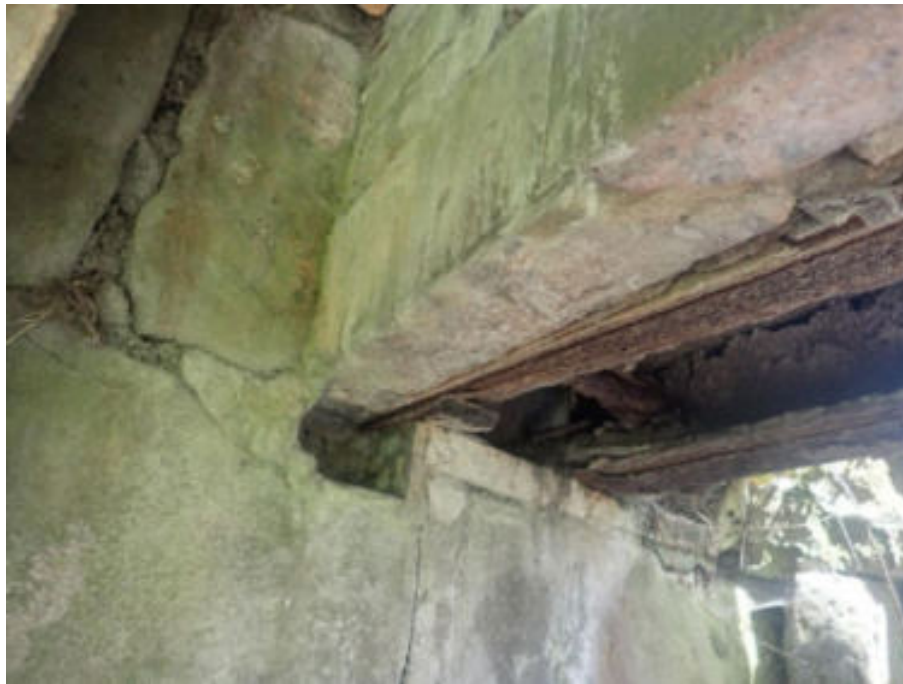
30.2.7 RW16J – The opening in the northern section of Retaining Wall 16, adjacent to the furnace, has been constructed using a back-to-back arrangement of steel PFC (Parallel Flange Channel) for the majority of the wall width. However, the precast concrete blockwork on the inner face is unsupported. Unfortunately, the steel PFCs have suffered significant deterioration due to corrosion and are displaying excessive deflection, leading to associated cracking in the masonry wall above. It appears that the previous lintel forming the inner face has deteriorated, leaving approximately 40% of the wall width unsupported. Immediate attention and remedial action are required to address this structural issue.

*Figure 151. Corroded PFCs and unsupported blockwork*
