# **BRYMBO HERITAGE PROJECT**

## **STRUCTURAL CONDITION ASSESSMENT**

**August 2023**  
**Suitability S2**  
**Revision P02**

**By:**  
Bingham Rawlings Partnership Ltd.

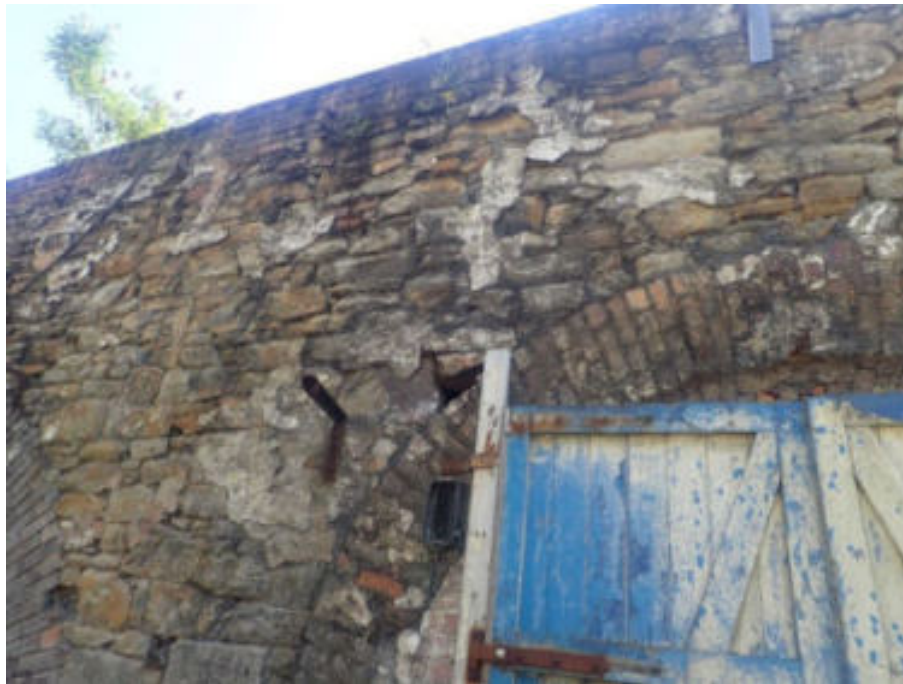
#### 30.2.8 RW16K – Perished render 90% of total area.

*Figure 152. Perished render*

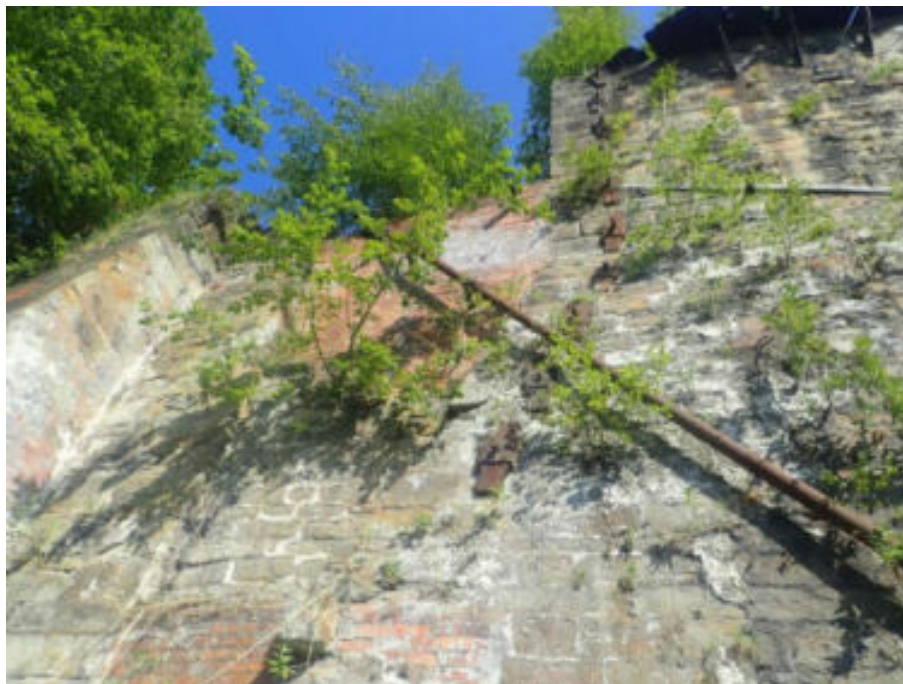
31.2.1 RW18A – Missing mortar 5-10% of total area.

*Figure 153. Typical mortar loss*

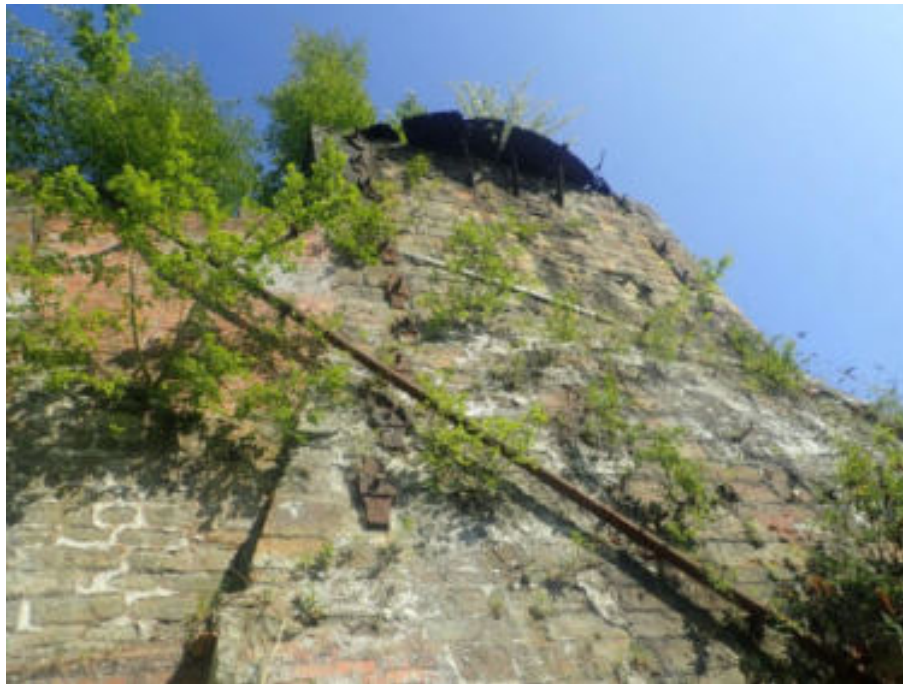
### 31.2.2 RW18C – Vegetation growth.

*Figure 154. Vegetation growth*

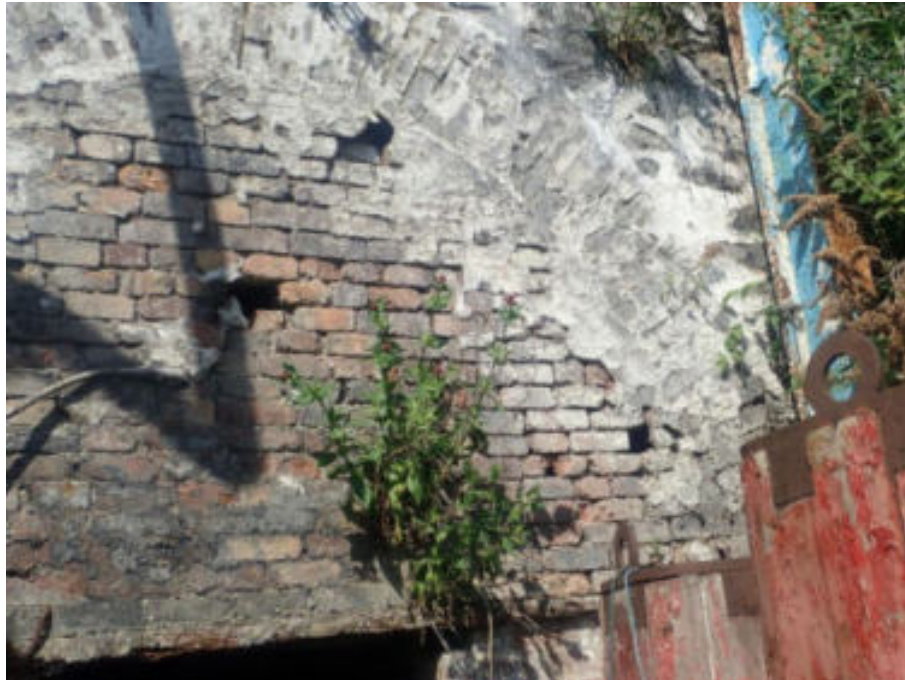
32.2.1 RW19A – Localised areas of missing masonry units, which is expected from wall of this type and age.

*Figure 155. Typical missing masonry*

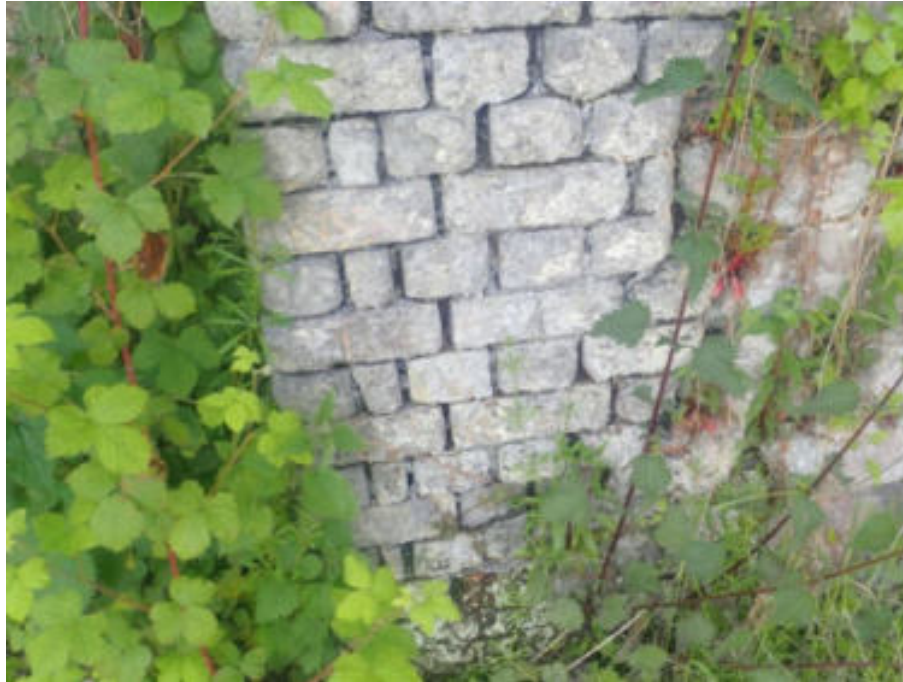
32.2.2 RW19B – Mortar loss. Less significant in pointing of natural stone units however much more prominent in the brickwork infill, approximately 60% of total area.

*Figure 156. Typical mortar loss*

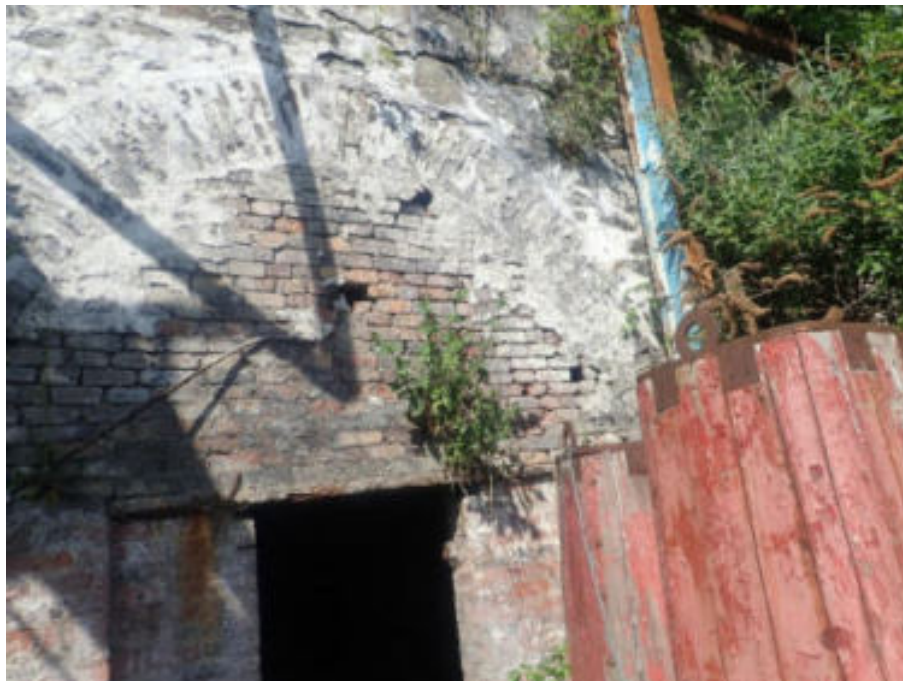
32.2.3 RW19C – General weathering of external render.

*Figure 157. Typical weathered render*

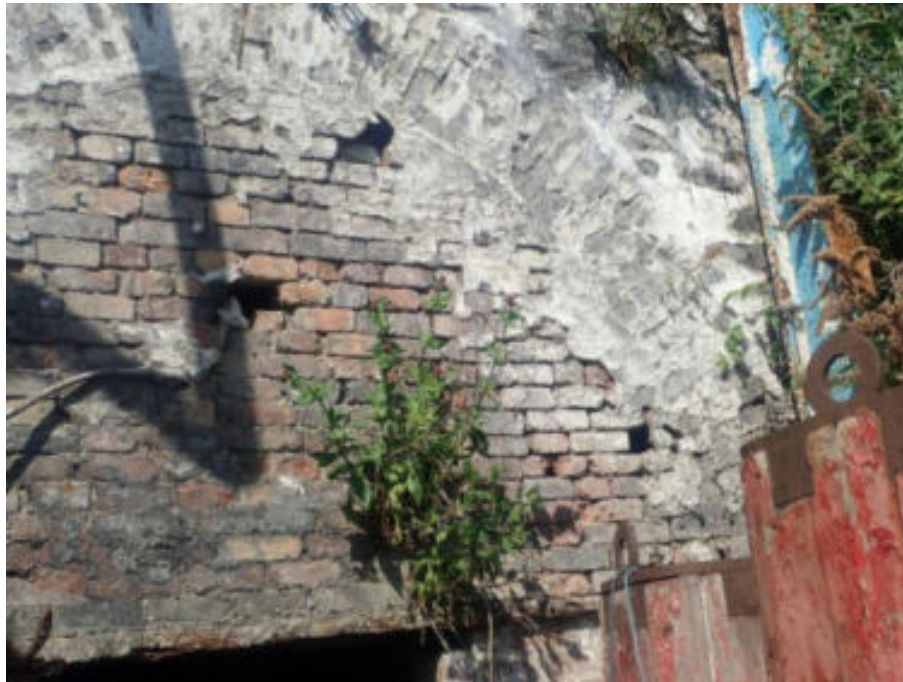
#### 32.2.4 RW19D – Vegetation growth.

*Figure 158. Typical vegetation growth*

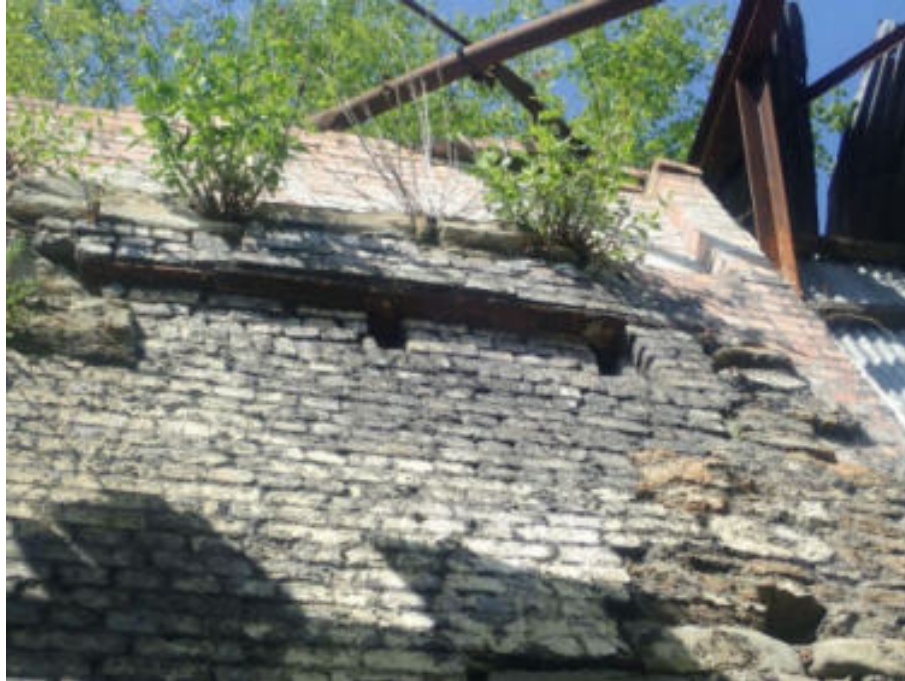
**33.2.2 RW20B – Localised areas of missing masonry units, expected with a historic wall of this nature. Approx. 5 - 10% of total area.**

*Figure 160. Typical missing masonry*

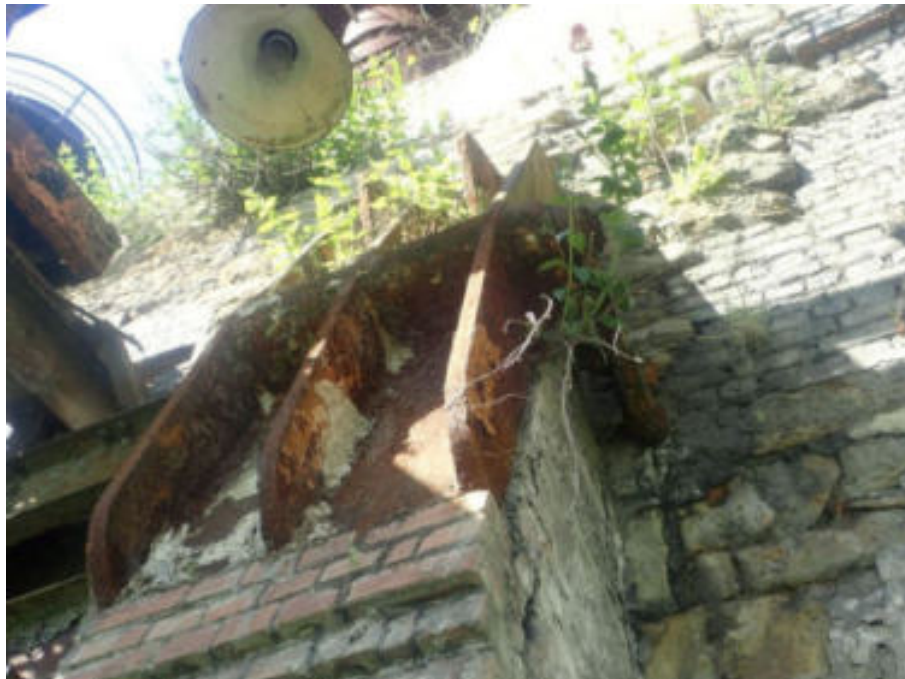
**33.2.3 RW20D – Vegetation growth.**

*Figure 161. Typical vegetation growth*

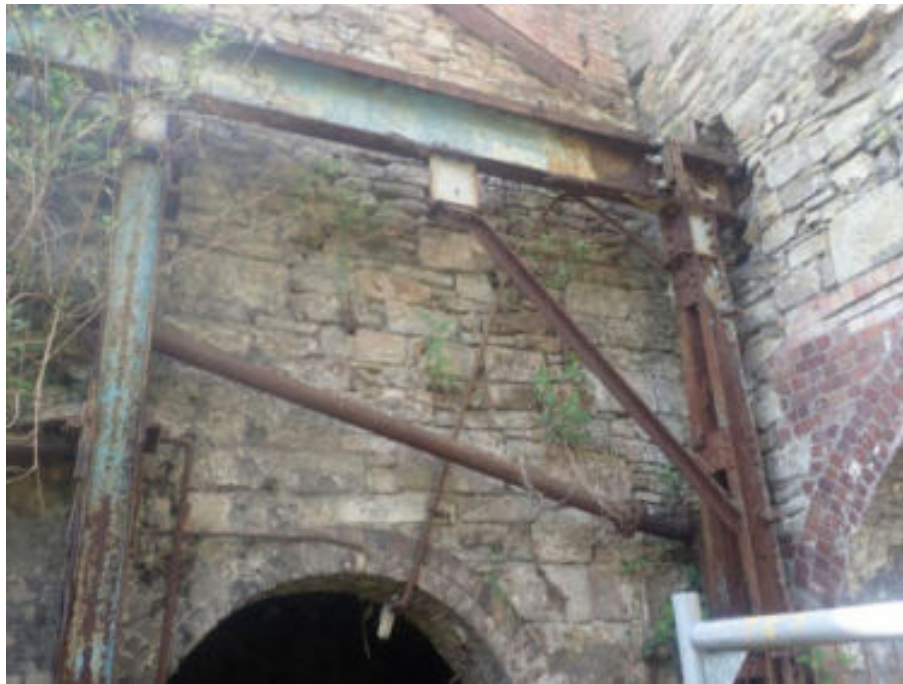
### 34.2.2 RW21C – Vegetation growth.

*Figure 163. Typical vegetation growth*

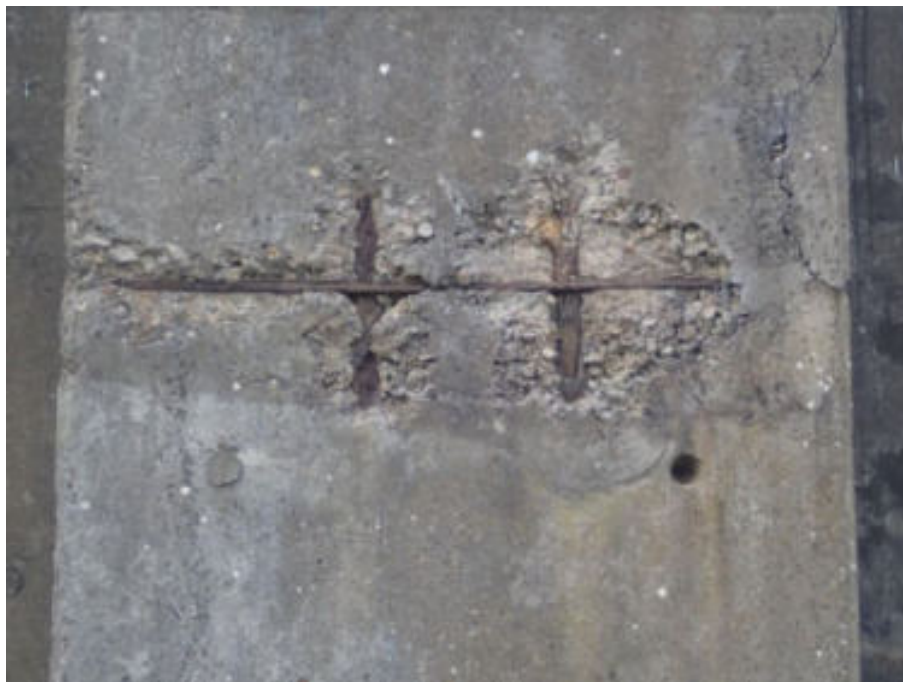
35.2.1 RW22A – Deterioration and spalling of concrete as a result corrosive expansion of reinforced steel bars. Exposed bars vary in terms of section loss between 40% and 100%.

*Figure 164. Exposed and corroded bars*

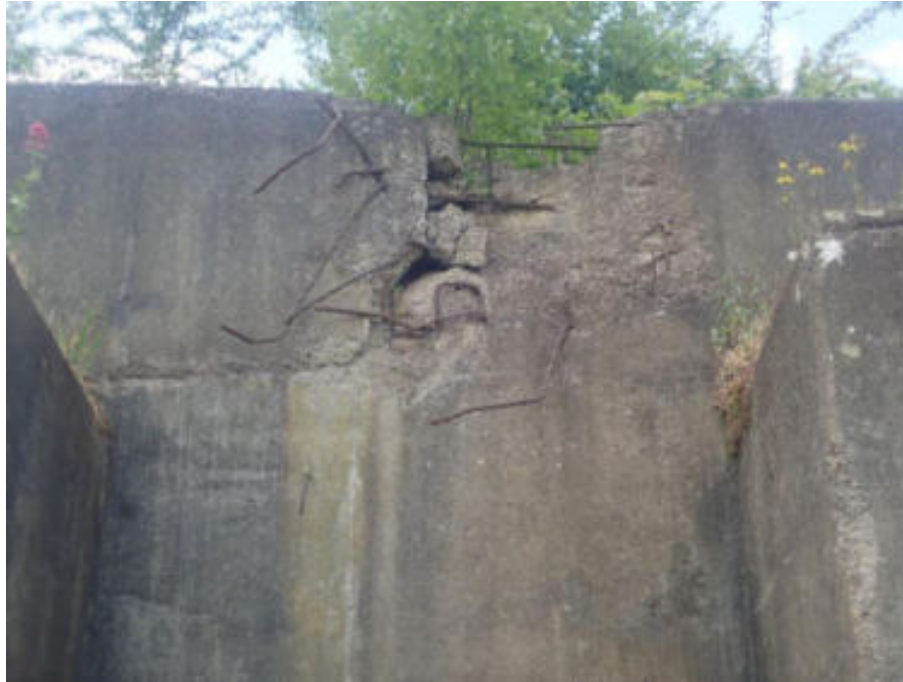
**35.2.2 RW22B – Localised areas of wall failure at high level due to a combination of impact, vegetation intrusive growth and expansive corrosion due to exposure of steel reinforcement.**

***Figure 165. Failed area of wall***

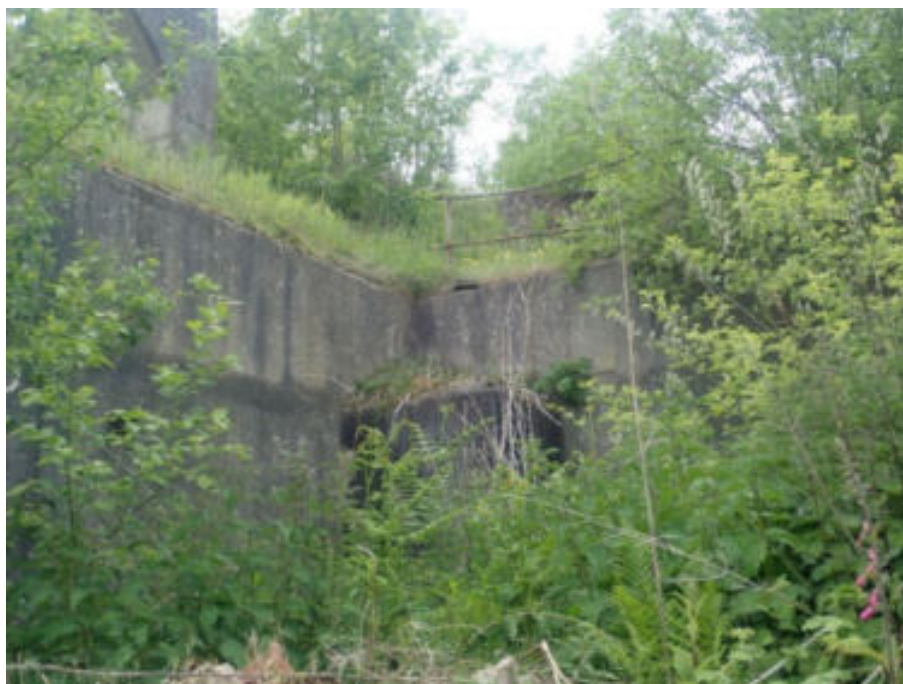
**35.2.3 RW22C – Vegetation growth in the south corner of the wall is significant.**

***Figure 166. Vegetation growth***

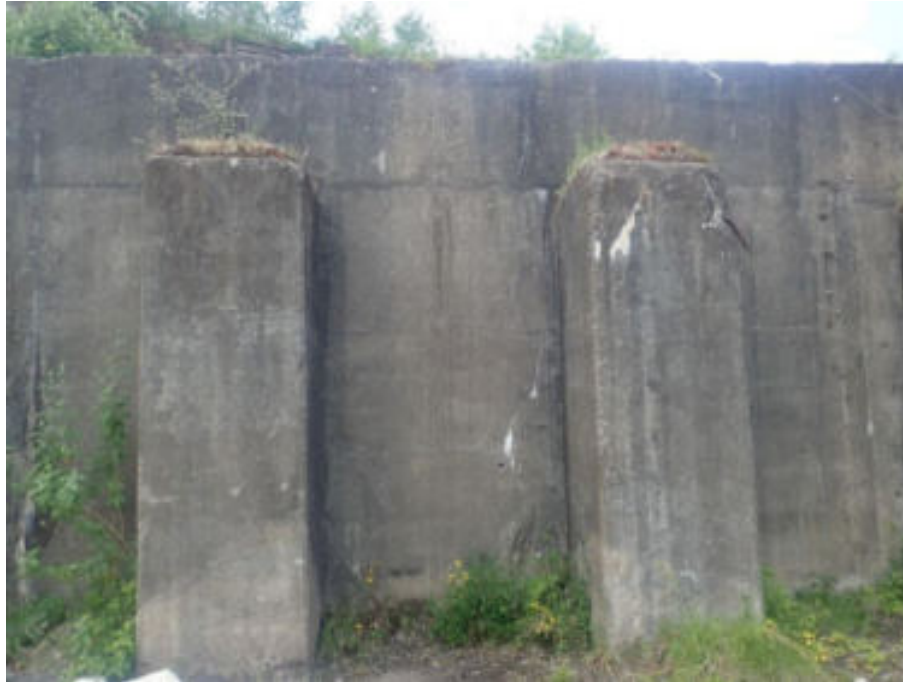
**35.2.4 RW22D** – The wall does not contain any form of allowance to allow the passage of ground water build up to release hydrostatic pressure. Evidence of seepage and oxide staining in various areas of the wall are noted along its entire length.

*Figure 167. Typical staining on wall*

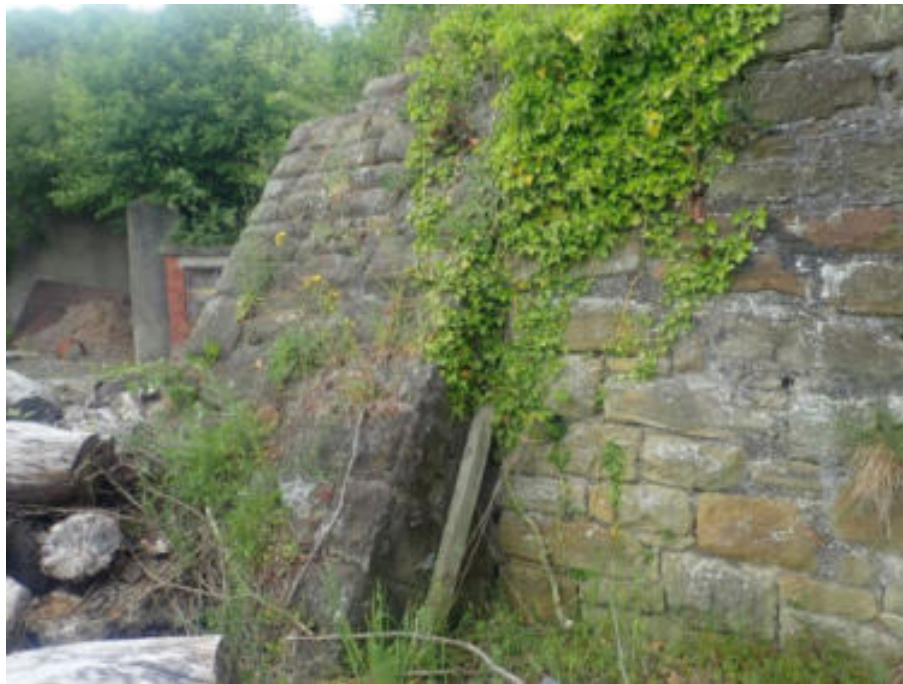
**36.2.2 RW23B – Mortar loss noted. Approx 10-20% of total area.**

***Figure 169. Typical mortar loss***

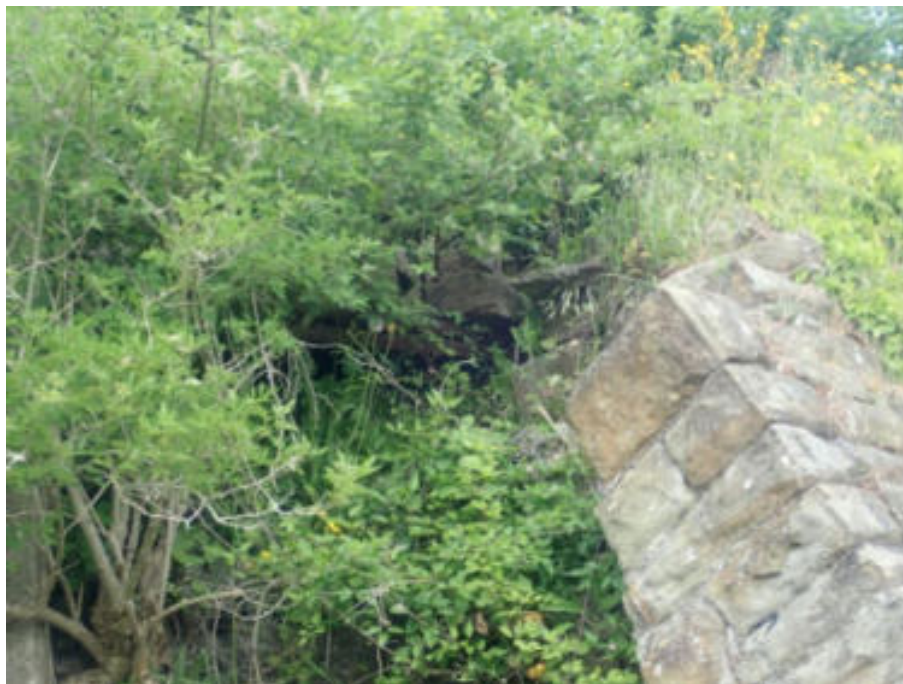
***Figure 170. Loose masonry***

**36.2.3 RW23C – Loose masonry noted at localised sections.**

36.5.2 Undertake masonry repair on wall on areas of loose masonry.

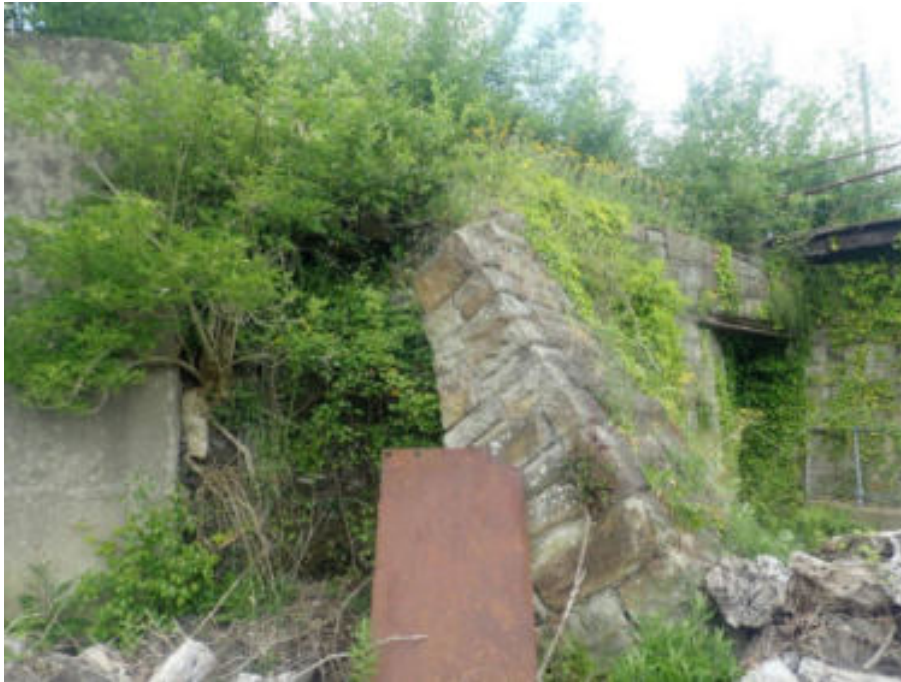
*Figure 171. Vegetation growth*

**36.2.4 RW23D – Vegetation growth.**

36.6.2 Implement a long term maintenance and inspection regime. For this type of structure, recommend annual vegetation removal with annual general inspection.

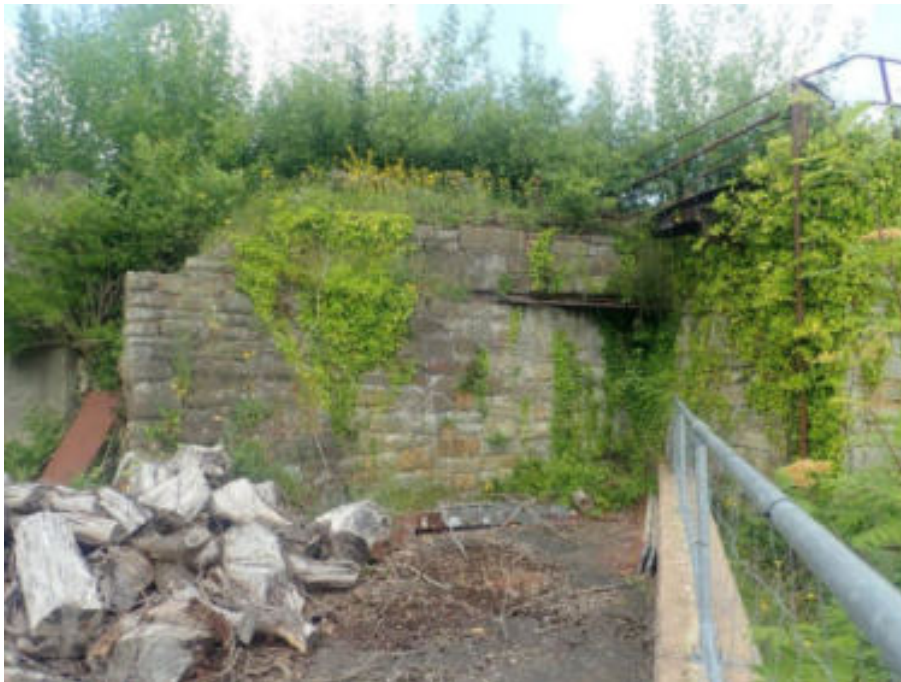
*Figure 172. Corroded fence*

**36.2.5 RW23E – Corroded safety fence.**

36.4.2 Restrict access beneath corroded fence.

36.5.3 Dismantle the steel safety fence to prevent any further corrosion and minimise the potential hazard of the fence falling onto pedestrians.

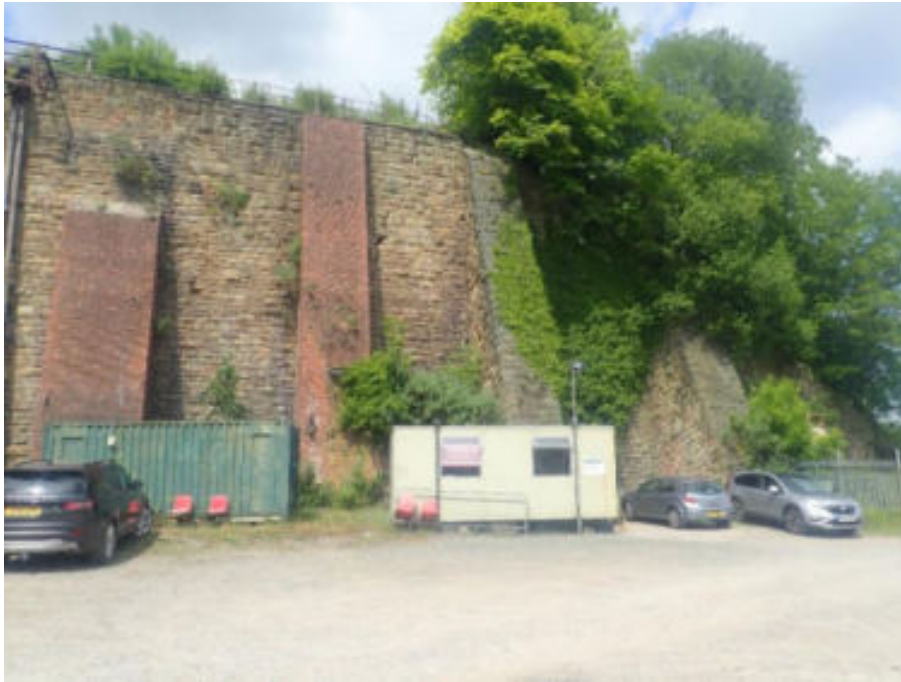
*Figure 176. Typical vegetation growth*

#### 37.2.4 RW24D – Vegetation growth.

37.6.7 Implement a long term maintenance and inspection regime. For this type of structure, recommend annual vegetation removal with annual general inspection.

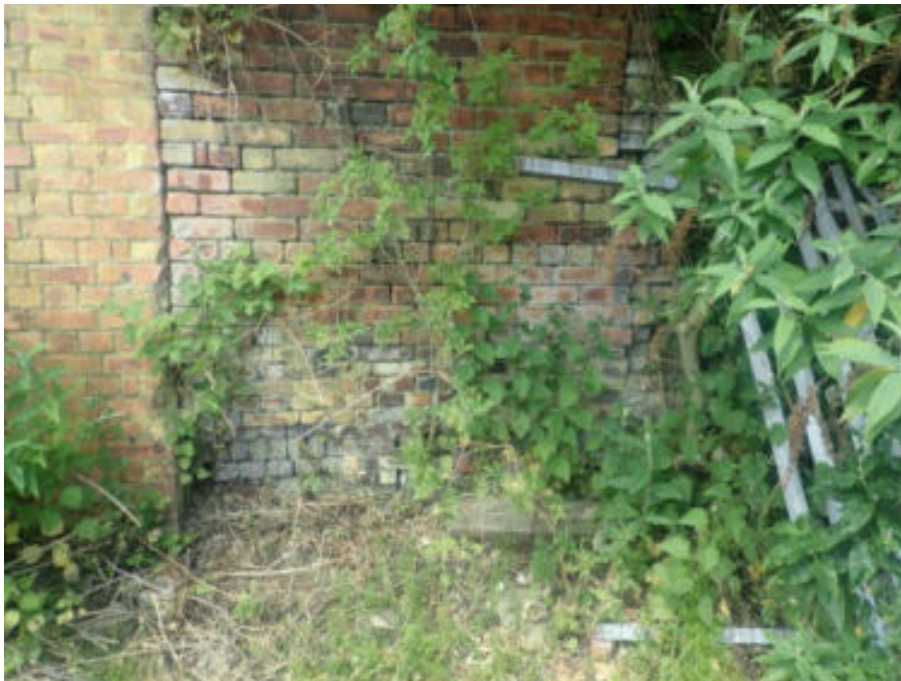
*Figure 177. Typical mortar loss*

#### 37.2.5 RW24F – Missing mortar 5-10% of section.

37.6.1 Undertake masonry repair on wall, ensuring that any fractures wider than 5mm are addressed through stitching (helibar or similar). Additionally, it is recommended to conduct annual monitoring of the wall for maintenance purpose.

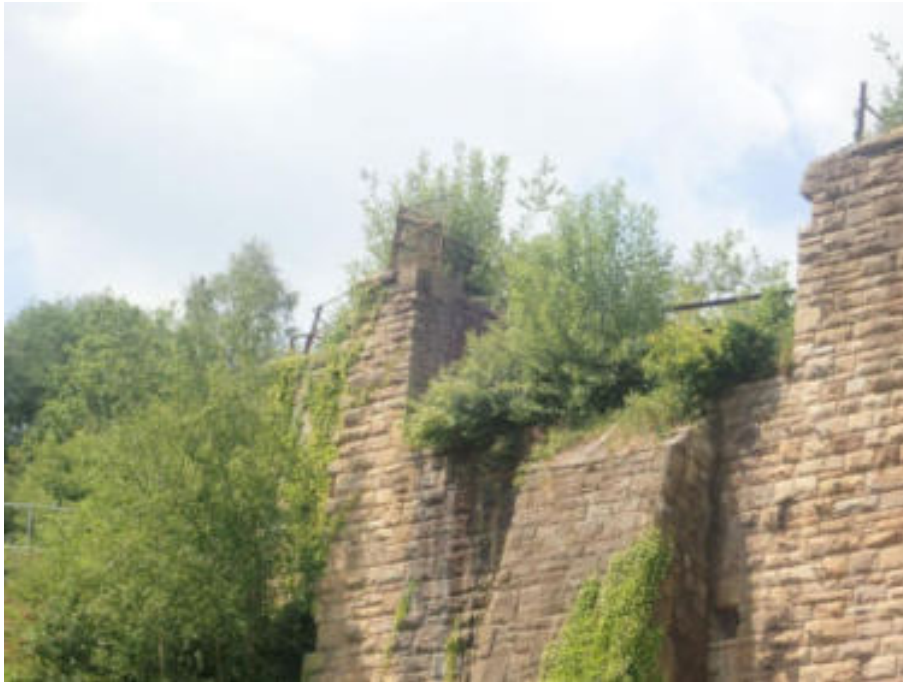
*Figure 178. Corroded fence*

**37.2.6 RW24G – Corroded safety fence at top of wall.**

37.5.1 Dismantle the steel safety fence to prevent any further corrosion and minimise the potential hazard of the fence falling onto pedestrians. Restrict access to top of wall via temporary fencing.

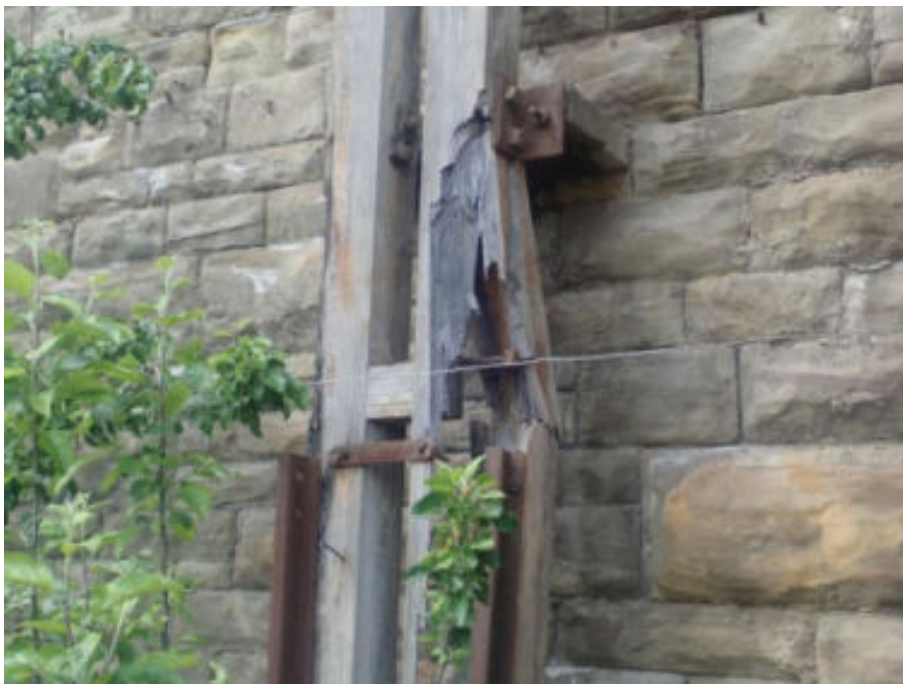
*Figure 179. Deteriorated timber*

**37.2.7 RW24H – Deteriorated timber.**

37.6.3 Replace timber propping with a suitably designed member.

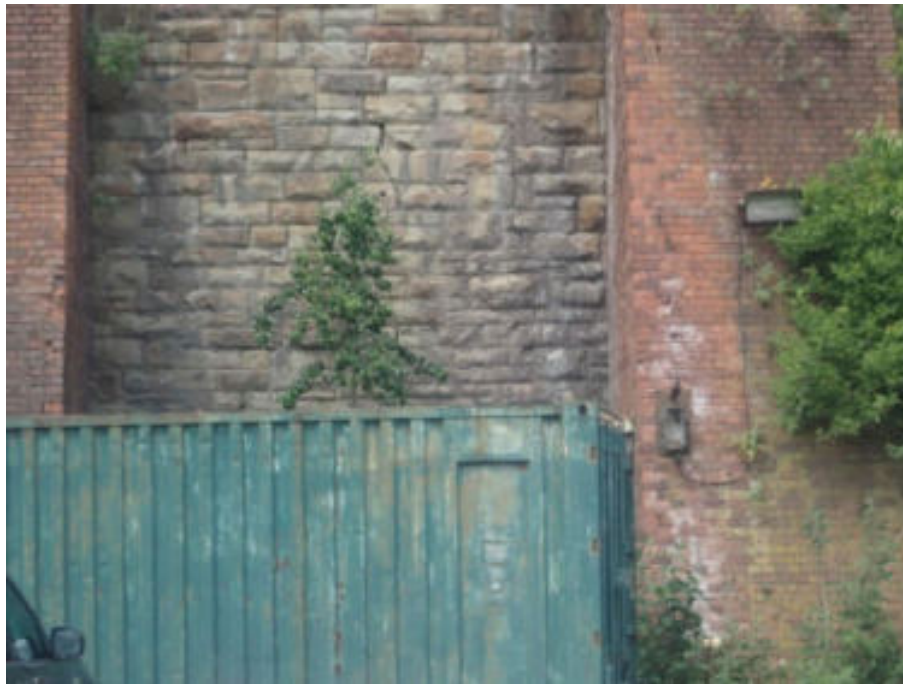
*Figure 180. Corroded lighting*

**37.2.8 RW24J – Corroded lighting on buttresses.**

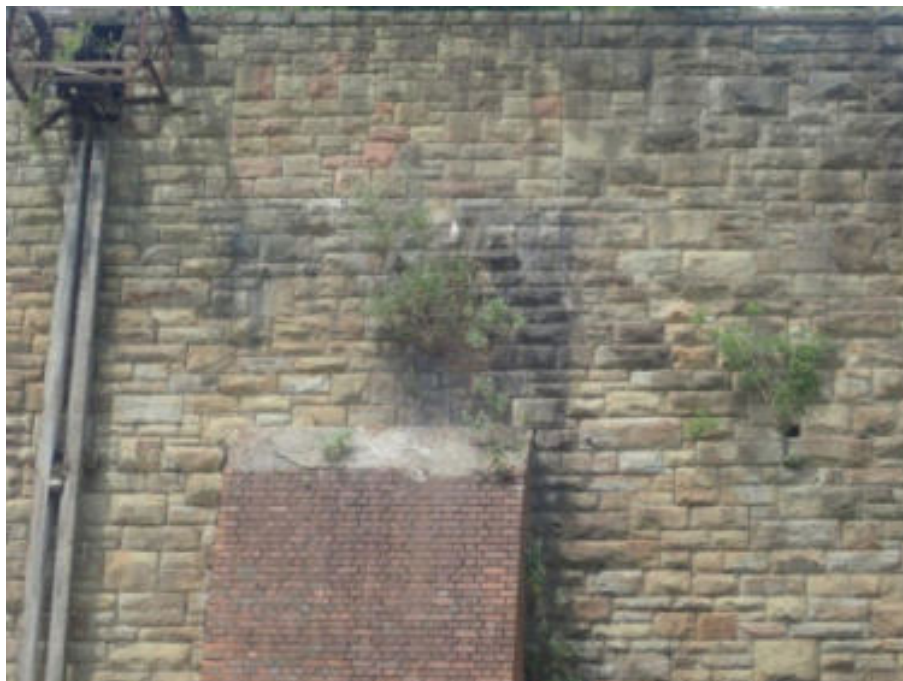
*Figure 181. Delaminated render*

**37.2.9 RW24K – Delaminated cementitious capping render on top of buttresses. 10% of total area.**

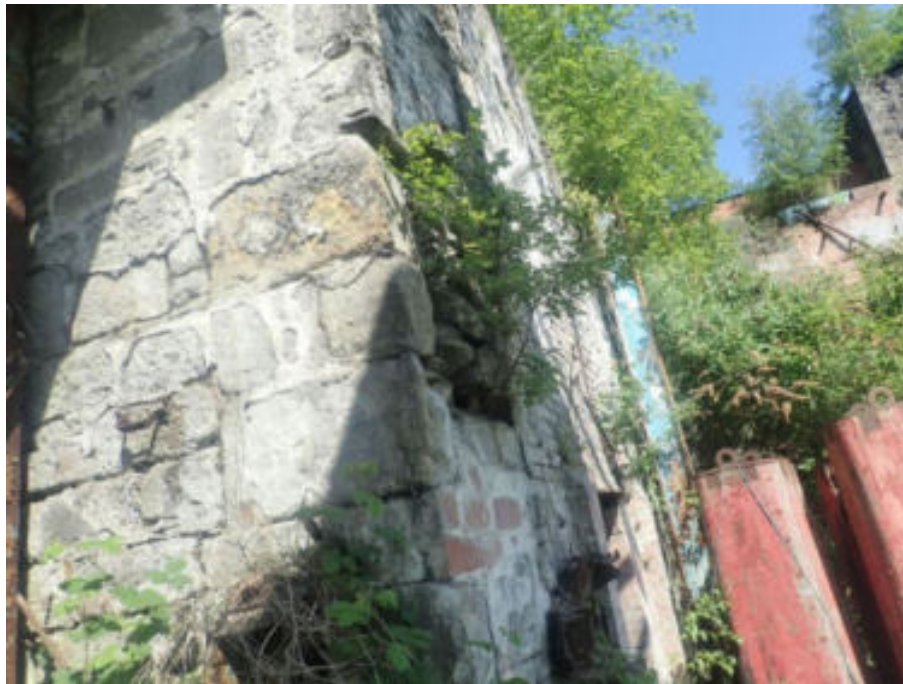
*Figure 187. Vegetation growth*

#### 38.2.6 R1G – Vegetation growth.

- 38.5.1 Restrict access to room.
- 38.5.2 Remove vegetation and implement a long term maintenance and inspection regime. For this type of structure, recommend annual vegetation removal with annual general inspection.
- 38.5.3 Overpump standing water to prevent moisture affecting the base of surrounding structures.

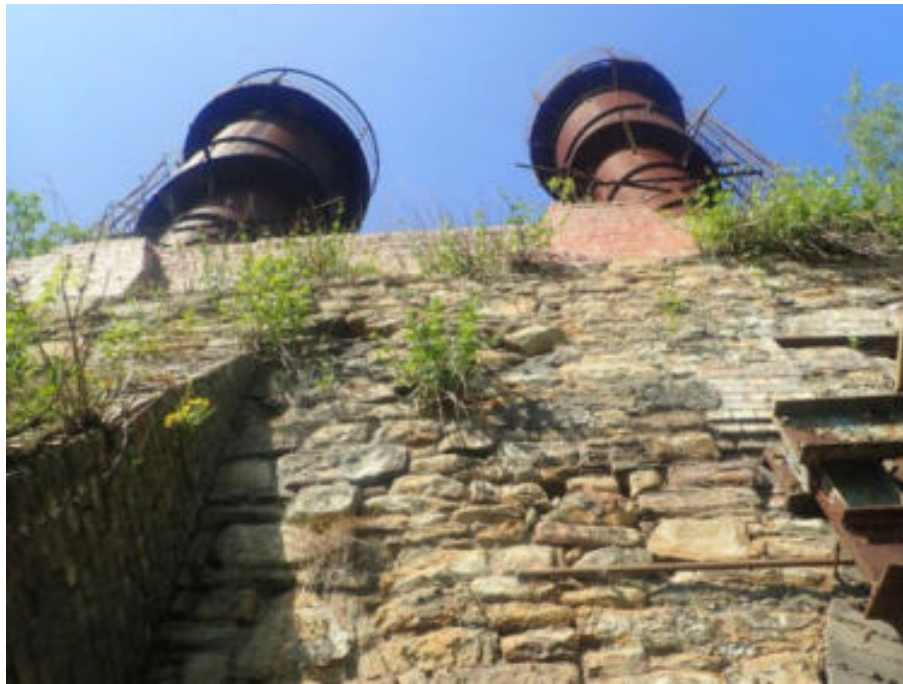
*Figure 190. Typical vegetation growth*

#### 40.2.2 R3B – Vegetation growth.

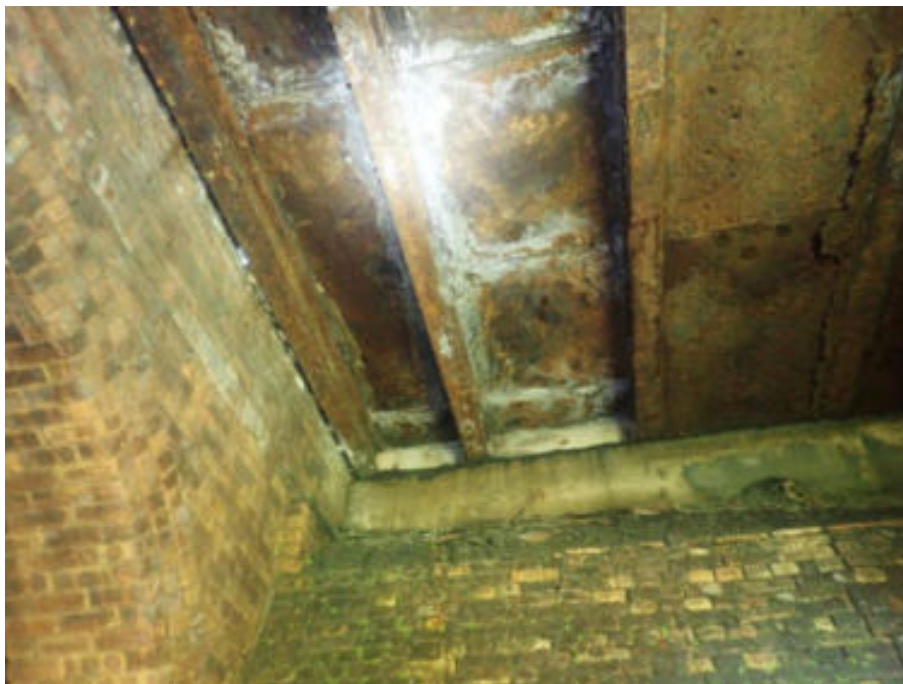
*Figure 191. Steel Members*

#### 40.2.3 R3C – Heavily corroded steel roof members.

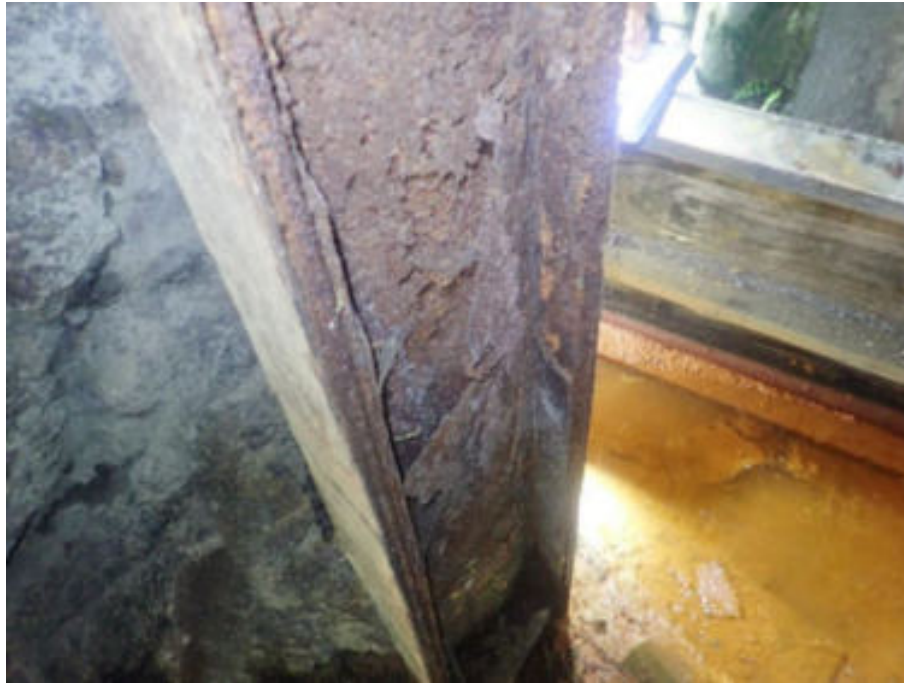
*Figure 192. Corrosion to column*

40.2.4 R3D – Severe corrosion was noted to the columns supporting the reinforced concrete deck.

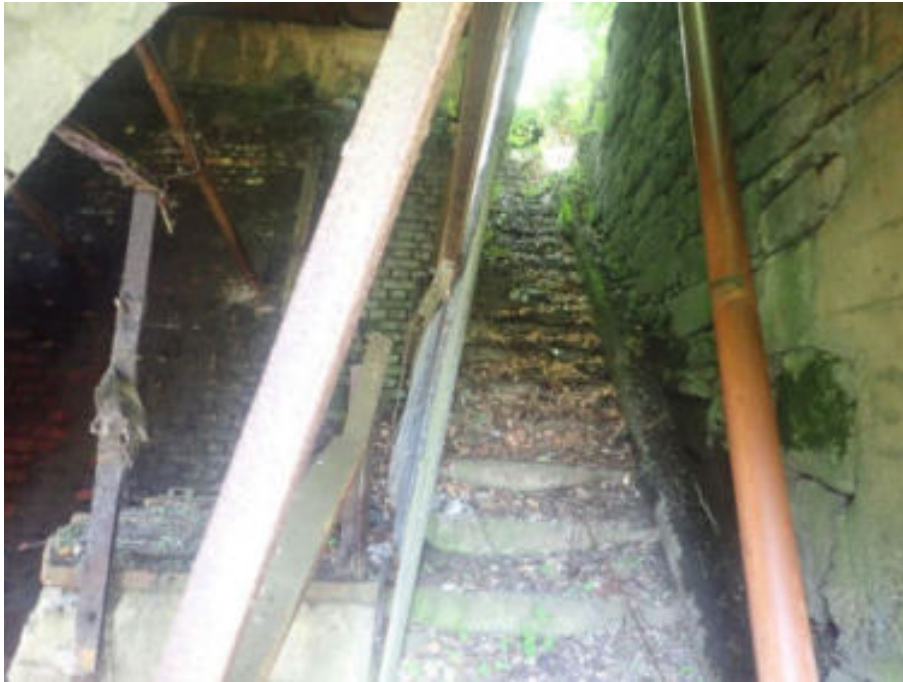
*Figure 193. Debris on stairs*

41.2.1 ST1 – Debris build up noted on stairs.

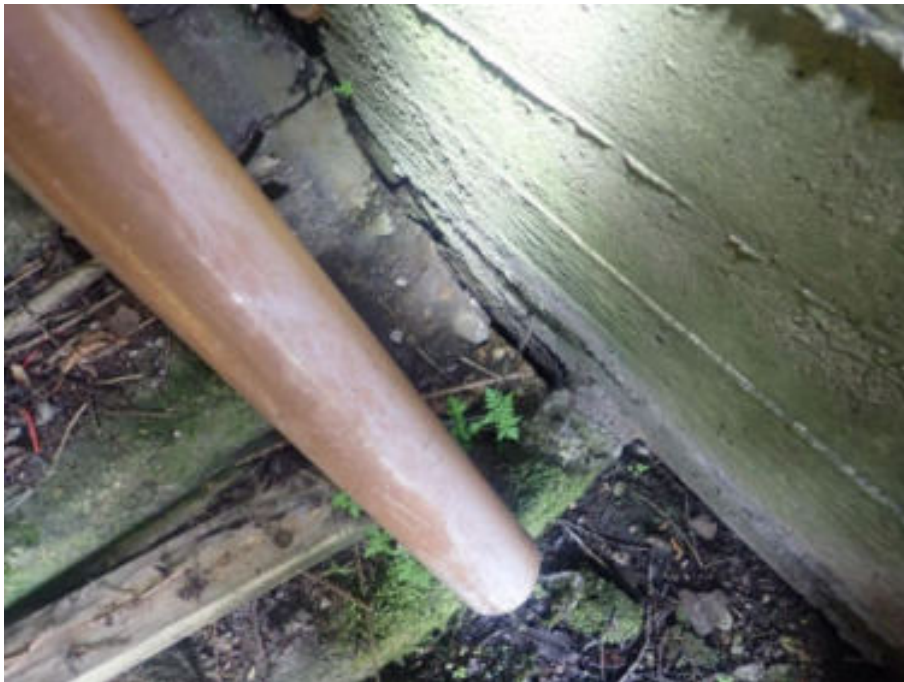
*Figure 195. Pipe discharging onto ground*

**41.2.3 ST3 – Rain water pipe discharging surface water at bottom of stairs straight onto ground,**

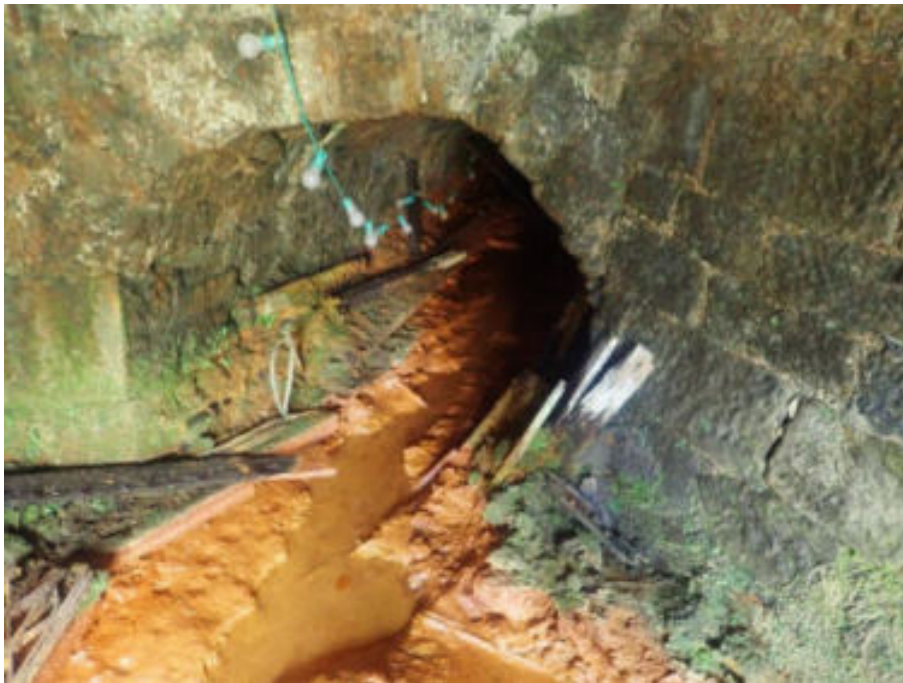
*Figure 196. Typical mortar loss*

42.2.1 R4A – Minor mortar loss, approx. 5% of total area.

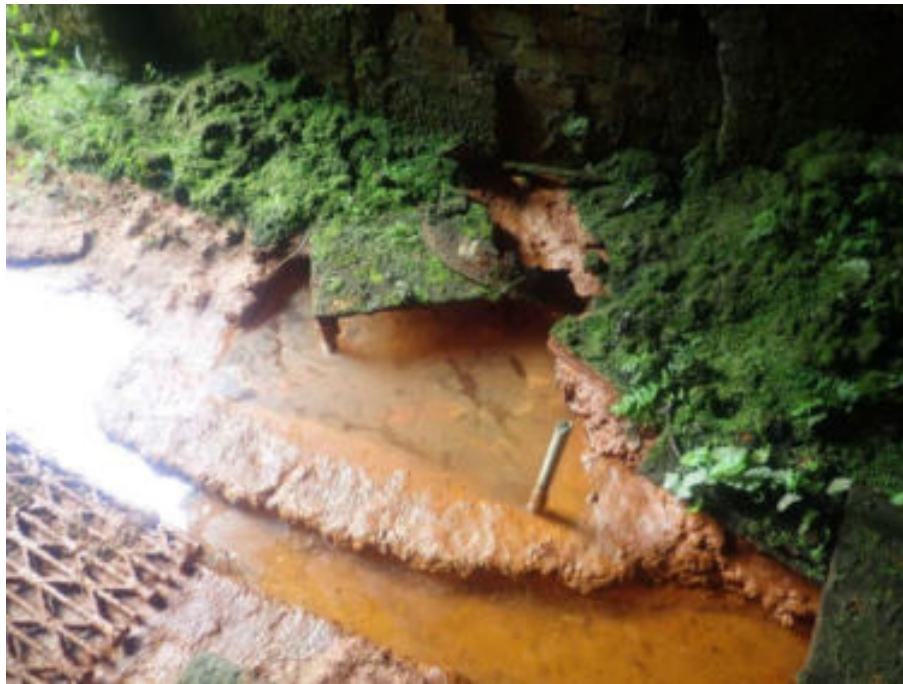
*Figure 197. Typical algae and moss growth*

#### 42.2.2 R4B – Algae and moss growth.

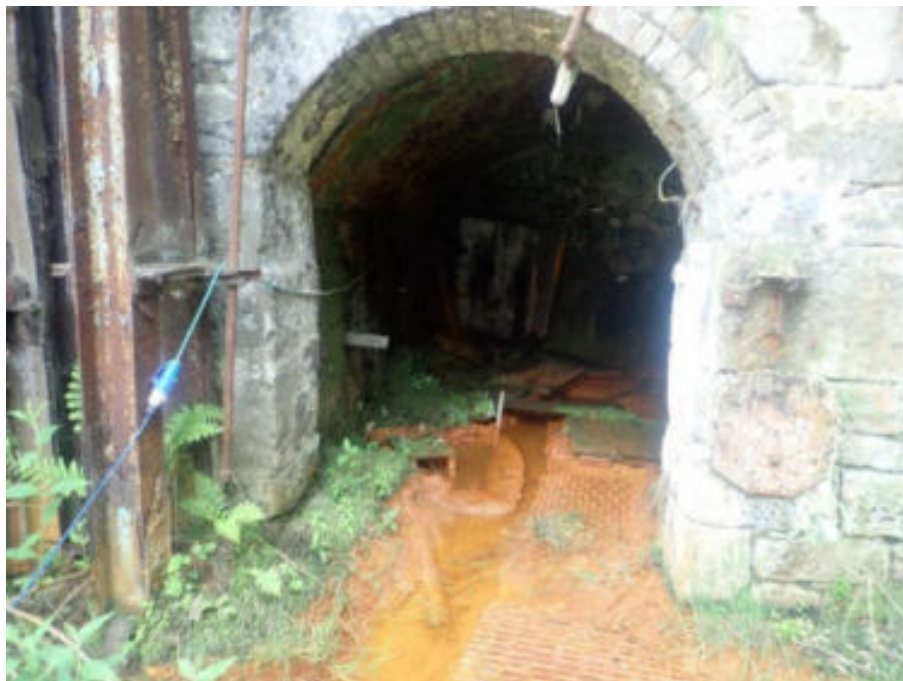
*Figure 198. General view of floor*

#### 42.2.3 R4C – The condition of the floor in Room 4 is highly unsuitable for walking due to corroded grates, a wet base, and noticeable voids present on the ground.

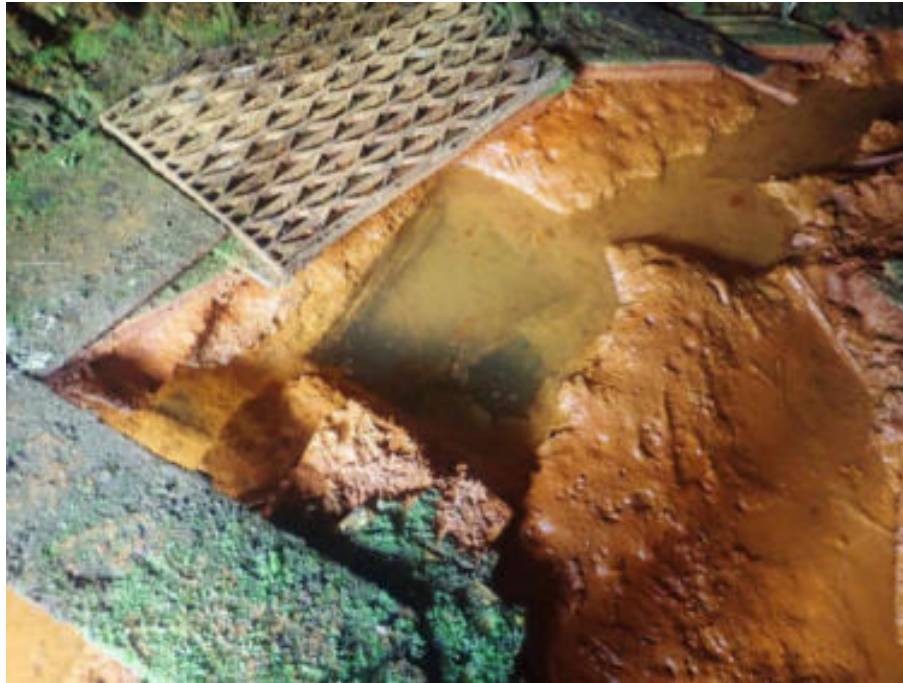
*Figure 199. Water presence*

42.2.4 R4D – There are visible signs of water presence in the room. The pipe within the channel is damaged and the drainage system is blocked up.

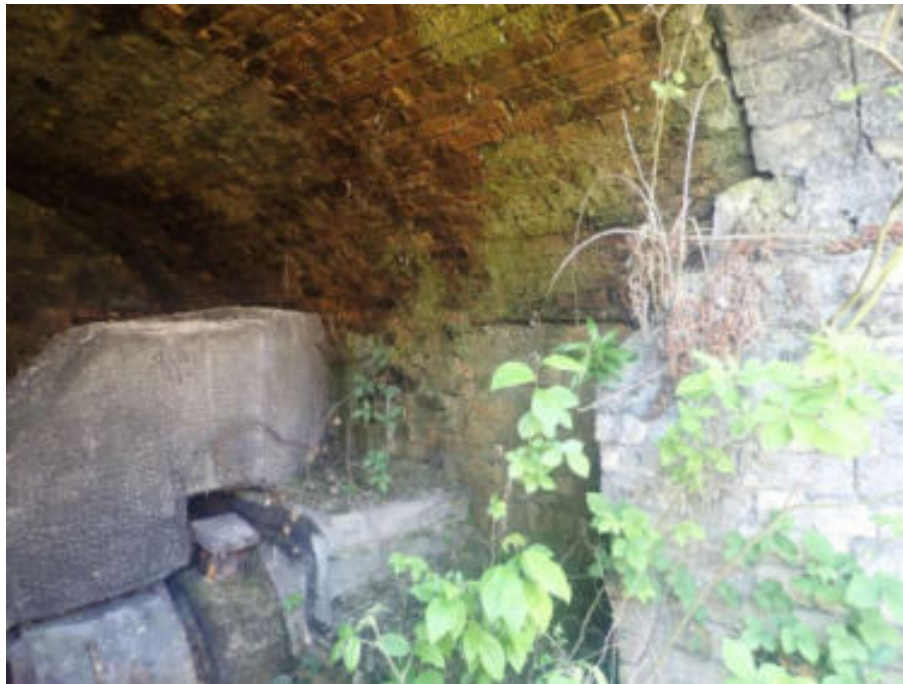
*Figure 201. Typical algae and moss growth*

**43.2.2 R5Aii/R5Biii – Algae and moss growth.**
