# **BRYMBO HERITAGE PROJECT**

## **STRUCTURAL CONDITION ASSESSMENT**

**August 2023**  
**Suitability S2**  
**Revision P02**

**By:**  
Bingham Rawlings Partnership Ltd.

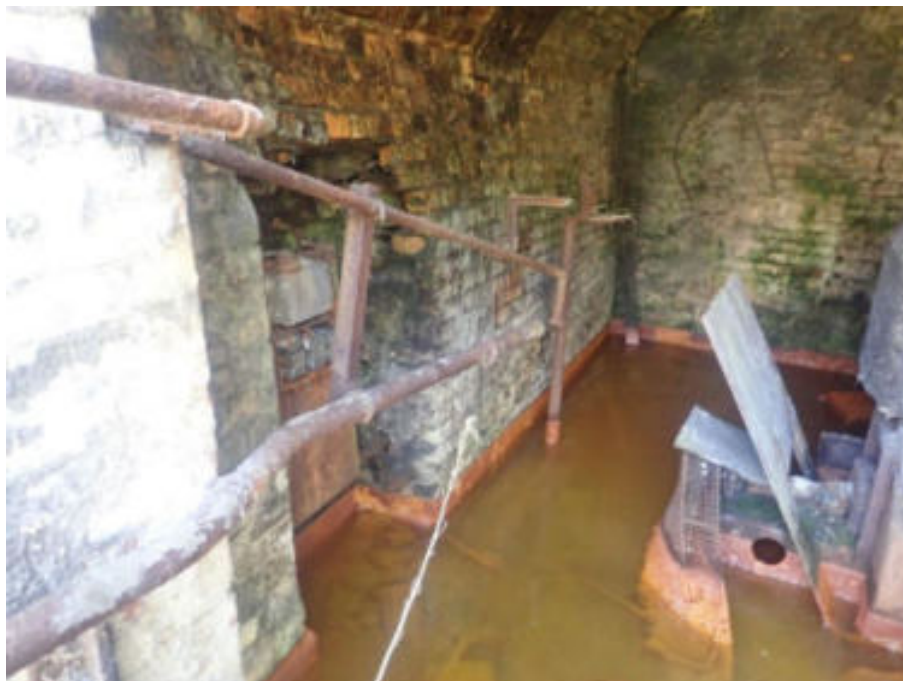
*Figure 202. Typical water ingress*

**43.2.3 R5Aiii/R5Biii – The room exhibits evident signs of water accumulation, which can be directly attributed to the obstructed drainage system in room 4.**

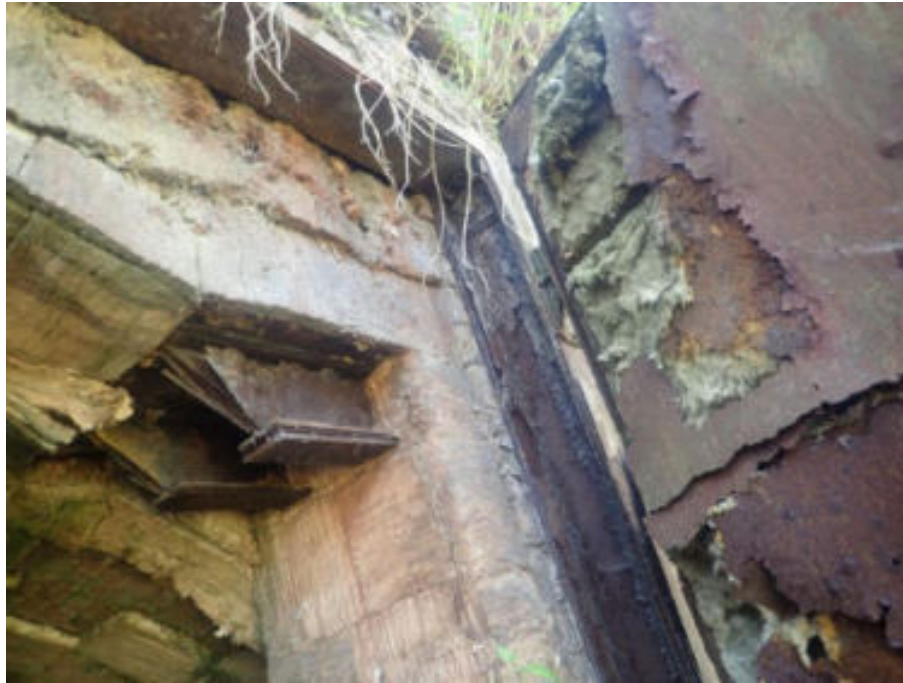
*Figure 203. Corroded beam*

- 43.2.4 R5Aiv – Expansive corrosion noted on steel beam at top right corner of opening. Beam is thought of a historic lintel and is no longer bearing any loading.

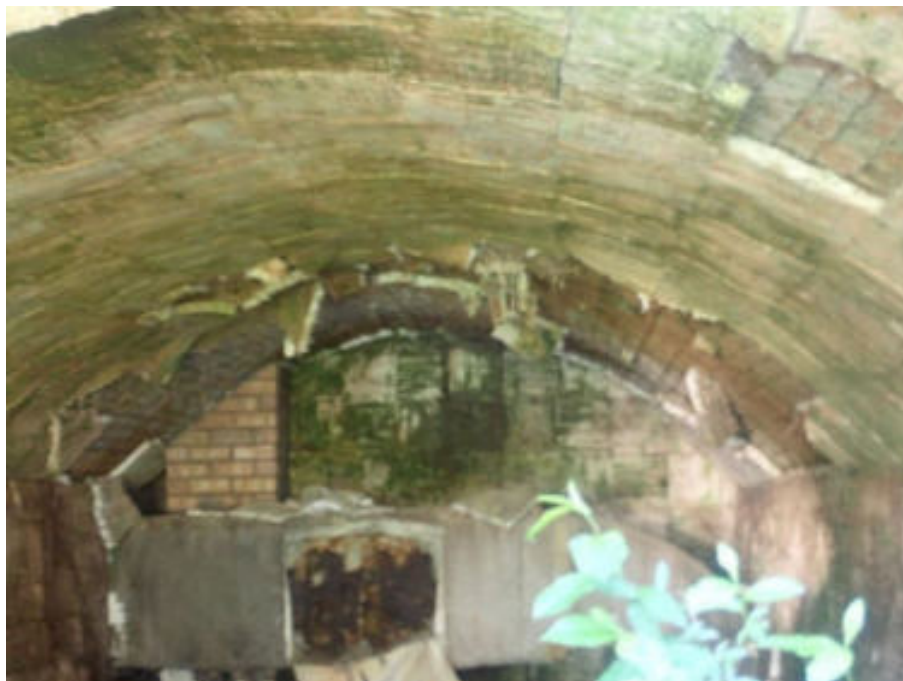
*Figure 204. Deterioration to plasterboard*

- 43.2.5 R5v – General weathering and deterioration noted on plasterboard.

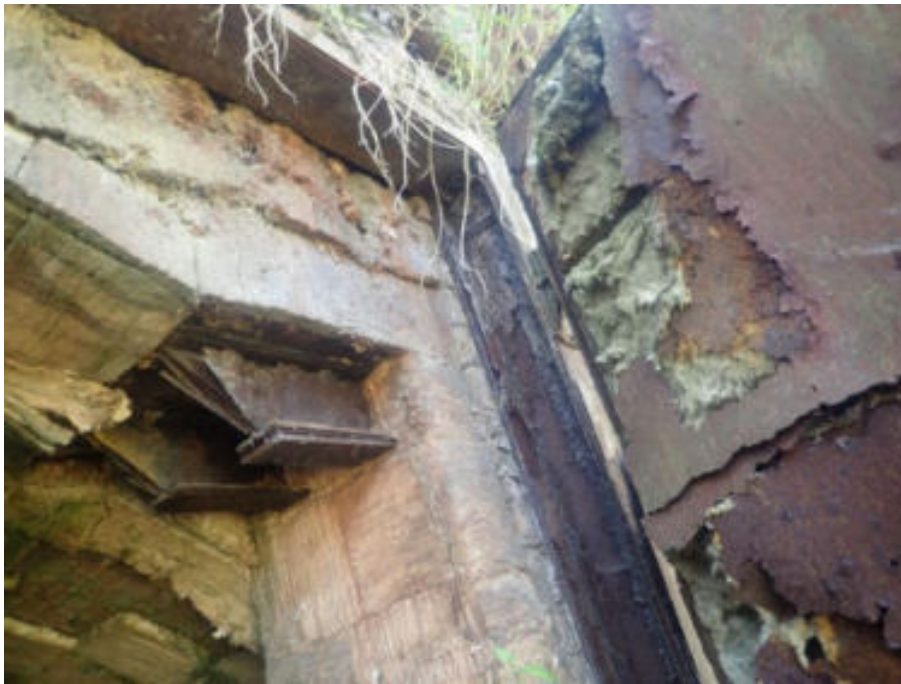
*Figure 207. Deteriorated brickwork and beam*

#### 43.2.8 R5Aviii – Deteriorated brickwork and beam

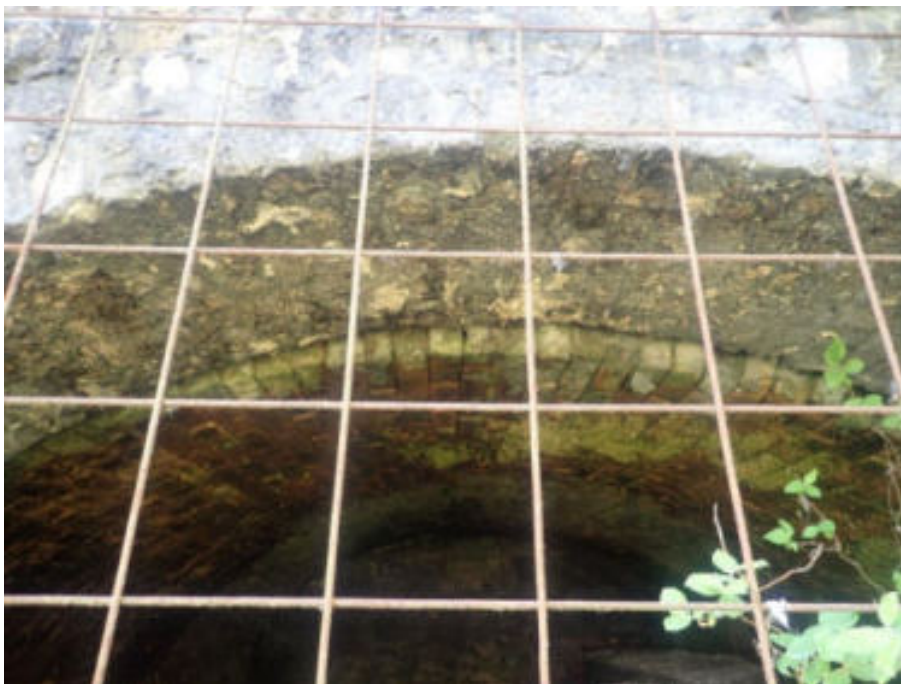
*Figure 208. Void*

#### 43.2.9 R5Biv – Void noted between arch barrels.

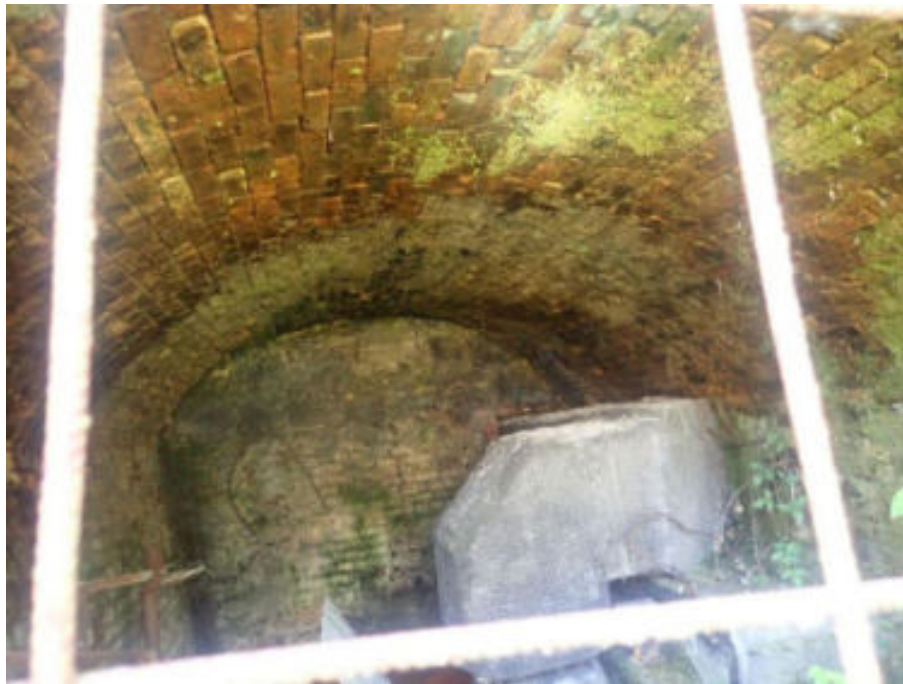
*Figure 209. Deteriorated masonry*

**43.2.10R5Bv – Deteriorated masonry noted above access.**

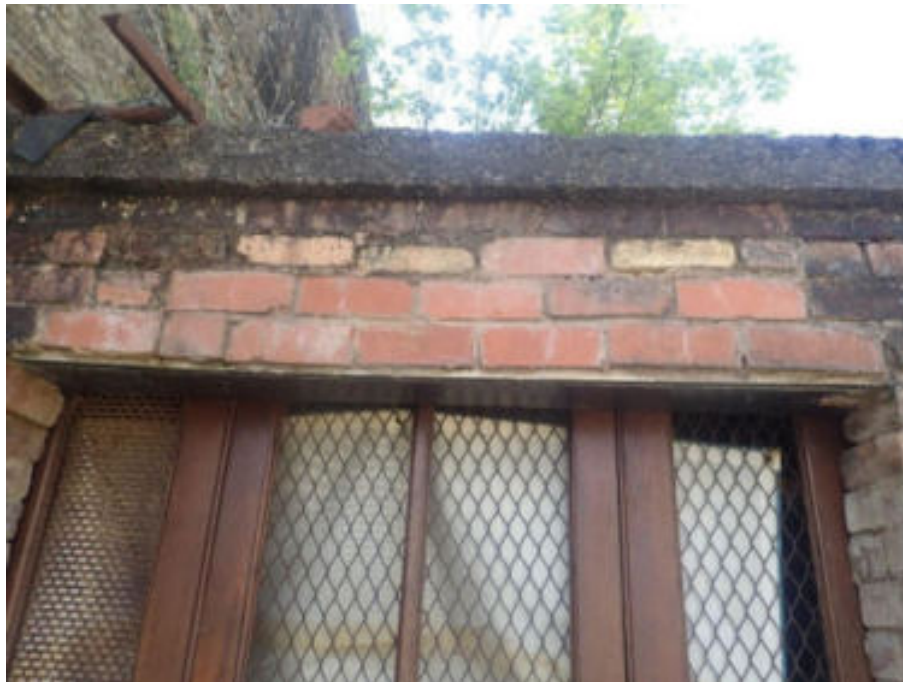
*Figure 210. Deflection to lintel*

44.2.1 R6A – Visual deflection noted on lintel, but has not entered a mode of failure.

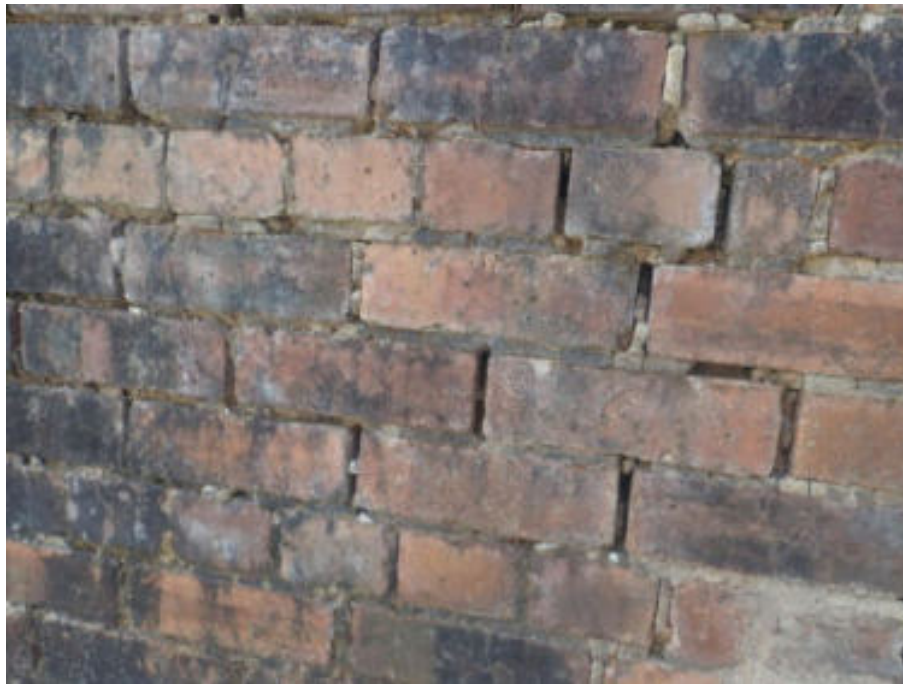
*Figure 211. Typical mortar loss*

**44.2.2 R6B – Missing mortar Approx 10% of total area.**

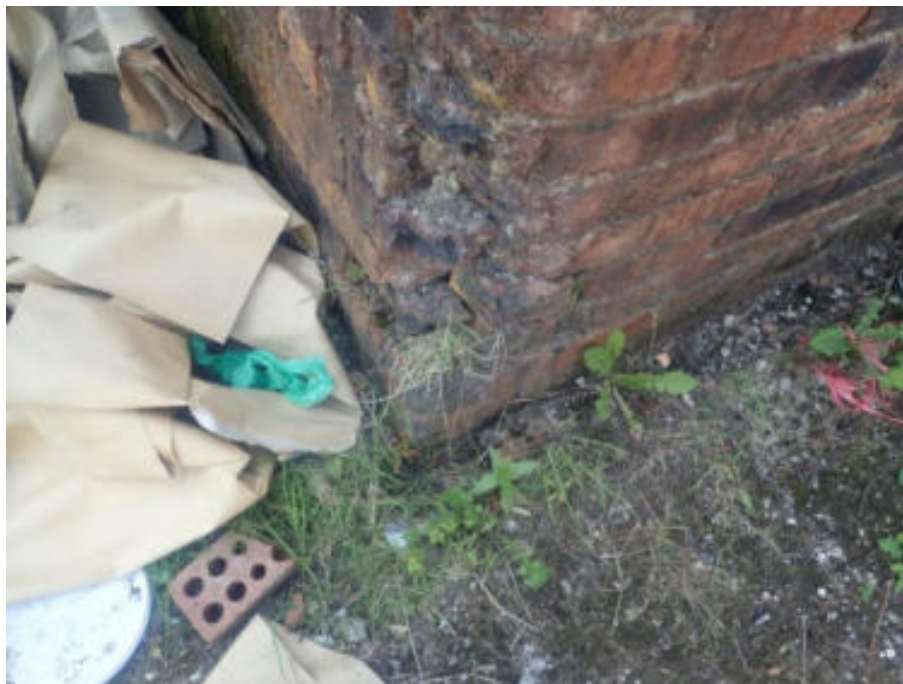
*Figure 212. Typical spalled brickwork*

**44.2.3 R6C – Spalling noted on brickwork <5% of total area.**

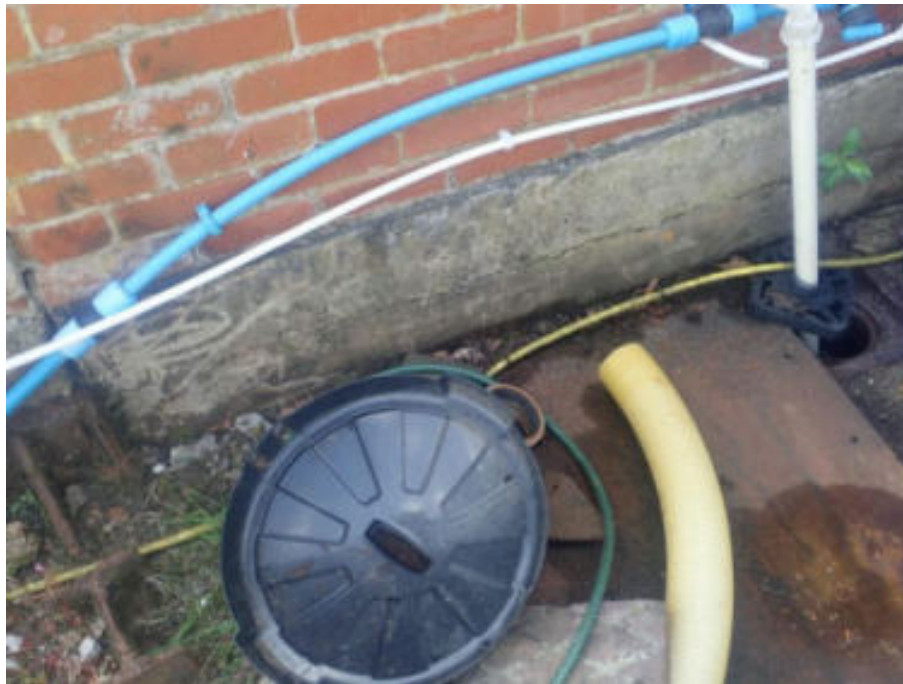
*Figure 214. Horizontal fracture*

45.2.2 R7B – Horizontal fracture noted on plinth.

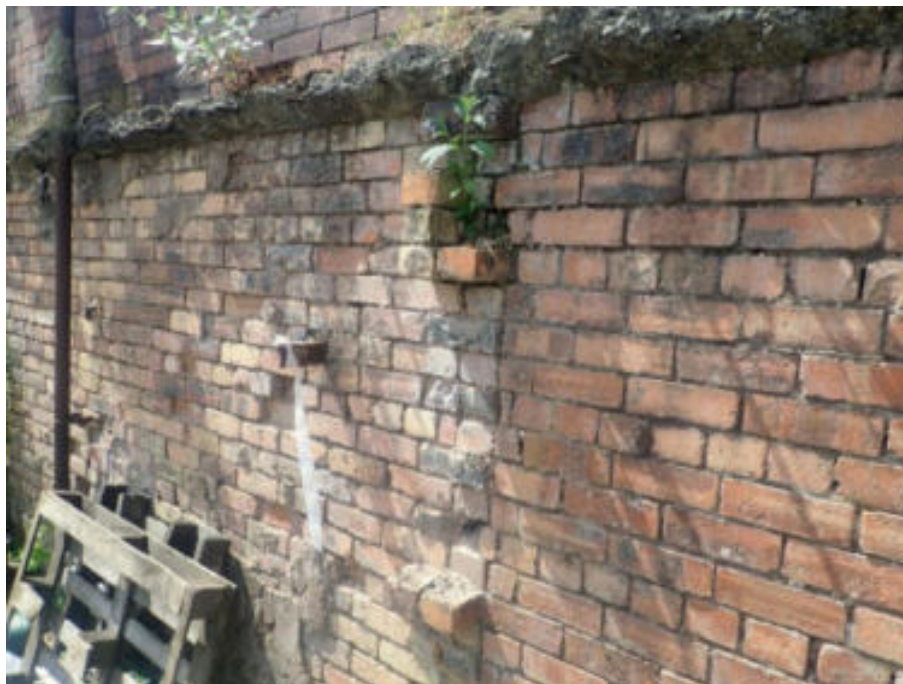
*Figure 215. Typical missing mortar*

45.2.3 R7C – Missing mortar joints 10-20% of total area.

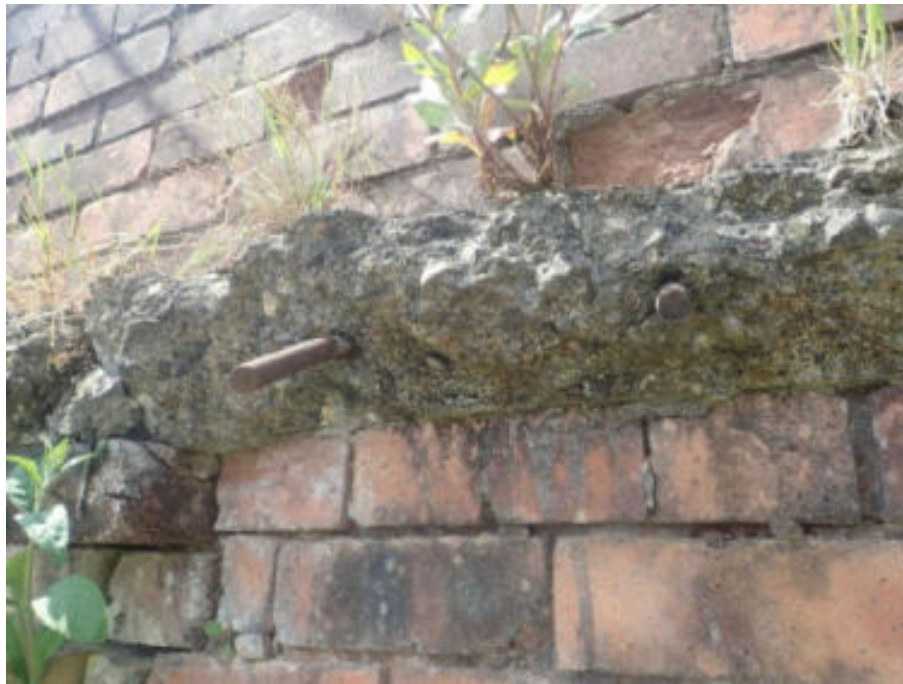
*Figure 216. Typical vegetation growth*

#### 45.2.4 R7D – Vegetation growth.

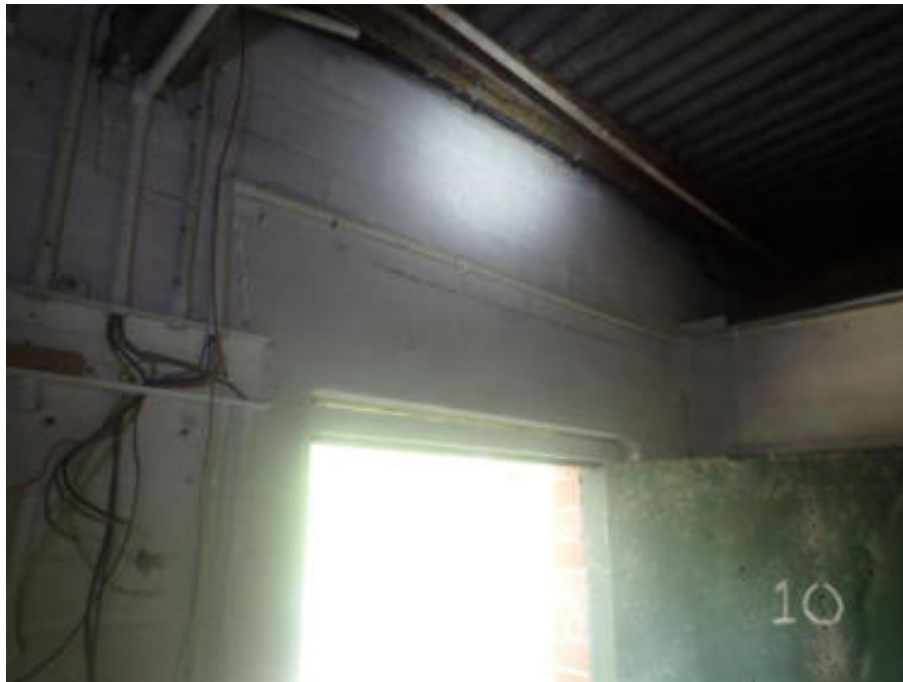
*Figure 217. Typical cracking above lintel*

46.2.1 R8A – Deflection and hairline fracture noted above 2 No. internal precast concrete lintel.

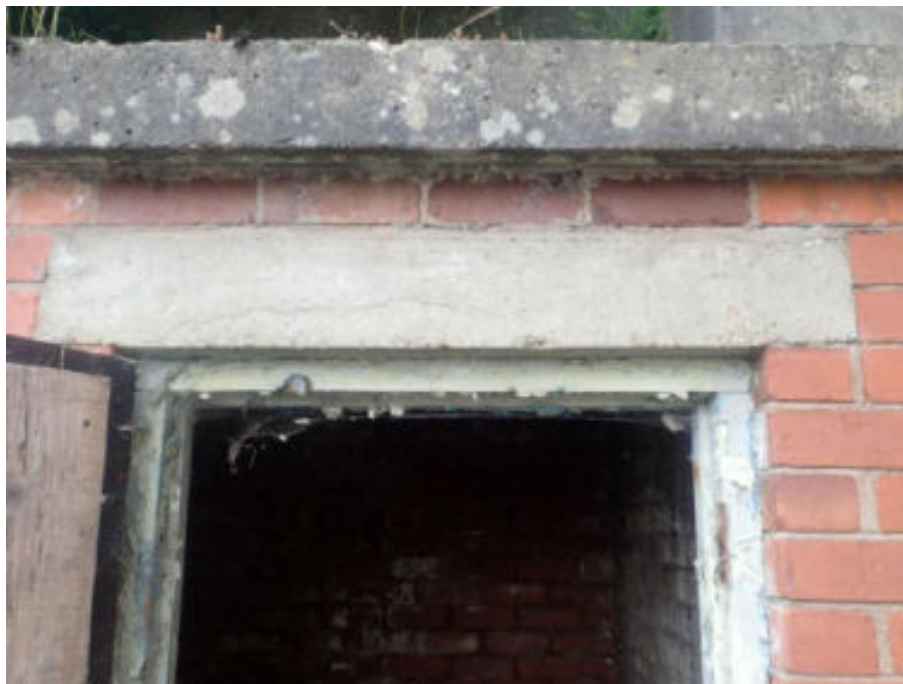
*Figure 220. Deflected and cracked lintel*

47.2.1 R9A – Deflection and hairline fracture noted on precast lintel above door.

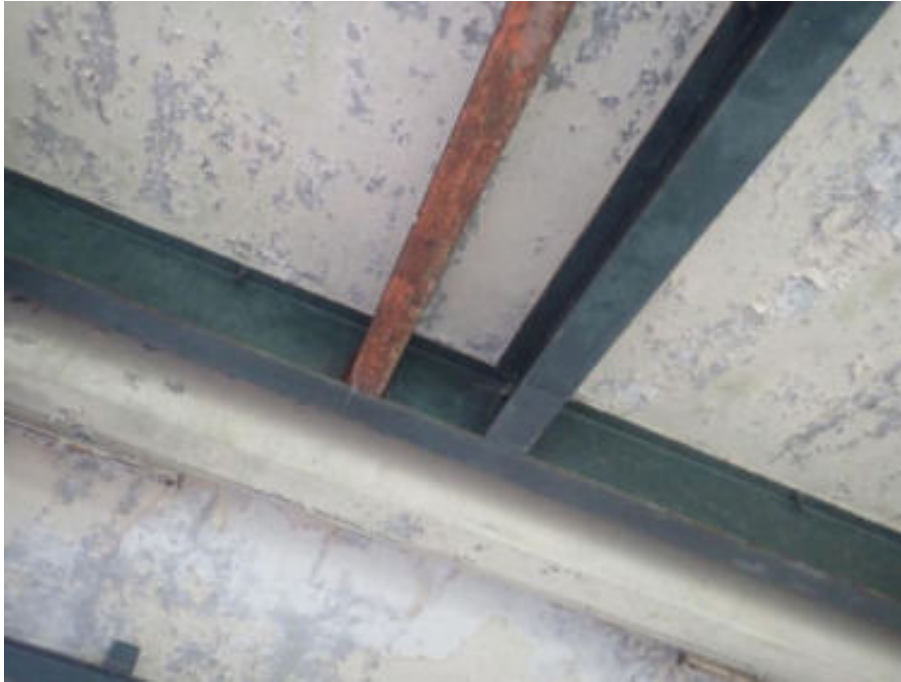
*Figure 221. Typical corrosion to beam*

48.2.1 R10A – Corrosion was noted to the beams under the roof.
