## Structural Survey

Timber Frame Barn, Top  
House Farm, Arowry,  
Wrexham, SY13 3EQ.

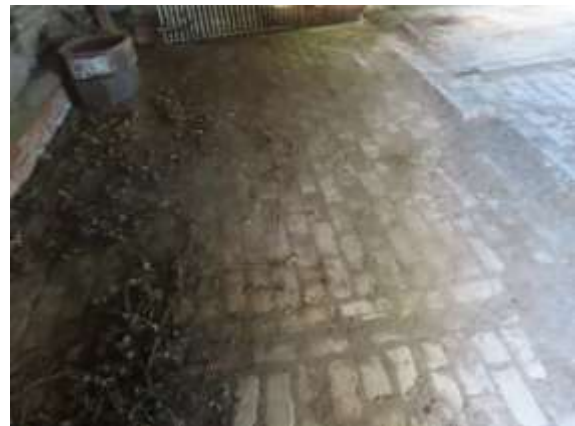
Mixture of brick and concrete floor

| <b>7. Ground Floor</b> | Part concrete base and part brick finish.. | Uneven flooring throughout. | Replacement floor required to incorporate DPM and insulation. |
