| <b>Report Title</b> | <b>Proposed Demolition of The Bungalow, Henblas Street, Rhostyllen, Wrexham – Preliminary Roost Assessment/ Nesting Bird Assessment</b> |
| <b>Date issued</b> | <b>11<sup>th</sup> August 2022</b> |
| <b>Report Version</b> | <b>C489/ 1.0/ PRA</b> |
| <b>Client</b> | <b>Wrexham County Borough Council</b> |

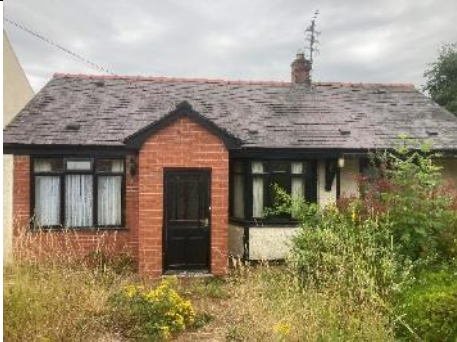
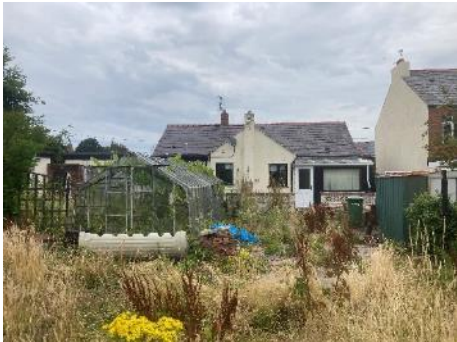
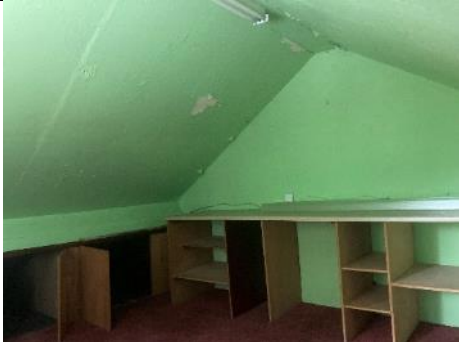
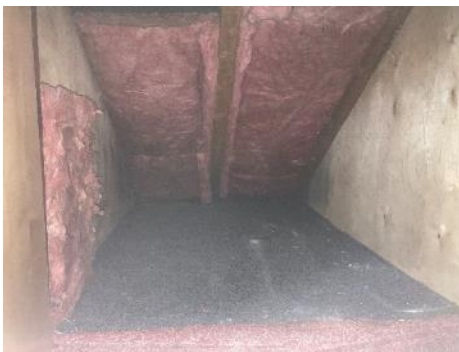
| Building 1 (B1) - Bungalow | | | |
|---|---|---|---|
| <p>Building 1 is a brick-built and rendered bungalow. The walls are very well sealed. The roof is slate with clay ridge tiles and a brick chimney protruding with lead flashing. A concrete verge is present on each gable.</p> <p>Barge-boards or soffit boxes are also present.</p> <p>Timber doors and windows are present on the southern, western and northern aspects only. These are in good condition.</p> <p>A small porch is present on the northern aspect and flat roofed lean-to extensions on the southern and western aspects.</p> | <p>Northern elevation.</p> <p>Southern elevation.</p> | <p>The bungalow has only recently become empty having previously been occupied. It has been emptied of furniture.</p> <p>In the western half of the roof no loft void exists, an 'office' room has been built in the pitched roof. Cupboards have been built at floor height that are under the roof slope.</p> | <p>Office within western roof space.</p> <p>Internal photo of cupboard within office, showing insulation.</p> |

- 4.2.2 Building B1, the Bungalow, is very well maintained and sealed to bats and birds. The walls are rendered and provide no roosting opportunities. The windows and doors also provide no cracks or gaps around them potentially useable by bats. The roof is in very good condition; no raised, broken or slipped slates were seen and the ridge tiles were all well sealed with no gaps beneath them. The verges are well sealed with no potential features seen. No gaps were present within the lead flashing around the chimney. No gaps were present under barge boards or into soffit boxes.

- 4.2.4 The loft of Building B1 was thoroughly checked and no droppings or evidence of bat use was found. No direct flight access points were present and no light ingress through cracks or similar was seen within the loft. The membrane was in excellent condition with no rips or damage.
- 4.2.5 Building B2, the garage/ snooker room provides no features suitable for roosting bats. The barge boards are all well sealed with only minimal gaps present (0 mm to 10 mm) and cobwebbed. The garage/ snooker room has a flat roof and provides no roosting features within it. There is no access onto the wall plate due to the barge boards. The building is

rendered and the walls, windows and doors provide no potential features, all being completely sealed with no cracks or gaps.

- 5.1.6 Based on the findings of the PRA no nocturnal (emergence) survey work in relation to bats is required and the proposed demolition work can proceed. However, as two sub-optimal features have been identified within Building B1, and those features are of a type that are suitable for species that are more likely to be present in an urban environment, proportionate Reasonable Avoidance Measures (RAMs) are recommended.

- 6.1.4 A licensed bat-worker or accredited agent should be present to oversee removal of the two sub-optimal potential bat features prior to any other demolition-related works on Building B1. The removal of any feature with bat roost potential, will be undertaken by hand in suitable weather conditions and under direct ecological supervision. Where applicable, materials will be removed carefully away and not rolled or sprung to avoid potential harm to bats. The undersides of these materials will be checked by the licensed ecologist or accredited agent for bats that may be clung to them before removal.

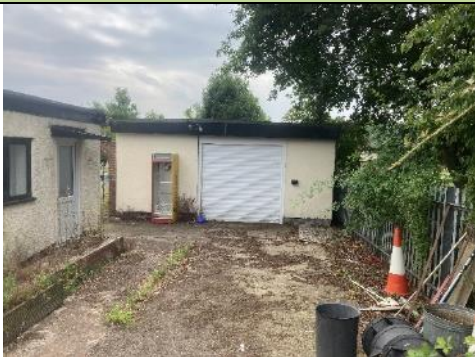
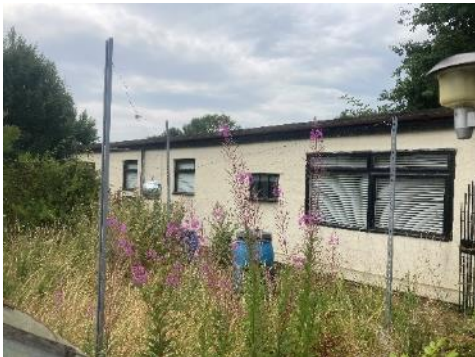
| Building 2 (B2) – Garage/ Snooker Room | | | |
|---|---|---|---|
| <p>Building 2 is a block-built garage/ snooker-room measuring approximately 15 m x 6 m. It has a flat roof and windows and door on the eastern aspect. A large roller shutter garage door is on the northern aspect.</p> <p>Barge boards are present on all sides with a narrow ventilation strip incorporated at its base.</p> | <p>Northern elevation.</p> <p>Eastern elevation.</p> | <p>Internally the building is split into a garage and a snooker-room with toilet and small kitchen also present.</p> <p>It has only recently been emptied.</p> | <p>No internal photos.</p> |
