Building 2 Demolition Extents

Bryn Farm, Hanmer

| DRAWN | WL | DRG No. | 23012 SK03 | REV | |

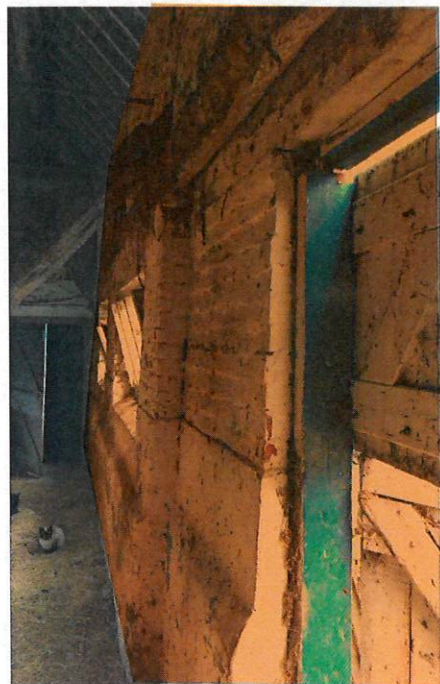
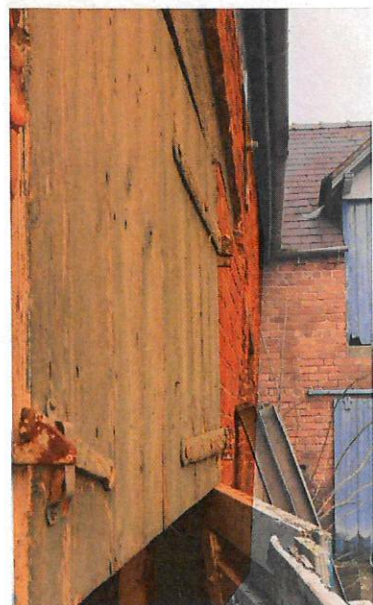
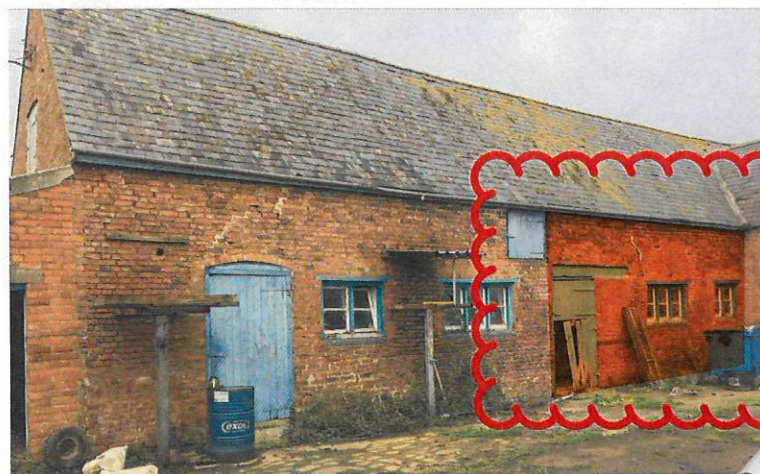
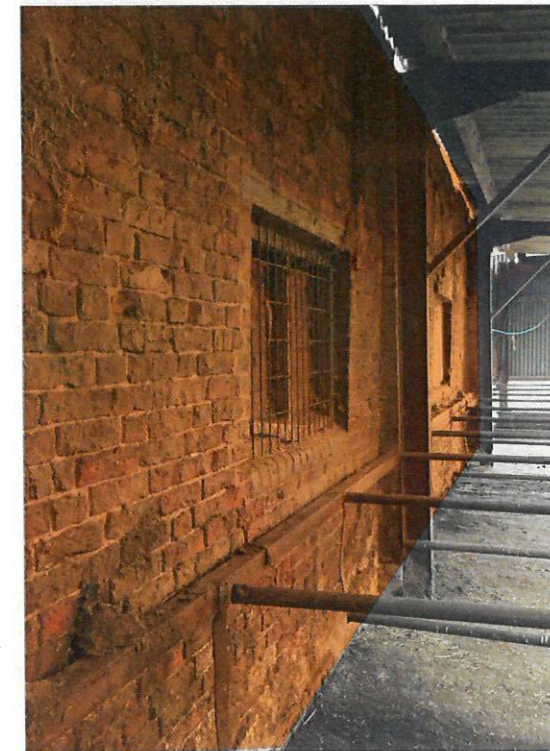
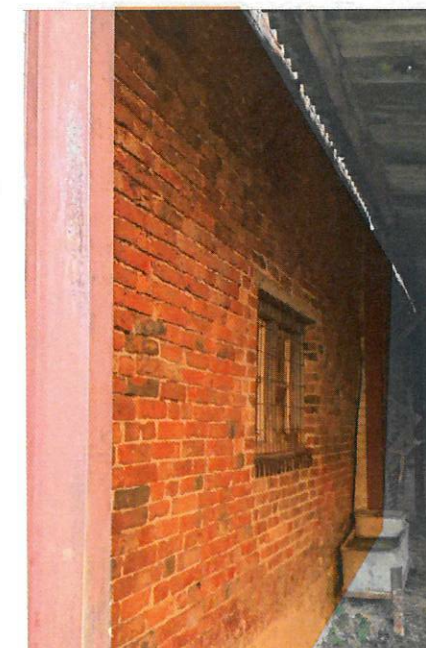
THIS WALL IS LEANING SIGNIFICANTLY AND THE CONCERN IS THAT THE WALL WILL BE UNSTABLE DURING THE REPLACEMENT OF THE ROOF AND ALLOWANCE SHOULD BE MADE FOR ITS DEMOLITION AND REBUILDING

PIER HAS SEPERATED AND NEEDS TO BE REBUILT LOCALLY

THIS WALL IS LEANING SIGNIFICANTLY AND THE CONCERN IS THAT THE NEWER BARN STRUCTURE IS GIVING IT SUPPORT. WHEN THIS IS REMOVED, THE WALL MAY BE UNSTABLE SO ALLOW FOR DEMOLITION AND REBUILDING
