# Chapel House, Bronington Bat Report

Project Number TT3507

Title Chapel House, Bronington

Document Number R01-Bat Report-Rev00

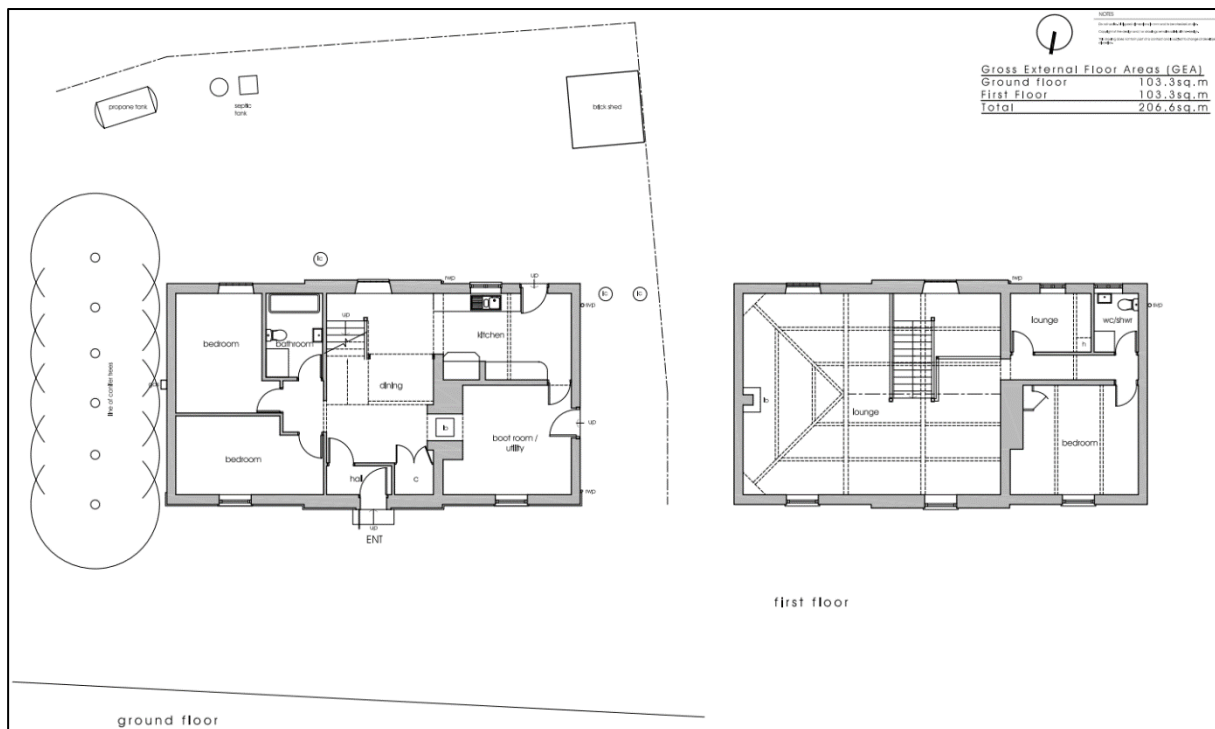
Figure 4. Existing floor plans of Chapel House

The proposed development site comprises a Grade II listed Methodist Chapel which has been converted into a residential dwelling. The converted Chapel has been unoccupied for approximately 10 years and left to fall into a state of disrepair. There is also a single-storey brick outhouse, front and rear gardens and sections of paved areas around the property. An old heating fuel tank is located within the rear garden which has not been used in recent years. The site is bordered by Leylandii hedgerows to the west and east, fence line overlooking an agricultural field to the south and open to the main road to the north. The existing layout of the site is shown in *Figure 4* and existing elevations of the Chapel are shown in *Figure 5*.

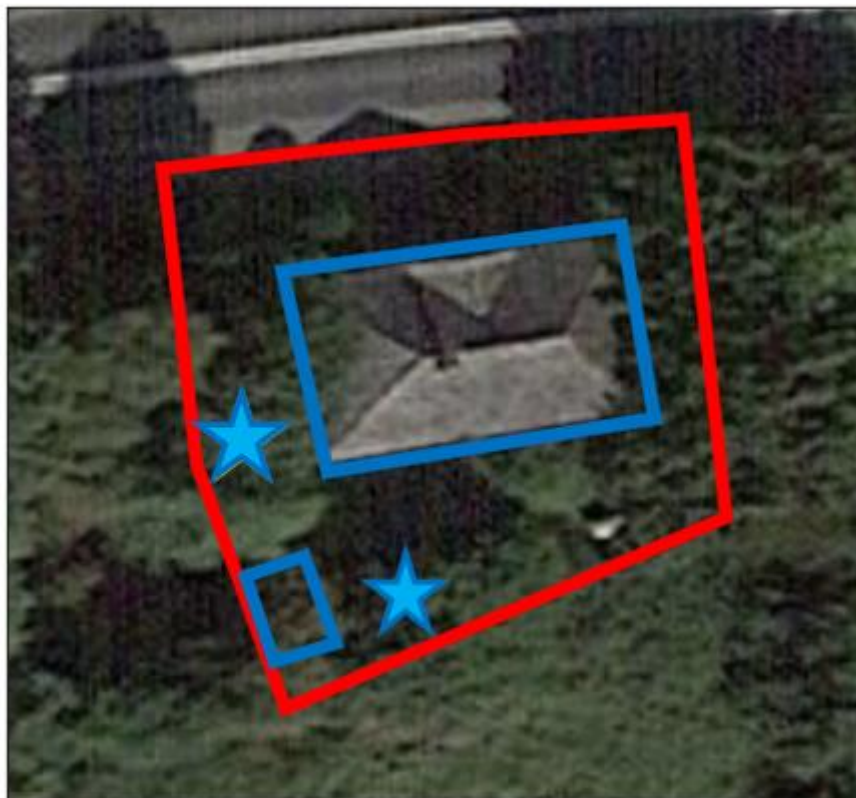
*Figure 8. Proposed bat and bird box locations on mature trees to the west and south of the site (blue stars =Schwegler 2F, or equivalent, and bird nest box)*

- Provision of roosting locations for the duration of works with two Schwegler 2F (or equivalent) bat boxes erected on retained boundary trees along the southern/western boundaries of the property, within the ownership boundary (*Figure 8*). The bat boxes will be retained and maintained for the lifetime of the development.

A combination of one hole-fronted and one open-fronted nest box will be erected on the mature trees to the west and south of the site adjacent to the bat boxes (*Figure 8*) and one Sparrow Terrace such as the Schwegler 1SP (or equivalent) should be incorporated into the new extension on the southern or western elevations.

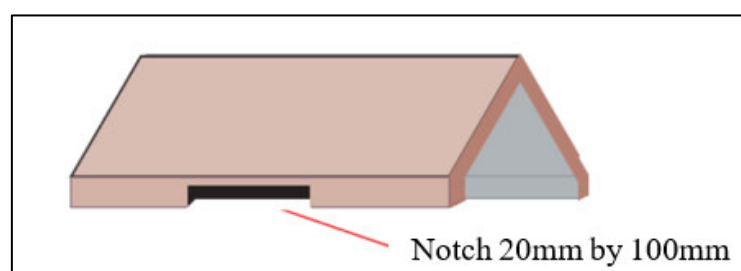
Figure 11. Creation of access and roosting opportunities under lifted ridge tiles in new roof

- If roosting features are to be lost then these must be replaced with similar features during the construction phase of the extension.
- Additional simple roosting features will also be created by incorporating at least two bat tiles and one Beaumaris Woodstone Bat Box (or equivalent) into the new extension section of the property (*Figures 9 & 10*).
