## **BAT GROUND LEVEL TREE ASSESSMENT**

### **Plot 3A**

Wrexham Industrial Estate  
Wrexham  
Wrexham County Borough  
L22 3XS

| UES reference: | UES03448/06 |

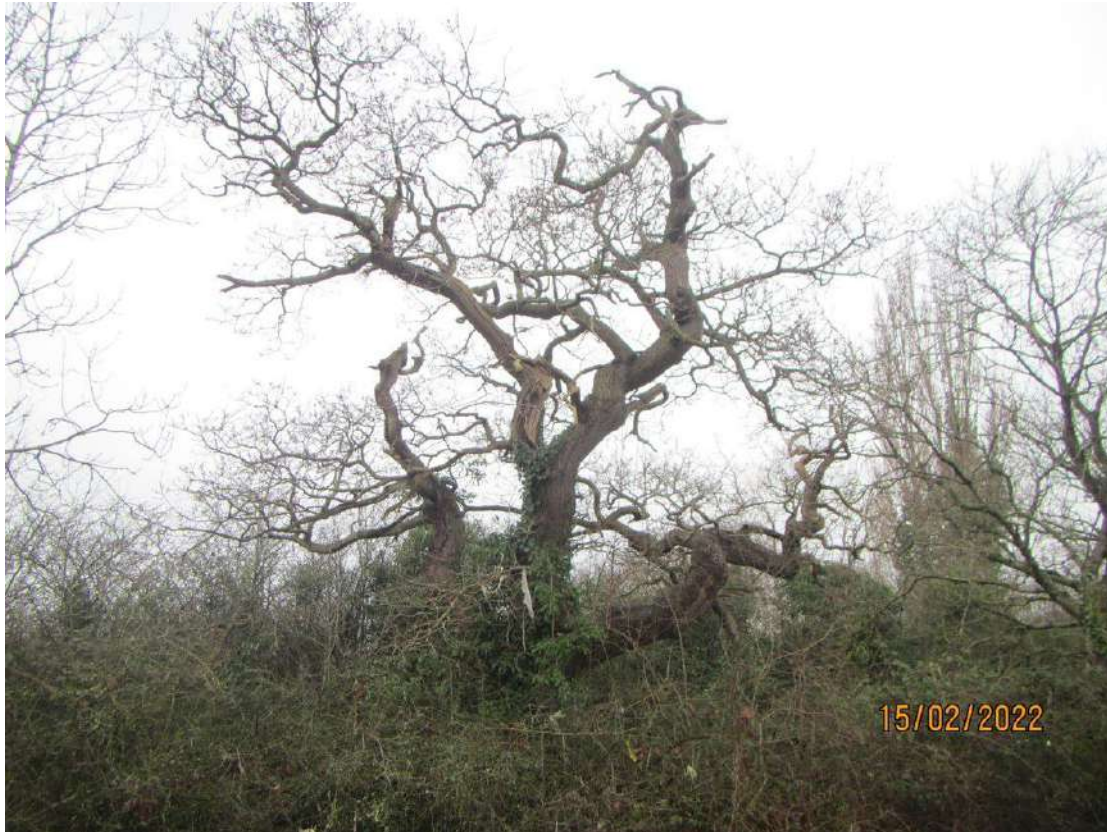
**T6** is the northernmost of a line of mature pedunculate oaks found in the continuous scrub which separates two areas of rough grassland in the north-west of the site. It is approximately 9m in height with a DBH of 0.8m. The tree features two tear outs on its western aspect at ~2.5m and 4m, large areas of flaking bark, and several hollow limbs. This tree is considered to have high potential to support roosting bats.

Photograph 7 – The crown of T6

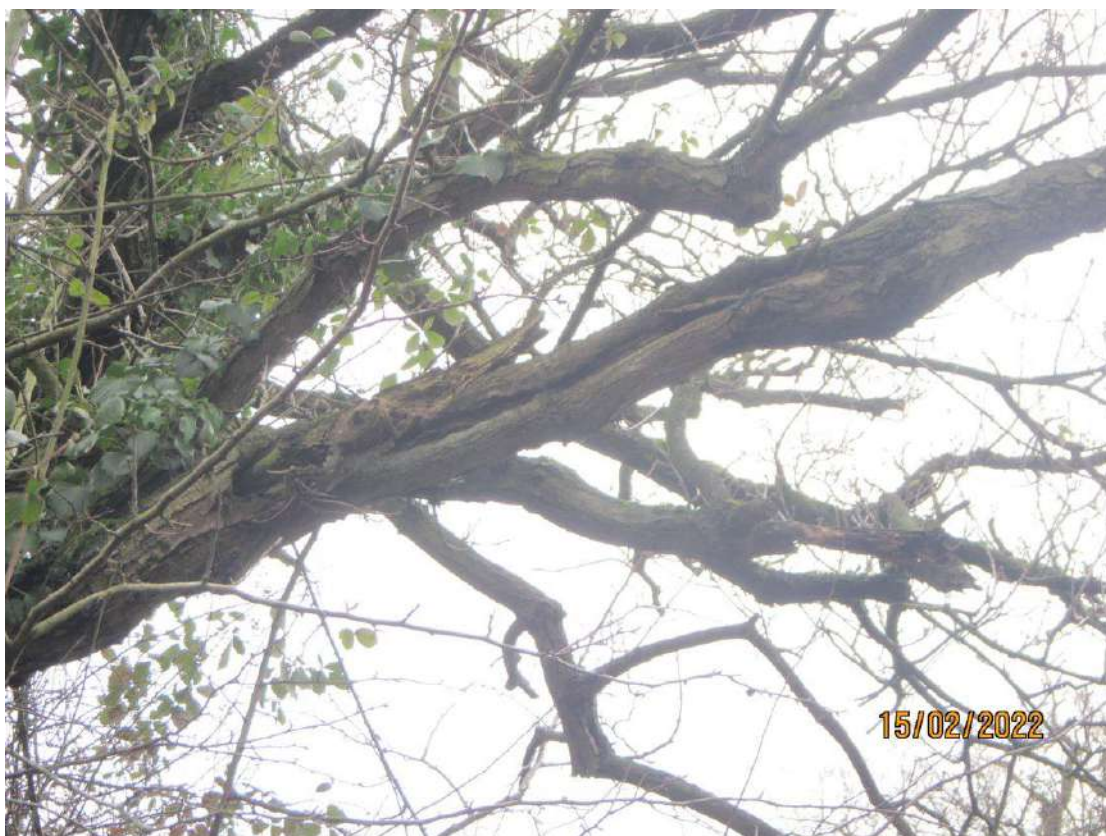
Photograph 14 – T9 showing lateral branch cavity.

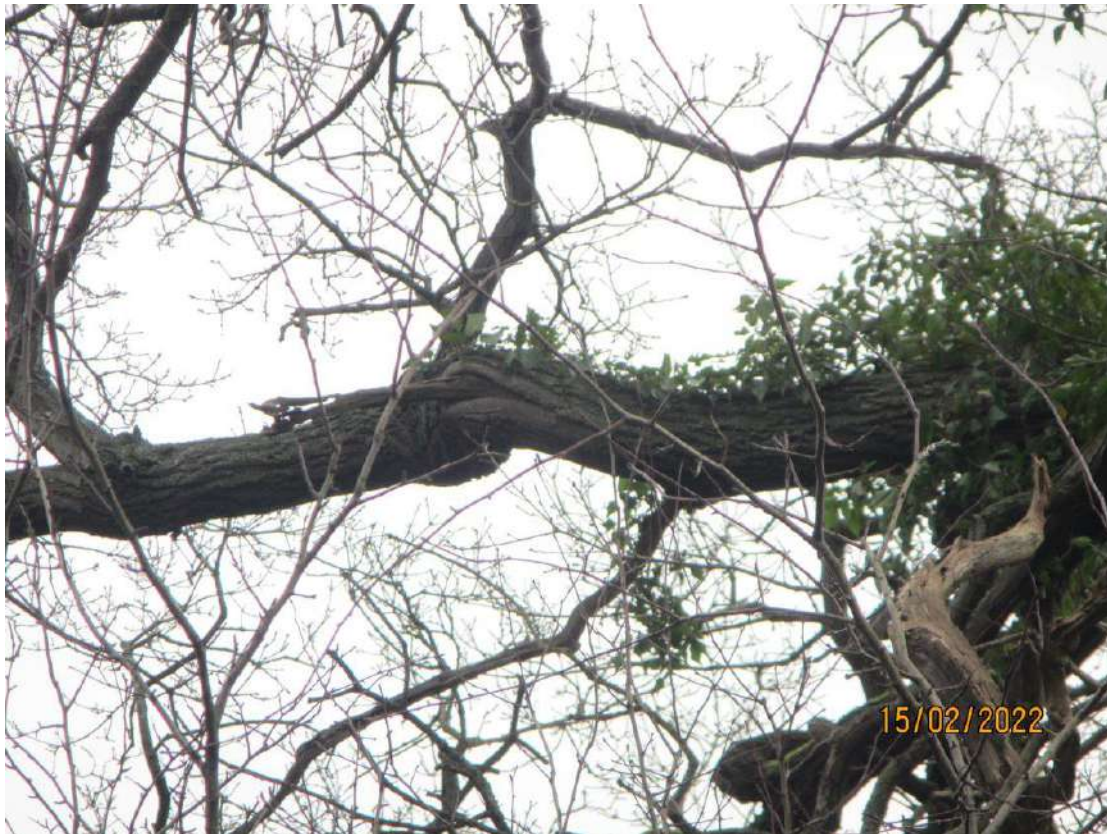
**T10** is the next mature pedunculate oak in the line of scrub, heading south. It is approximately 15m in height with a DBH of 1.0m. The tree features loose bark around some deadwood at 7m on its western aspect, a tear out at 6m on its northern aspect, a callus roll at ground level and another at 4m on its southern aspect, and a knot hole at 12m on its southern aspect. This tree is considered to have high potential to support roosting bats.

Photograph 16 – T10 showing tear-out on horizontal branch.

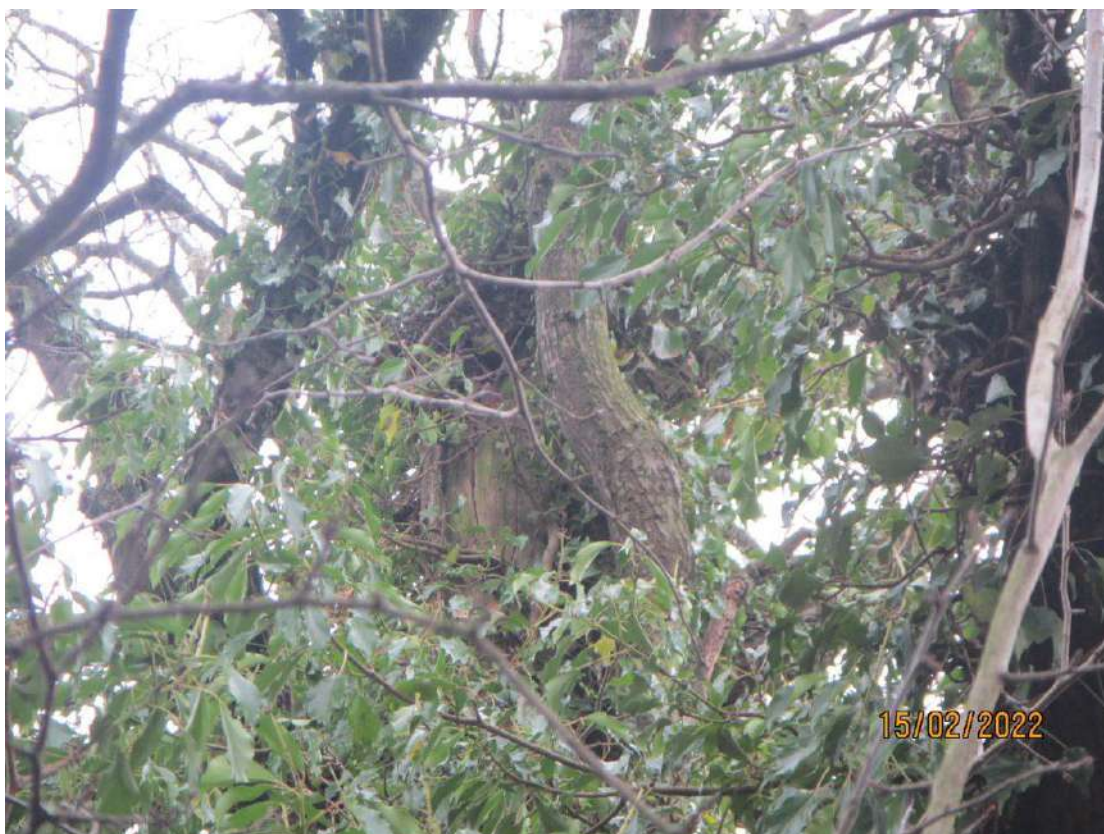
Photograph 27 – T15 showing exposed heartwood.
