# **AROSFA, FRON ISAF, CHIRK WREXHAM**

## **HERITAGE IMPACT STATEMENT**

**May 2023**

## **AROSFA, FRON ISAF, CHIRK LL14 5AH**

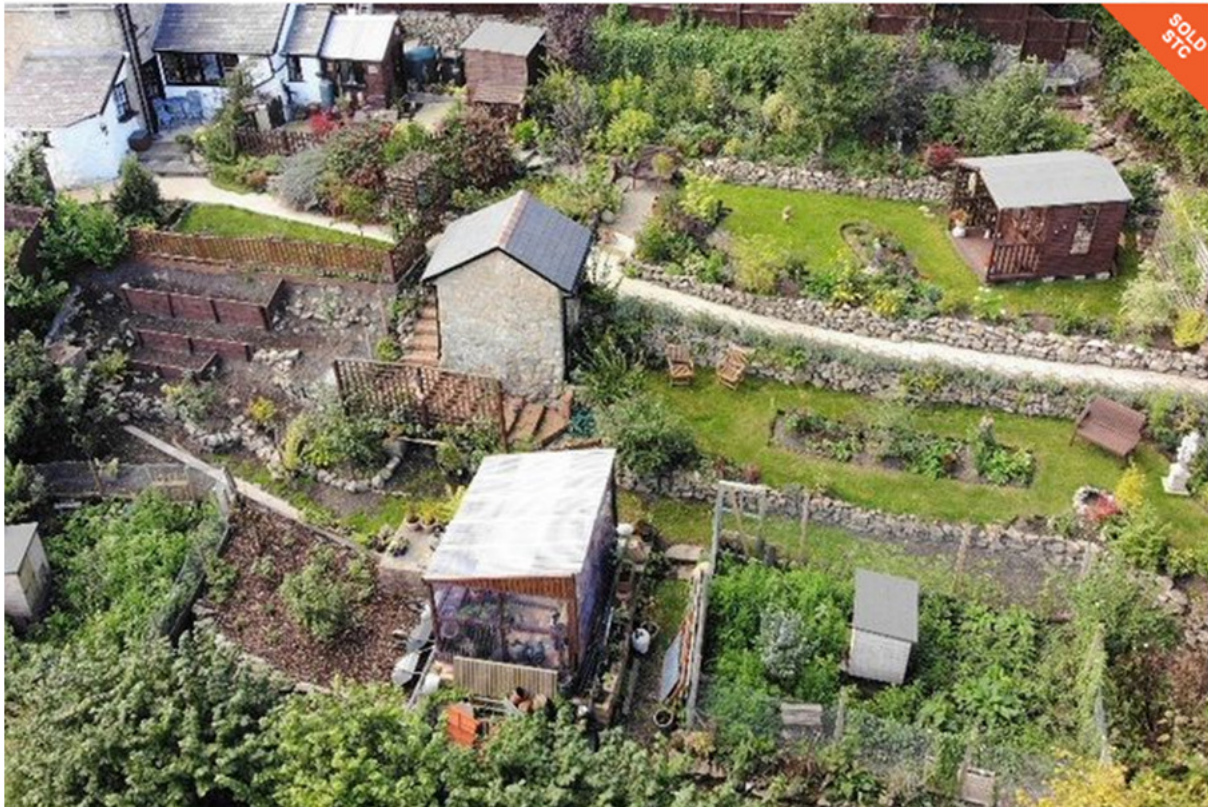
Screenshot from 2022 Zoopla website

Compared to the 2019 Zoopla archive screenshots this shows the extensive amount of work that has been carried out by the previous owner to landscape the garden.

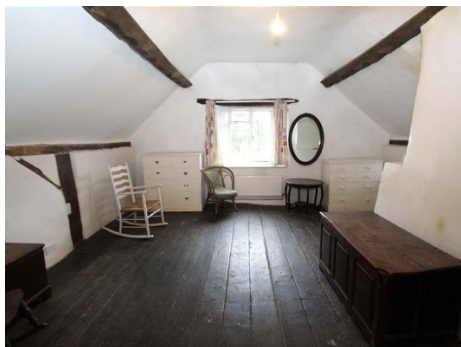
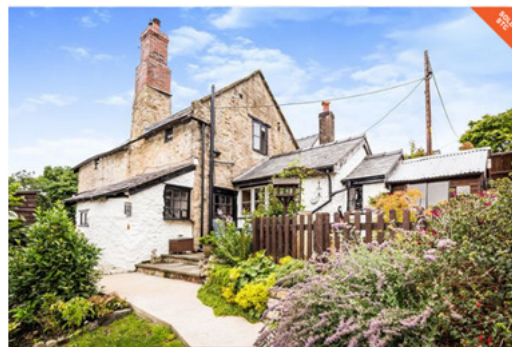
Screenshots from Zoopla 2019 archive and Zoopla 2022

The previous owner has clearly tried to reduce the impact particularly on the floor, but without an invasive investigation of the state of the boards below the new floor it is difficult to say whether they have been significantly damaged. The partition is stud and therefore a reversible intervention. On balance therefore the additional amenity would in my opinion compensate for any loss of significance. The plastic pipework is more problematic. Whilst cast iron is a suitable material for rainwater goods, it is not really suitable for foul drainage. I would therefore recommend leaving the SVP and associated plumbing as it is. It would be more damaging to route the pipework inside the building.
