## NORTH WALES TREE CONSULTANCY

### Maes Y Pant QTRA 2023

**Date:** Thursday, 30 March  
2023

**Report Ref:**  
NWTC\_QTRA\_23\_01\_MYP

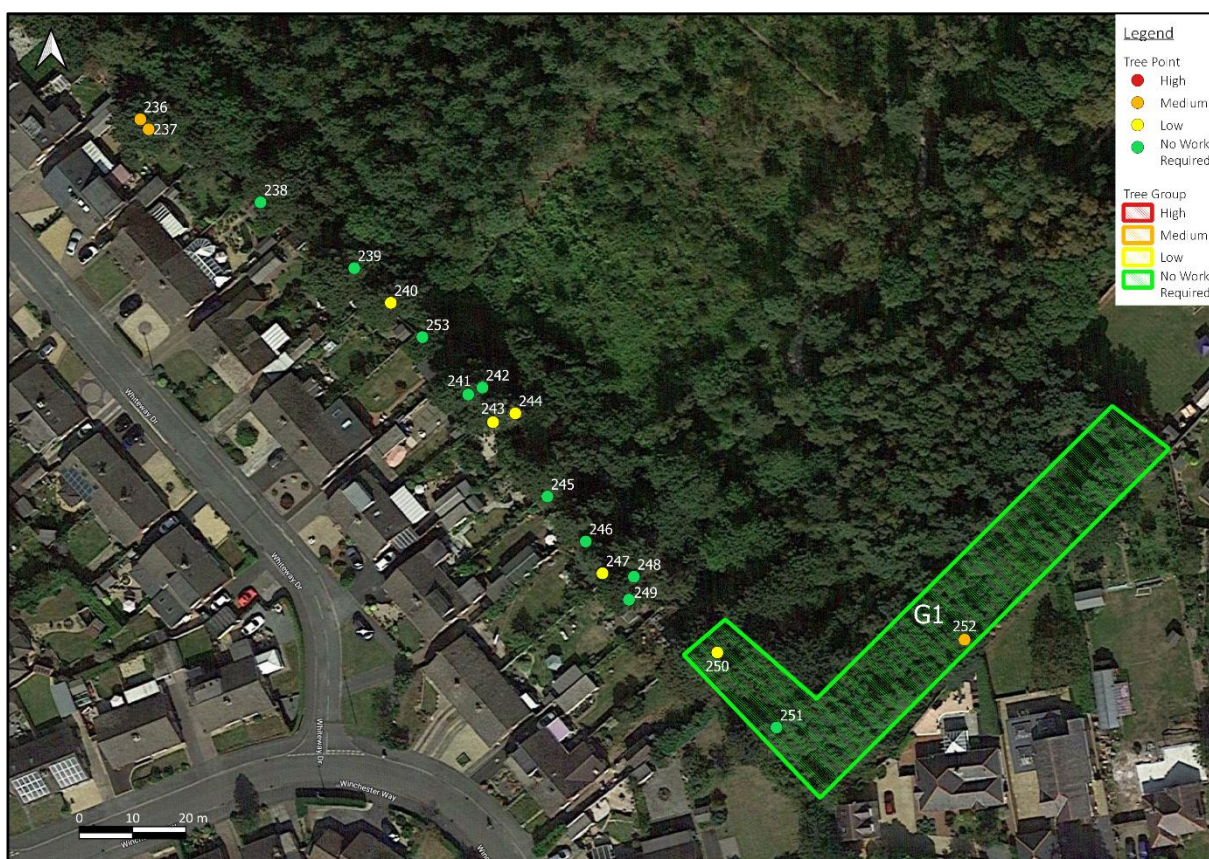
Figure 1 Tree location map

The trees surveyed are located along the southwest and southeast boundaries of Maes Y Pant (figure 1). These trees are located on the rear garden boundary of residential houses on Whiteway Drive, Winchester Way and Pant Lane. A fence line separates the boundary, the southwest boundary trees are located at the bottom of a steep bank that rises to the public footpath within Maes Y Pant.

The tree population is subject to prevailing south-westerly winds (figure 1) as a result the majority of stems have a slight lean to the northeast, away from the residential properties. These trees are
