**Report Type:** Mitigation Strategy

**Site Address:** Brunett Barns  
Lower Wych Lane  
Ty Broughton  
Whitchurch  
SY13 3BA

**Report Reference:** 20-05 107.5Mit

**Date of Issue:** 6<sup>th</sup> April 2023

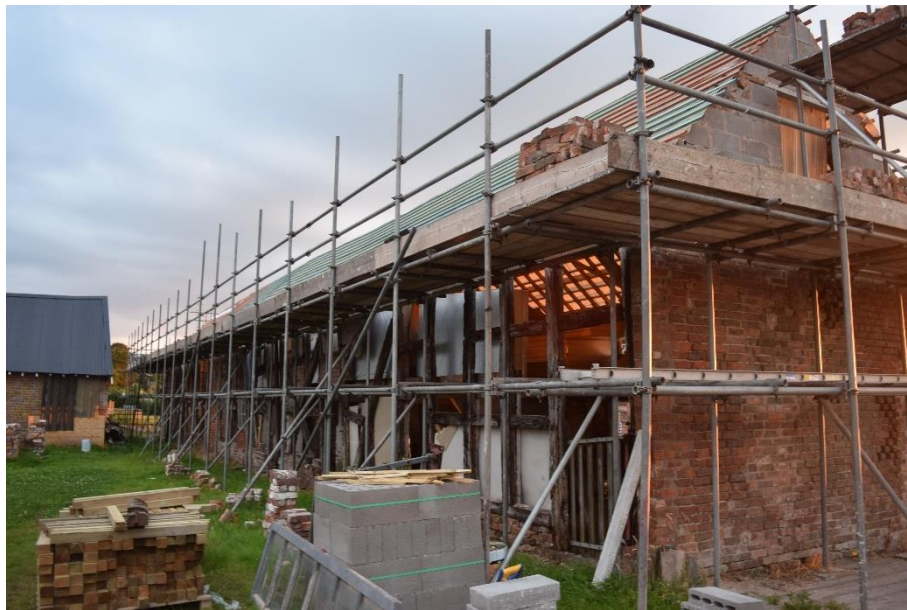
**Figure 3.2. Building 1.1 (Aug 2021)**

In 2018 Barn 1.1 had a metal roof.

**2021-** Since the survey in 2018, the roof of building 1 had been stripped and the metal roof replaced with modern breathable membrane. There were significant gaps along the eastern elevation of the building where, for structural reasons, the building has had to be strapped and secured.

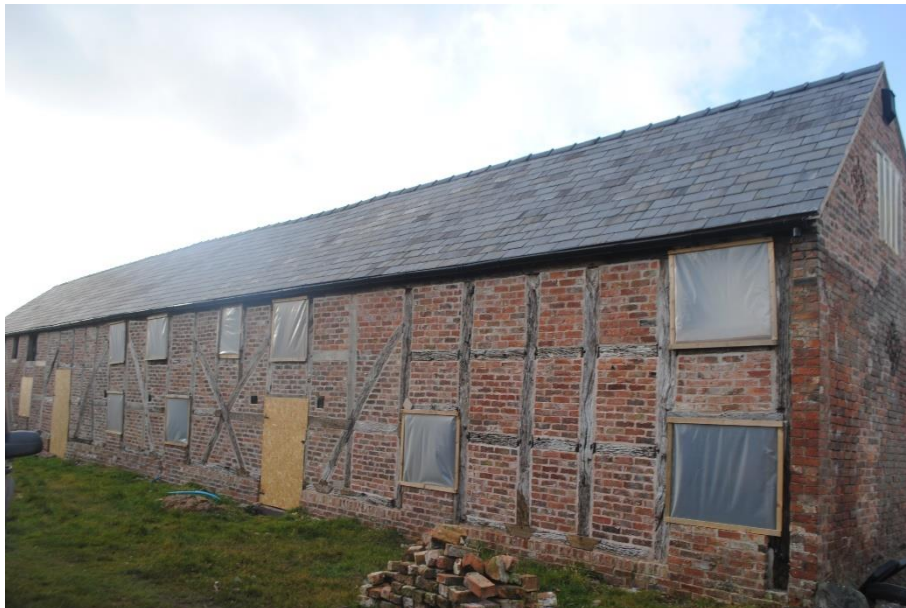
**Figure 3.5. Barn 1.1 in February 2023**

**2023** - The missing brickwork has been replaced and internal stud work erected. This makes the building on the first floor darker and potentially of more interest to bats for roosting. A bat box has been erected on the northern elevation of the building.

No bat droppings were observed. The constraint for this observation was that the survey was conducted in February when bats are not active. No indication of how much clearing had been made during the ongoing work on site.

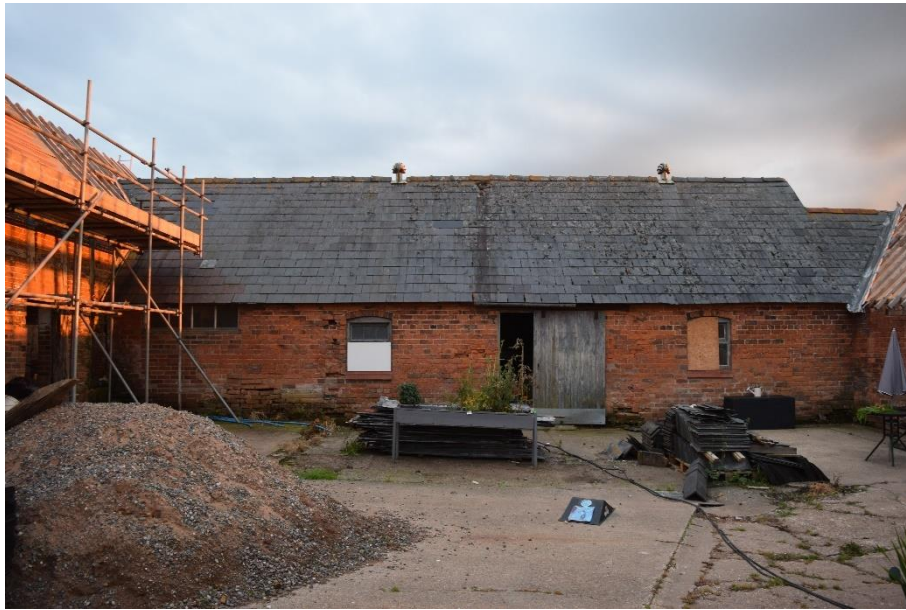
**Figure 3.8. Barn 1.2 (Aug 2021)**

**2021-** Barn 1.2 had not been worked on by the current client. The slate roof was seen to have no lining material. A bat detector was left in this area and bat activity monitored during the bat surveys.

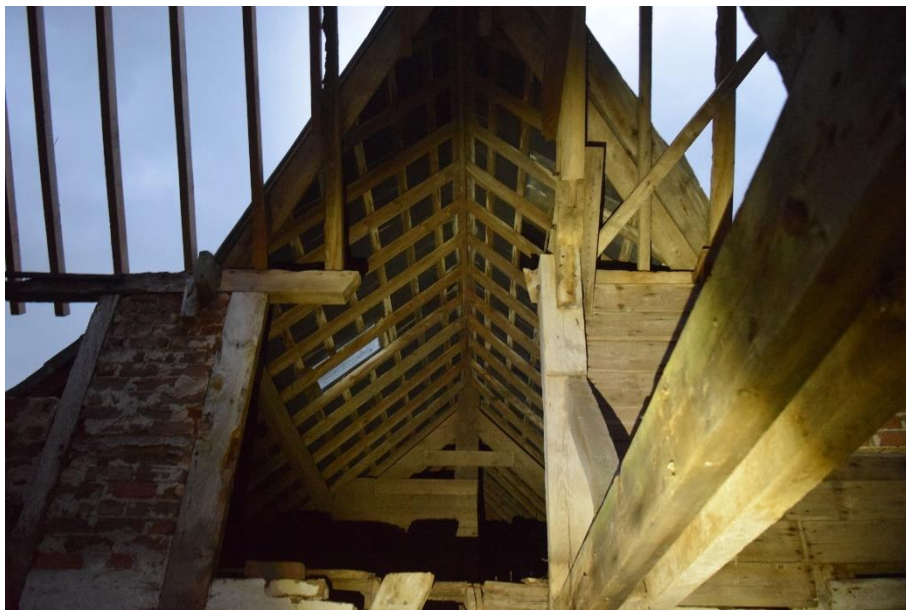
**Figure 3.9. Opening into barn 1.1 (Aug 2021)**

The eastern end of this building opens into barn 1.1.

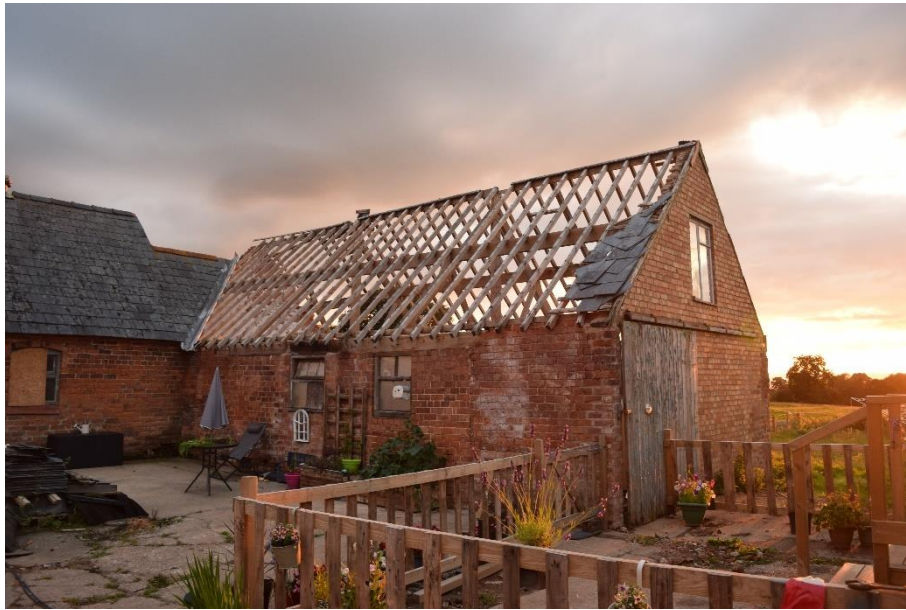
**Figure 3.14. Barn 1.3 (Aug 2021)**

**2021-** Barn 1.3 had no roof. The building was examined internally and no evidence of bat activity was noted. The building was considered to have negligible potential for bat roosts.

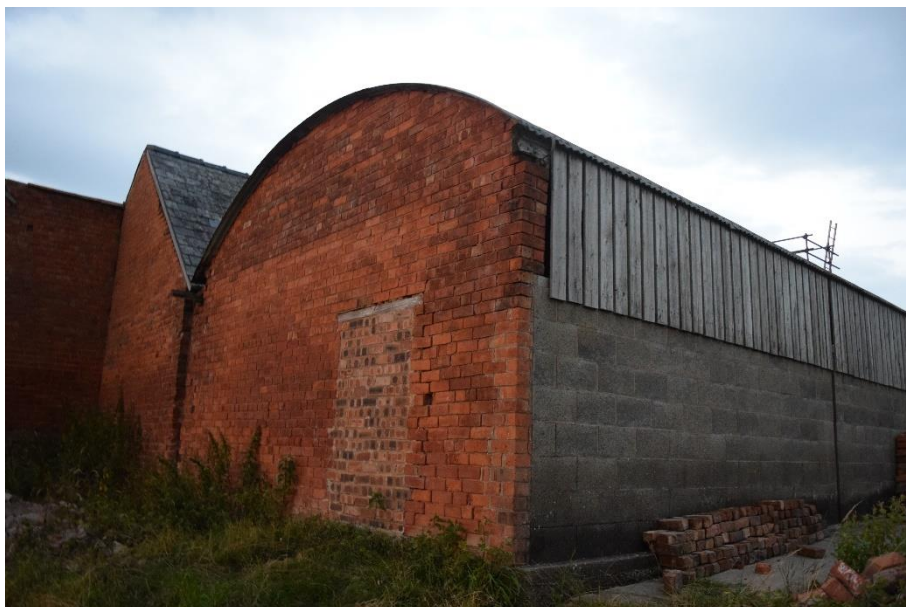
**Figure 3.15. Building 1.4 (Aug 2021)**

**2021 -** There have been no alterations to building 1.4 since 2018. This is still a metal roofed structure with block and timber on the southern elevation.

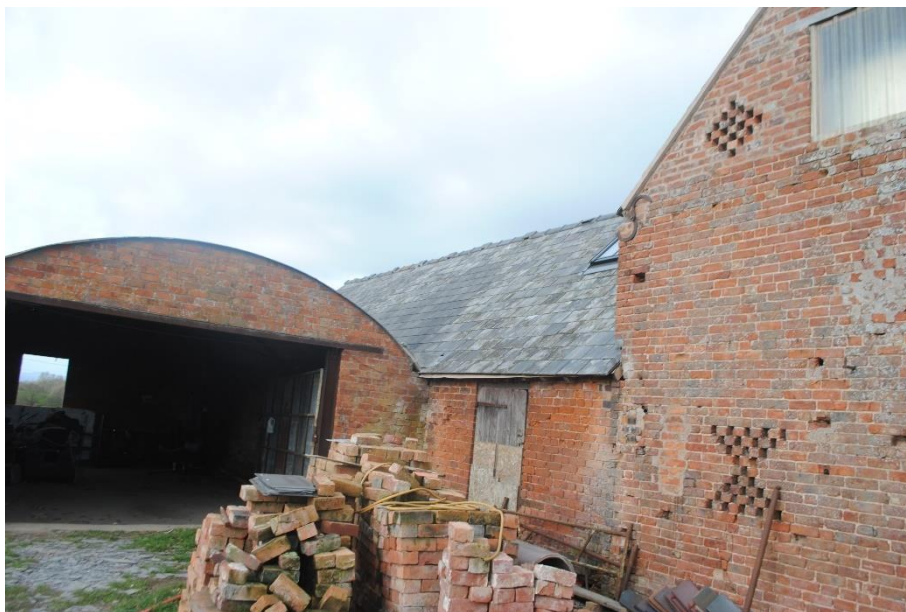
**Figure 3.17. Barn 1.4 Feb 2023**

**2023-** no alterations had been made to this building.

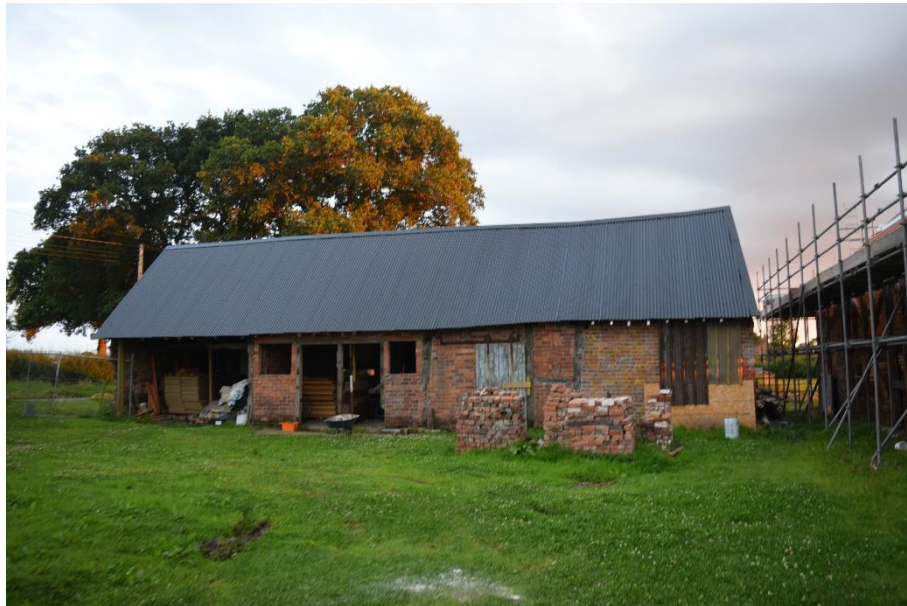
**Figure 3.18. Building 2 (Aug 2021)**

**2021-** Barn 2 has been re-roofed with a replacement metal roof and breathable membrane. The building had a metal roof in 2018 so this was essentially a like for like replacement.

Large spaces are visible into the roof void of the building which allows continued access for bats.

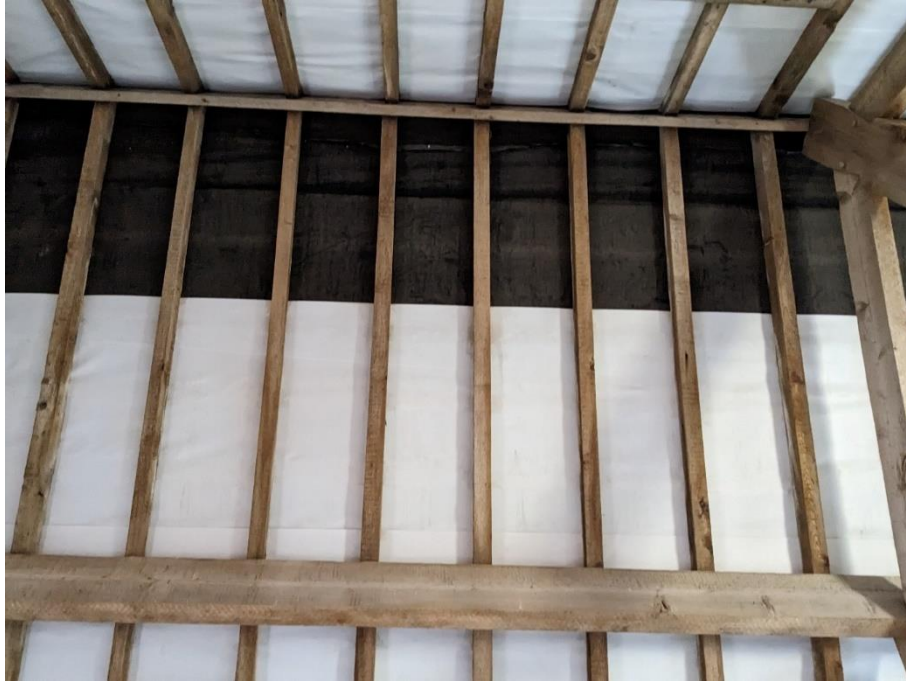
photo showing the existing roof with the BRM (white) and the Bitumen (grey / black)

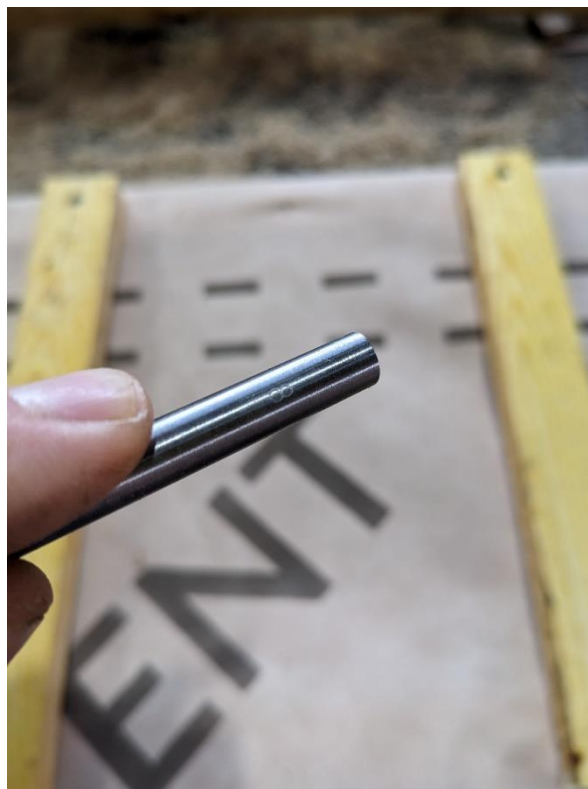
the 8 mm drill bit used to test the potential for bat access

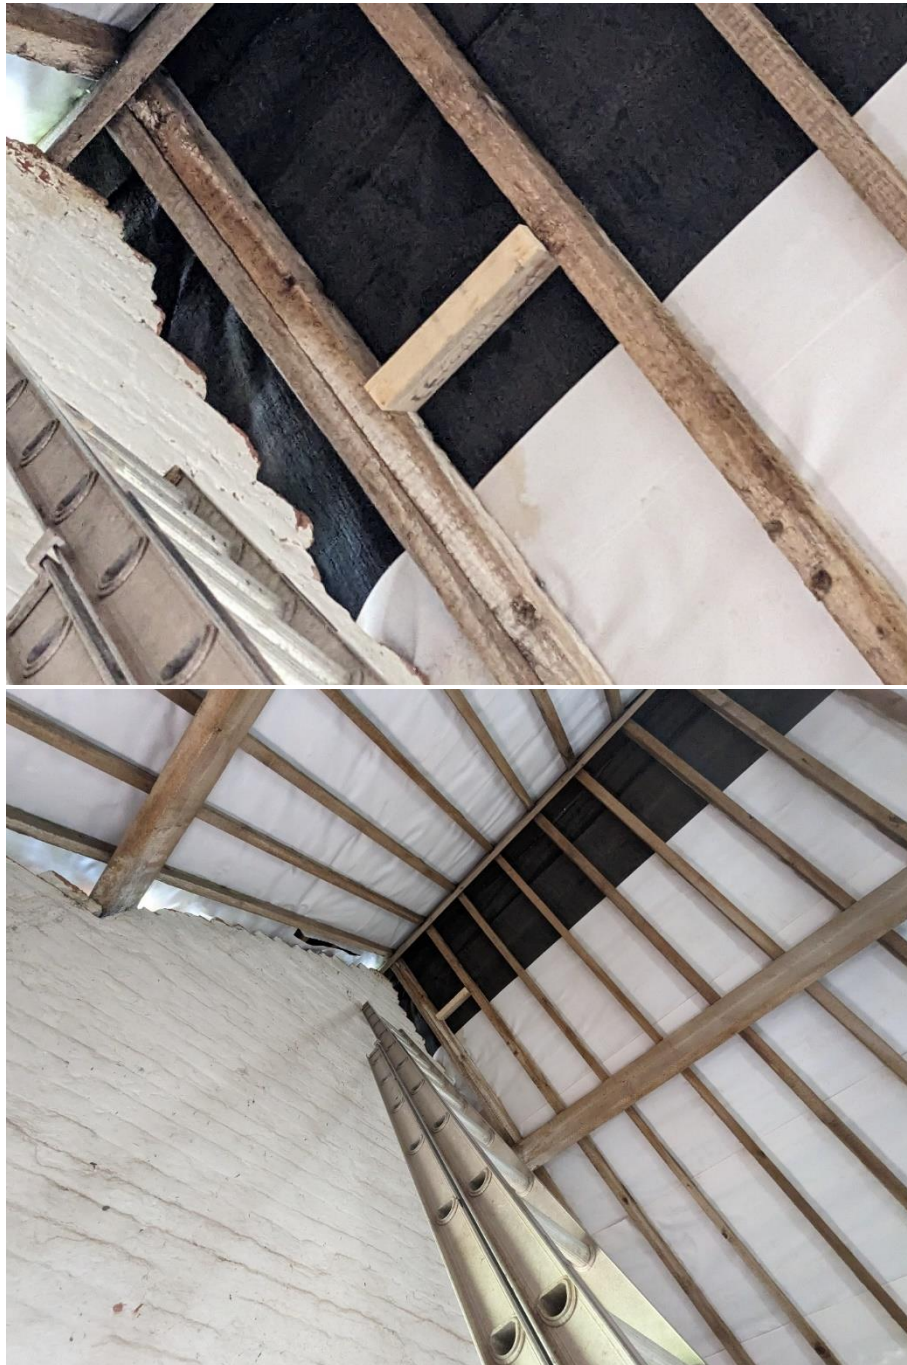
Showing the timber in place.
