PHOTOGRAPHIC SURVEY

58 HOPE STREET, WREXHAM

AINSLEY GOMMON ARCHITECTS AGA

This Photographic Record supports the Full Planning and Listed Building Consent Application for the reordering and restoration of the existing shop front, basement, ground floor and upper floors to. **No.58 Hope Street, Wrexham, LL11 1BE** for a commercial unit to the lower floors and 3no. 2 bedroom apartments to the upper floors.

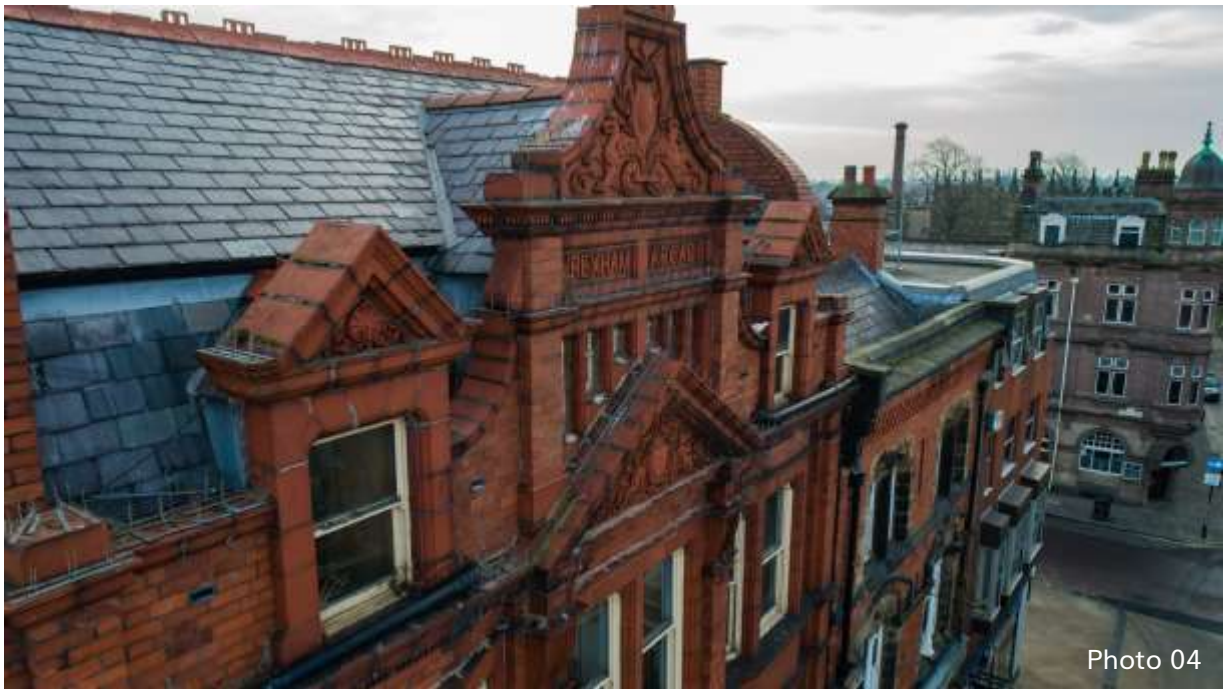
Photo 04

PHOTO 01 - Exterior drone imagery of front elevation provided by Wrexham Council  
PHOTO 02 - Exterior drone imagery of front elevation provided by Wrexham Council  
PHOTO 03 - Exterior drone imagery of roof provided by Wrexham Council  
PHOTO 04 - Exterior drone imagery of front elevation provided by Wrexham Council

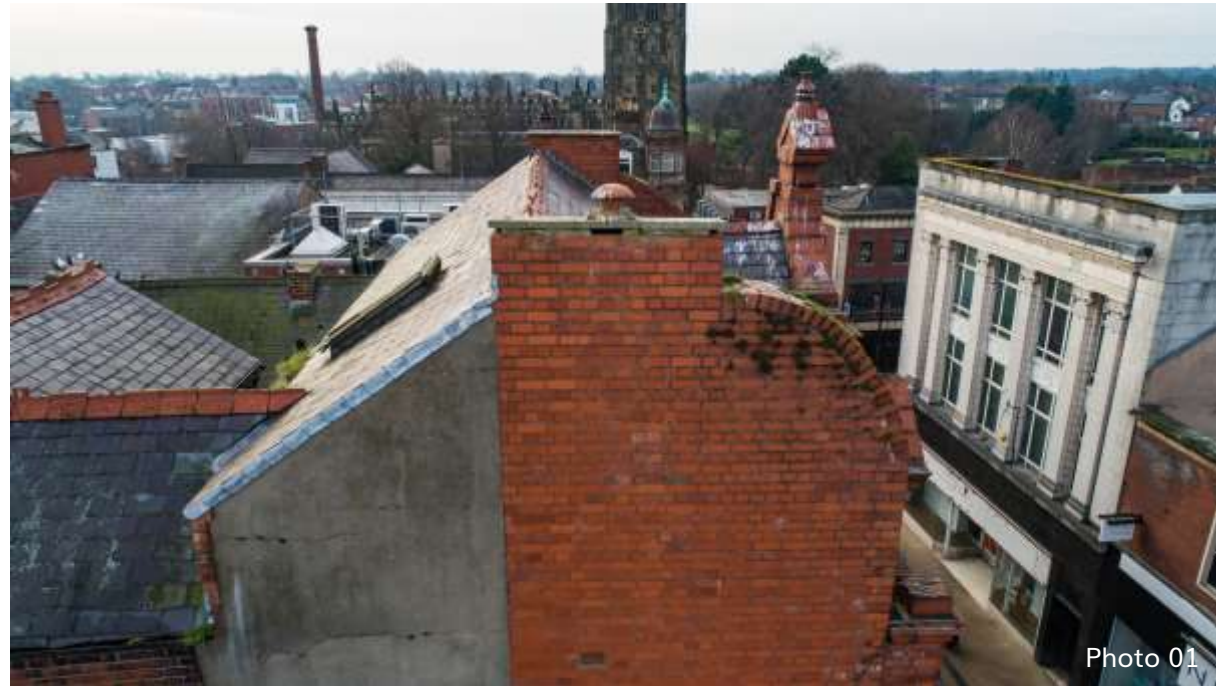
Photo 01

PHOTO 01 - Exterior drone imagery of side elevation provided by Wrexham Council  
 PHOTO 02 - Exterior drone imagery of side elevation provided by Wrexham Council  
 PHOTO 03 - Exterior drone imagery of roof provided by Wrexham Council  
 PHOTO 04 - Exterior drone imagery of back elevation provided by Wrexham Council

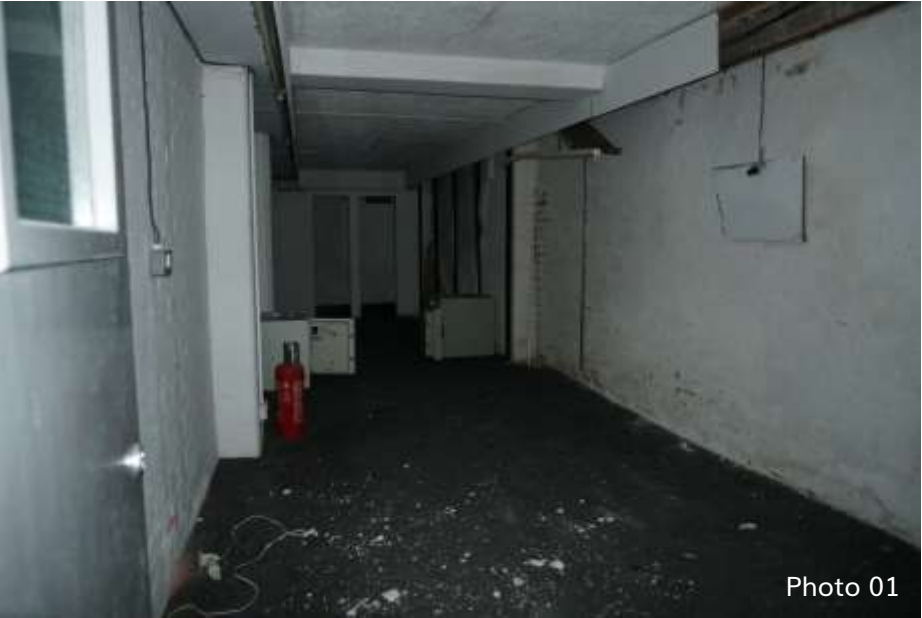
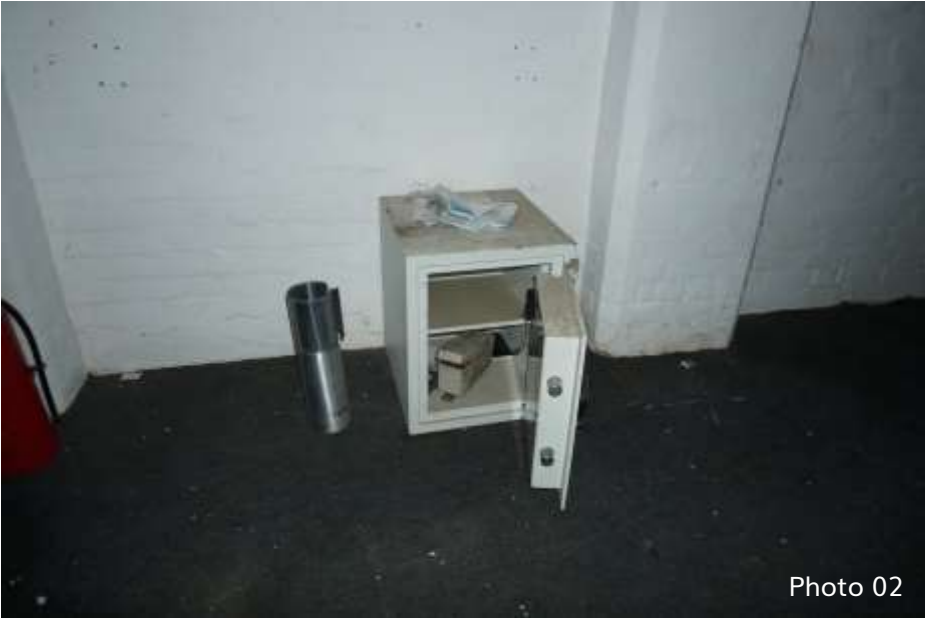
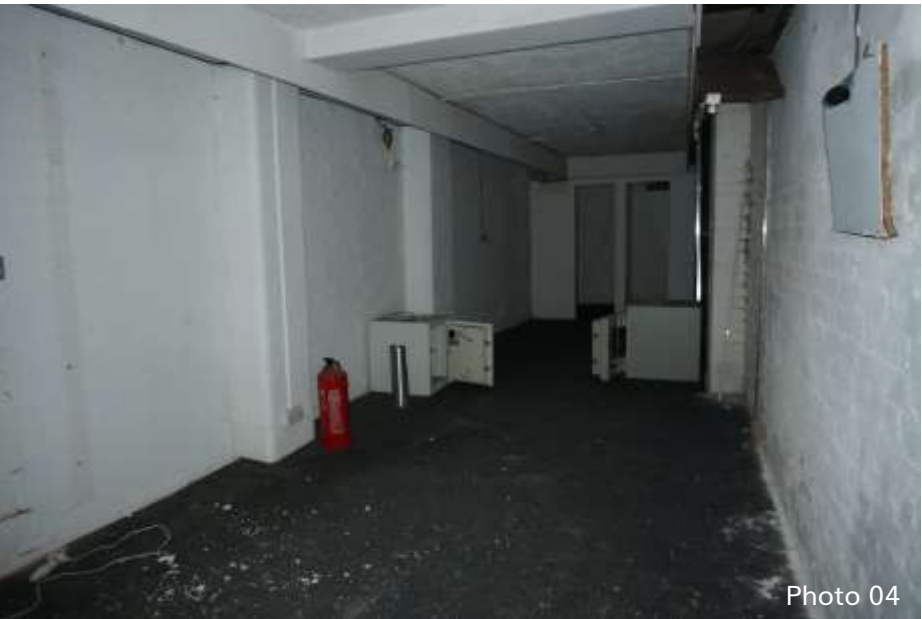
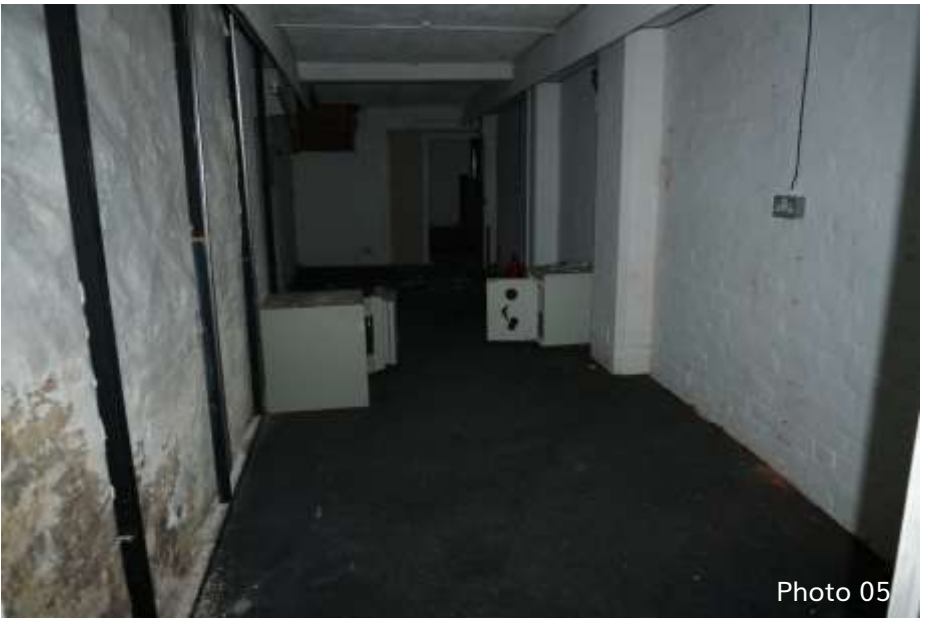
PHOTO 01 - Current condition of basement  
PHOTO 02 - Current condition of basement  
PHOTO 04 - Current condition of basement  
PHOTO 05 - Current condition of basement  
PHOTO 06 - Current condition of wall

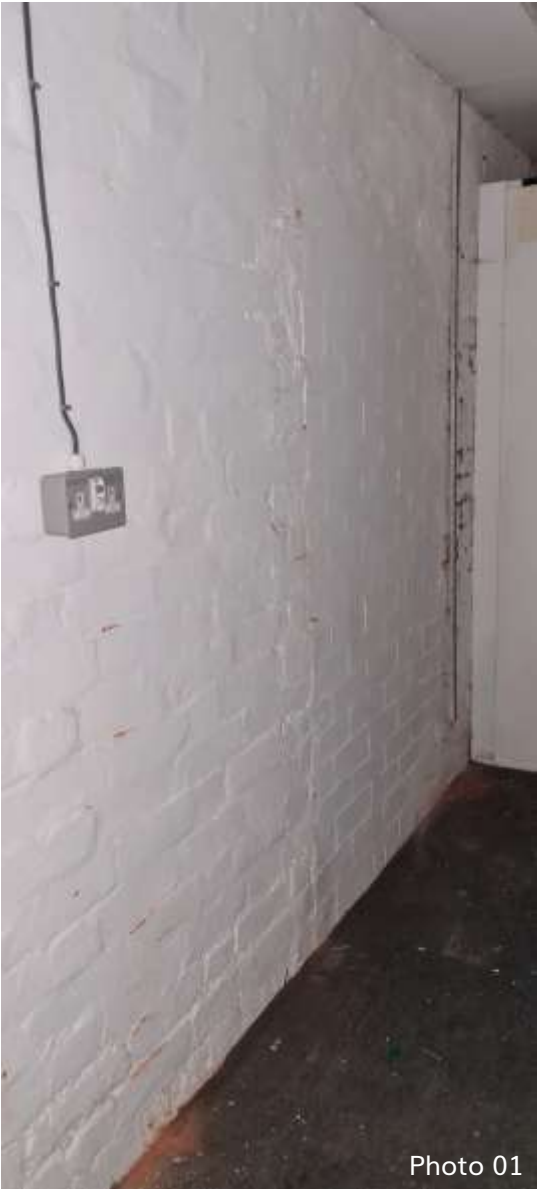
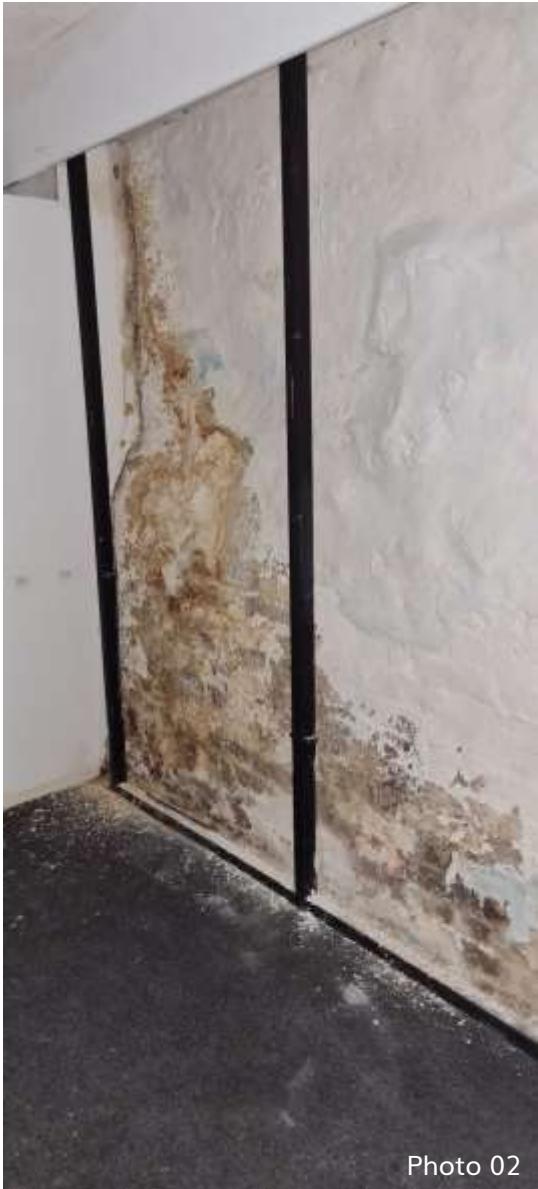
PHOTO 01 - Current condition of wall and floor  
PHOTO 02 - Current condition of wall and floor  
PHOTO 03 - Existing wall vent in basement  
PHOTO 04 - Existing water metre in basement  
PHOTO 05—Bulkhead of stairs leading into basement

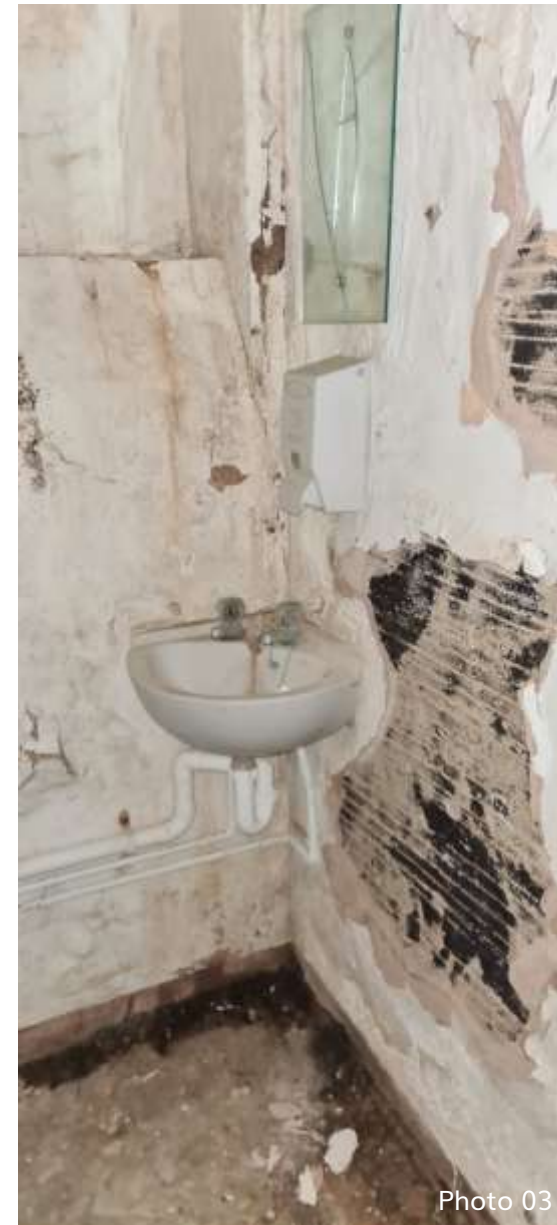
Photo 03

PHOTO 01 - Current condition of basement bathroom and existing toilet  
 PHOTO 02 - Current condition of basement bathroom  
 PHOTO 03 - Current condition of basement bathroom and existing sink  
 PHOTO 04 - Current condition of basement bathroom

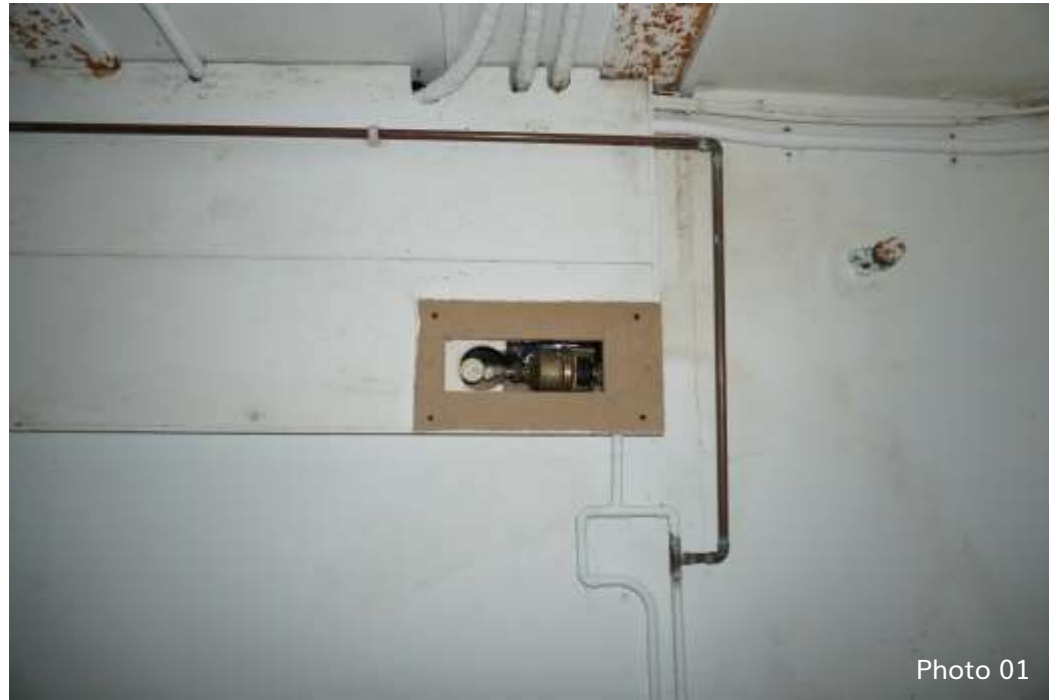
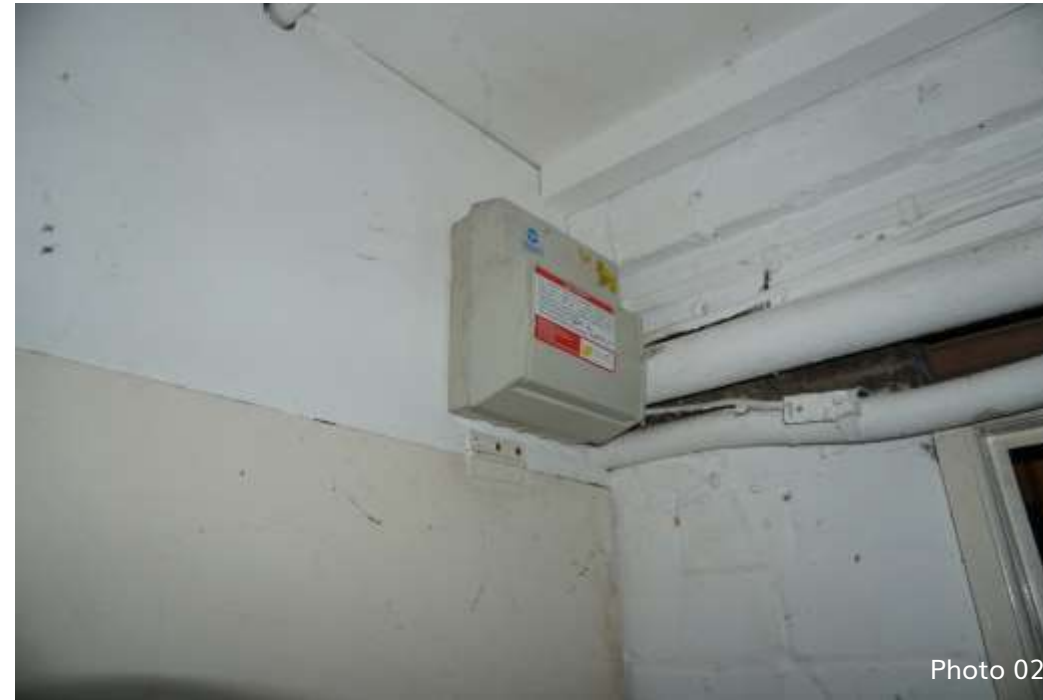
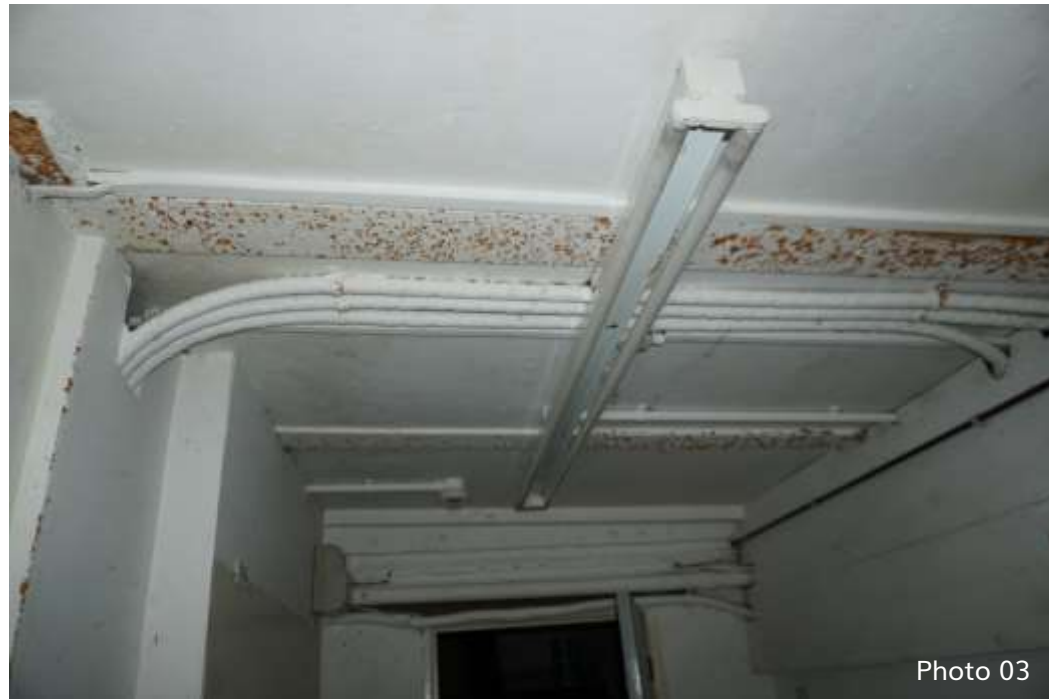
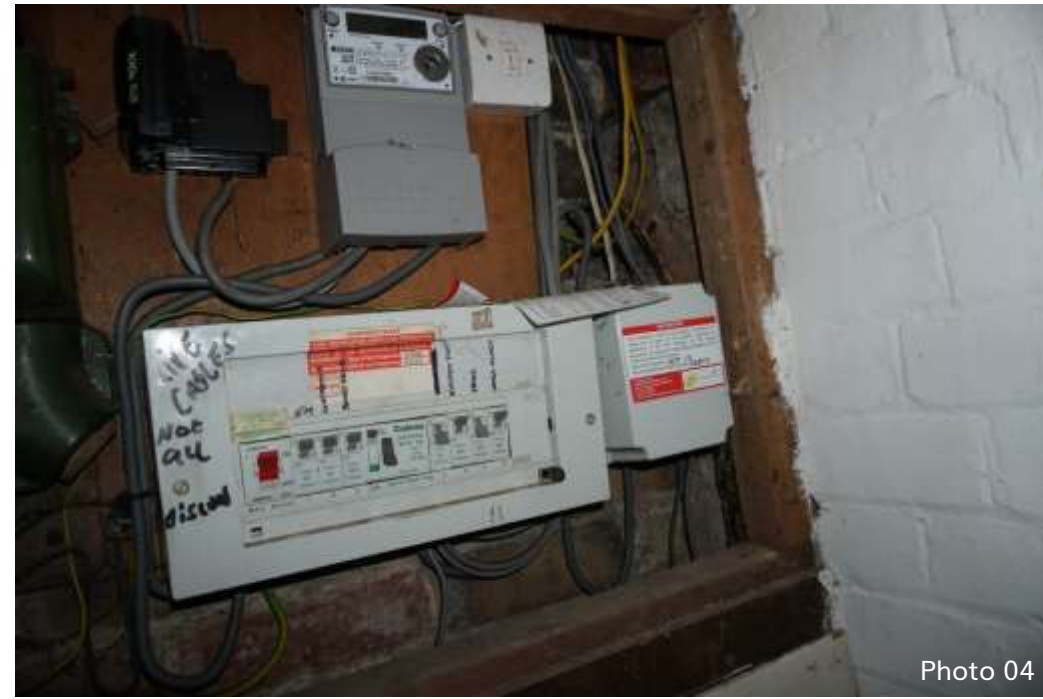
PHOTO 01 - Current condition of wall / exposed pipework/services  
 PHOTO 02 - Existing electrical box  
 PHOTO 03 - Current condition of ceiling and exposed services  
 PHOTO 04 - Existing electric metre

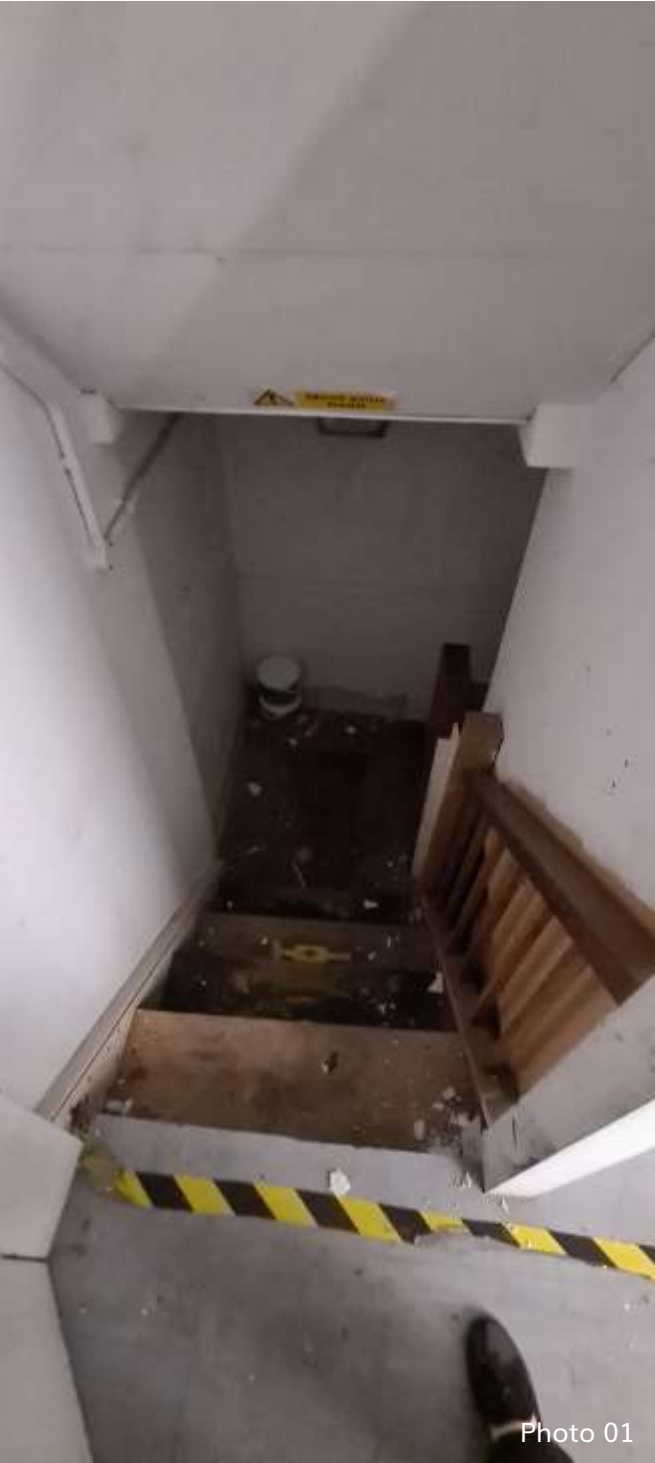
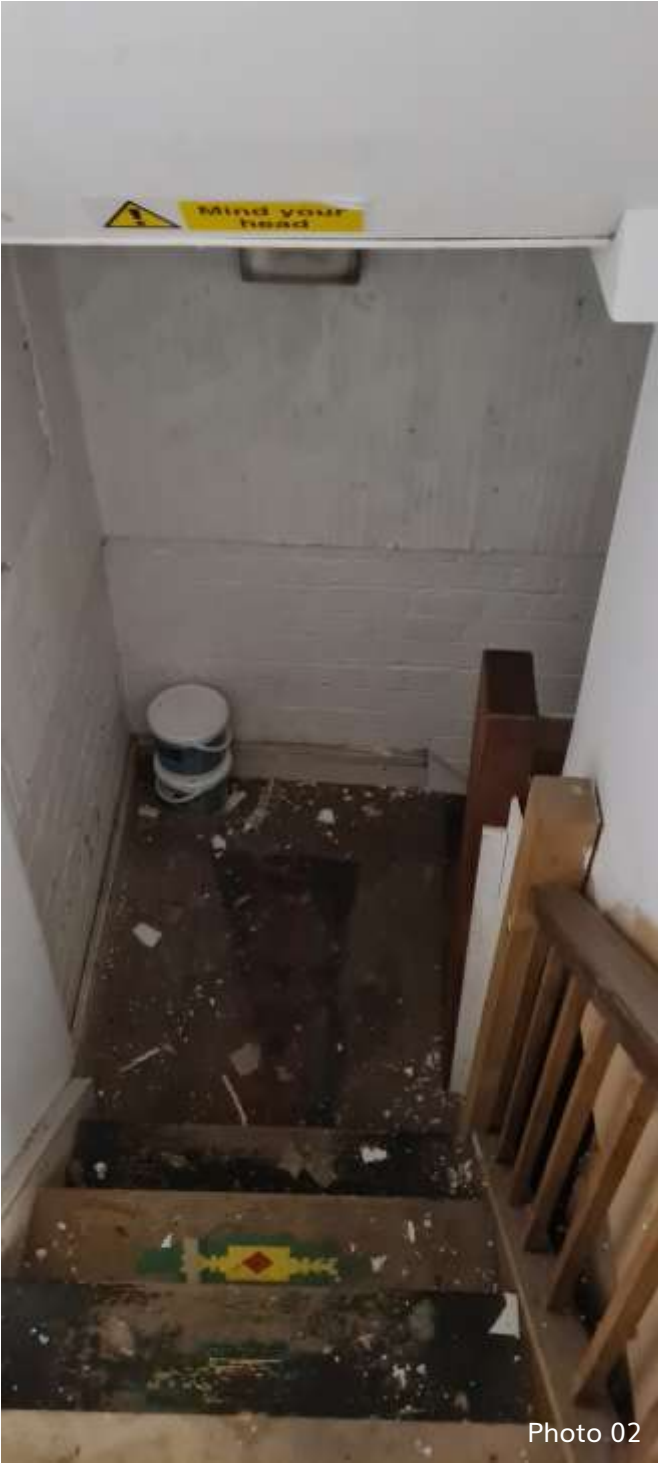
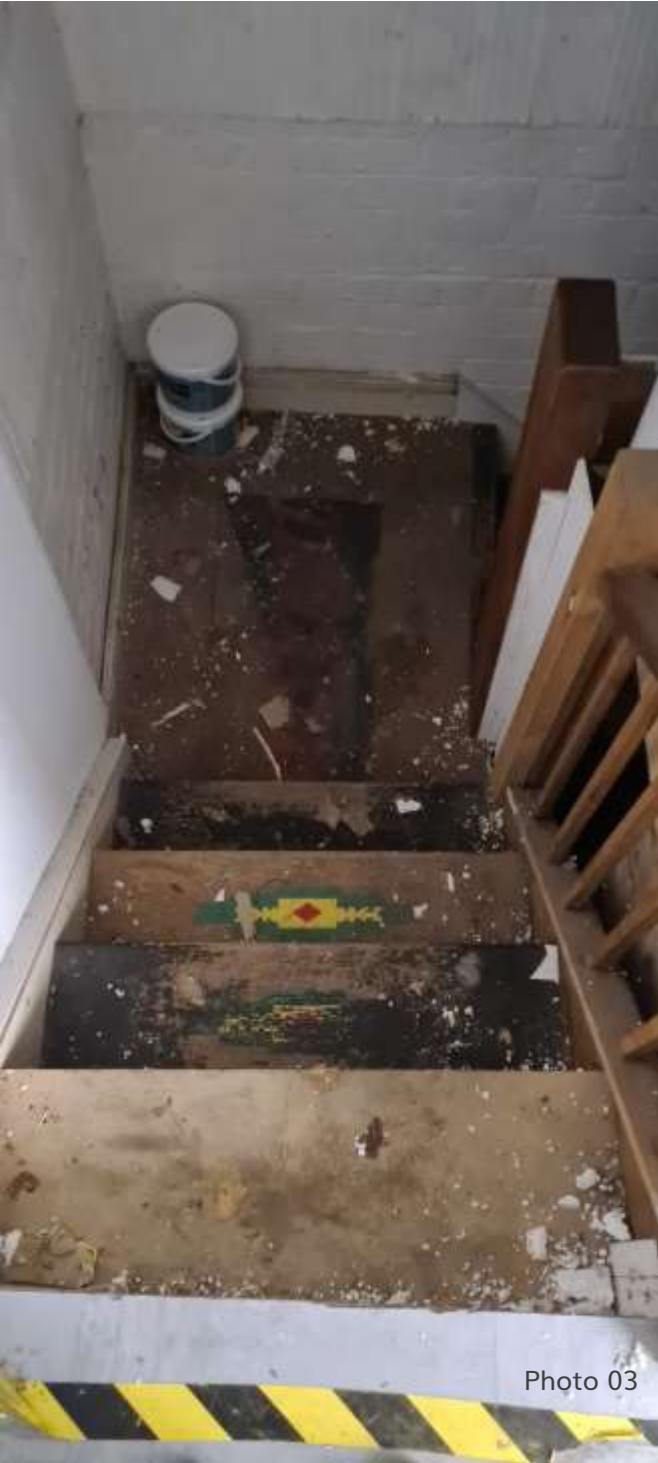
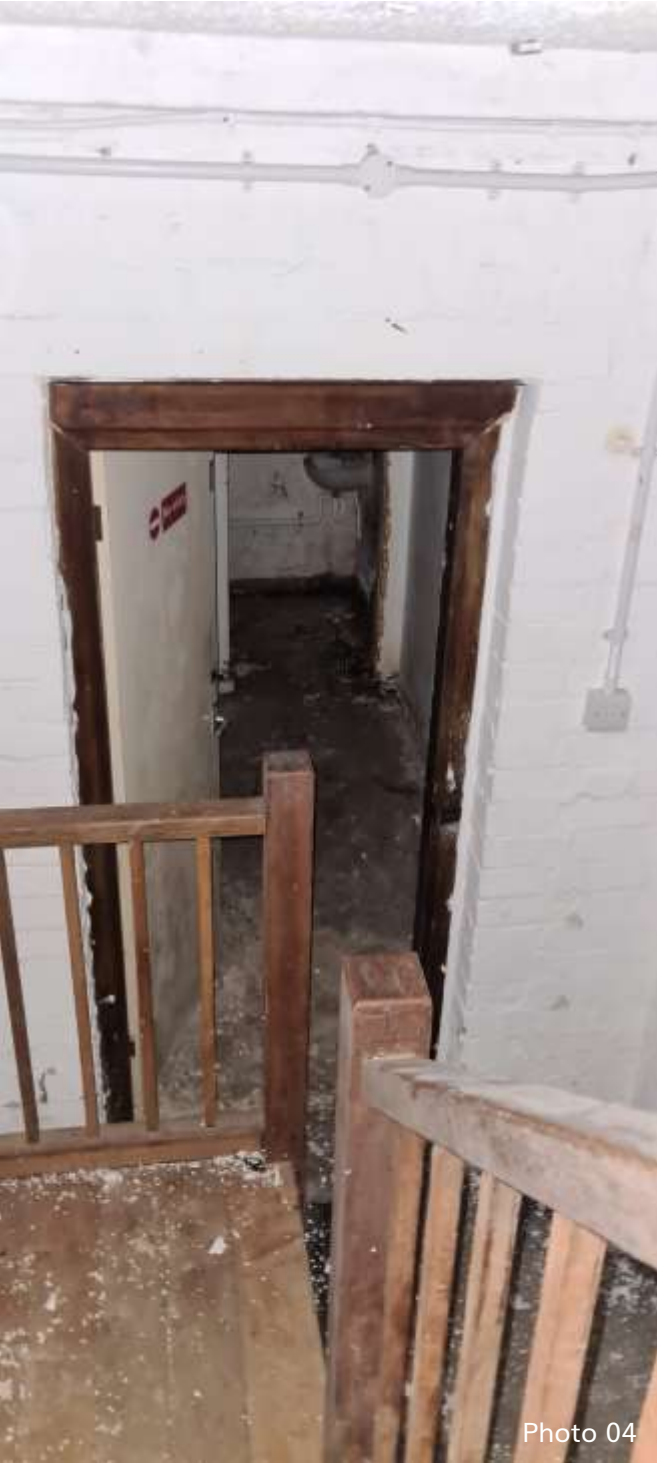
PHOTO 01 - Current condition of existing staircase  
PHOTO 02 - Half landing of existing staircase  
PHOTO 03 - Current condition of existing staircase  
PHOTO 04 - Bottom of staircase

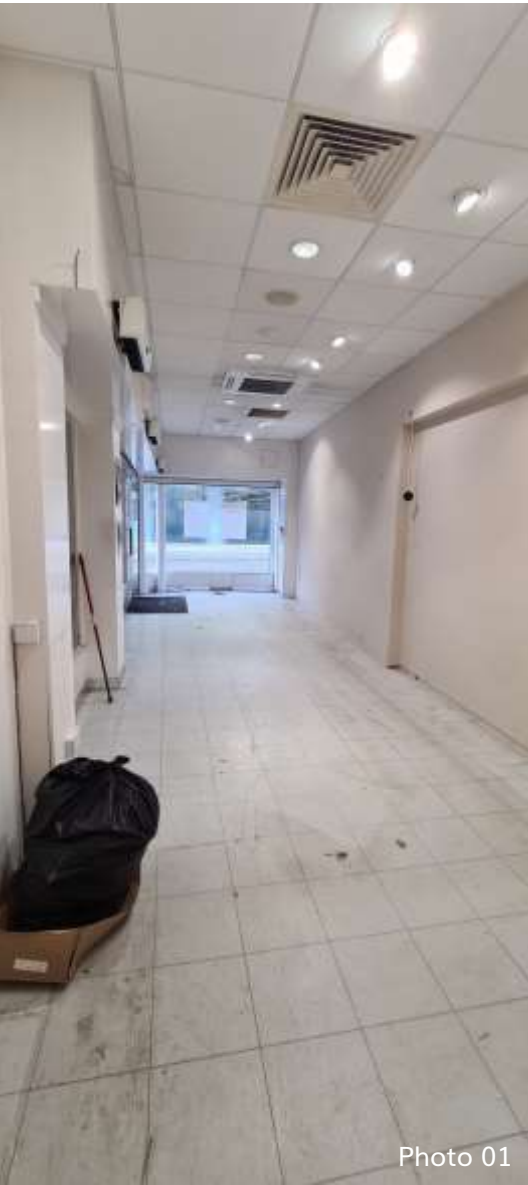
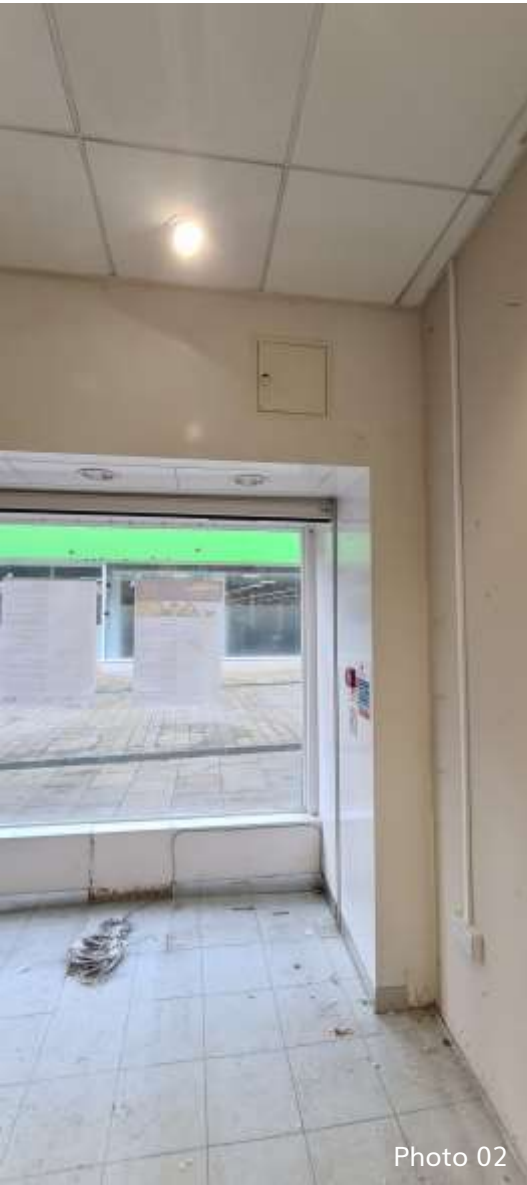
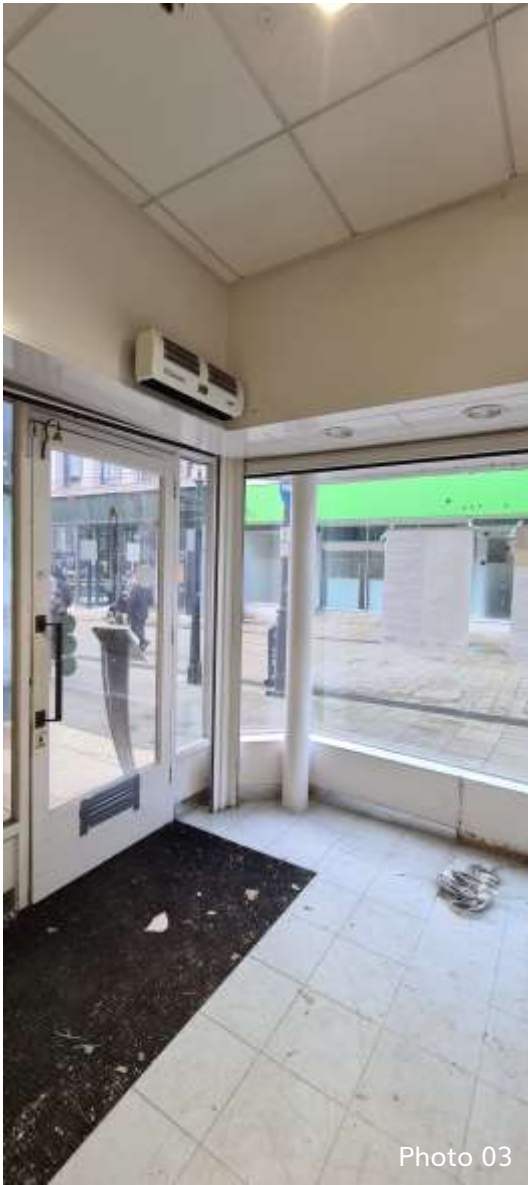
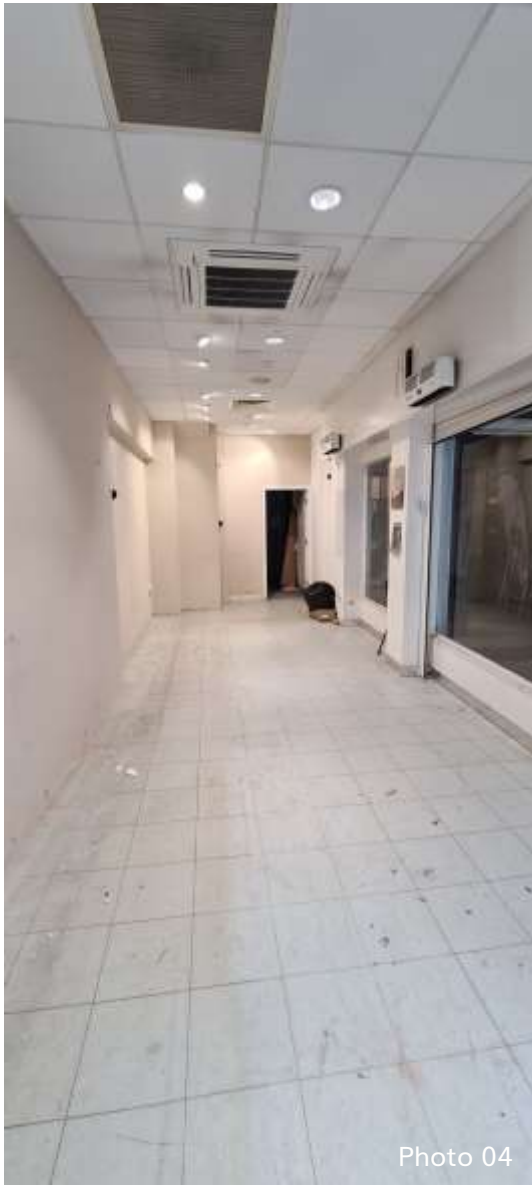
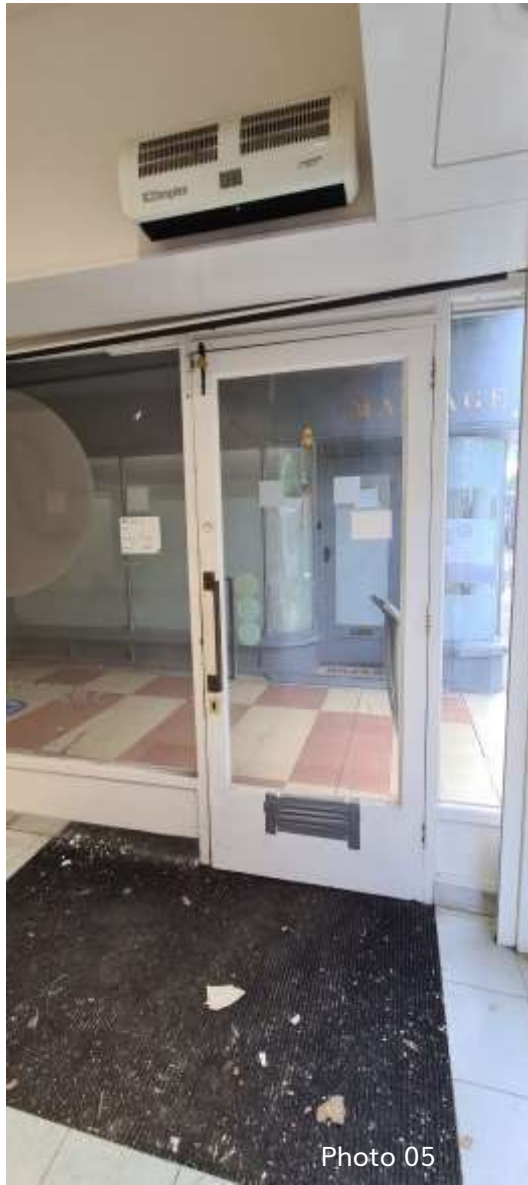
PHOTO 01 - Current condition of existing floor  
PHOTO 02 - Existing window  
PHOTO 03 - Existing windows fronting the building  
PHOTO 04 - Current condition of room 5  
PHOTO 05 - Current condition of windows, doors and door matt

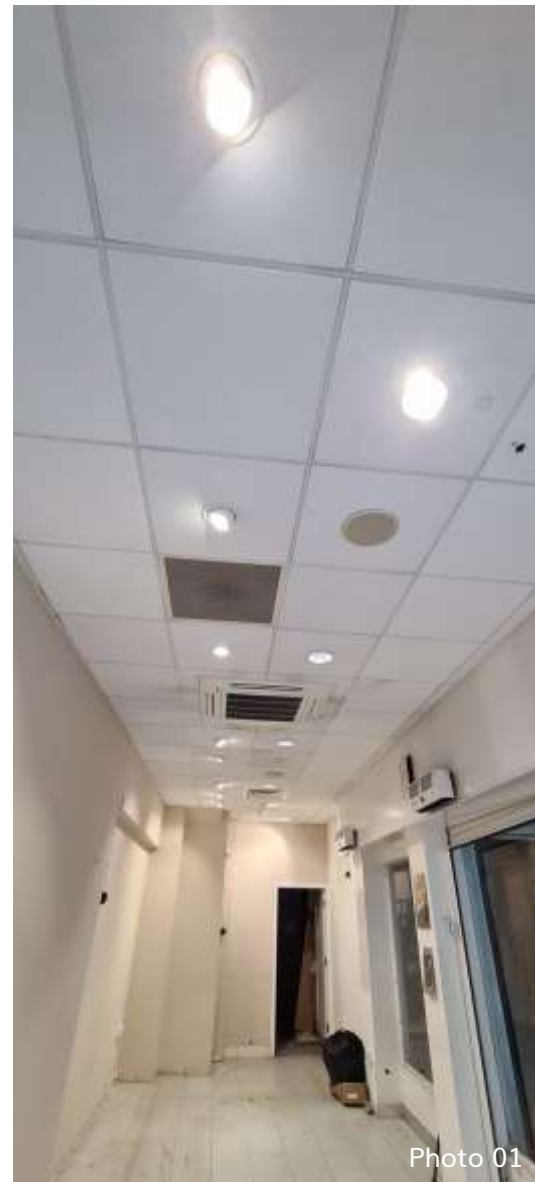
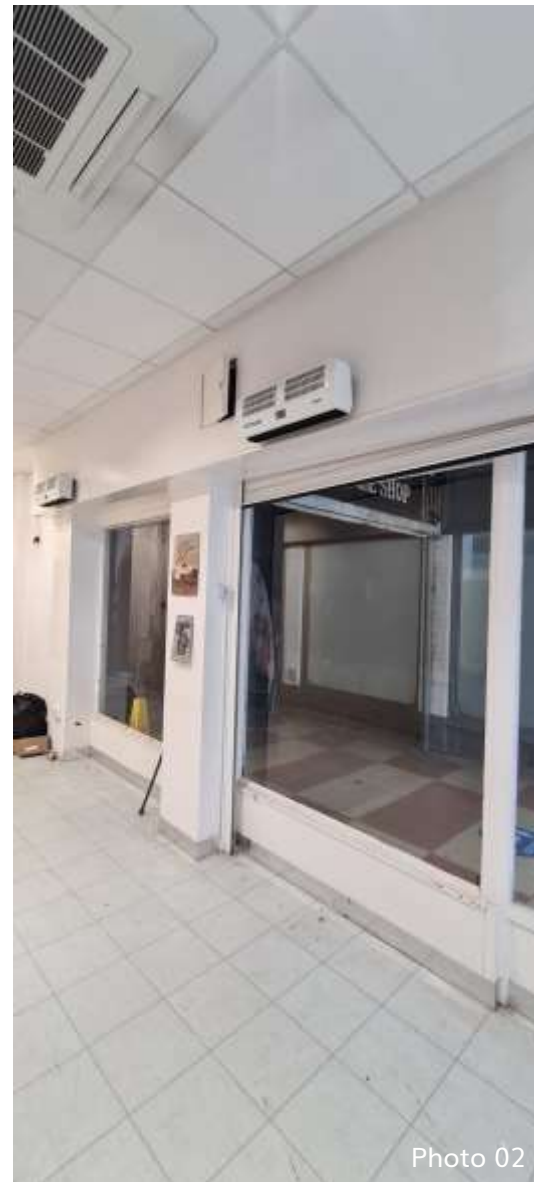
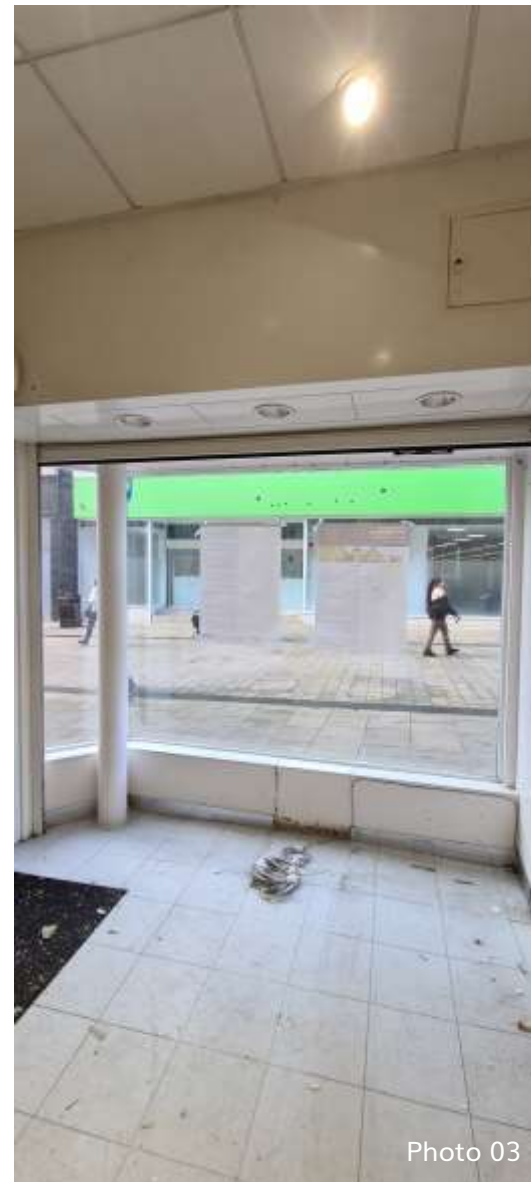
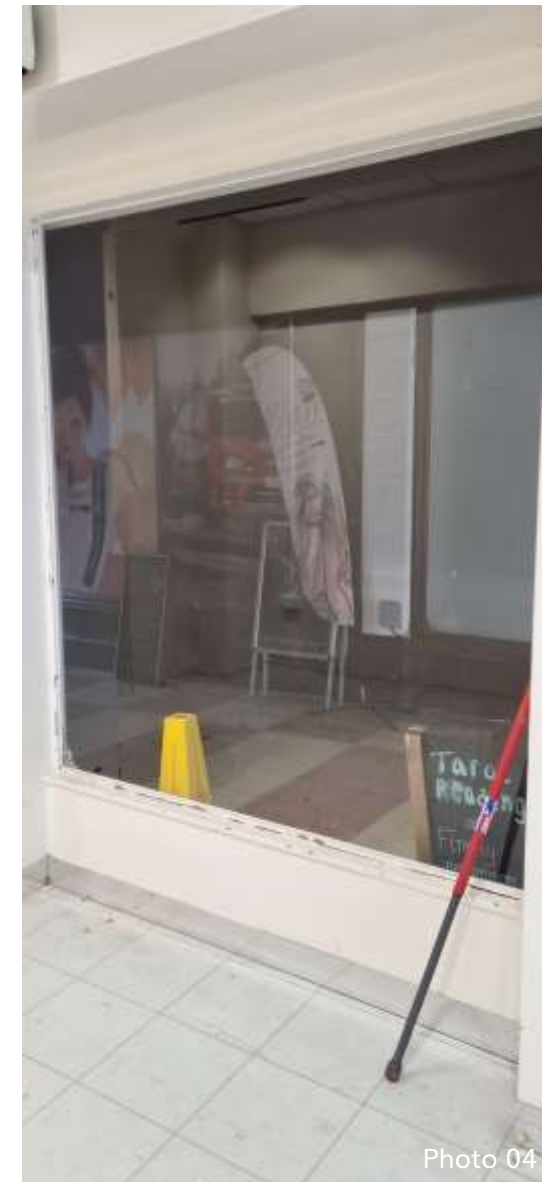
PHOTO 01 - Current condition of room 5  
 PHOTO 02 - Current condition of windows  
 PHOTO 03 - Current condition of front bay window  
 PHOTO 04 - Current condition of floor and walls

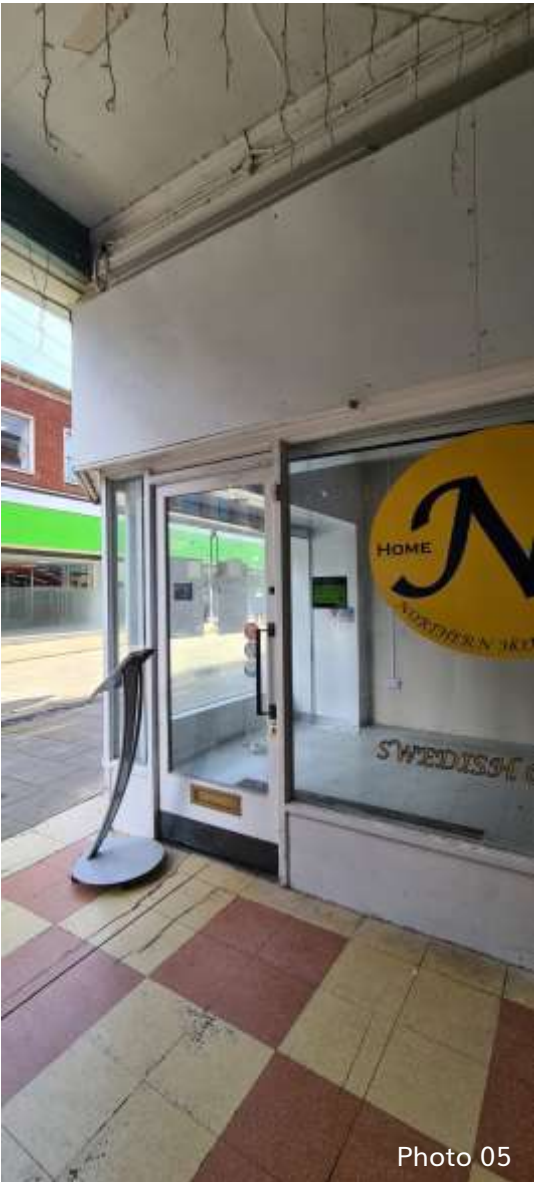
Photo 05

PHOTO 01 - Current condition of wall  
PHOTO 02 - Current condition of ceiling and lights  
PHOTO 03 - Current condition of tiles and windows  
PHOTO 04 - Current condition of tiles and windows  
PHOTO 05 - Current condition of entranceway

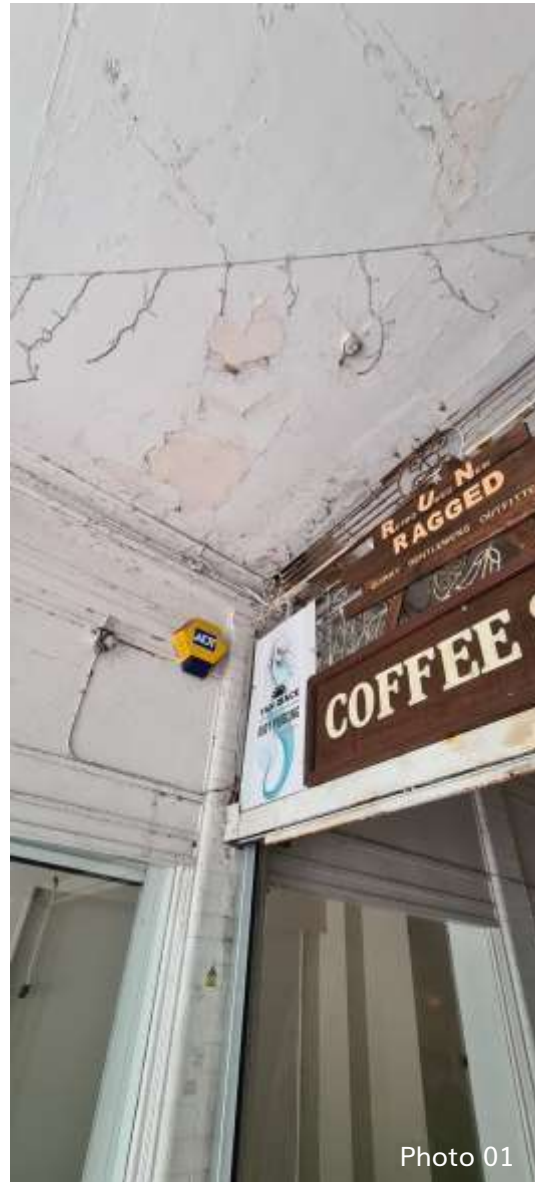
Photo 01

PHOTO 01 - Current condition of ceiling and signage  
 PHOTO 02 - Current condition of roller shutters  
 PHOTO 03 - Current condition of room 5  
 PHOTO 04 - Current condition of room 5

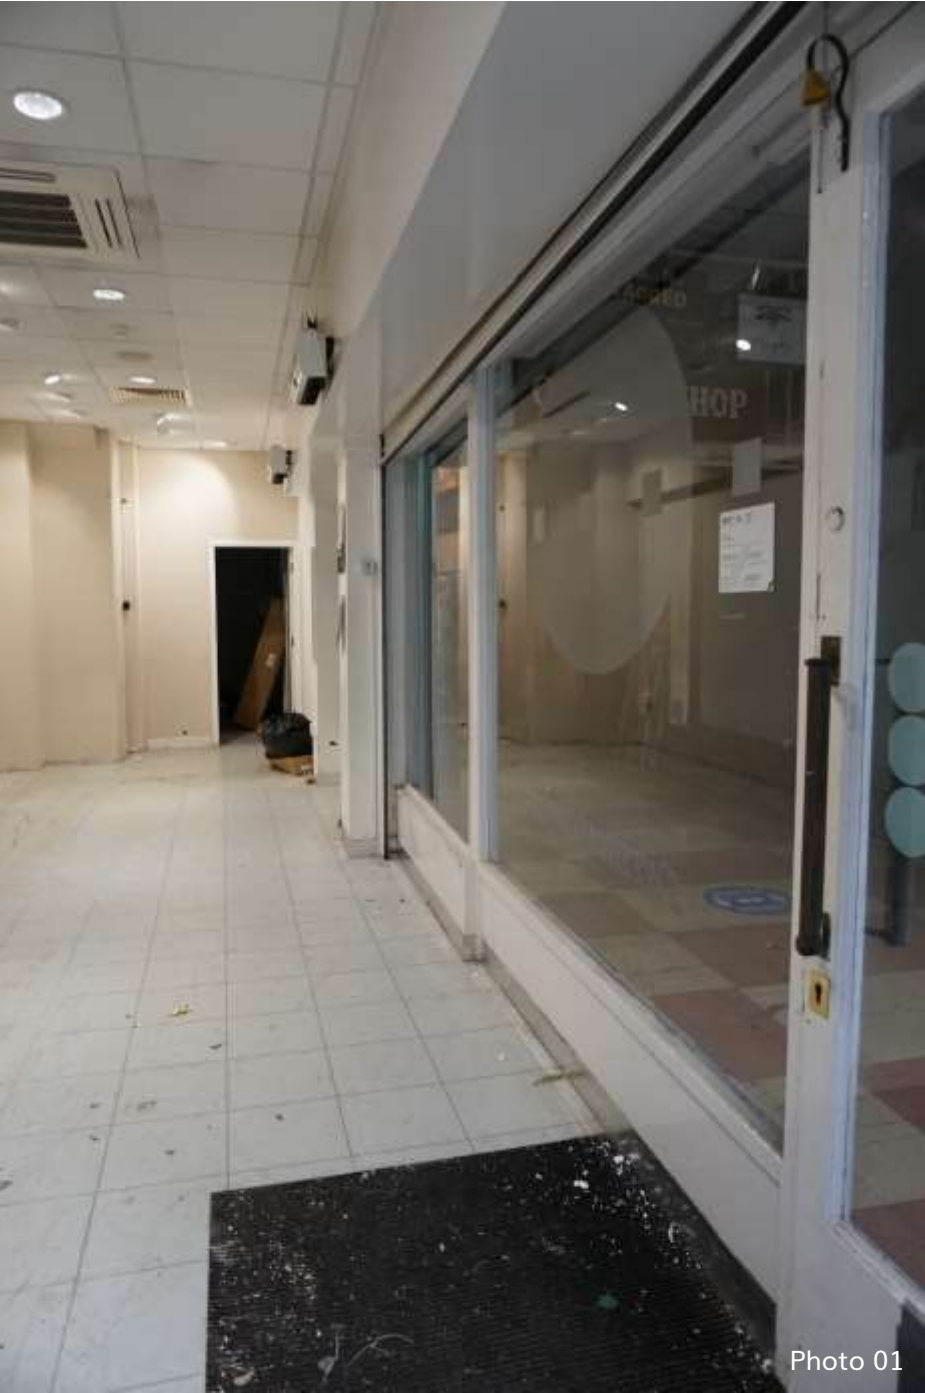
Photo 01

PHOTO 01 - Current condition of room 5  
PHOTO 02 - Current condition of room 5  
PHOTO 03 - Current condition of room 5

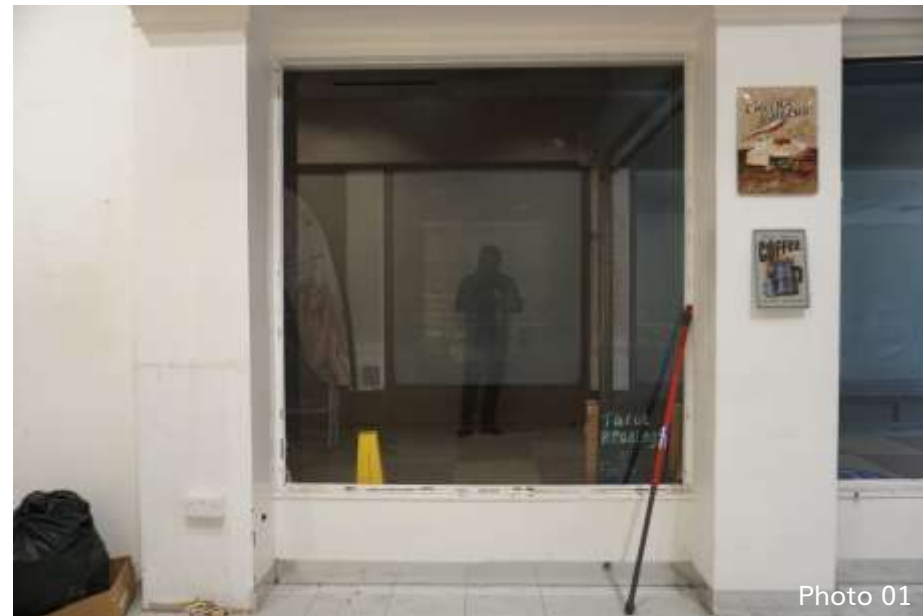
Photo 01

PHOTO 01 - Current condition of windows  
 PHOTO 02 - Current condition of room 5  
 PHOTO 03 - Current condition of floor and window frame  
 PHOTO 04 - Current condition of room 5  
 PHOTO 05 - Current condition of room 5  
 PHOTO 06 - Current condition of room 5

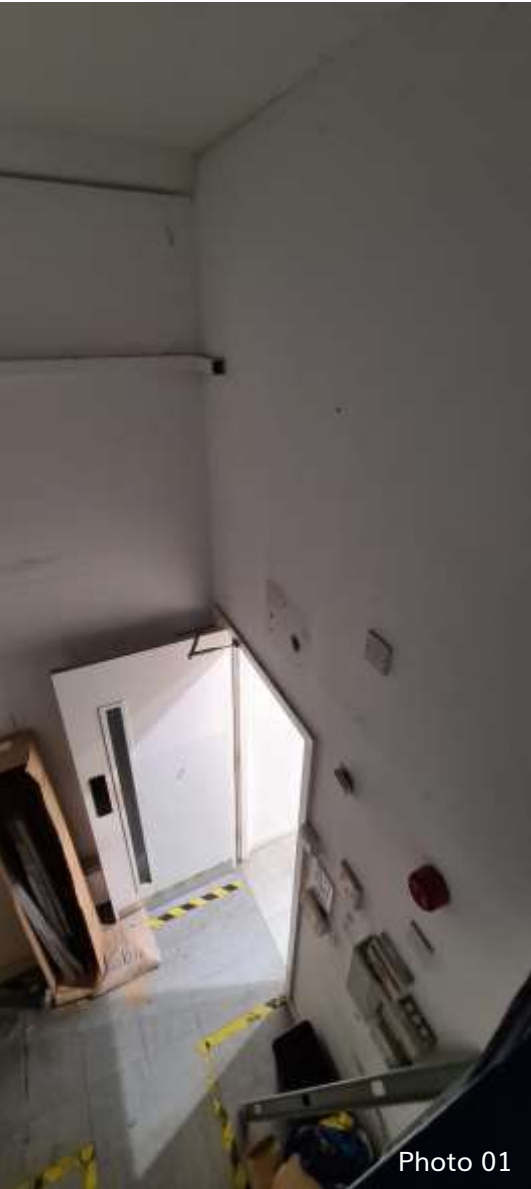
Photo 01

PHOTO 01 - Current condition of room 6  
PHOTO 02 - Existing light switch and fire alarm  
PHOTO 03 - Existing switches  
PHOTO 04 - Existing cupboard containing energy metre  
PHOTO 05 - Current condition of floor and cupboard
