PHOTOGRAPHIC SURVEY

58 HOPE STREET, WREXHAM

AINSLEY GOMMON ARCHITECTS AGA

This Photographic Record supports the Full Planning and Listed Building Consent Application for the reordering and restoration of the existing shop front, basement, ground floor and upper floors to. **No.58 Hope Street, Wrexham, LL11 1BE** for a commercial unit to the lower floors and 3no. 2 bedroom apartments to the upper floors.

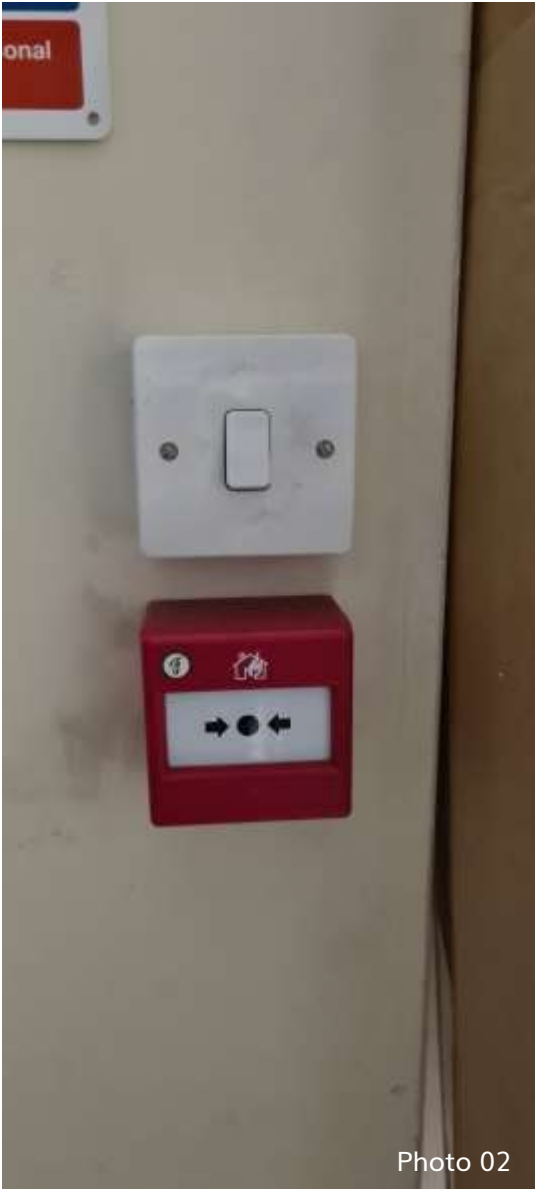
Photo 02

PHOTO 01 - Current condition of room 6  
PHOTO 02 - Existing light switch and fire alarm  
PHOTO 03 - Existing switches  
PHOTO 04 - Existing cupboard containing energy metre  
PHOTO 05 - Current condition of floor and cupboard

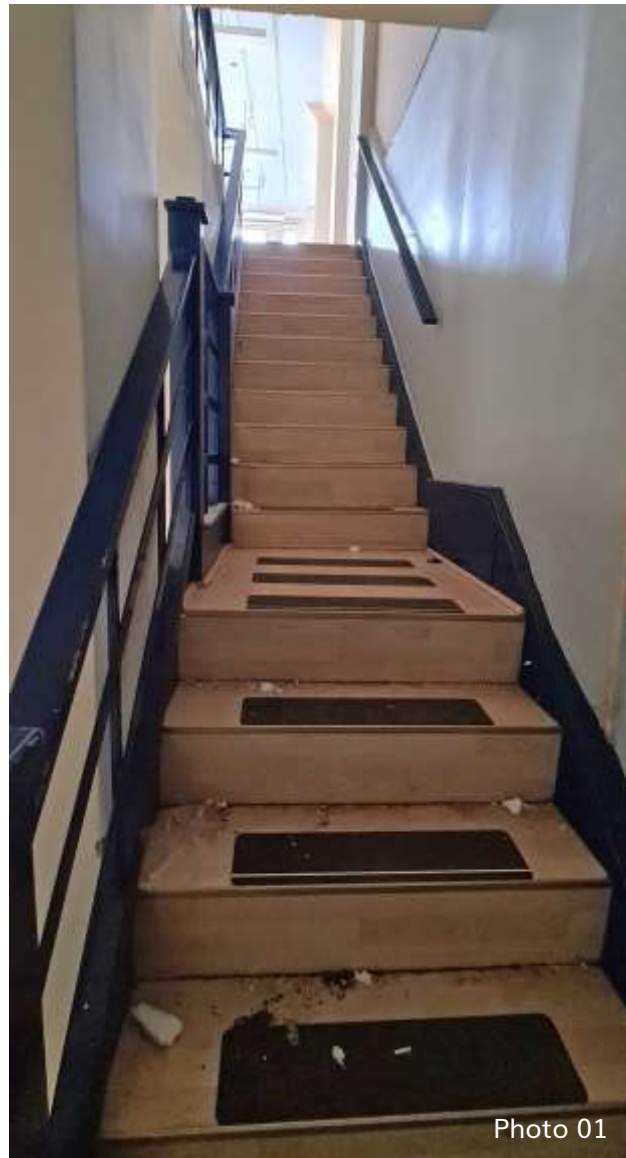
Photo 01

PHOTO 01 - Current condition of staircase  
 PHOTO 02 - Current condition of flooring and staircase  
 PHOTO 03 - Current condition of staircase banister  
 PHOTO 04 - Current condition of existing door  
 PHOTO 05 - Current condition of wall with existing switches

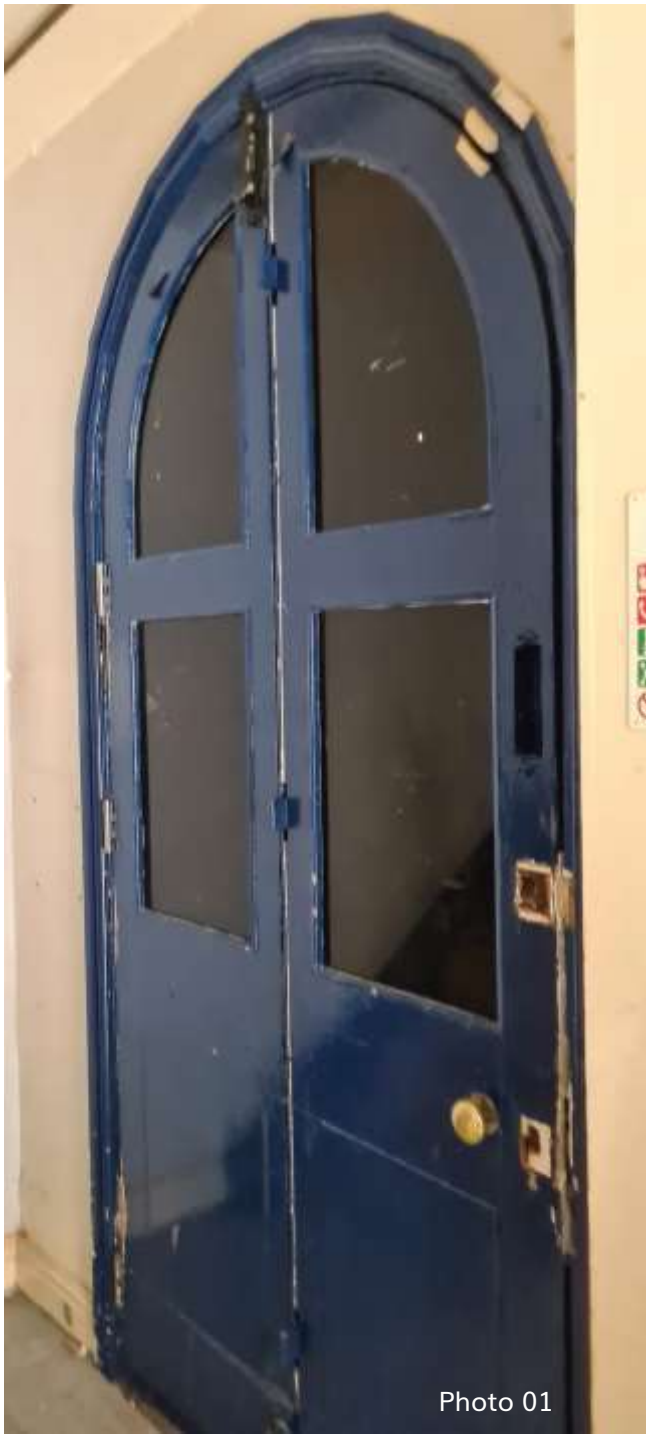
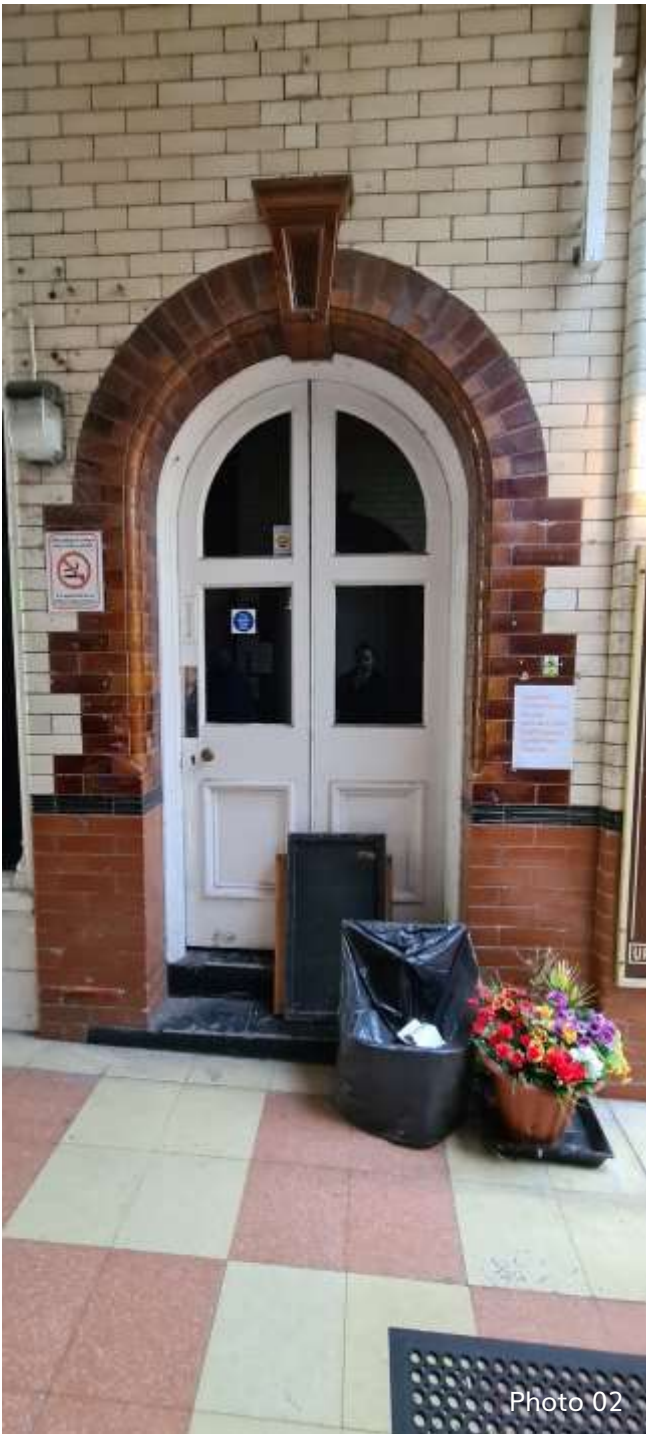
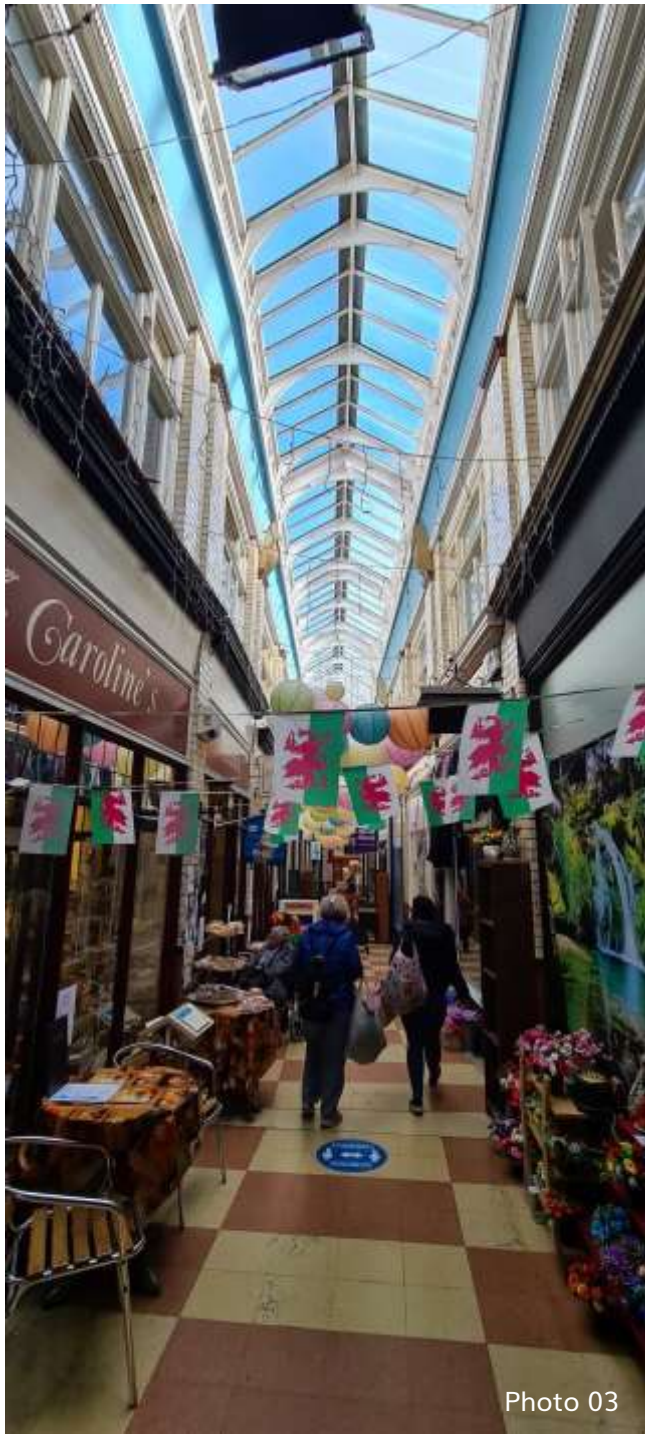
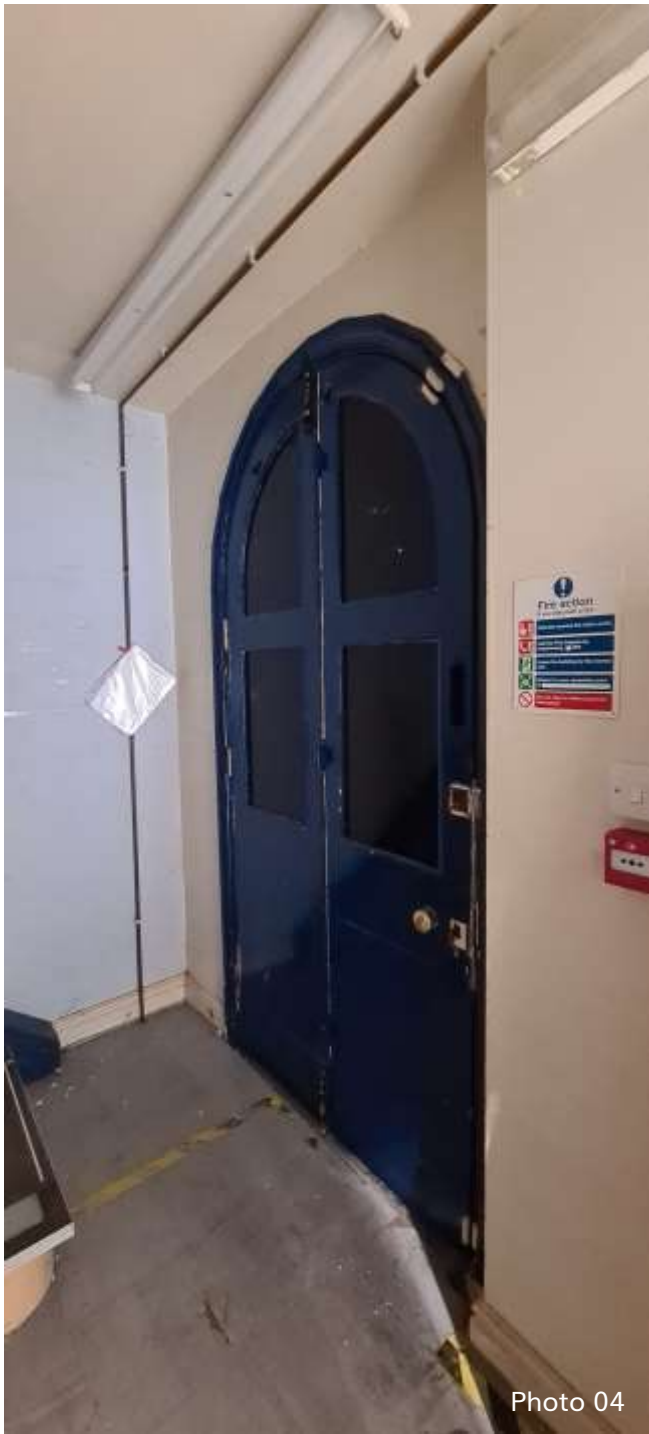
PHOTO 01 - Current condition of existing door  
PHOTO 02 - Current condition of existing door/tiles, flooring within atrium  
PHOTO 03 - Current condition of atrium  
PHOTO 04 - Current condition of door and flooring

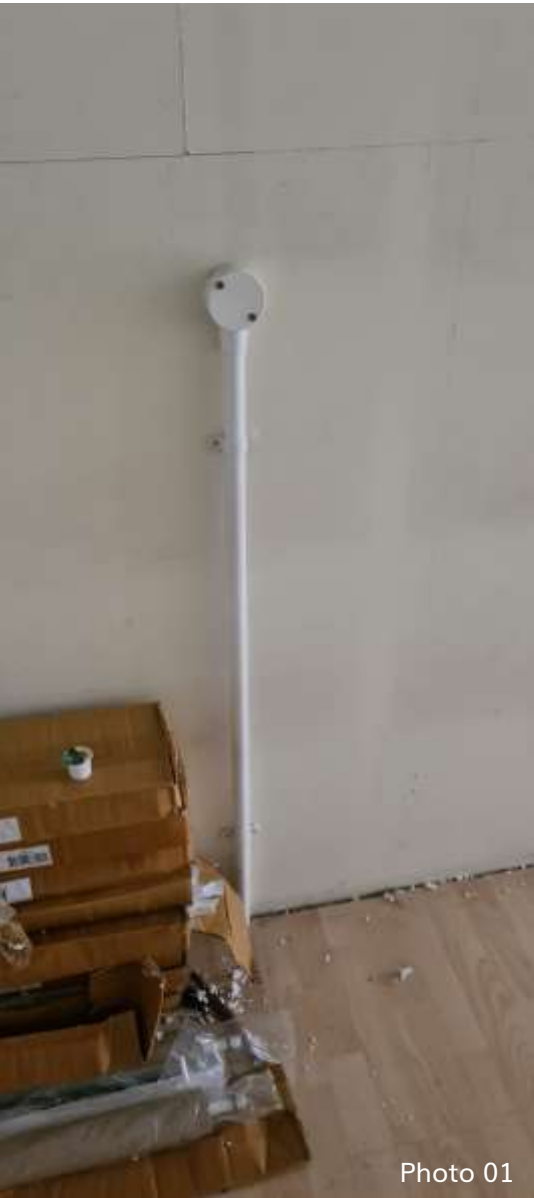
Photo 01

PHOTO 01 -  
PHOTO 02 - Current condition of floor and walls  
PHOTO 03 - Exposed services/pipe  
PHOTO 04 -  
PHOTO 05 -

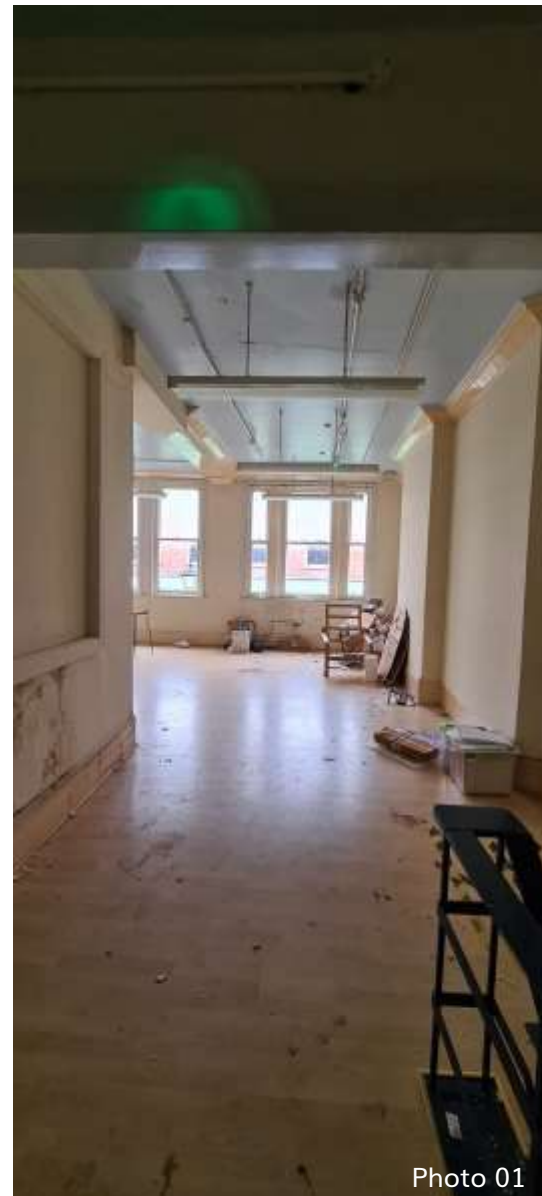
Photo 01

PHOTO 01 - Current condition of room 7  
 PHOTO 02 - Current condition of wall within room 7  
 PHOTO 03 - Current condition of room 7  
 PHOTO 04 - Current condition of room 7  
 PHOTO 05 - Current condition of stairwell leading out of room 7

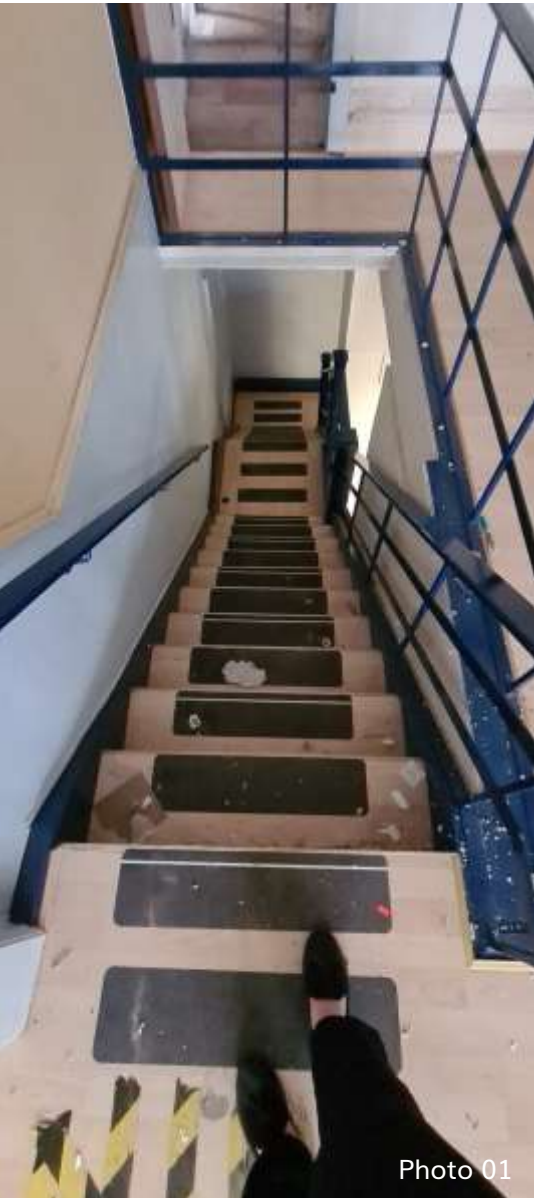
Photo 01

PHOTO 01 - Existing stairwell leading down from room 7  
PHOTO 02 - Current condition of room 7  
PHOTO 03 - Existing fire hydrants within room 7  
PHOTO 04 - current condition of ceiling  
PHOTO 05 - Current condition of room 7

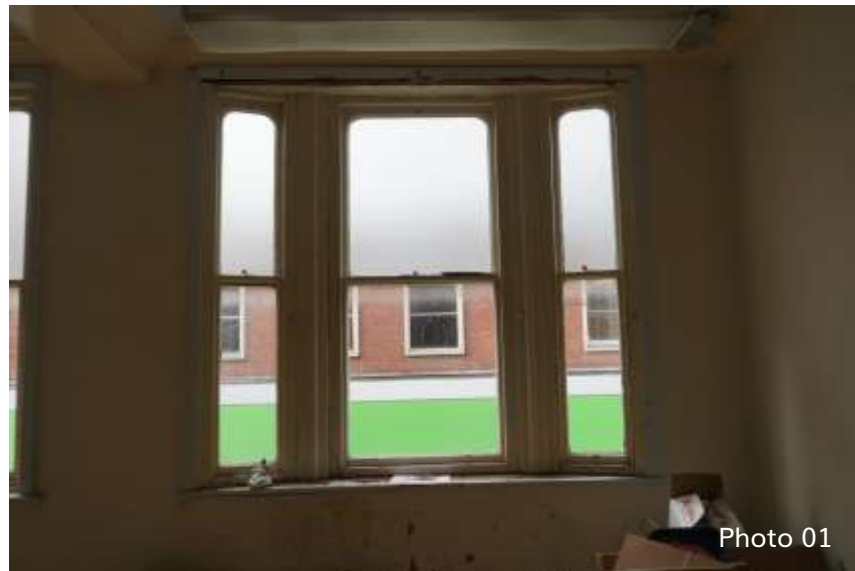
Photo 01

PHOTO 01 - Current condition of window within room 7  
 PHOTO 02 - Current condition of windows and ceiling within room 7  
 PHOTO 03 - Current condition of wall within room 7  
 PHOTO 04 - General condition of room 7

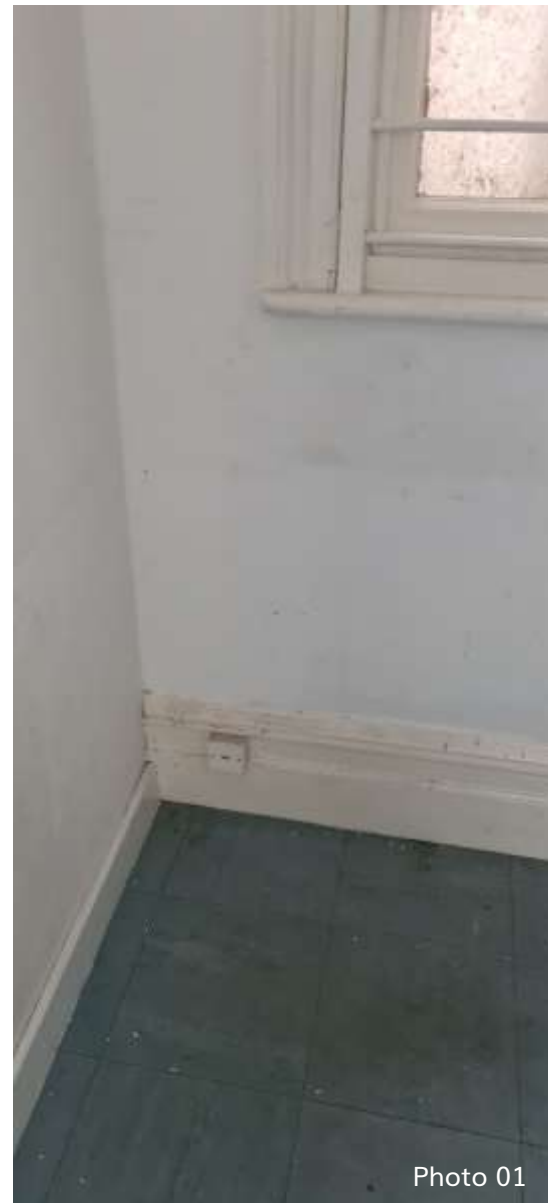
Photo 01

PHOTO 01 - Current condition of flooring and skirting board  
 PHOTO 02 - Existing safe  
 PHOTO 03 - Existing counter tops  
 PHOTO 04 - Existing doorway through to room 7  
 PHOTO 05 -

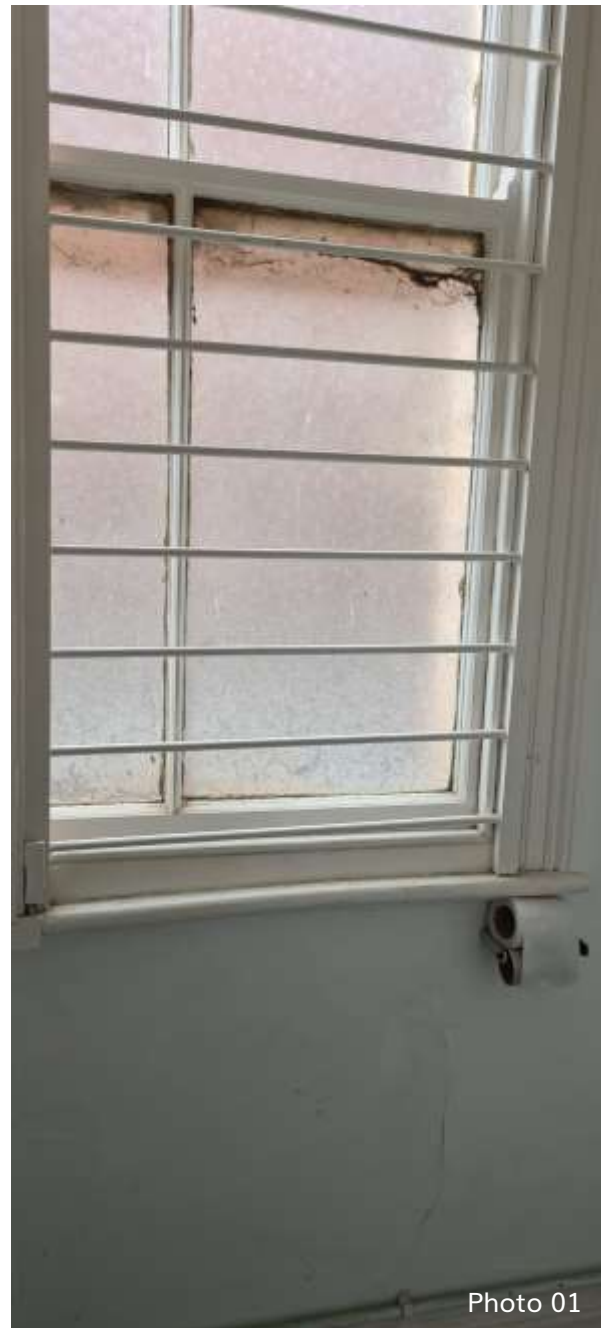
Photo 01

PHOTO 01 - Current condition of window  
 PHOTO 02 - Current condition of windows and existing smoke detector  
 PHOTO 03 - Current condition of windows

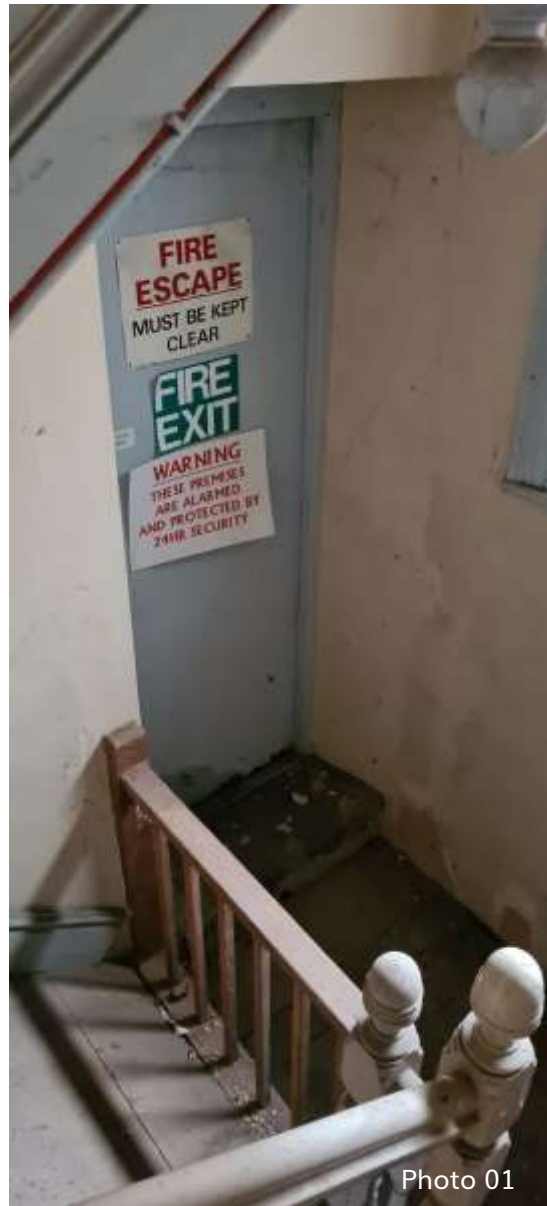
Photo 01

PHOTO 01 - Existing fire exit  
 PHOTO 02 - Existing staircase leading to fire exit  
 PHOTO 03 - Current condition of walls  
 PHOTO 04 - Current condition of walls  
 PHOTO 05 - Current condition of walls

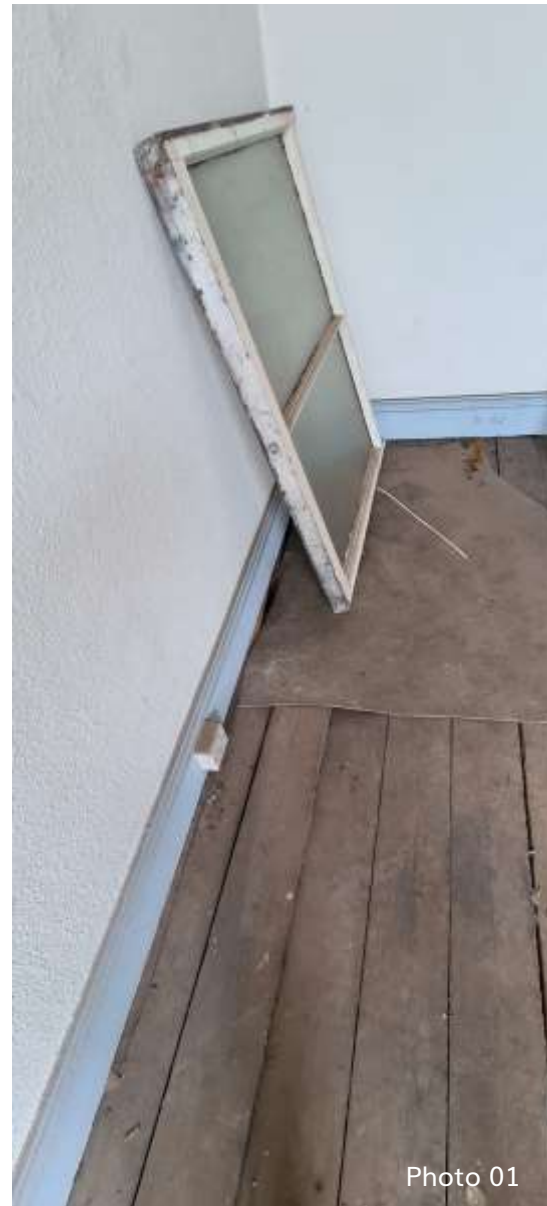
Photo 01

PHOTO 01 - Current condition of floorboards  
 PHOTO 02 - Existing shelves / current condition of walls and floor  
 PHOTO 03 - Existing door leading out of room 11  
 PHOTO 04 - Existing shelves / current condition of walls and floor

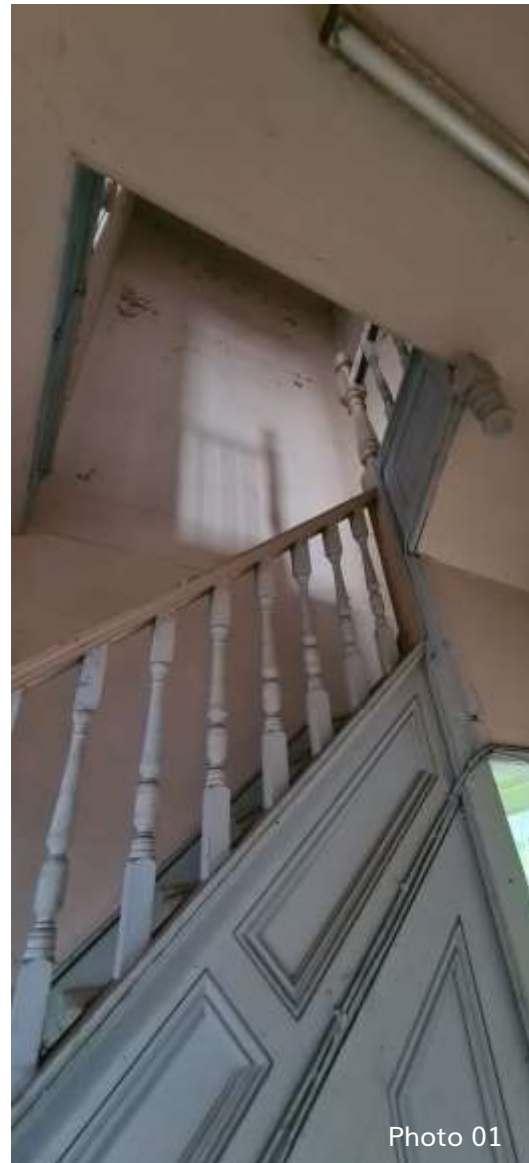
Photo 01

PHOTO 01 - Existing staircase leading up to room 12  
 PHOTO 02 - Current condition of wall  
 PHOTO 03 - Current condition of wall  
 PHOTO 04 - Current condition of wall  
 PHOTO 05 - Current condition of wall and floorboards

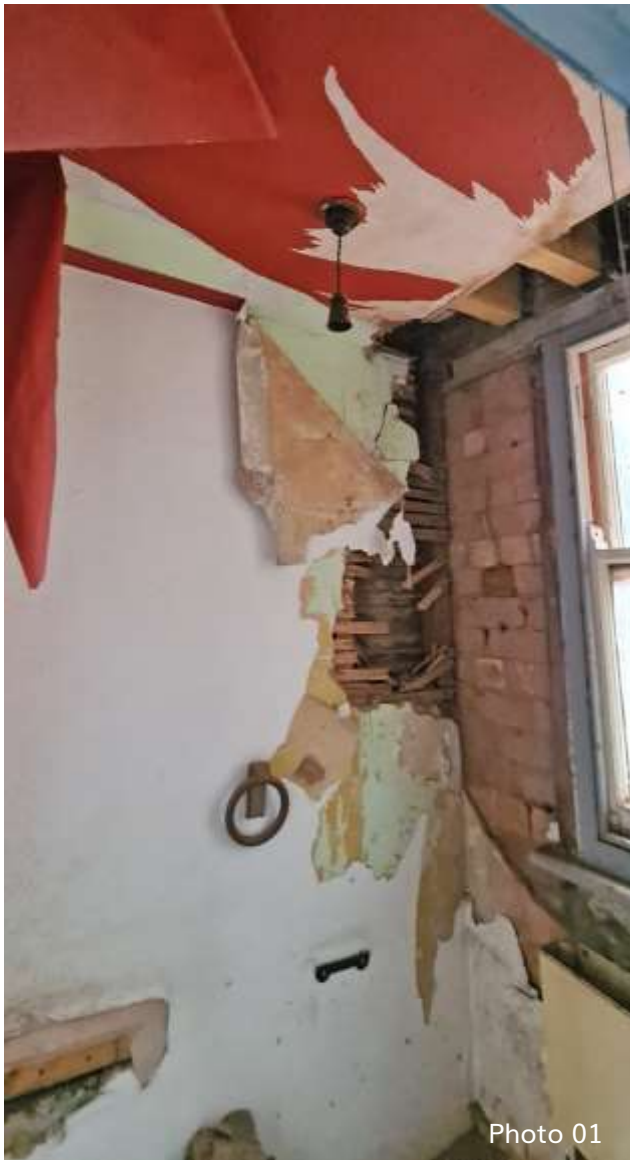
Photo 01

PHOTO 01 - Current condition of wall  
PHOTO 02 - Current condition of room 14  
PHOTO 03 - Current condition of room 14  
PHOTO 04 - Current condition of room 14  
PHOTO 05 - Current condition of room 14

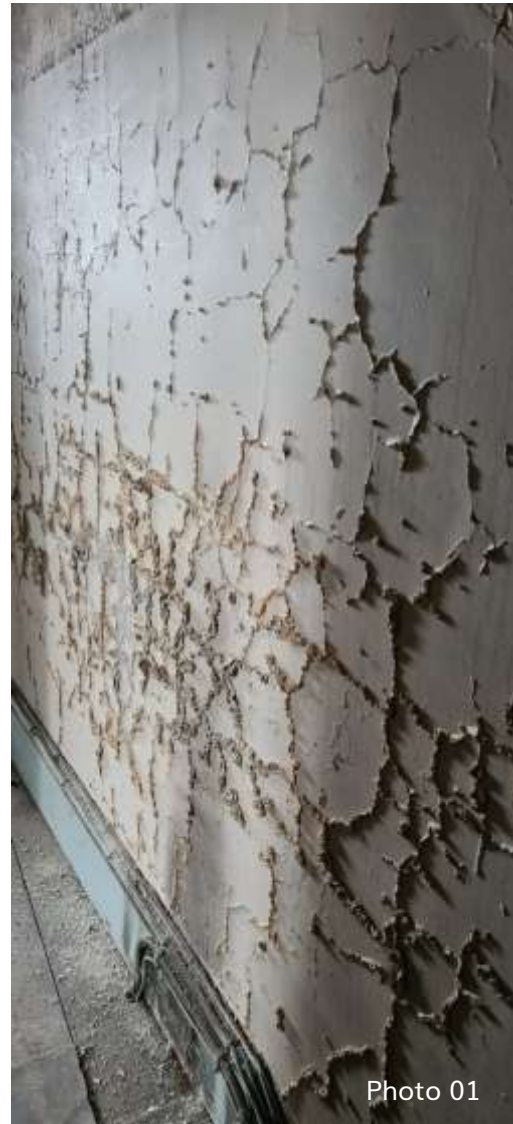
Photo 01

PHOTO 01 - Current condition of wall  
 PHOTO 02 - Existing toilet  
 PHOTO 03 - Existing sink  
 PHOTO 04 - Existing doorway

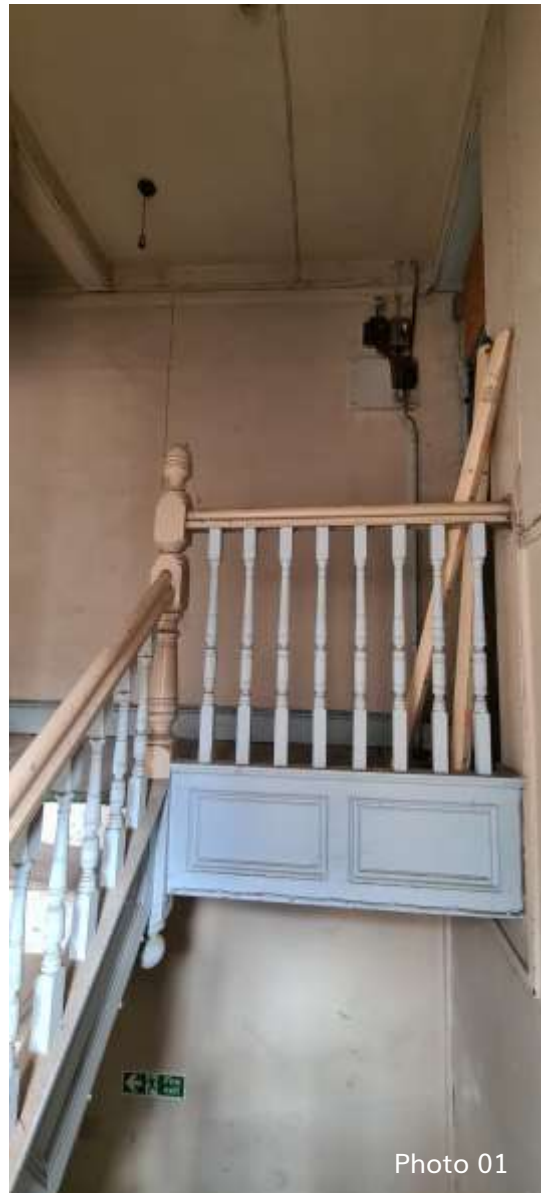
Photo 01

PHOTO 01 - Current condition of staircase  
PHOTO 02 - Current condition of floorboards  
PHOTO 03 - Current condition of floorboards and walls  
PHOTO 04 - Existing door  
PHOTO 05 - Current condition of staircase and landing

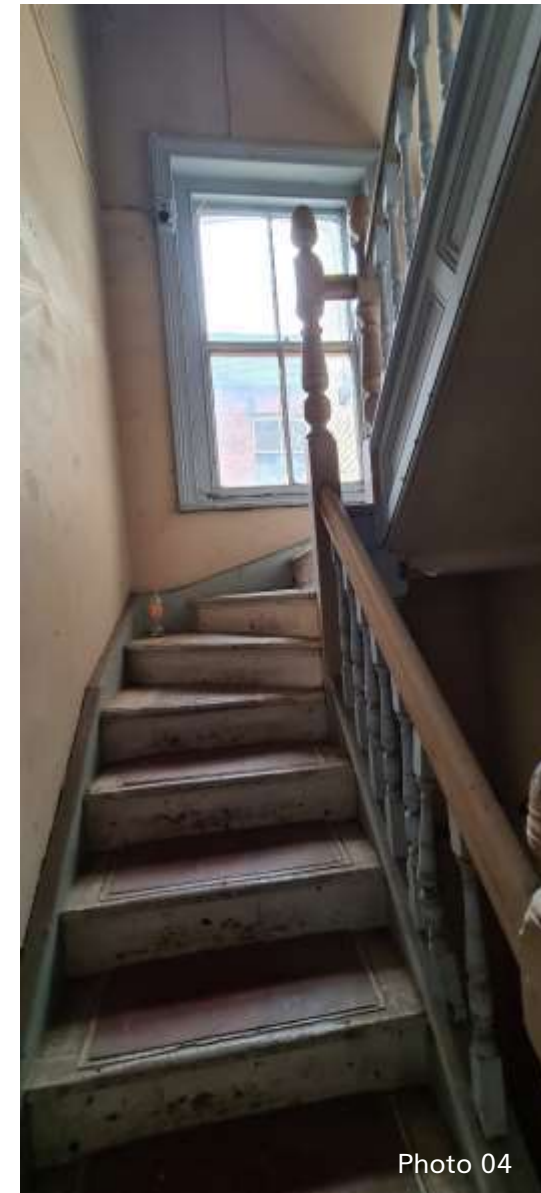
Photo 03

PHOTO 01 - Current condition of existing staircase  
 PHOTO 02 - Current condition of existing staircase  
 PHOTO 03 - Current condition of existing staircase  
 PHOTO 04 - Current condition of existing staircase  
 PHOTO 05 - Current condition of walls beneath staircase

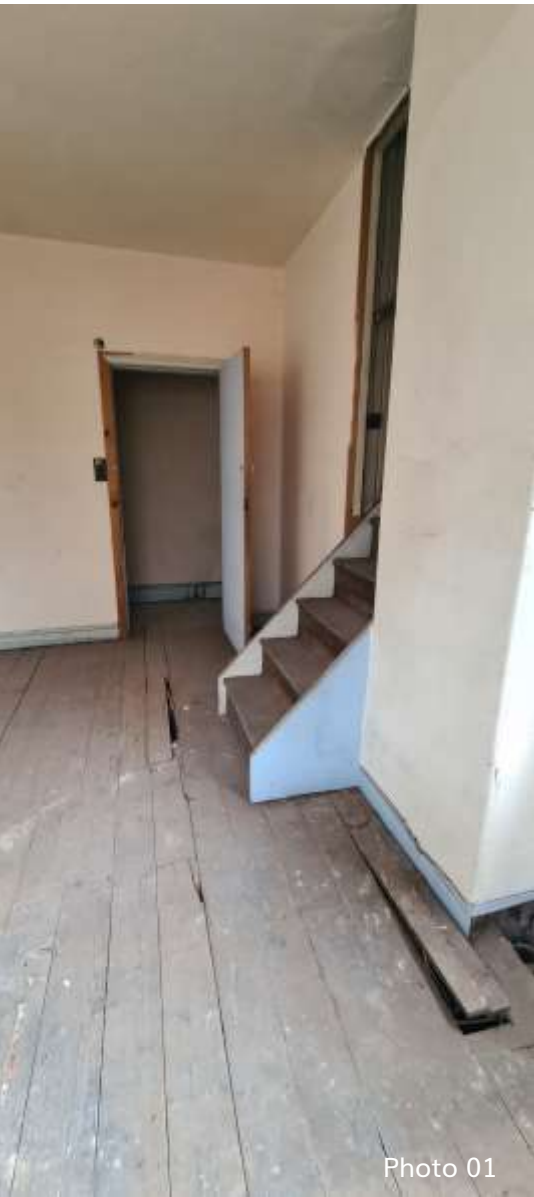
Photo 01

PHOTO 01 - Current condition of room 17  
PHOTO 02 - Existing cupboards and units with sink  
PHOTO 03 - Existing doorway  
PHOTO 04 - Existing doorway into room 17  
PHOTO 05 - Current condition of window

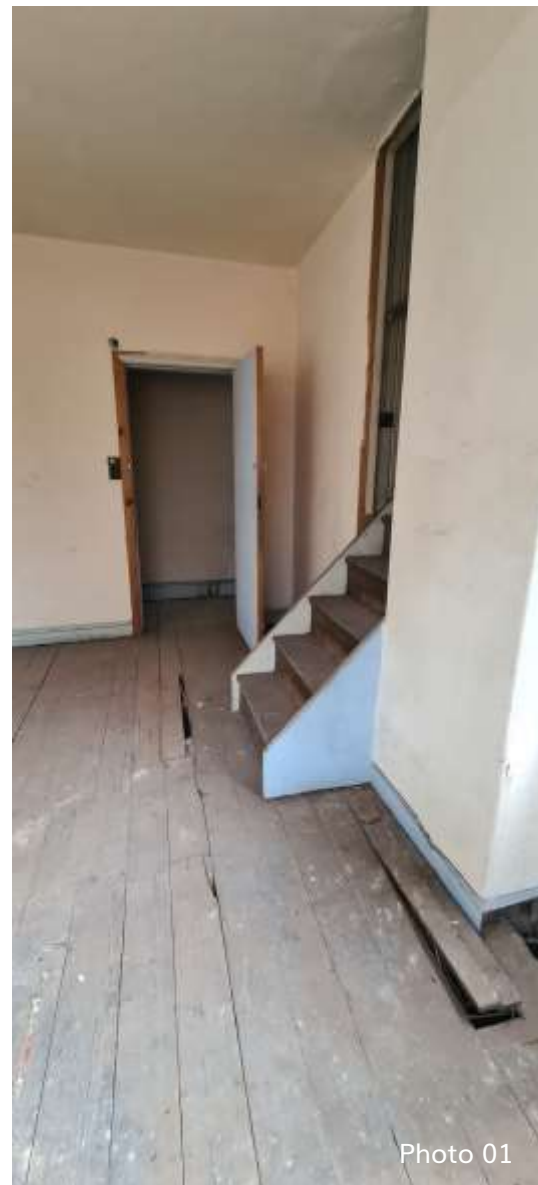
Photo 01

PHOTO 01 - Current condition of room 17  
 PHOTO 02 - Current condition of window  
 PHOTO 03 - Current condition of staircase  
 PHOTO 04 - Current condition of floorboards

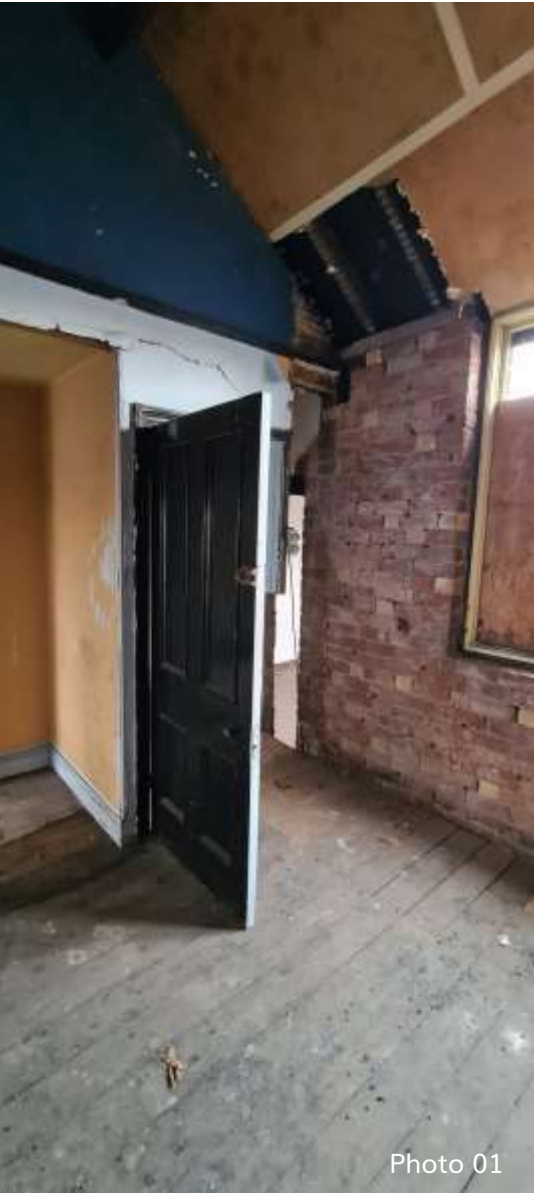
Photo 01

PHOTO 01 - Current condition of room 18  
PHOTO 02 - Current condition of room 18  
PHOTO 03 - Current condition of room 18  
PHOTO 04 - Current condition of wall/brickwork  
PHOTO 05 - Current condition of ceiling

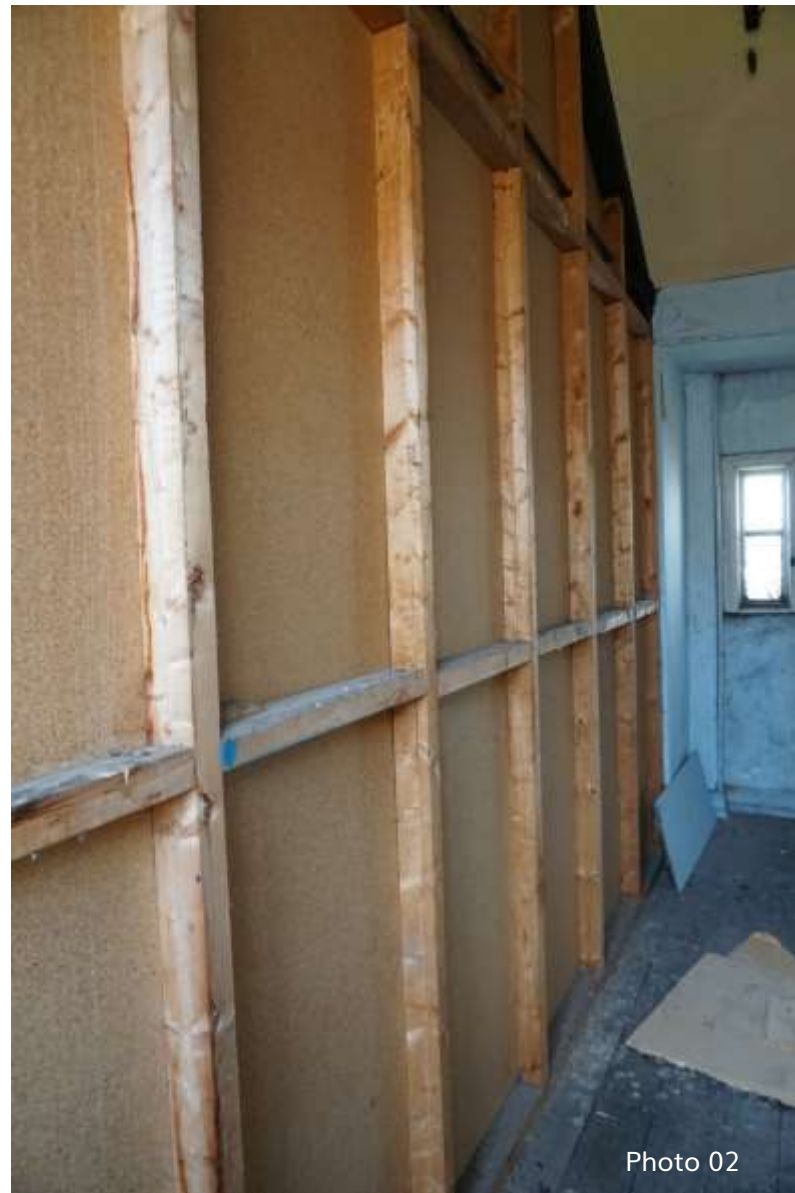
Photo 02

PHOTO 01 - Current condition of walls  
 PHOTO 02 - Current condition of walls  
 PHOTO 03 - Current condition of bay window area

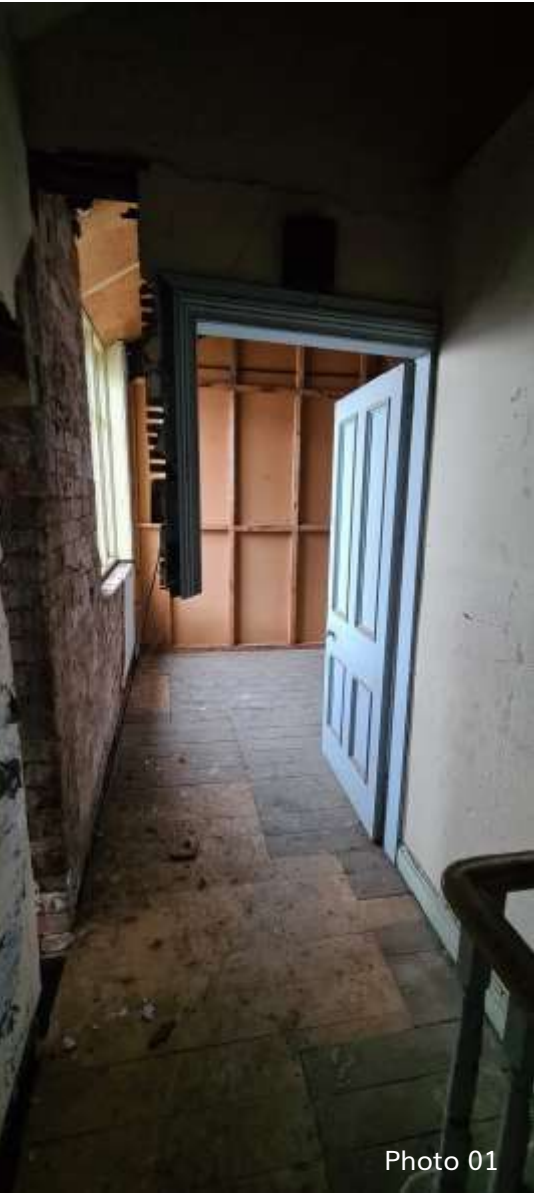
Photo 01

PHOTO 01 - Current condition of room 19  
PHOTO 02 - Current condition of landing area  
PHOTO 03 - Current condition of existing staircase  
PHOTO 04 - Existing doorway into room 18  
PHOTO 05 - Current condition of walls

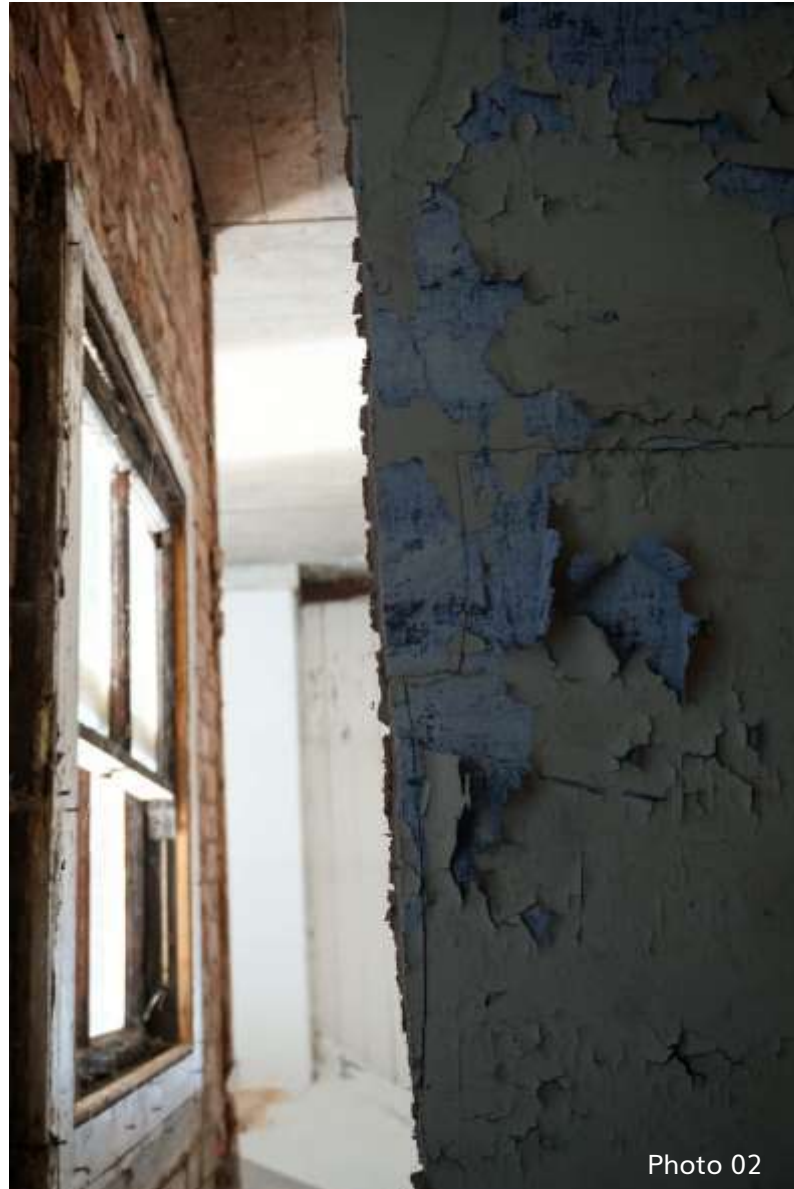
Photo 02

PHOTO 01 - Current condition of room 19  
 PHOTO 02 - Current condition of walls  
 PHOTO 03 - Current condition of ceiling

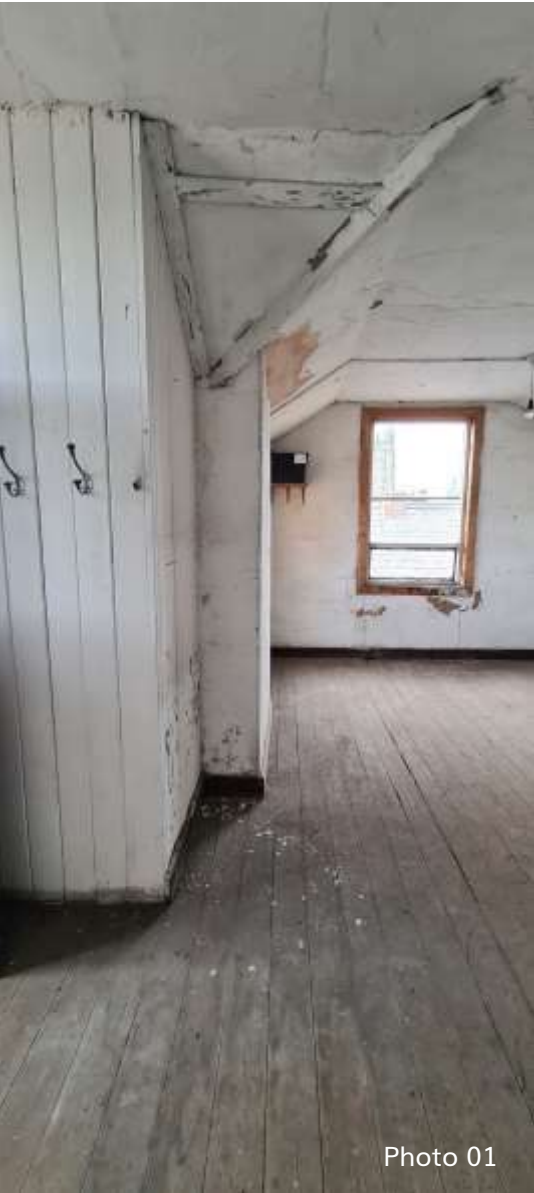
Photo 01

PHOTO 01 - Current condition of room 20  
PHOTO 02 - Current condition of room 20  
PHOTO 03 - Current condition of staircase into room 20  
PHOTO 04 - Current condition of walls and floorboards  
PHOTO 05 - Current condition of room 20

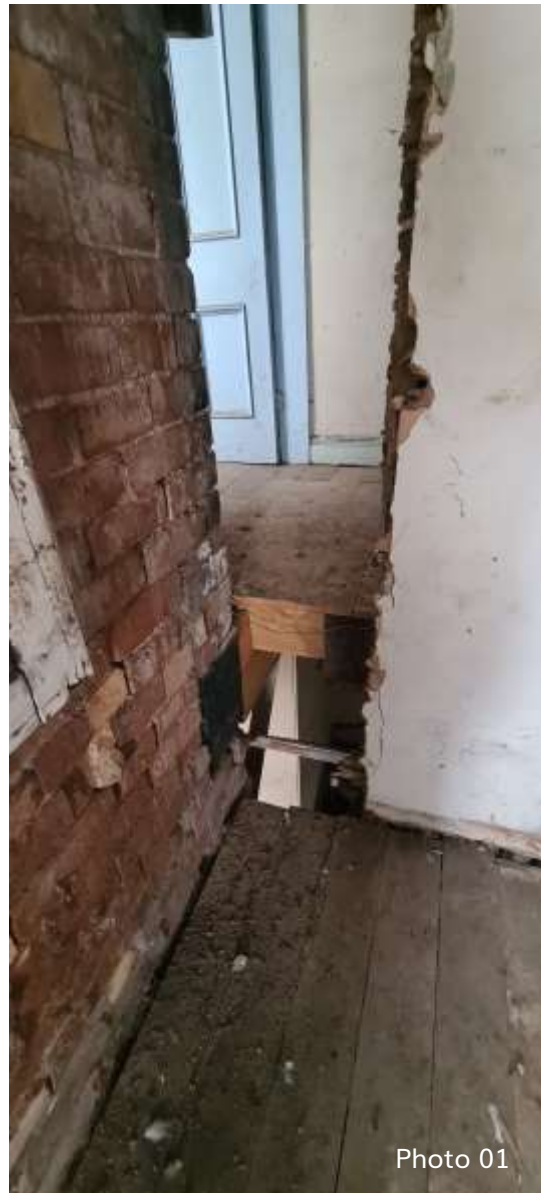
Photo 01

PHOTO 01 - Current condition of walls and floorboards  
 PHOTO 02 - Current condition of room 20  
 PHOTO 03 - Current condition of room 20  
 PHOTO 04 - Current condition of existing staircase

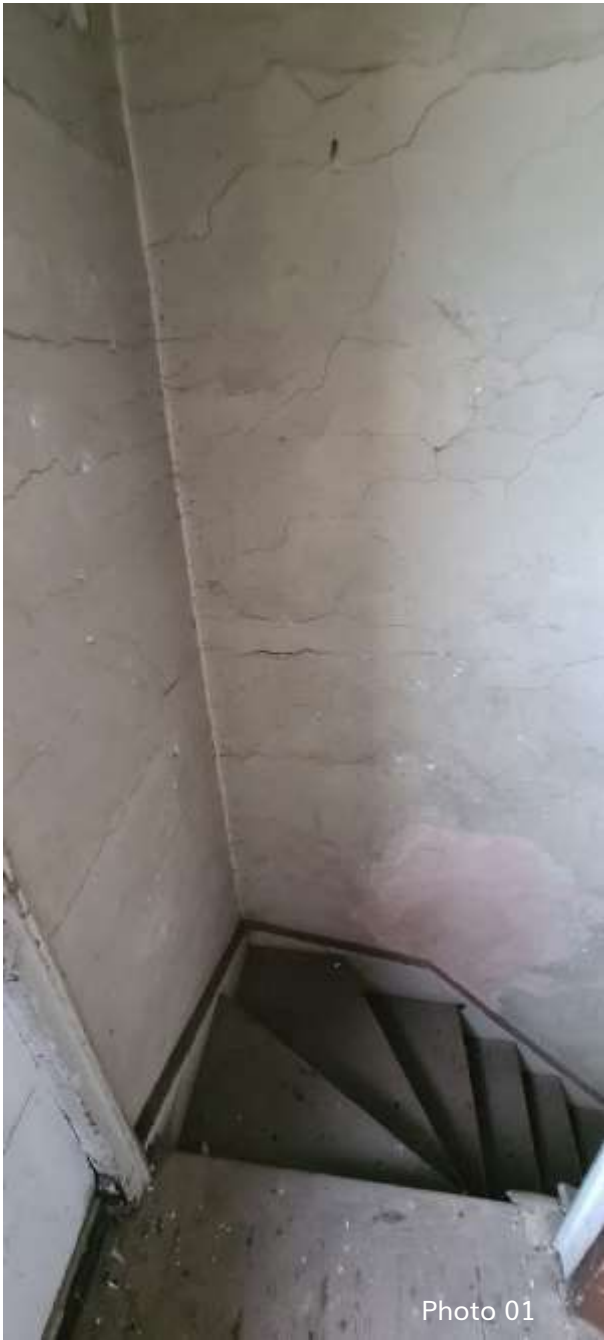
Photo 01

PHOTO 01 - Current condition of walls  
PHOTO 02 - Current condition of existing staircase  
PHOTO 03 - Current condition of existing staircase
