## 9 SHERBOURNE AVENUE; BAT AND NESTING BIRD SURVEYS

Report Ref: EE.1156.22.A KW

| <b>Site</b> | 9 Sherbourne Avenue, Bradley, Wrexham, LL11 4AZ<br>Approx. OS Grid Ref: SJ3245653648 |
| <b>Type of survey</b> | Bats - Preliminary Roost Assessment (PRA) and Emergence Survey (19/07/2022)<br>Birds – Nesting Bird Survey |

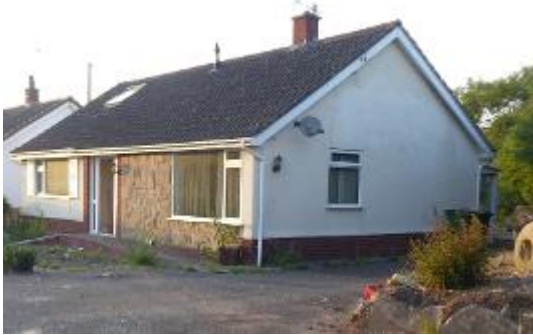
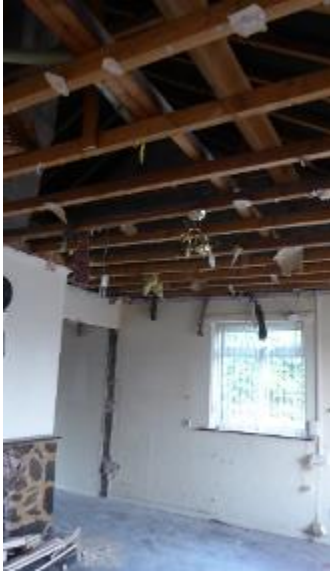
| Bungalow – Approx. 12m x 8m x 5m high | | | |
|---|---|---|---|
| <p>The walls were breezeblock, brick and render, with natural stone cladding over the south western elevation.</p> <p>The roof was pitched with wavy concrete tiles and one chimney towards the eastern end of the roof and a skylight on the western corner.</p> <p>There was a plastic framed, glass conservatory on the north eastern elevation, with a single pitch, plastic roof.</p> <p>The fascias, soffits, doors and windows were all plastic and well-sealed.</p> | <p><b>SOUTH WESTERN AND EASTERN ELEVATIONS</b></p> | <p>Internal conversion works had commenced and the building had been stripped internally. The ceiling had been removed in most areas so the roof void was exposed. The walls were plastered and well-sealed. The roof had a wooden frame and was lined with felt. There was one small area of the loft floor left intact, which was boarded but open to the ground floor at the edges. The internal gables of the roof were exposed breezeblock and there were high light levels throughout via windows and the skylight.</p> | <p><b>GROUND FLOOR - ROOF EXPOSED</b></p> |
