# Heritage, Design and Access Statement | Hollybush Cellar Restoration

## 1.0 Introduction

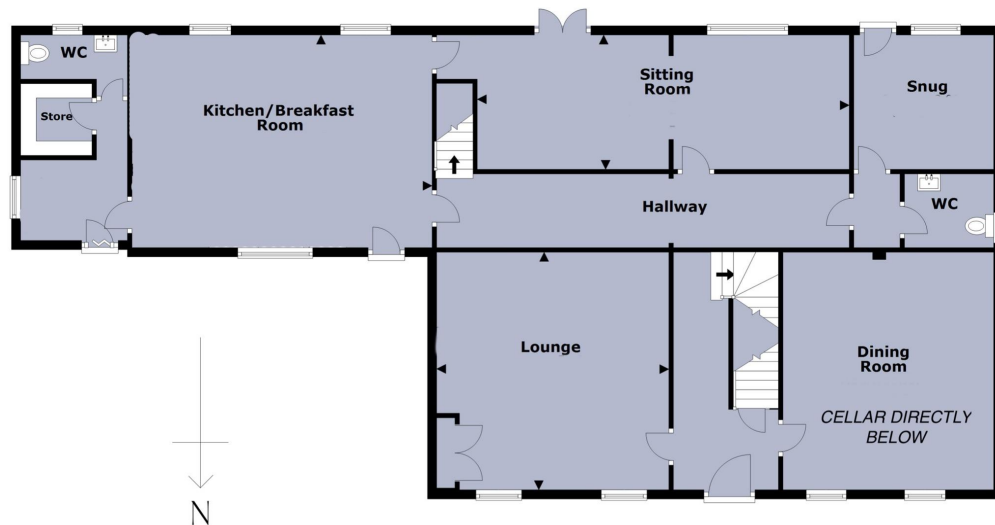
Figure 4 - Position of Cellar on Sketch Plan

The cellar is located in the North-West corner of the house, immediately below the Dining Room - Figure 4 - The walls of the cellar are constructed from hand-moulded brick. The floor is made from a flooring tile laid directly onto clay. Center to the North-wall is a small-paned iron framed window referred to in the listing. The suspended ceiling is constructed of full-span timber joists notched and laid into recesses in the brickwall. The cellar is accessed by a brick stair that descends to the south-east corner.
