**Building Survey**  
**12/01/22**

**Dymock Arms**  
**Penley, Wrexham**  
**LL13 0LS**

Date of first issue : 19<sup>th</sup> January 2022

## **BUILDING CONDITION REPORT**

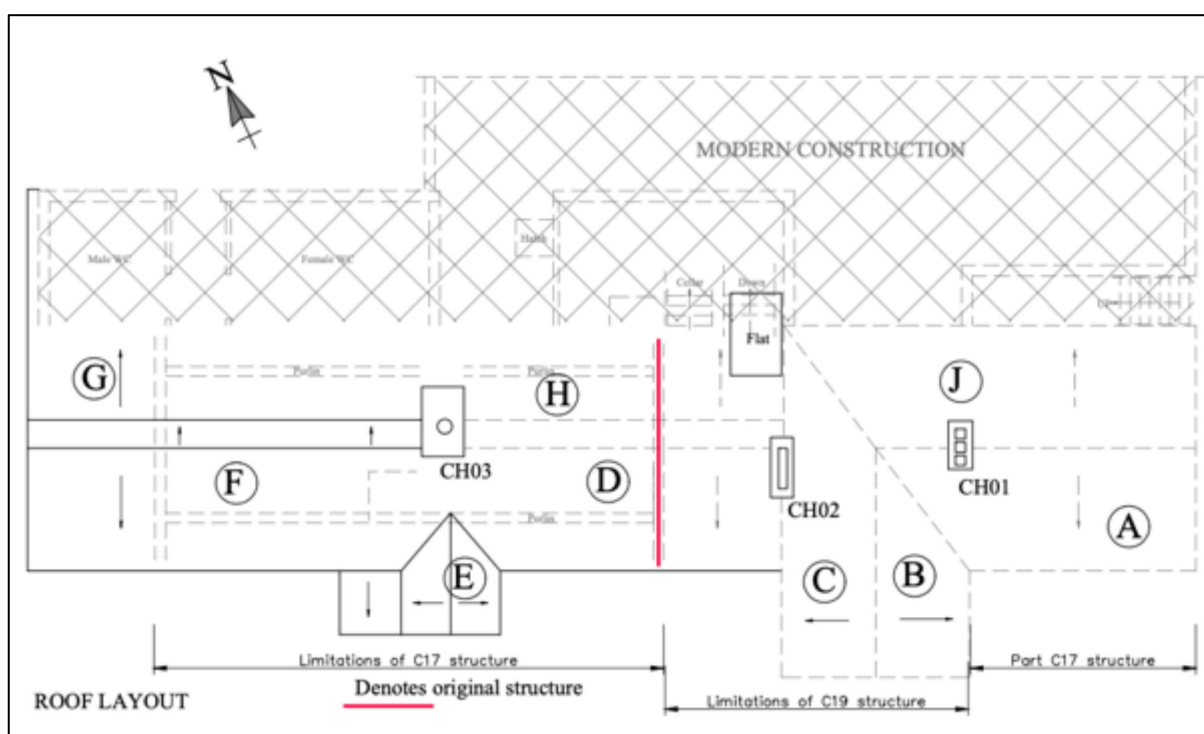
**Condition** – Roofs A,B,C,D,J were not present. Remaining roofs E,F,G,H contained many slipped slates. Underfelt was noted to some roof surfaces. Extensive water ingress was noted to open areas of the remaining roofs, and may be advisable to install covers to protect the integrity of the structure. Significant fire damage to purlins within roofs F,G,H will render their structural reuse not possible, but may be adequate for the support of temporary sheeting.

**Action** – Install temporary waterproof sheeting above roofs E,F,G,H (Rating D2)

Full re-roofing and reconstruction of structure will be required subject to decisions on works to structures below. (Rating D3 - budget)
