# 8 Dispensary Row

## Heritage Impact Assessment and Design Access Statement

Rev A - January 2022

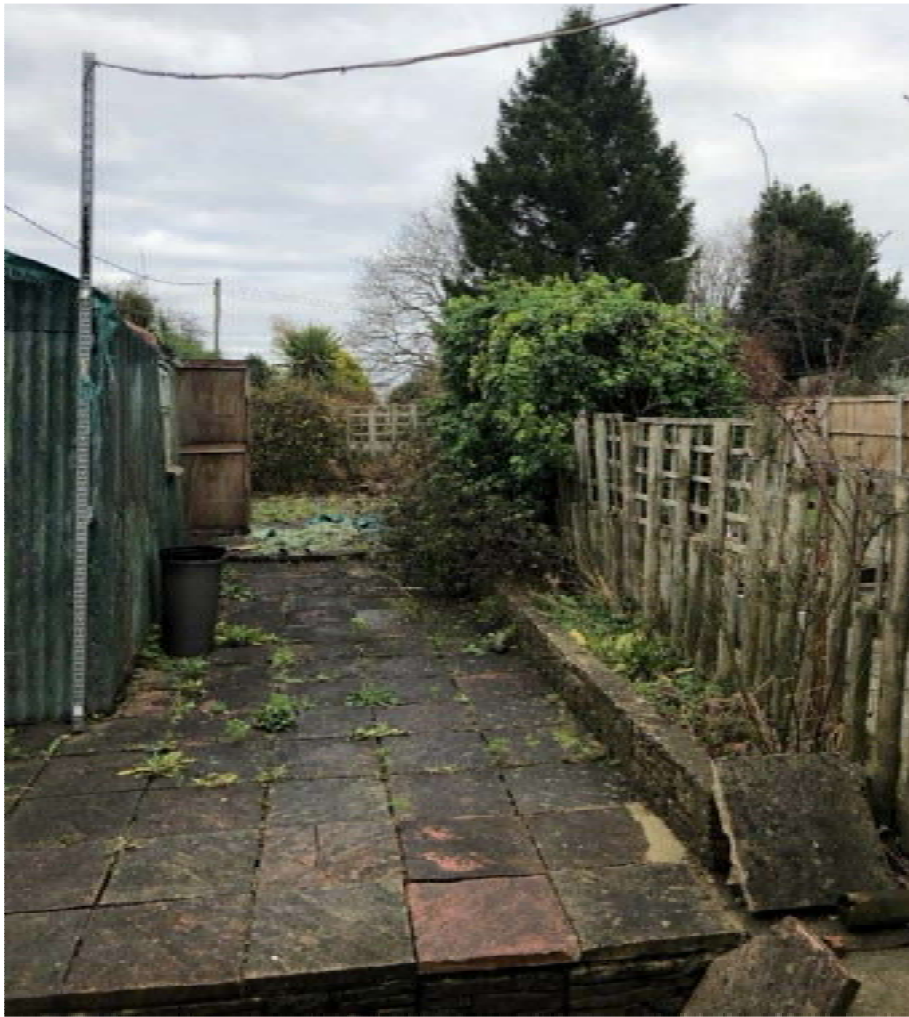
6

Garden

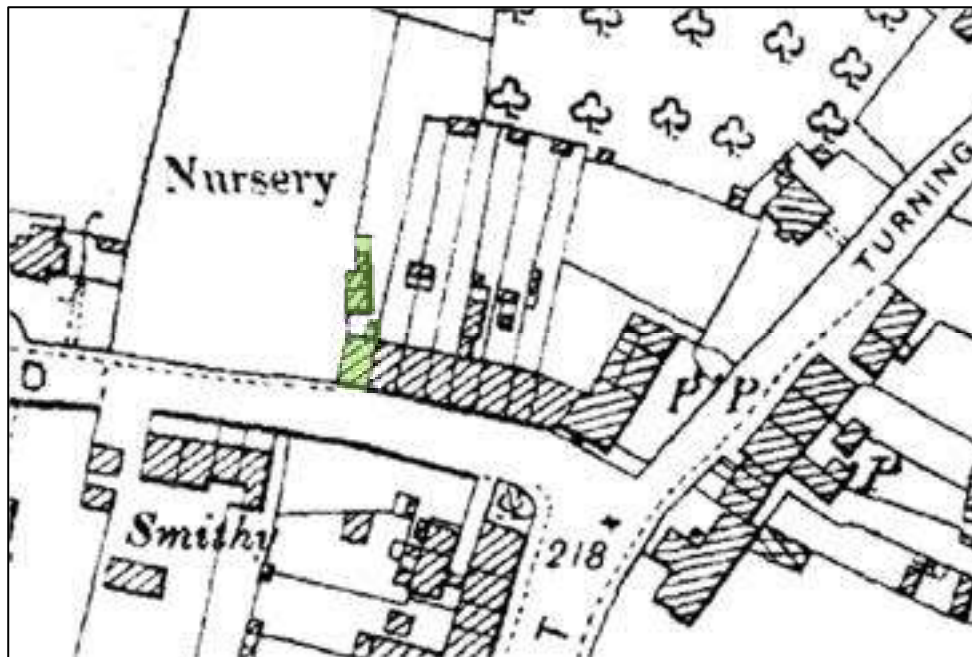
Figure 1:  
1890 OS Map

Historic maps show the presence of outbuildings in the same location as the current, and it appears that the footprints are roughly similar to the early records (see figures 1, 2 and 3 below).
