# Asbestos Demolition Survey

The Moreton Inn  
Ruabon Road  
Johnstown  
Ruabon  
Wrexham  
LL14 6PU

Sentinel Environmental Consultancy Ltd  
Unit 17 Gwenfro  
Technology Park  
Wrexham  
LL13 7YP

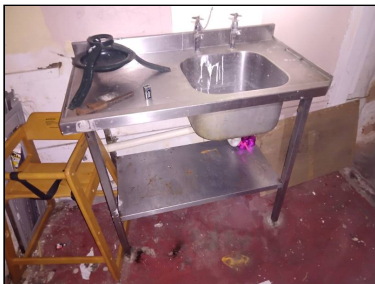
| | 2 Feb 2022 to 3 Feb 2022 | Luke Jones | Demolition Survey | Ground Floor | No Asbestos Detected |

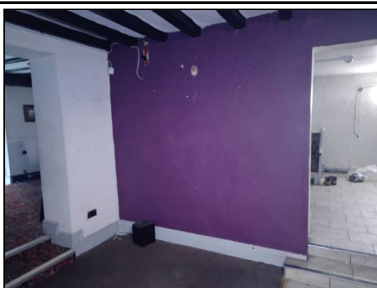
| | Survey Date: | Lead Surveyor | Survey Type | Floor | Analysis |
|---|---|---|---|---|---|
| Surveyor comments | adhesive present to tile and floor, located to bar entrance | | | | |

| | 2 Feb 2022 to 3 Feb 2022 | Luke Jones | Demolition Survey | Ground Floor | No Asbestos Detected |

| | Survey Date: | Lead Surveyor | Survey Type | Floor | Analysis |
|---|---|---|---|---|---|
| Recommended action | Remove | | | | |

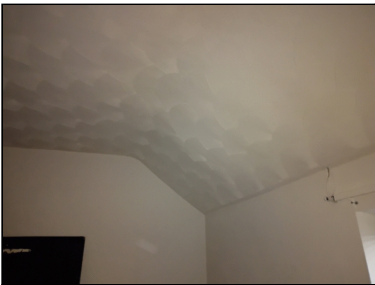
| Surveyor comments | | no access within, presumed to be present | | | |

| Recommended action | | Inspection Required | | | |

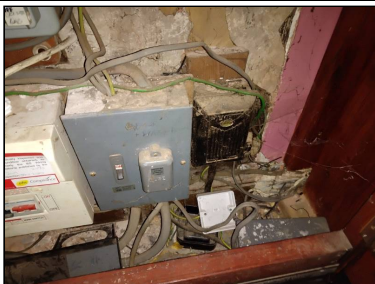
| | Survey Date: | Lead Surveyor | Survey Type | Floor | Analysis |
|---|---|---|---|---|---|
| | 2 Feb 2022 to 3 Feb 2022 | Luke Jones | Demolition Survey | 1st Floor | Chrysotile (1) |

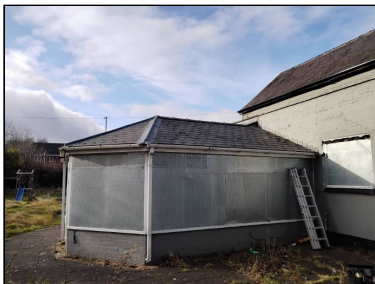
| | 2 Feb 2022 to 3 Feb 2022 | Luke Jones | Demolition Survey | External | Chrysotile (1) |

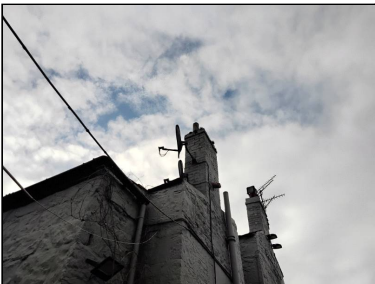
| | Survey Date: | Lead Surveyor | Survey Type | Floor | Analysis |
|---|---|---|---|---|---|
| | 2 Feb 2022 to 3 Feb 2022 | Luke Jones | Demolition Survey | External | Chrysotile (1) |
