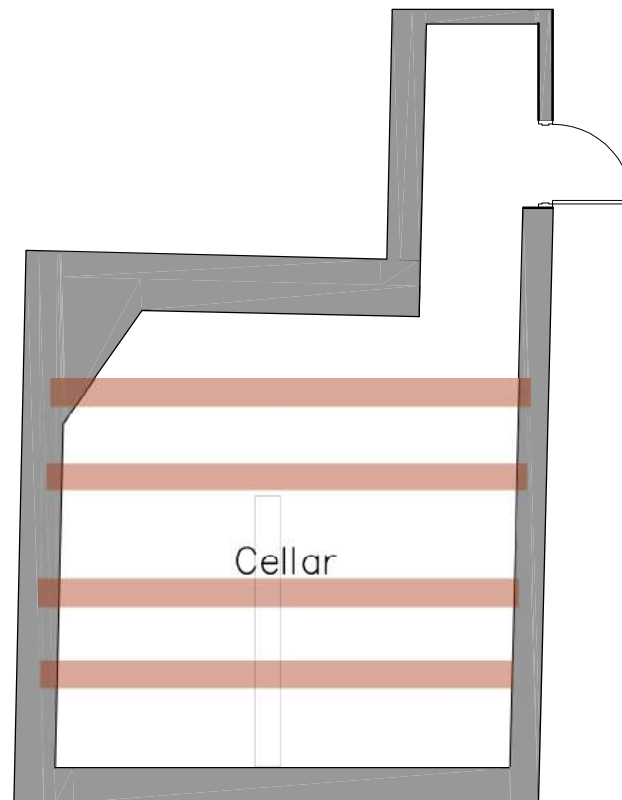
Extent of wall that has already been removed and needs to be rebuilt. Note front facing brick differs from backing brick. Install stainless steel ties between inner and outer masonry.

Approximate extent of wall that has disturbed / loose masonry. Carefully dismantle, clean bricks, fit onto covered palates until needed and then rebuild wall as upper masonry.

Original wall to be retained. Outer facing brick to be tied to inner masonry using stainless steel ties. Check bed coursing to see if it matches. May need to drill and anchor ties into inner brickwork.

1. All replacement mortar to be sand lime mix ideally hot lime based.
2. All new vousoir arched lintels to match existing.
3. Whole of retained wall to be raked out (partially complete) and then repointed using lime based mortar. Conservation officer to comment on the need for replacement tuck pointing.

4. Check verticality of each wall then tie wall to each floor / roof plane using stainless steel ties.
5. All timber structure taking support from the external walls to be microdrill checked to confirm suitability.

6. There is little evidence of foundation movement but existing footings to be checked by excavation of trial pits if not already undertaken.
7. Cement based stucco to string courses and just above ground level to be reapplied as a lime based / render. See architect's specification

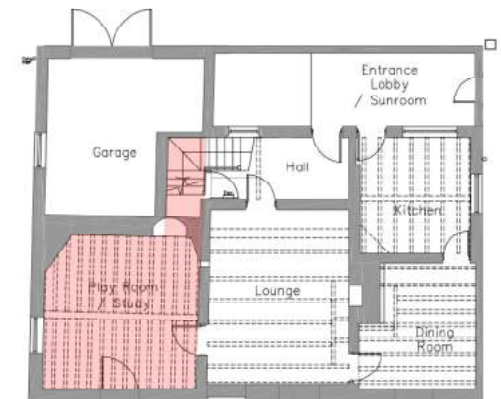
Approximate extent of wall that has disturbed / loose masonry. Carefully dismantle, clean bricks, fit onto covered palates until needed and then rebuild wall as upper masonry.

Original wall to be retained. Locally rake out loose mortar and repoint as necessary particularly in area of former RWPs.

Extent of wall that will be disturbed when the garage beam is replaced. Allow for replacement. Where stepped cracked masonry occur above this zone fix helibars in bed joints
