Historic Building Recording at

# LOWER FARM BOWLING BANK

Planning App: P/2021/0604

Doc Ref: LP4028C-HBR-v1.1

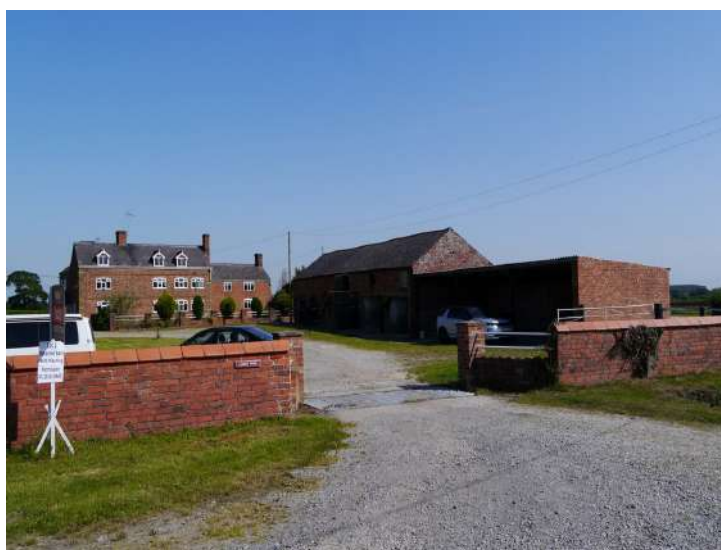
Plate 1 - General shot in context

- 6.3.1. The building is located directly north of Lower Farm Road, part of a series of similar agricultural buildings including a dwelling, set within a large open forecourt and comparatively level plain site, which presents extensive vistas over the surrounding agricultural landscape (PLATE 1).
- 6.3.2. The complex sits on a north-west to south-east axis with access into each floor level made via the south-west elevation. The fabric consists primarily of brick and mortar with timber framing, and a pitch slate gable rooftop with plain ceramic ridge tiles (PLATE 2).
- 6.3.3. The brick course is of english garden wall style, and although generally uniform breaks in formation can be seen, with random rows of stretchers between each row of headers.

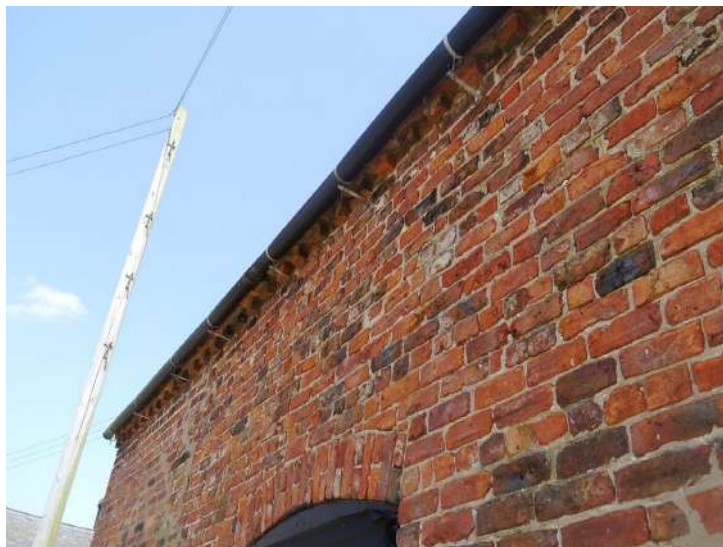
Plate 4 - Dentil top course south- west elevation

- 6.3.4. The south-west elevation functioned as the front facade and main access point into the building (PLATE 3). Protruding brick end top coursing decorated in dentil fashion, were featured below the slate roofline (PLATE 4).
- 6.3.5. Three wide barn doorways were evident along the south-west elevation. One located on the far north-west end of the facade, and two adjacent another

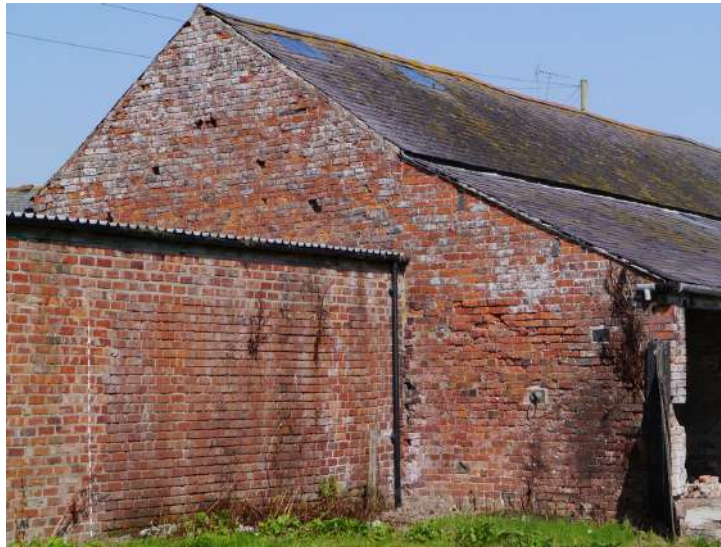
Plate 8 - South-west elevation

- 6.3.13. Ghosting of a previous building marked the south-east elevation wall, which appeared to have resembled a pitched roof. Timber beam slot holes chased the impression in a triangular fashion, further indicating an earlier structure (PLATE 8).

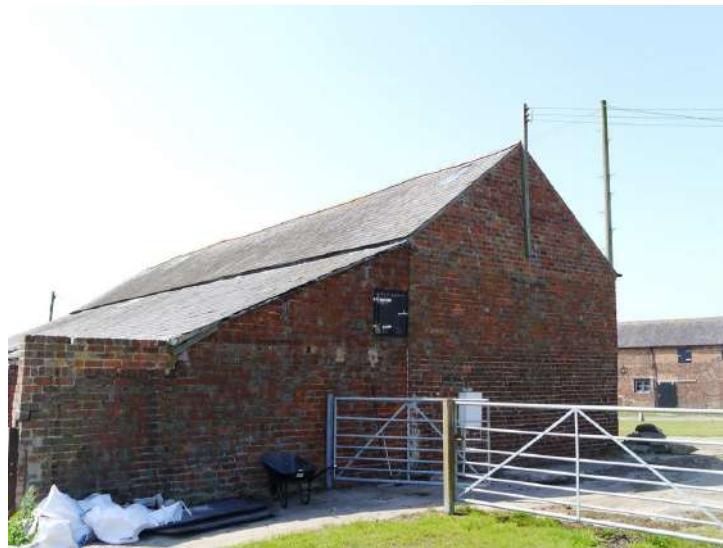
Plate 9 - North-west elevation

- 6.3.18. The gable end was fashioned in english garden wall bond, with rows of stretchers between each row of headers (PLATE 9).
- 6.3.19. An earlier rectangular shaped opening, located on the lower left corner of the wall, had been bricked up during the time of survey (PLATE 10). The feature would have presented an open void into room B5. A modern gas box meter was fused against the bricked feature.

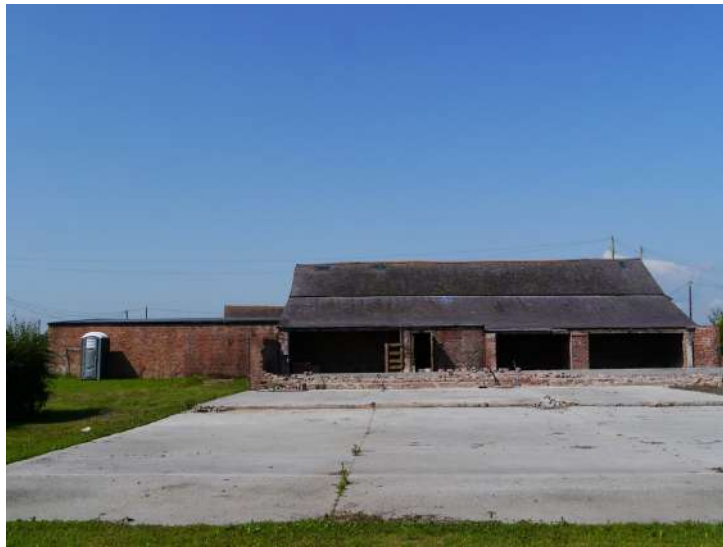
Plate 11 - North-east elevation

6.3.26. The extent of the north-east elevation comprised of a later extension phase, which consisted of three large open planned barns and one internal barn accessed via a single doorway (PLATE 11).

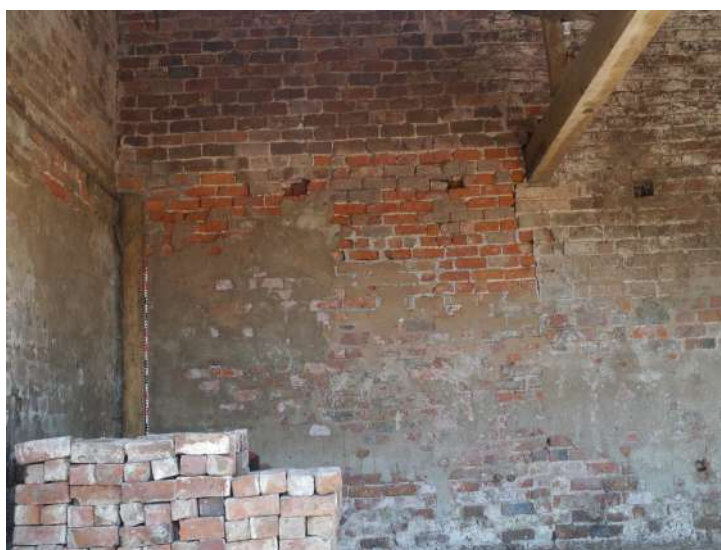
6.4.27. Possible reconstruction work was evident to the south-west wall near where an interruption to the brick bond arrangement had been chased by a discolouration in mortar (PLATE 22). May have originally been an open threshold into room B9.

Plate 22 - South-west reconstruction wall room B4

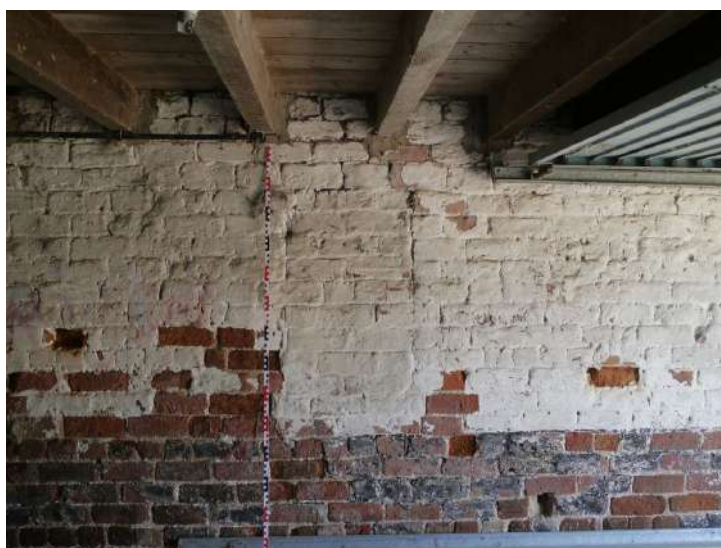
later stage. Originally, the feature would have created an open window between room B5 and the adjacent room B6 (PLATE 24). Possibly an air ventilation system or feeding bay.

Plate 24 - Sealed air ventilation feature north-west elevation room B5

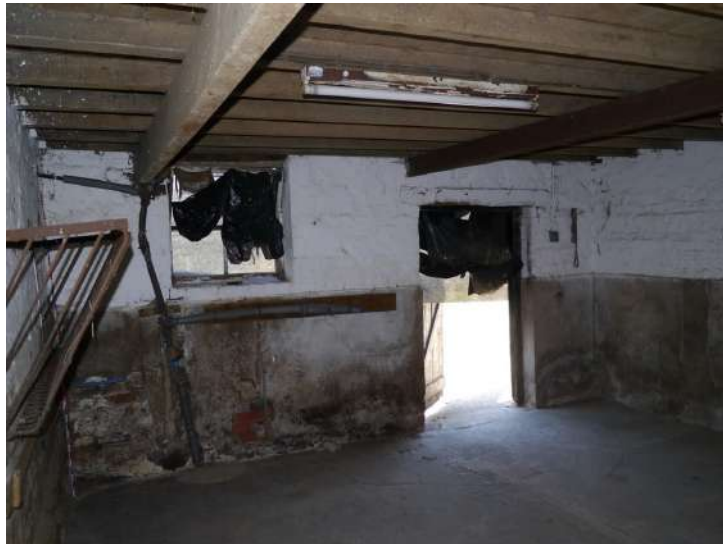
6.4.38. A later phase of reconstruction was evident where a central positioned steel joist, and south-east positioned modern timber framed joist, fused to the north-east and south-west elevation walls (PLATE 25). A series of modern timber framed hanging beams positioned in a north-west to south-east alignment above the steel and timber joists, were fused either end into the north-west and

Plate 25 - Threshold and Window on south-west elevation in room B6

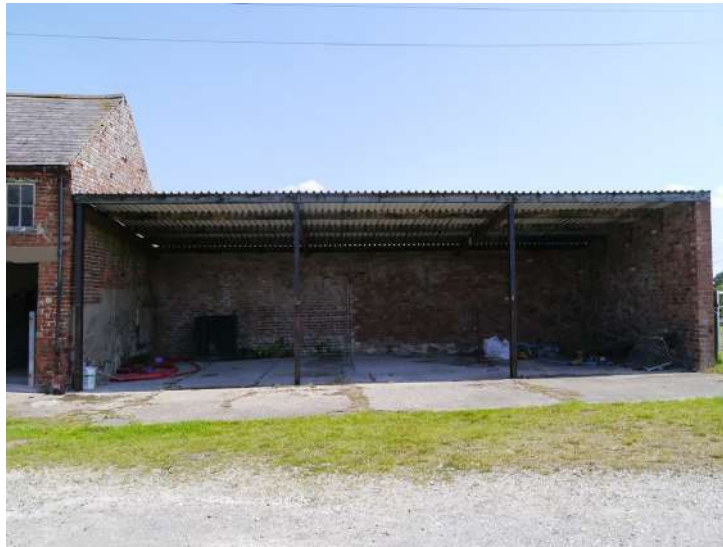
Plate 32 - Room B10

6.4.62. B10 was a contemporary addition, completely open with exposed steel supporting beams which held up the corrugated metal roof sheeting. The roof gradually sloped north-eastwardly towards the ridge of the north-east brick wall (PLATE 32).

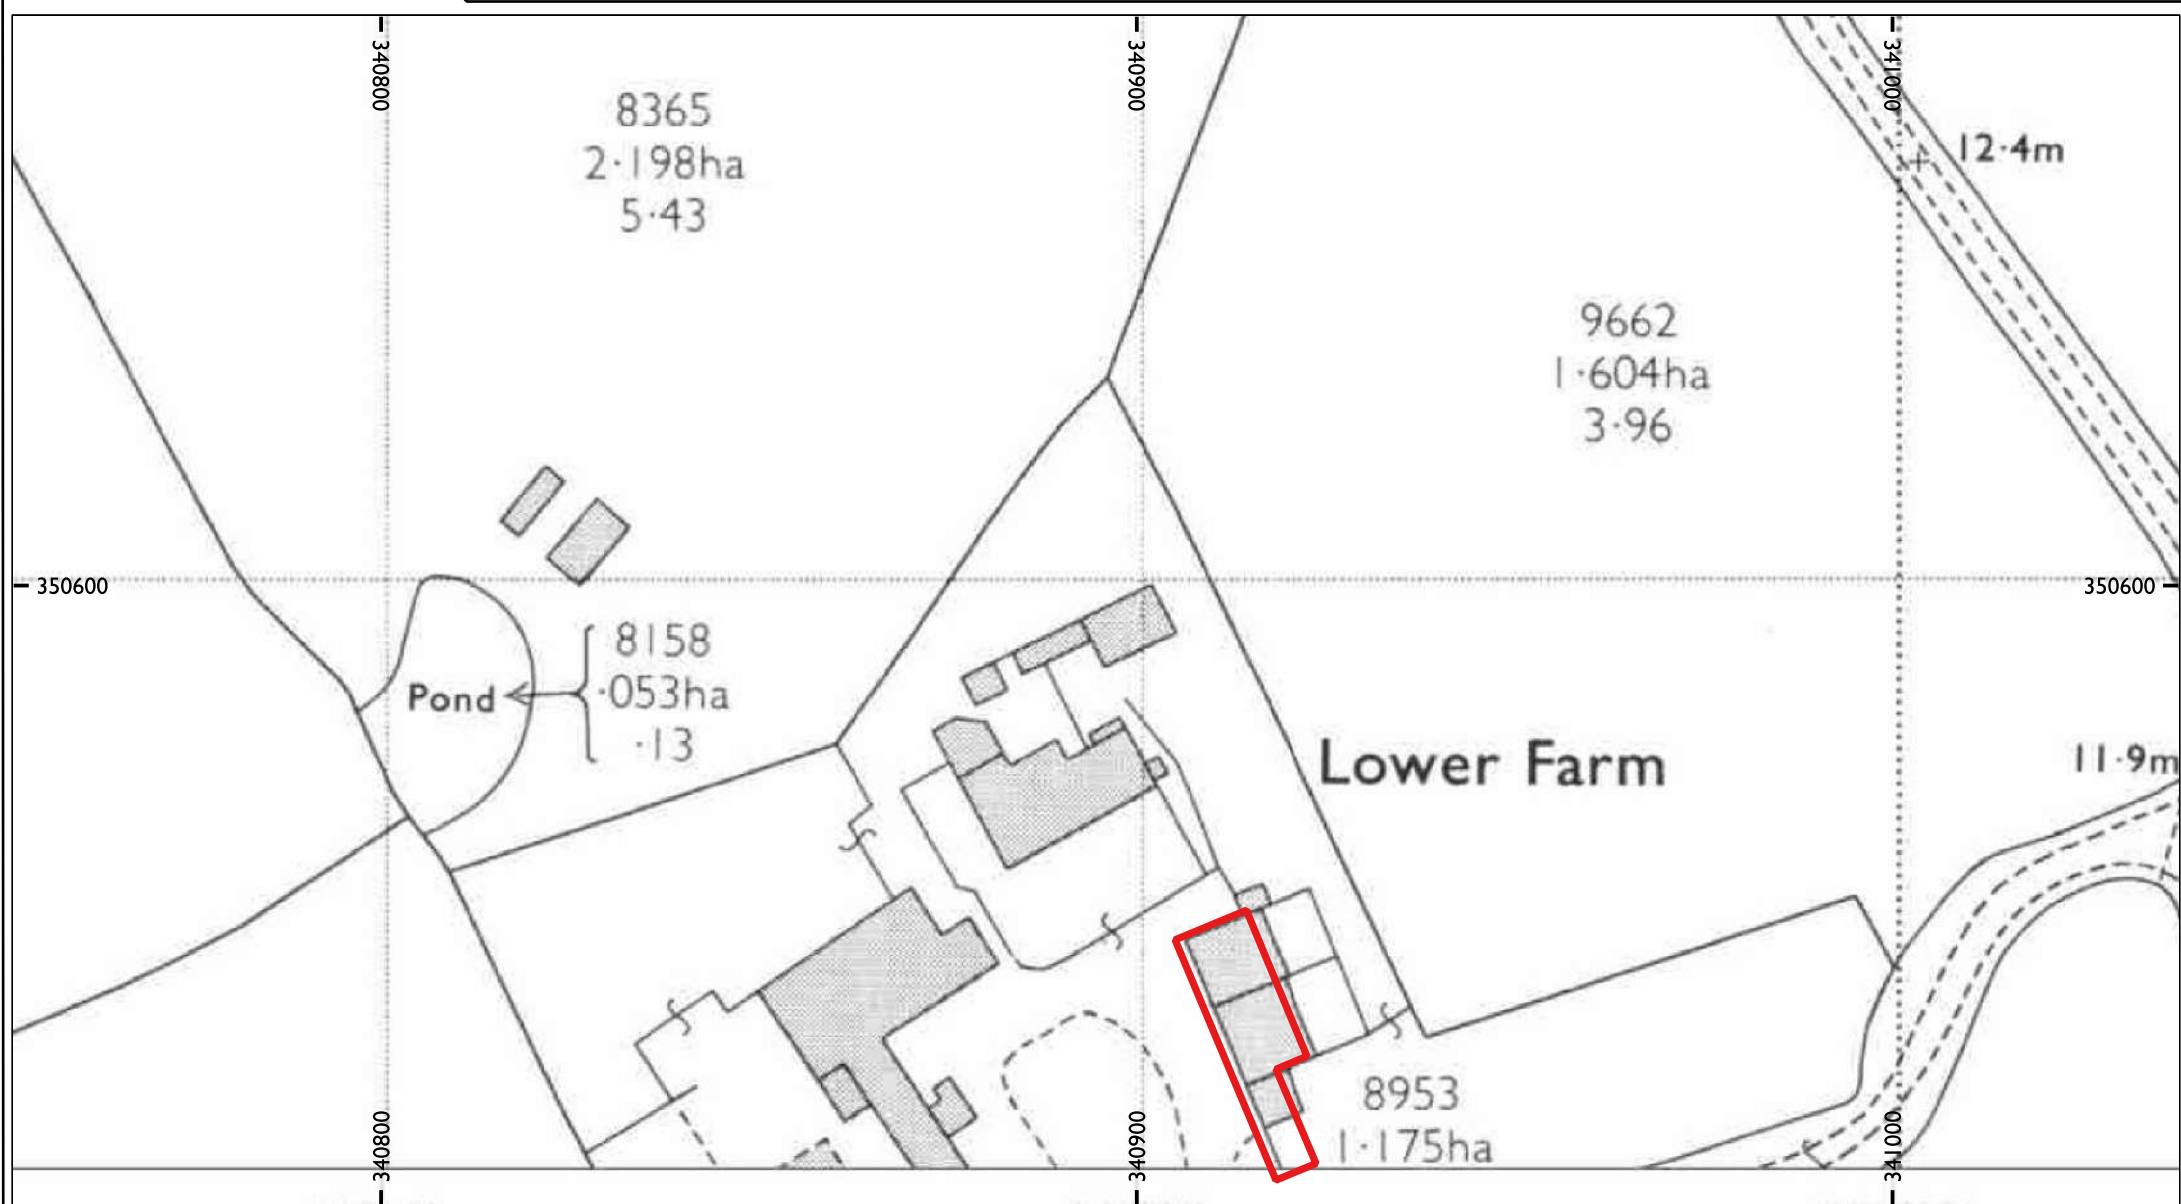
FIGURE 11 // 1970 OS Map

- 4.1.7. The 1970 OS Map edition (FIGURE 11) depicts a small extension to the north most corner of the complex, and another extension on the south most corner. The south-east expansion had been extended further in the 1993 OS Map (FIGURE 13), while another rectangular complex appears to the north-east, parallel to the barn building, where it is seen on the 2001 OS Map (FIGURE 14).

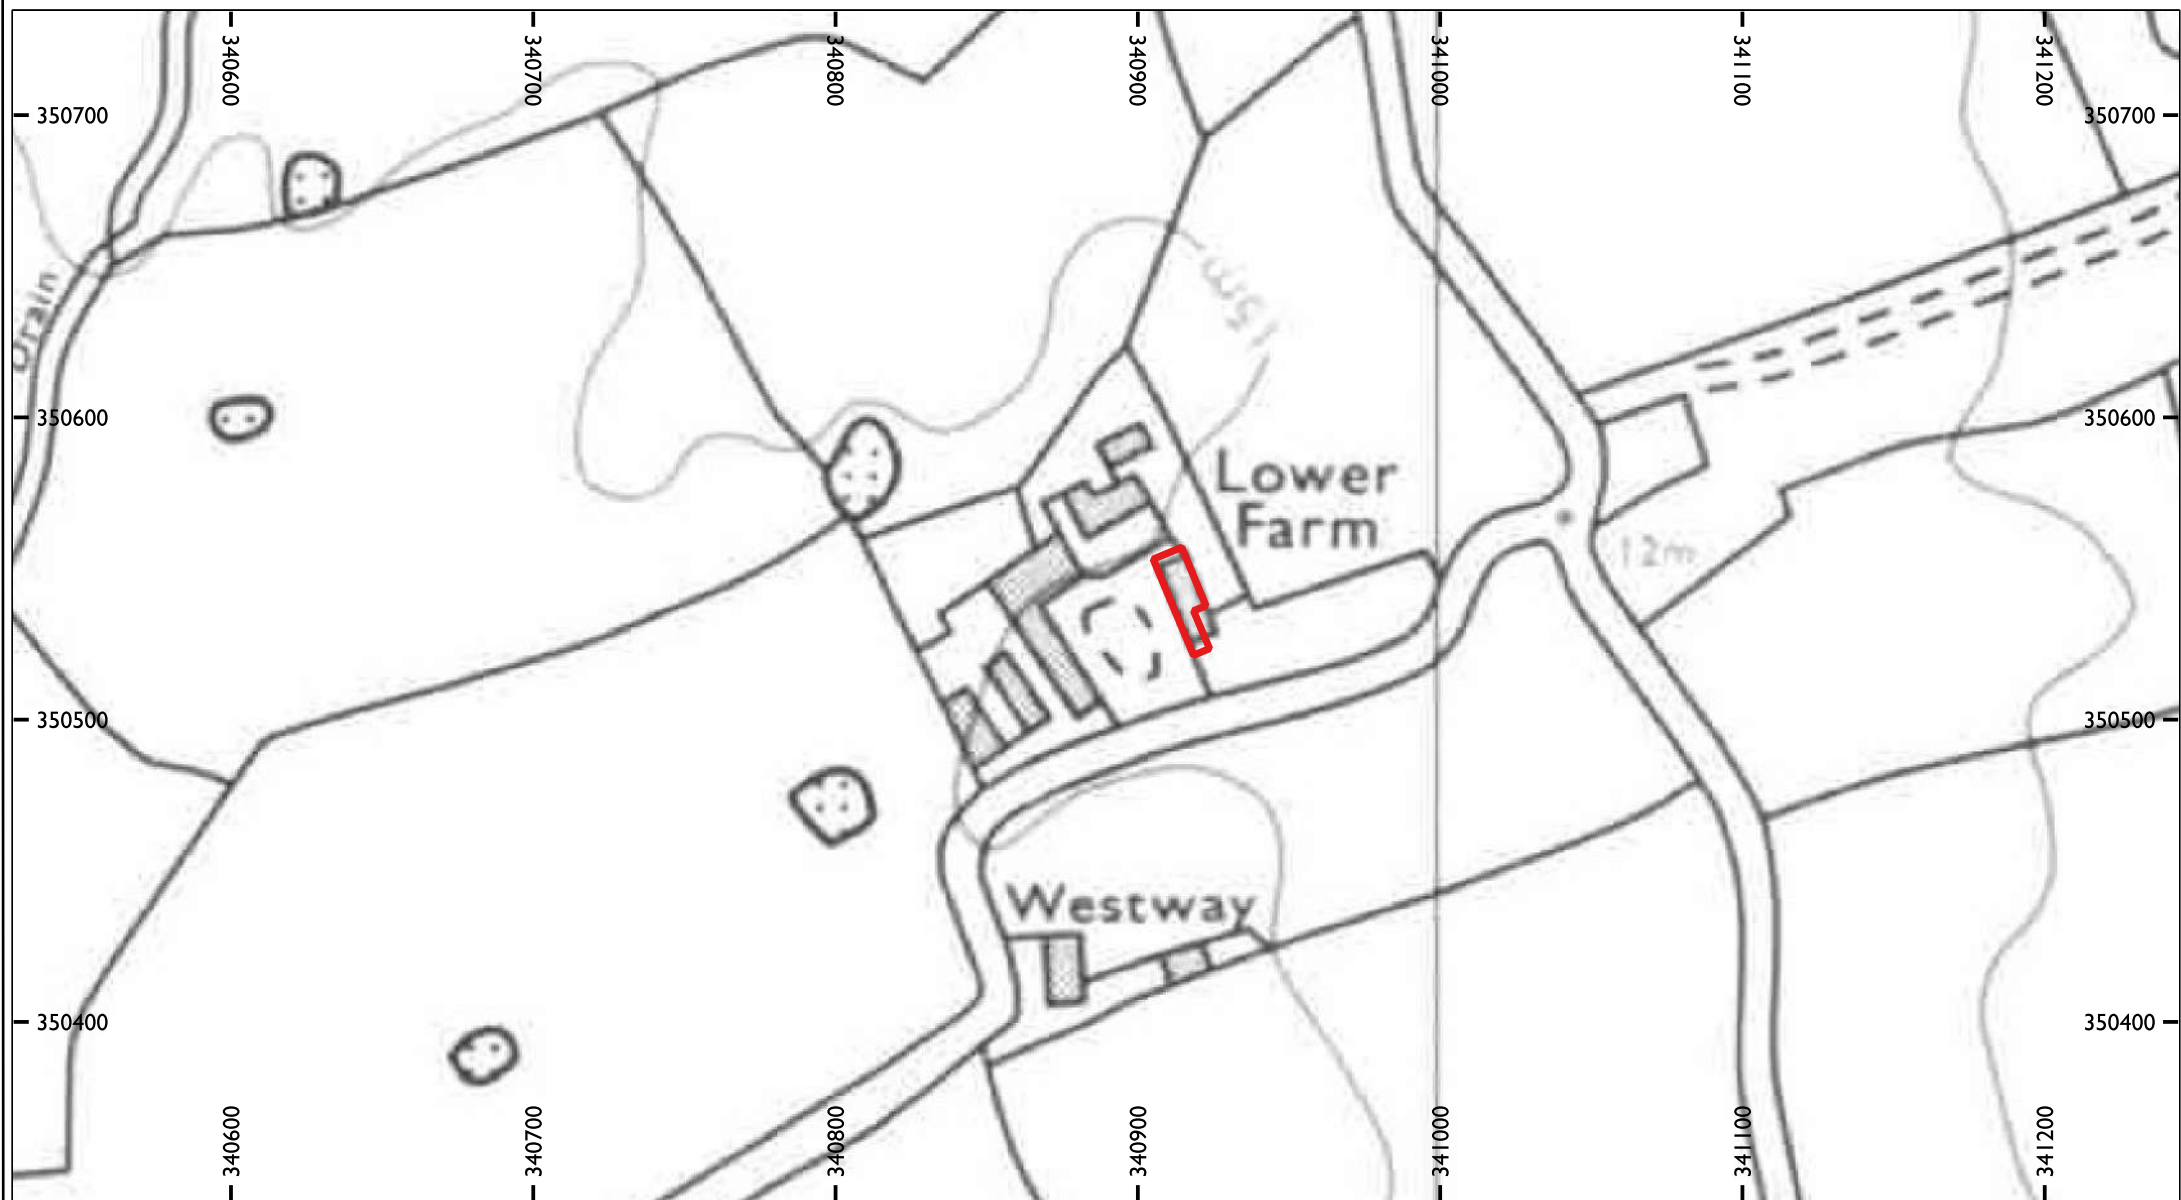
FIGURE 12 // 1976 OS Map

- 4.1.8. During the time of survey, the 1970 and 1976 (FIGURE 12) expansions, including the 1993 building to the north-east, were absent, while the main 1843 illustrated building complex was present.
